**PICKERING BECK FAS**

**TRIAL TRENCHING & WATCHING BRIEF**

**PICKERING BECK, BLANSBY PARK LANE,**

**FINAL REPORT**  
Report number 2014/62

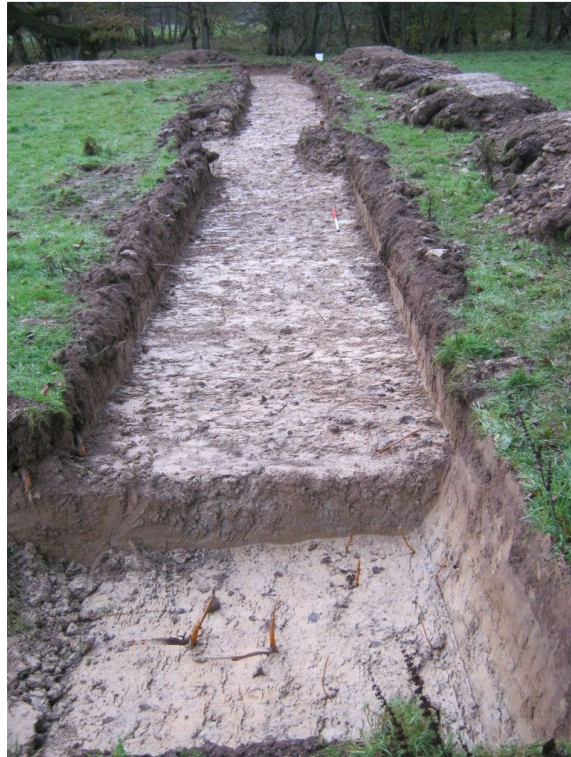
The earliest deposit encountered was undisturbed natural sandy clays (1002) at c.300mm Below Ground Level (BGL). This was overlain by c.150mm of yellowy grey silty clay sand subsoil (1001) and then a further c.150mm of soft greyish brown topsoil.

*Plate 1 Trench 1 looking west*

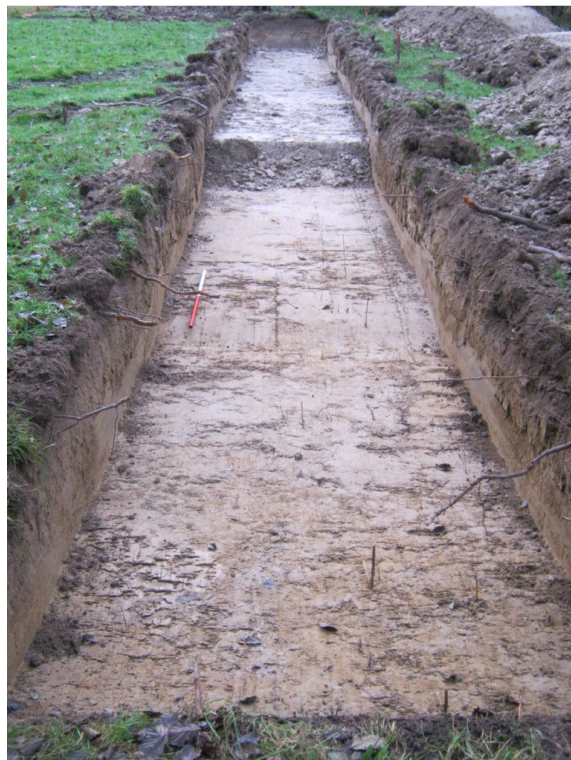
The archaeology within Trench 2 was similar to that found in Trench one. In this instance natural deposits (2002) were encountered at a slightly deeper c.400mm BGL, the subsoil (2001) was c.220mm deep, and topsoil (2000) was c.180mm deep. In general the deposits were more sandy, which may be linked with being slightly closer to the tree canopy and stream channel.

Roughly central to the trench a ceramic land drain (2003) was cutting into natural, running nne-ssw towards the stream.

*Plate 2 Trench 2 looking west*

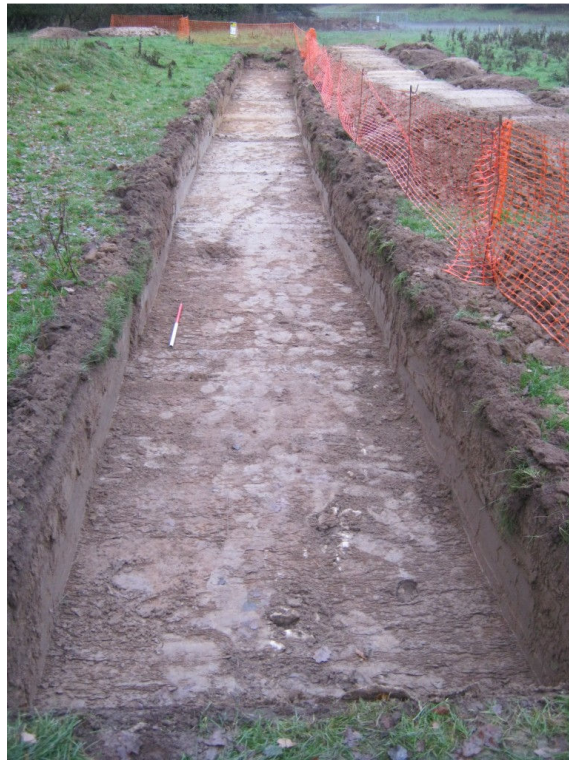
Within Trench 3 the natural clay deposits (3002) gradually sloped down from the east to the west, following the slope visible at ground level, though natural deposits were c.450mm BGL along this profile.

Plate 3 Trench 3 looking east

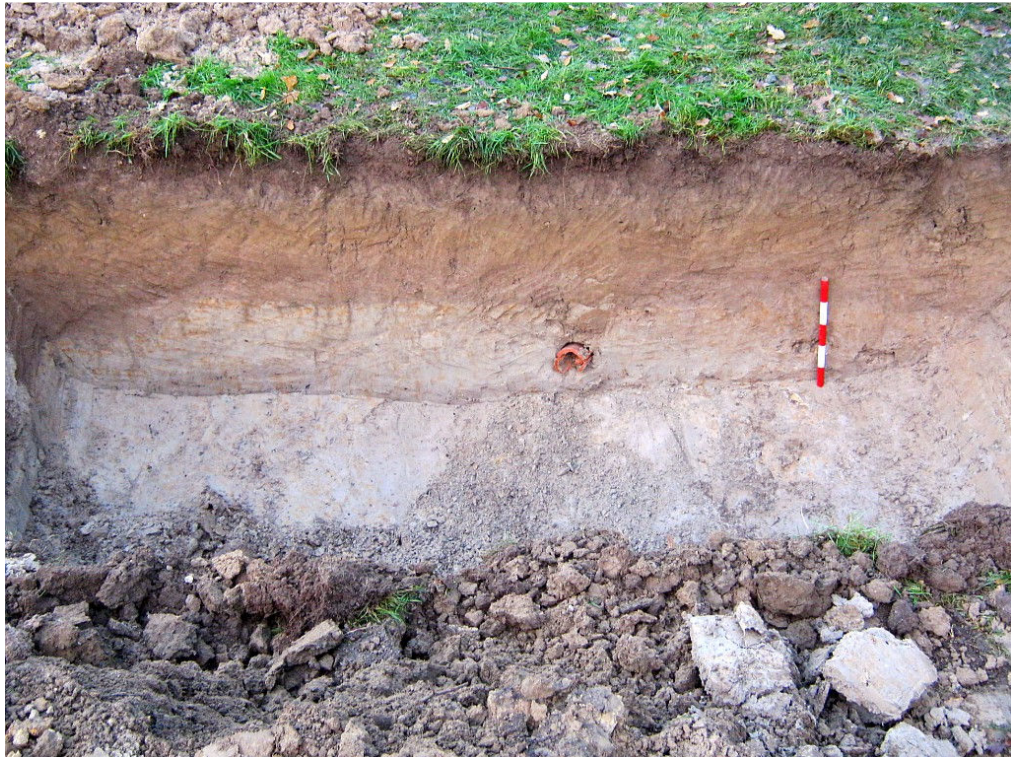
A more pronounced slope was visible for the last c.6m at the western end of the trench, possibly a natural hollow which previously existed. This hollow had been infilled (3005) with orangey brown sandy silt which contained fragments of tile and pot from the 19<sup>th</sup> century. The previous buried topsoil was visible at the base of this deposit, but was not assigned a new number. This hollow, or the further slope at its southern edge (visible on the section), may be linked with a field boundary which is visible on the late 19<sup>th</sup> century map of the area.

At the western end of the trench, cutting through the infilling, three separate land drains were encountered. These were aligned approximately east-west, running towards the southern curve of Pickering Beck to the east. Two of the drains (3003 & 3006) were ceramic, whilst one (3004) was constructed using a fill of limestone rubble.

Plate 3 Trench 3 sondage east facing section

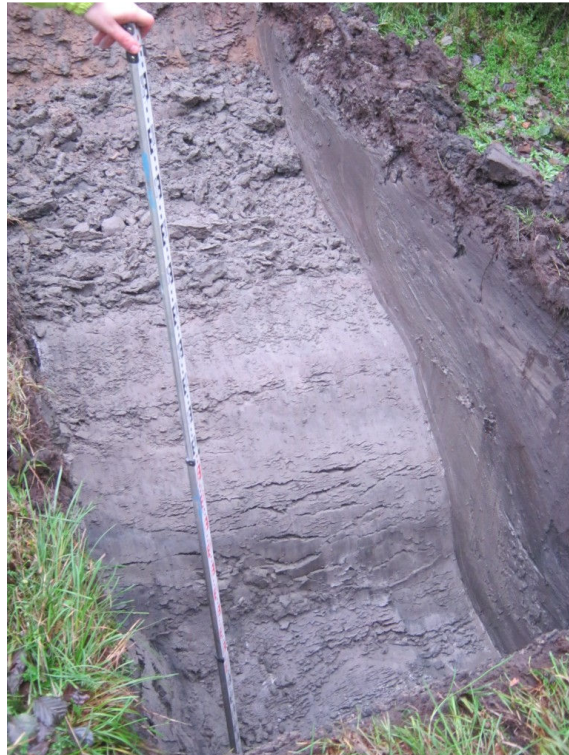
In excavating the trial pit it was possible to discern a former line of Pickering Beck. On the eastern side of the pit the steep slope of the former stream channel was indicated by a

buried soil which was similar to the soils seen on the banks over the rest of the site. The fill of the stream channel was made up of grey and yellow silty sands overlain by what looked like deliberate infilling in the uppermost deposits. These upper deposits contained stone and tile of 19<sup>th</sup> century or later date, nothing was retained.

*Plate 6 Trial Pit looking east*

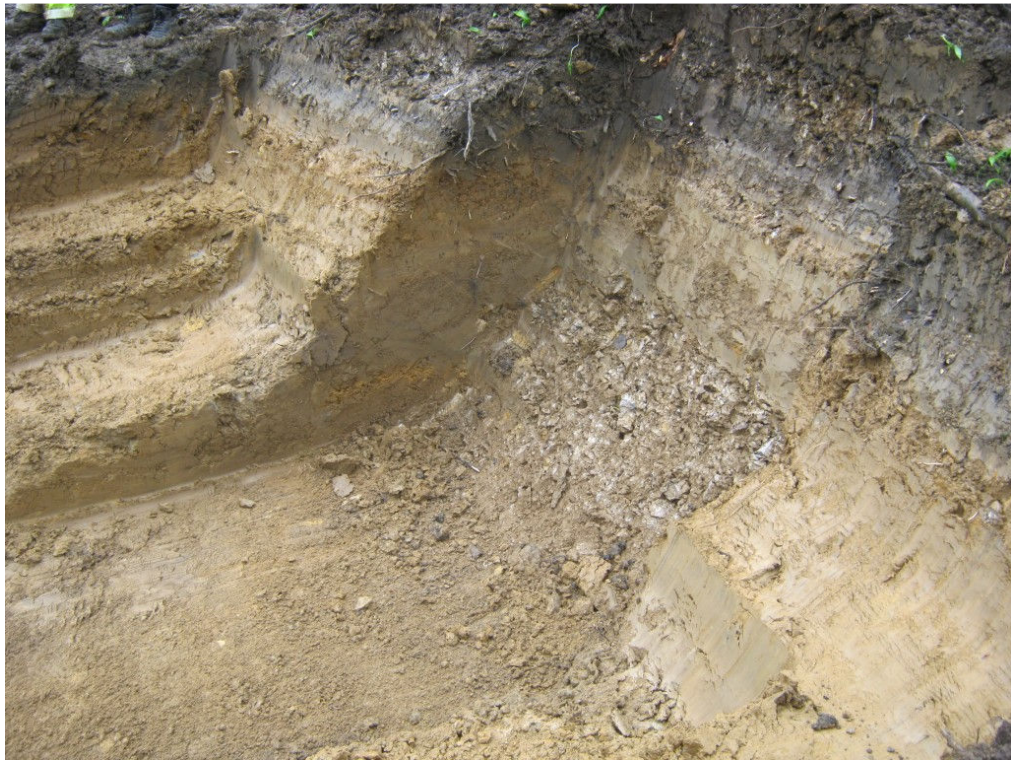
At the terminal end of the key trench the uppermost topsoil had been stripped in advance of the work, but no clear features were seen in the stripped area. As excavation continued into the deeper deposits the colluvial material from the southern slope of the valley was easily identified. There were no archaeological deposits associated with or sealed by this material (plate 7).

*Plate 7 Watching brief colluvial deposits facing south-east*

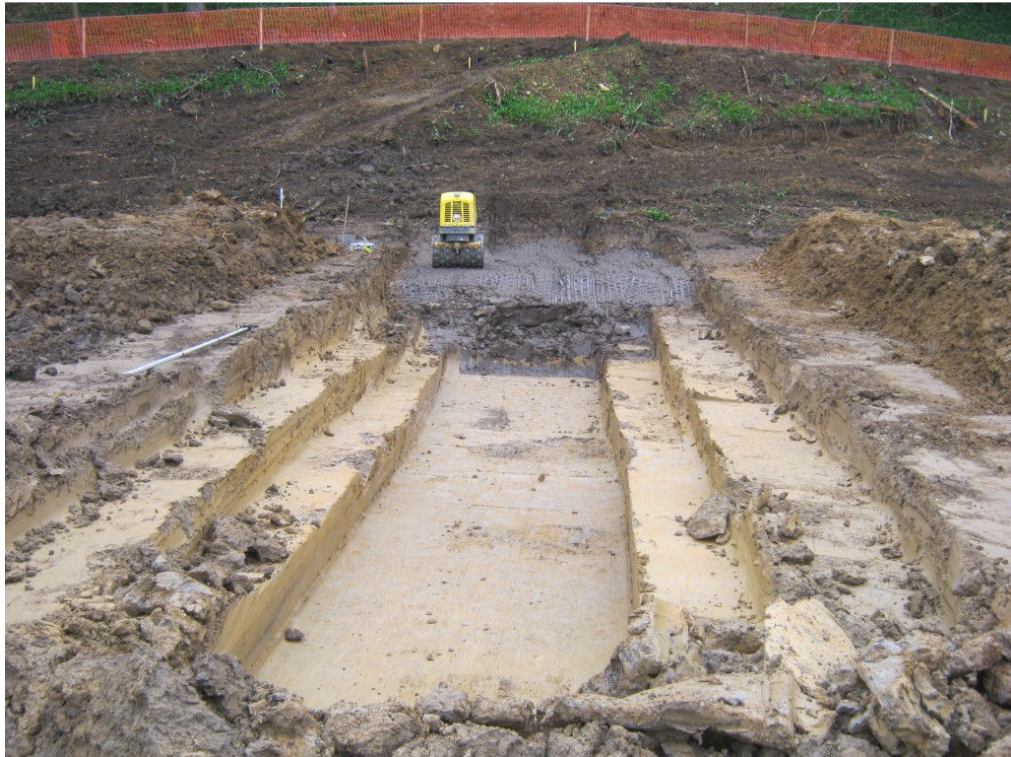
Further away from the valley side a single possible pit/ditch was backfilled with material that contained no dating evidence. A single 20<sup>th</sup> century was also observed in the trench section. However these were isolated features in undisturbed natural clay (plate 8)

*Plate 8 Watching brief natural clays & key trench profile facing south-west*
