**ARCHAEOLOGICAL WATCHING BRIEF AT  
NEWGATE MARKET, YORK**

*WATCHING BRIEF REPORT*

Report Number 2014/04    January 2014

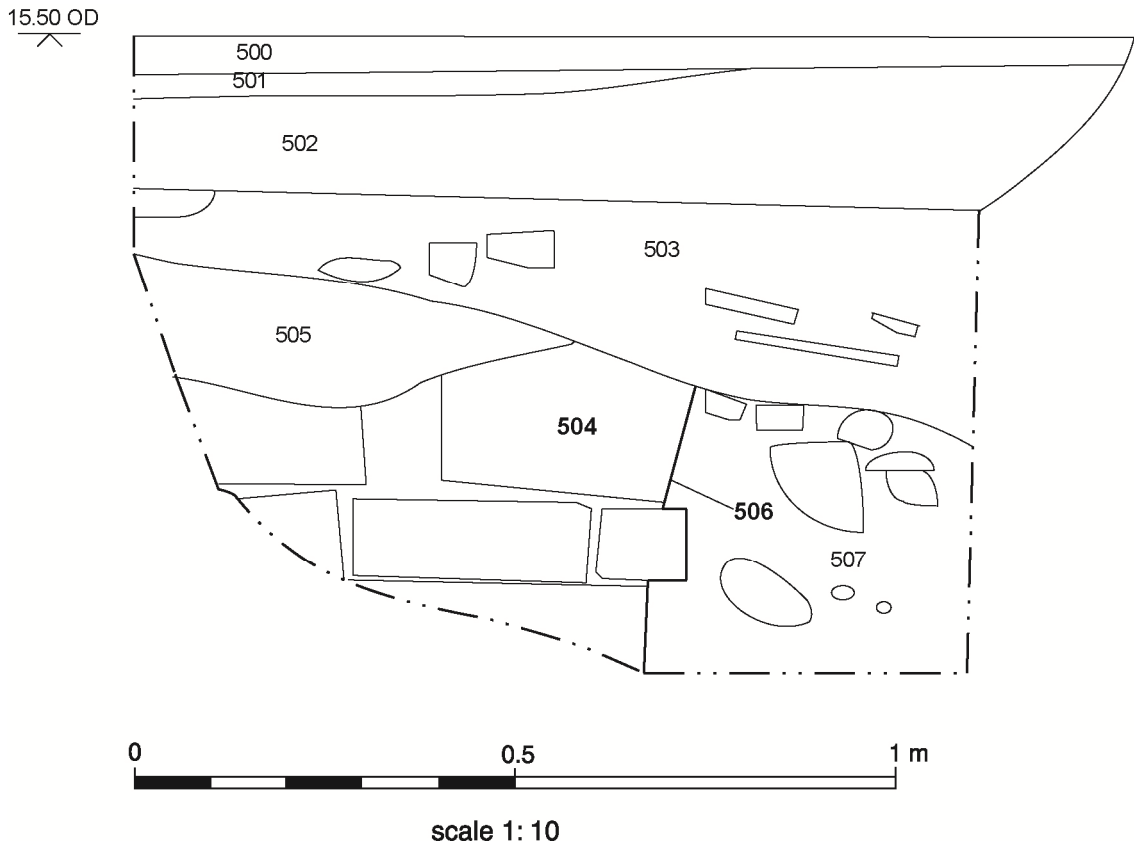
Figure 6 north-west facing section of Trench 5.

course black sand and gravel extended across the trench. Beneath (502) a demolition deposit (503) extended across most of the trench. After excavation it was determined to be thicker towards the south, with a maximum thickness of 0.31m. This deposit contained very modern material and is likely to be related to the redevelopment of the area in 1955. After the removal of (503) the cut (508) of a NE-SW running drainage trench became visible at 0.25m below ground level, this trench cut was 0.6m wide. The backfill (509) was excavated down to a depth of 0.84m below ground level on the eastern side of the drainage pipe. On the western side it was excavated down to a depth of 0.64m below ground level. The ceramic drainage pipe was 260mm in diameter, the top of which was 0.64m below ground level. Context (508) cut through a waste deposit (507). Trench conditions were poor and (507) was only recorded in section. It was 0.46m deep, there were no finds recovered. This deposit is the fill of a cut (506) that was, again, only visible in section. The cut had vertical sides and its base extended beneath the limit of excavation. It is possible that the cut (506) is a robber cut to remove material from a NE-SW running limestone wall (504). The construction cut for the wall was not visible due to it being outside the limit of excavation and due to truncation by (508) and (506). The material backfilling the cut though, was evident. A yellowish-white silty sand and sub angular limestone mix (505) was packed against the wall. The wall (504) was only visible in the NW facing section as it ran parallel but underneath the limit of excavation on the south east side of the trench. The wall was composed of well dressed substantial limestone blocks. Wall (504) was bonded to an earlier limestone wall footing (510) that ran approximately north-south. Only a small fragment of this structure was visible within the trench. This footing was laid onto a construction horizon (511), again only a small amount of this material was visible given the confines of the trench.

Trench 5 demonstrated much of the activity within Newgate in a very small area. The very modern demolition deposit (503) related to the areas redevelopment in the 20<sup>th</sup> century. The drainage pipe trench (508) representing the areas use in the 19<sup>th</sup> century as tenement housing with improved drainage. Despite only being visible in section wall (504) was perhaps the most important feature within this trench. It was most likely built out of reused blocks from demolished earlier medieval structures that are known to have existed in the area. This is supported by the recovery of residual late 13<sup>th</sup>-14<sup>th</sup> century pottery sherds and 13<sup>th</sup> to 16<sup>th</sup> century CBM fragments within the backfill of the construction cut for the wall. The wall is on the same alignment as an alleyway leading through to the Shambles and matches up with the alignment of structures known to be in the area based on the 1852 OS map. Without further excavation, wall footing (510) and deposit (511) are very difficult to interpret and date, they are however the earliest remains found within Trench 5, and may represent the only medieval deposits observed on the watching brief.

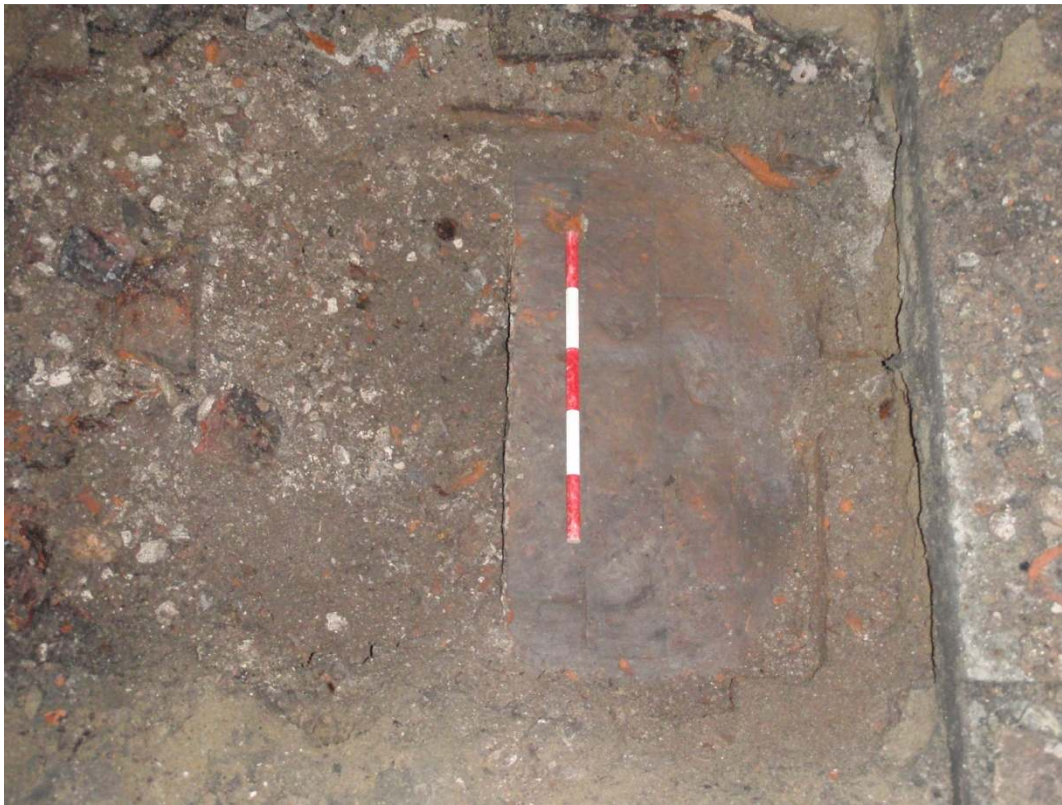
**Plate 1 Floor surface 107, north-east facing, 0.1m scale divisions**

Within trench 1 a sequence of well preserved post medieval layers was observed. Three prior surfaces (104), (107) and (110) indicate the areas constant reuse. Evidence survived to suggest a structure had been present as floor surface (107) was in use but has been removed in antiquity. This is entirely consistent with the known usage of the area as tenement housing until the construction of Newgate market.

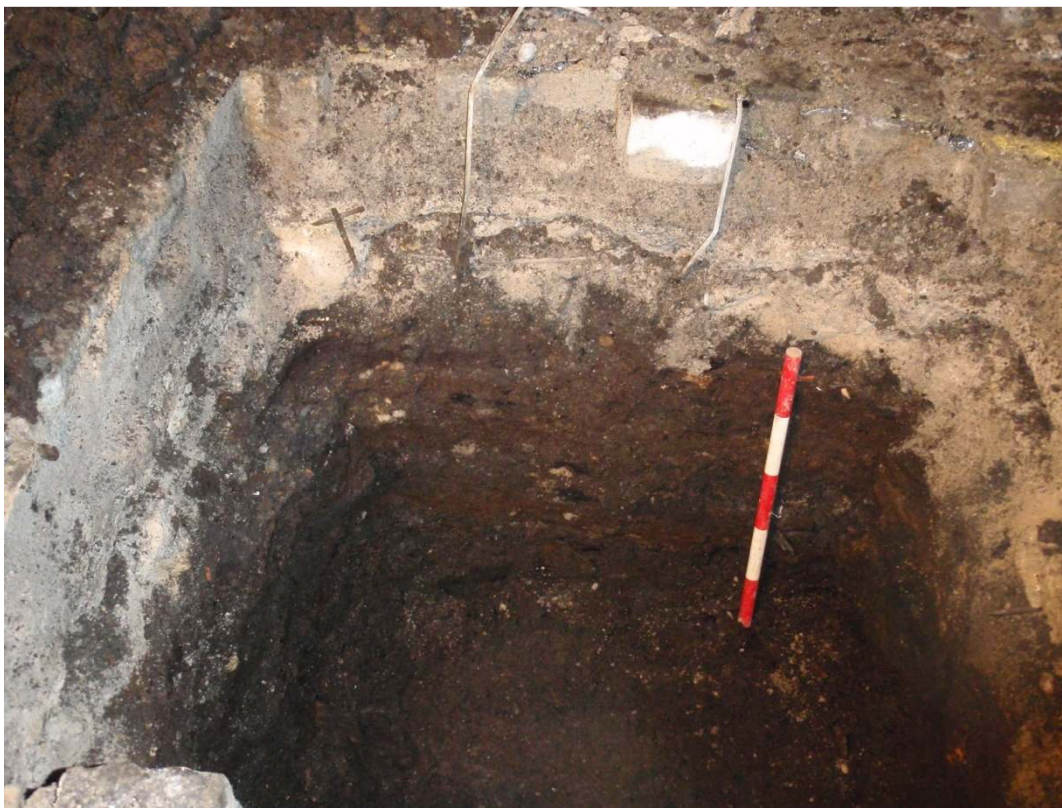
**Plate 2 Section of Trench 2, north-east facing, 0.1m scale divisions**

The existing ground surface consisted of granite sets (200) with a sand & mortar bedding layer (201). Beneath the bedding layer was a 0.16m thick steel reinforced concrete slab (202). Directly underneath the concrete slab, a sequence of clearly stratified dumping and waste deposits was observed. All these deposits extended across the trench and contained a mix of occupation debris (pottery sherds and butchered animal bone) and demolition/construction debris (tile, brick, stone and mortar). A list of deposits is given in Appendix 2. The trench was excavated down to a depth of 0.8m.

Deposit (205) had a high proportion of organic material well preserved within its matrix. Each subsequent deposit below (205) had very well preserved organic material within them. CBM recovered and analysed from deposit (203) & (209) indicated a date range of 13<sup>th</sup> to 16<sup>th</sup> century for the material, see table below. The deposits are likely to be later however with earlier material reused and dumped in later deposits. The well stratified waste deposits within

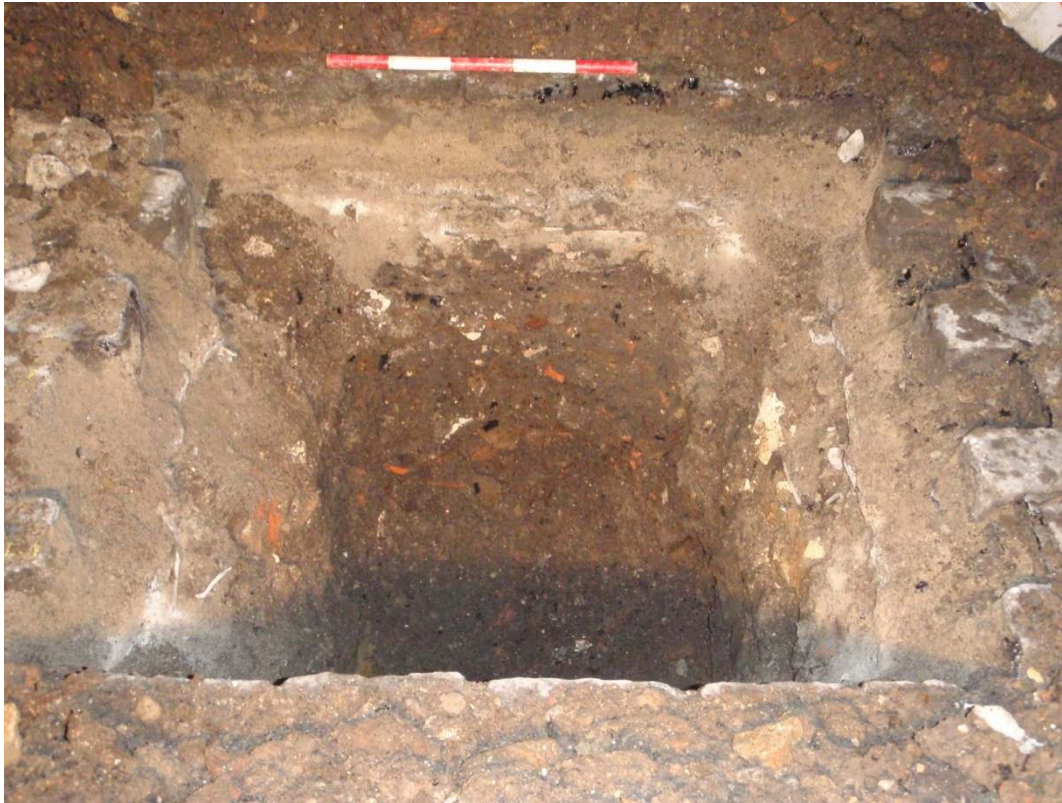
**Plate 3 Section of Trench 3, north-west facing, 0.1m scale divisions**

The existing surface consisted of the same granite sets (300) and a similar bedding layer (301) as Trench 2. In this trench a concrete slab (302) was also encountered and was 0.12m thick. Below this was single homogenous waste deposit (303) that extended across the trench and to the maximum excavation depth of 0.95m. No dating evidence was recovered from this deposit, it is likely to be 19<sup>th</sup> or early 20<sup>th</sup> century in origin however.

The waste deposit (303) beneath the concrete further suggests that this area was used as a waste dump similar to that observed in Trench 2. Unlike Trench 2 (303) is a single deposit, this may be a deposit within a larger cut feature beyond the limit of excavation of the trench.

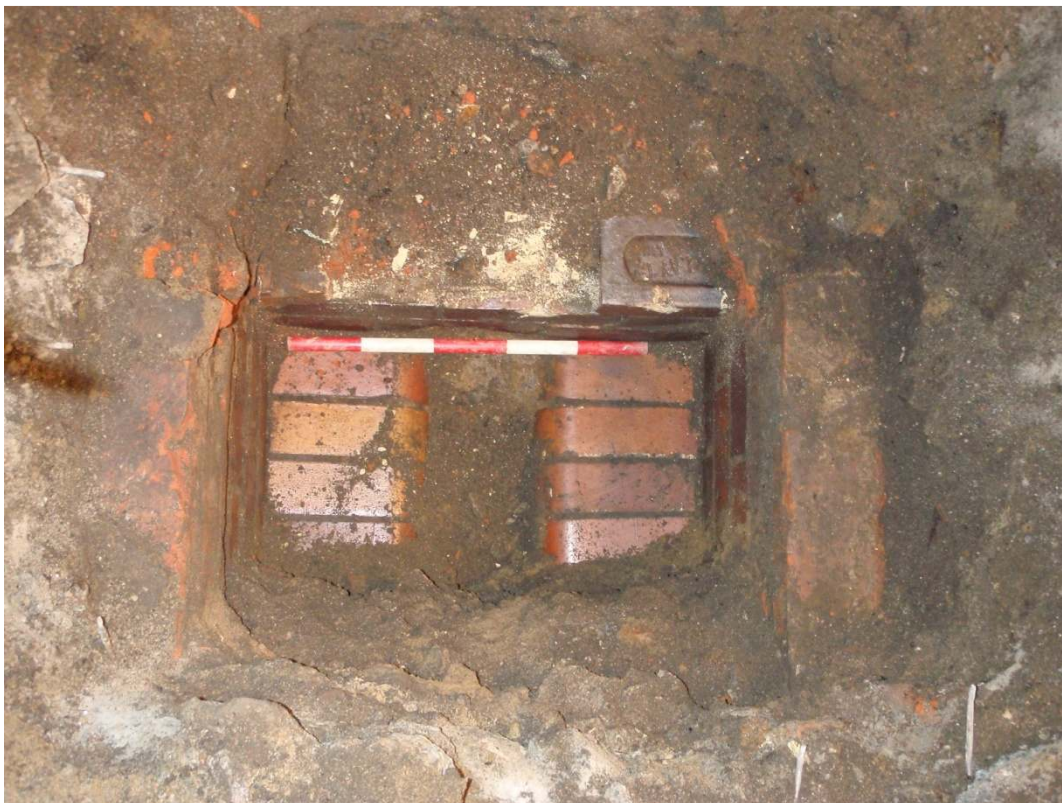
**Plate 4 Vertical view of 404, 0.1m scale divisions**

The existing surface consisted of the same granite sets (400) and a similar bedding layer (401) as Trenches 2 and 3. In this trench a concrete slab (402) was also encountered and was 0.11m thick. Beneath the concrete slab a deposit of demolition debris (405) was evident across the trench. After the removal of 0.1m of this material a square red brick drain inspection chamber (404) was observed, having been backfilled by the same deposit (405). The chamber was 0.8m long and 0.4m wide in plan, with three sides visible within the trench. Exterior to the chamber a deposit of demolition material (403) backfilled the construction cut for the chamber which was not within the limit of excavation. Context (403) was excavated to a thickness of 0.38m but continued on. After the removal of the material (405) backfilling the chamber, and the removal of 3 courses of brick on the north-west side, the base of the chamber became evident at a depth of 0.95m. The drain itself was set into the base of the chamber and ran NNE-SSW.

Bricks taken from structure (404) were dated to between 1857 and 1889, see report in Appendix 4. The construction of this 19<sup>th</sup> century structure has removed any earlier archaeological deposits at this depth. The alignment of the drain matches the alignment of the buildings fronting onto the Shambles and may suggest 19th century structures were on the same alignment. Chamber (404) probably went out of use during the development of Newgate Market in 1955.

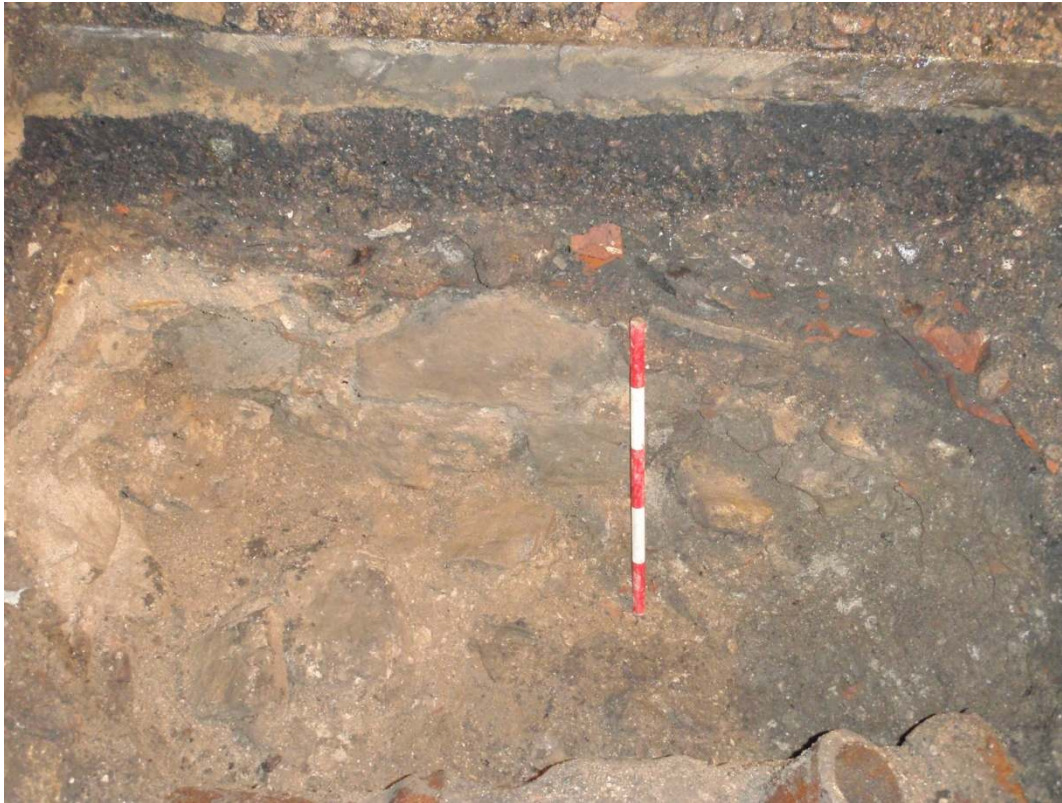
**Plate 5 Section through Trench 5 showing wall 504, north-west facing, 0.1m scale divisions**

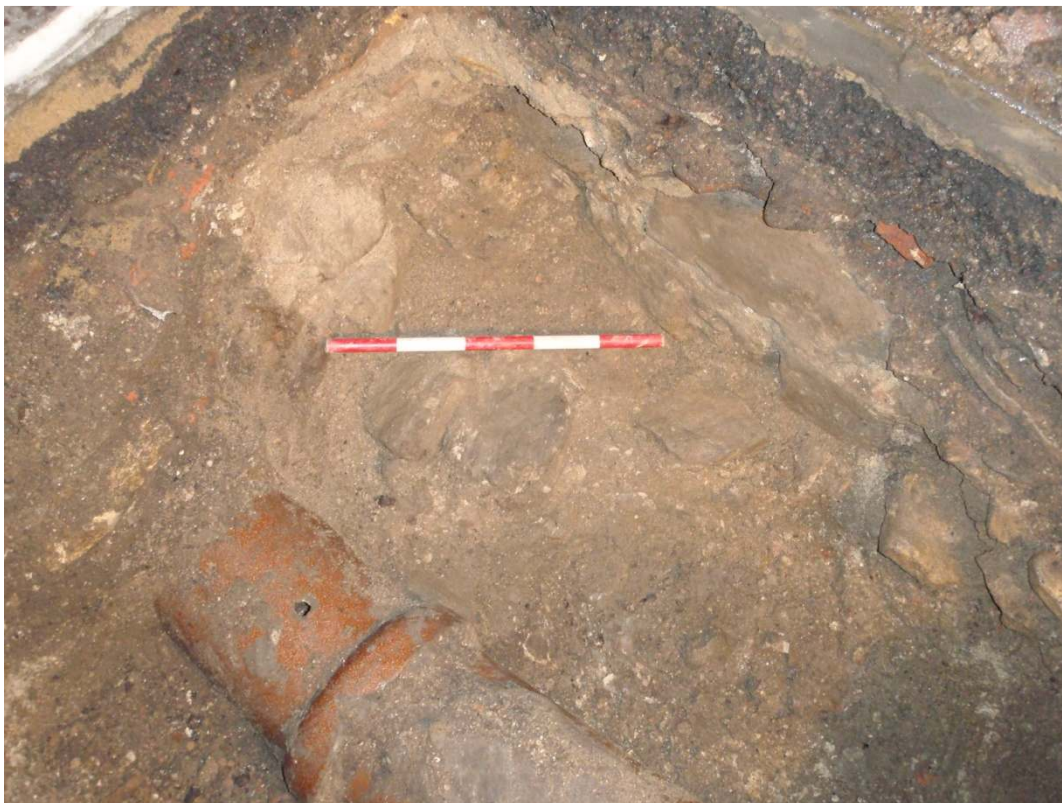
**Plate 6 Wall 510, east facing, 0.1m scale divisions**
