## YORK ARCHAEOLOGICAL TRUST REPORT

<b>SITE ADDRESS</b>	St. Peter's School, York		
<b>CLIENT NAME</b>	St. Peter's School		
<b>YAT PROJECT #</b>	5768	<b>YAT REPORT #</b>	2014/26
<b>MUSEUM ACCESSION #</b>	N/A	<b>GRID REFERENCE</b>	NGR SE 5965 5270
<b>PLANNING REFERENCE #</b>	N/A	<b>AAI OPS NOTICE #</b>	TBC

Between the 1<sup>st</sup> and 9<sup>th</sup> of April 2014 York Archaeological Trust undertook an archaeological Watching Brief at St. Peter's School, York (Figure 1). Sited in a small court yard on the southeast side of Manor Boarding House, Area 1 was the site of foundation excavation for an extension. Located in an entrance alcove space on the north side of St. Peter's School House, Area 2 was the site of excavations for a new main entrance.

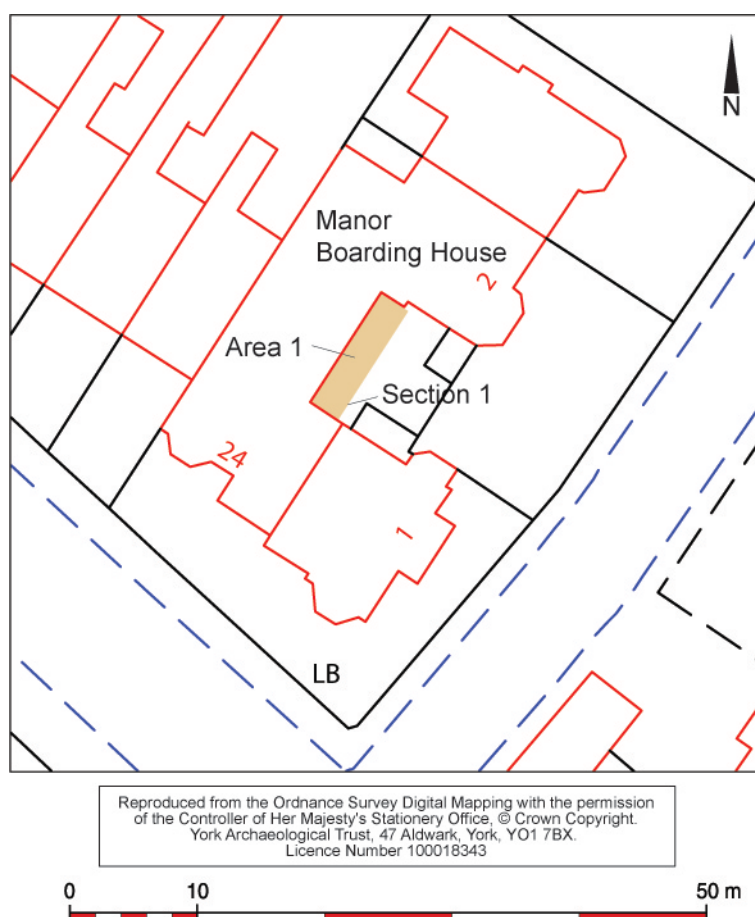
Figure 2. Area 1.

Area 1 was located in a small court yard on the southeast side of Manor Boarding House (Figure 2). Aligned NE to SW and rectangular in plan it measured 10.15m long and 2.45m wide. It was excavated to a depth of 1.15m.

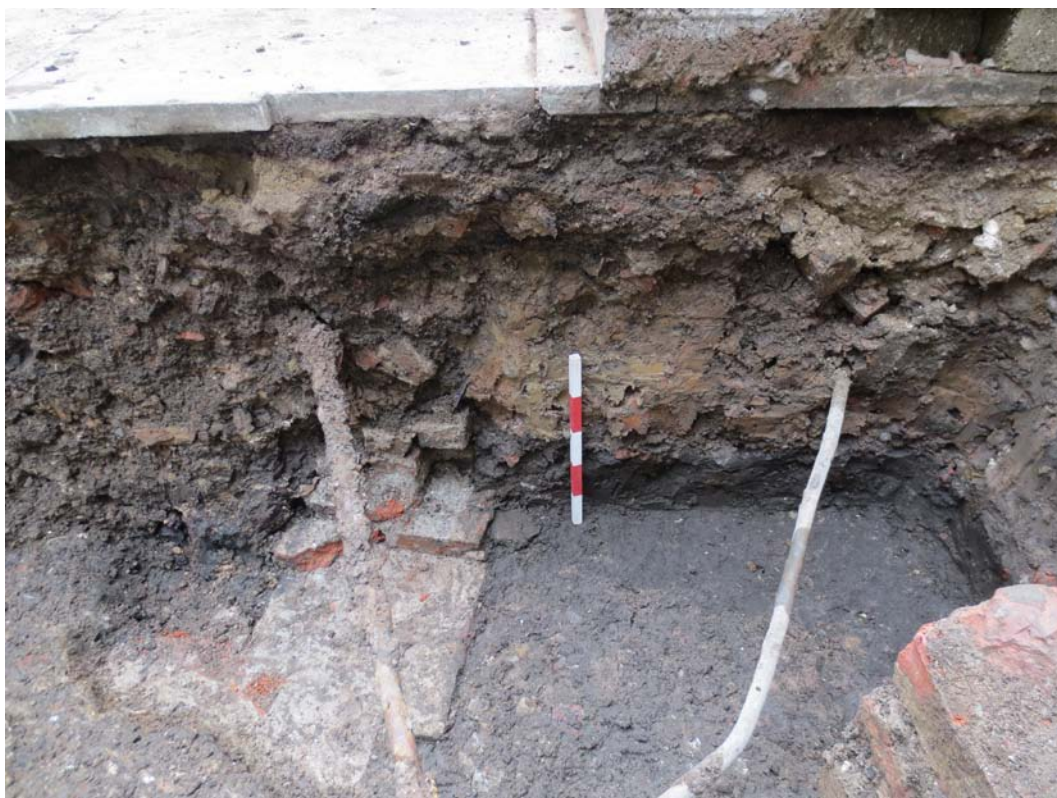
Two brick structures extended into Area 1. From the SE side of the trench, approximately 2.30m from the SW end, a brick wall, context 109, extended into the trench on a SSE – NNW alignment (Plate 1). Although disturbed by a later concrete encased drain a small fragment of the wall could be seen returning on a NNE alignment. The wall was three courses wide with the bricks laid in a stretcher bond and bonded with a hard light gray mortar. In section this structure was observed to survive to a height of five courses, extending up to 0.75m BGL. Despite the top of this structure being disturbed the original construction cut, context 110, was seen to survive to 0.40m BGL in section. Here the SW side of 110 was observed to cut clay deposit 112 (Figure 3). Above the intact remains of wall 109, context 107 consisting of loose rubble, filled in the upper extent of cut 110.

Plate 1. This Plate shows the area of Section 1 and includes Wall 109. Looking SE, 0.10m scale divisions.

The two structures appear similar in terms of their form and construction materials. Context 115, located at the NE end of the trench, was found directly below the current entrance to the NE wing of the boarding house and it is possible that these remains are the footings of a previous porch. The alignment of 109 is rather different to that of 115 and the boarding house, the likelihood is that context 109 is the footings of a structure demolished before the construction of the boarding house.

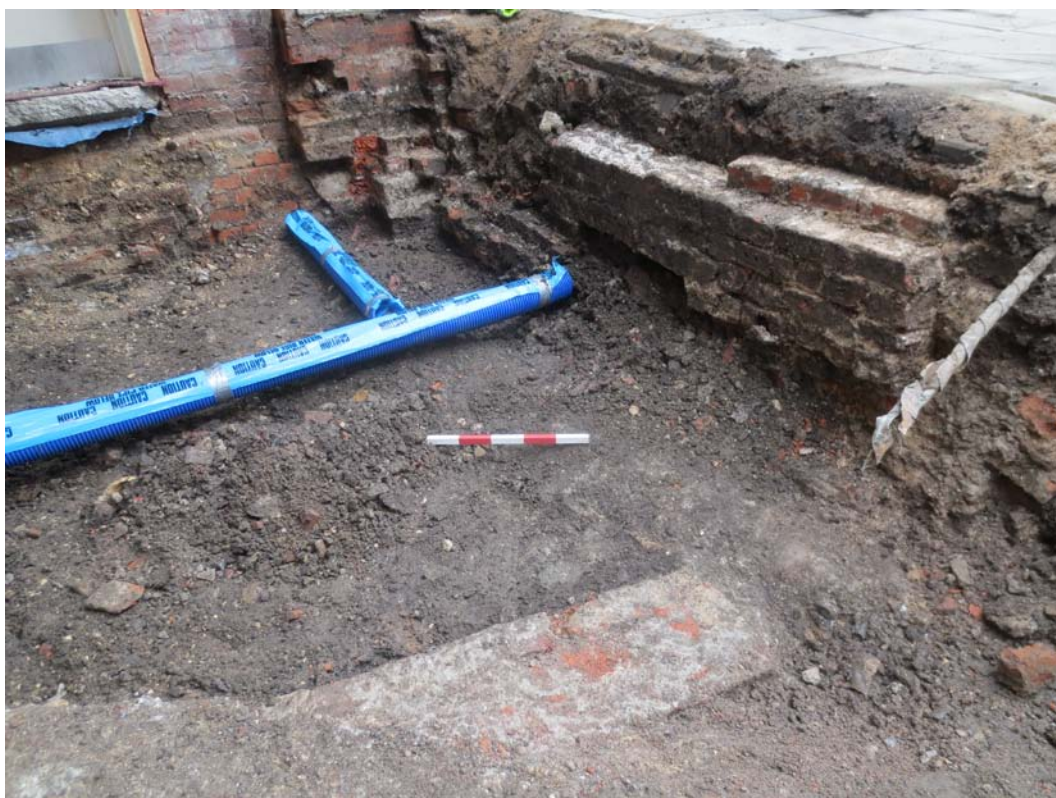
At the NE end of Area 1 a second brick structure was encountered (Plate 2). This structure, context 115, survived up to ten courses in height in places despite considerable truncation from later services. A small stub of wall, 0.65m long, was seen to be tied into the footings of the NE wing of the boarding house. From there 115 extended on a NE – SW alignment for a distance of 2.60m. The wall then returned on a NW – SE alignment towards the NW wing of the boarding house. Here the full width of

the wall was exposed. It was seen to be 0.35m wide with the bricks laid in a stretcher bond three courses in width and bonded with a hard grey mortar. It was truncated by a concrete encased drain at a distance of 0.50m from its SE end and again at 1.75m. This disturbance had dragged the wall out of alignment pulling it further to the north.

Plate 2. . Brick structure, context 115, at NE end of Area 1. Looking East, 0.10m scale divisions.

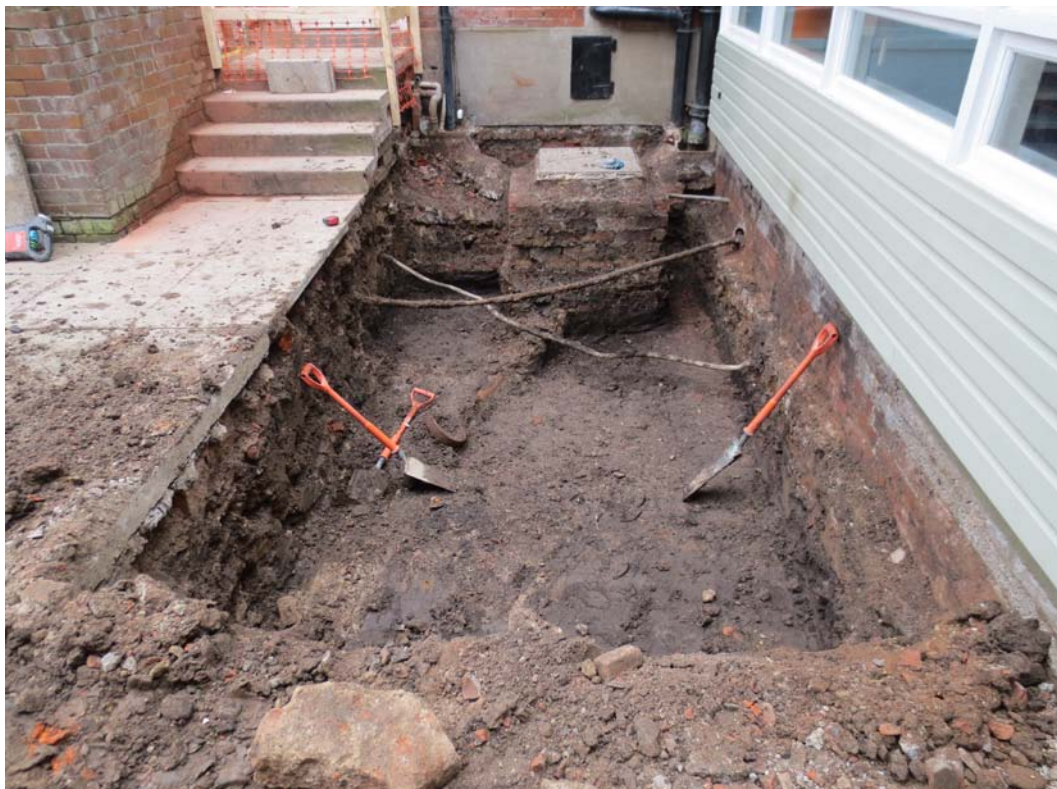
Plate 3. Services at SW end of Area 1. Looking SW.

Significant truncation and disturbance of the stratigraphic sequence was encountered throughout the extent of the foundation trench during its excavation. One inspection chamber, and associated concrete encased drains, occupied the SW end of Area 1 and a second inspection chamber lay just beyond the SE side of the excavation area.

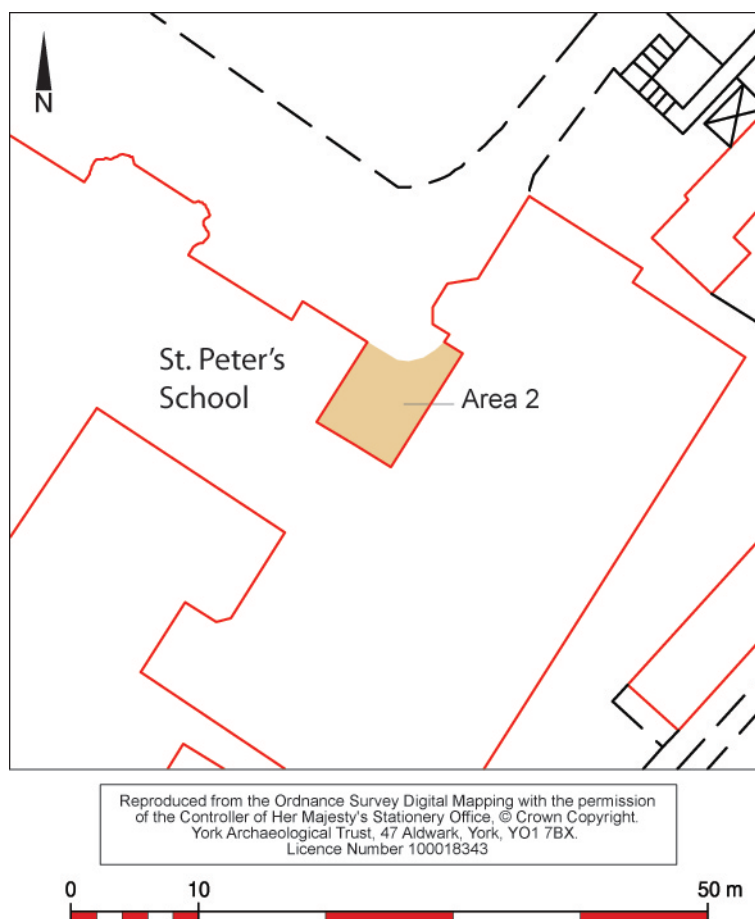
Figure 4. Area 2.

Area 2 was located in the small space of the entrance alcove on the north side of St. Peter's School House, adjacent to the SE wing of the school buildings and the main pupil entrance to the SW. The extent of excavation covered an area approximately 10.50m long and 6.75m wide on a NE to SW axis (Figure 4). Although an excavation depth of c0.30m was intended across the area the discovery of a basement along the NW side of the SE wing required additional unexpected work. It was decided that it was necessary for the basement to be infilled with concrete and the full extent NE wall of the basement removed to ensure stable foundations for the extension. From its NW end, butting up against the School House, the wall footing extended on a straight NW-SE axis for a distance of c2.50m at a depth of c0.50m. From this SE point the wall, articulating with the NW wall of the cellar, curved through 90° to the NE and extended to a depth of c1.65m (Plates 4 and 5).

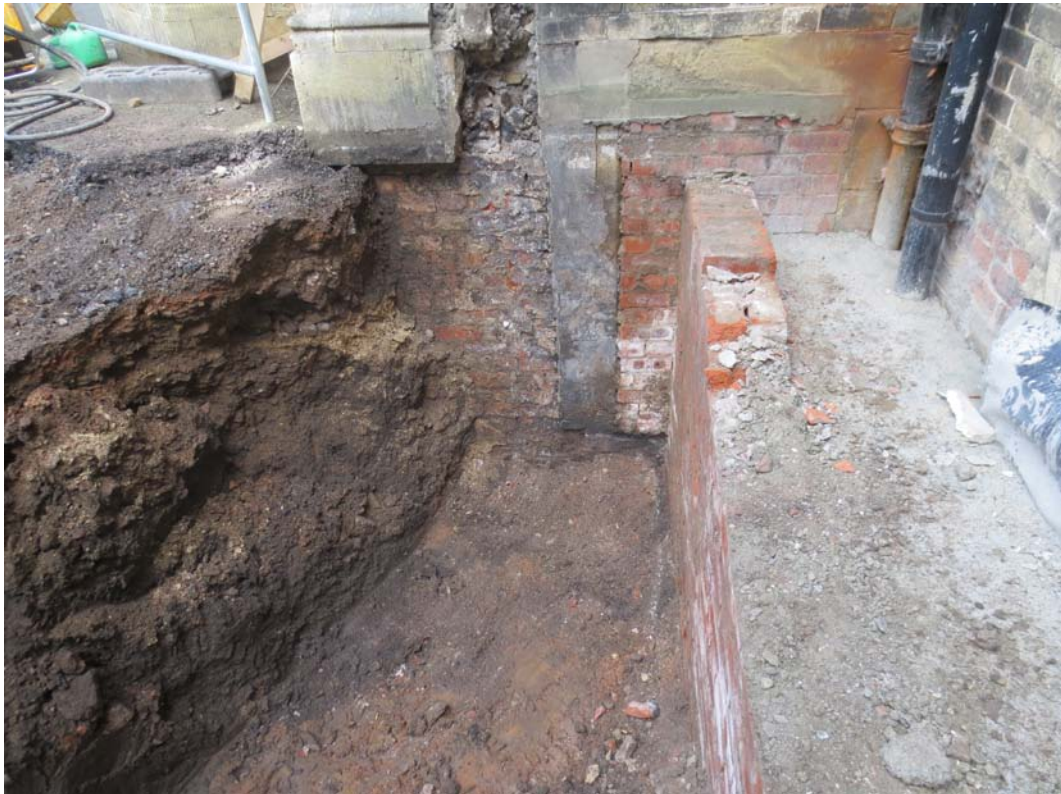
*Plate 4. The NE end of the excavated trench after the NE basement wall had been removed. Note the bricked up basement door and on the right of frame and a later wall inserted to create a light well.*

The basement was constructed with bricks laid in a stretcher bond, three courses wide (0.35m) and 15 courses high. The interior faces of the walls were painted white. A doorway accessed the basement at its NE end (Plate 4). A series of brick walls were later inserted into the basement creating light wells for the basement windows of the SE wing of the school (Plate 7). These walls appear to be mid to late 20<sup>th</sup> century in date.

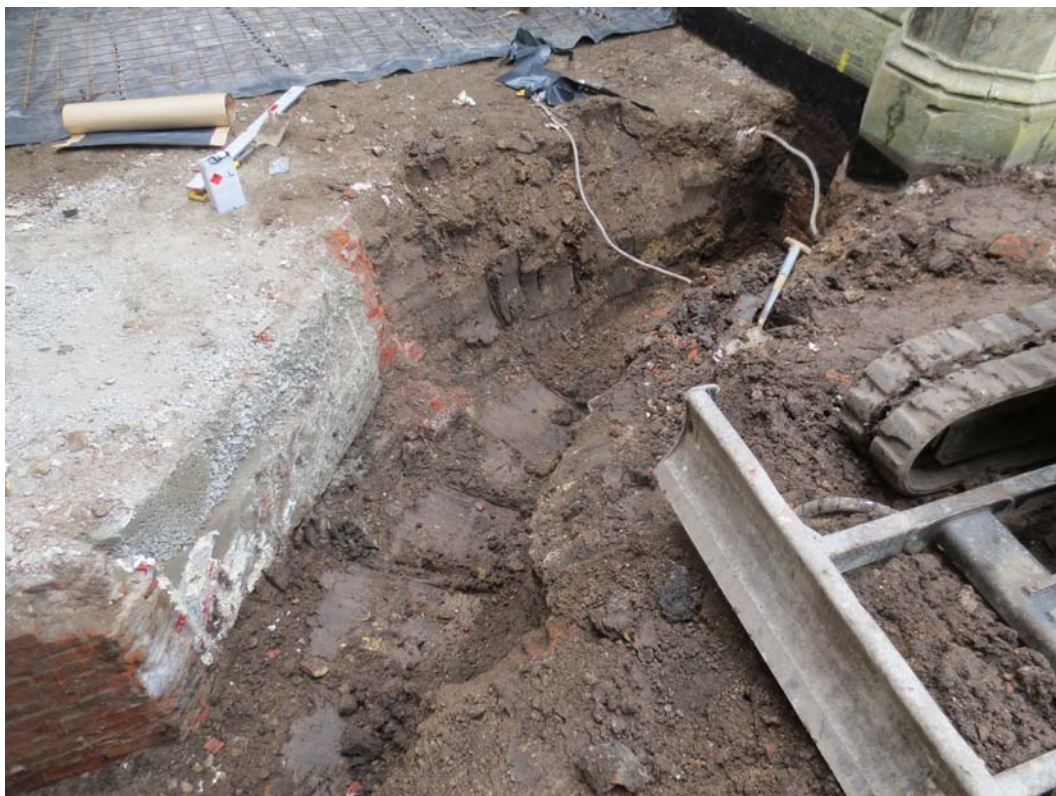
Figure 5. The NW end of the excavated trench after the NE basement wall had been removed; part of the concrete infilling of the basement can be seen on the left. Looking SW.

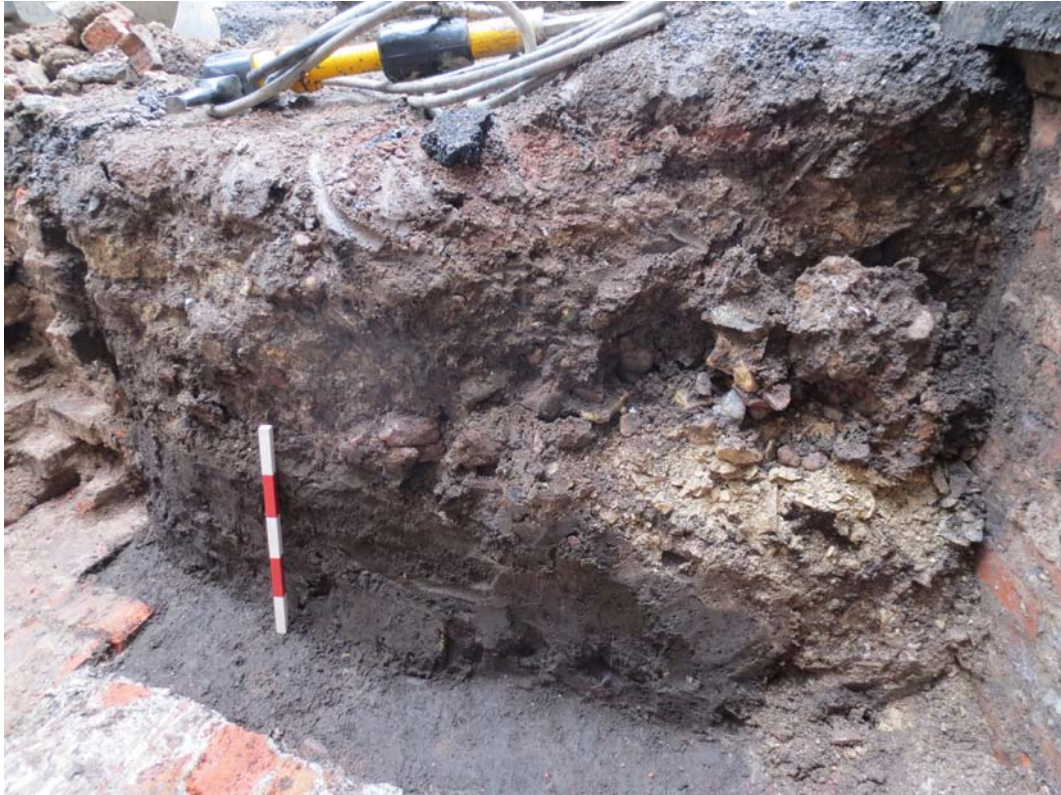
The earliest deposits were encountered in the trench excavated for the removal of the NE basement wall. A mottled mid brown and light brown orange silty sand was observed from 1.65m to 1.45m BGL. This material was overlaid by a deposit of dense dark brown silt, approximately 0.40m thick this material extended to a depth of 1.00m BGL (Plate 6).

In section at the north end of Area 2, a 0.65m stony infill of the construction cut for the standing SE wing of the school building was observed, this cut a thick deposit of loose rubble that overlaid the compact dark brown silt (Plate 6), this in turn was overlaid with the current asphalt ground surface.

*Plate 6. Loose rubble made ground overlying a dark brown silty plough soil. The construction cut and light coloured stony infill of the SE wing of the School building is visible on the right. Looking North, 0.10m scale divisions.*

It is probable that the top of archaeologically significant deposits were reached where the curving wall was removed. Unfortunately the depth of excavation and the instability of the overlying deposits severely limited their investigation. Very little of the nature and date of these deposits could be directly established and no finds were recovered. There is however a significant difference with the overlying accumulation of dark silt, perhaps representing a significant change in land use. This plough soil, with a thickness of 0.40m, identifies a period of reasonably intense agricultural activity as attested by its dense, fine composition. It is also notably similar to that found in Area 1.

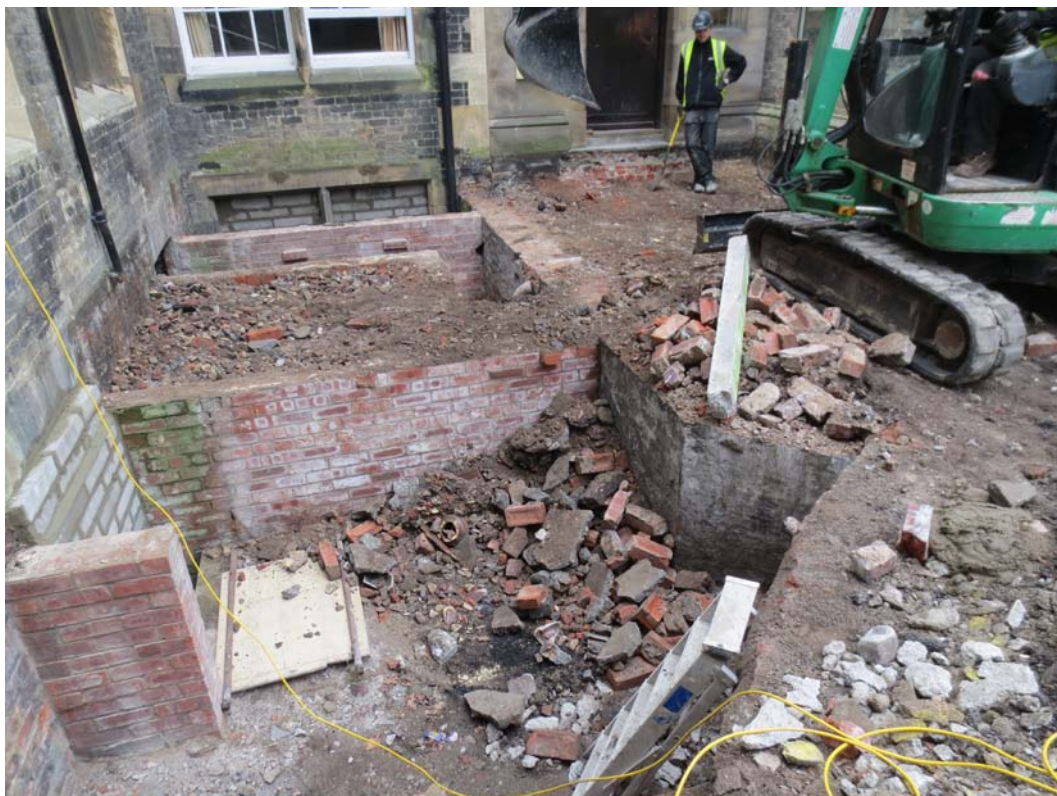
Located in the entrance alcove and running adjacent to the SE wing of the school, the basement structure had a sub rectangular shape in plan and was orientated on a NE to SW axis. It measured 10.50m long and between 1.40m and 3.00m wide with the floor at c1.10m BGL, the excavated NE wall footings however were found to extend to a depth of c1.65m BGL. The NE end of the curving NE wall butted up against the standing SE wing of the school building from a point directly below a buttress (removed as part of the extension works), and adjacent to the NW side of the doorway used to access the basement (Plate 4). The SW end of the NW basement wall butted up against part of the school that post dates the SE wing (Plate 7).

*Plate 7. Basement in Area 2. The curving NE wall can be seen in the foreground and the NW wall in the centre of the frame. The later walls run from left to right. Looking South.*

St. Peter's School House, including the SE wing for which part of the construction cut was seen in section, date to 1838. The gap between the SE wing and the Memorial Hall wing of the school was gradually infilled by building work carried out at some point between 1858 and 1873, and then finally in 1905. The NE wall of the basement clearly butted up against the 1838 phase of buildings and where visible the NW wall appeared to butt up against the edge of the late 19<sup>th</sup> century phase of building. It's positioning in relation to this later 19<sup>th</sup> century phase of building is an indication that the basement is likely to have been constructed at around that time. This would also suggest that the doorway leading into the basement from the SE wing was almost certainly a late 19<sup>th</sup> century insertion. The curved wall also provided footings for a three arched, single storey stone wall or 'screen', traces of which remain visible where its NW extent articulated with the school building. The wall potentially remained in place up until the early 1950's. The 1954 Listing description does not mention the wall, suggesting that it had been dismantled by this point. The change in use of the basement, where brick walls were inserted preserving light wells to windows in the basement level of the SE wing, appears to be mid 20<sup>th</sup> century in date. It is possible that reworking of this space happened around the same time as the removal of the three arched stone wall. Information on dates and documentation has been provided by archive research carried out by HarmerFitz.
