**ARCHAEOLOGICAL INVESTIGATIONS AT THE
FORMER MONK BAR GARAGE, LORD MAYORS
WALK, YORK**

WATCHING BRIEF REPORT

Report Number 2015/12 March 2015

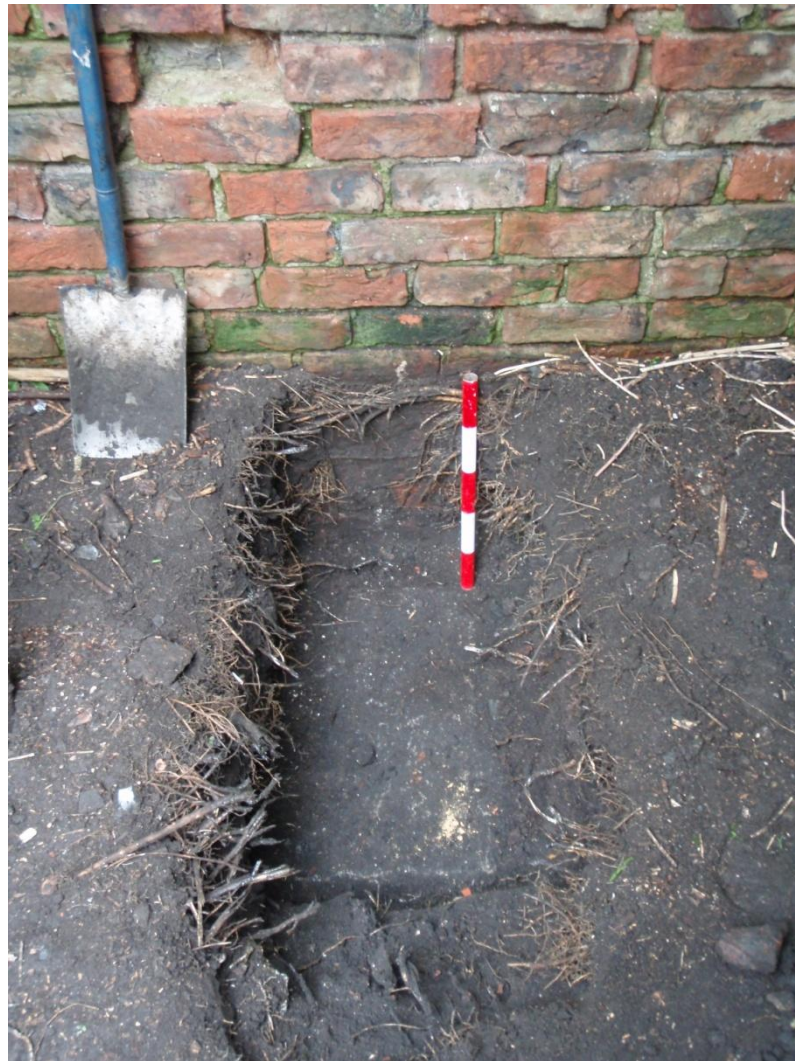
This trial pit was situated on the south-west side of the retaining wall, opposite a parking bay to the south-east of the former garage and measured 1.00m x 0.50m x 0.50m (Figure 2, Plate 1). Excavation revealed an accumulation of up to 0.50m of friable, dark-brown sandy silt from the rampart covering over the retaining wall and built up against the rear wall of the parking garage.

Plate 1. North-east facing view of Trial Pit 1. Scale units 0.10m

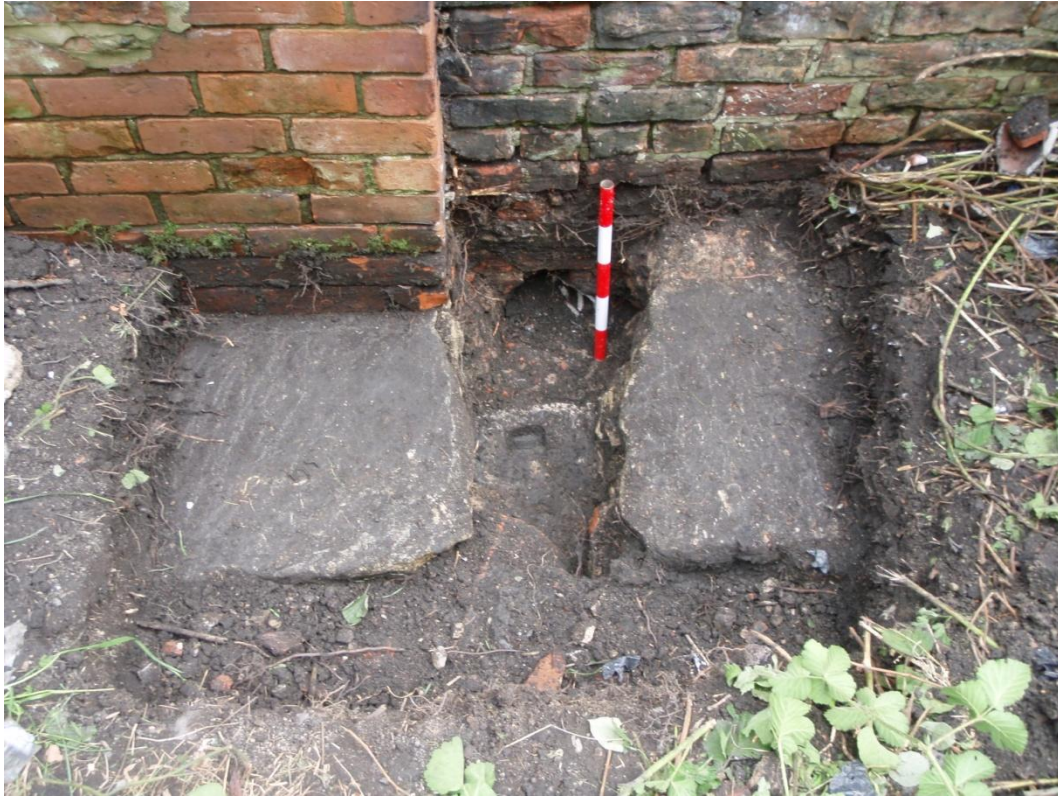
Trial Pit 2 was situated on the south-west side of the retaining wall, behind the south-east corner of the former garage (Figure 2, Plates 2 & 3). The trial pit measured 1.30m x 0.80m x 0.64m.

Plate 2. North-east facing view of Trial Pit 2. Scale units 0.10m

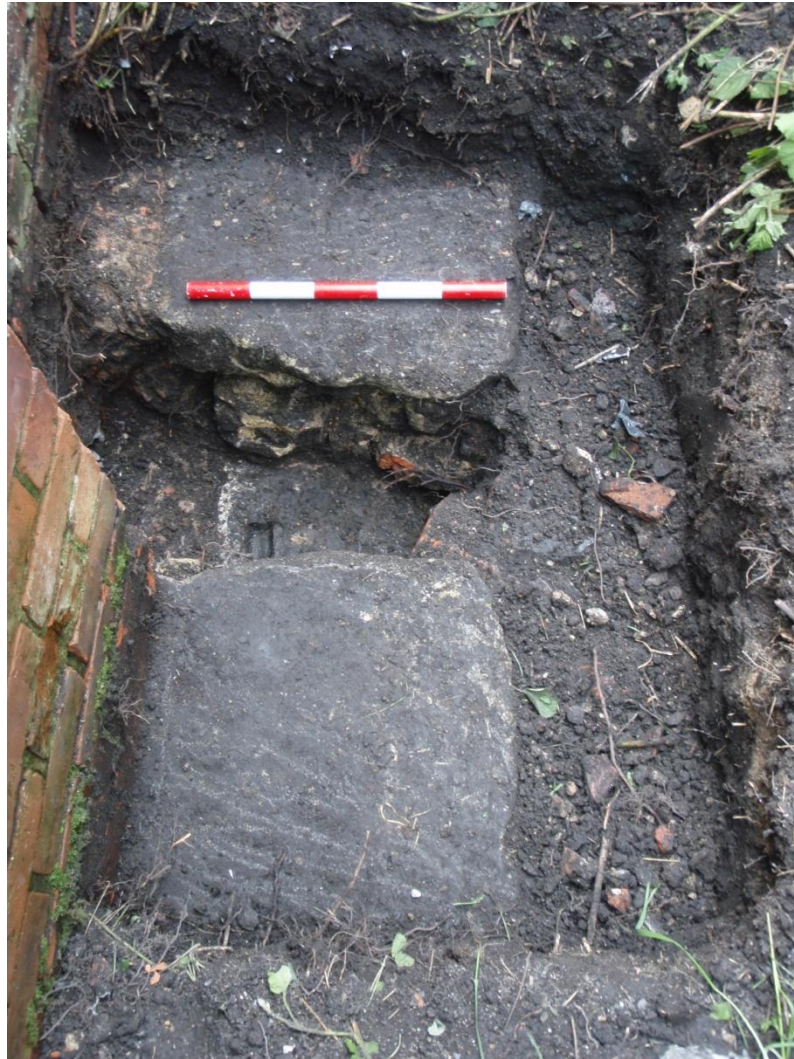
The trial pit revealed that the retaining wall had been partially built over by the 19th century and later brickwork of the former garage before being entirely covered by slumped material from the rampart. Both the retaining wall and the rear wall of the garage complex were also cut by a north-east/south-west aligned trench measuring 0.20m in width. The cut contained a ceramic drain pipe (Plate 3).

Plate 3. South-east facing view of Trial Pit 2. The ceramic drain pipe is visible on the right side of the drain trench. Scale units 0.10m

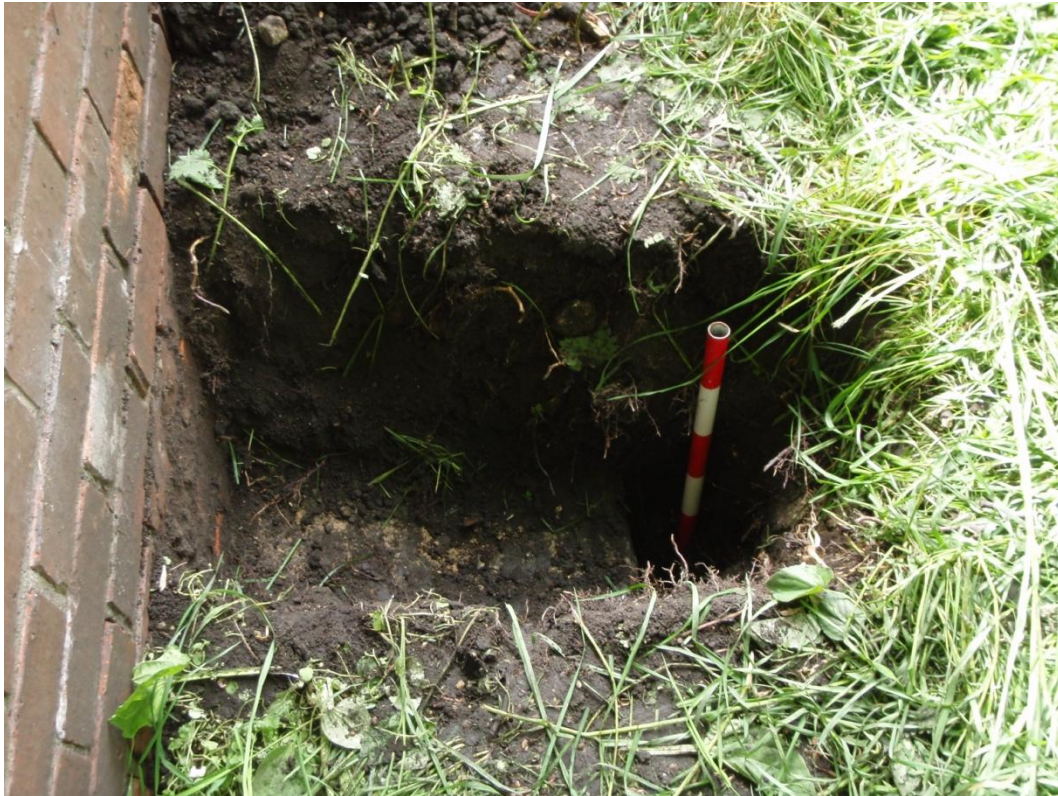
This intervention was located over the retaining wall, opposite the south-west corner of the former garage (Figure 2, Plate 4) and measured 0.80m x 0.40m x 0.60m. The trial pit revealed that the retaining wall had been partially built over by the rear wall of the garage prior to being covered over by 0.38m of silty slumping from the rampart.

Plate 4. South-east facing view of Trial Pit 3. Scale units 0.10m

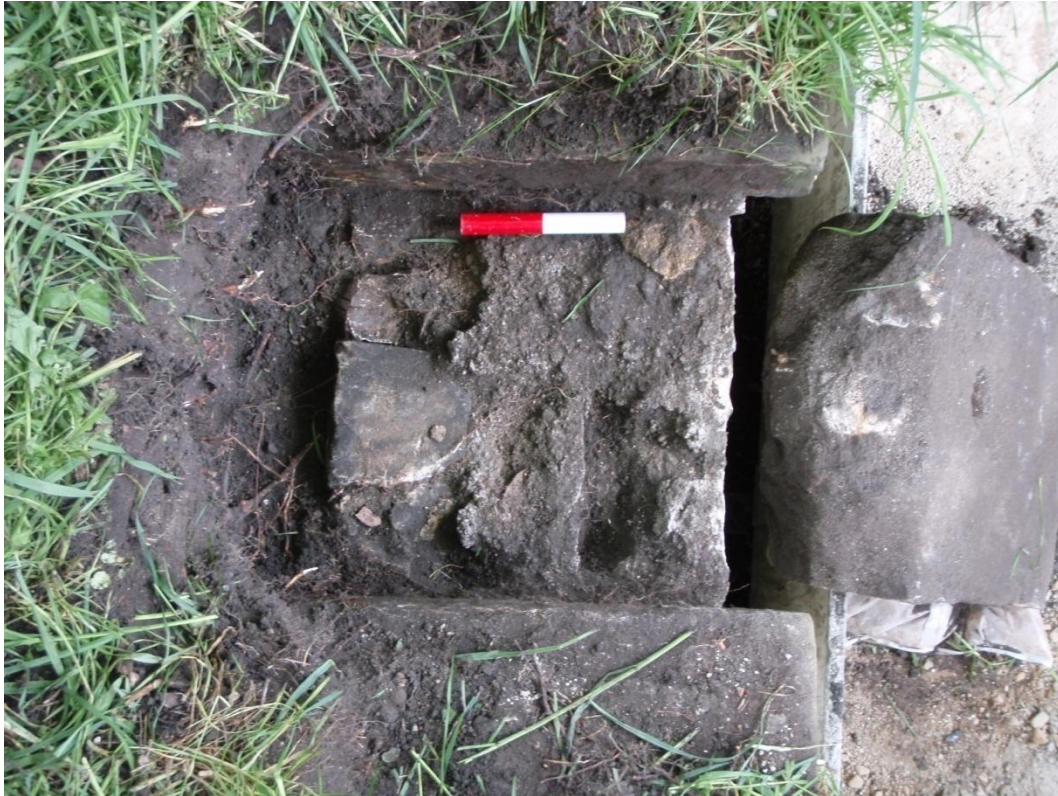
Trial Pit 4 was situated over the retaining wall at the south-west end of the garage's north-west forecourt (Figure 2, Plate 5). The slot measured 0.80m x 0.60m x 0.20m and revealed that the retaining wall was covered by up to 0.20m of slumped silty material from the rampart.

A section of limestone capstone measuring 0.60m x 0.50m x 0.17m was lifted to reveal the upper course of the retaining wall. This wall comprises faced exterior courses of limestone blocks and a core of rubble and cement.

Plate 5. North-west facing view of Trial Pit 4 following removal of the capstone. Scale units 0.10m

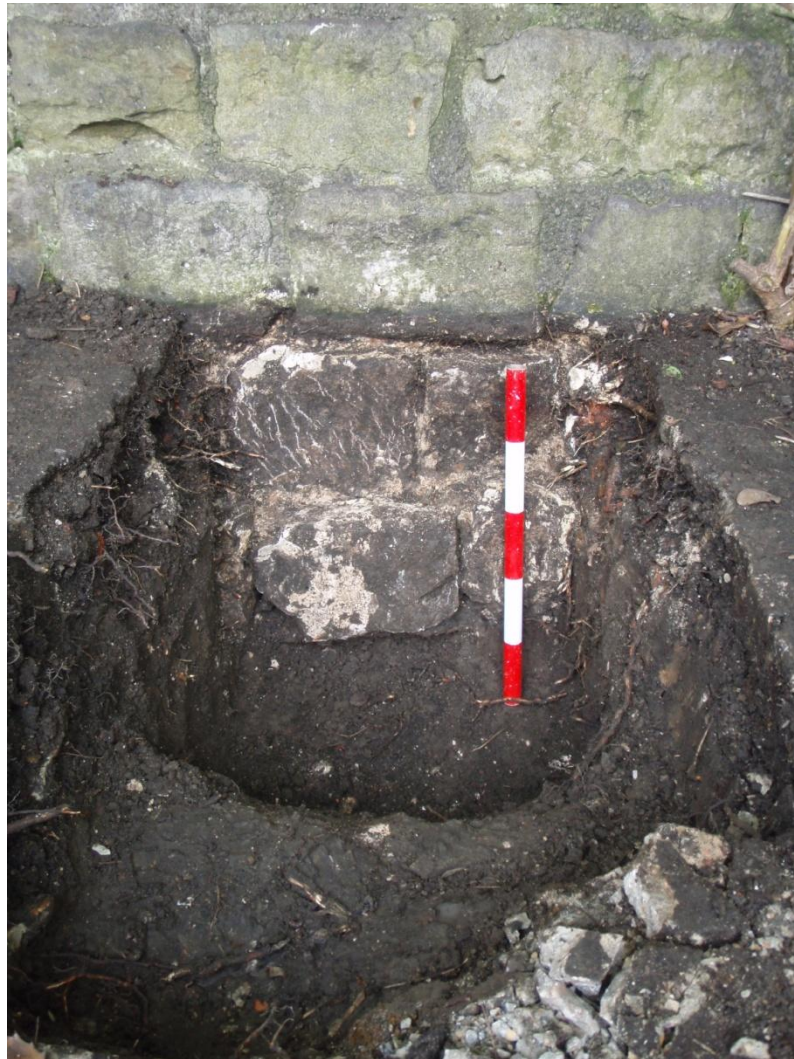
Trial Pit 5 was located flush to the north-east face of the rampart retaining wall, in the north-west forecourt of the former garage, 3.70m north-west of the garage wall (Figure 2, Plate 6). The trench measured 0.90m x 0.70m x 0.55m and was excavated to expose the base of the retaining wall footings. Excavation revealed that the wall sits on two courses of limestone footings, the upper course kicking out 0.05m from the wall and a further 0.10m on the lower course. The trial pit also demonstrated that the retaining wall is set in a construction cut approximately 0.60m in width on the north-east face. The construction of the wall clearly cuts clayey deposits that form part of the city walls rampart.

Plate 6. South-west facing view of Trial Pit 5 and the retaining wall footings. The clayey material beneath the stonework relates to the ramparts. Scale units 0.10m

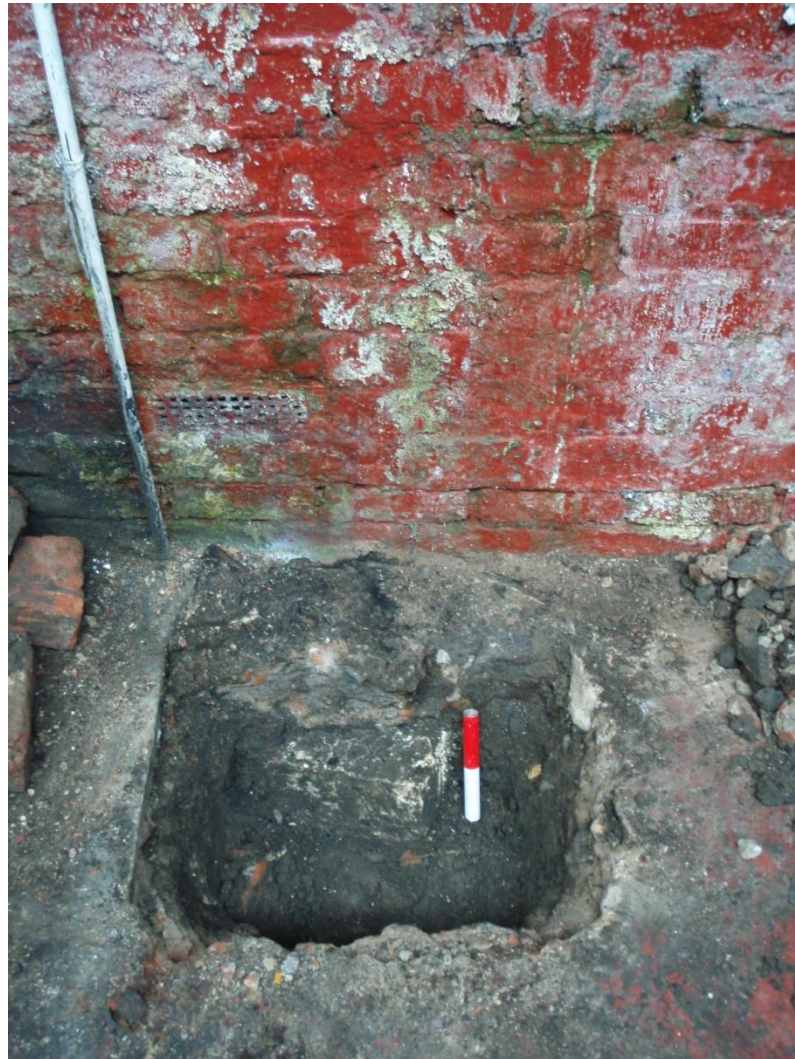
This trial pit was situated within the former garage building, flush to the rear wall and measured 0.60m x 0.60m x 0.40m (Figure 2, Plate 7). The pit revealed that the garage wall is built on a footing of concrete which is in turn built over an earlier brick footing that incorporates a re-used limestone block. As this footing was located at the limit of excavation, it could not be further excavated, although a visual inspection of the brickwork suggests a 19th century date. The structures described above were cut into deposits of material related to the rampart of the city walls.

Plate 7. South-west facing view of Trial Pit 6. Scale units 0.10m

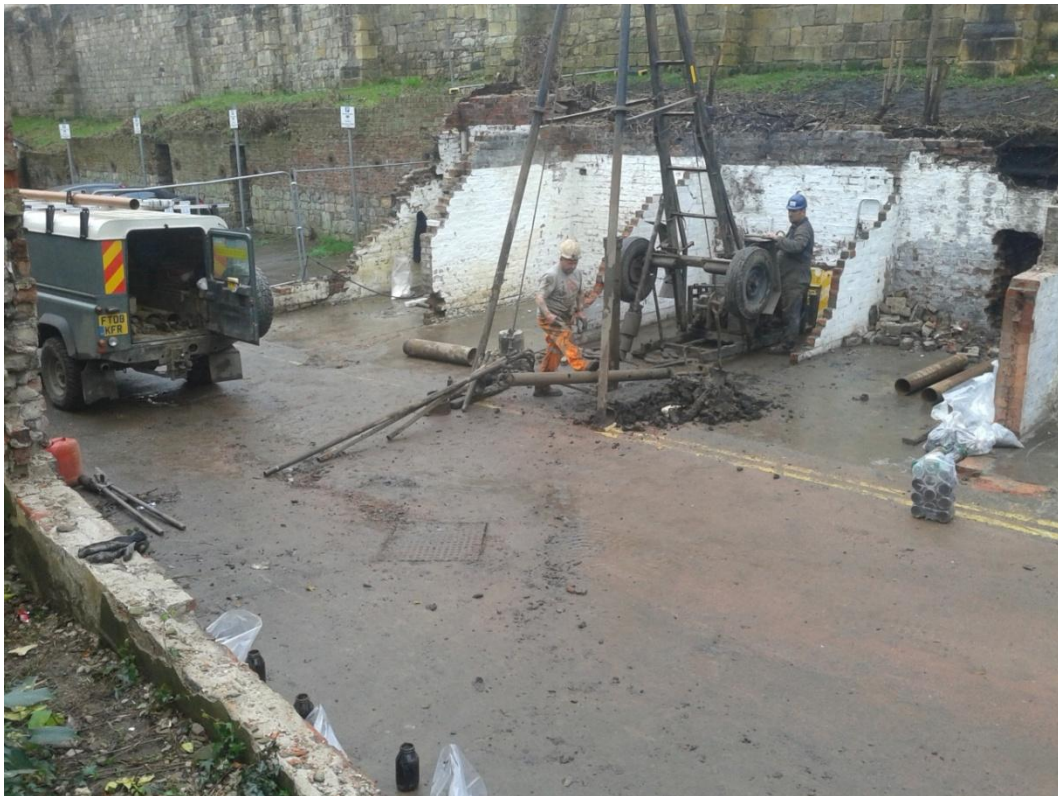
This borehole was situated in the middle bay of a five bay parking garage adjacent to the south-east side of the former garage (Figures 2 & 3, Plate 8). The ground level presently sits at approximately 15.00m AOD. The present concrete surface and make-up occupied the upper 0.25m of the borehole.

Beneath the concrete, a deposit of rubble and soil was present to a depth of 0.60m BGL; this was interpreted as a make-up layer. The make-up material overlaid a deposit of dark-brownish grey silty clay that was present to a depth of 1.20m BGL. This deposit is likely to represent the uppermost surviving layer of the rampart of the city walls. Beneath the upper rampart material, a further rampart layer of lighter grey clay was present to a depth of 1.40m BGL. This in turn overlaid a darker grey silty clay with frequent limestone and mortar fragments. Present to a depth of 2.40m BGL, this deposit may also be part of the medieval rampart.

Plate 8. Borehole 1 under excavation.

Between 2.40m and 4.00m BGL, a very dark, humic deposit was encountered. No dating evidence was recovered, but it is possible that this material could be medieval infilling of the Roman fortress ditch contemporary with the construction of the medieval rampart. Beneath this organic layer, a siltier, less humic deposit was observed to a depth of 4.30m. This deposit may represent the initial silting up of the Roman ditch during its use. Natural clays were present from this point downwards.

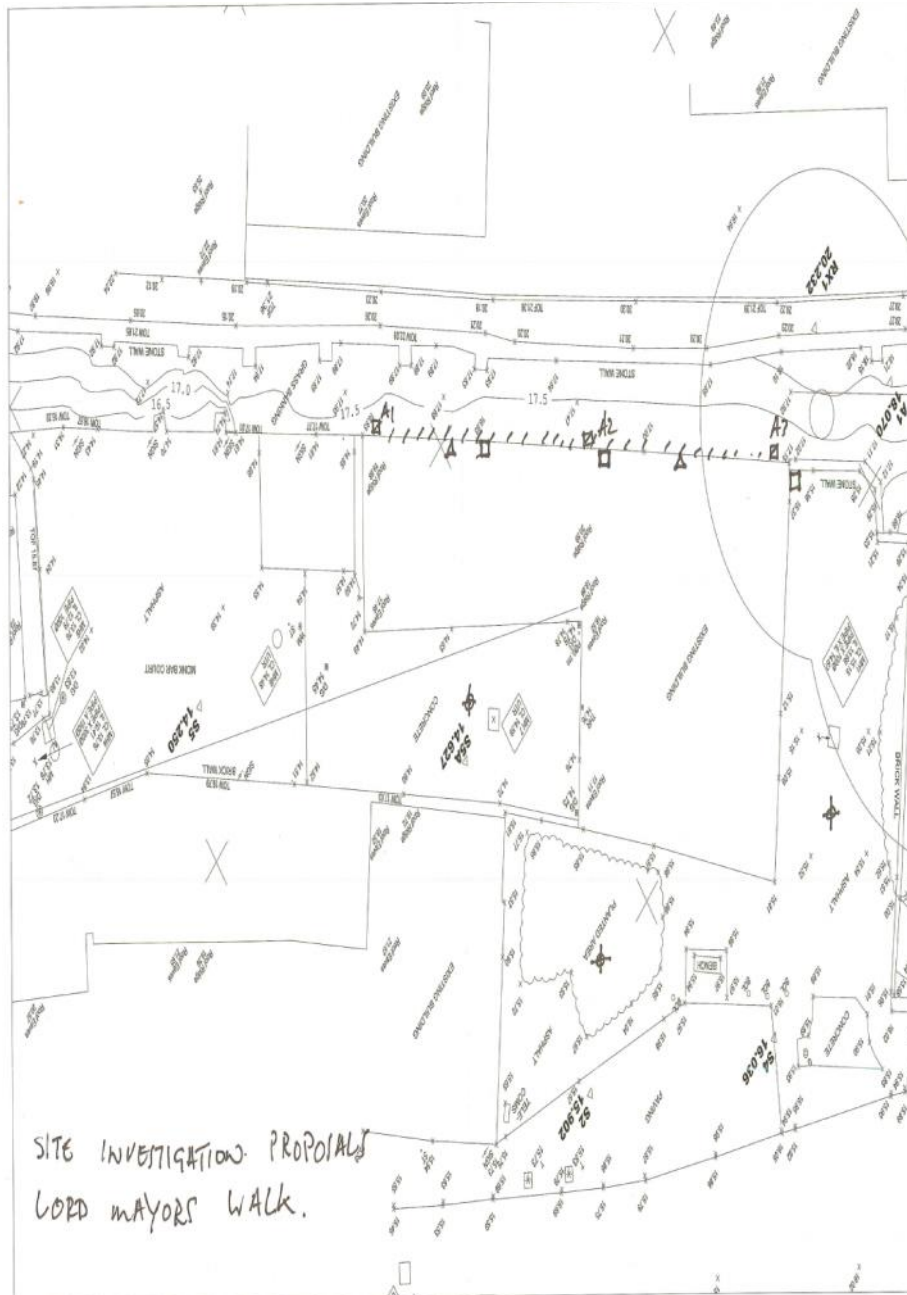
Figure 2: Proposed location of trial pits

SITE INVESTIGATION PROPOSALS
LORD MAYORS WALK.

Excavation hand dug trial holes approx.. 600 x 600mm, depth ext. 600mm to expose base of wall/foundation
-

Removal 4 no. existing bricks to check wall thickness (replace) hand chisel only
-

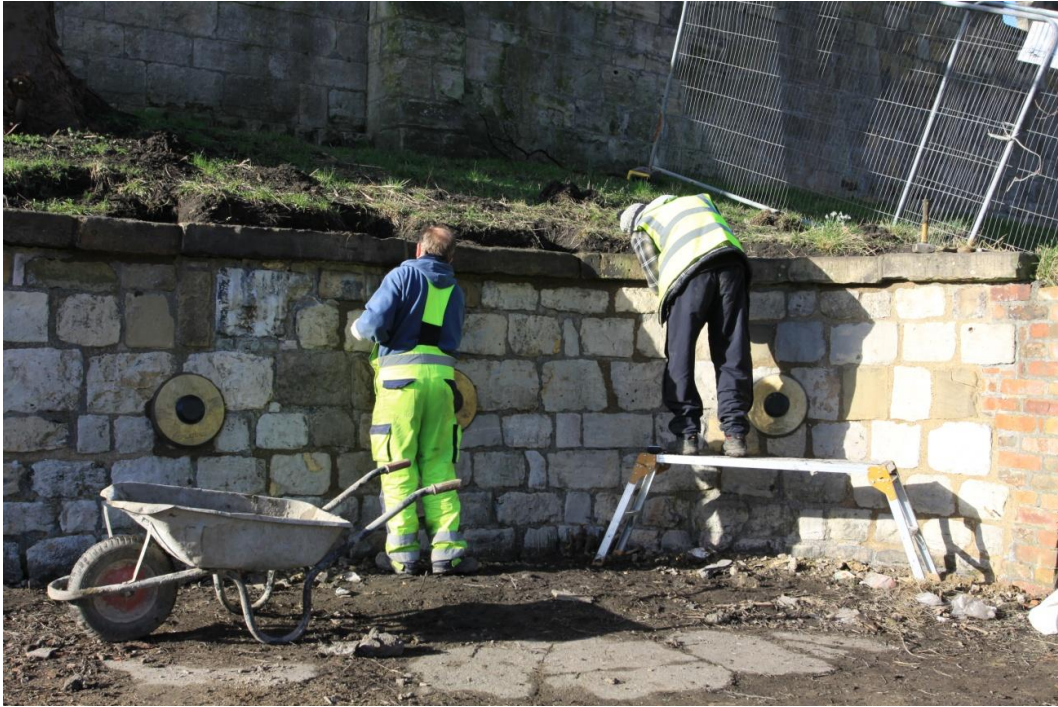
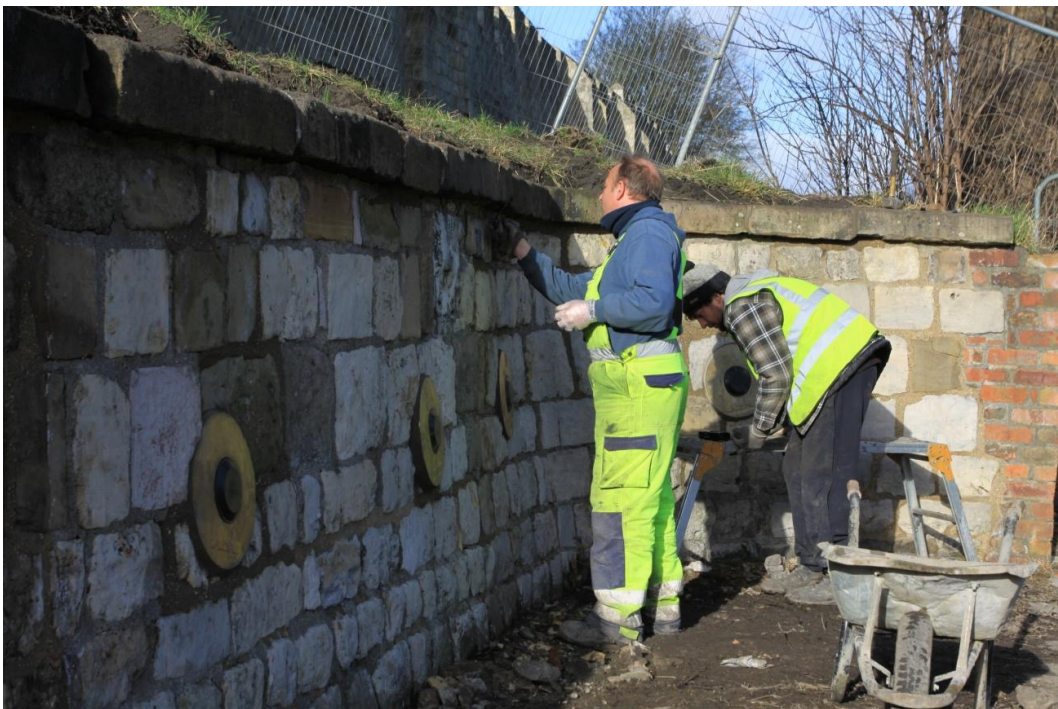
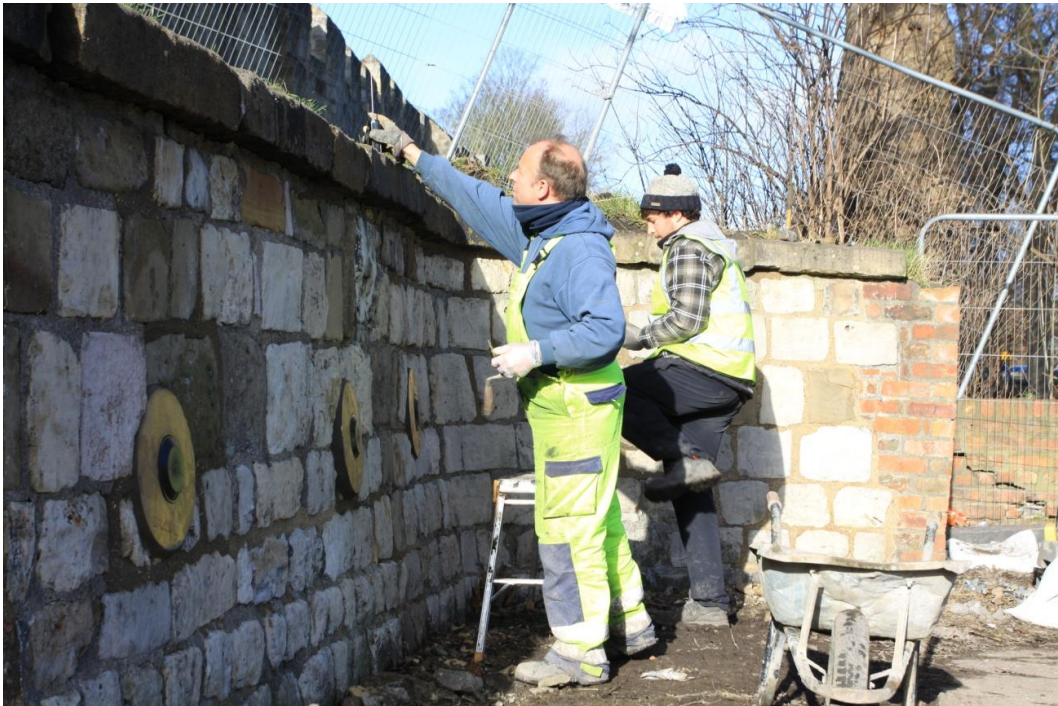
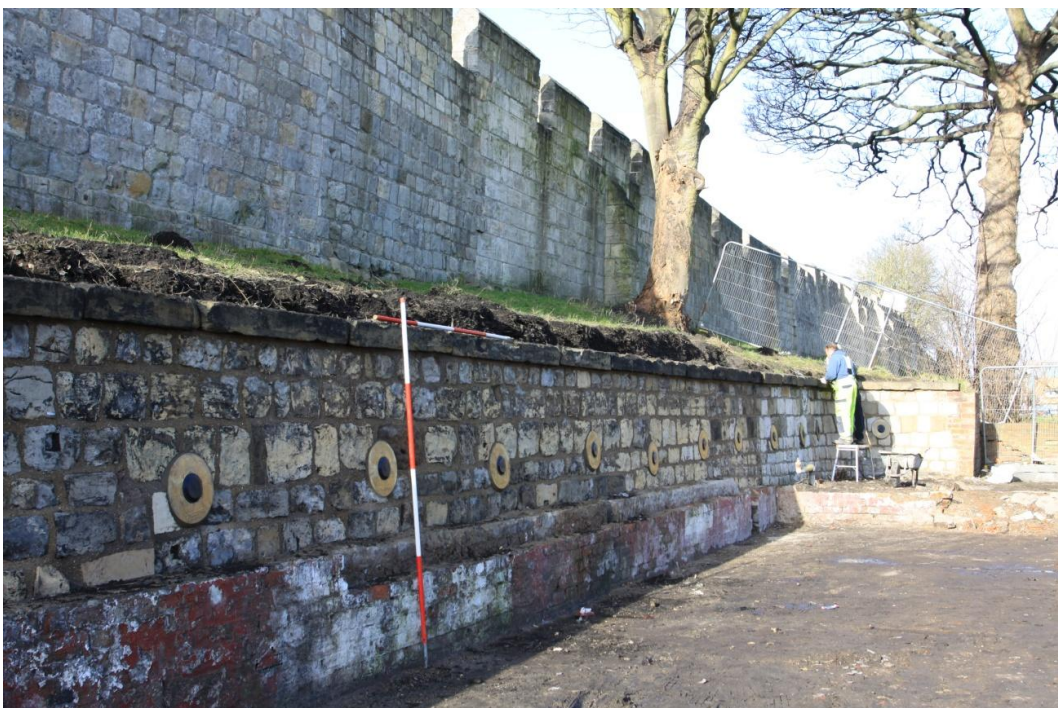
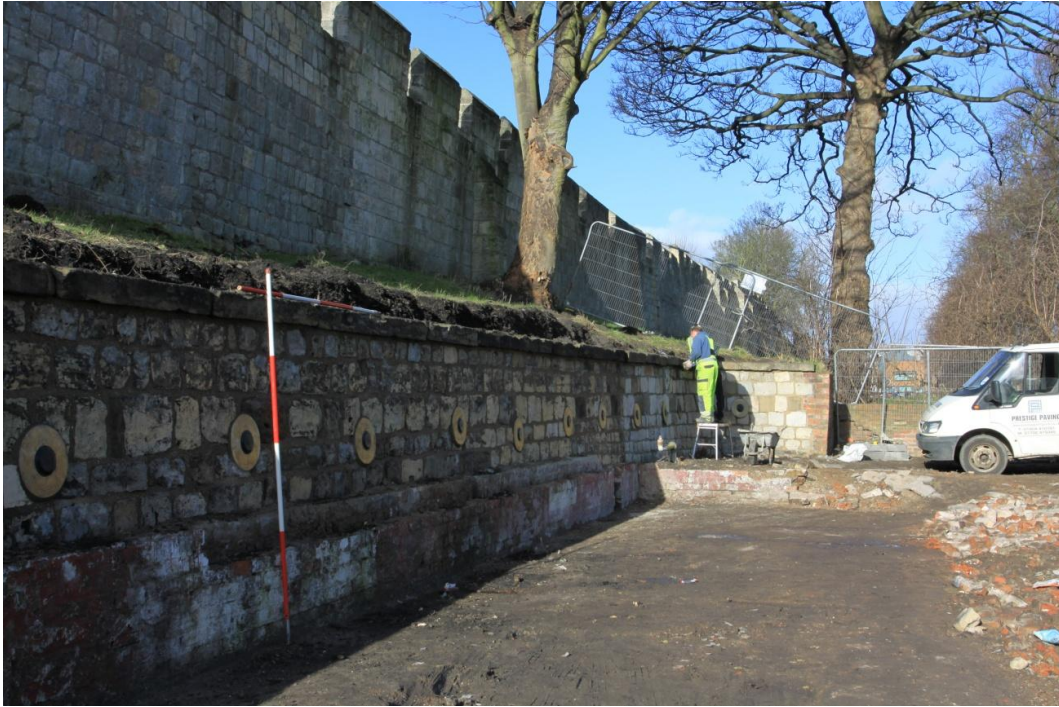
35. West facing view of the retaining wall during restoration

36. West facing view of the retaining wall during restoration

37. West facing view of the retaining wall during restoration

38. West facing view of the retaining wall during restoration. Scale units 0.5m

39. West facing view of the retaining wall during restoration. Scale units 0.5m

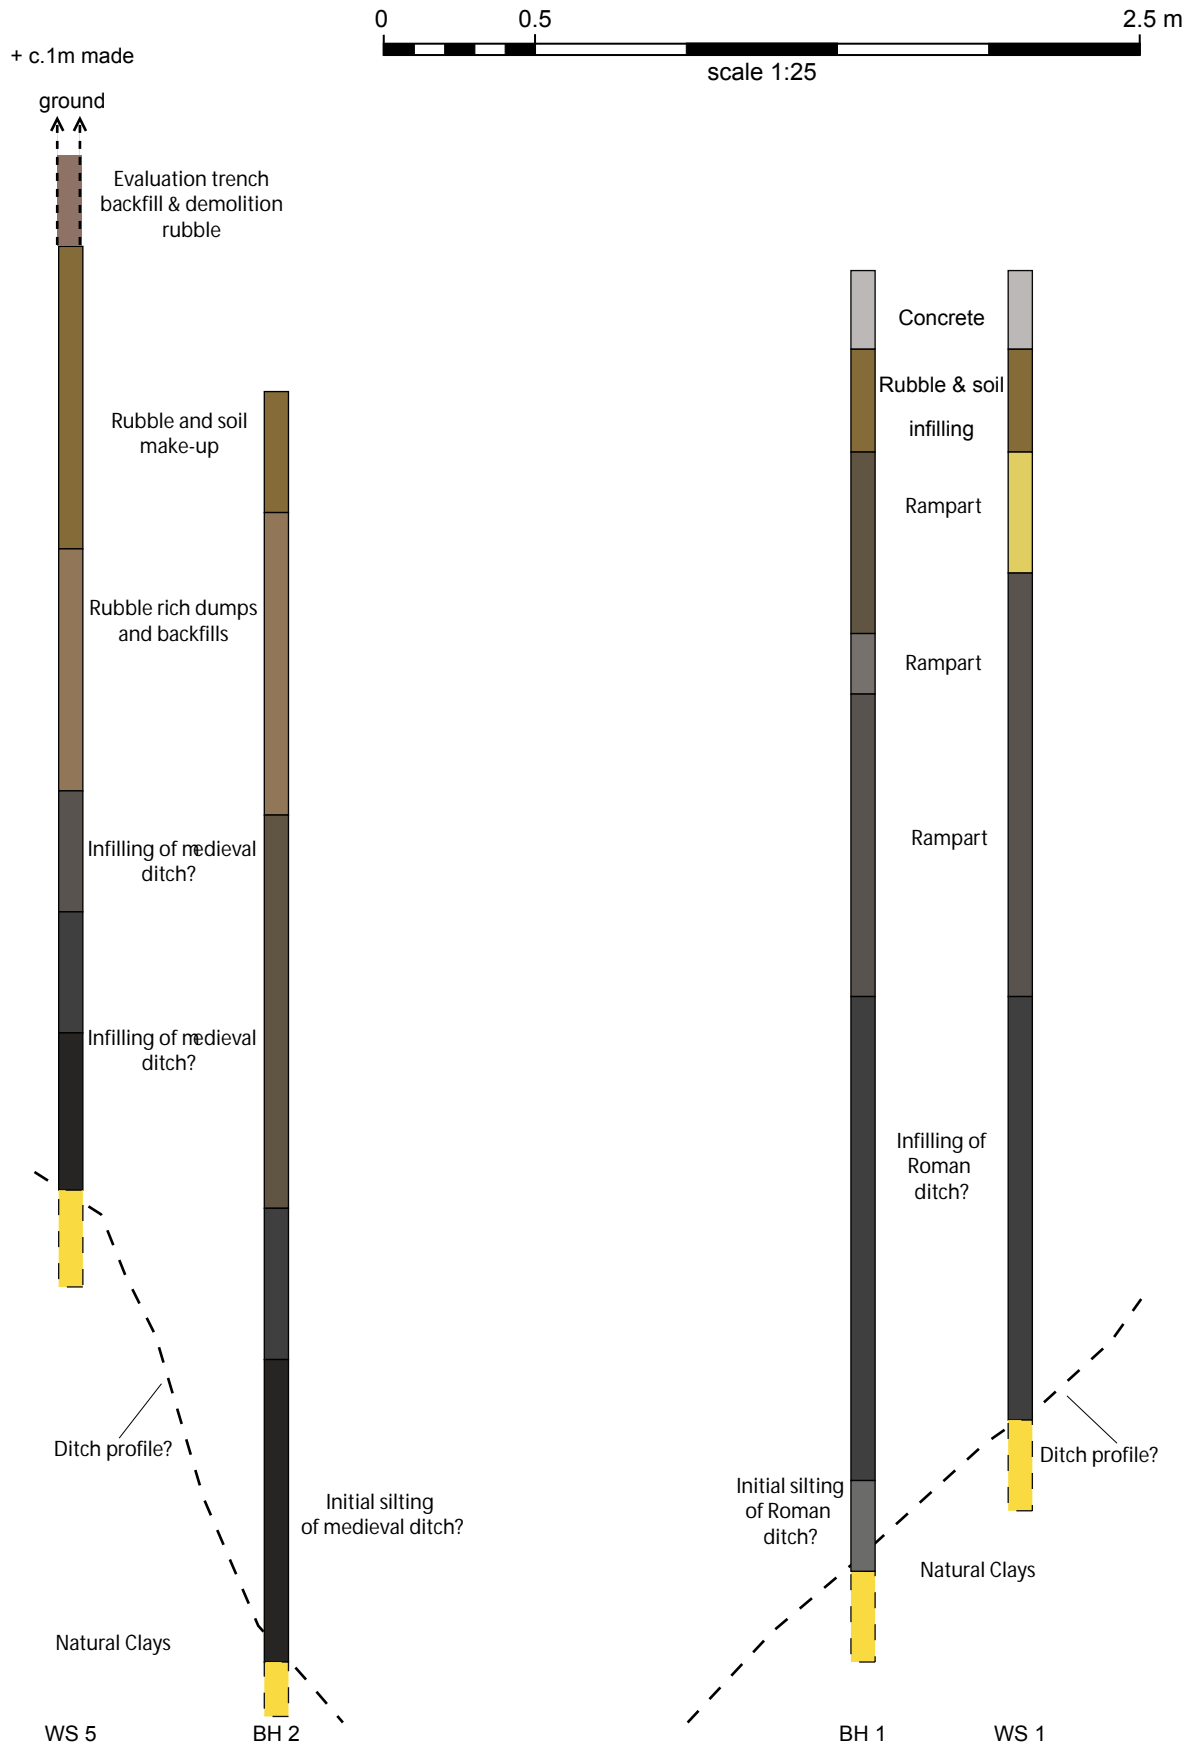
Figure 3: Boreholes and window samples

The uppermost deposit to be observed was a dark greyish brown rubble rich soil and was present to a depth of 0.40m BGL. Between 0.40m and 1.40m BGL, a greyish brown silty sand with frequent rubble inclusions was present. This was interpreted as silting/infilling of the medieval ditch. Below this, present to a depth of 2.70m, was a more rubble rich deposit most likely of similar function and date.

Between 2.70m and 3.20m BGL, a layer of dark organic silt was observed. This could be evidence of the initial silting/infilling of the medieval ditch. Beneath this layer, a very dark layer of further organic silting was present to a depth of 4.20m at which point natural clays were reached.

The results of the archaeological watching brief discussed above have provided a valuable insight into the nature of the archaeological resource on the former Monk Bar Garage site. As the majority of the deposits will not be disturbed by the development, archaeological monitoring of the borehole and window sampling has provided an opportunity to project a deposit model for the site. The profile of the Roman ditch can be inferred from the varying depth of natural deposits across the samples (Figure 3).
