ARCHAEOLOGICAL INVESTIGATIONS AT 24 FOSSGATE, YORK.

WATCHING BRIEF REPORT

Report Number 2015/23 May 2016

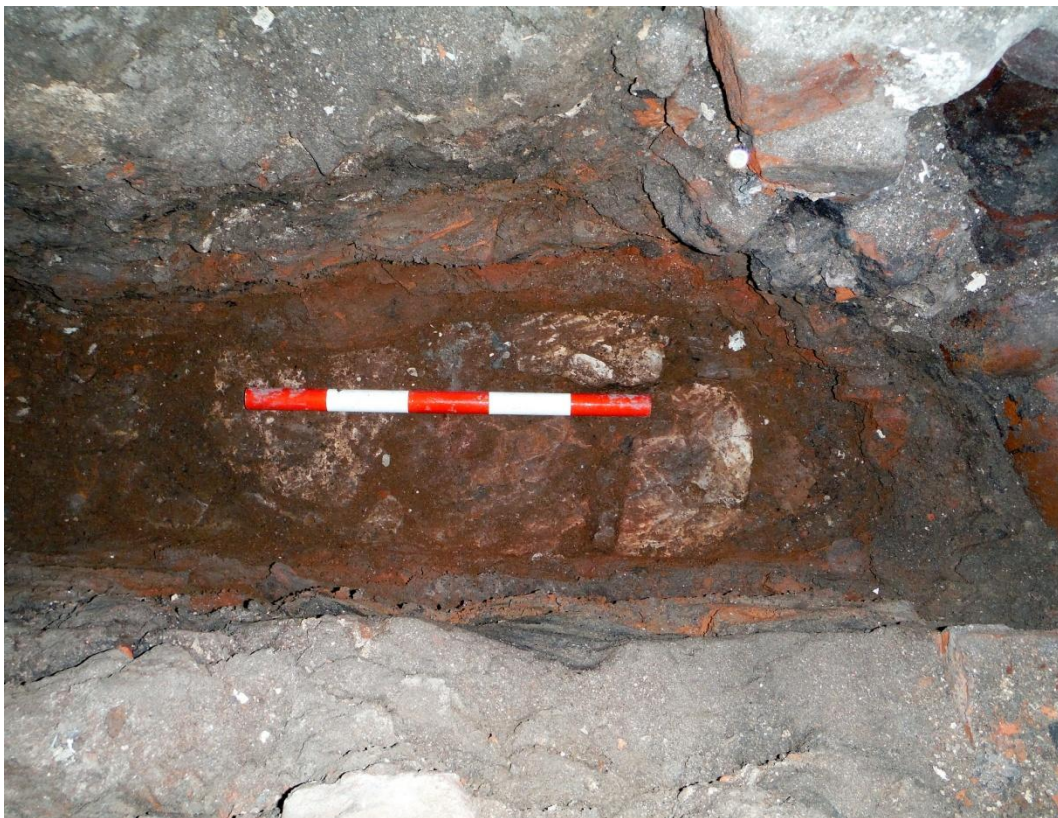
The archaeology changed considerably at approximately 5m back from the front of the building where the bottom of the services cut revealed a tile on edge hearth. This was encountered at c.800mm BGL and continued beyond the limits of the trench both north and south. Burnt material from this extended further to the west but it was not possible to determine precisely how far due to later disturbance. This can be seen in Plate 3 indicating the survival of the hearth in relation to a later drain. To the west of the drain, where it had not disturbed lower deposits, the hearth had been laid upon a flat limestone footing (Plate 4).

Plate 4 Base for tile on edge hearth, room 1. Facing North, scale unit 100mm

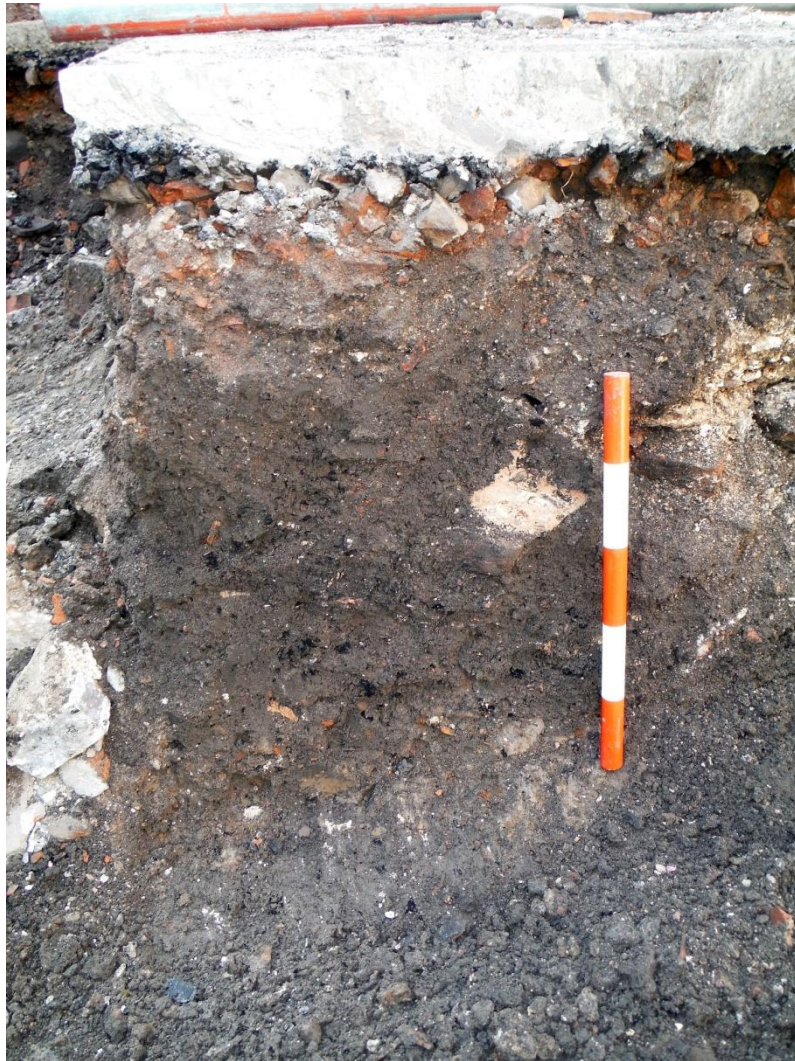
Above the horticultural soil the uppermost 350mm was comprised of 100mm of disturbance, possibly linked with 19th century construction, then 150mm of rubble make up for a 100mm concrete slab (the present day ground surface). See Plate 9 for full soil profile.

Plate 9 Footing section through horticultural deposits. Facing south, scale unit 100mm
