ARCHAEOLOGICAL INVESTIGATIONS AT THE FORMER FIRE STATION, CLIFFORD STREET, YORK

EVALUATION REPORT

Report Number 2015/43 September 2015

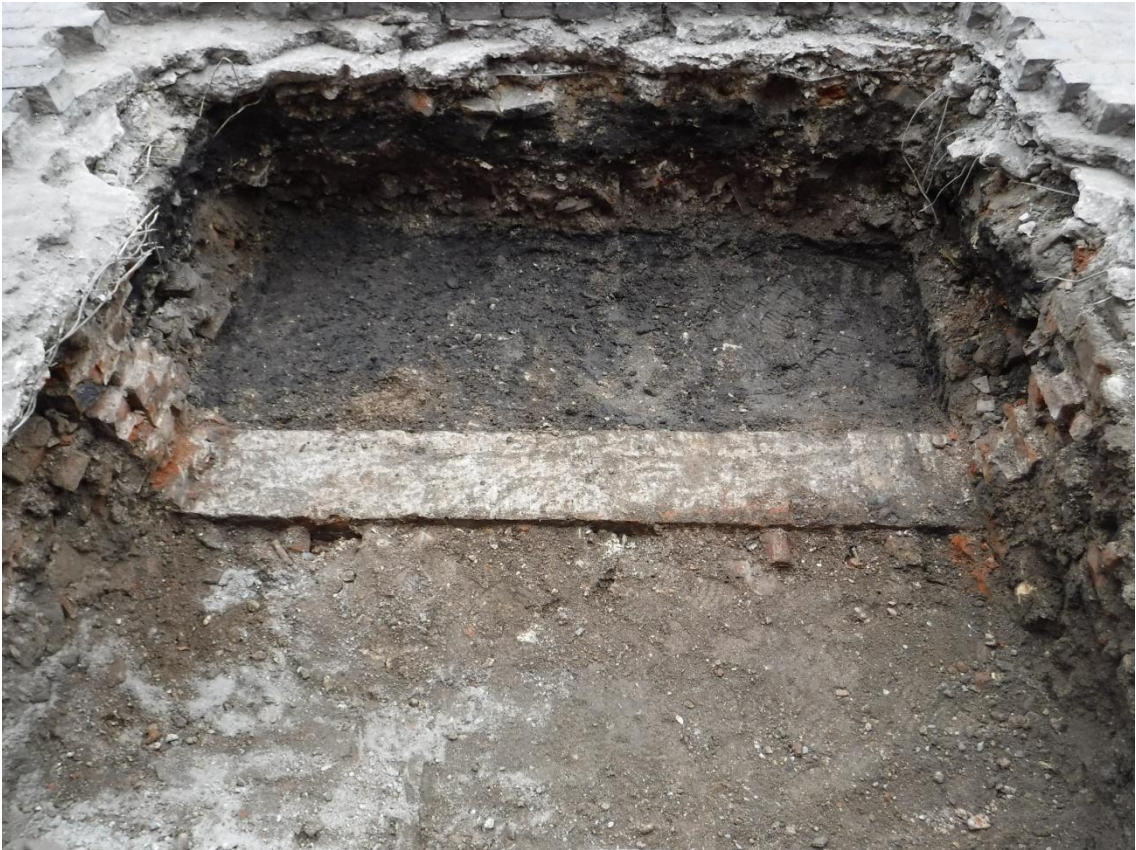
Plate 1 Trench 1 general view looking NE

Trench 1 was located towards the north-east end of the site on the Clifford Street frontage of the Former Fire Station. It measured 3m x 3m and was excavated to a depth of 1.25m BGL (Below Ground Level) or 9.86m AOD with the top of the trench at 11.06m AOD (Figures 1 and 3 ; Plates 1-2).

The cobble sets, context 1001, that form the existing forecourt on the Clifford Street frontage of the Former Fire Station were removed by hand before the commencement of machine excavation of Trench 1. Two underlying layers of concrete were broken out with a pneumatic breaker. The resulting rubble was then removed with a 0.8m toothed bucket, below which a 1.4m wide flat bladed ditching bucket was used for the remaining excavation.

The earliest deposit encountered, context 1007, was located across the north-east half of the trench. It consisted of firm dark grey brown clayey silt and was interpreted as a garden or horticultural soil. This deposit had been truncated in the south-west half of the trench by the construction of a brick wall, contexts 1010, 1011, 1012 and 1013, and associated construction material, context 1009, on the south-west side of the wall (Plate 1). Orientated on a north-west to south-east axis, the wall extended along the entire length of the trench and was seen

to continue beyond it in both sections. The base of the wall's foundations were observed to extend beyond the lower limit of excavation at approximately 9.9m AOD with the top of the wall surviving to a height of ten courses at 10.79m AOD.

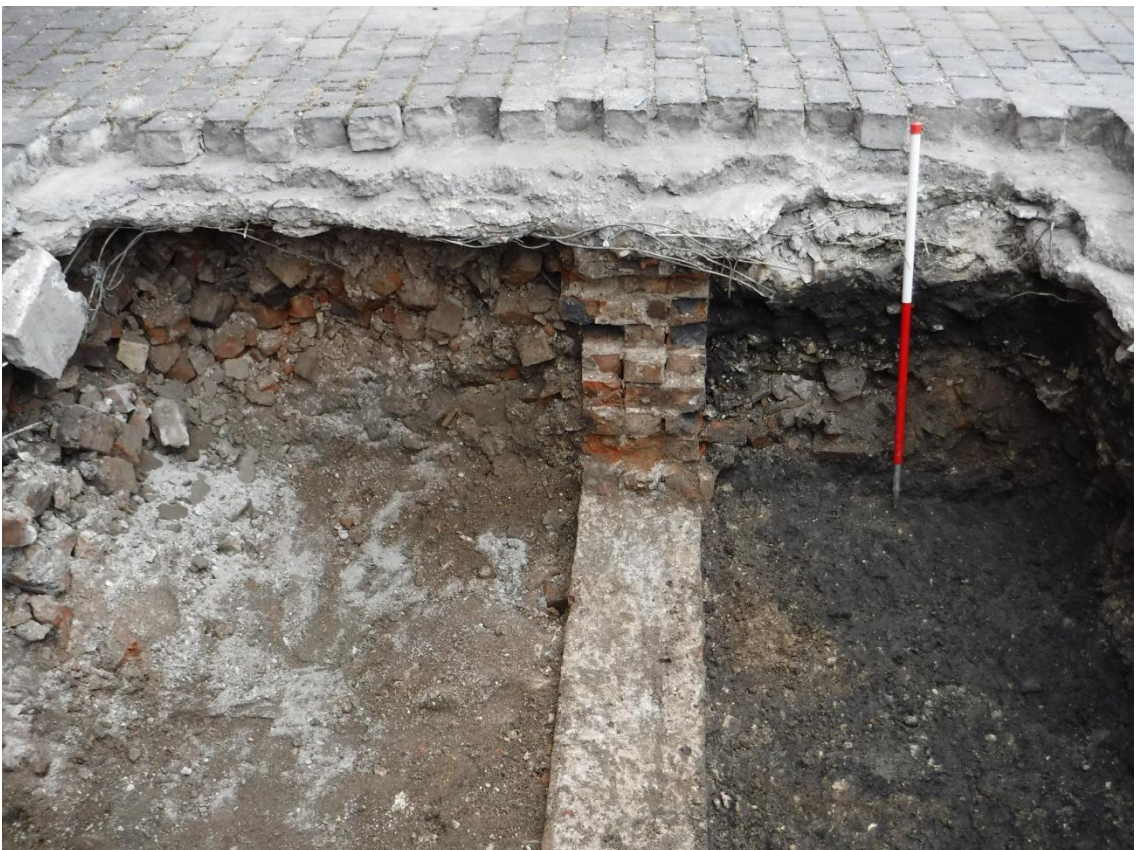
Plate 2 Trench 1 SE facing section

Deposits situated on the south-west of the wall indicate extensive excavation, most likely in relation to the construction of the wall and the structure of which it was a part. Again this material extended below the limit of excavation. Butting up against the north-east side of the wall contexts 1005 and 1006 both contained a large element of brick rubble and are likely to relate to the construction of the wall or levelling up along the Clifford Street side of that structure.

Material most likely deriving from the demolition of the structure, context 1008, was seen to be infilling a space in the east corner of the trench extending to a point where it butted up against the south-west side of the wall.

Overlying the demolished structure were deposits relating to the existing cobble set hard standing. These included two distinct layer of concrete, contexts 1002 and 1003, of which the lower layer was reinforced with a steel mesh.

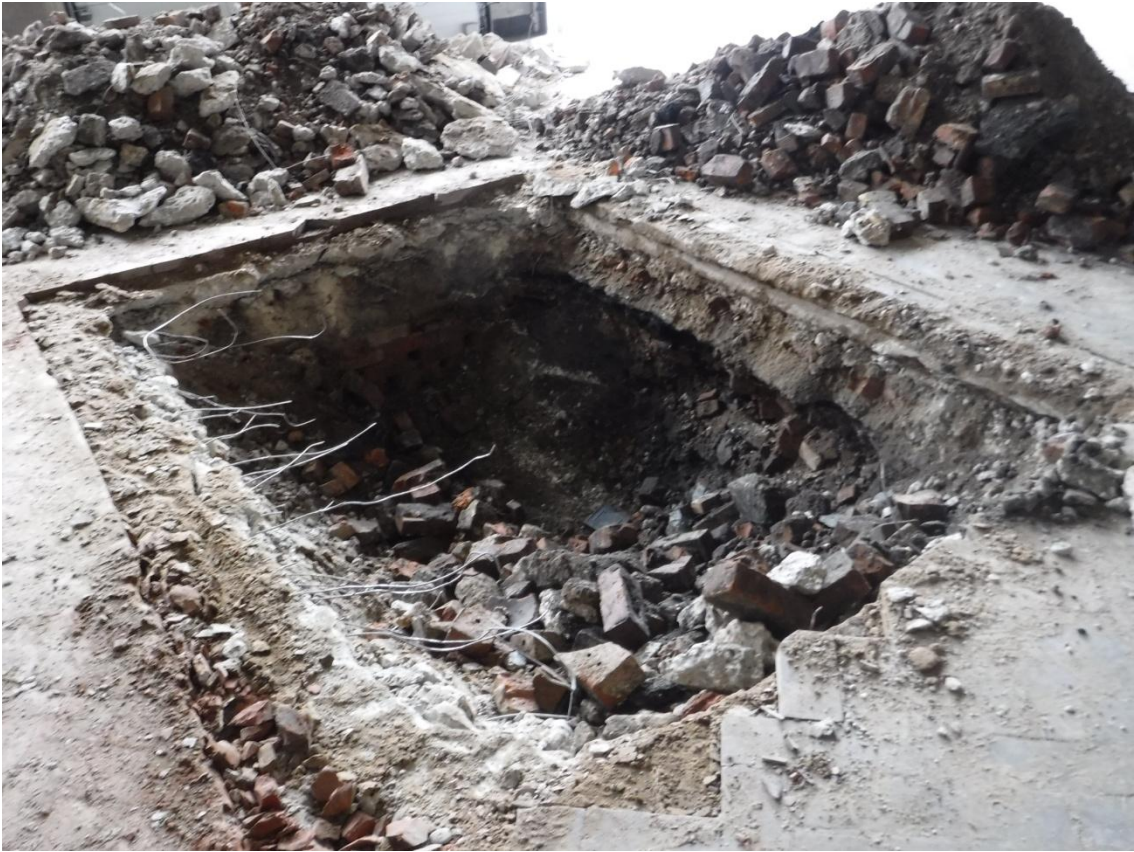
Plate 3 Trench 2 general view, looking east

Trench 2 was located within the Fire Station building as close as was practicable to the neighbouring Magistrates Court (Figures 1 and 3; Plates 3-4). It measured 3m north-east to south-west and 2.8m north-west to south-east and was excavated to a depth of 1.25m. The foreshortened axis was due to available space being limited by a vehicle inspection pit, situated on the north-west side of the trench, and a surface drain running to the south-east of the trench. The top of the trench was at 11.00m AOD.

Following the breaking out of the current brick set floor and an underlying layer of reinforced concrete it became apparent that safe access would not be possible because of the instability of the trench sides (Plate 2). As a result only a limited record consisting of photographs, observation notes and a measured sketch could be produced.

The trench instability was caused by an approximately 1m thick layer of loose building debris, context 2007.

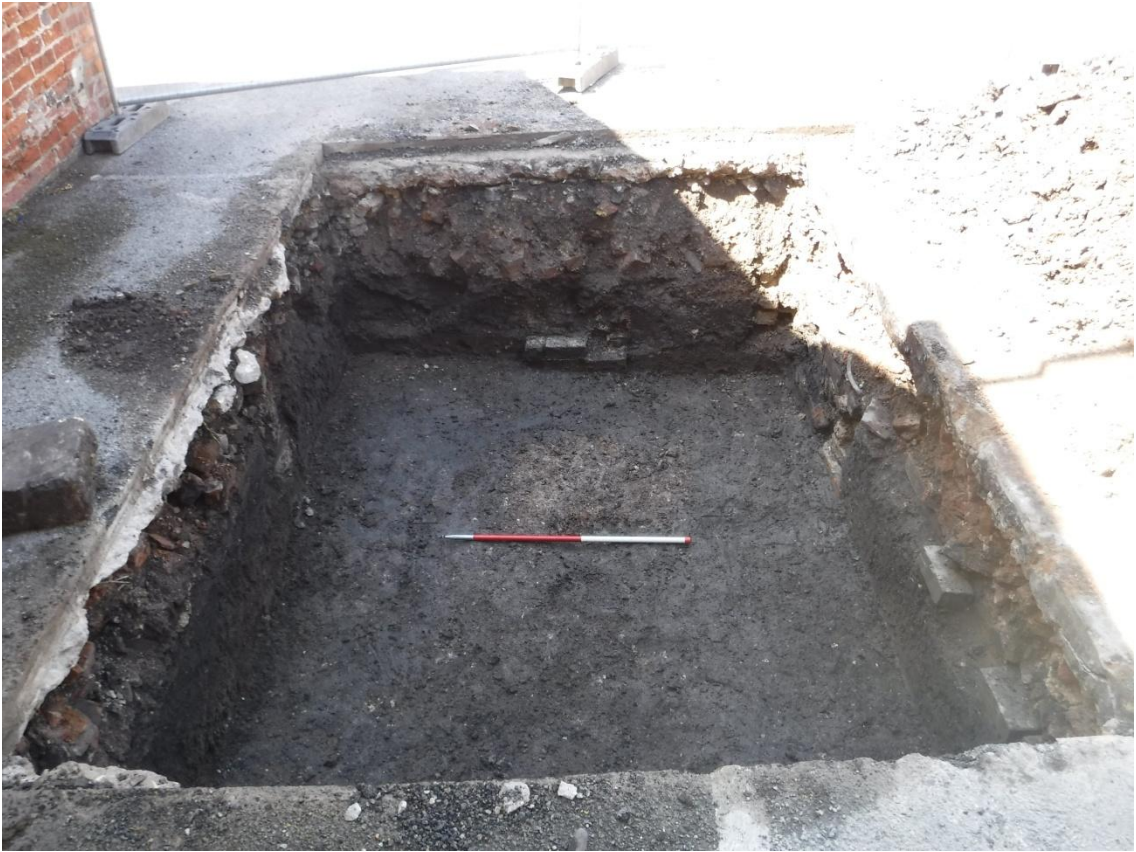
Plate 5 Trench 3 general view looking SW

Trench 3 was located in a car parking area on the south-west side of the main Fire Station building (Figures 1 and 4; Plates 5-7). It measured 4m north-east to south-west and 2.6m north-west to south-east. Time restrictions imposed on the use of the breaker led to alteration

in the dimensions of the trench, the determining factor in the eventual dimensions being the trench location in relation to seams in the layer of concrete underlying the asphalt car park surface. The ground in this area slopes gently down towards the south-west and the river Ouse. At its highest point the top of the trench was at 10.05m AOD, falling to 9.84m AOD at its lowest. At its deepest point the trench was excavated to 8.61m AOD, giving a maximum depth of 1.39m, in its east corner.

A mechanical excavator employing a 0.6m wide toothed bucket was used to break out and remove the car park surface and an underlying layer of concrete, together with a thickness of approximately 0.2m. A further 0.4m – 0.5m of brick rubble, context 3003, was removed in the same way. Once structural remains were encountered further excavation was undertaken with a 1.4m wide flat bladed ditching bucket. This methodology was used for the remaining depth of the trench.

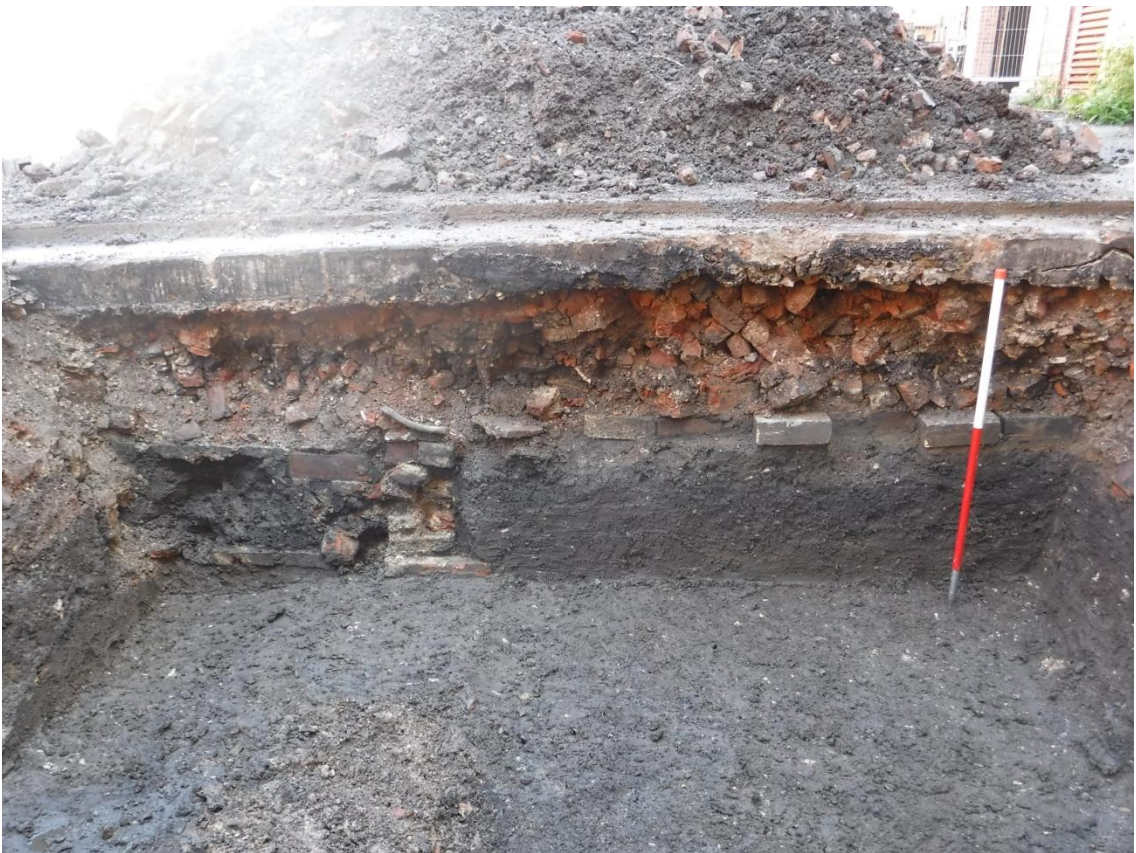
Plate 6 Trench 3 SW facing section

The earliest feature encountered was an oval pit, context 3015, situated at the depth limit of excavation at 8.67m AOD. This contained context 3014 a single backfill consisting of light brown clayey silt with inclusions of mortar. Overlying this feature was context 1012 a firm, mid brown grey clayey silt. Up to 0.28m thick this deposit sloped down to the south-west from a maximum height of 9.05m AOD to 8.71m AOD. Its density is considerably greater than the later soils above it and as such its character is broadly in line with local late medieval and early post-medieval soil accumulations. Overlying this material was a deposit of garden or horticultural type soil, contexts 3007 and 3019, which measured between 0.25m and 0.45m thick. The top of these deposits appear to have been levelled off by later structures, surfaces and demolition activity giving a relatively flat profile the top of which ranged between 9.15m to 9.33m AOD.

The structures consisted of three brick built walls. Wall 3005 ran along a north-west/south-east alignment, bonded into this and extending on a perpendicular line to the south-west was wall 3022. Both extend beyond the limits of excavation. Another brick wall, context 3016, was only identified in the north-east facing section of the trench. This feature had been extensively robbed out; only two courses remained in section and were not observed to extend further to the north-east during the course of excavation.

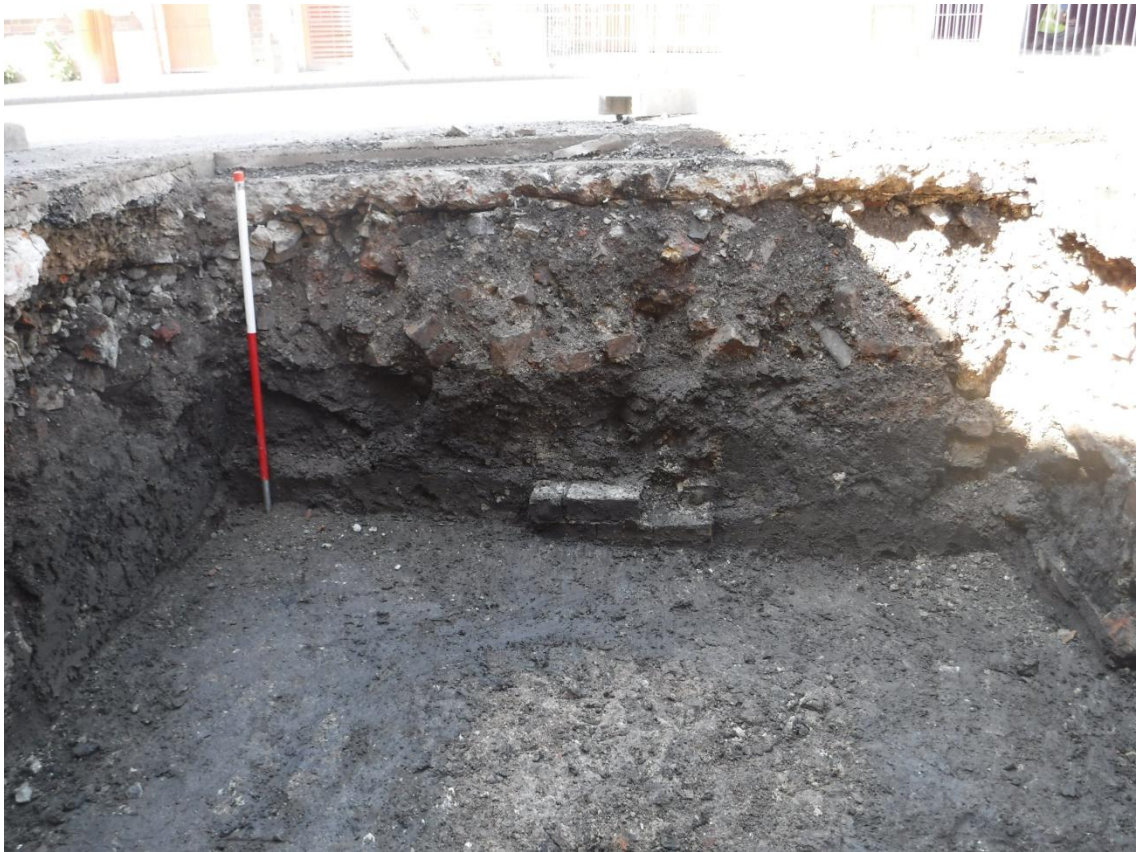
Plate 7 Trench 3 SE facing section

Abutting the north side of the junction of wall 3005 and 3022 was a drainage feature with a ceramic drain cover. This was cutting through or abutted by a thin concrete surface. Seen in section this appeared to continue to the north and west. The top of these features were at 9.21m AOD. Also extending from the south-east facing section of the trench was a brick set surface, context 3004. It was situated to the north-east of the walls at 9.39m AOD. These structures were sealed by context 3003 a layer of brick rubble approximately 0.5m thick.

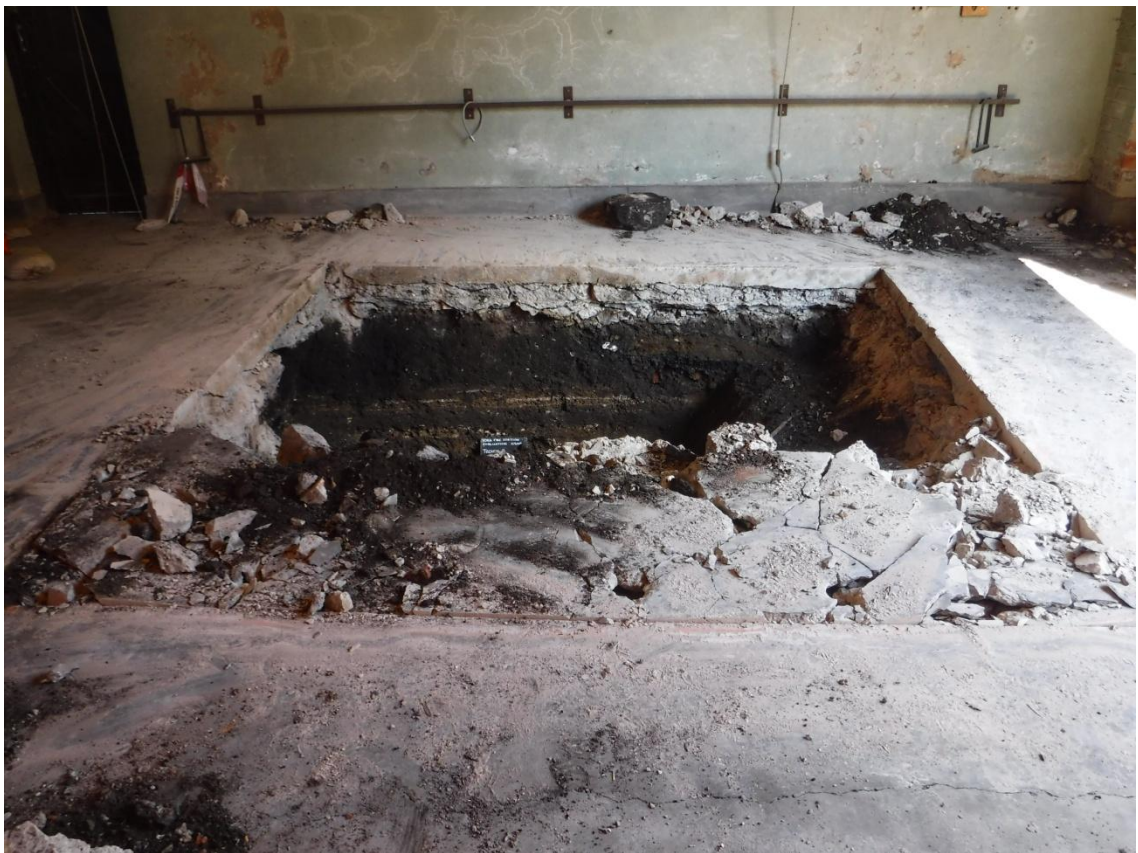
Plate 8 Trench 4 general view looking NE

Trench 4 was excavated inside the garage located at the south-west end of the site (Figures 1 and 5; Plates 8-9). Only a 1.2m wide slot along the north-west side of the trench could be excavated due to the restricted working space. The garage floor consisted of a 0.3m thick layer of concrete. After this material had been broken out excavation of the trench was carried out using a 0.8m wide toothed bucket enabling the south-east facing section of the trench to be recorded. The top of the trench was at 8.69m AOD, at its deepest point it was excavated to 7.49m AOD.

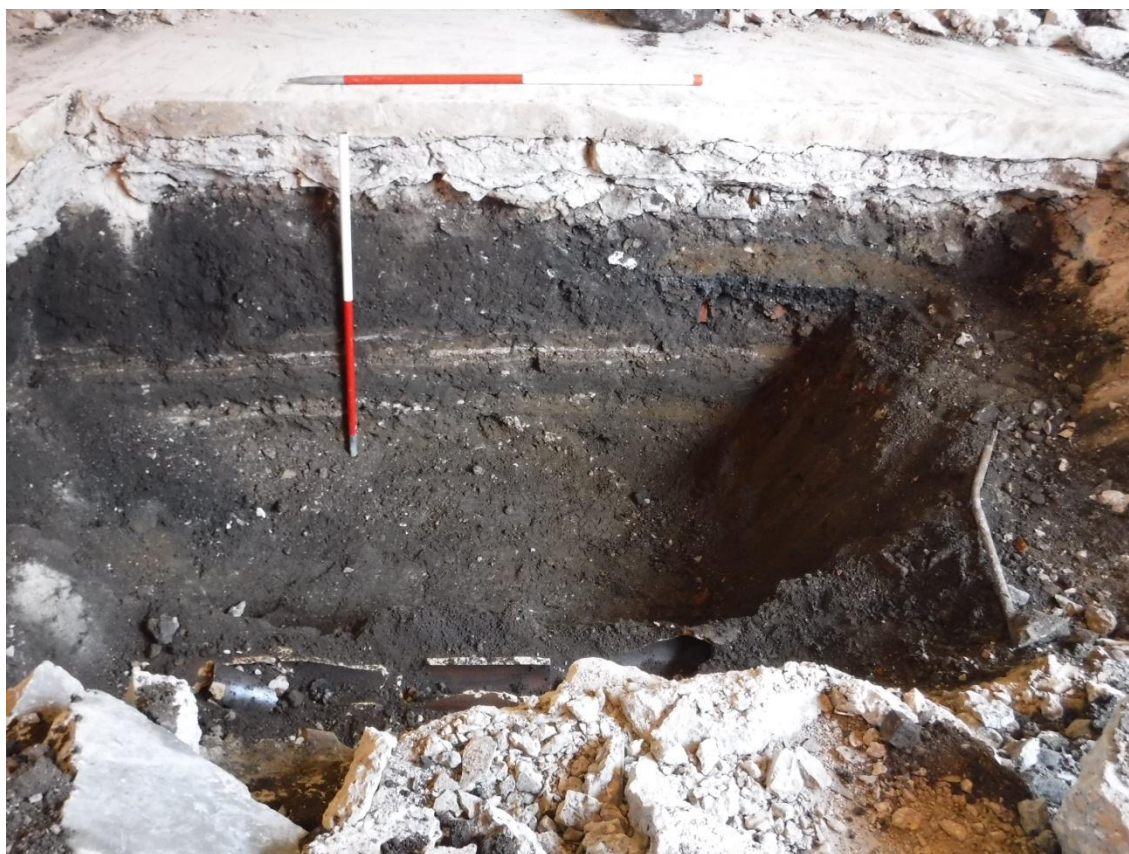
Plate 9 Trench 4 SW facing section

A sequence of dumps constituted the earliest deposits in this trench. The top of these deposits extended up to 8.01m AOD with a very slight downward trend to the south-west. No dateable material was retrieved. Above these deposits and extending up to 8.40m AOD was context 4009, a friable mid brown silty sand deposit interpreted as a garden or horticultural soil. The top of this material was disturbed by what may possibly be a cinder path, context 4006, and 19th century services.

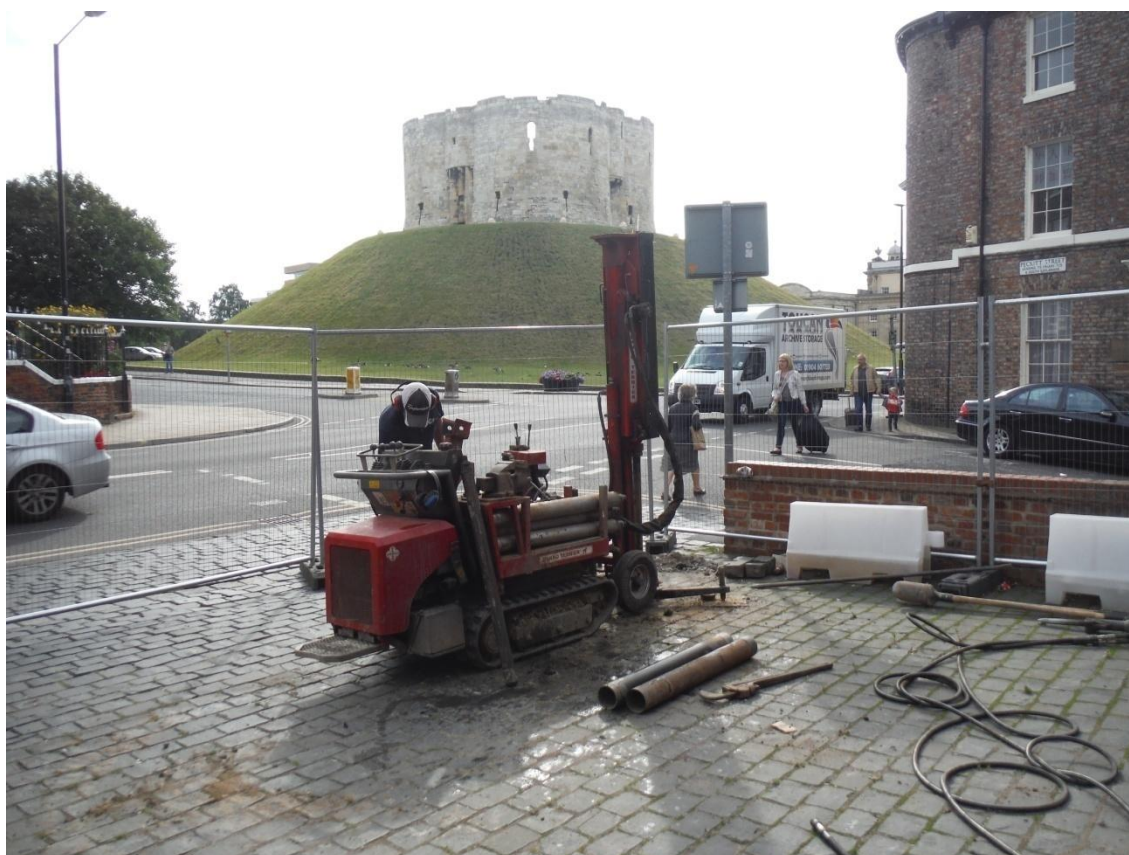
Plate 10 Borehole 1 during drilling

Five boreholes were drilled across the site, forming a transect aligned NE-SW (Figure 2; Plate 10). Borehole 1 was drilled as close as possible to the Clifford Street frontage. Boreholes 2-5 were drilled through each of the four excavated trenches. The original WSI stated that 12 boreholes would be drilled; after discussion with City of York Archaeologist John Oxley regarding the physical access and noise restriction constraints present on the site, this number was reduced to 5.

Each borehole was drilled to a depth of at least 8m Below Ground Level (BGL). Greater depths were attempted but below c.9m BGL the holes began to collapse, rendering deeper survey impossible.

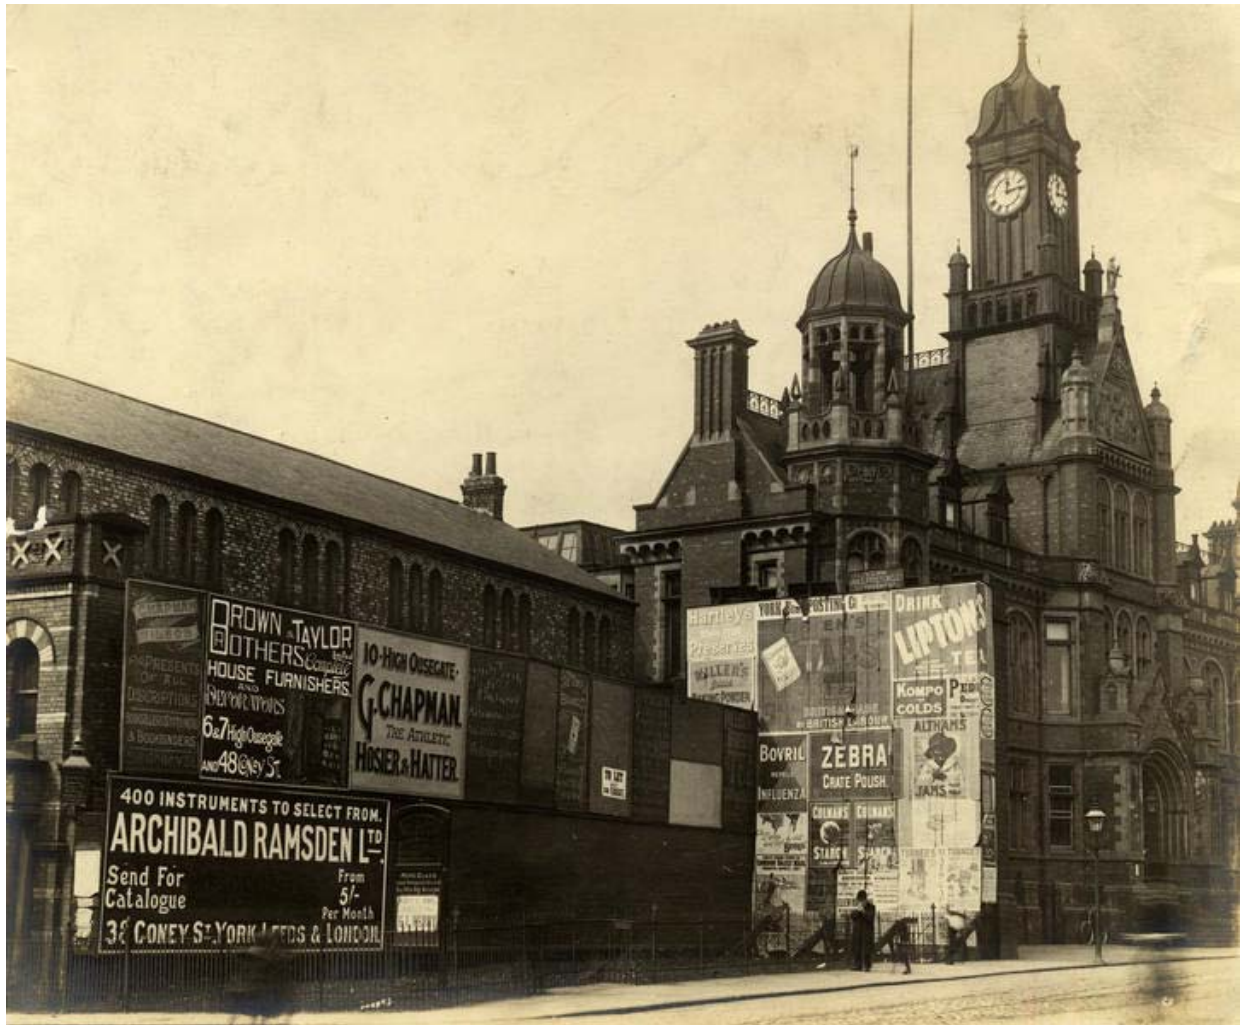
Figure 10: Trinity Chapel Showing aisle wall behind hoarding prior to demolition (Image from City Archives)

The 19th century wall observed in trench 1 is probably the aisle wall of Trinity Chapel, which was demolished when the building was converted for the fire station. 19th century pottery was recovered from the demolition deposit, 1008, but this is clearly residual as the demolition date is known to be 1935. The location of this wall can be inferred from historic photographs showing it being used for billboard posters prior to the expansion of the fire station (Figure 10). The walls identified in Trench 3 are also of probable 19th century date and may represent structures relating to the chapel.
