ARCHAEOLOGICAL INVESTIGATIONS AT THE MANSION HOUSE, YORK

ARCHAEOLOGICAL WATCHING BRIEF REPORT

Report Number 2016/27 June 2016

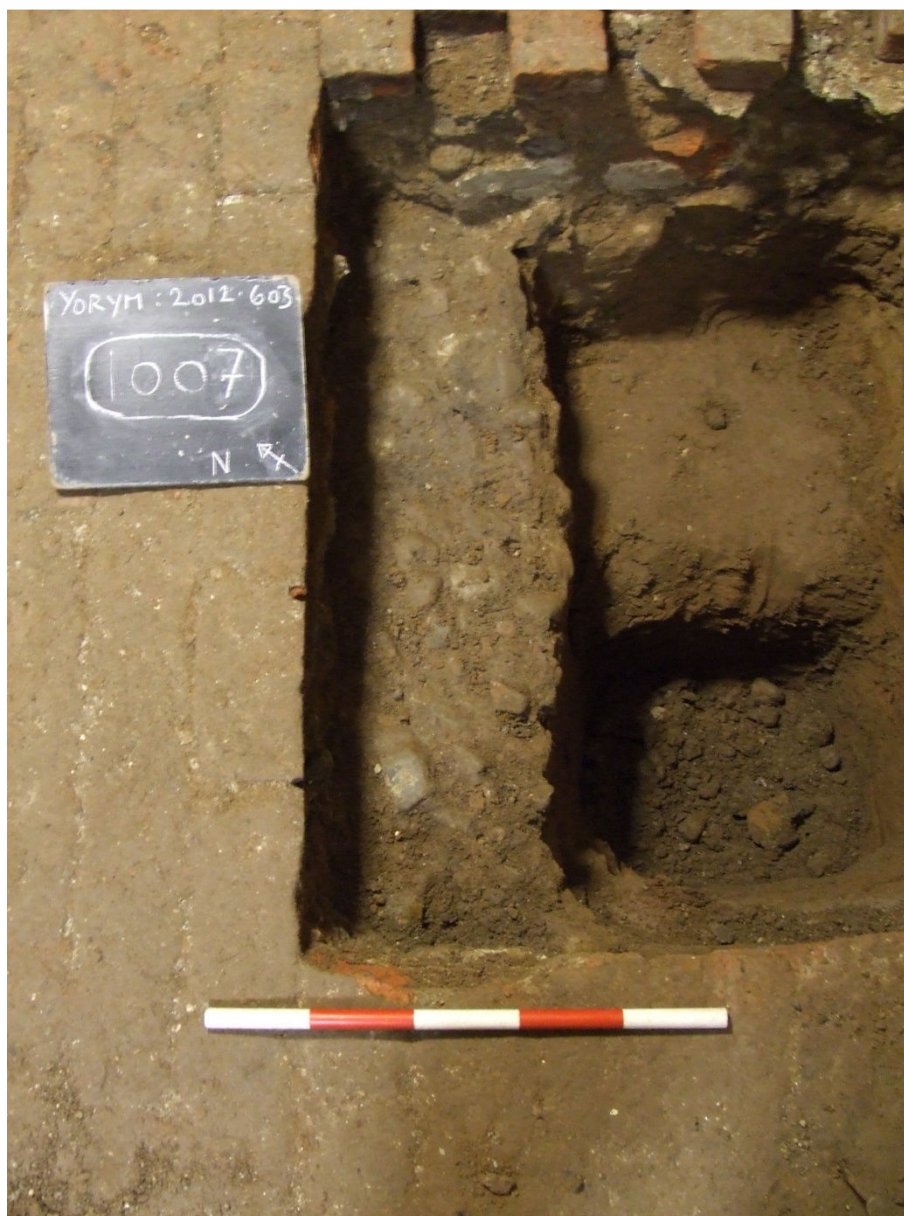
Plate 1 - Trial Trench 1 2012 works, cobbles set into clay (context 1007) possibly as part of a road make-up or surface, facing north-east, 0.1m scale units

In 1993 YAT undertook a watching brief which exposed the cobble foundations of the standing building (YAT project 1993.5, YAT Gazetteer). More recently, in 2012, a small 1m² trench excavated through the brick floor of the cellar exposed natural deposits c.400mm below the surface, suggesting other archaeological deposits had been removed during its construction (Whyman 2012, 22). Context 1007, a compacted layer of cobbles c.0.1m thick, was observed situated directly above natural deposits and to extend below the cellar wall (Figure 3, Plate 1). Proving whether this layer was part of an earlier cellar floor or a surface pre-dating the Mansion House was not possible as no dateable material had been recovered.

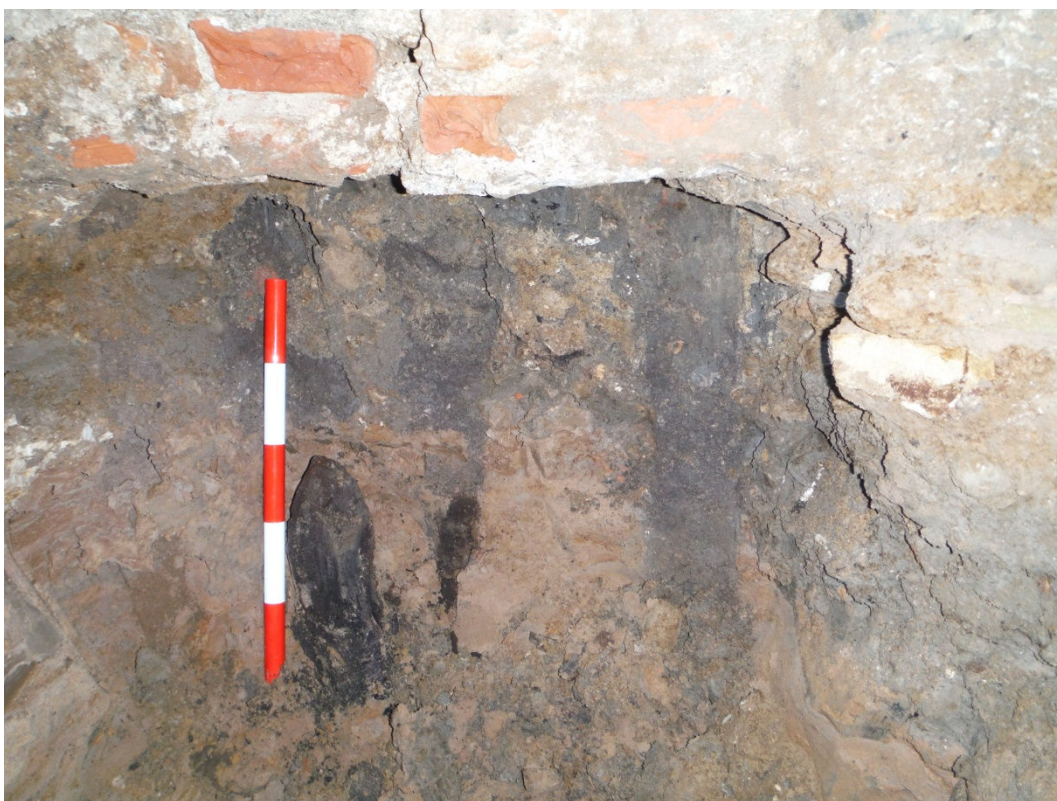
Plate 2 - Wooden stakes (contexts 3006 and 3007) below 18th century wall footings, facing south, 0.1m scale units

The disturbance of the cobble layers may relate to a series of square timber stakes that appear to have been driven through them and on into the natural below (Figure 4, Plate 2). The stakes measured c.100mm wide and in excess of 500mm long and were exclusively found below the north-west/south-east aligned cellar wall. As they continued below the excavation depth limit required for the underpinning they were not fully excavated. These stakes were interpreted as markers laying out the original foundations as they appear to lack the necessary size and strength to fulfil a structural role as piles to support the foundation.

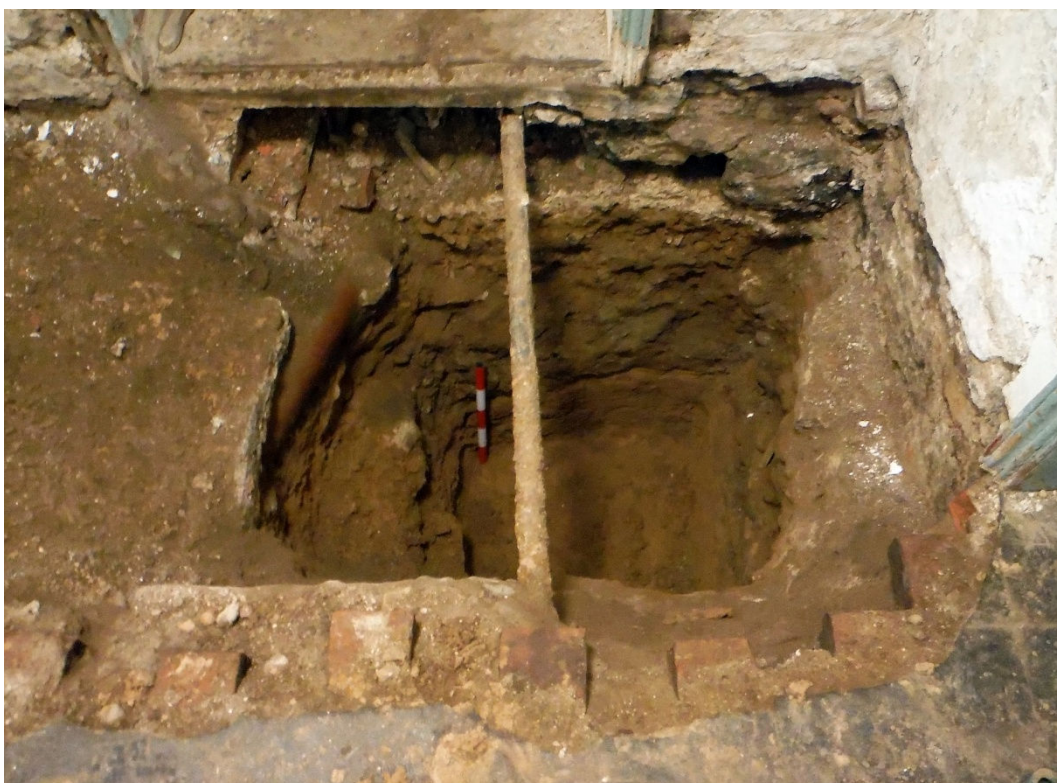
Plate 3 - Section 2 Trench 1 showing services, cellar wall foundations, including a layer of mortar (context 3011) overlying cobble layers (contexts 3012 and 3013) and natural, facing south-east 0.1m scale units

Formal construction of the 18th century cellar wall foundations commenced at around 11.50m AOD where a layer of mortar, context 3011, formed the bedding for limestone blocks and then brick coursing. The wall footing had been extensively perforated by drains, pipes and other services (Plate 3).

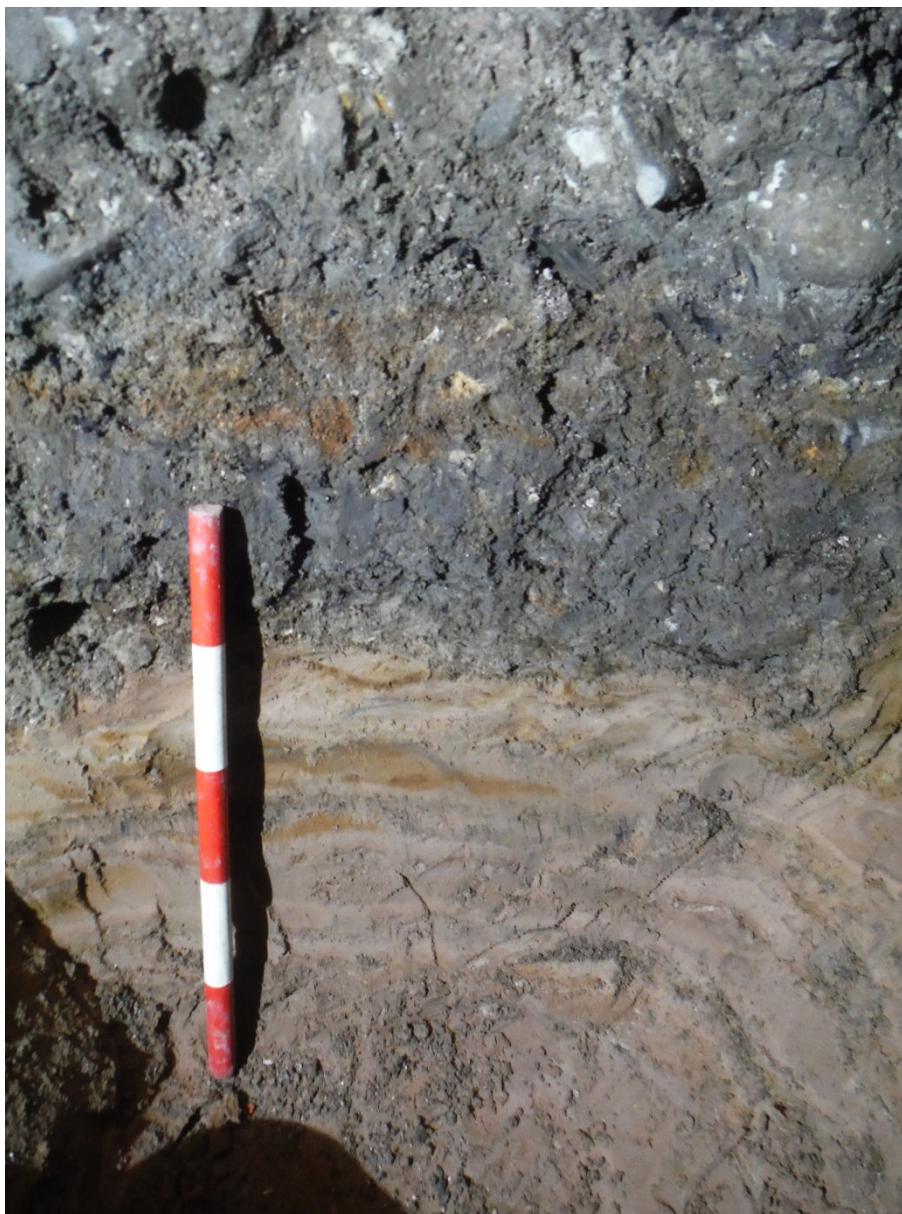
Plate 4 - Trench 2 layers (contexts 4005,406 and 4007) present above natural deposits, facing north-east, 0.1m scale units

Natural clayey sands were encountered at 10.83m AOD, a depth of 1.05m below floor level. Above the natural deposits a succession of sandy silt layers, contexts 4005, 4006 and 4007 was observed in section (Figure 5, Plate 4). The middle of these deposit, context 4006, differed from those immediately above and below. It was orangey brown rather than dark grey in colour, likely as a result of extensive iron panning, and contained a significantly greater gravel content. This layer, which may be the disturbed remains of a surface, extended to c.11.08m AOD.

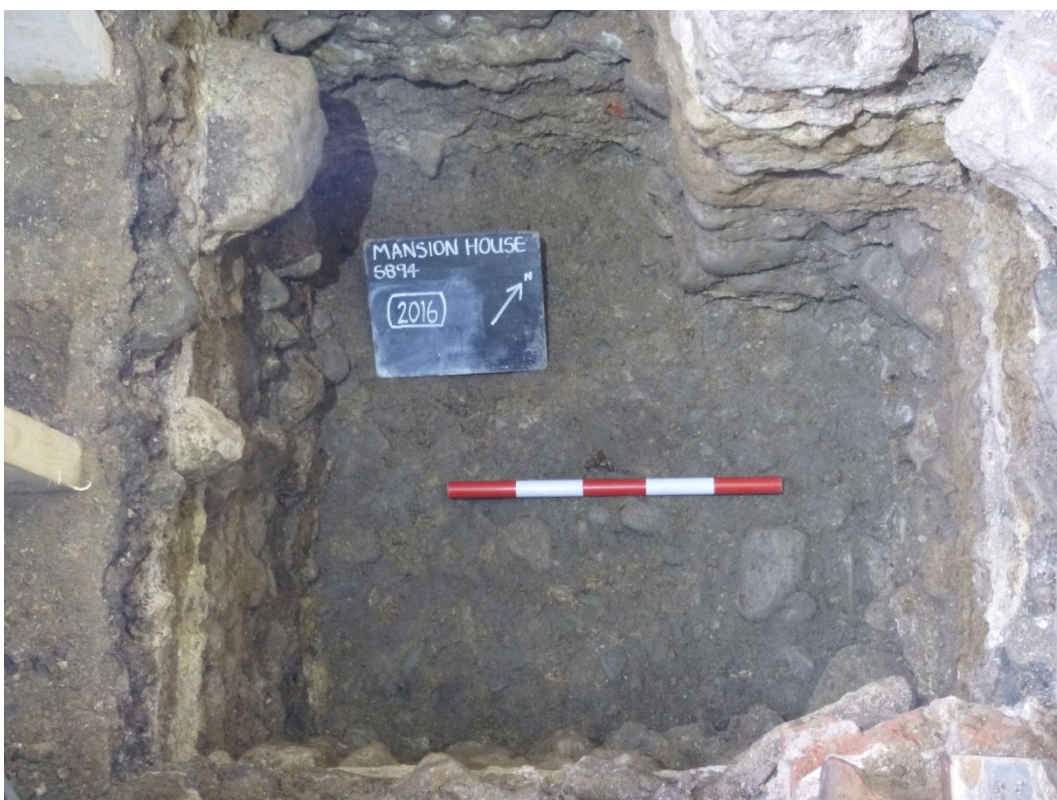
Plate 6 - Trench 3 road surface (context 2016), facing north-west, 0.1m scale units

Present directly above the natural sands was a layer of a large cobbles and limestone fragments overlaid by compacted sand, gravel and small, generally well-sorted pebbles. These deposits, contexts 2016 and 2017, formed what is tentatively interpreted as the earliest road make-up and surface (Figures 6 and 7, Plate 6). This material was up to 0.23m thick, extending up to around 10.60m AOD, and relatively level albeit with some irregularity probably due to abrasion through use. A fragment of a glass melon bead was retrieved from the top of deposit 2017 (Plate 7).

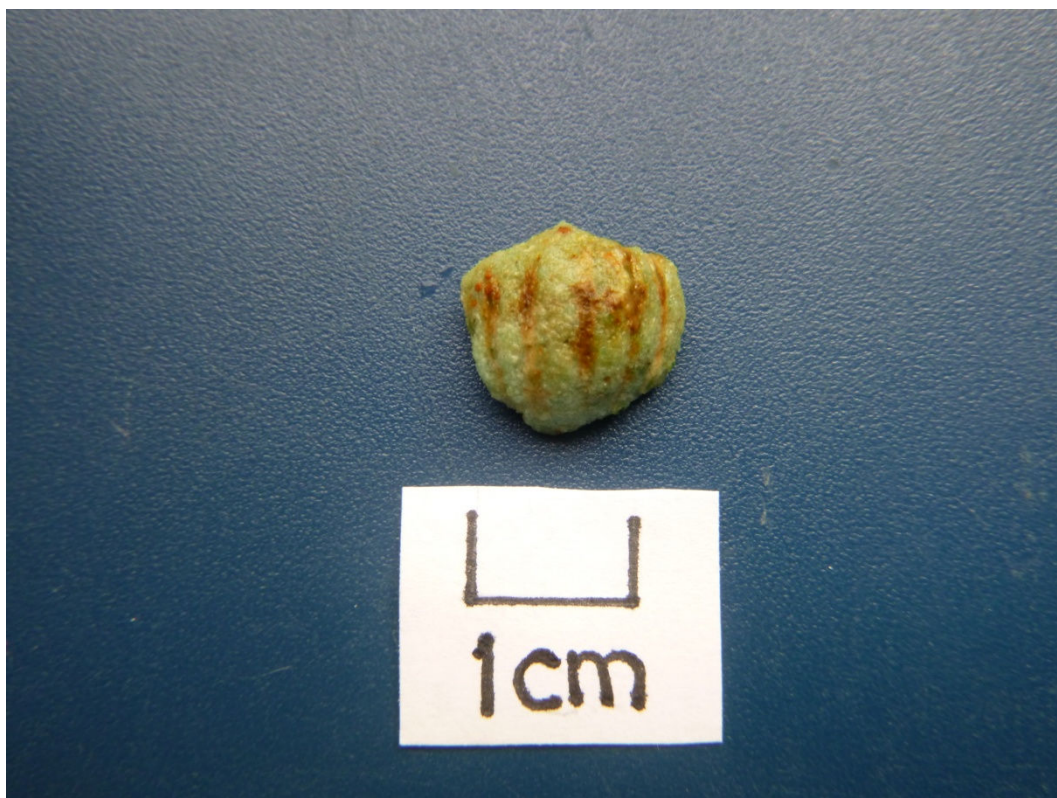
Plate 7 - Melon bead recovered from context 2016

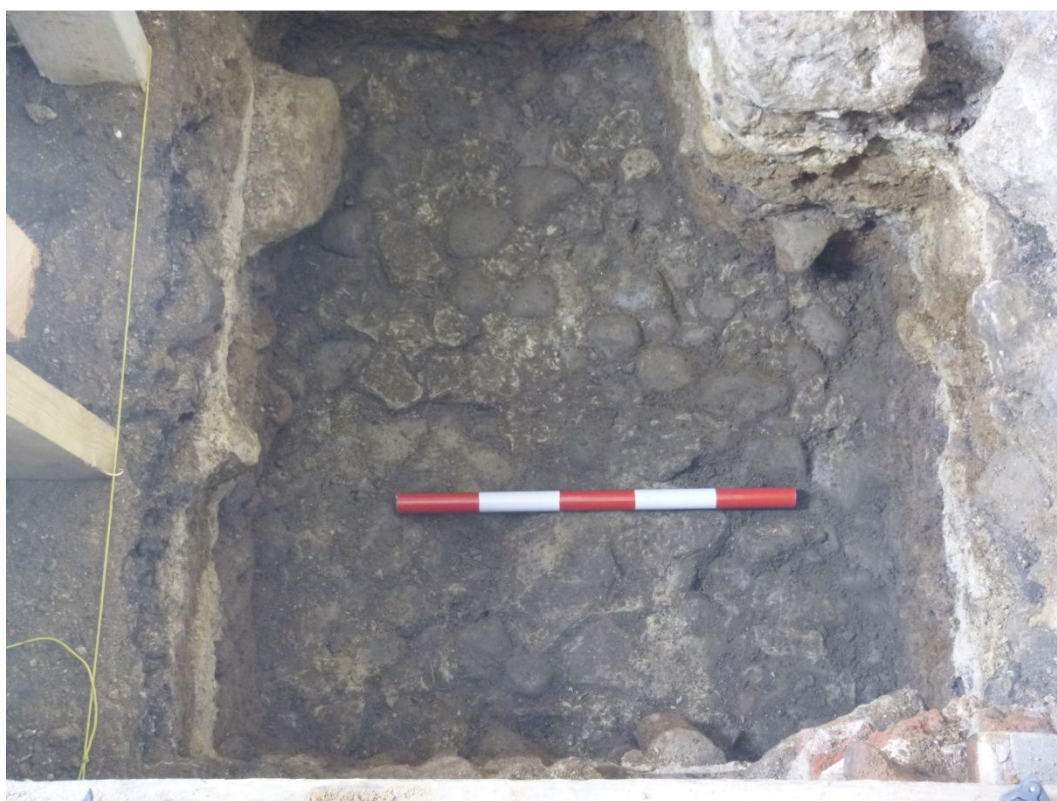
**Plate 8 - Trench 3 road surface (context 2012),
facing north-west, 0.1m scale units**

The next clearly identifiable surface, context 2012, was found at 11.00m AOD, 0.85m BGL, approximately 400mm above the previous road surface (Plate 8). Four distinct layers, contexts 2012-2015, were identified in the make-up of this phase of the road (Figures 6 and 7). The lowest consisted of compacted mortar into which coarse sand, gravel and cobbles had been set. Whilst it is possible that context 2013 constituted a surface, it should be noted although it was extremely compact, the upper surface was clean and did not have a layer of trampled material across it as might be expected. In contrast the upper surface of context 2012 had both well worn cobbles and a thin layer of trample and looser pebbles indicating use. Pottery and CBM recovered from deposits within this phase of the road supports the initial assessment of a Roman date for the construction and use of the road.

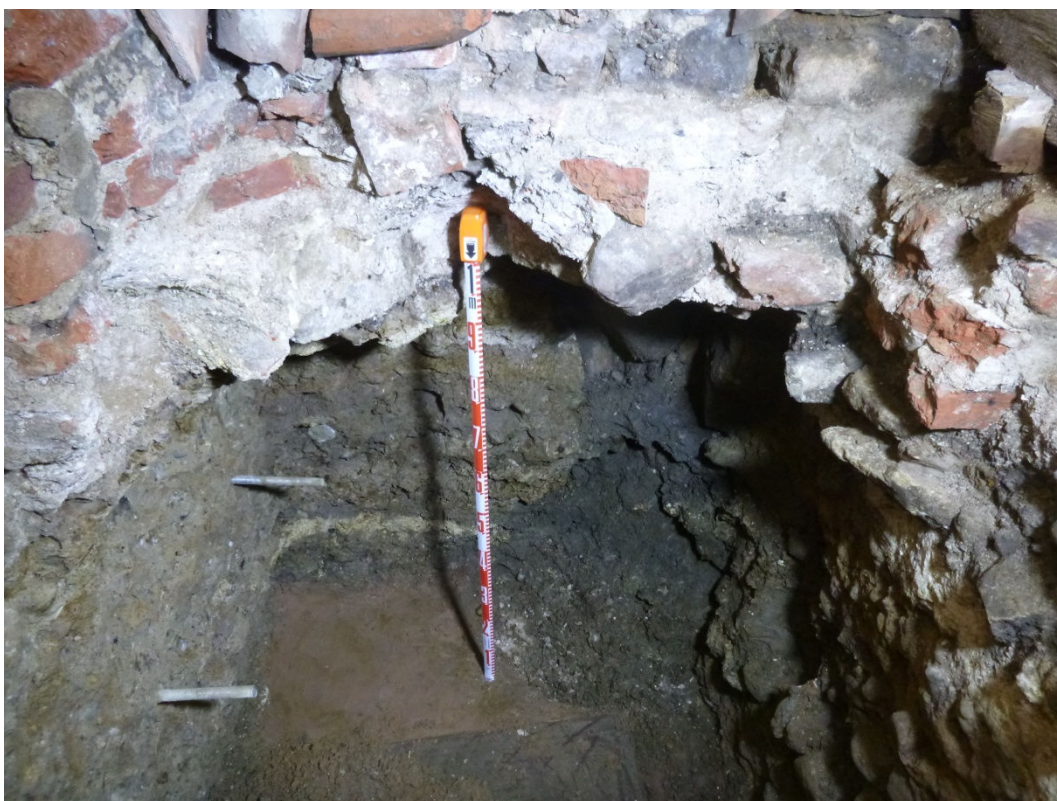
Plate 9 - Section 7 Trench 3, following undercutting of wall foundation, showing medieval pit (Context 2021) cutting a succession of road make-up and surface deposits, facing northeast

Extending in to the eastern corner of Trench 3 was a deep intrusive feature, context 2021 (Figure 7, Plate 9). This feature was backfilled with dark grey silt, pebbles and cobbles. All the road surface and make-up deposits from context 2004 down were truncated by this feature which has been interpreted as a pit.

A deep intrusive feature was observed cutting down through nearly the entire sequence of road make-up and surfaces in the eastern corner of Trench 3. This feature, interpreted as a pit, contained two backfills. Similarities in composition exist between the pit's lower backfill, context 2020, and deposit 4008 located in the southern end of Trench 2. That the two deposits equate is also suggested by their proximity and that both extend beyond the depth of excavation. Interestingly a single large unabraded sherd of 9th/10th century pottery was recovered from context 4008, indicating an early medieval date of deposition. The relationship between the presumed pit, context 4009, and the sandy silt layers in Trench 2 was not clear. This lack of clarity was largely due to the way Trench 2 was dug. The trench was dug in three sections (Figure 5) enabling a staged approach to the underpinning, unfortunately the interface between the layers and the pit fell on the cusp of two underpinning sections. At best it is only possible to suggest that the pit cuts through contexts 4005, 4006 and 4007. If that interpretation is correct it implies that the layers may be pre-conquest in date.

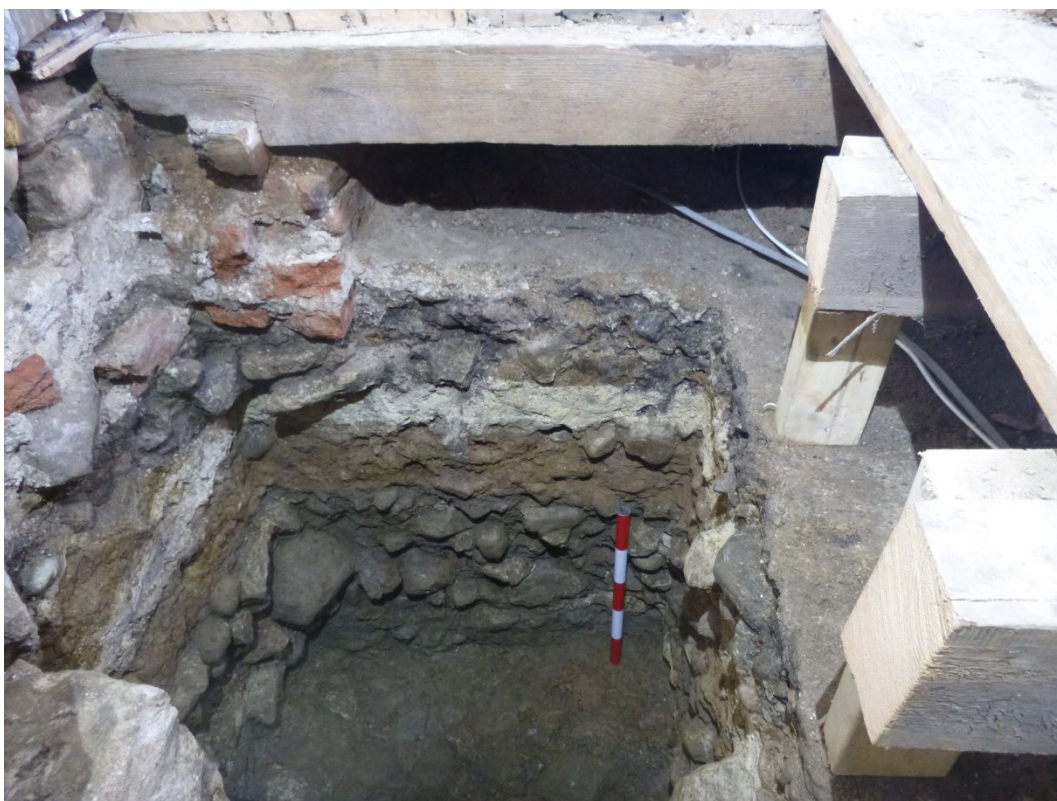
Plate 10 - Section 6 Trench 3, showing a succession of road make-up and surface deposits, facing south-east, 0.1m scale units

The last identified road surface was similar in appearance to that of context 2012, and again a number of distinct layers within the make-up of the main body of the road structure were evident (Figures 6 and 7). In this instance two distinct layers of compacted mortar, contexts 2005 and 2008/ 2009, forming part of the road make-up, were identified. There was a trend for these deposits to tip down a little to the north-west. The upper most deposits, context 2002 and 2003, suggest abrasion and repair to the surface. Together the deposits in this phase of the road measure up to 0.5m thick, extending up to 11.50m AOD, around 400mm below the existing floor level. Taken as a whole the various road make-up and surface layers are approximately 1.05m thick.

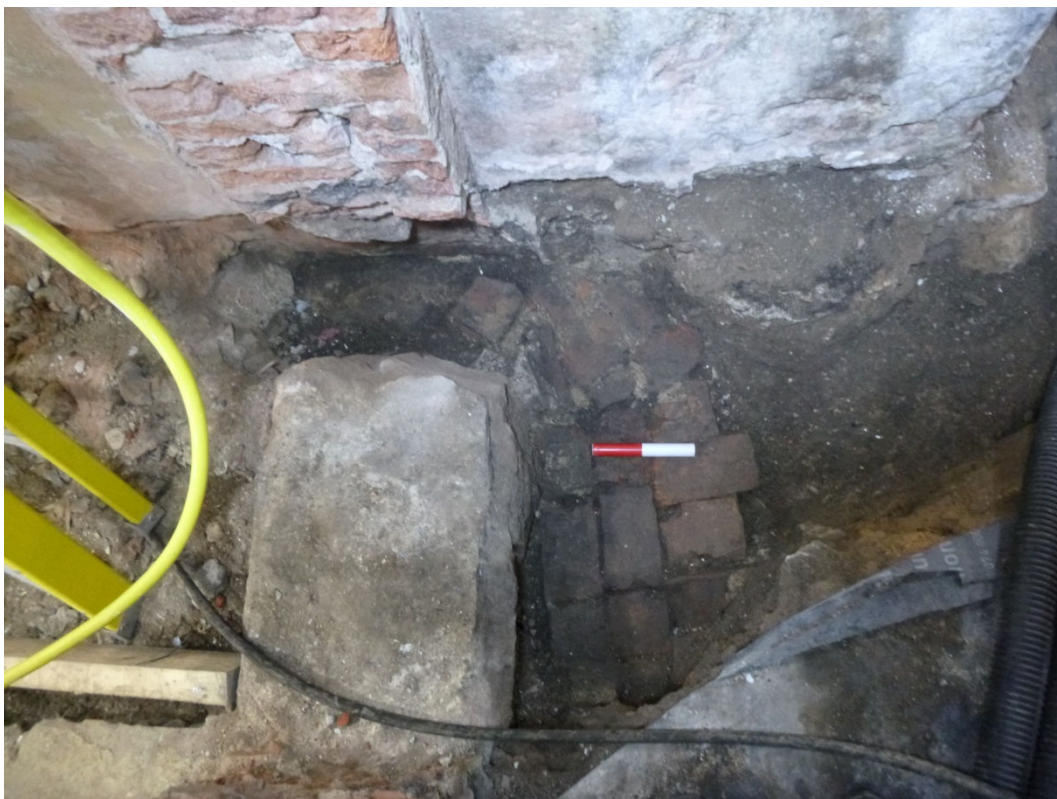
**Plate 11 - Trench 4 brick built drain or culvert,
facing south-west, 0.1m scale units**

north-east/south-west alignment. Lying close to the wall the arrangement of bricks turned to the south-west where there was a break in the wall foundation (Plate 11). The bricks measured 50mm thick, 110mm wide, and up to 200mm long, although none of these was a complete length. There was no indication that the bricks would have continued to the north-west. It is likely this represents the remains of a drain rather than a surface.
