YORK ARCHAEOLOGICAL TRUST REPORT

SITE	204 Mount Vale, York		
CLIENT NAME	Mrs. C. Condon		
YAT PROJECT #	5891	YAT REPORT #	30/2016
MUSEUM ACCESSION #	N/A	GRID REFERENCE	SE 5929 5088
PLANNING REFERENCE #	15/02574/FUL	AAI OPS NOTICE #	N/A

Between 30th March and 4th April 2016 a watching brief on drainage channels and footings for a single storey rear extension to 204 Mount Vale, York YO24 1DL was undertaken by York Archaeological Trust (Figure 1). The objective of the watching brief was to record any archaeological deposits, features or buried structures exposed by the groundworks. The site lies within York's designated Area of Archaeological Importance.

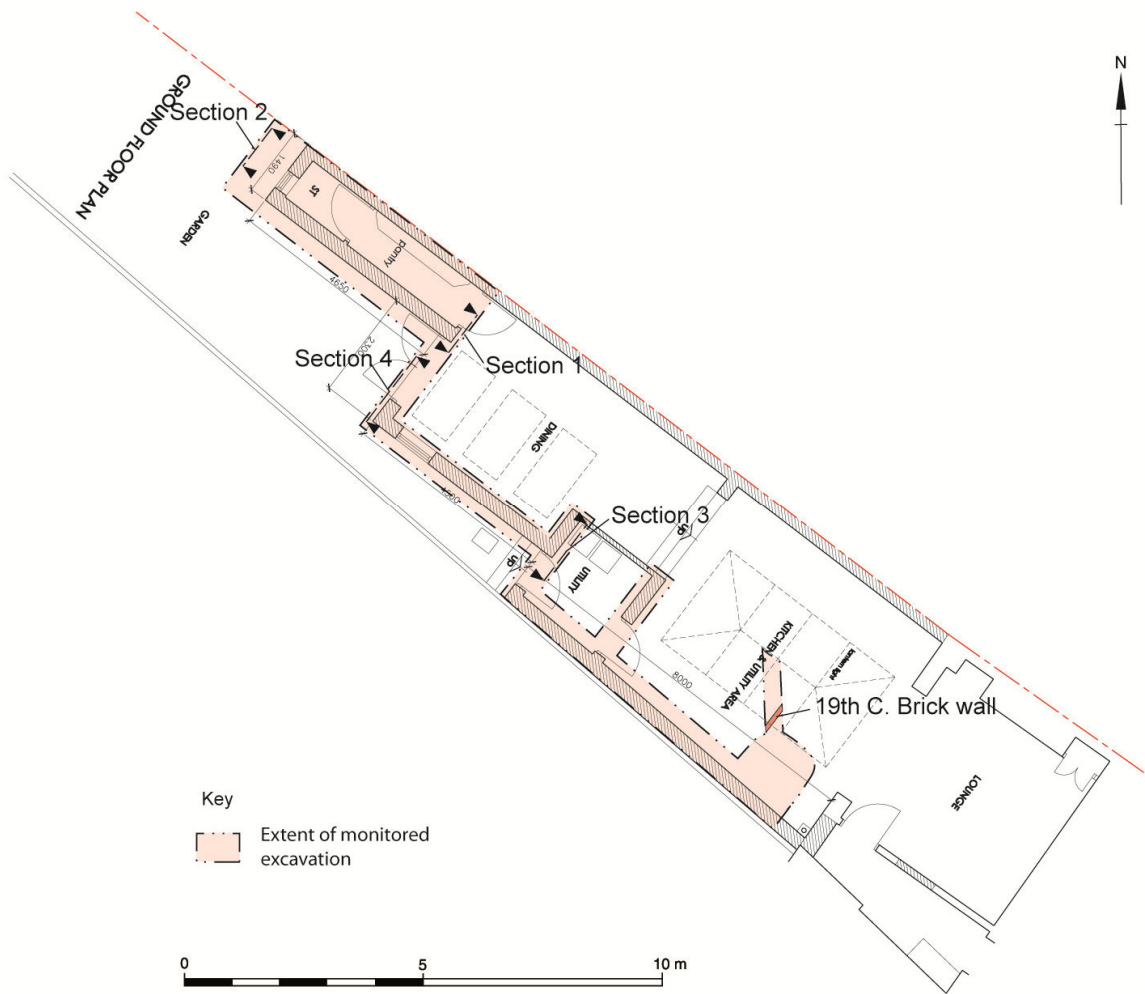
Excavation was carried out with a combination of hand digging and a 1 tonne tracked mechanical excavator employing a 0.6m wide toothed ditching bucket. Excavation to facilitate the rerouting of a drain was undertaken in the SW corner of the site close to the back door of the existing house. This area measured roughly 1.8m X 1.5m with a depth of up to 0.9m. It was irregular in shape with a trench measuring 1.7m X 0.35m X 0.45m projecting from its north corner. The footings of the single storey extension, where they lay outside of the footprint of the existing rear extension, measured 0.6m wide and up to 0.8m deep (Figure 2). These were opened before demolition of all but the furthest NW part of the existing rear extension took place.

Figure 2 Trench location plan based on drawing by White Rose Architectural Ltd.

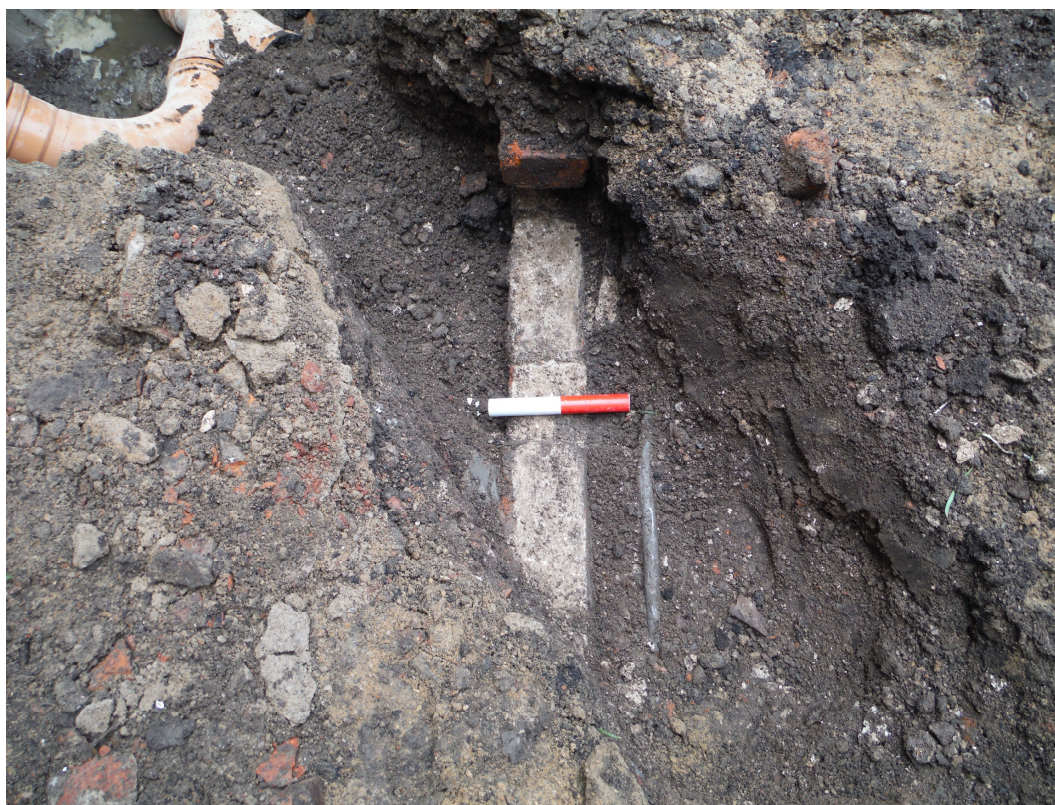
The trenches at the SW end of the site, including the drainage channel and the wall foundation trench running up against the NE side of the garden wall, exposed disturbed ground. This disturbance derived from both active and redundant drains as well as a brick wall (Plate 1). The wall was aligned NE – SW, consisted of mortar bonded bricks a single course wide, four courses in height and extended from 0.1m Below Ground Level (BGL) to the base of the drainage channel cut at 0.45m BGL.

Plate 1 NE – SW aligned brick wall, facing SW, 0.1m scale units

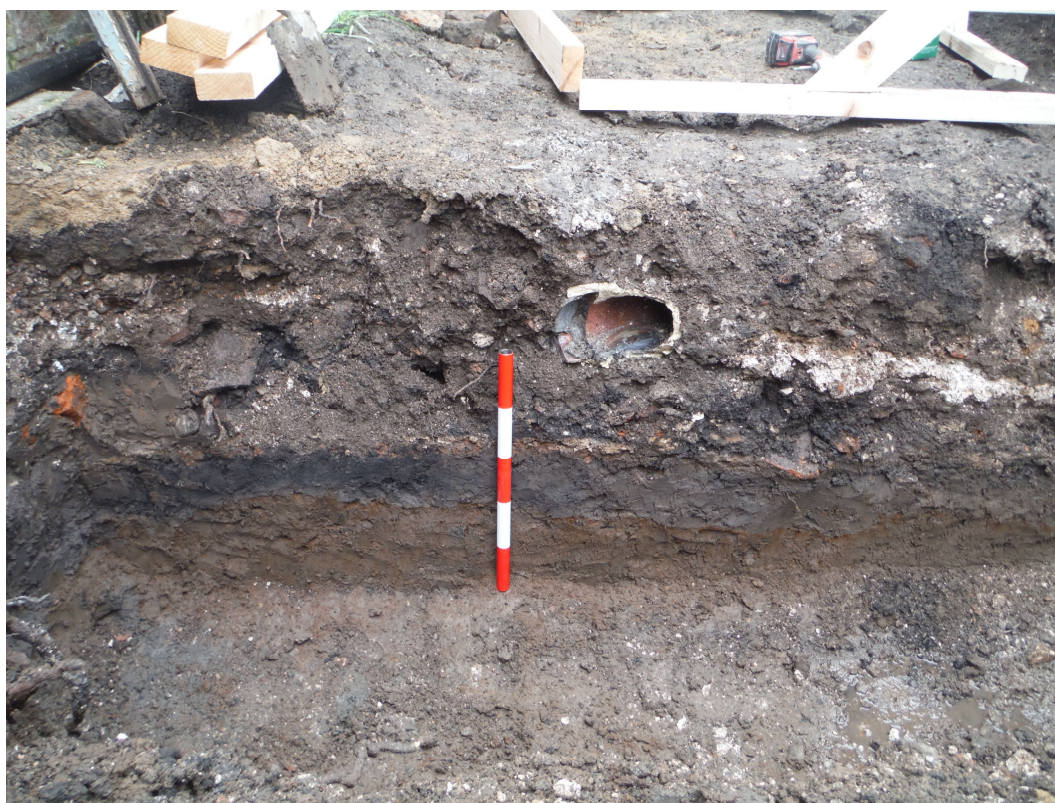
Plate 2

The disturbed area extended to the NW as far as the first NE –SW aligned section of foundation trench. Beyond that point, extending from approximately 5.2m from the back of the house, the sequence of deposits typically followed that shown in the section below (Plate 2). The lowest deposit was of firm, mid brown, sandy clay with red brown streaks running throughout with inclusions consisting of charcoal flecks and small abraded Ceramic Building Material (CBM) fragments. This deposit extended from 0.6m BGL at its observed SE extent, rising to 0.3m BGL to the NW, its thickness ranging from 0.2m to 0.3m, again increasing to the NW. Two pottery sherds, including a fragment of 1st to 3rd century Samian pottery were recovered from this material but were not retained. Above this was a 0.1m thick deposit of firm, mid grey silty clay with occasional charcoal and CBM fleck. A single sherd of 19th century pottery was recovered from this deposit but was not retained. A layer, approximately 20mm thick, of compact mortar and occasional small CBM fragments separated the lower deposits from the continuation of the disturbed upper build-up. The disturbed material measured up to 0.5m thick.

Section 4 showing plough soil underlying post medieval build-up and disturbance, facing SE, 0.1m scale units

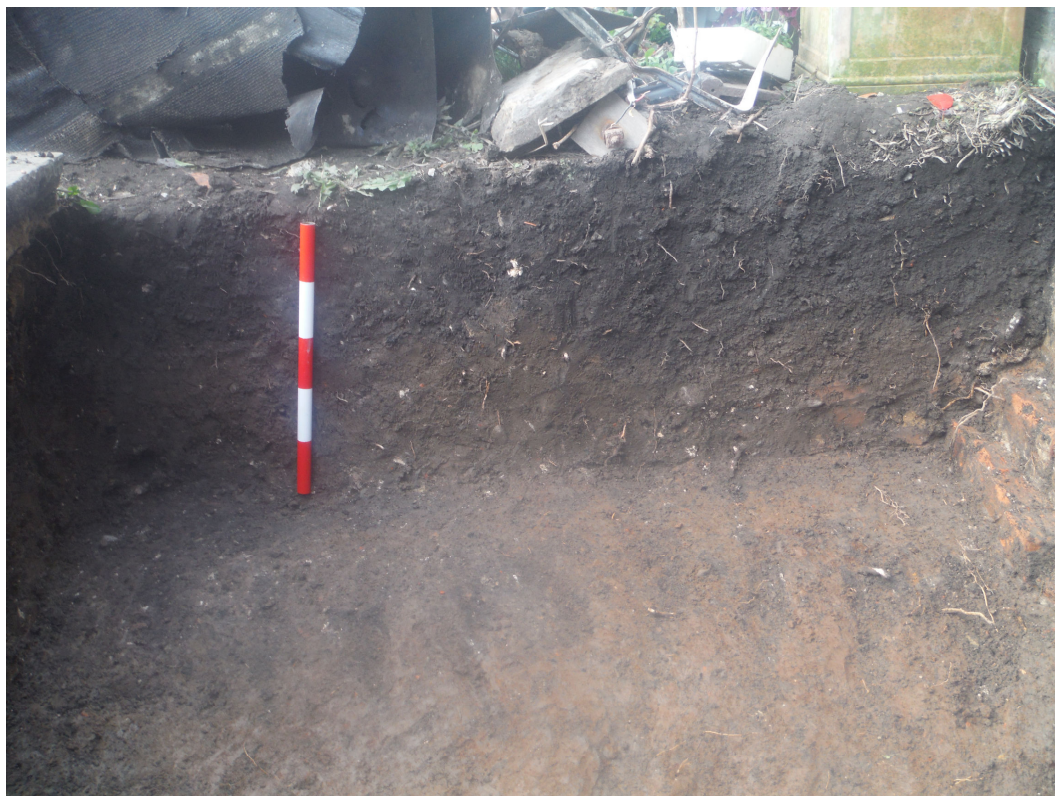
Plate 3

Towards the far NE end of the excavation the disturbed ground gave way to a dark brown silty garden soil (Plate 3).

Section 2 showing garden soil overlying plough soil, facing NW, 0.1m scale units
