## **ARCHAEOLOGICAL WATCHING BRIEF AT THE KNAVESMIRE, TADCASTER ROAD, YORK**

*WATCHING BRIEF REPORT*

Report Number 2016/22    March 2016

Project Name	Knavesmire Northern Powergrid Utility Trench
YAT Project No.	5890
Report status	Final
Type of Project	Watching Brief
Client	Northern Powergrid
Planning Application No.	N/A
NGR	SE 5906 5038, SE 5998 5019, SE 5885 4992
Museum Accession No.	YORYM:2016.252
OASIS Identifier	yorkarch1-246906

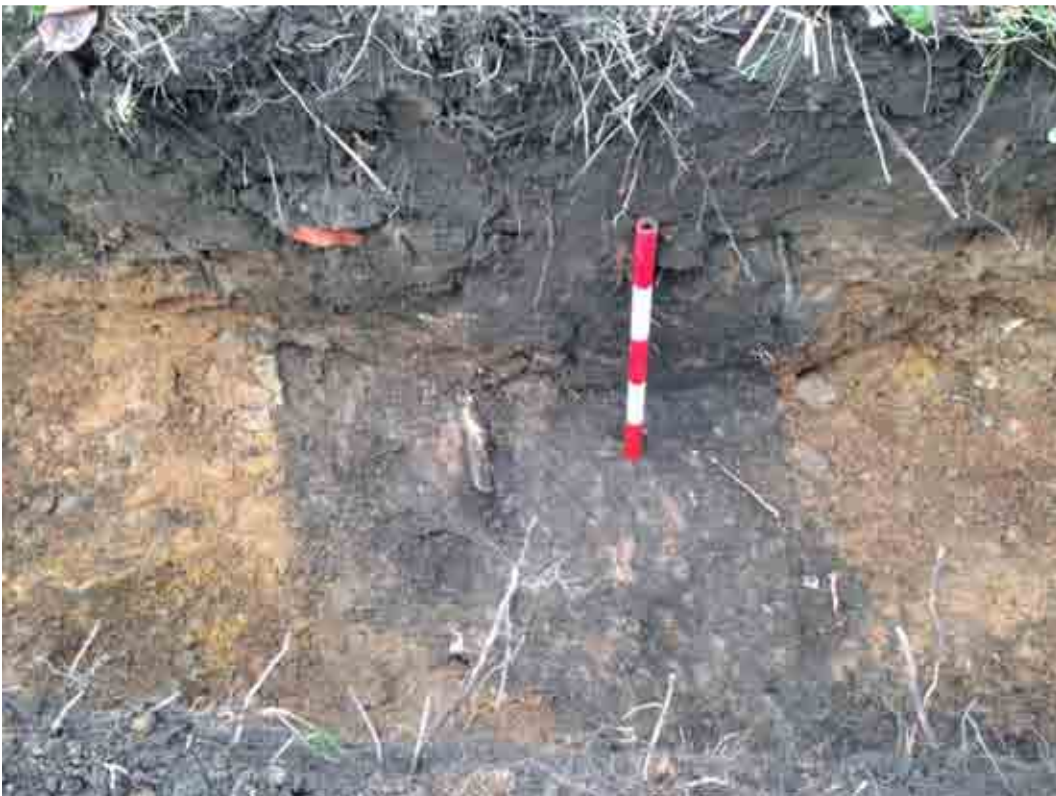
**Plate 4 Linear feature, Context 5008 and 5009, looking NW, 0.1m scale units**

To the south of Trench 7 the natural clay (Context 5003) contained a larger quantity of stony fragments. This zone extended from the south-western edge of Trench 7 as far as a narrow linear feature (Context 5009), a distance of c.7.5m. Beyond that feature the natural reverted to less stony sand. The linear feature (5009) had vertical sides, was aligned east/west and contained a single backfill (Context 5008) that consisted of a loose mix of dark brown silt and clay (Figure 5, Plate 4). Fragments of 19<sup>th</sup> or 20<sup>th</sup> century tile were visible in section close to the top of context 5008, where a diffuse interface with the overlying topsoil was observed. It is unlikely that this feature is particularly old.

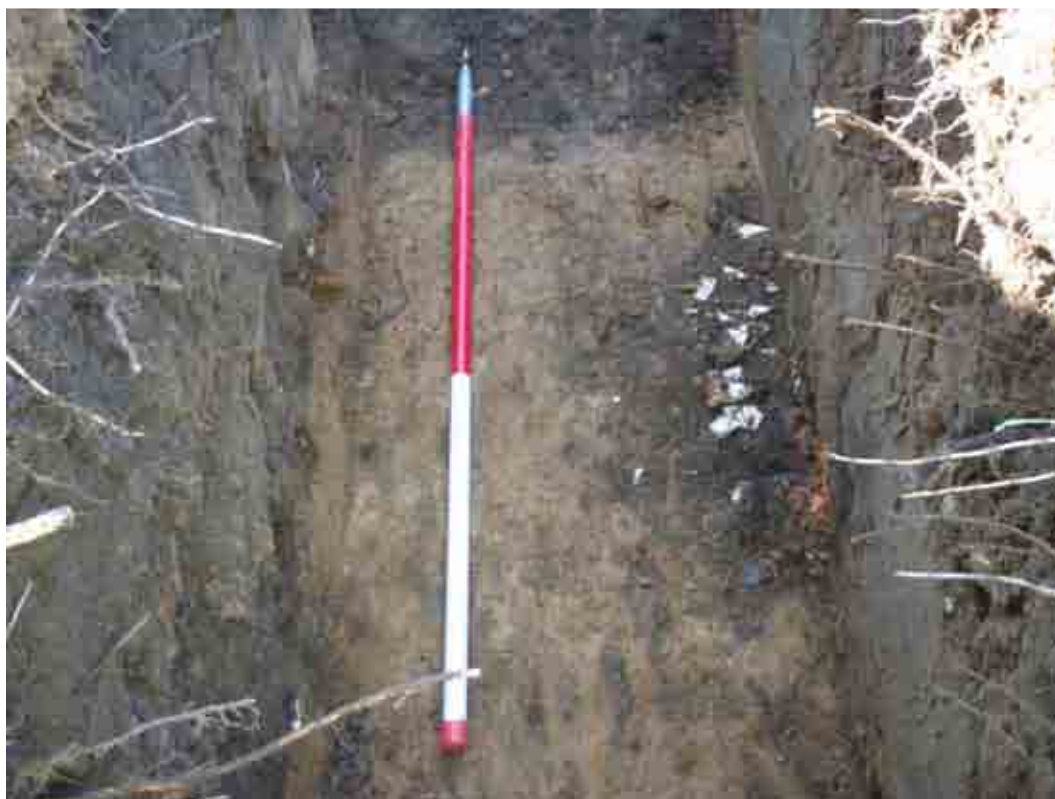
**Plate 7 19<sup>th</sup> / 20th century refuse dump in Trench 5, looking SW, 0.5m scale units**

Poorly defined areas of the 18<sup>th</sup>/19<sup>th</sup> century refuse material was observed as a layer (Context 5007) directly overlying the natural and recorded in Section 6 (Figure 5). It is likely that this material had accumulated through dumping as no intrusive cut was identifiable (Plate 7).

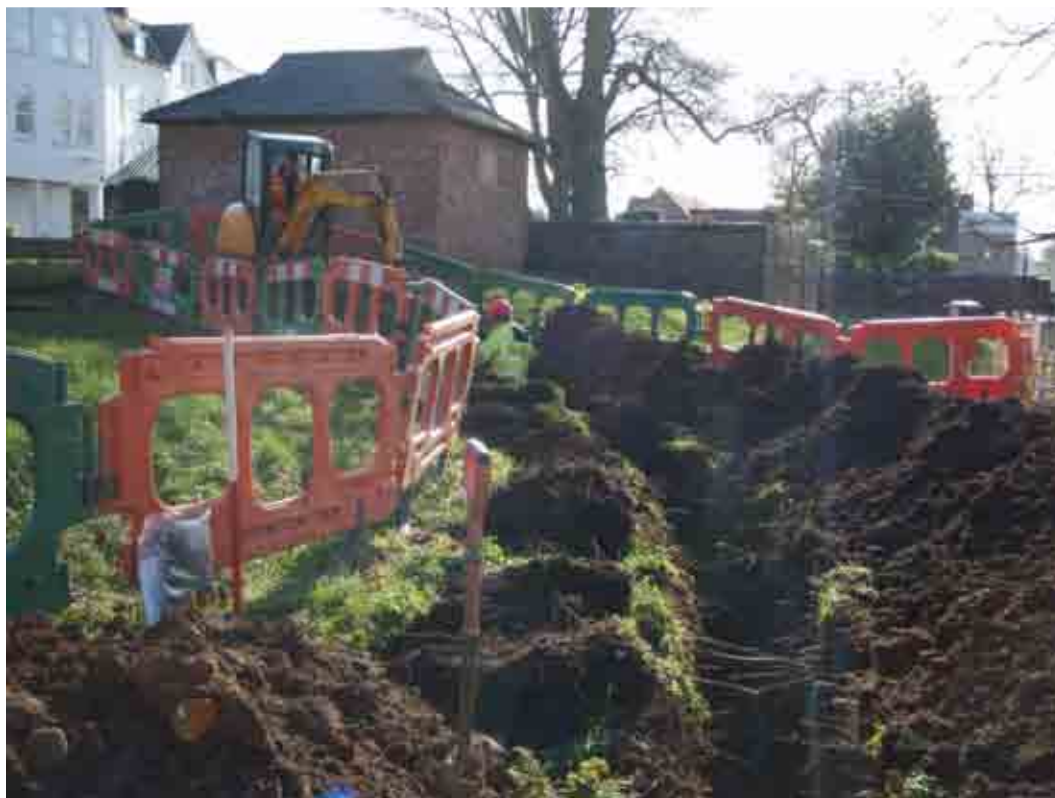
**Plate 8 Trench 5 on approach to electric substation, Looking S**

The southern end of Trench 5 took a route angling across to the south-east around the east side of an electricity substation occupying a slightly elevated position (Plate 8). The trench then swung around to join in to the back of the substation (Figure 4). To the north-east of the substation the topsoil was 0.2m thick and contained modern bottle glass and a modern bicycle lock, beneath this a 0.25m thick deposit of mid-light brown silty clay, beneath which was a very stony clay that was interpreted as being of natural origin. On the elevated portion of land around the substation the uppermost two deposits were identical, with the underlying clay being noticeably less stony.
