ARCHAEOLOGICAL EVALUATION AT THE SITE OF PROPOSED HOTEL, DUNDAS STREET, YORK

EVALUATION REPORT

Report Number 2016/28 April 2016

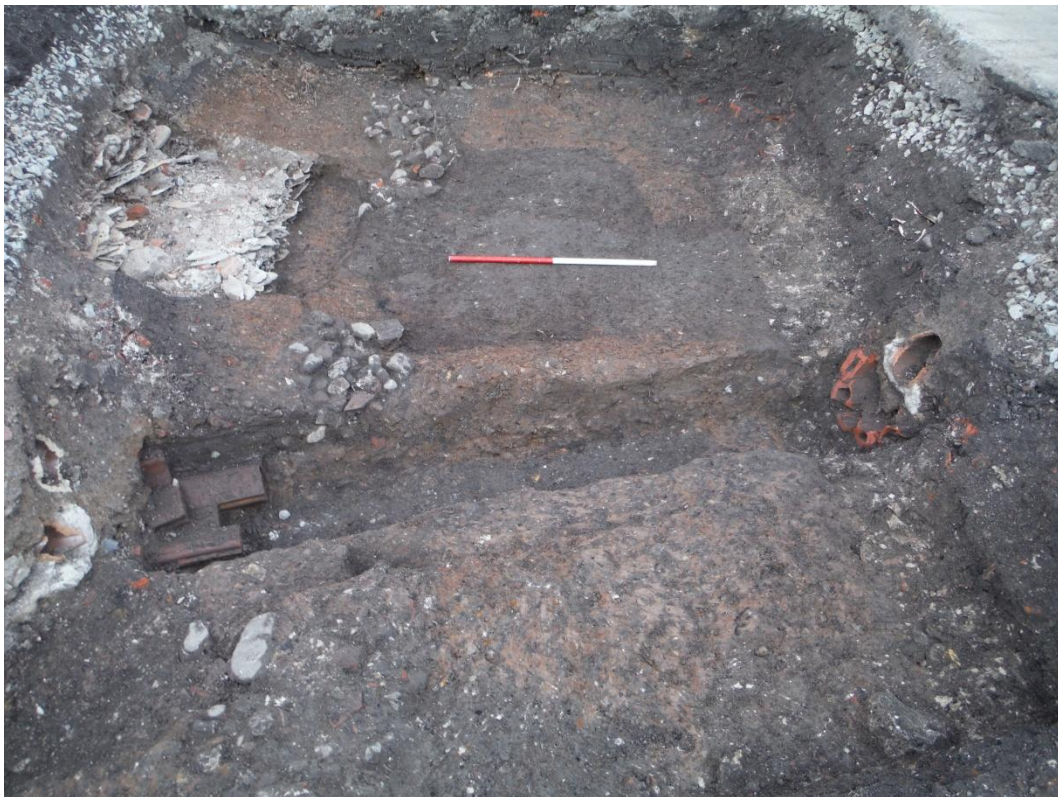
Plate 1. North-east facing view of Trench 1 showing features cut into Roman terracing deposit Context 1027 (1.00m scale)

The earliest archaeological context to be reached during the excavation was a widespread terracing deposit of firm, mid-orange brown clay with cobble inclusions (Context 1027, Plate 1). No dateable material was recovered from this context, although the same deposit was encountered during YAT's 2012 excavation of the neighbouring Haymarket Car Park site where it was securely dated to the Roman period (Johnson 2013, 15). The deposit survives at a maximum height of 9.38m AOD.

This layer of re-deposited natural clay, sand and cobbles was the earliest material to be observed in Trench 1 (Figure 5, Plate 1). As the aim of the evaluation was to locate and characterise the survival of a range of medieval buildings, this deposit was not investigated. It is, however, likely that residual Roman finds recovered from medieval pits that cut into the terracing (see Section 6.2.2) were up-cast from their original position within this context. The fact that the terracing material is so widespread across the Hungate area highlights the magnitude of the endeavour; it is a significant landscaping event.

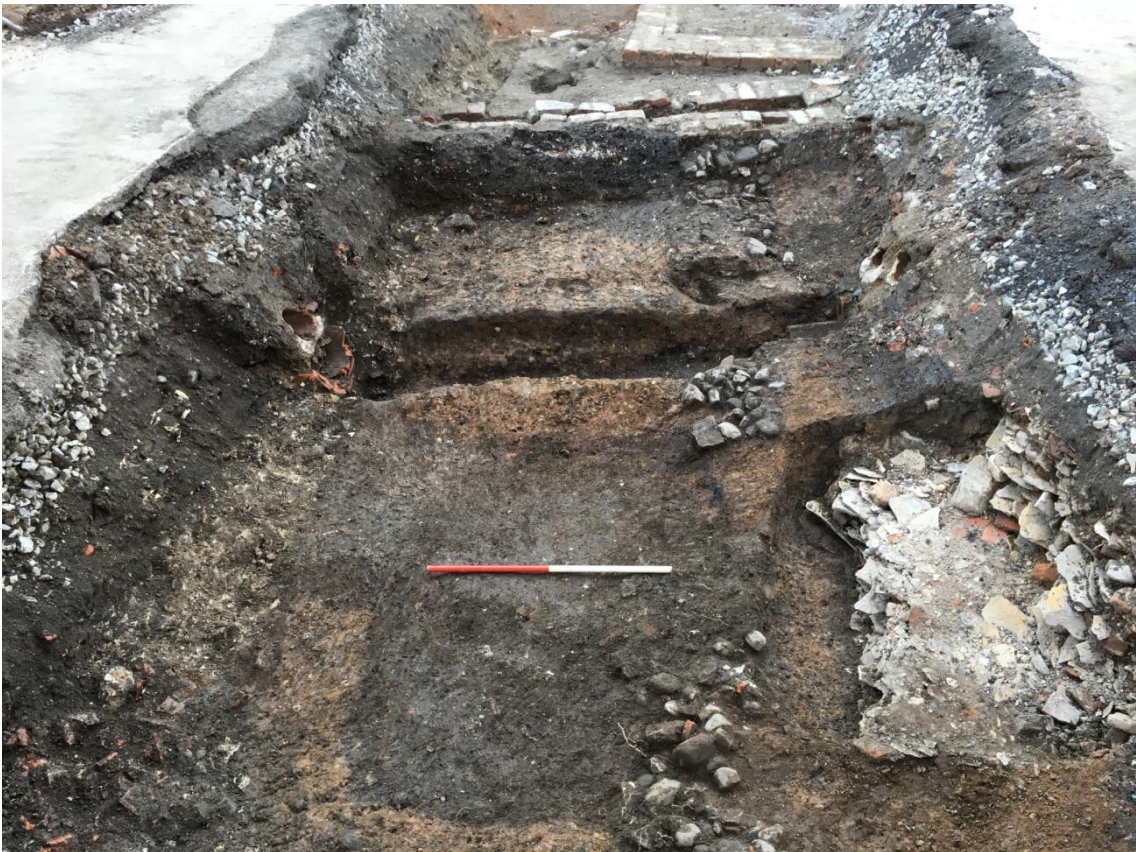
Plate 2. South-west facing view of Trench 2. The medieval wall footings (Set 116) appear to the left of the image, a cobble footing (Set 115) can be seen to the right (1.00m scale)

A substantial wall footing comprising of limestone rubble in a matrix of lime mortar was found at a depth of 9.27m AOD, running on a north-east/south-west alignment along the south-eastern edge of the trench (Set 116, Figure 5, Plate 2). The wall footing was exposed to a maximum length of 6.60m and a width of 0.54m and is a clear continuation of a wall discovered during the 2012 Haymarket excavations (Context 83306, Johnson 2013, 18). The

A highly truncated cobble filled wall footing was observed at a depth of 9.57m AOD (Set 115, Plate 2). The structure follows the same north-east/south-west alignment as the medieval wall footing (Set 116) and is located 1.69m further to the north-west. The footing was uncovered to a length of 5.22m and a width of 0.58m and continued beyond the north-eastern limit of excavation. The cobbles and stone fragments within the construction cut were un-mortared, suggesting that the wall will have been less substantial than Set 116.

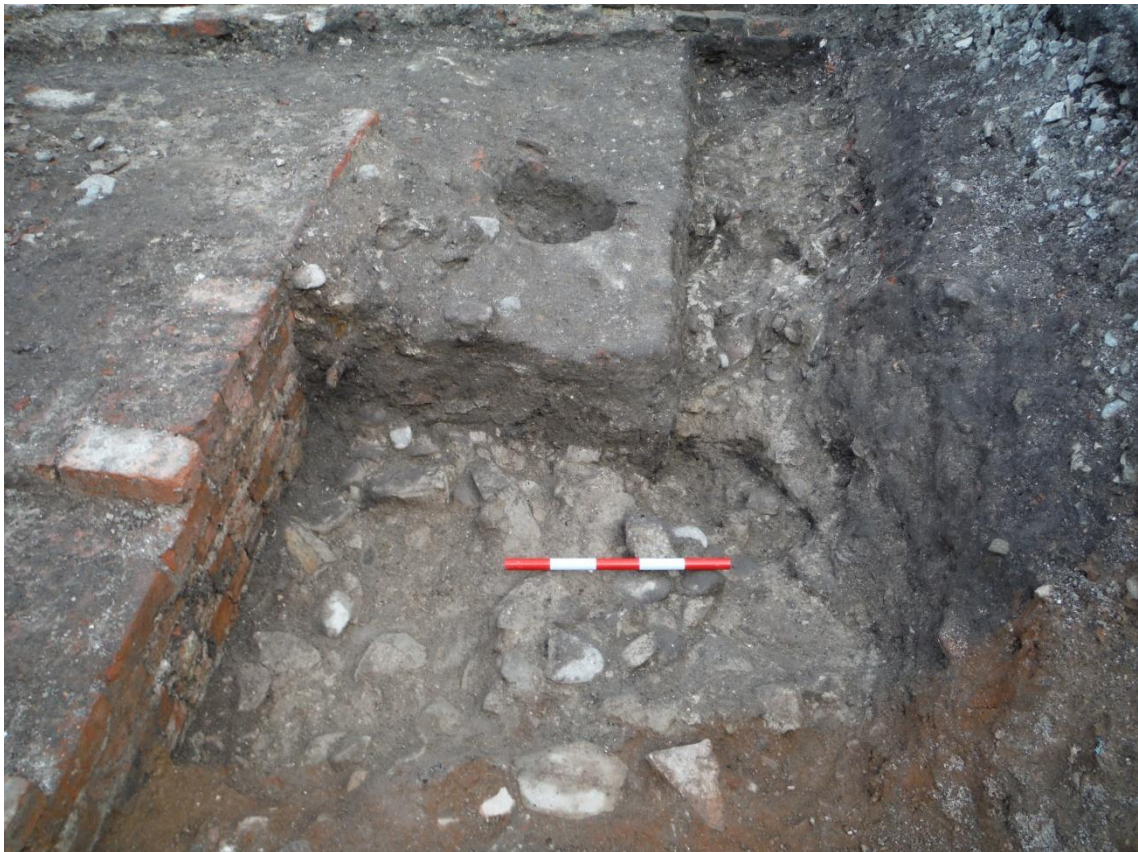
Plate 3. North-east facing view of a medieval wall footing (Context 1028, 0.50m scale)

At the south-west corner of the trench, a loose dump of mortar, silt and limestone fragments (Context 1024) was found to directly overlie the remains of the medieval wall and its north-west/south-east return (Context 1028, Plate 3). The deposit contained 13th-16th century ceramics and survived to a height of 9.48m AOD. Post-dating this deposit, a sequence of four

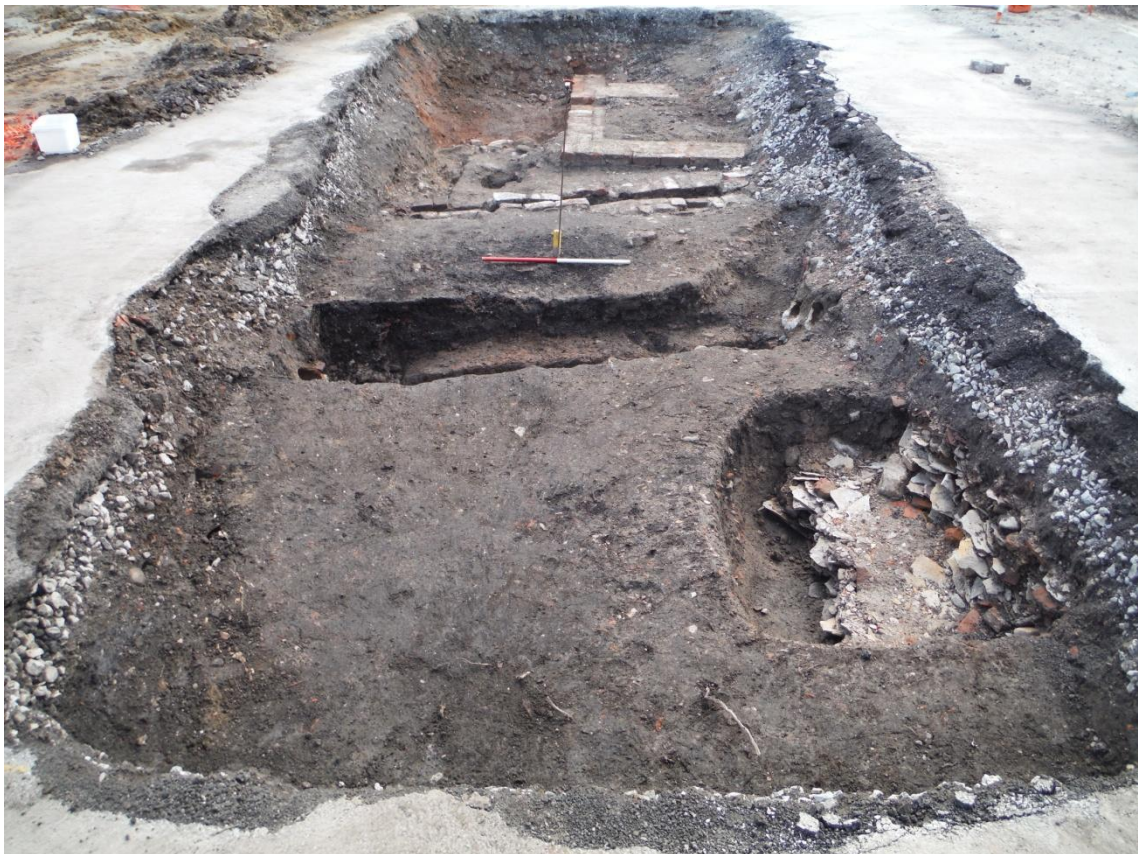
Plate 4. South-west facing view of 18th/early 19th century dump deposits (Set 114) and pits (Sets 109 and 110, 1.00m scale)

The late/post-medieval horizon was sealed by two widespread dump deposits (Set 114) that covered the whole north-eastern half of the trench and were present from a depth of 9.71m AOD. The dumps contained domestic refuse (animal bone, shell, etc.) and were presumably deposited as a deliberate attempt to raise and flatten the ground level.

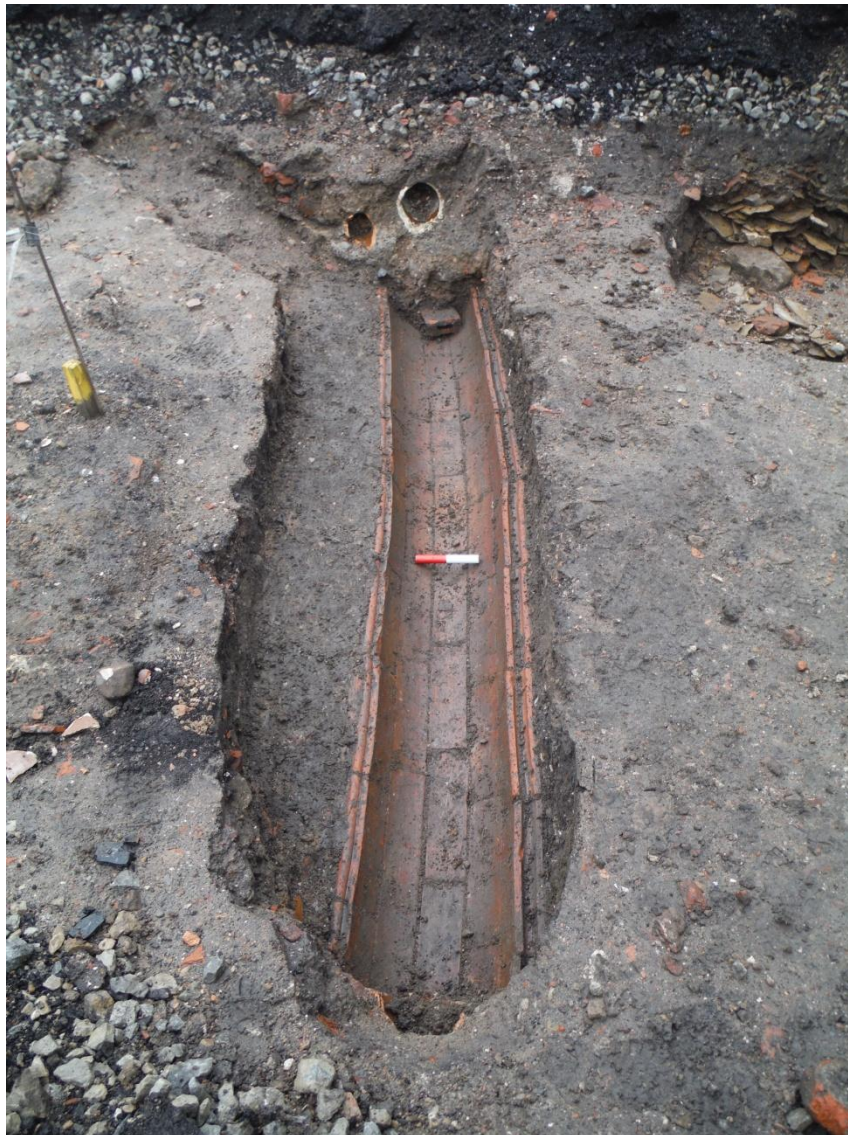
Plate 5. North-west facing view of Set 103, a truncated drain comprising of interlocking ceramic tiles (0.20m Scale)

The 19th century activity identified within Trench 1 was exclusively associated with the former Leeds Arms public house which stood until the mid-20th century. The earliest features of 19th century date were a sequence of ceramic drains. Set 103 survived from a depth of 9.33m AOD and comprised of individual ceramic tiles that interlock to create a self supporting cylinder (Plate 5). The drain was exposed to a length of 2.84m, aligned north-west/south-east and followed the general topography of the site in gently falling towards the south-east.

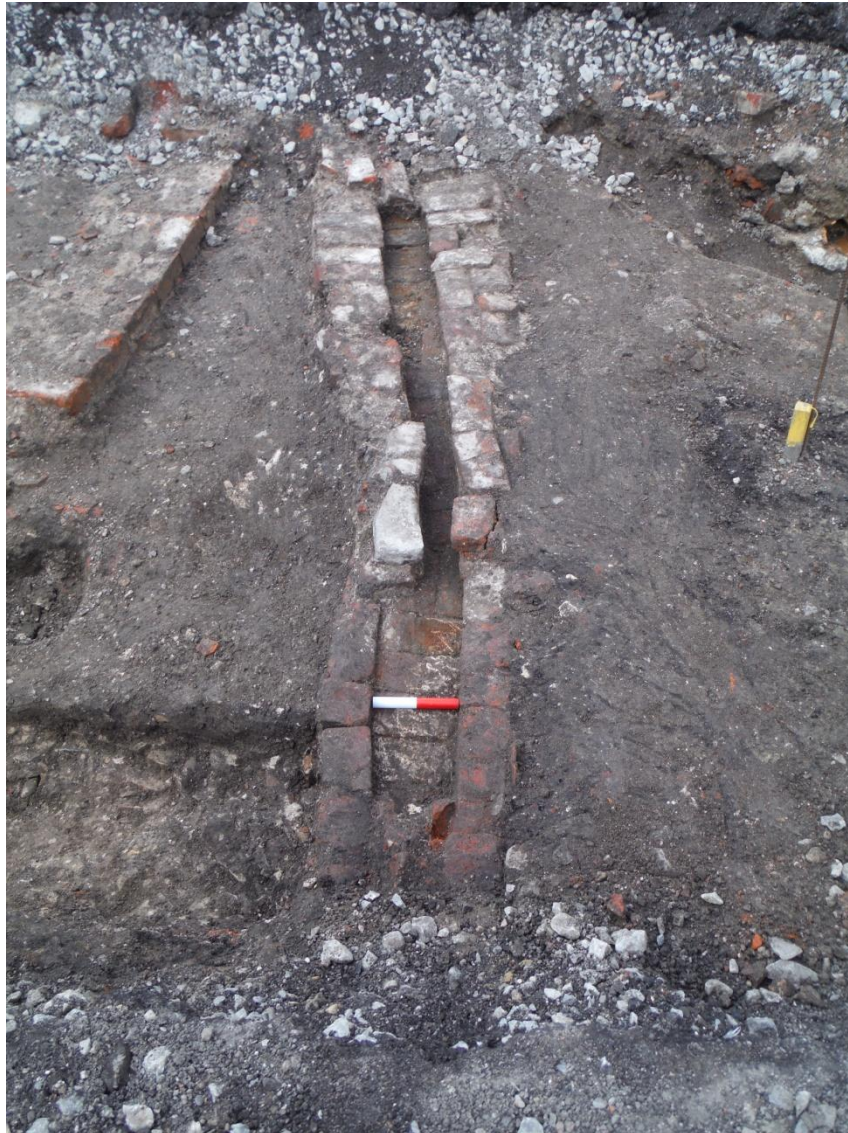
Plate 6. North-west facing view of brick culvert Set 107 (0.20m scale)

To the south-west of the ceramic drain sequence, a roughly built brick culvert on a north-west/south-east alignment was observed at a depth of 9.72m AOD (Set 107, Plate 6). The structure was exposed to a length of 3.80m and measured up to 0.84m in width and was built in the late 18th/19th century. The culvert was not excavated during this evaluation.

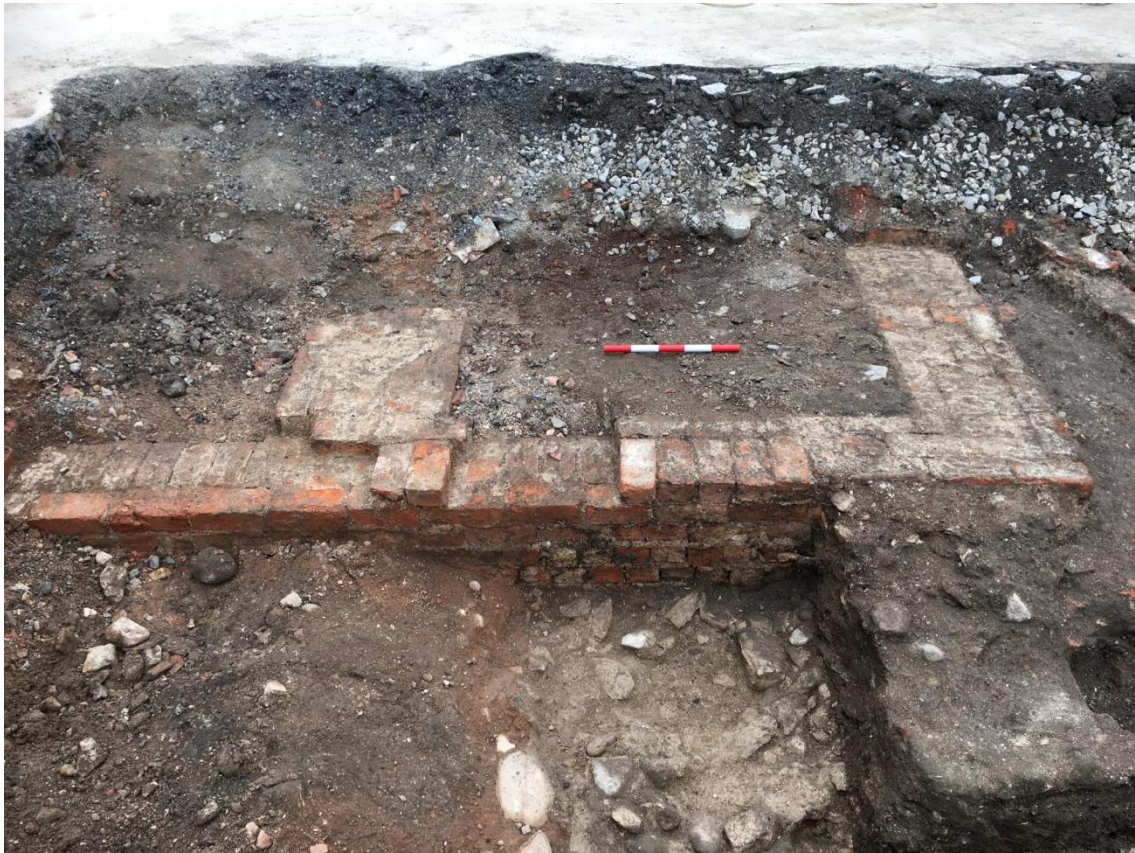
Plate 7. North-west facing view of Leeds Arms cellar walls (Set 104, 0.50m scale)

Substantial brick walls associated with the Leeds Arms were observed at the southern end of the trench (Set 104). These walls were part of a cellar that was partially exposed during the 2012 Haymarket excavations (Johnson 2013, 26) and were revealed to a length of 3.46m x 1.64m at a depth of 9.72m AOD. The brickwork ranged in width from 0.40m to 0.47m and comprised of mid to late-19th century brickwork. The cellar was infilled with a deposit of slag and brick rubble (Context 1032) in the early 20th century.

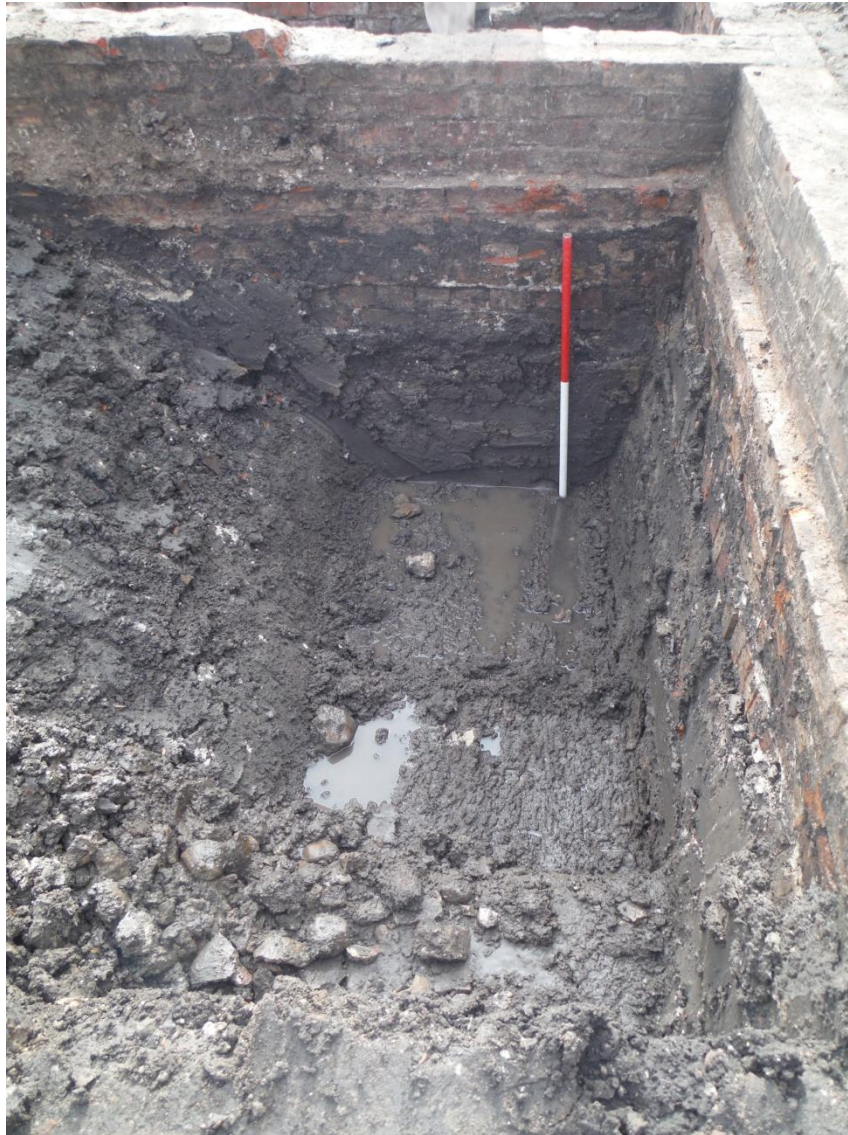
Plate 8. South-east facing view of horticultural soils (Context 2048) following machine excavation (1.00m scale)

The earliest deposit to be observed in Trench 2 was a soft, dark blackish brown highly organic clay silt (Context 2048, Plate 8). Similar deposits have been identified in YAT excavations across much of the Hungate development area and the neighbouring Haymarket and Ambulance Station excavations (Reeves 2010, 32). The deposits appear to have been in use between the late 16th and early 19th centuries when much of the area was given over to horticulture (Kendall 2009, 7). No finds were recovered from this deposit as it was only observed in a machine excavated slot from a depth of 8.50m AOD to the maximum depth of 7.83m AOD.

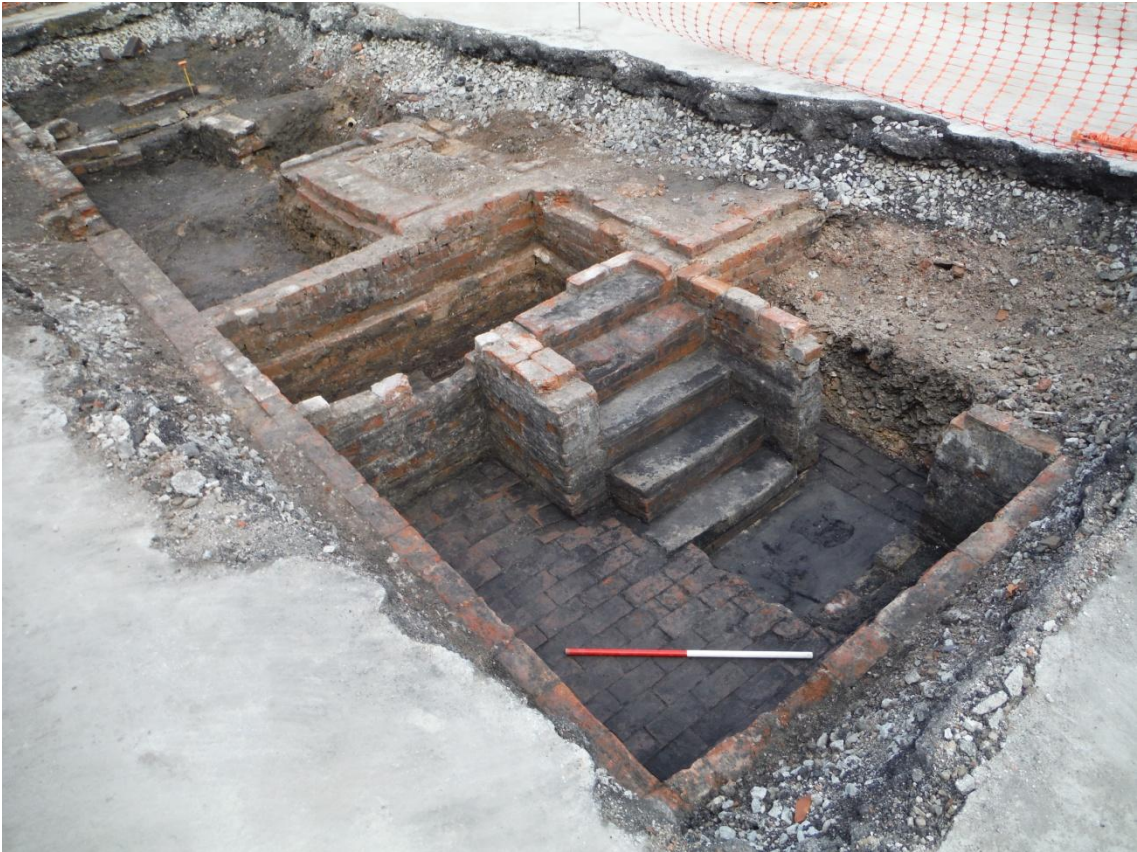
Plate 9. North facing view of the Leeds Arms buildings (Set 209, 1.00m scale)

The vast majority of the structures and deposits observed in Trench 2 were associated with the Leeds Arms public house (Figure 9, Plate 9) which survived from a depth of 10.07m AOD. The structure was aligned north-west/south-east and was exposed to a total length of 9.28m and would have been considerably wider than the 4.00m area revealed in the trench. The construction cut for the main walls of the building (Set 209) was excavated to cellar depth (8.54m AOD) across the whole area, despite only the south-western end of the structure actually having a cellar. Where a cellar was not built, the space was infilled with re-deposited horticultural soils (Set 211).

The building was constructed of handmade red brick dating to the mid-18th to mid-19th century. This compliments historic references which suggest that the pub was trading by 1838 (Johnson 2013, 11)

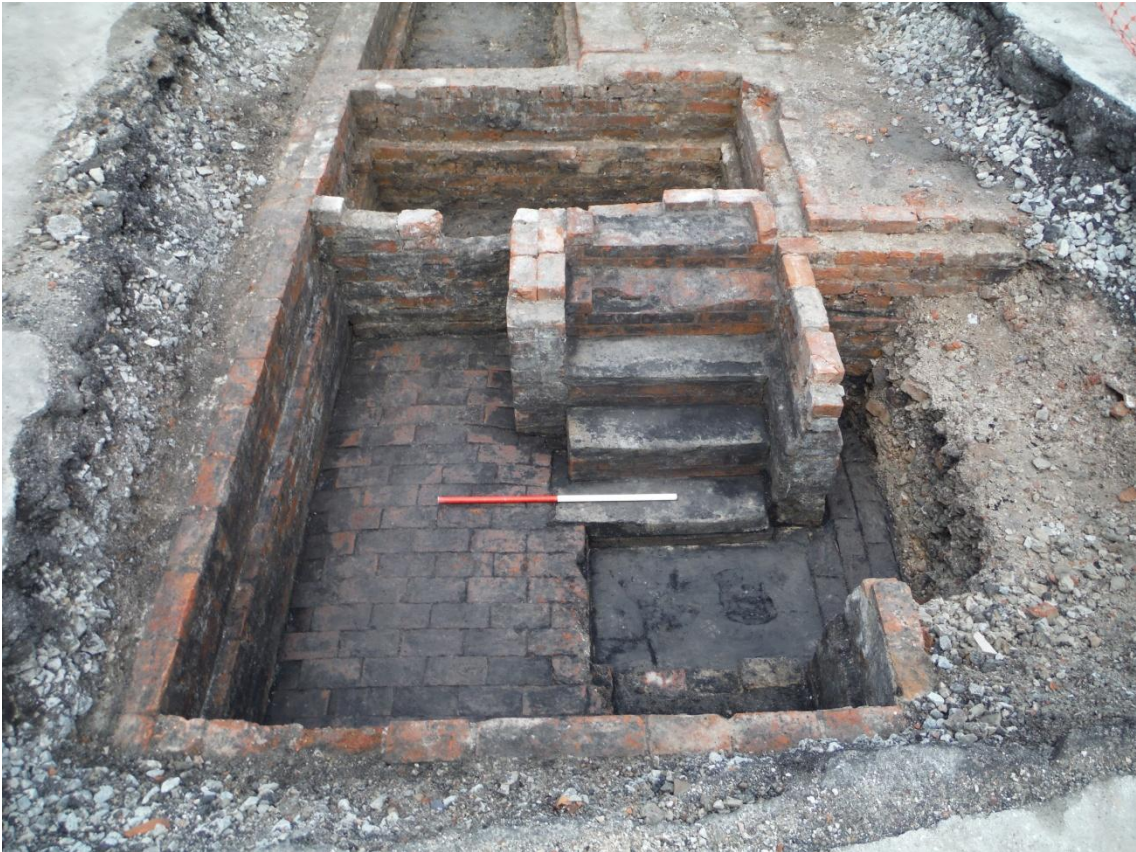
Plate 10. North-west facing view of the Leeds Arms coal cellar (set 213, 1.00m scale)

The cellar that occupies much of the south-eastern end of the trench comprises of several partition walls, a brick and sandstone stairway and a brick and sandstone floor surface (Set 213, Plate 10). The floor surfaces were set at a depth of 8.79m AOD and were covered with a thin residue of coal dust, suggesting that the cellar was used to store coal.

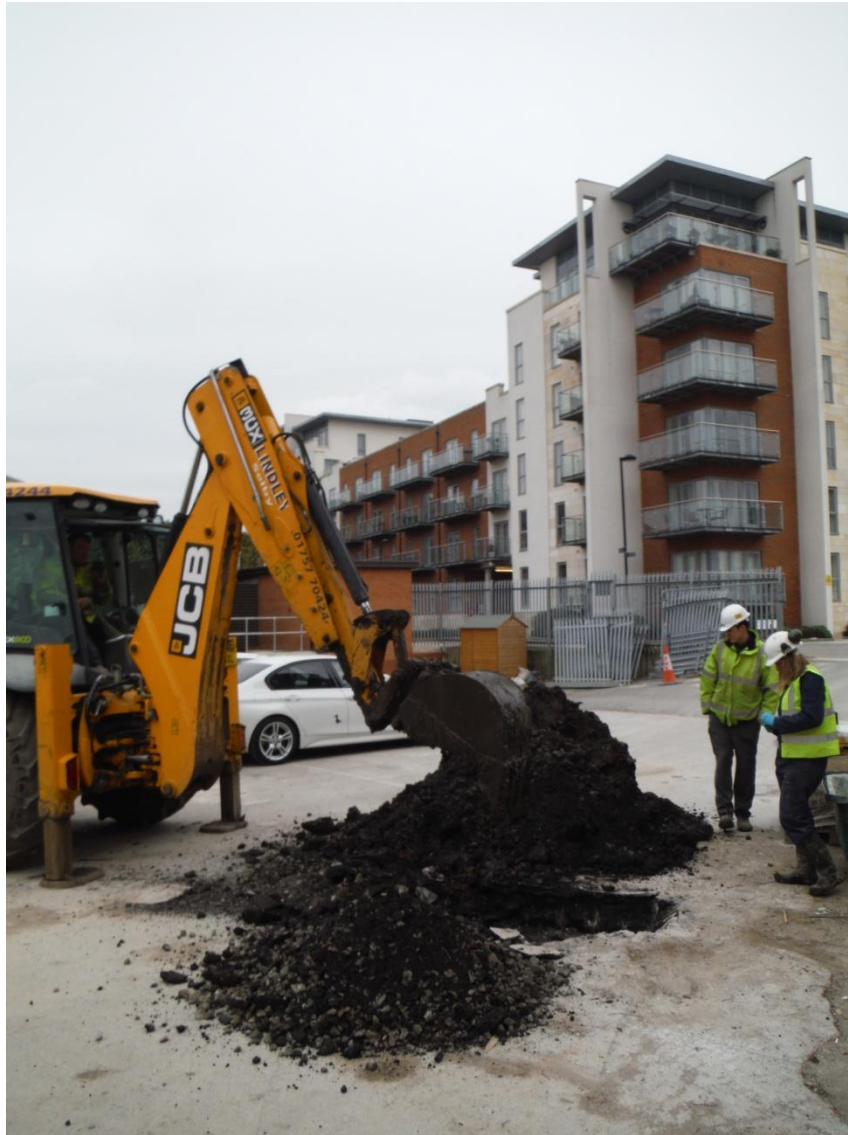
Plate 11. South-east facing view of organic Anglo-Scandinavian/medieval pit fills from Test Pit 4.

Below modern overburden, a sequence of 19th century dumps was found to overlie horticultural soils; these were present from a depth of 2.05m BGL. From a depth of 3.20m BGL to the maximum depth of 3.90m BGL, organic cess and refuse backfills were observed. Due to waterlogged conditions at this depth, the preservation of organic materials including timber, leather and moss was excellent. Disturbed Anglo-Scandinavian banded deposits were noted within the organic material, these deposits were very similar to deposits excavated during the Hungate H2 excavations (Kendall, pers. comm.) and may suggest a 10th century date (Plate 11).

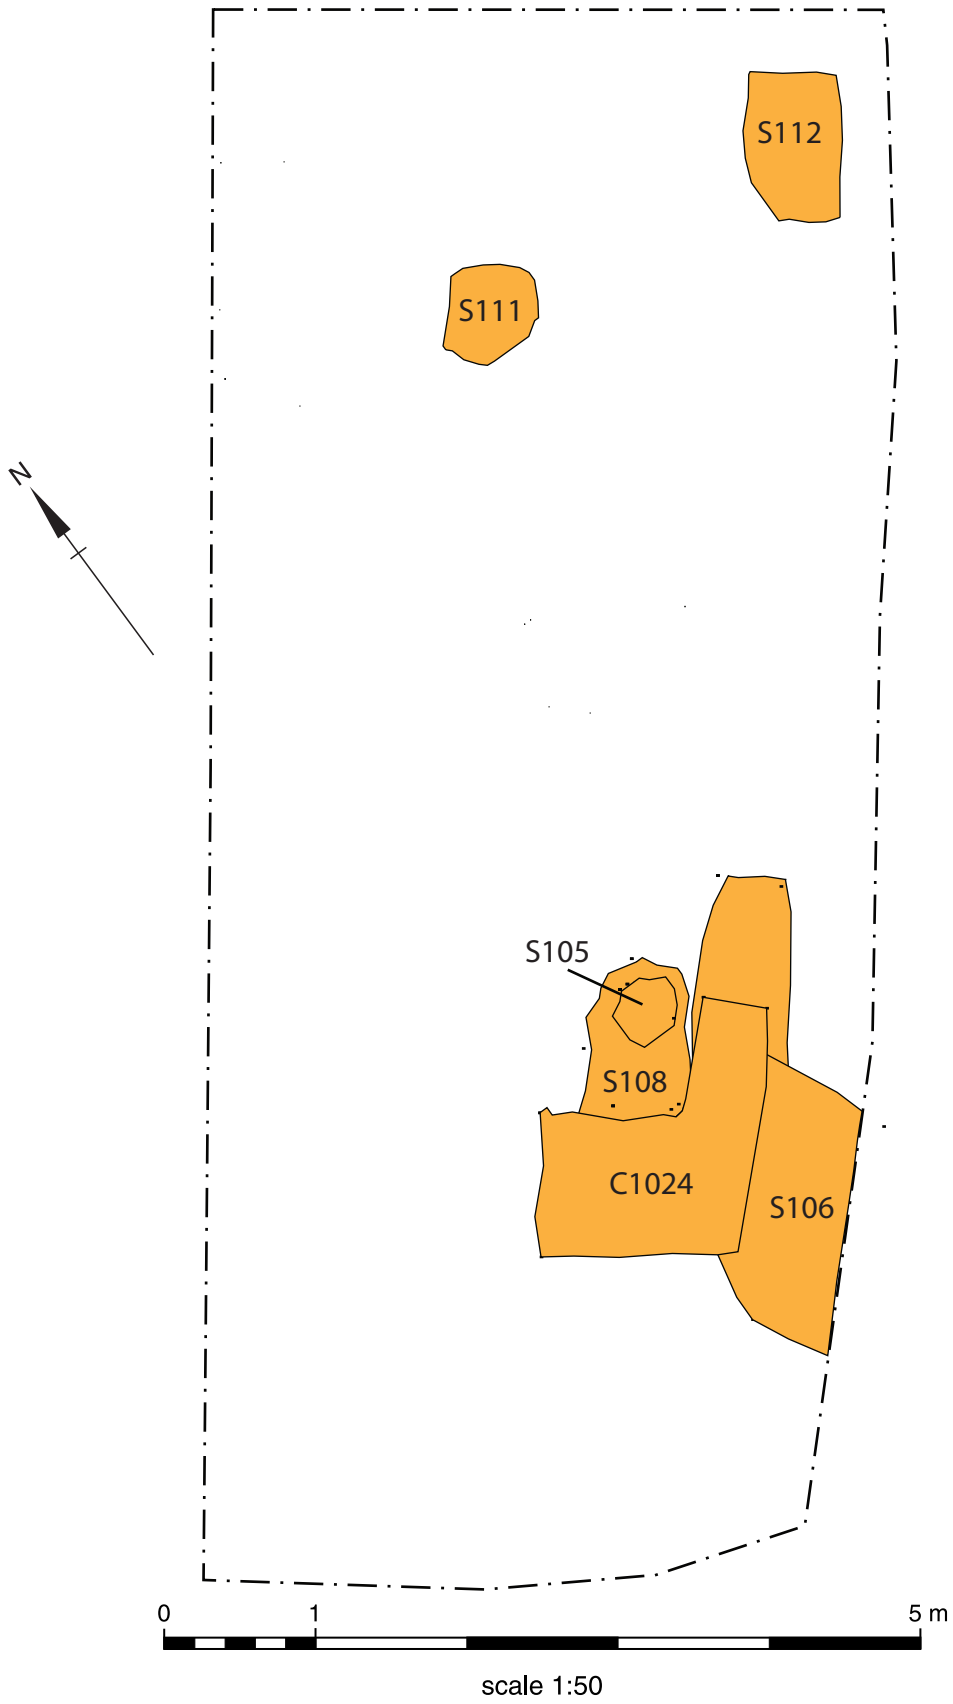
Fig. 6 Post-medieval pits and dumps

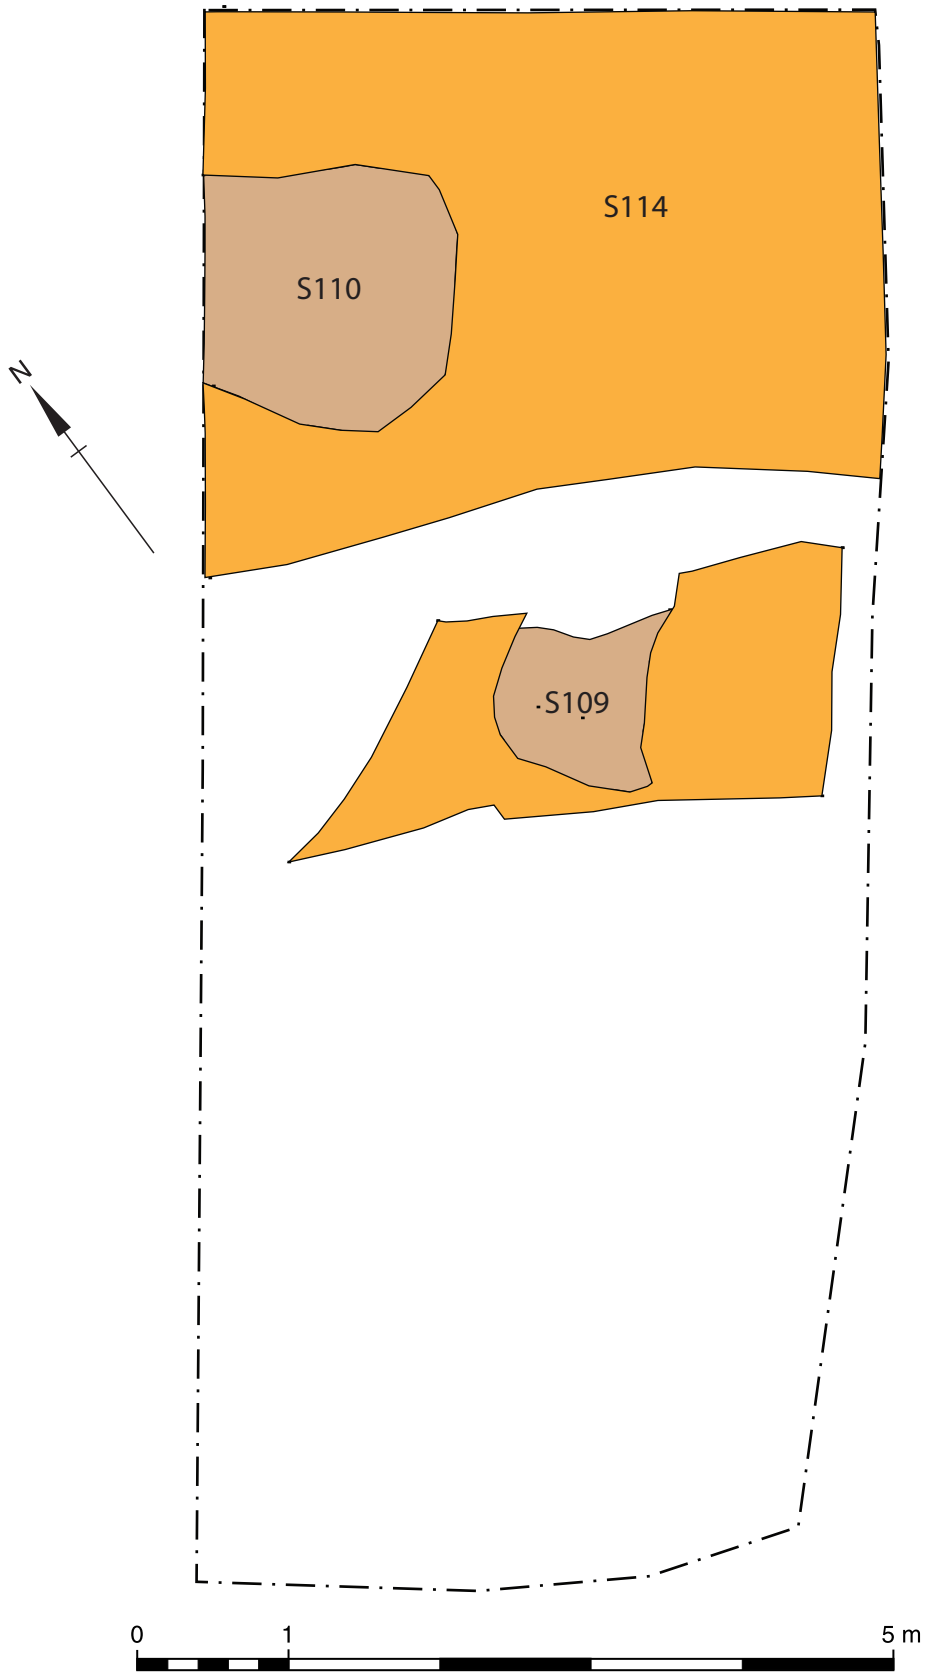
Fig. 7 18th/19th pits and dumps

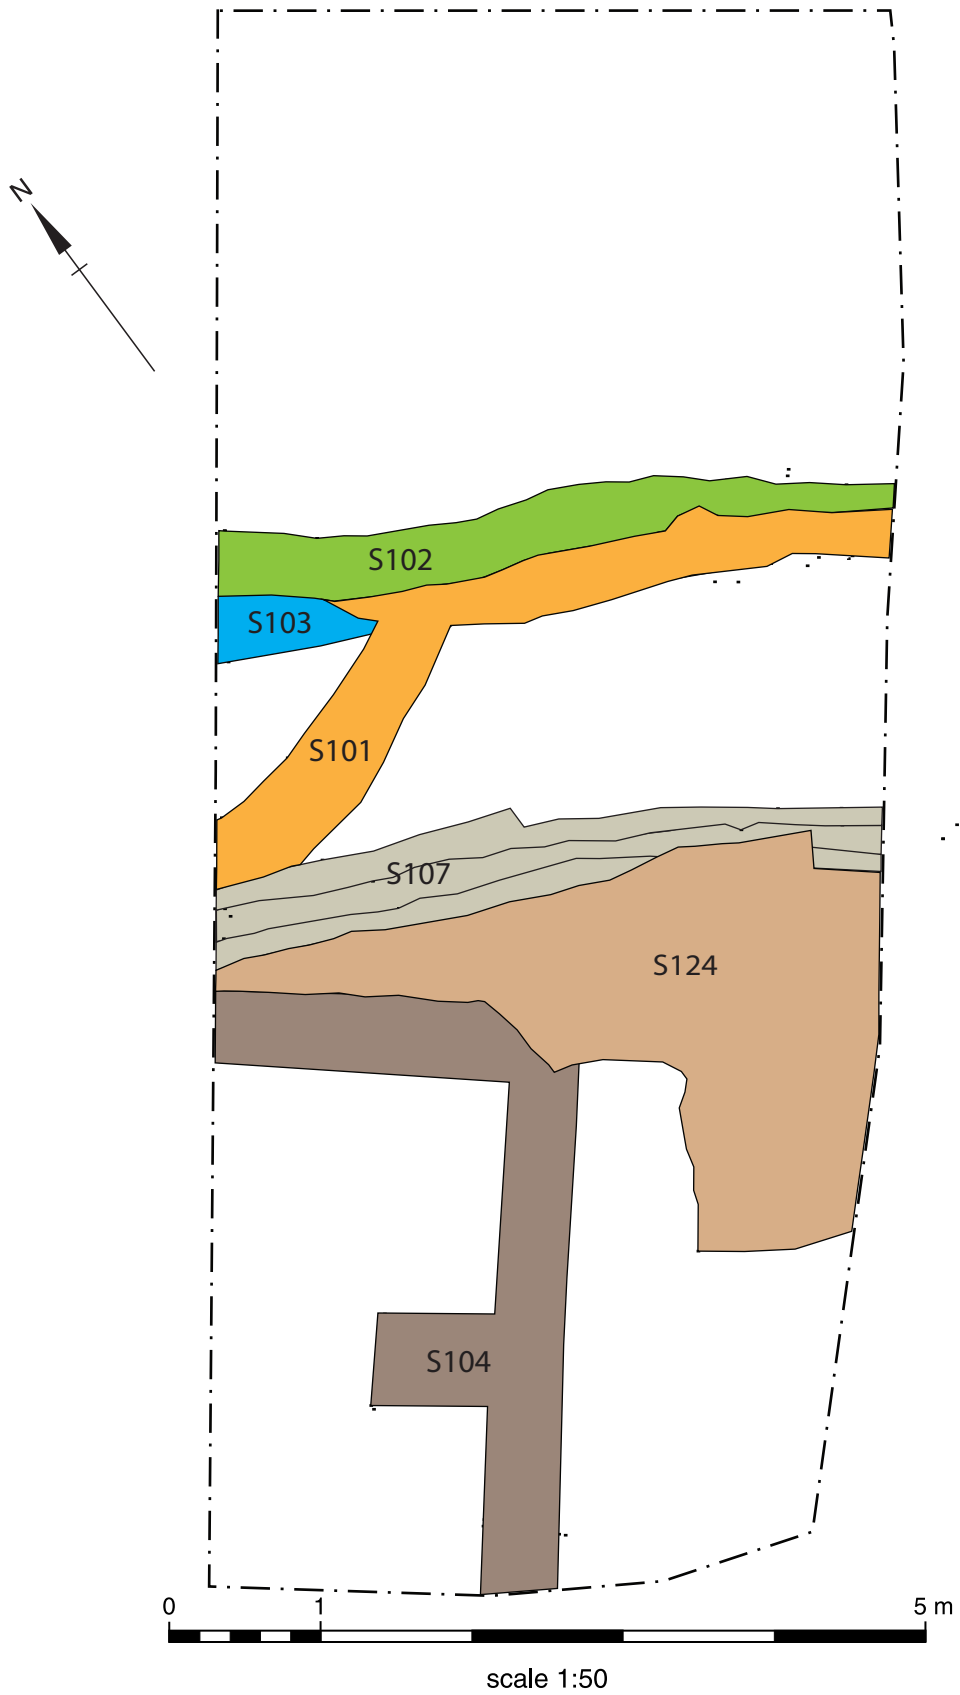
Fig. 8 19th century deposits and structures

Documentary sources suggest that the Leeds Arms was opened in 1838, and numerous associated structures and drains were identified in Trench 1 (Figure 8, Plates 4-7). A sequence of drainage features, from a rudimentary brick culvert to a ceramic drain that was replaced on two occasions, is likely to have relate to late 19th and early 20th century sanitation improvements that have been identified in the Hungate and Haymarket excavations (Johnson 2013, 27).

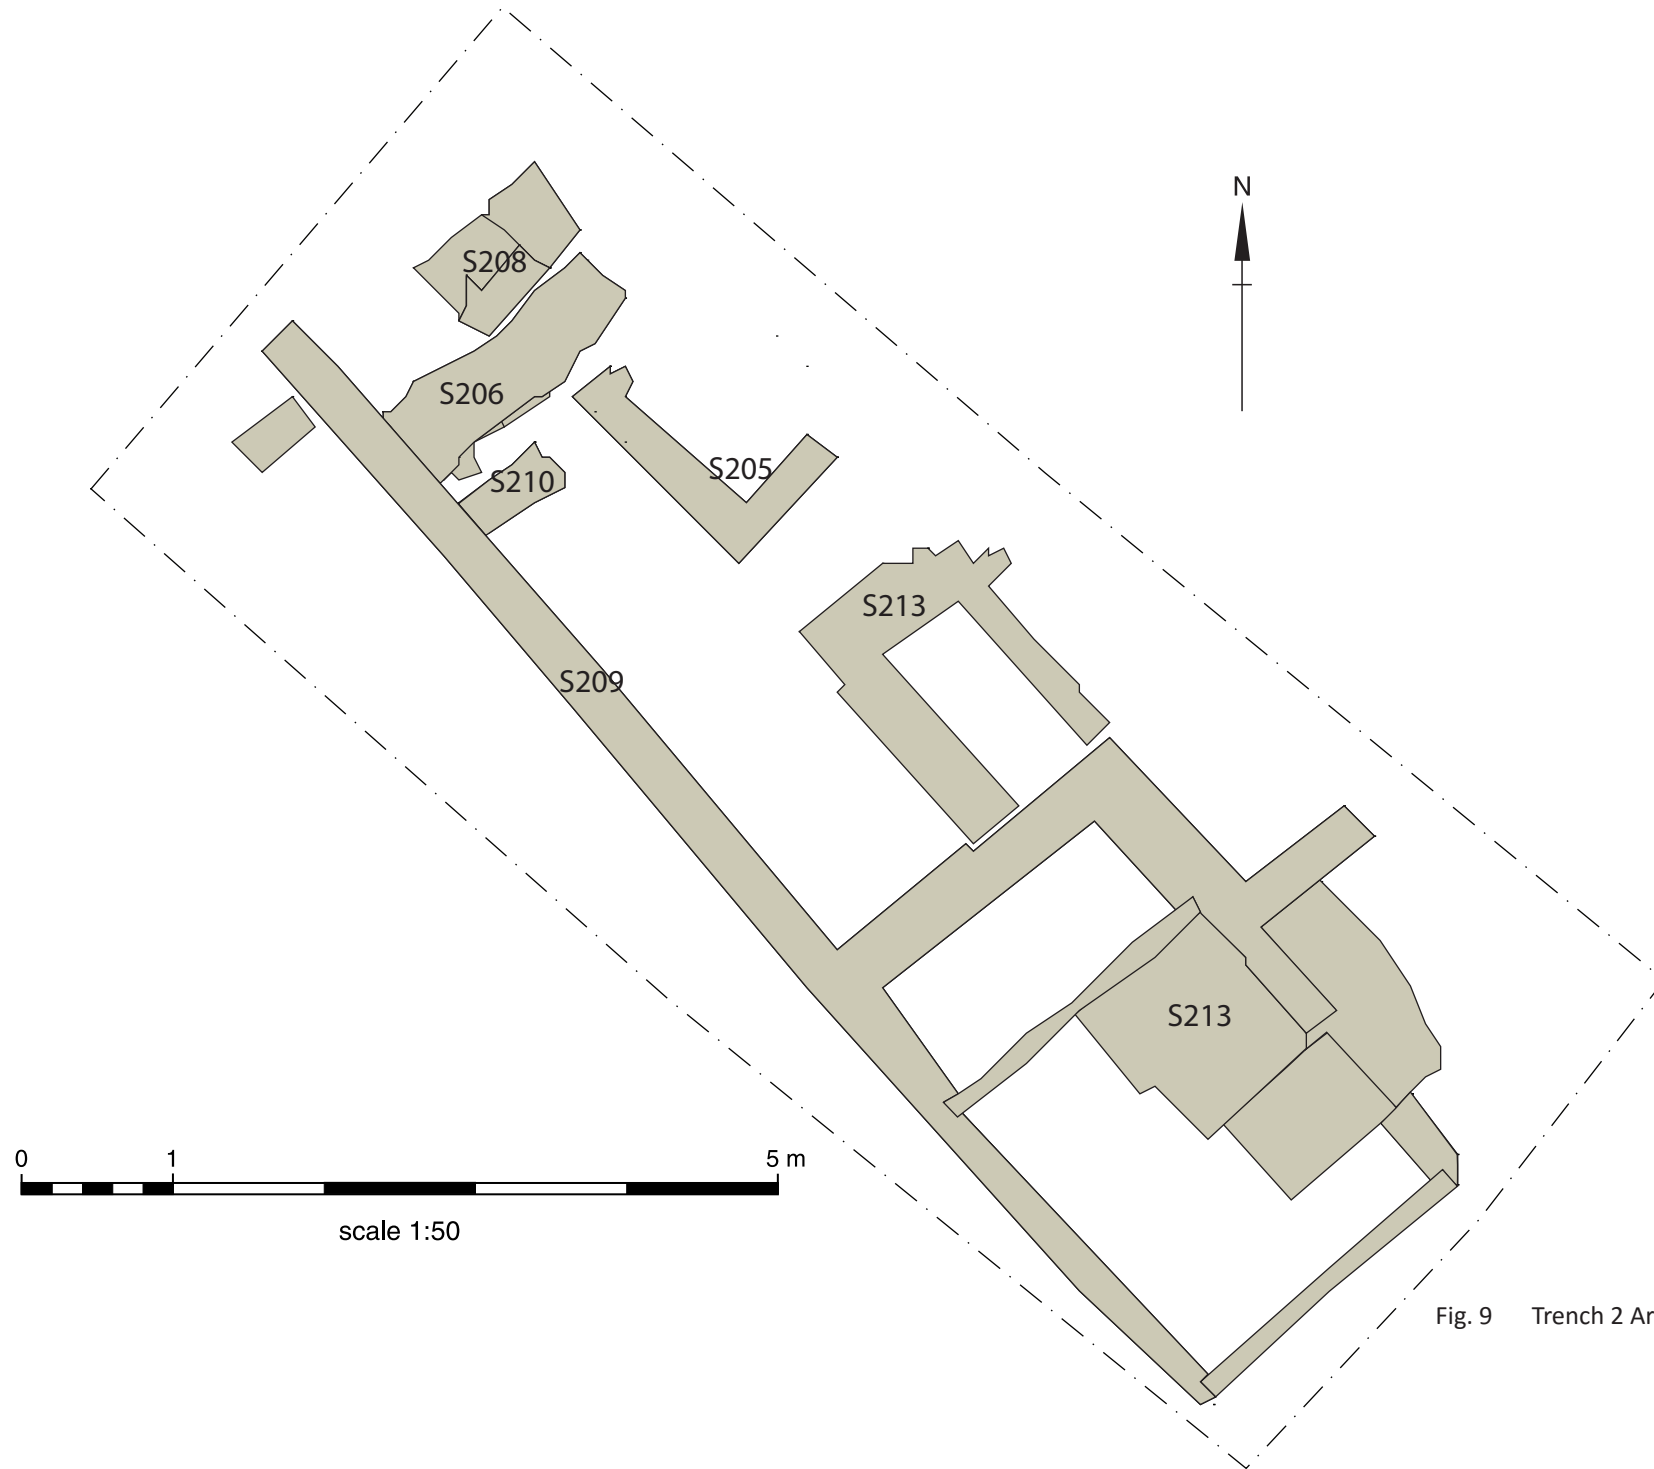
Fig. 9 Trench 2 Archaeology
