**BUILDING RECORDING AT
CLEMENTHORPE MALTINGS,
LOWER DARNBOROUGH STREET, YORK**

BUILDING SURVEY REPORT

Report Number 2015/31 July 2015

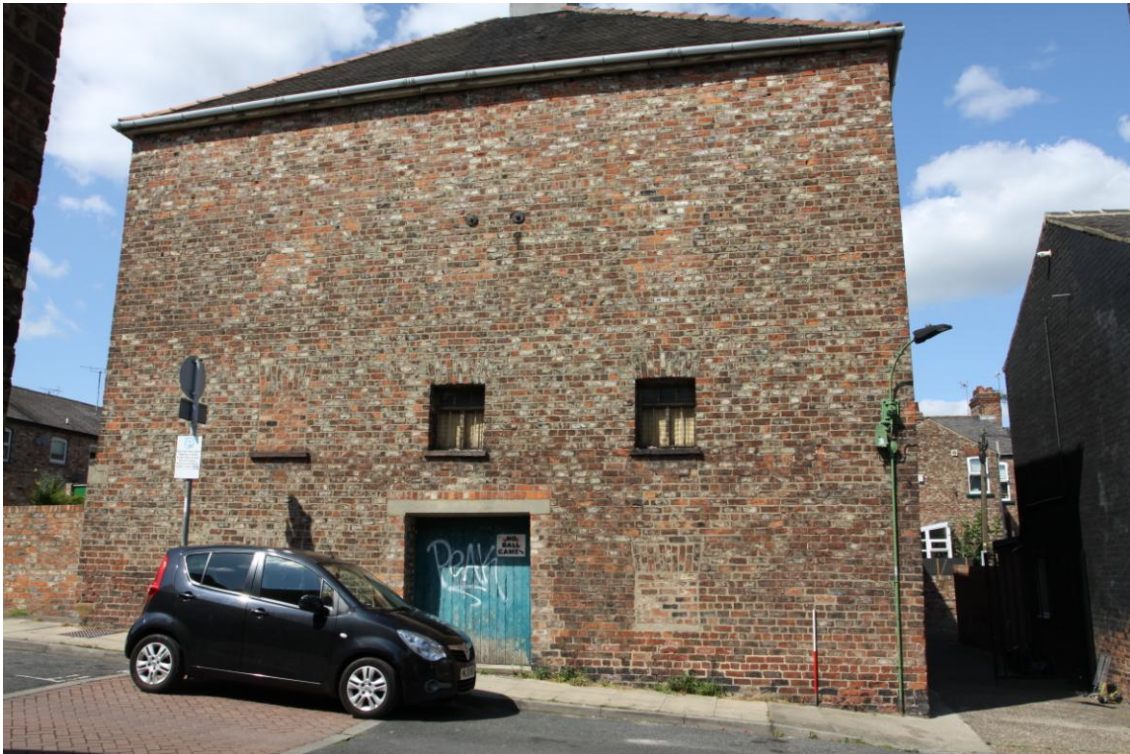
Plate 1: South elevation of Kiln (Photograph 234).

The kiln is positioned at the south end of the building and is three storeys in height. It is constructed out of brick and laid in English Garden Wall Bond with flat terracotta roof tiles. It has a pyramidal roof and a tall, square kiln cowl (Plate 1).

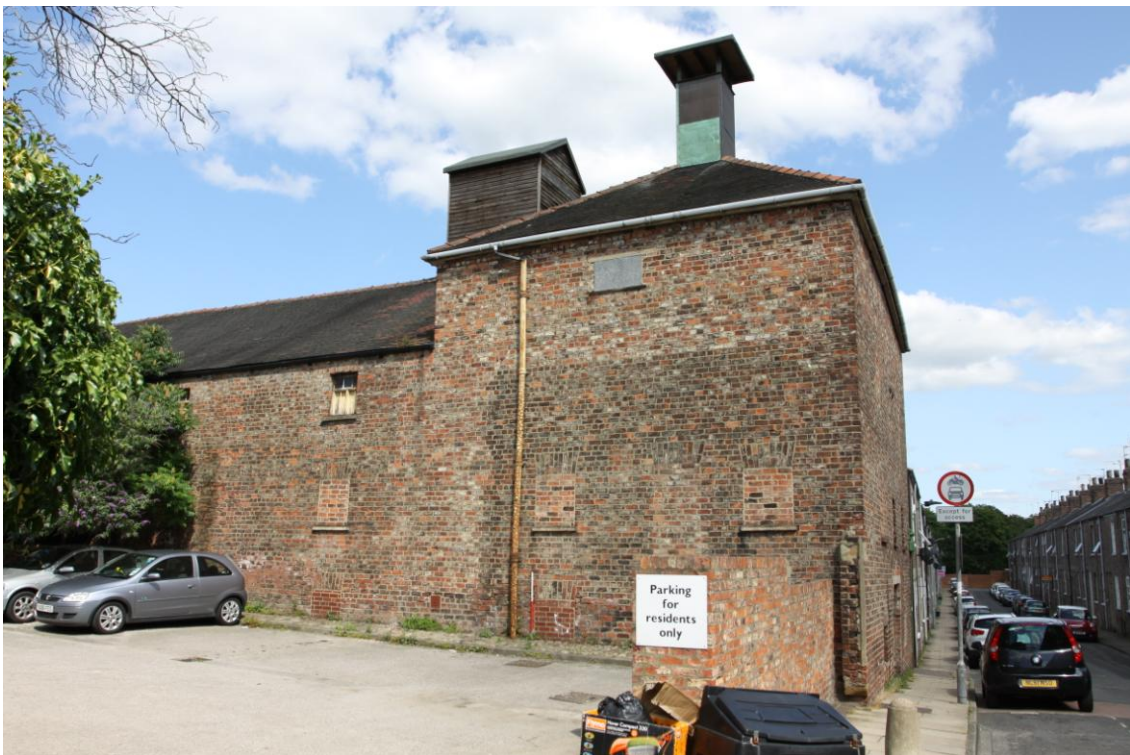
Plate 2: West Elevation of Kiln (Photograph 245).

There are a series of original window openings at Ground and 1st Floor Level to the south and west elevations. The window heads take the form of flat segmental arches and several of the cills project out beyond the building line (Plate 2).

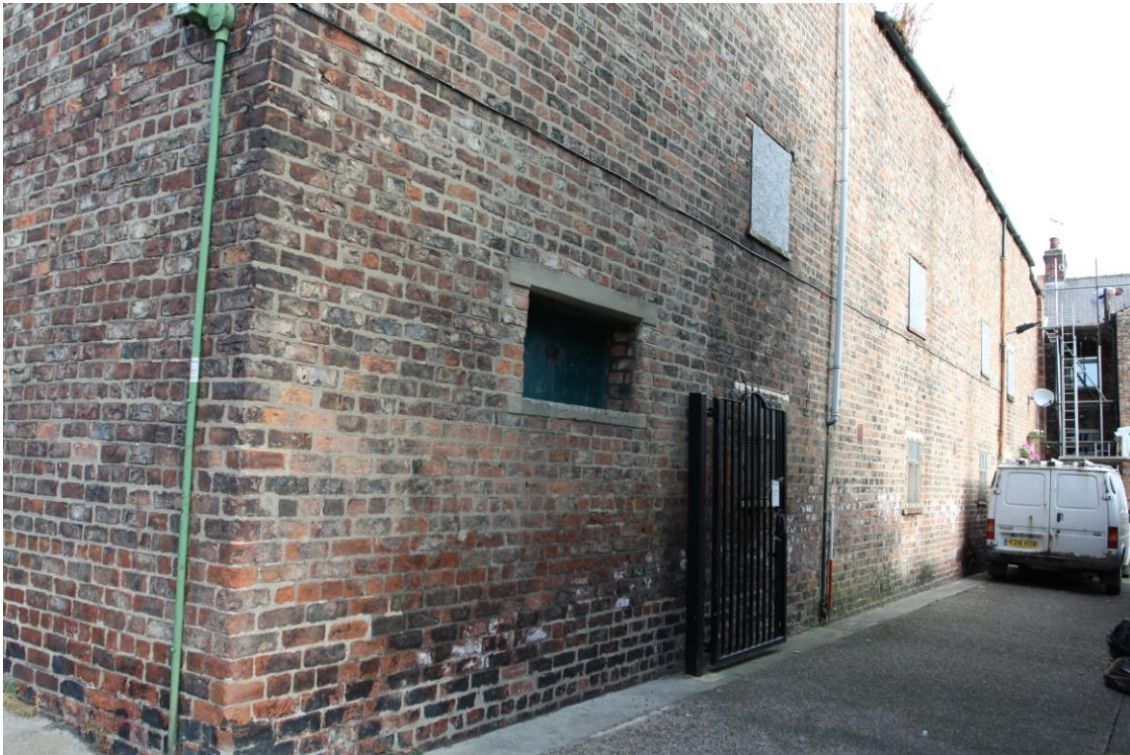
Plate 3: East Elevation of Kiln (Photograph 4).

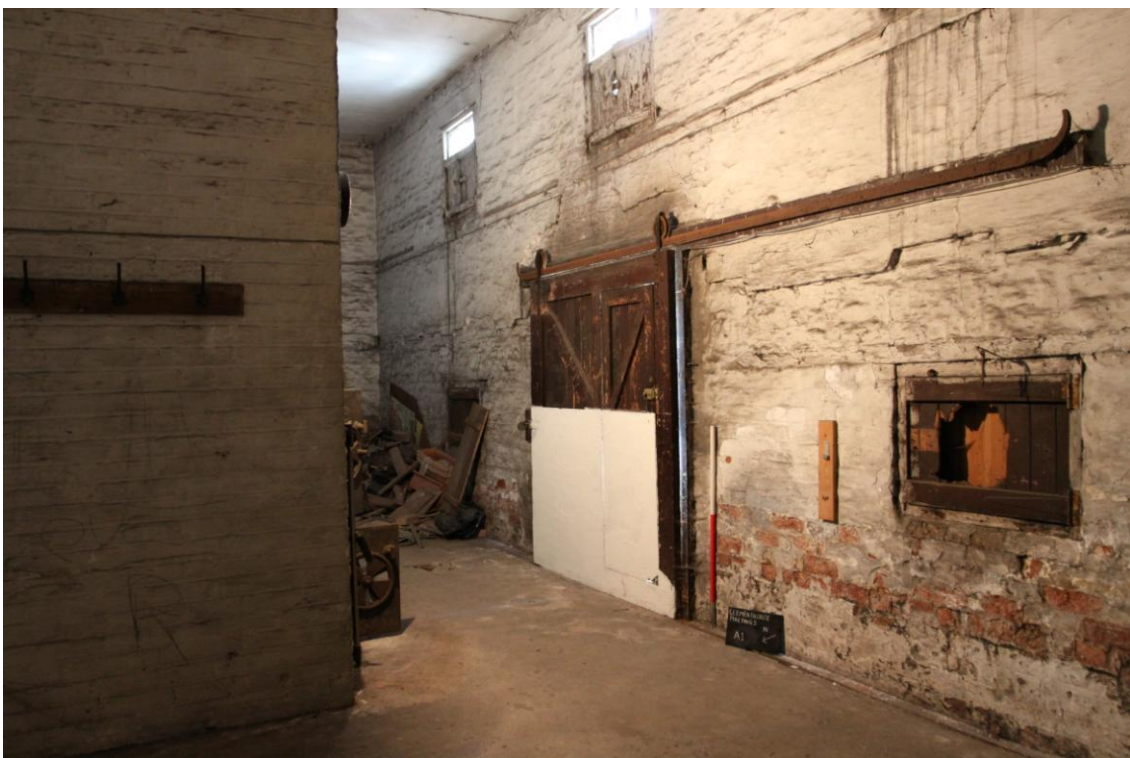
Plate 4: Kiln Ground Floor Level (Photograph 91).

The Kiln is open across the Ground and 1st Floor Level (Plate 4). The original window openings are fitted with wooden shutters to the lower part and three horizontal lights above. The later windows are also fitted with wooden shutters. The kiln furnace is situated on a dividing wall between the kiln and the malthouse. The kiln furnace (**C**) is a H.J.H. King patent kiln furnace (Plates 5 and 6). The kiln is very well preserved with the kiln doors, side and top ventilators, furnace, and fire bars all in excellent condition. The fuel would have been anthracite (Patrick, pers comm.).

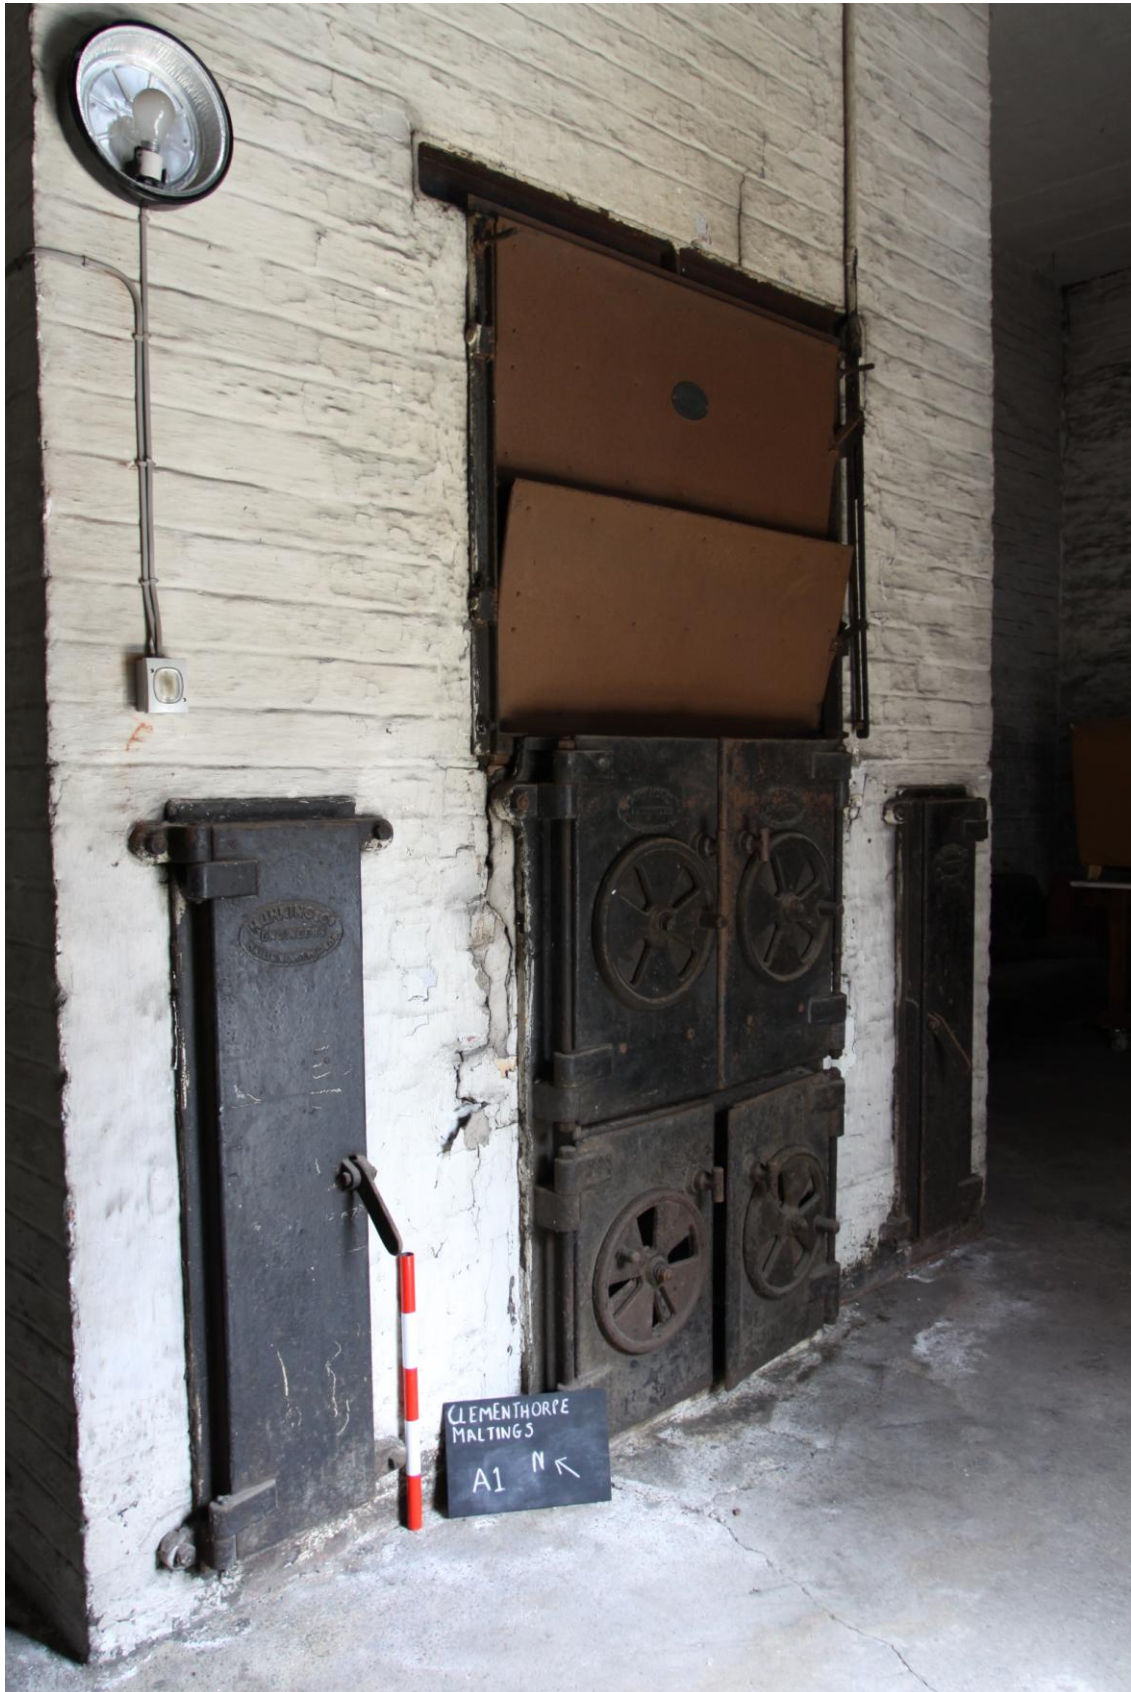
Plate 5: H.J.H. King Kiln Furnace (Photograph 103).

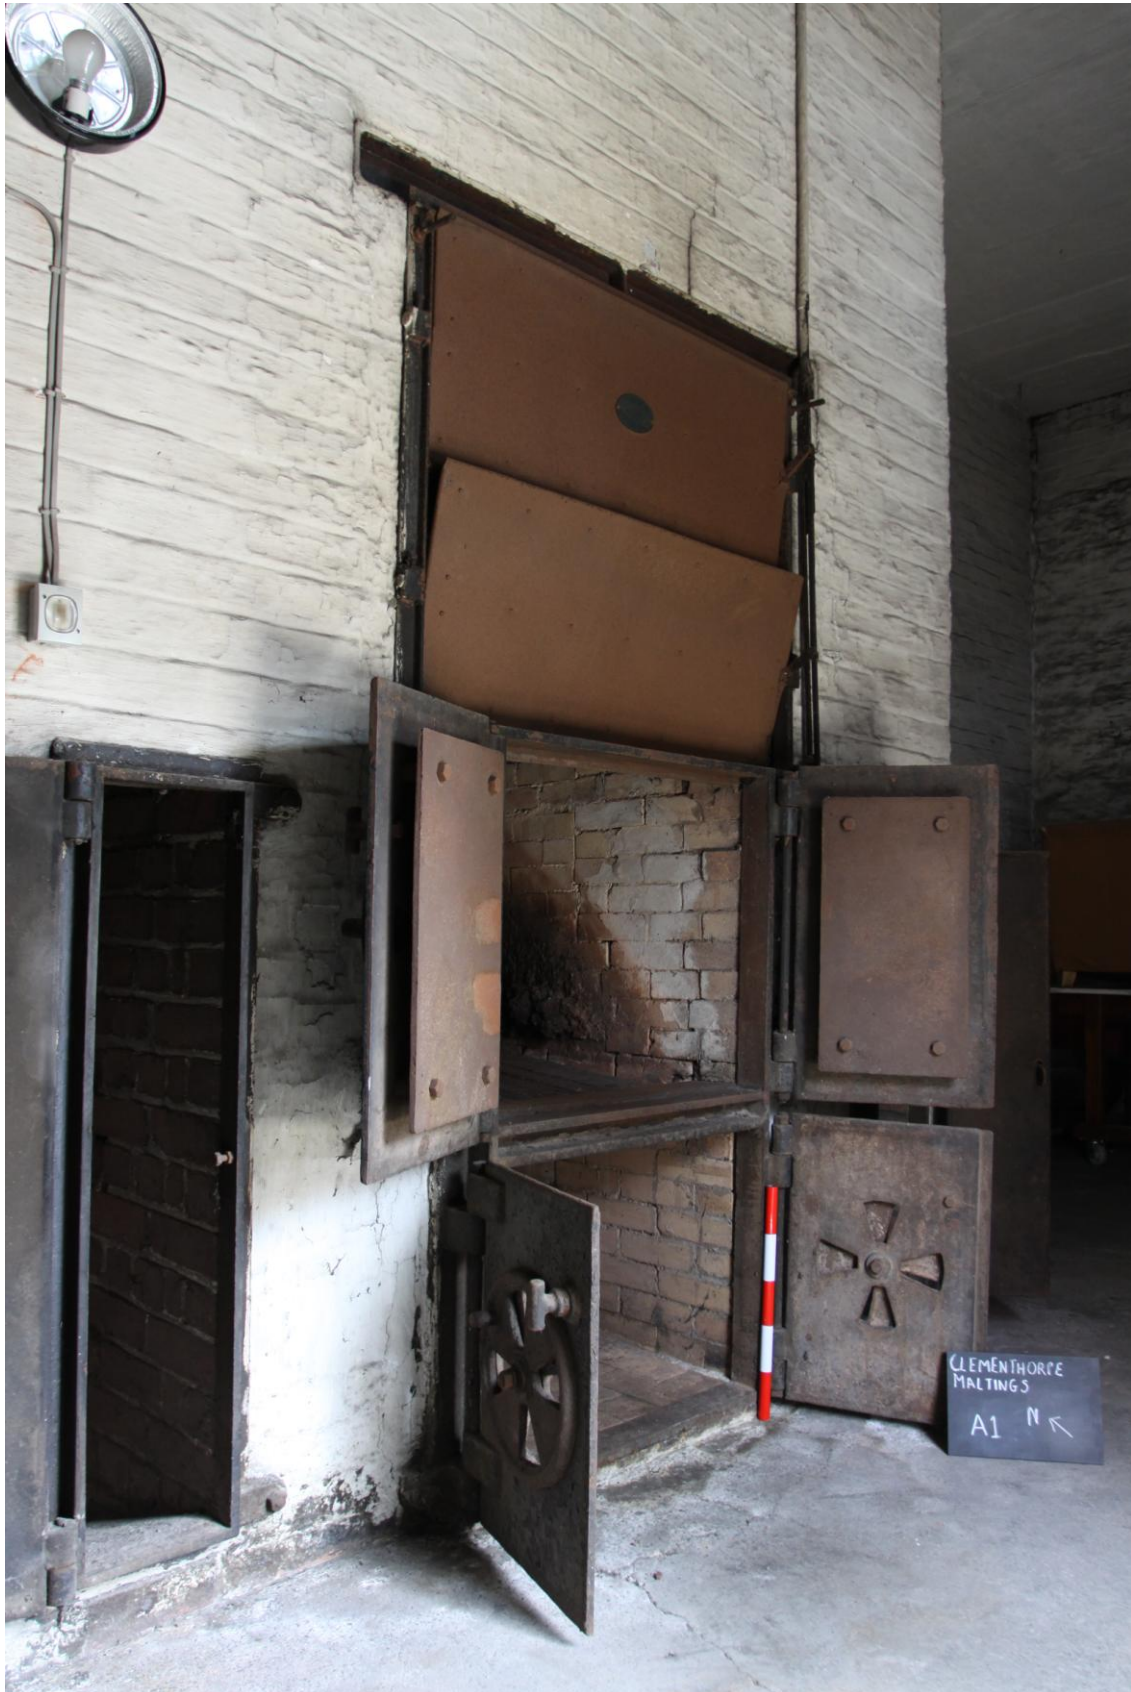
Plate 6: H.J.H. King Kiln Furnace (Photograph 105).

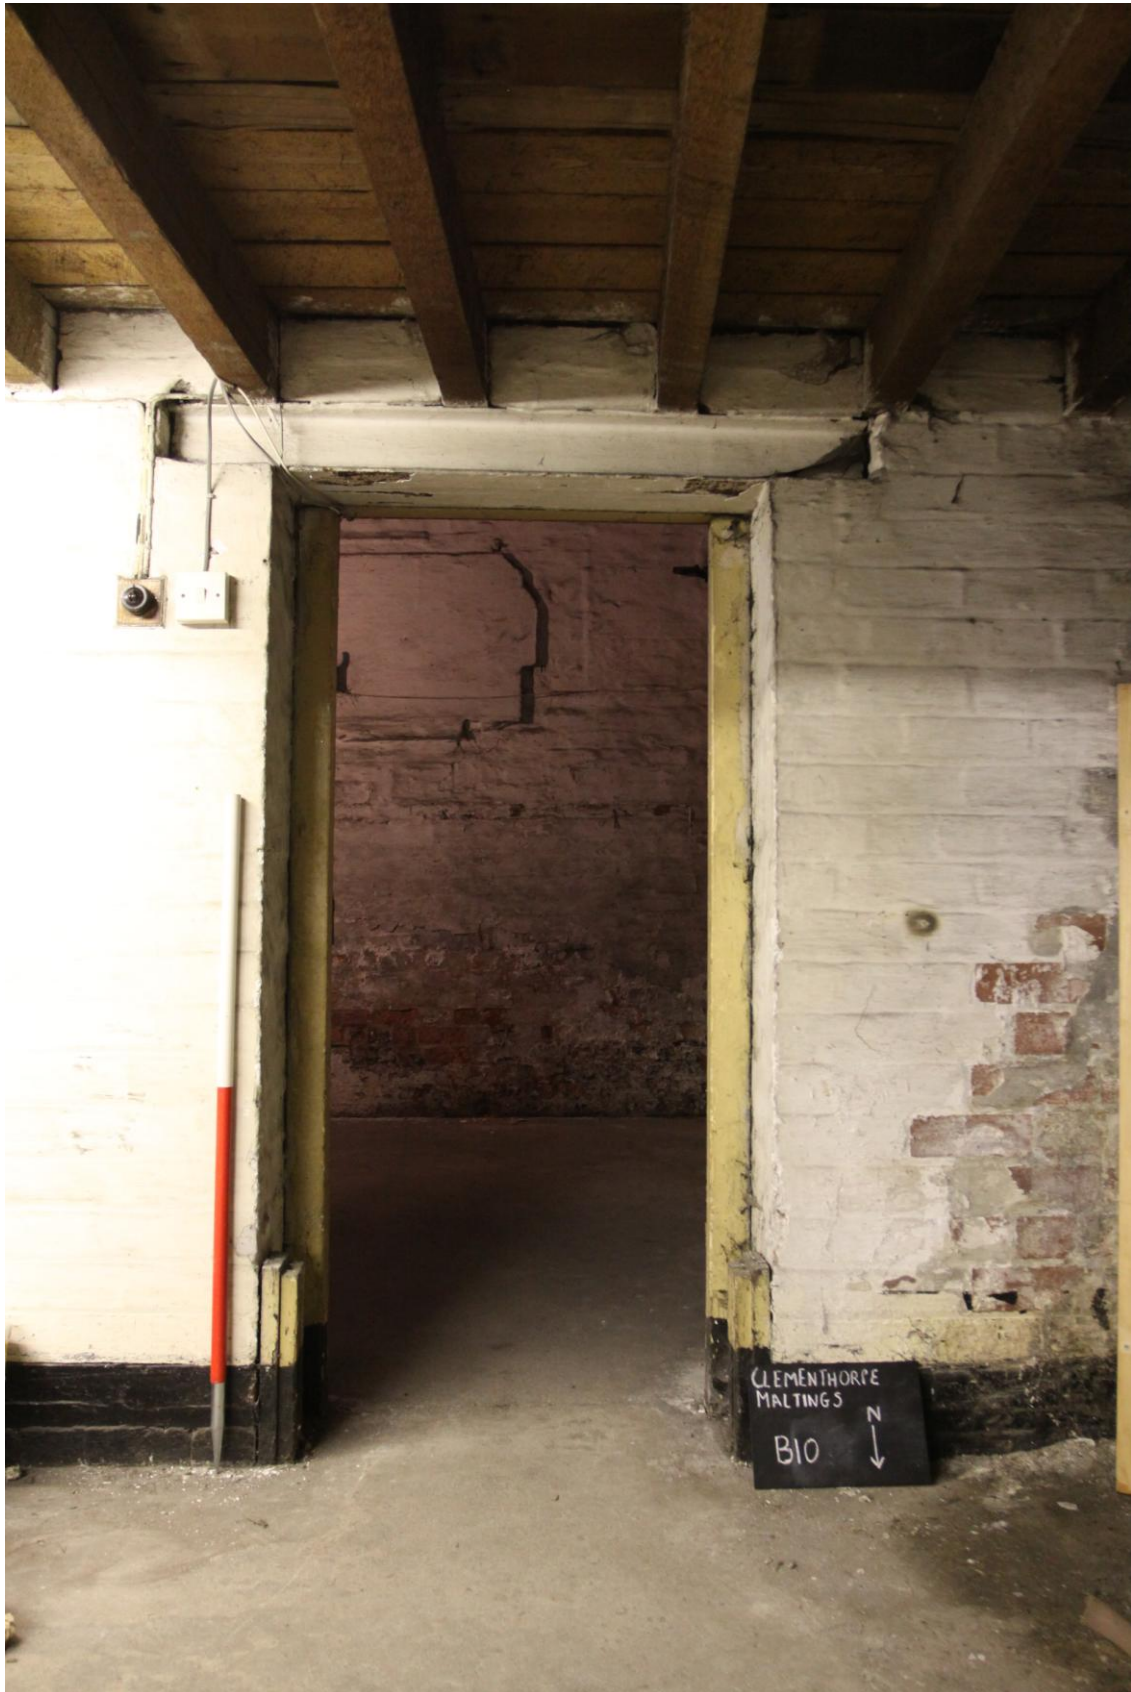
Plate 7: Doorway between Kiln and Malthouse (Photograph 89).

Access between the malthouse and the kiln is through a doorway at the west end of the dividing wall. Fitted into either side of the door jamb are two low-level timber posts with slots for a grain board, presumably to prevent the grain from spreading from the germination floor onto the kiln furnace floor (Plate 7).

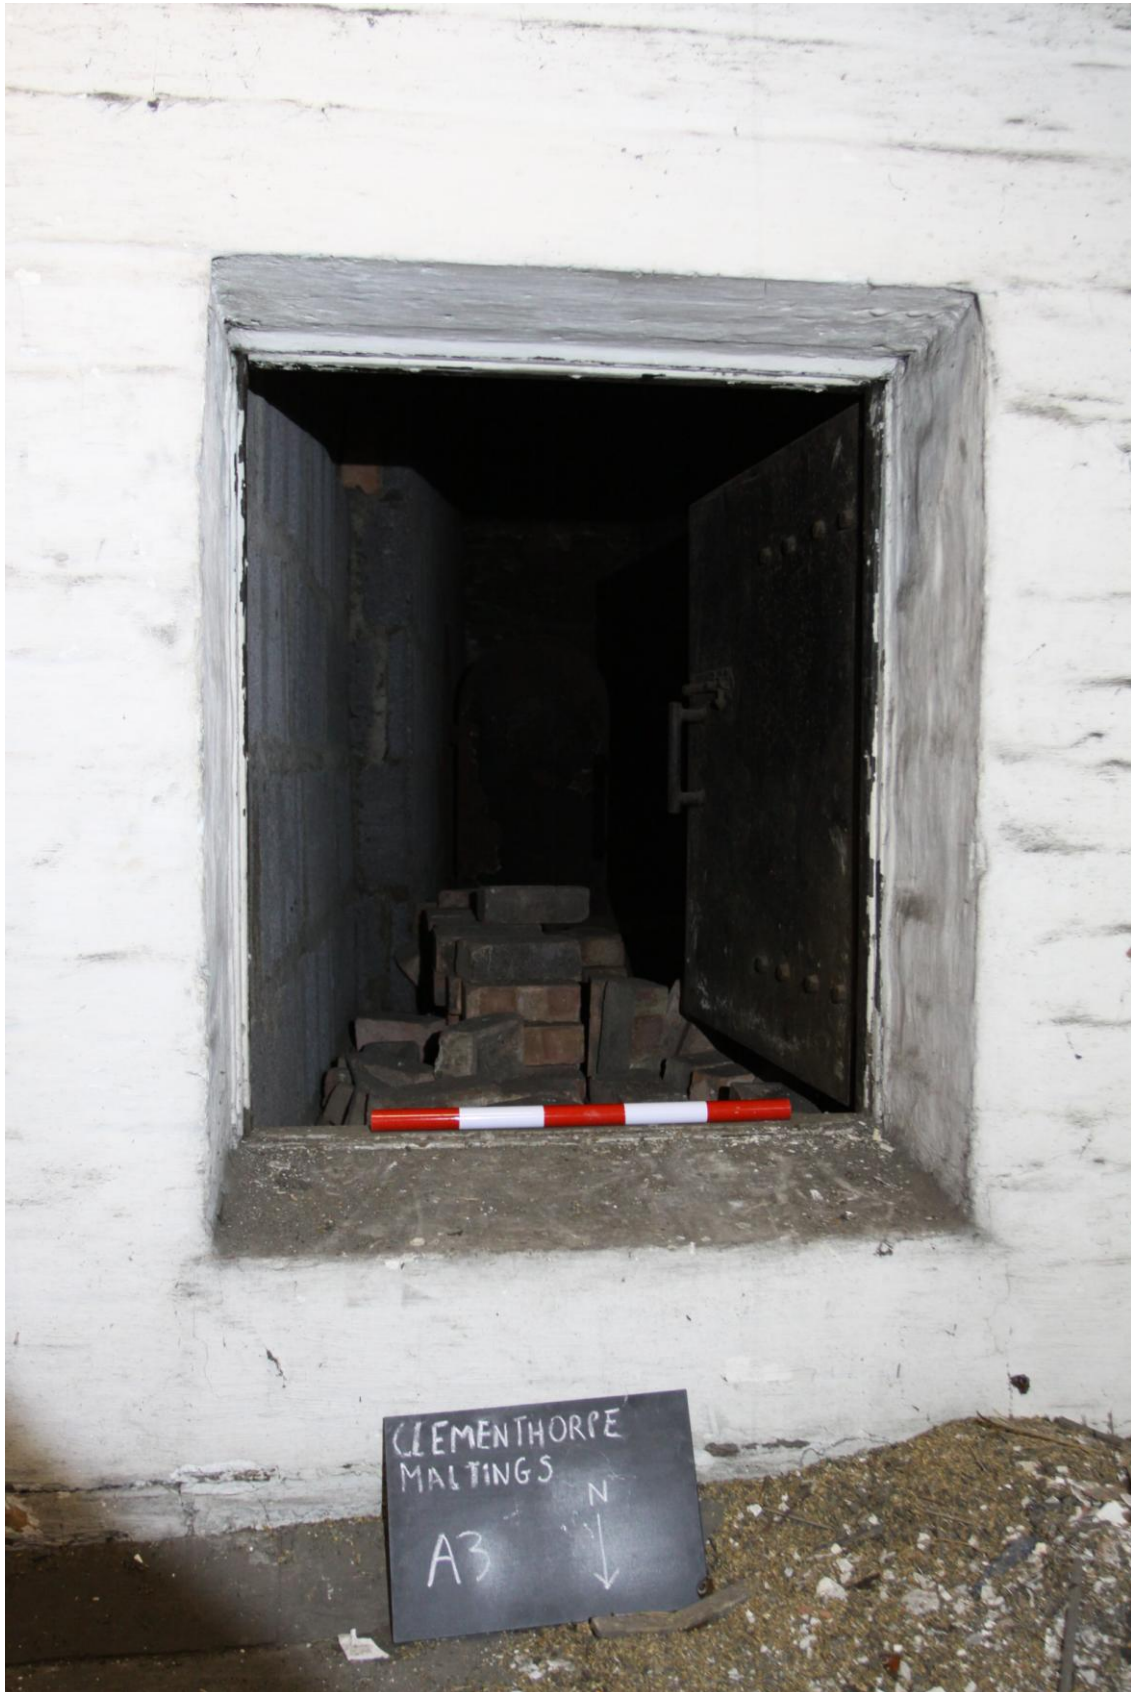
Plate 8: 2nd Floor Level Doorway into the underside of the kiln drying floor (Photograph 195).

The corridor is accessed through a cast iron door positioned on the dividing wall between the Kiln and the malthouse (Plate 8). Half way along the corridor is a further cast iron door which appears to provide access into the rest of the kiln. The internal corridor wall appears to have been clad in modern breeze block. To the right of the doorway is a metal holder for a fire extinguisher (Plate 9).

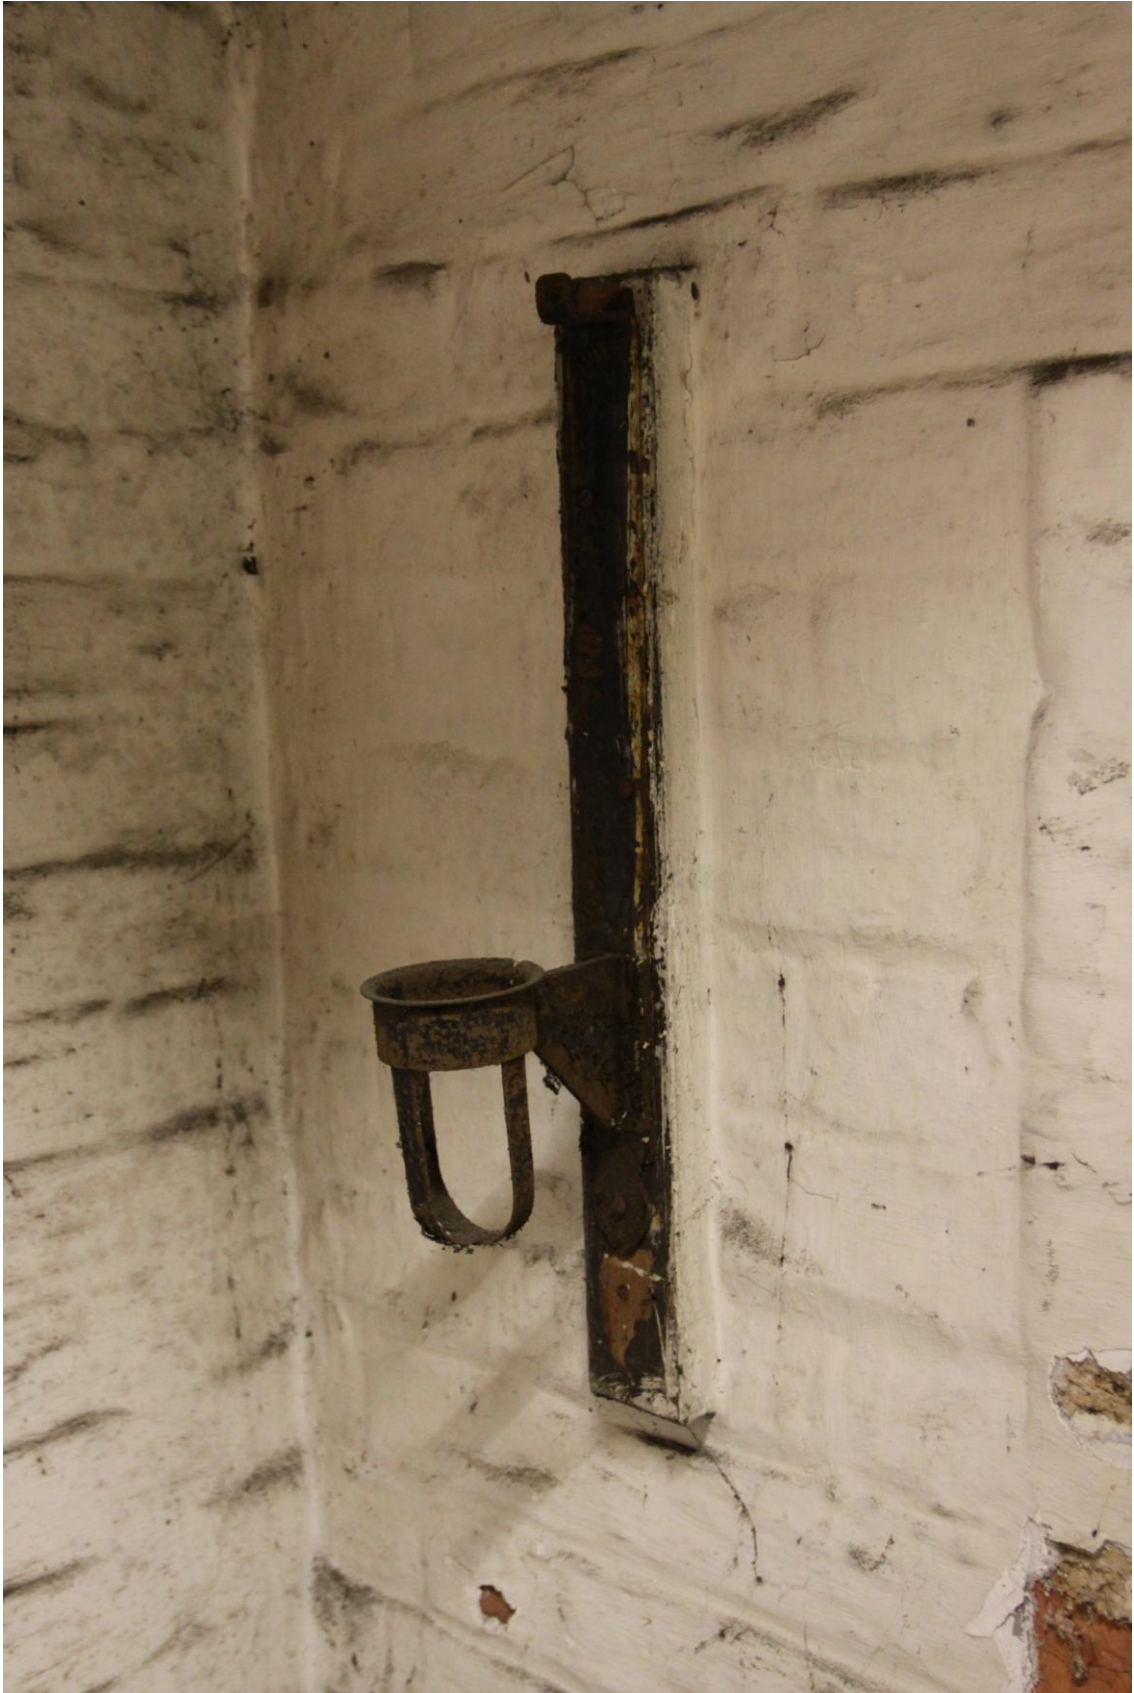
Plate 9: Metal Holder to right of Doorway into Kiln, 2nd Floor Level (Photograph 197)

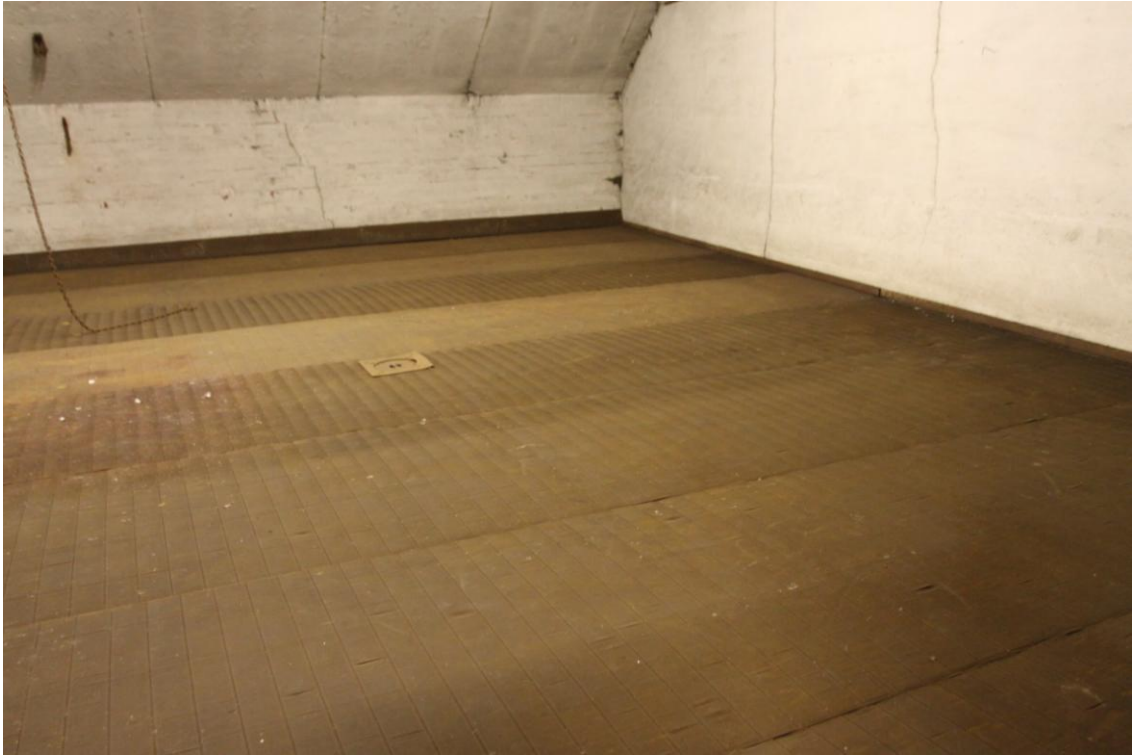
Plate 10: 3rd Floor Level Kiln Drying Floor (Photograph 217).

The Kiln is open to the roof at this level. The floor comprises a metal wedge wire surface where the green malt was placed during the kilning process (Plate 10). The cowl is positioned at the centre of the pyramidal roof. The fan on the underside of the cowl is opened and closed by means of a pulley system (Plate 11). It is probable that this is a H.J.H. King fan (Patrick, pers comm.).

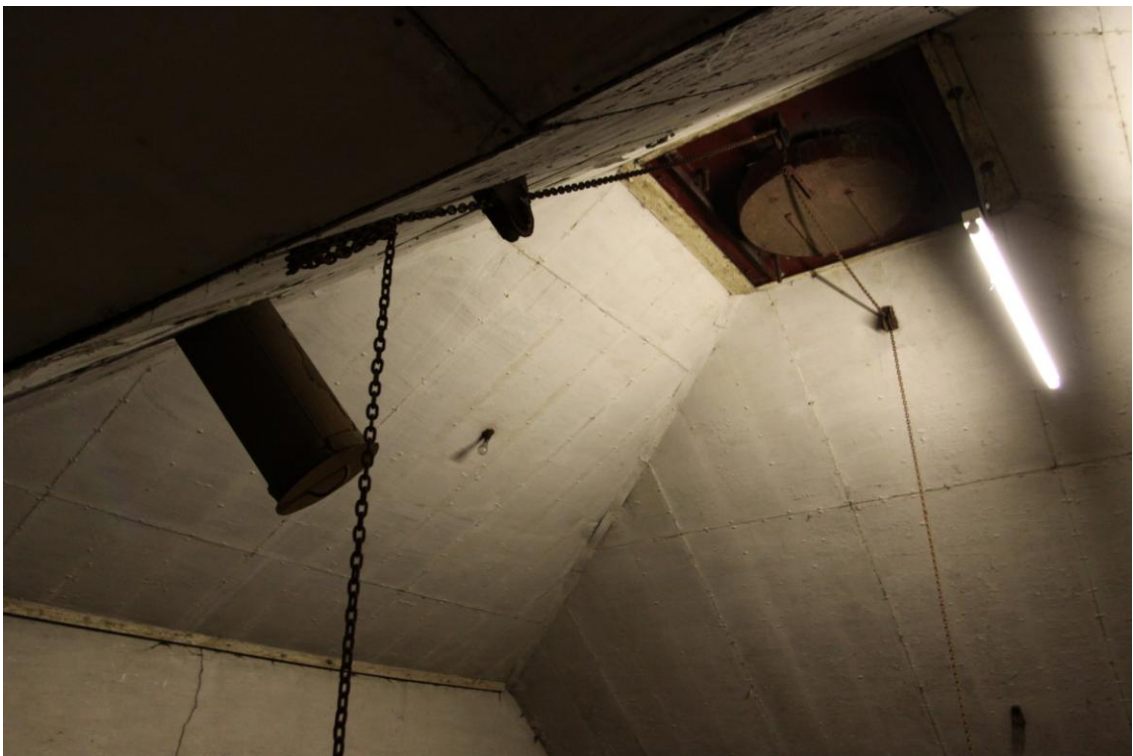
Plate 11: 3rd Floor Level Kiln Roof (Photograph 216).

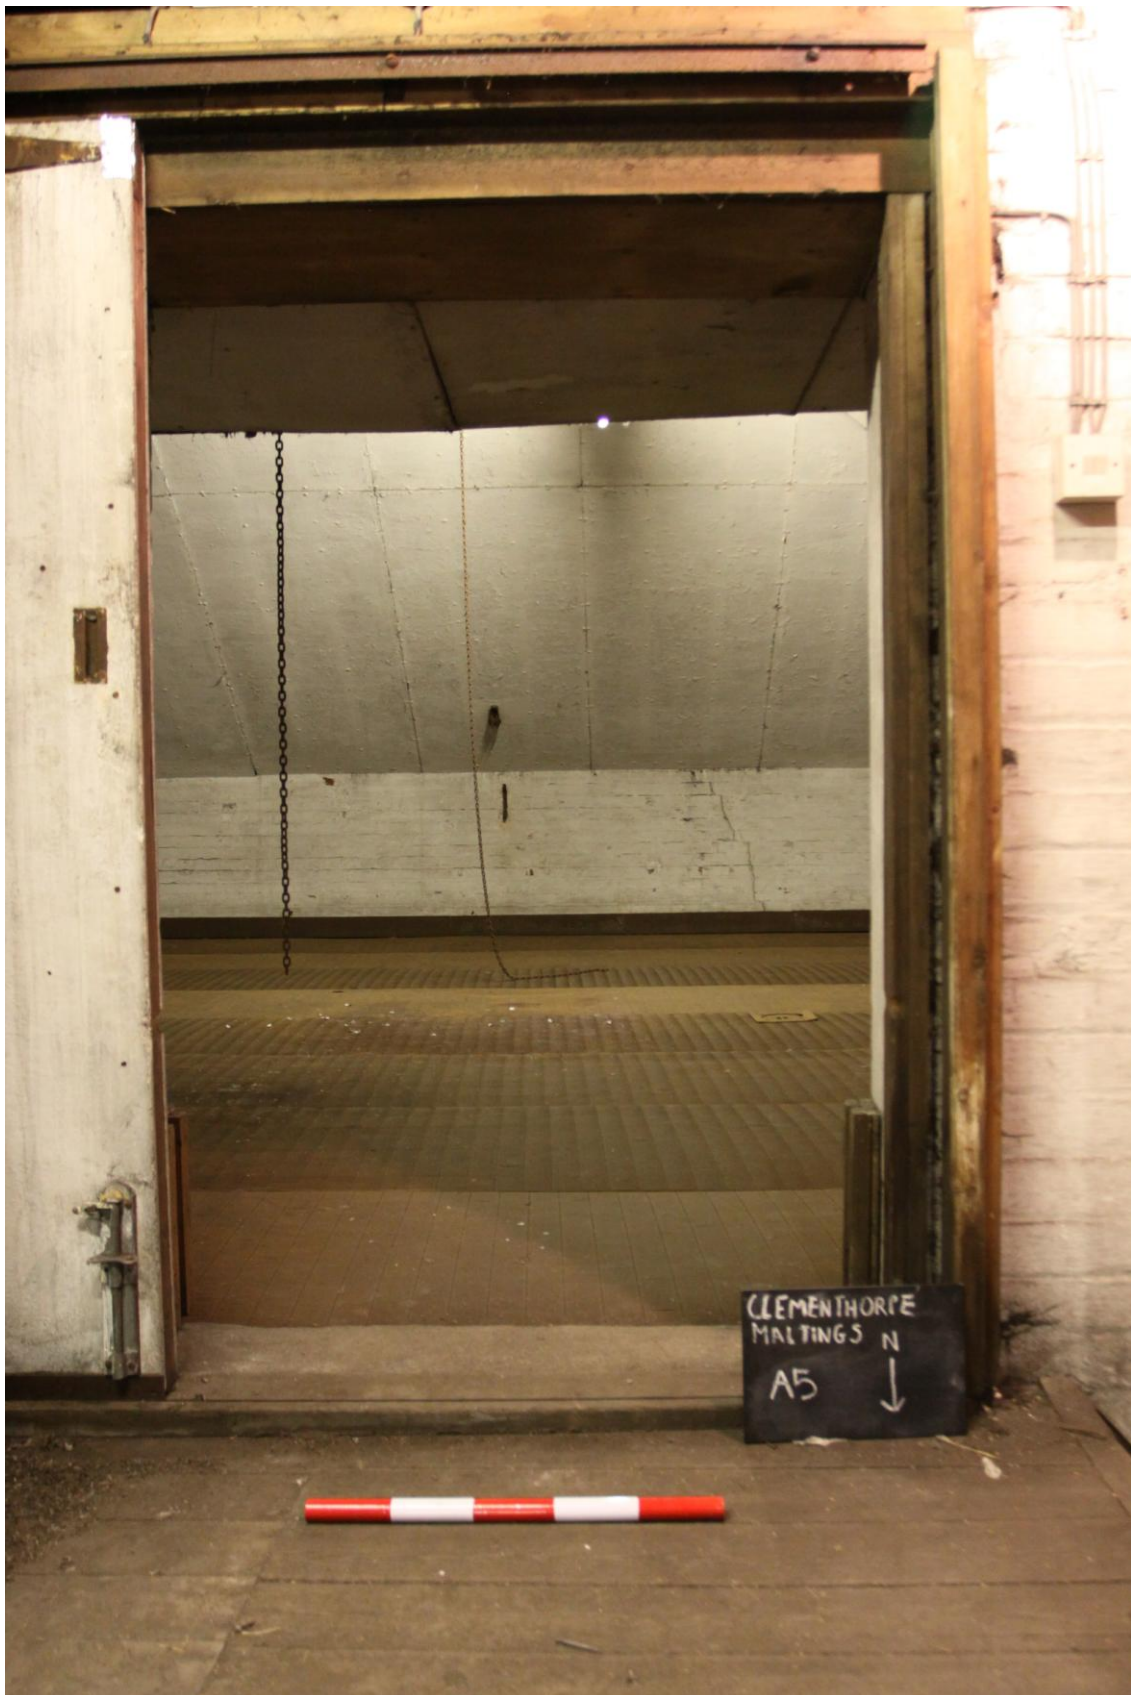
Plate 12: 3rd Floor Level Doorway into Kiln (Photograph 214).

The drying floor is accessed through a doorway positioned in the dividing wall between the kiln and the malthouse (Plate 12). Fitted into either side of the door jamb are two low-level timber posts with slots for a kilning malt board, presumably to prevent the grain from spreading onto the storage floor of the malthouse when the door was opened during kilning.

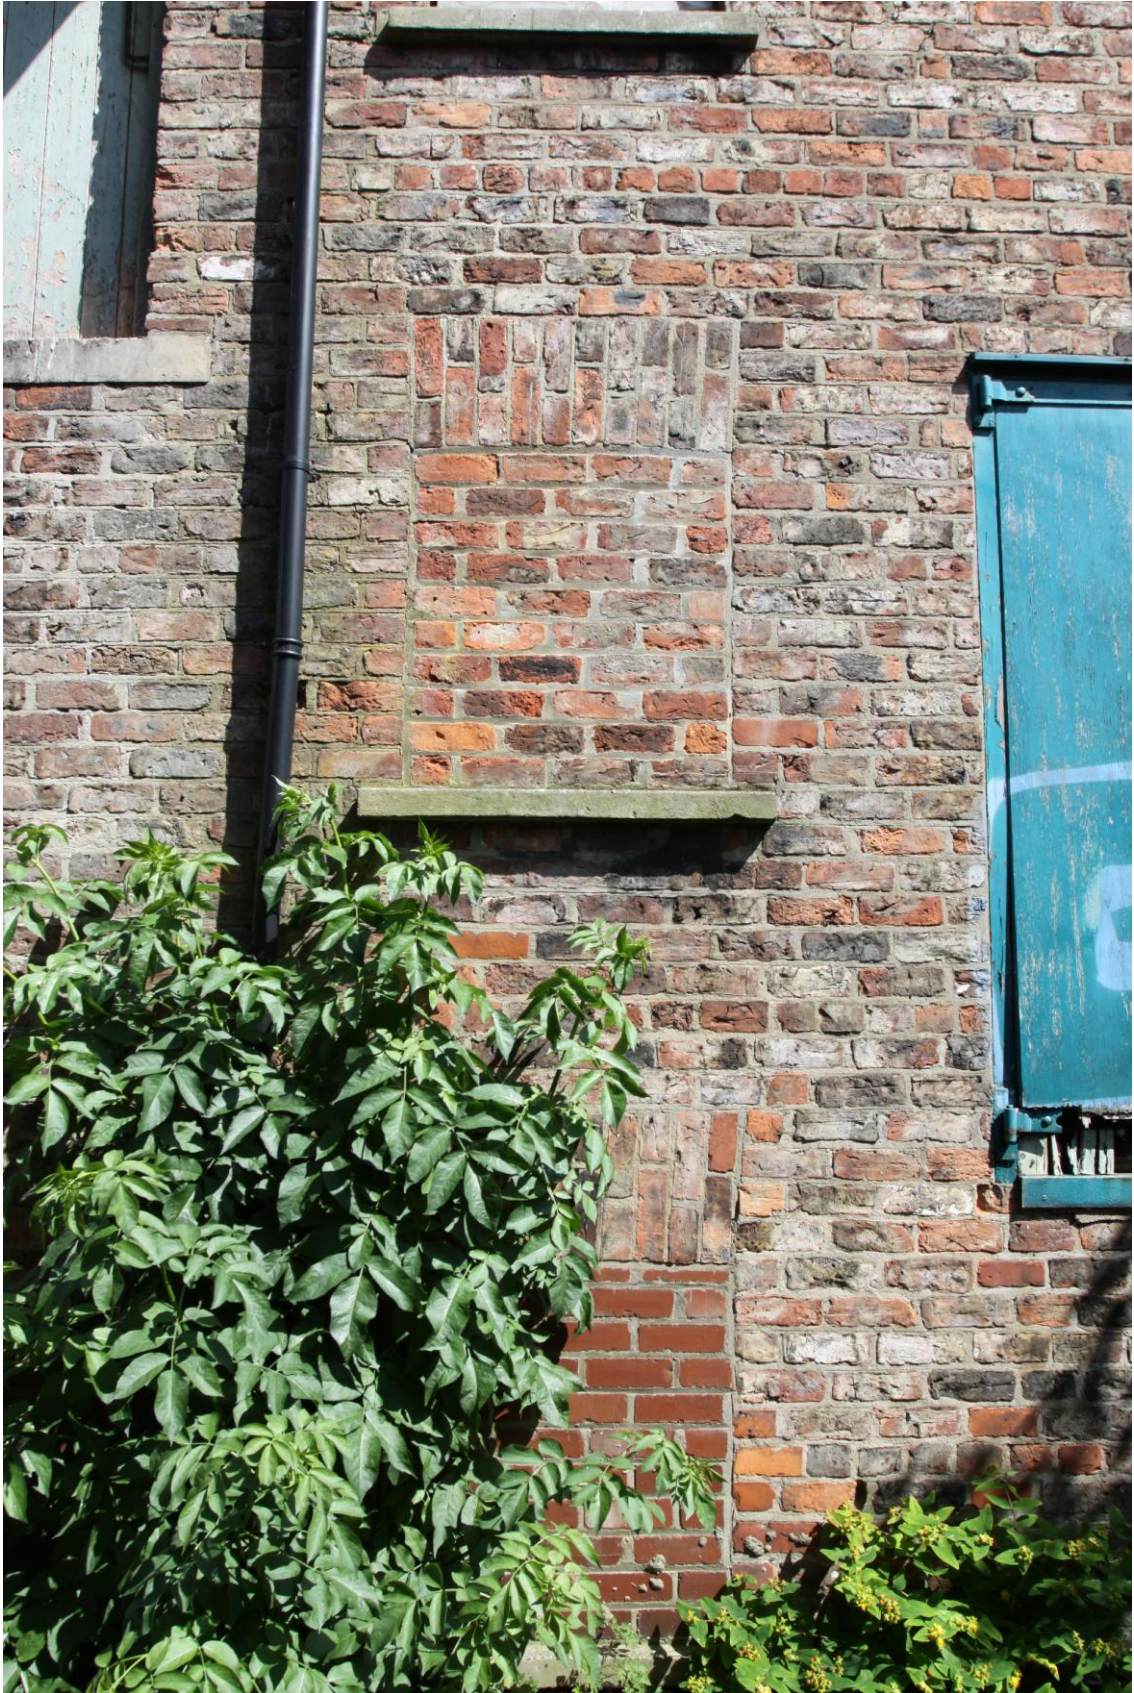
Plate 13: West Elevation Malthouse, Window Details (Photograph 230).

There are a series of original window openings positioned along the west elevation of the malthouse at Ground, 1st and 2nd Floor Level (Plate 13). Similar to the kiln, the window heads take the form of flat segmental arches, and a number of the cills project out beyond the building line. To the west elevation is a further scheme of later, inserted windows (Plate 14). A series of ventilation holes have been introduced into the building at Ground Floor Level, and at roof height under the eaves, along the east and west elevations. Though some of these

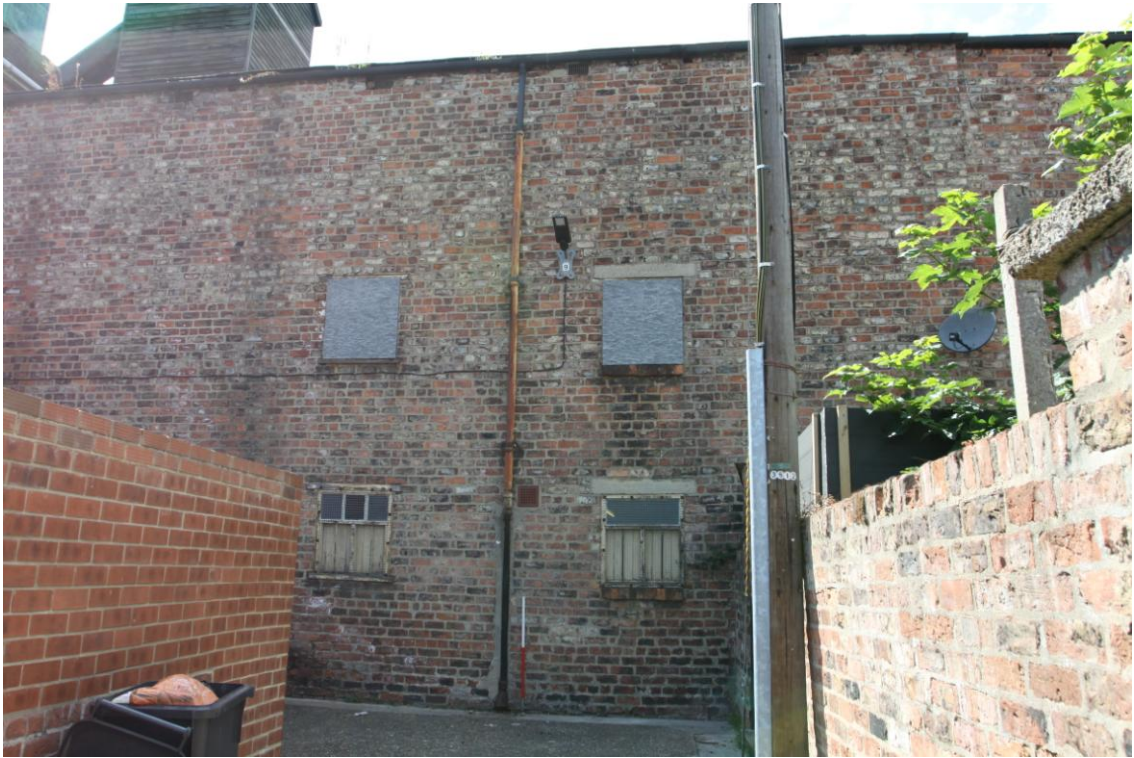
Plate 14: East Elevation malthouse, Window Details (Photograph 240).

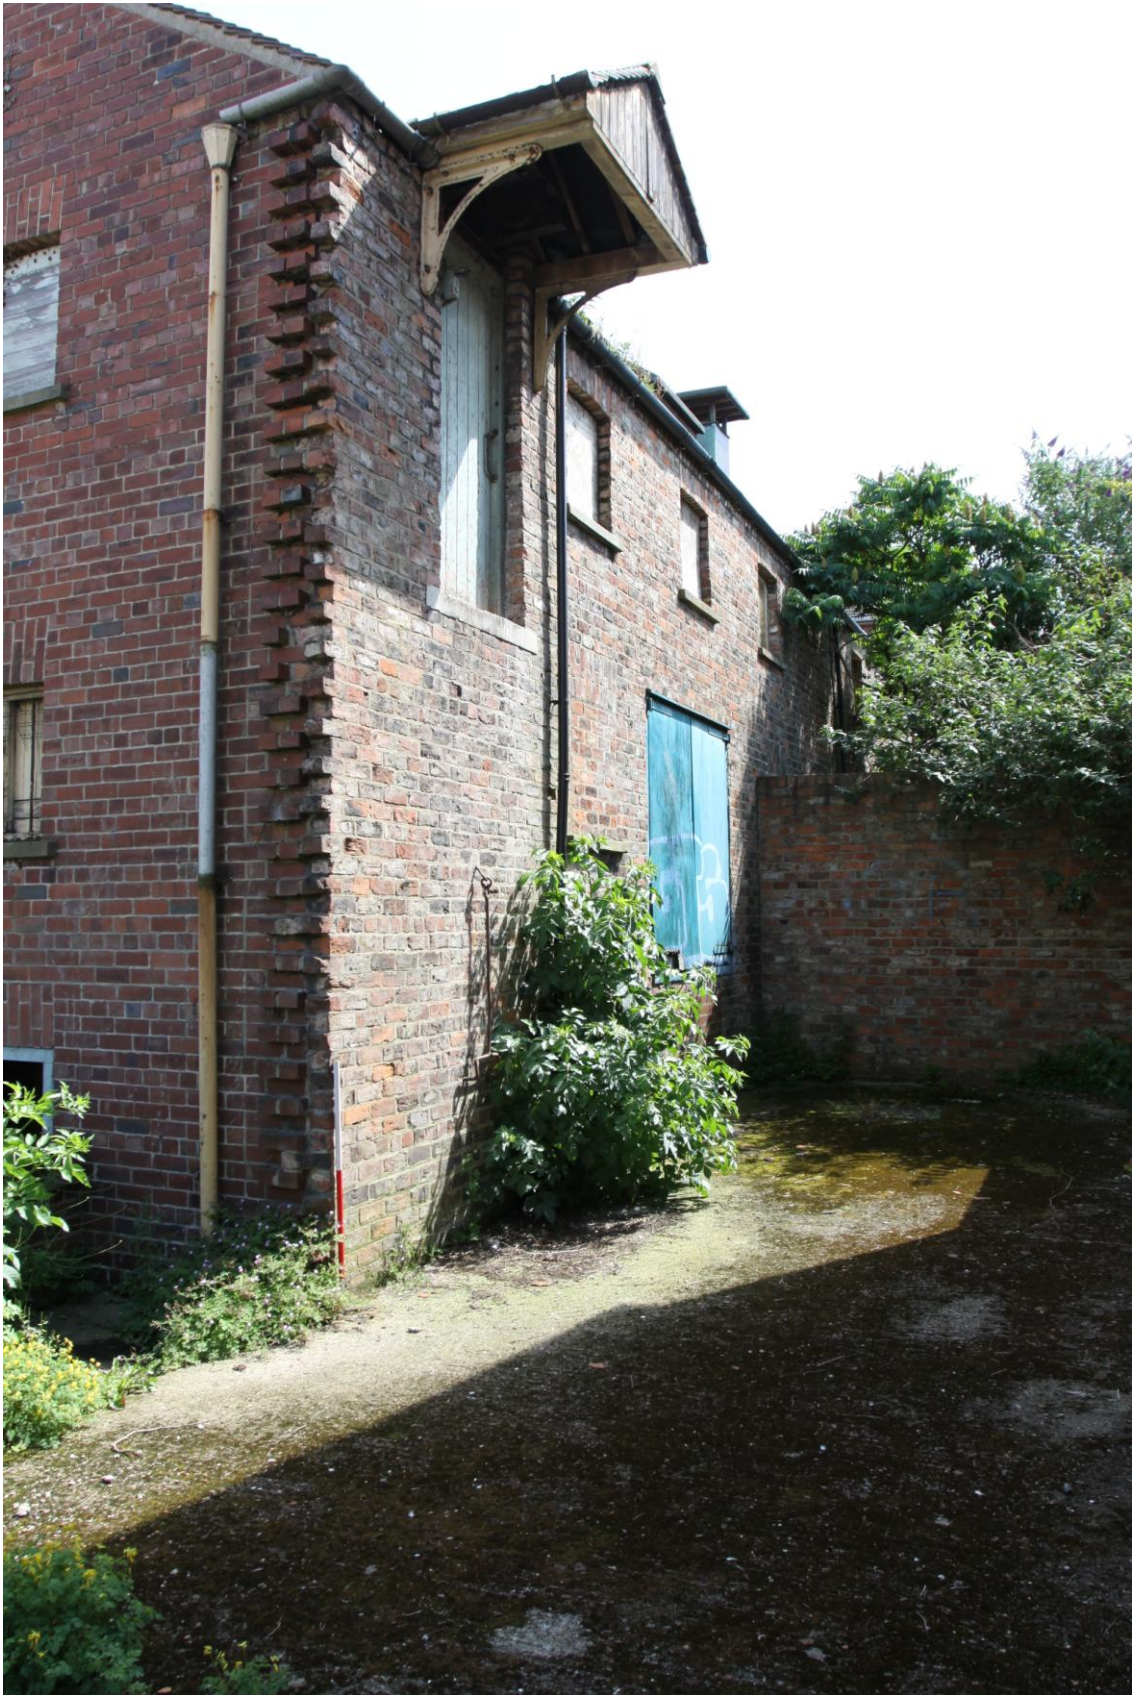
Plate 15: West Elevation Malthouse, Hoist Door (Photograph 227).

A doorway has been inserted at 1st Floor Level on the west elevation (see Plate 15). It is possible that this entranceway relates to the building’s later uses as a storage warehouse.
