**BUILDING RECORDING AT
CLEMENTHORPE MALTINGS,
LOWER DARNBOROUGH STREET, YORK**

BUILDING SURVEY REPORT

Report Number 2015/31 July 2015

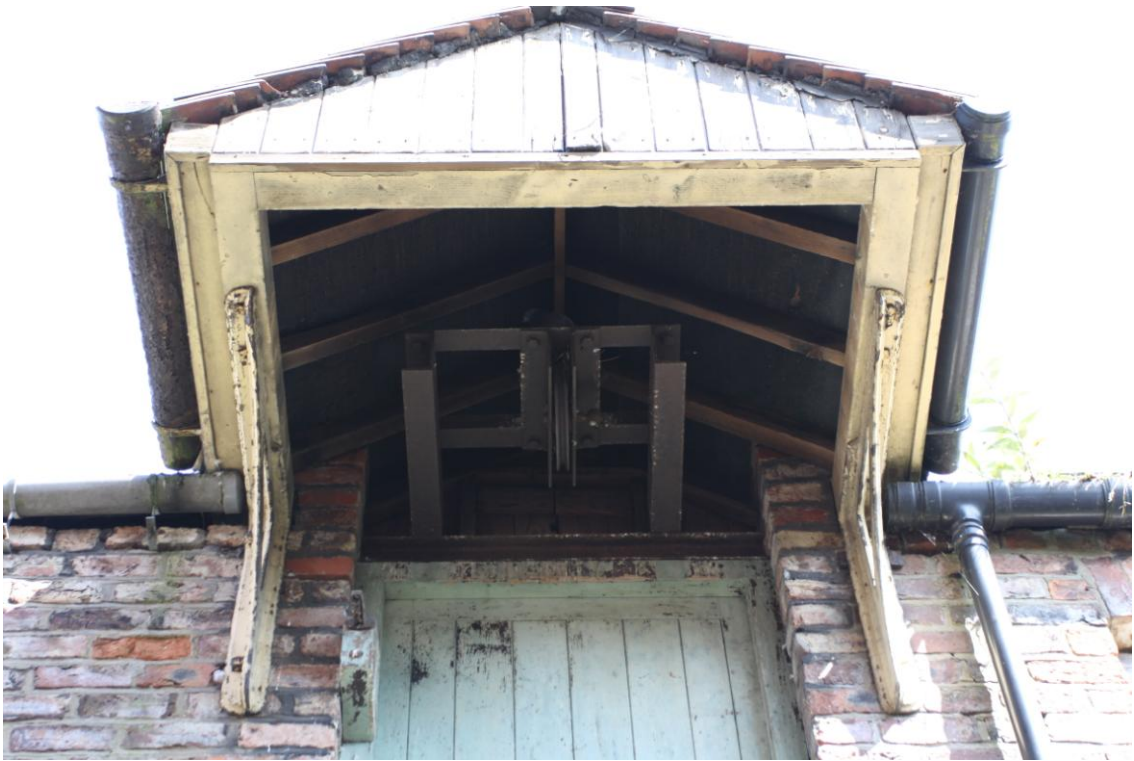
Plate 16: Hoist Door, Detail of Hoist Mechanism (Photograph 229).

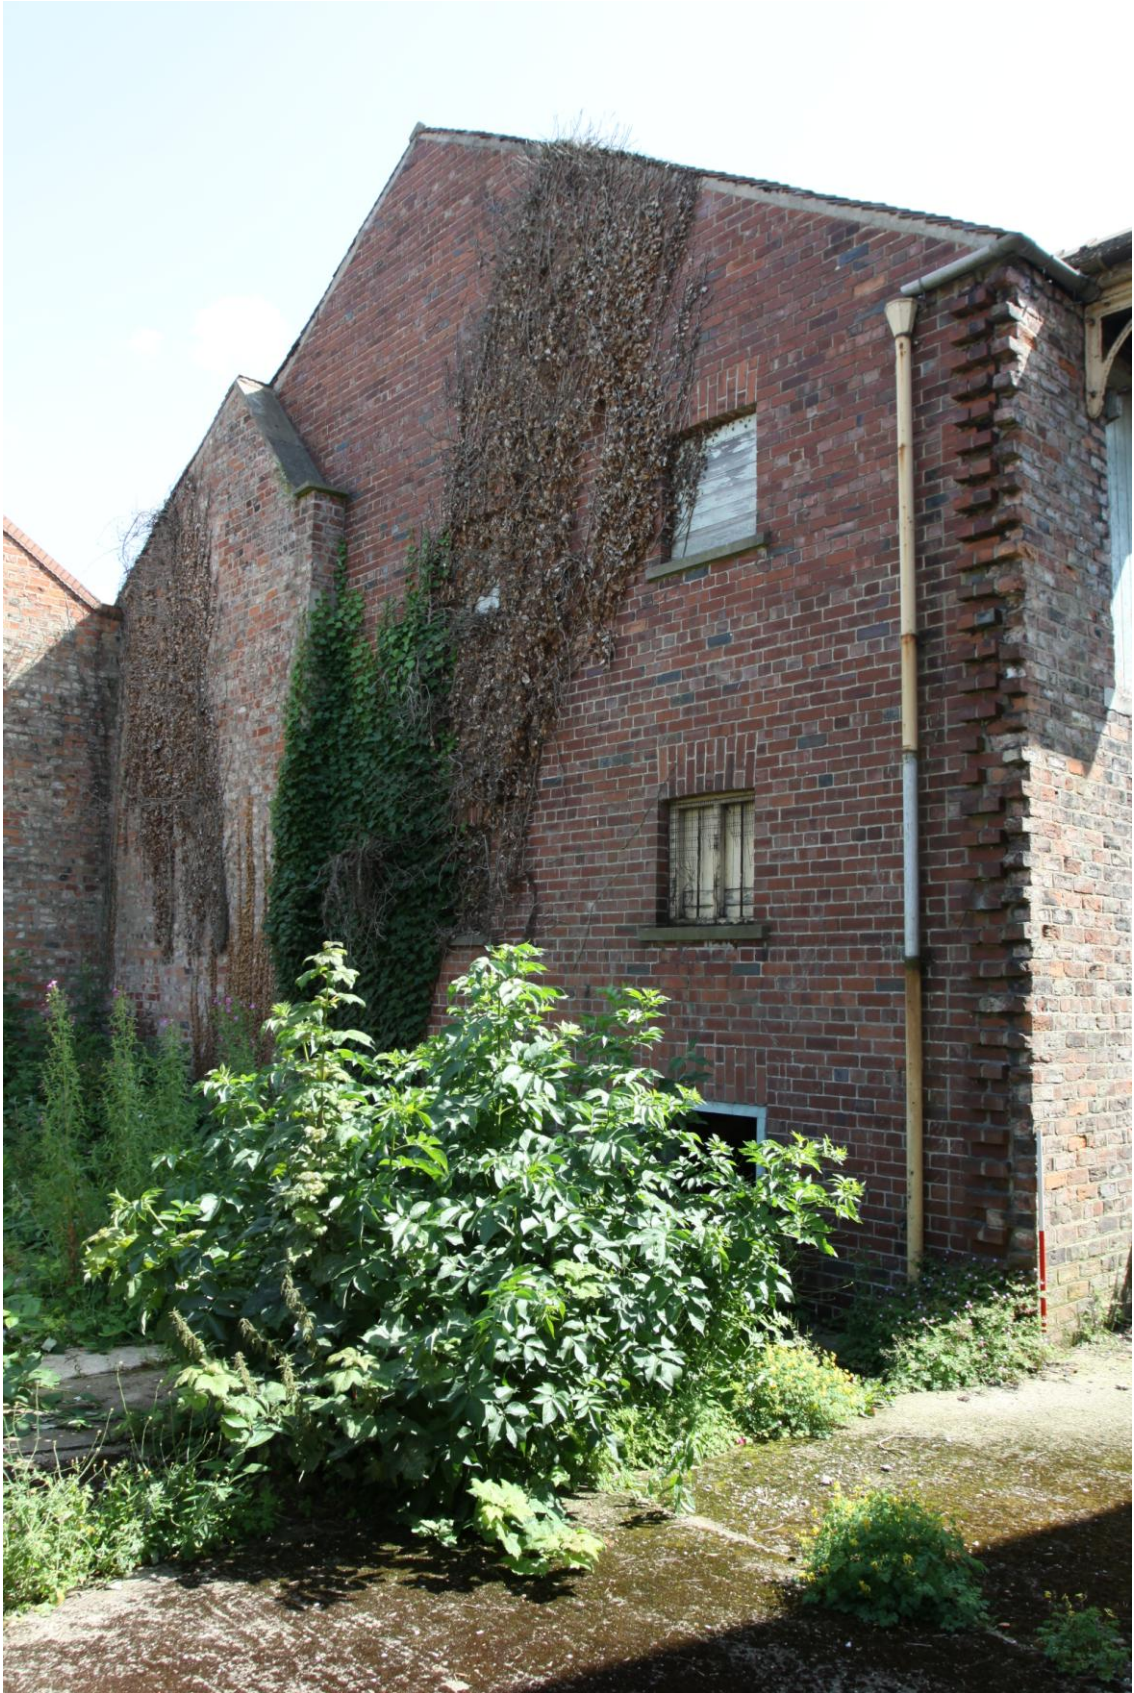
Plate 17: North Elevation of Malthouse (Photograph 220).

A number of changes have occurred at the northern end of the malthouse (Plate 17). The brickwork to the west end of the north elevation is of a different character to the rest of the malthouse, and is more modern in appearance, suggesting that it has been rebuilt. The brickwork at the north-west corner of the building is ragged from ground to gable-height. There are a number of window openings in this elevation with window heads that take the form of flat segmental arches, and cills that project out beyond the building line. There is a sunken ground-floor doorway at the west end of the north elevation. To the east of the elevation are the remains of a blind end gable of a former building which would have once occupied the yard space at the north of the malthouse. This building was “L” shaped and was identified on the OS map of 1891.

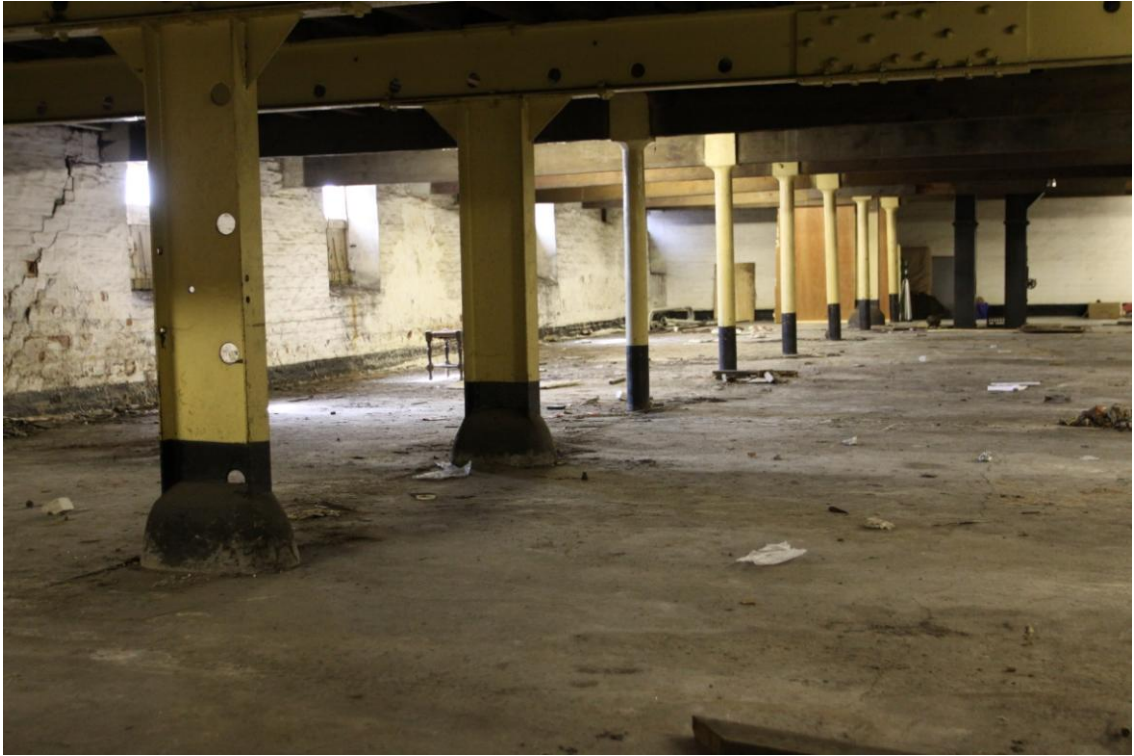
Plate 18: Germination Floor Ground Floor Level (Photograph 87).

The germination floors extend across the length of the malthouse. At Ground Floor Level the germination floor is three bays wide with two rows of cast iron columns forming ten bays in length (Plate 18 and Plate 19). At 1st Floor Level the germination floor is divided into nine bays in length. At the north end of the malthouse the cast iron columns were replaced with three sets of H-shaped girders at Ground and 1st Floor Level (Plate 20). A further set of H-shaped girders have been inserted at Ground Floor Level to the south of the bucket elevator. A number of these H-shaped girders are stamped with “British Steel”, which dates them from c. 1948 (Sissons and Beilby, pers comm.). The ground floor surface is modern concrete screed floor. The first floor surface is tiled, though some areas have been replaced with concrete screed. At 2nd and 3rd Floor Level the floor surface is timber boards. Strips of metal have been nailed down over some of the gaps between the boards to prevent the barley from becoming lodged in them (Patrick pers comm. See Plate 38).

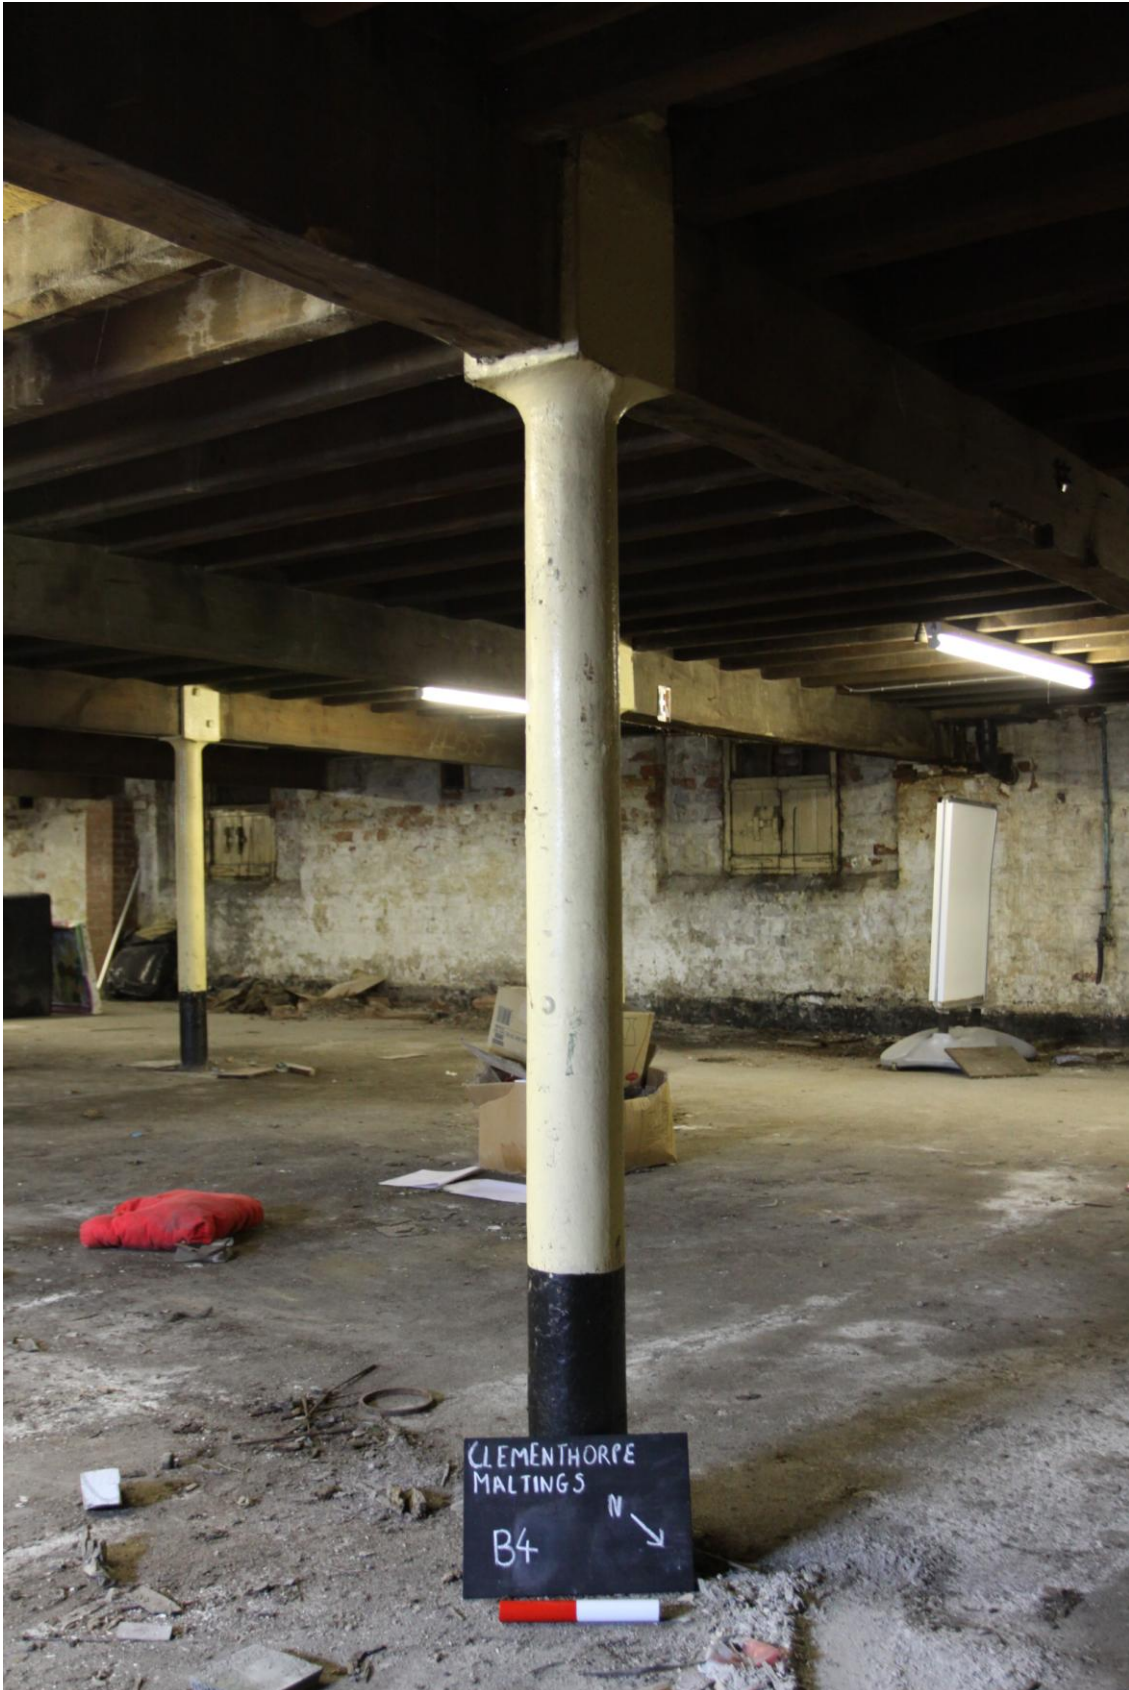
Plate 19: Cast Iron Column, Ground Floor Level (Photograph 72).

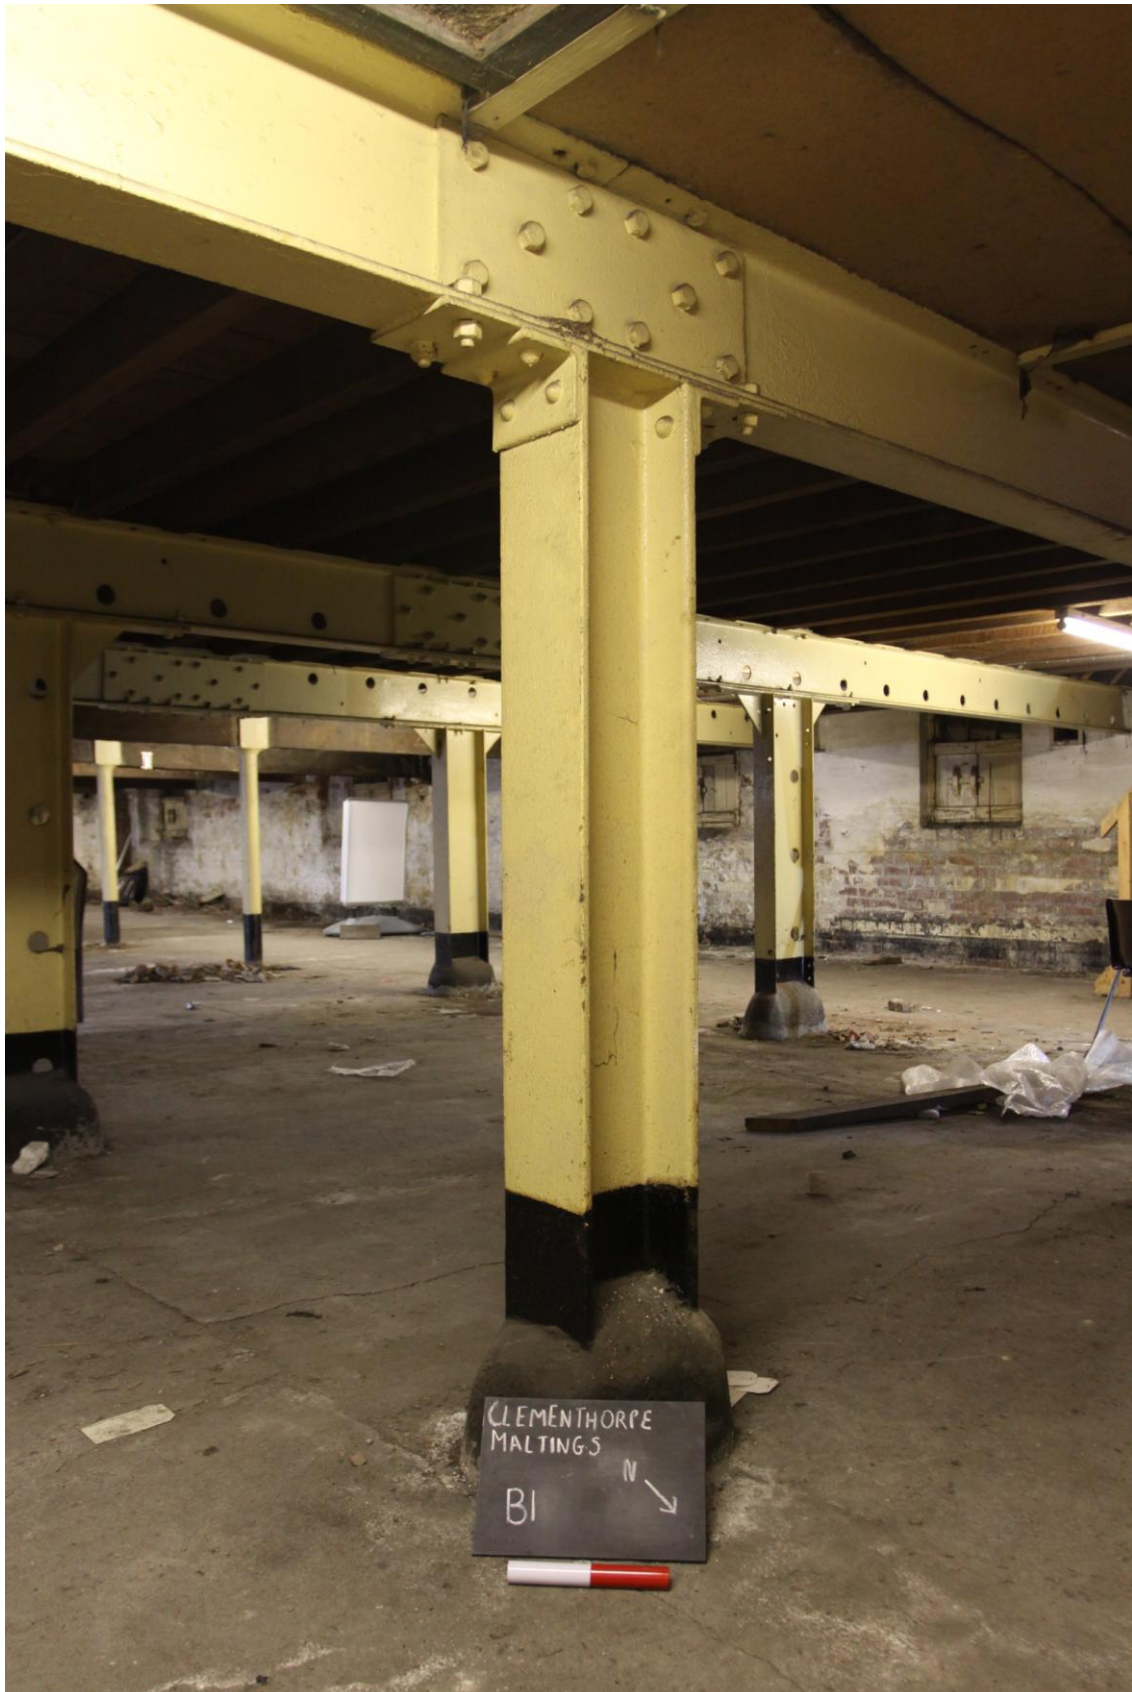
Plate 20: H-shaped Girder, Ground Floor Level (Photograph 68).

The introduction of new H-shaped girders at the north end of the building, along with the rebuilt north elevation, suggests that there were substantial modifications at this end of the building. It is possible that this was the result of a partial collapse (Patrick, 1999).

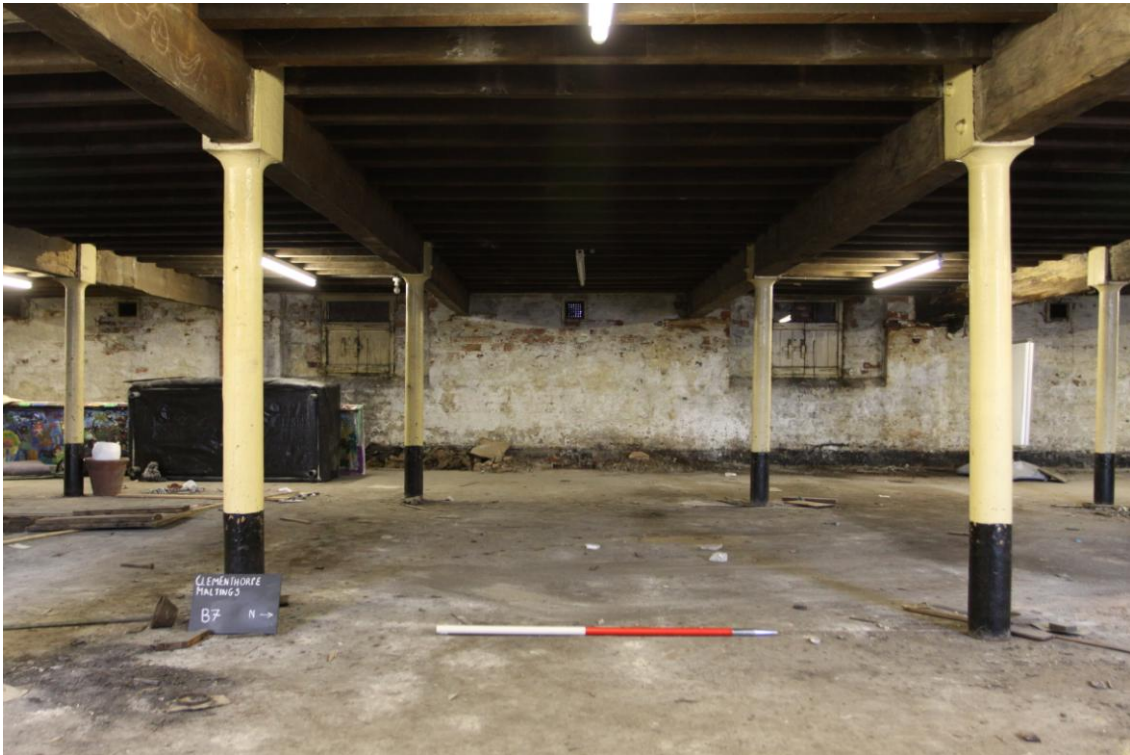
Plate 21: Windows to West Wall, Ground Floor Level (Photograph 43).

The majority of the window openings to the west elevation are set within wide recesses (Plate 21). The later, inserted window openings to the east elevation do not have recesses (Plate 22). All of the windows are fitted with wooden shutters to the lower part and three horizontal lights above. The shutters are fitted with wooden bolts (or replacement metal bolts in some

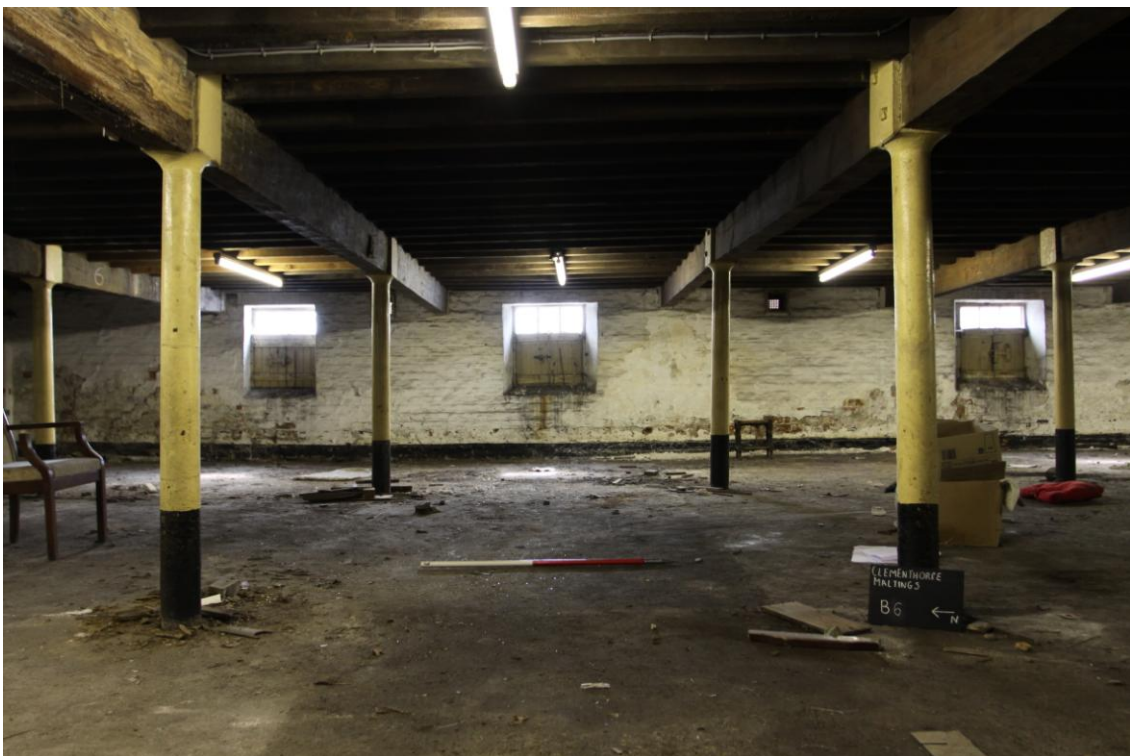
Plate 22: Windows to East Wall, Ground Floor Level (Photograph 21).

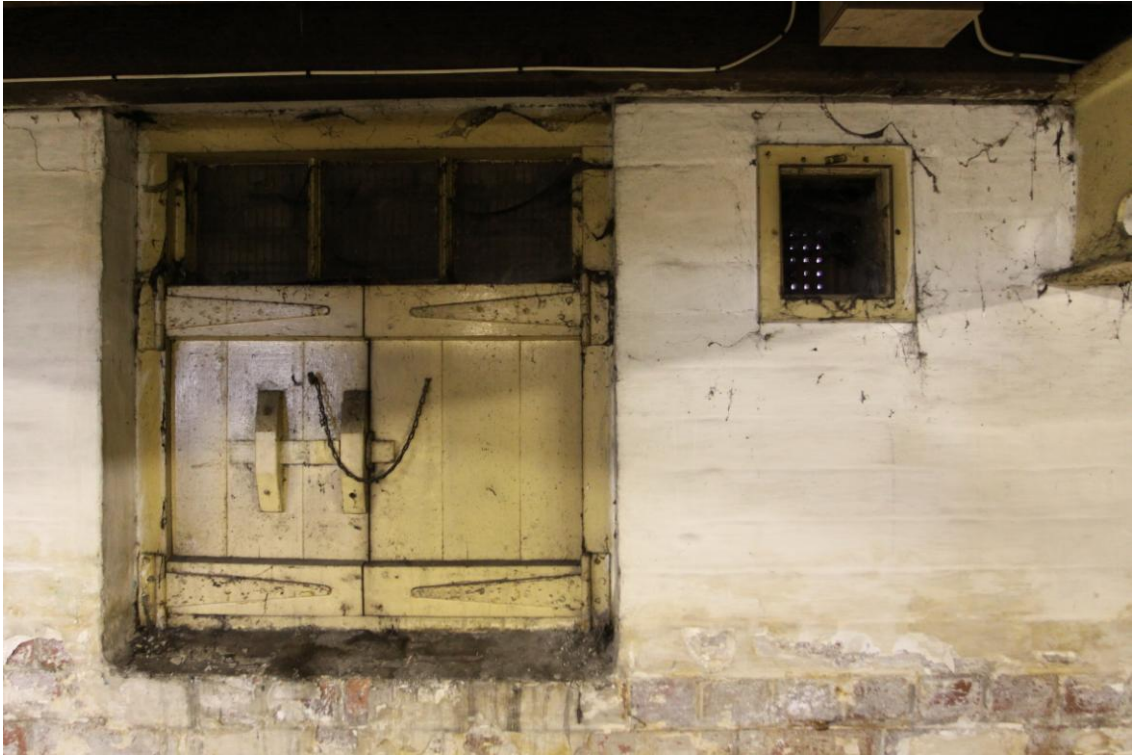
Plate 23: Window and Ventilation Hole Detail Ground Floor Level (Photograph 77)

instances) to provide security when closed, and iron stays and chains to enable them to be kept open at a number of different angles (Plate 23 and Plate 24).

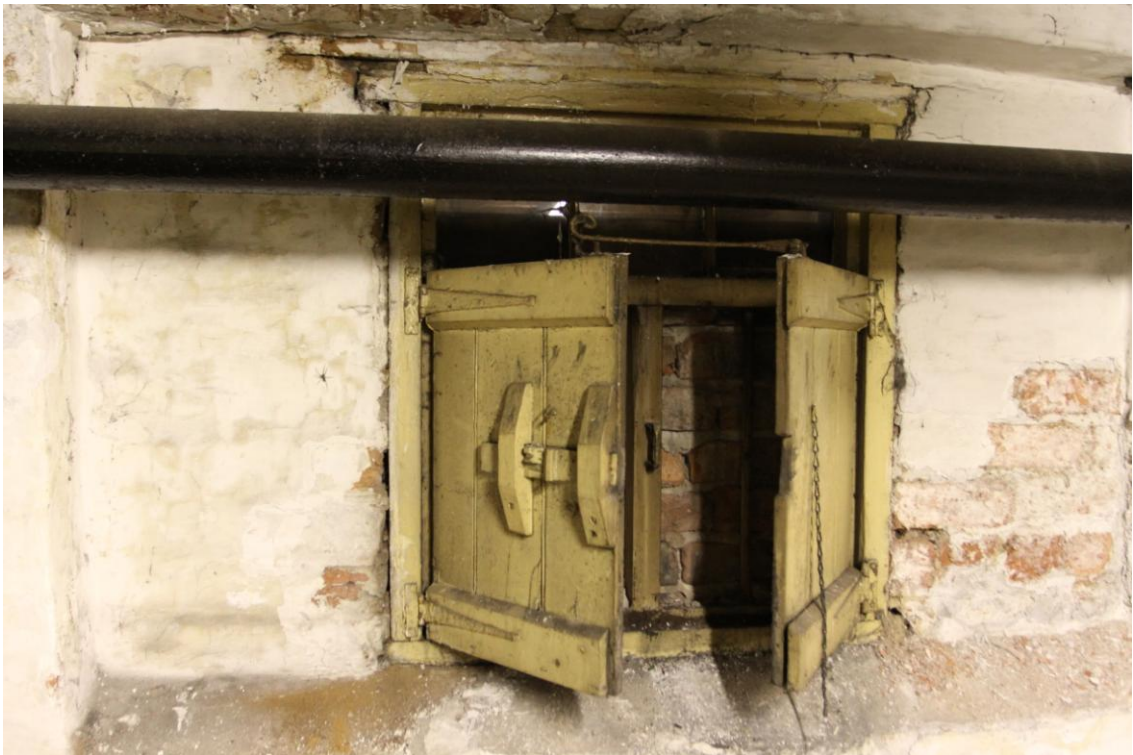
Plate 24: Window Detail 1st Floor Level (Photograph 145).

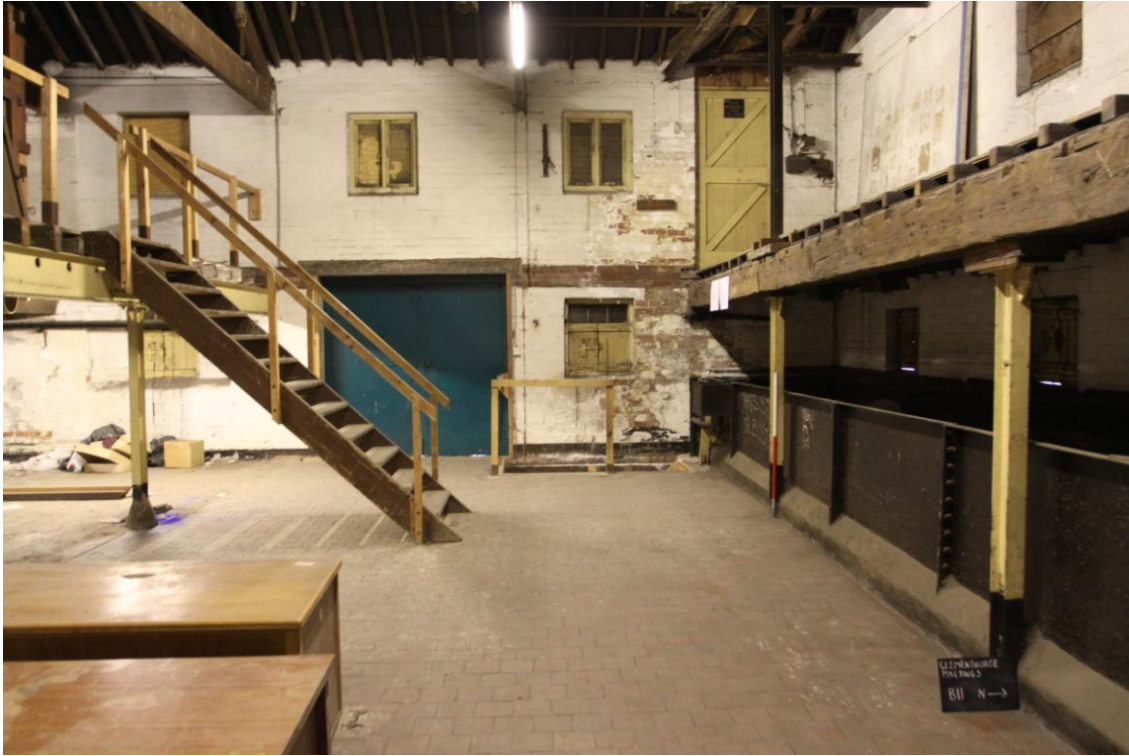
Plate 25: Removed Section of Floor at 2rd Floor Level (Photograph 125).

At 2nd Floor Level a section of floor has been removed at the north end of the malthouse (Plate 25). The staircase from ground to first floor is a later replacement, although it may well mark the position of an original access point between these two floors. The wide timber staircase leading from first to second floor is a later replacement constructed after the section of floor had been removed at 2nd Floor Level. The staircase leading from second to third floor level at the south end of the malthouse is original.

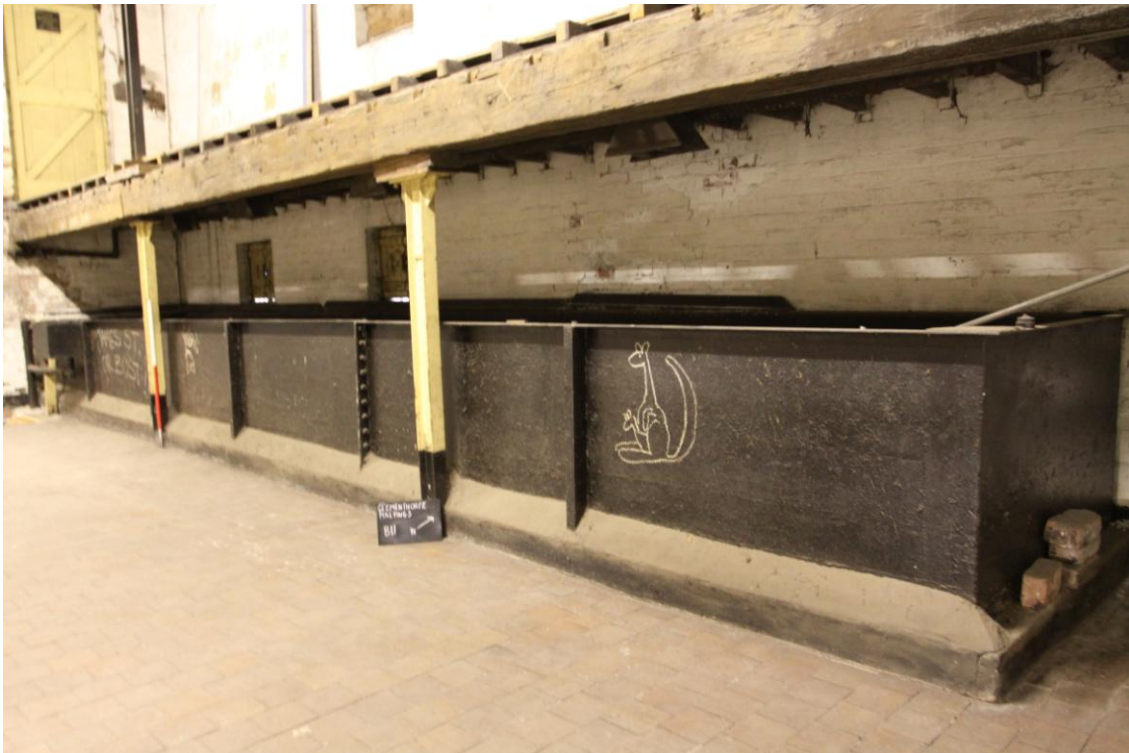
Plate 26: Steeping Cistern (Photograph 155).

The cast iron steeping cistern is located at 1st Floor Level at the northern end of the building (Plate 26). It is rectangular in shape with a flat bottom, and extends to nearly the whole width of the building. The water inlet pipe for filling the cistern runs along the west wall of the building, starting in the south-west corner of the kiln (presumably where the mains water supply was located) and terminating at the north-east end of the cistern (Plate 27 and Plate 28). The pipe is punctured with holes along the length of the cistern to allow water to be sprinkled down onto the barley (Plate 29). An overspill tank is positioned at the north-west end and is linked to an outlet pipe with a stopcock situated beneath the cistern at Ground Floor Level (Plate 30). The outlet pipe discharges from the exterior of the west elevation (see Figure 12).

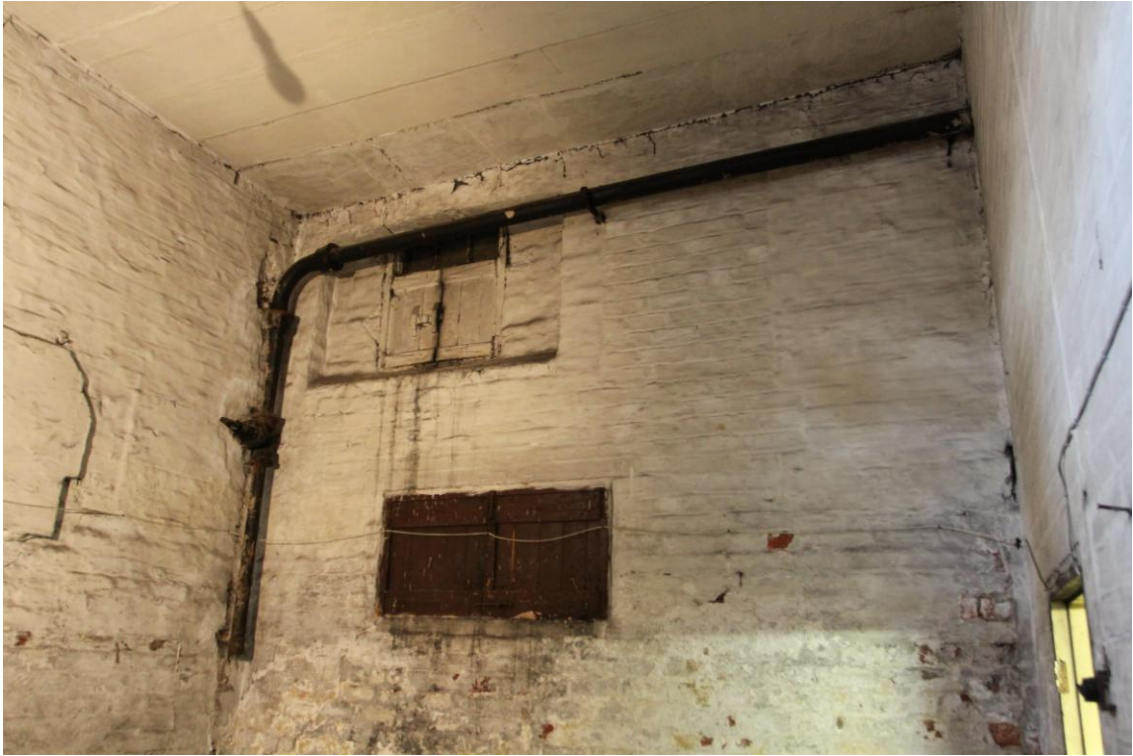
Plate 27: Water Inlet Pipe, West Elevation of Kiln, Ground Floor Level (Photograph 97).

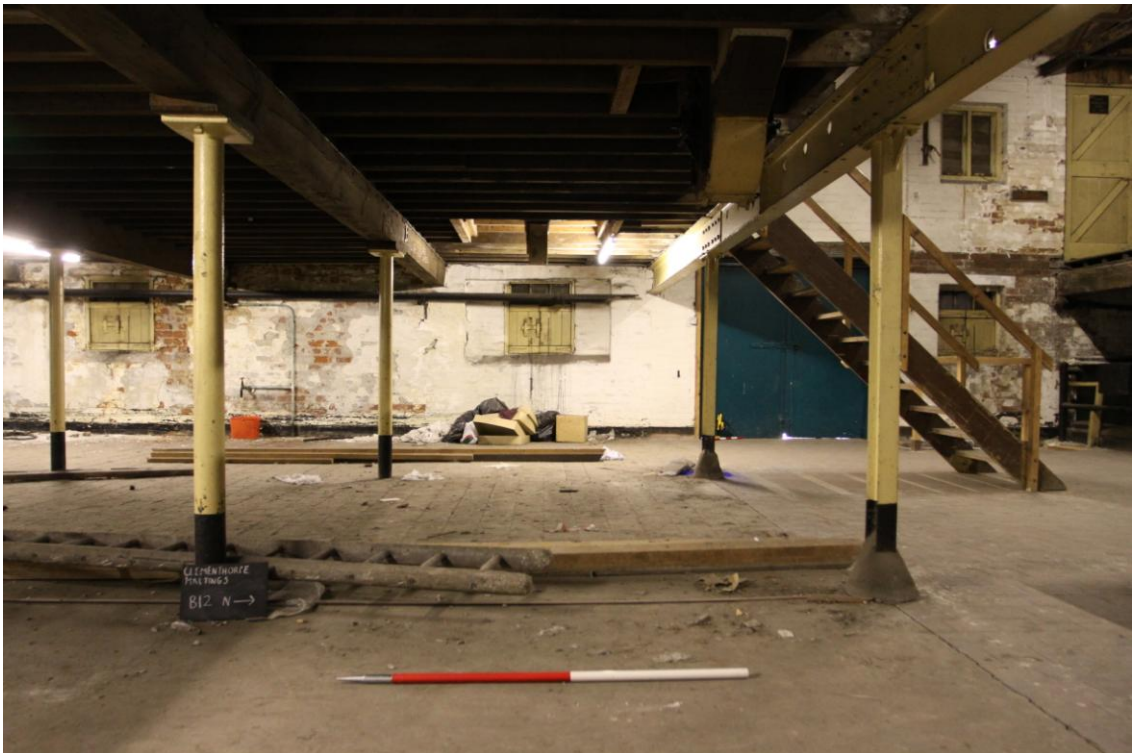
Plate 28: Continuation of Water Inlet Pipe along West Elevation, 1st Floor Level (Photograph 127).

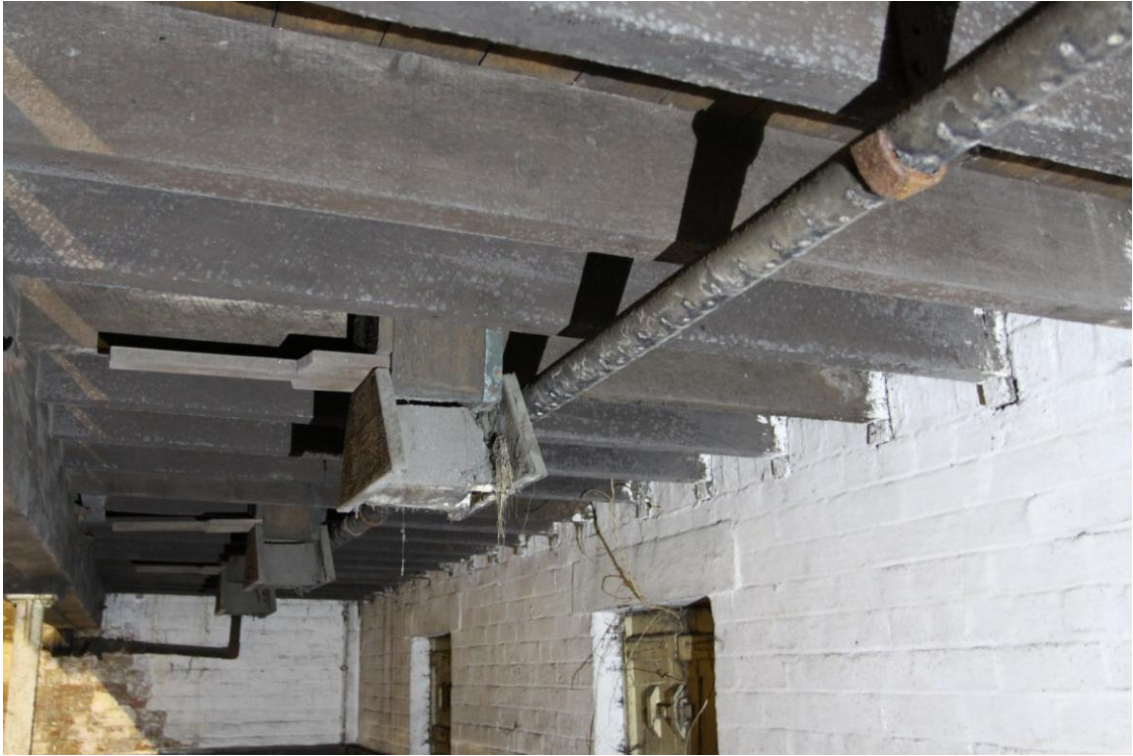
Plate 29: Water Inlet Pipe above Steeping Cistern, punctured with holes and grain chutes (Photograph 159).

The barley was dispensed into the steeping cistern from 3rd Floor Level via a series of wooden grain chutes, which were regulated by wooden paddles (Plate 31 and see Plate 29). Hatches to the underside of the cistern allowed the steeped barley to be deposited directly onto the germinating floor at Ground Floor Level (Plate 32).

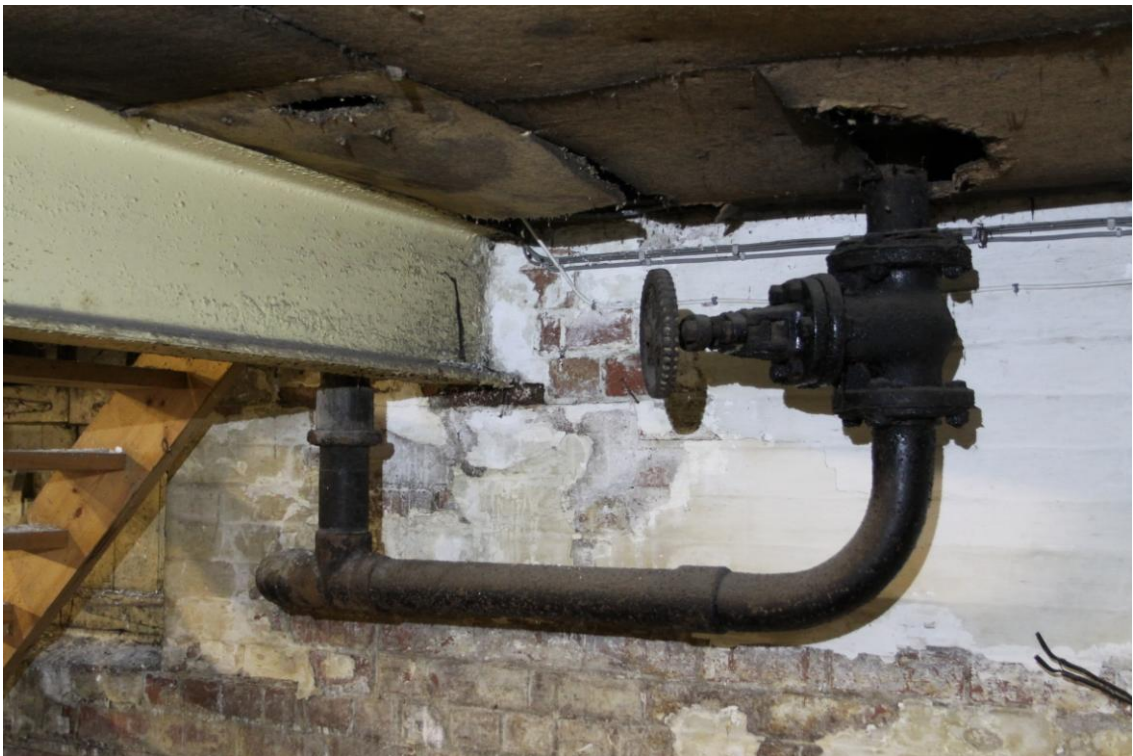
Plate 30: Outlet Pipe and Stopcock for Steeping Cistern Ground Floor Level (Photograph 53).

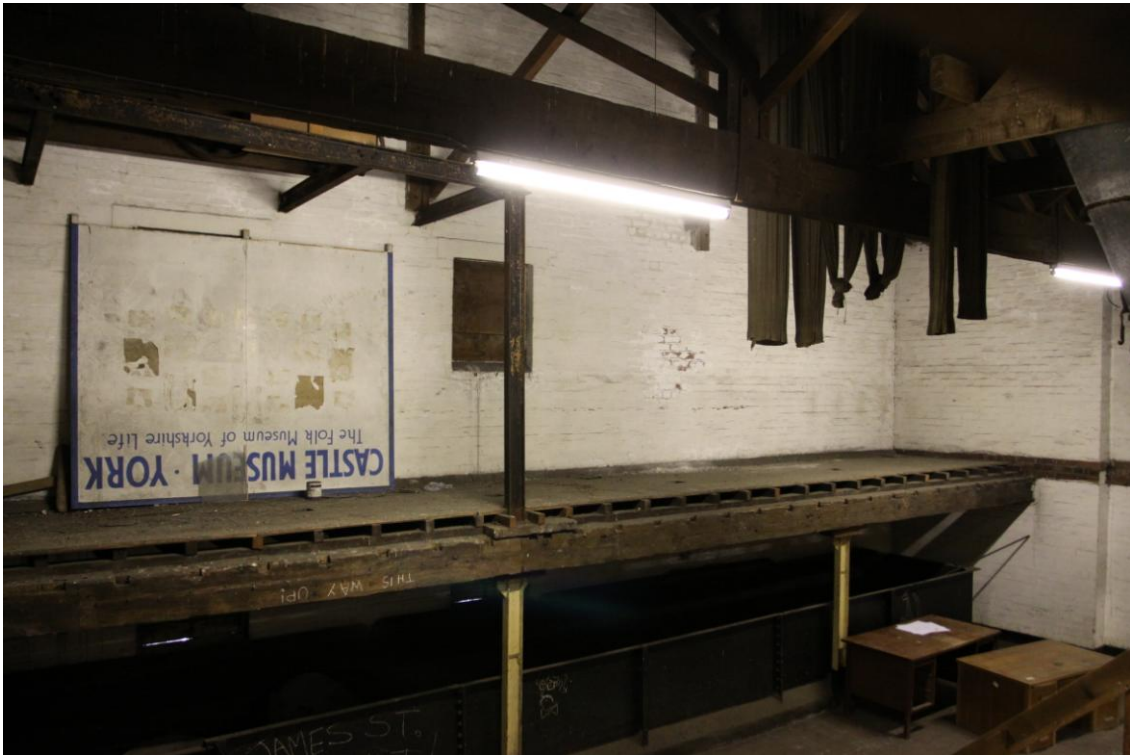
Plate 31: 3rd Floor Level showing grain holes above Steeping Cistern (Photograph 167).

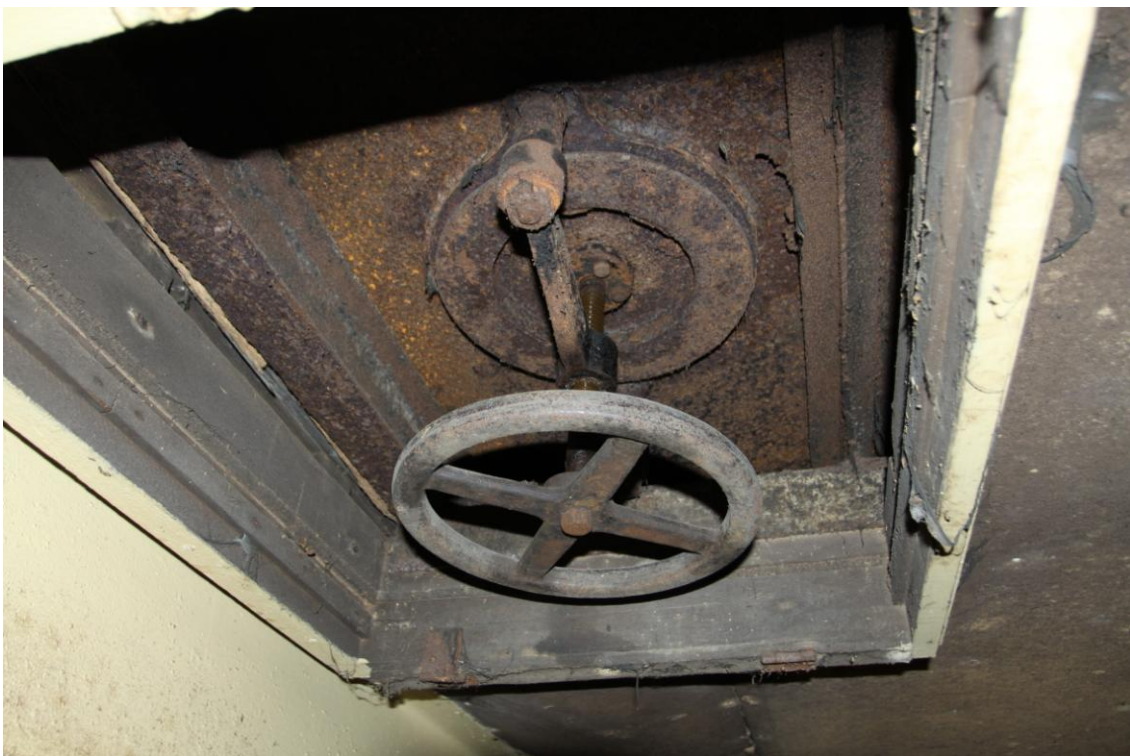
Plate 32: Hatches to Underside of Steeping Cistern (Photograph 66).

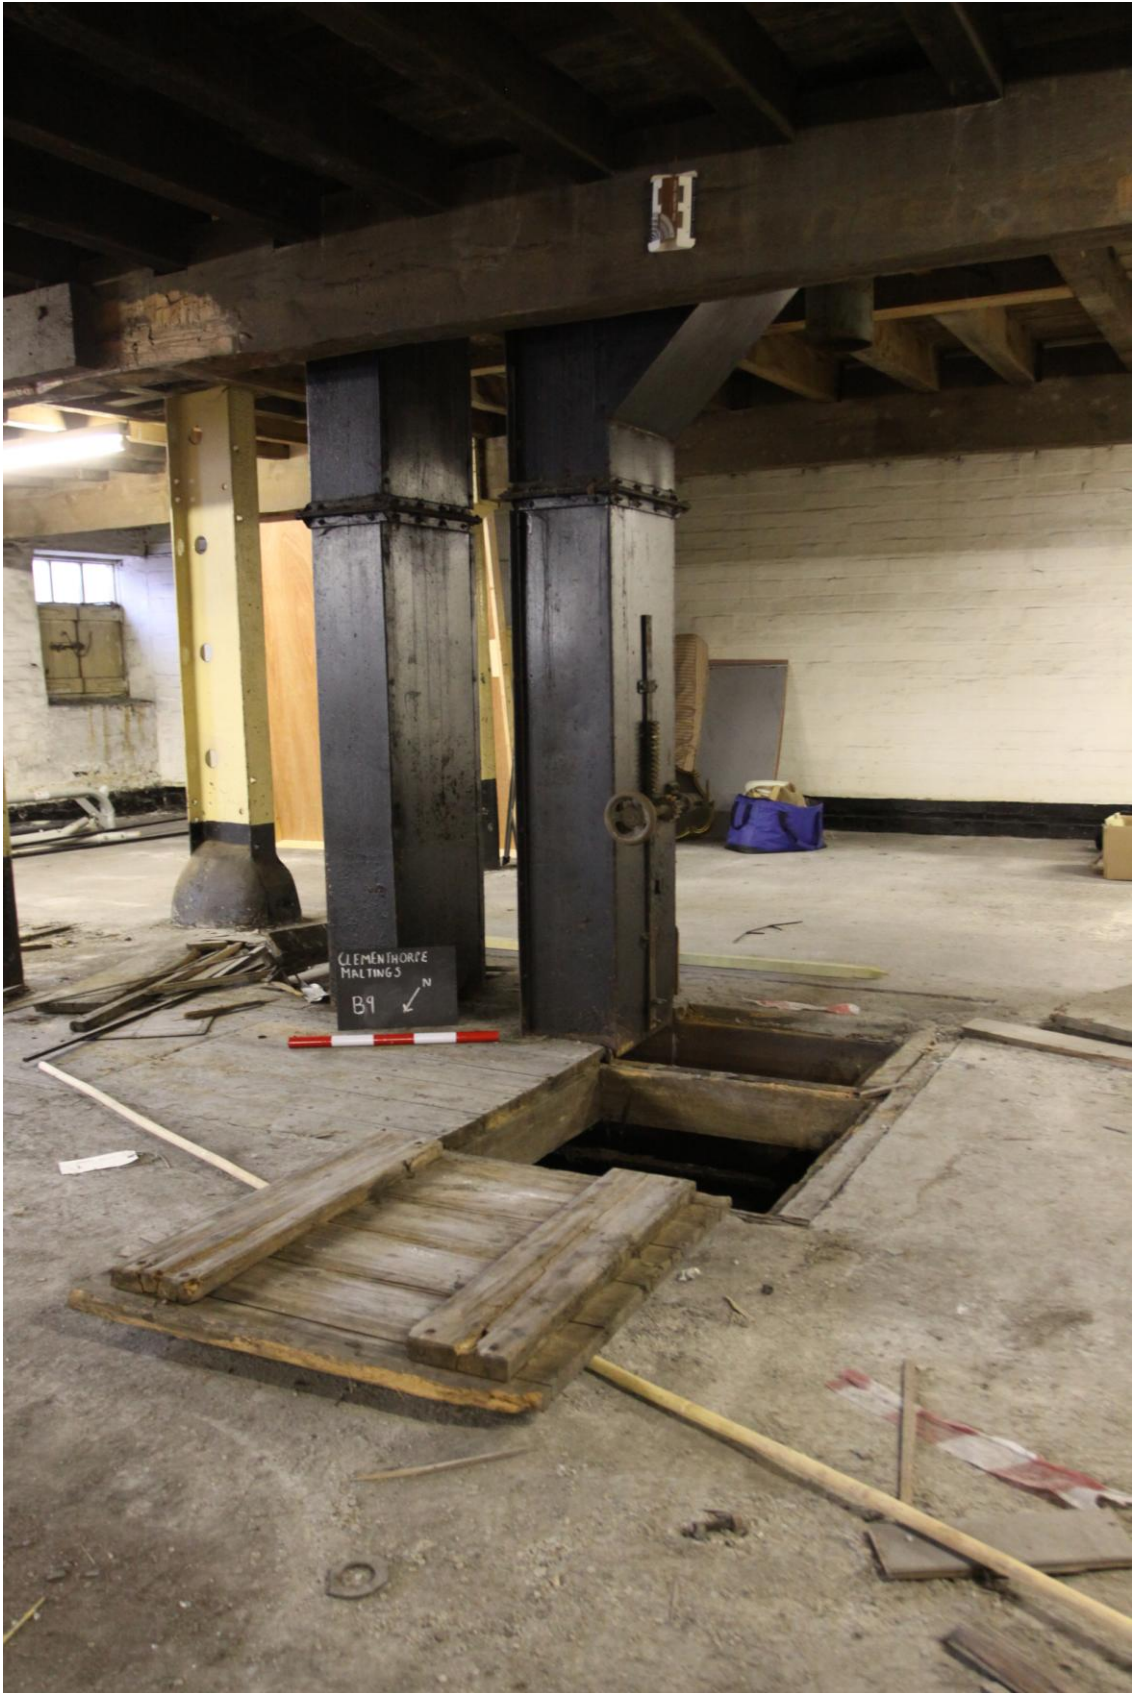
Plate 33: Double Bucket Elevator, Ground Floor Level (Photograph 81).

A double-bucket elevator is situated at the south of the malthouse (Plate 33). It extends from Ground Floor Level upwards through the three floors to the elevator block positioned on the roof. This equipment comprised a continuous chain/belt with attached buckets for conveying the green malt through the floors of the building (Plate 34). The green malt was dispensed into the buckets via access hatches at Ground and 1st Floor Level. It was taken up through the building and deposited directly onto the drying floor of the kiln at 3rd Floor Level via a round metal chute (See Plate 11). A further pipe/chute network allowed the barley to be deposited in the storage area (S) on the 3rd floor (Plate 35). The top section of the Elevator, situated on the Roof of the malthouse, is accessed from a ladder at 3rd Floor Level. A further metal fire extinguisher holder (as observed at 2nd Floor Level (Plate 9)), is located next to this access ladder.

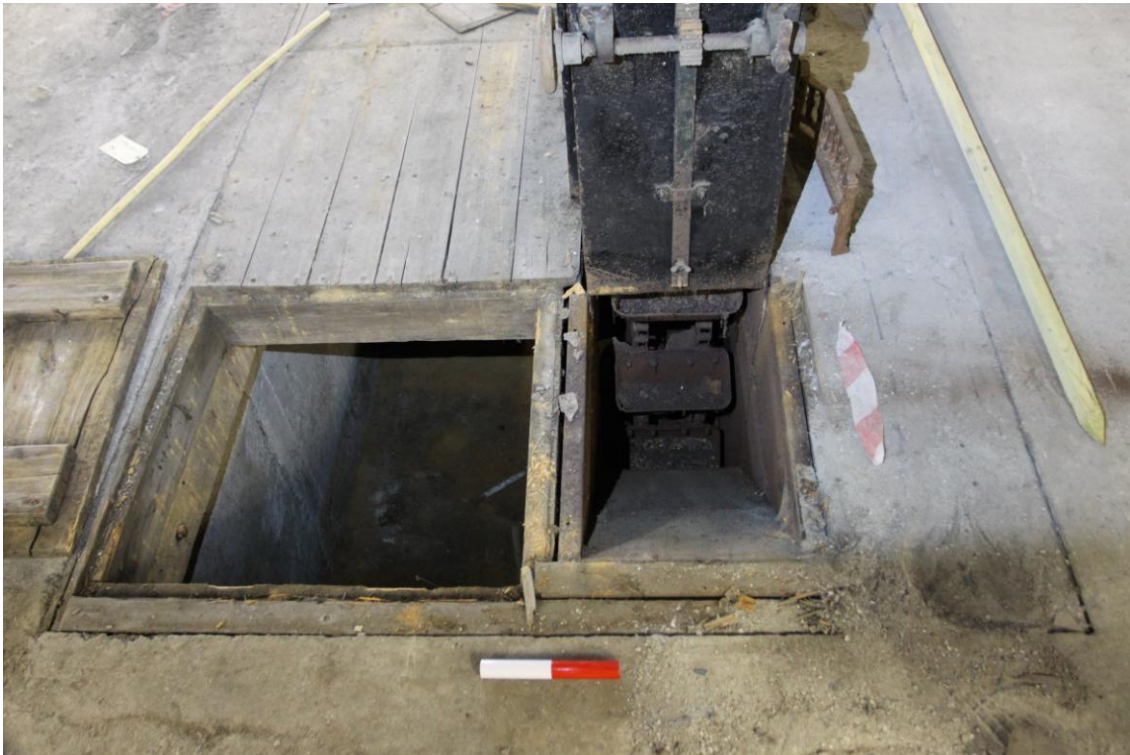
Plate 34: Double Bucket Elevator mechanism and inspection chamber, Ground Floor Level (Photograph 83).
