**BUILDING RECORDING AT
CLEMENTHORPE MALTINGS,
LOWER DARNBOROUGH STREET, YORK**

BUILDING SURVEY REPORT

Report Number 2015/31 July 2015

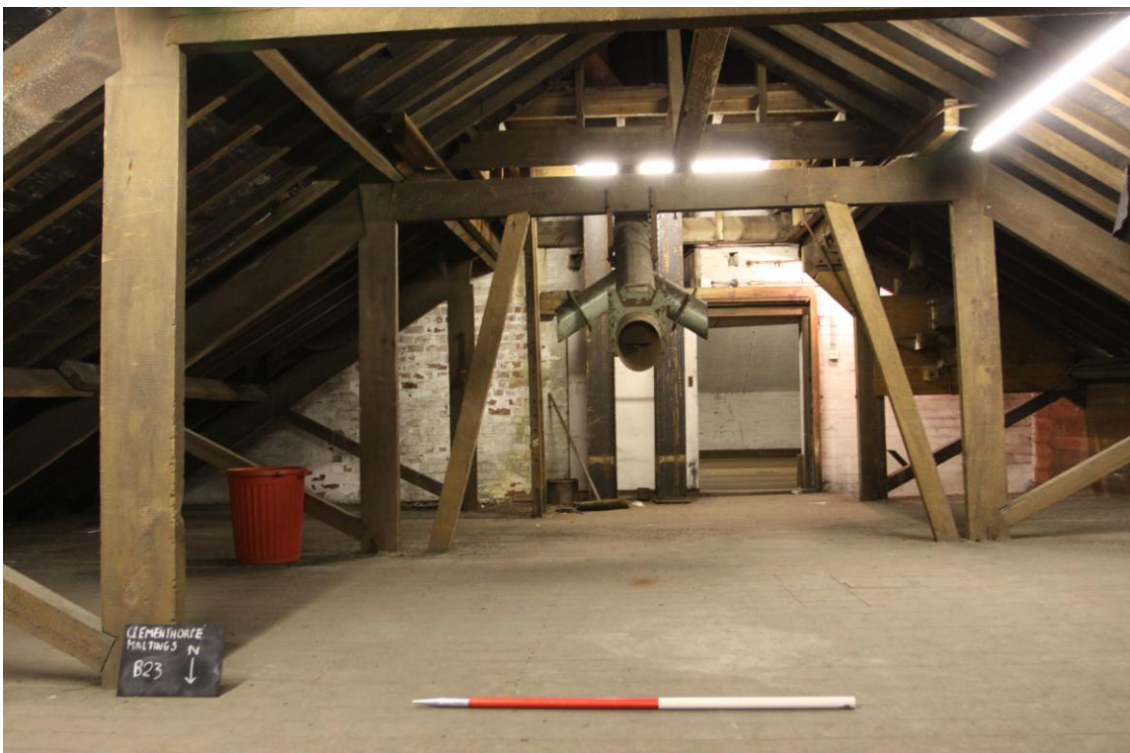
Plate 35: 3rd Floor level showing pipes attached to Double Bucket Elevator (Photograph 207).

The grain was deposited directly into the storage bins from the storage area at 3rd Floor Level via two small trap doors to each bin (see Plate 35).

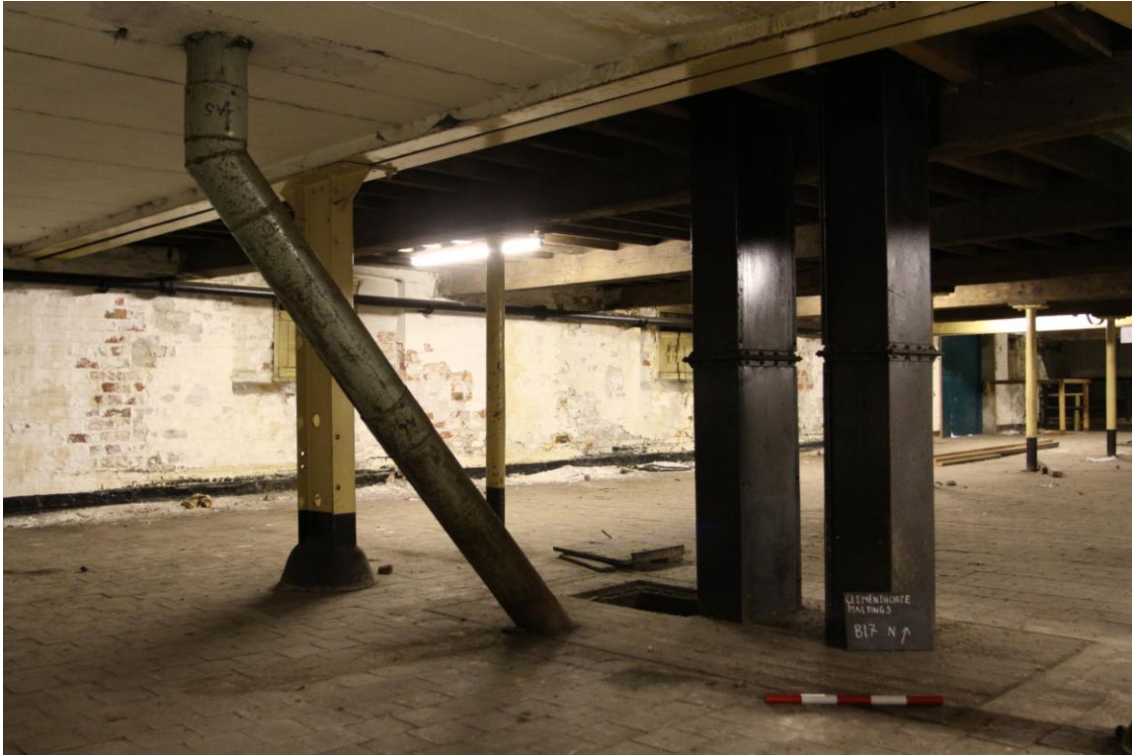
Plate 36: Pipework to the south end of the Malthouse (Photograph 139).

Further pipework was identified at Ground and 1st Floor Level at the south end of the malthouse. The pipework extends upwards to the kiln and would have possibly connected with the trap in the wire wedge floor, enabling the kilned malt to be deposited back down at Ground Floor Level (Plate 36).

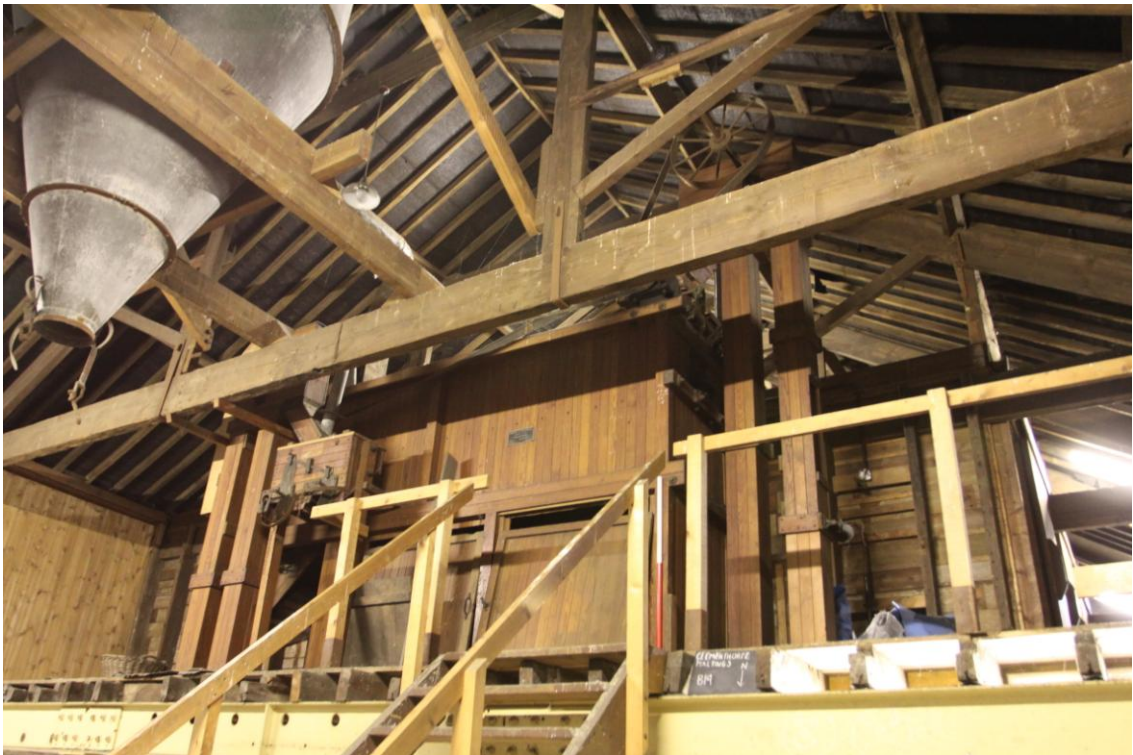
Plate 37: Dressing machine, 2nd Floor level (Photograph 174).

A dressing machine is situated in to the northern half of the malthouse at 2nd Floor Level (Plate 37 and Plate 38)). The dressing machine was manufactured by Nalder & Nalder Ltd at the Challow Iron Works in Wantage, Oxfordshire (formerly Berkshire). Dried malt was passed through a dressing machine to remove the rootlets.

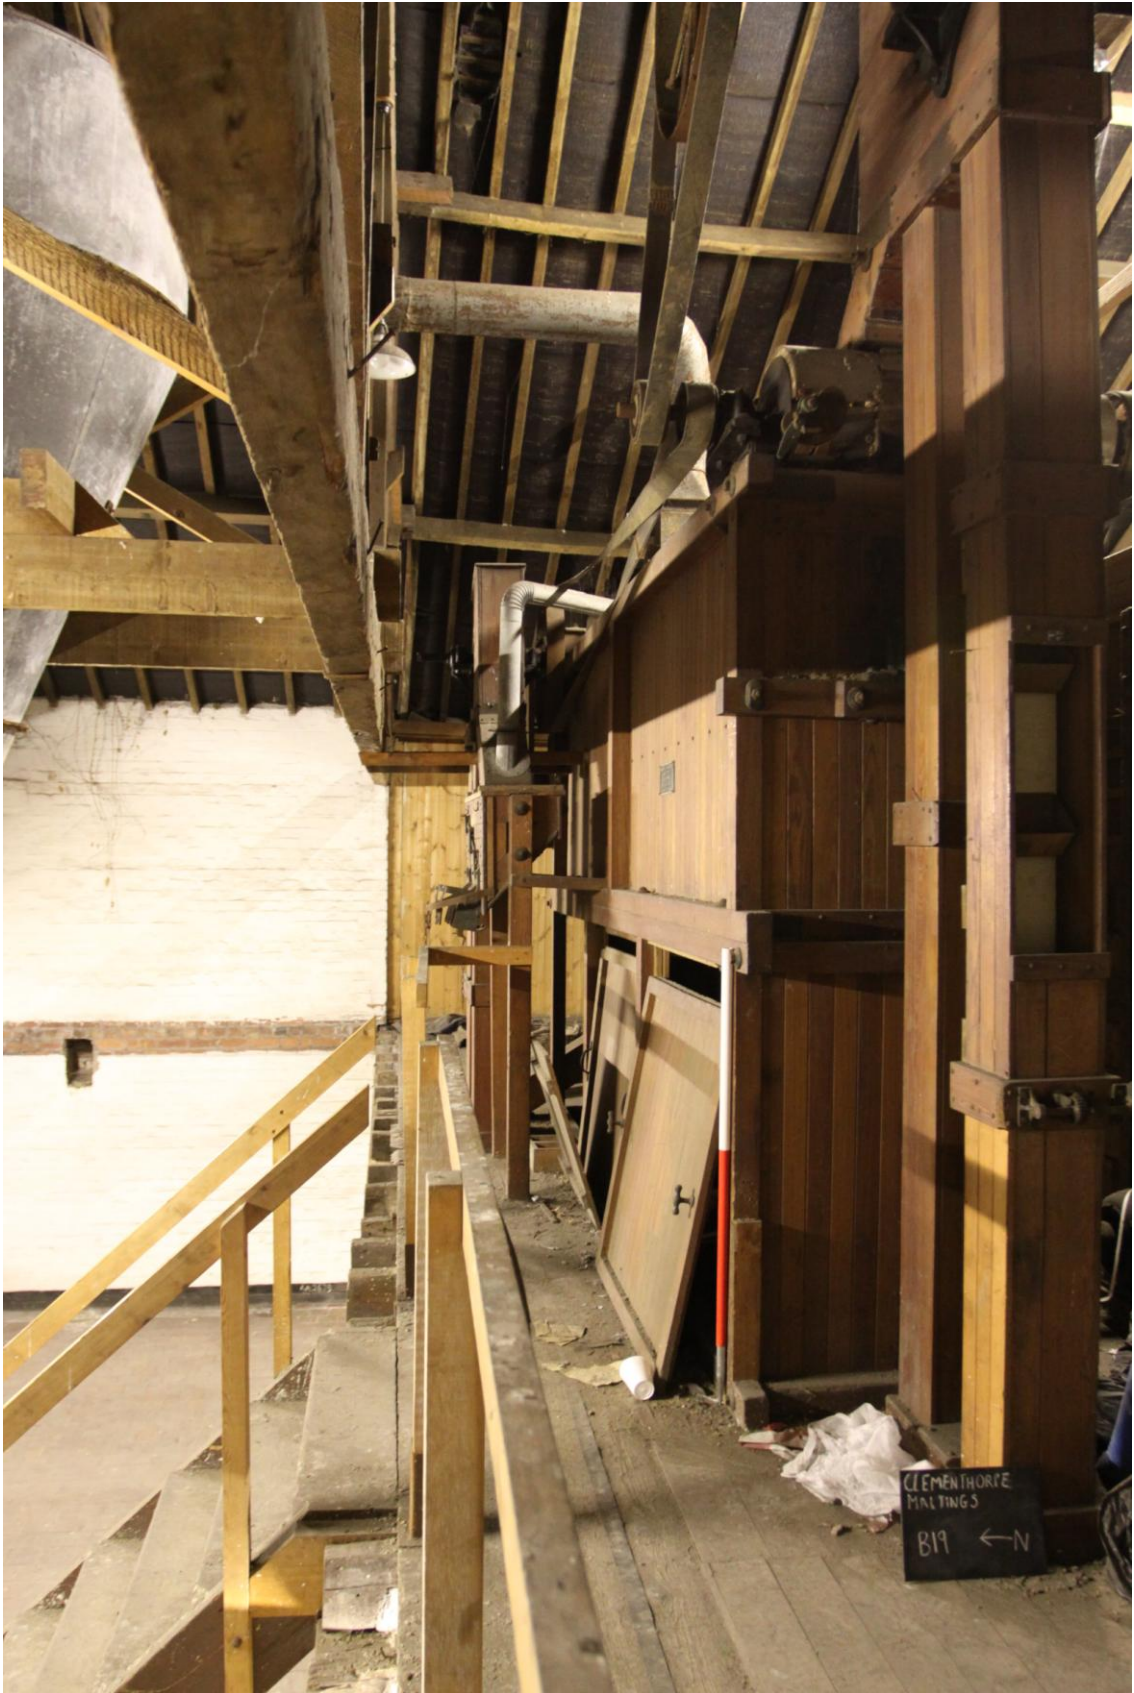
Plate 38: Dressing machine, 2nd Floor Level (Photograph 181).

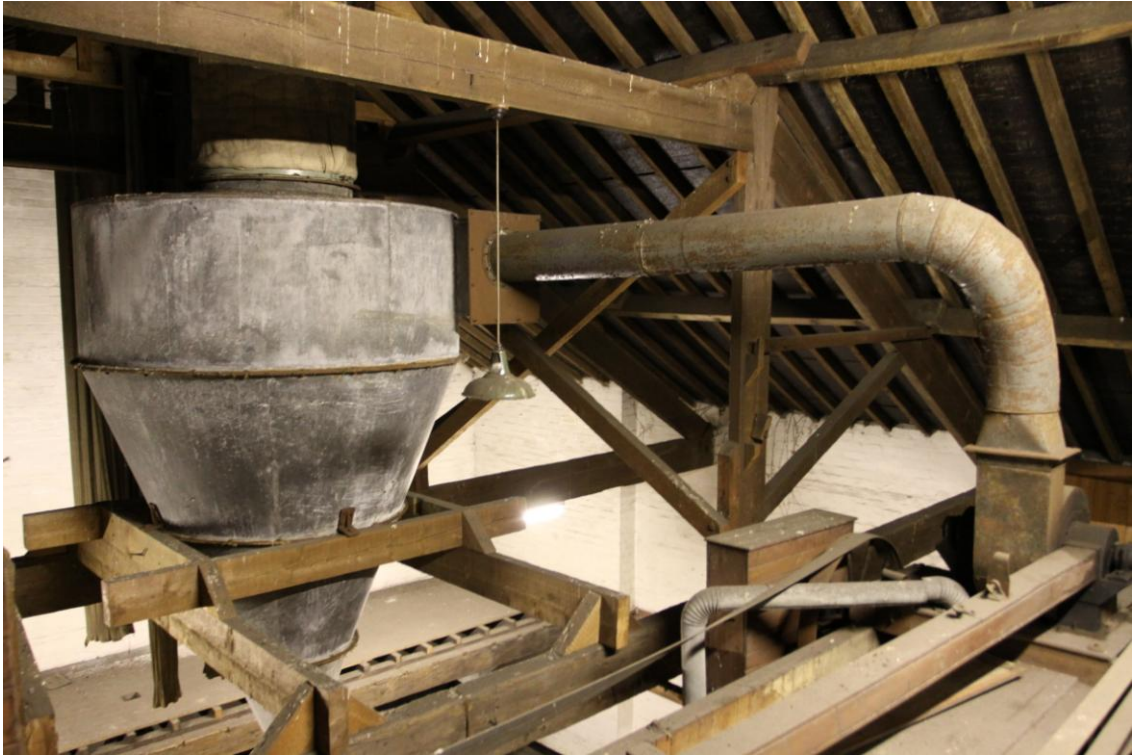
Plate 39: Pipe attachment from Dressing Machine to Hopper, 3rd Floor Level (Photograph 202).

The dressing machine is attached to a large hopper suspended over the 3rd Floor by means of a steel pipe (Plate 39). To the north of the hopper is a series of fabric sack fillers or cleaners.

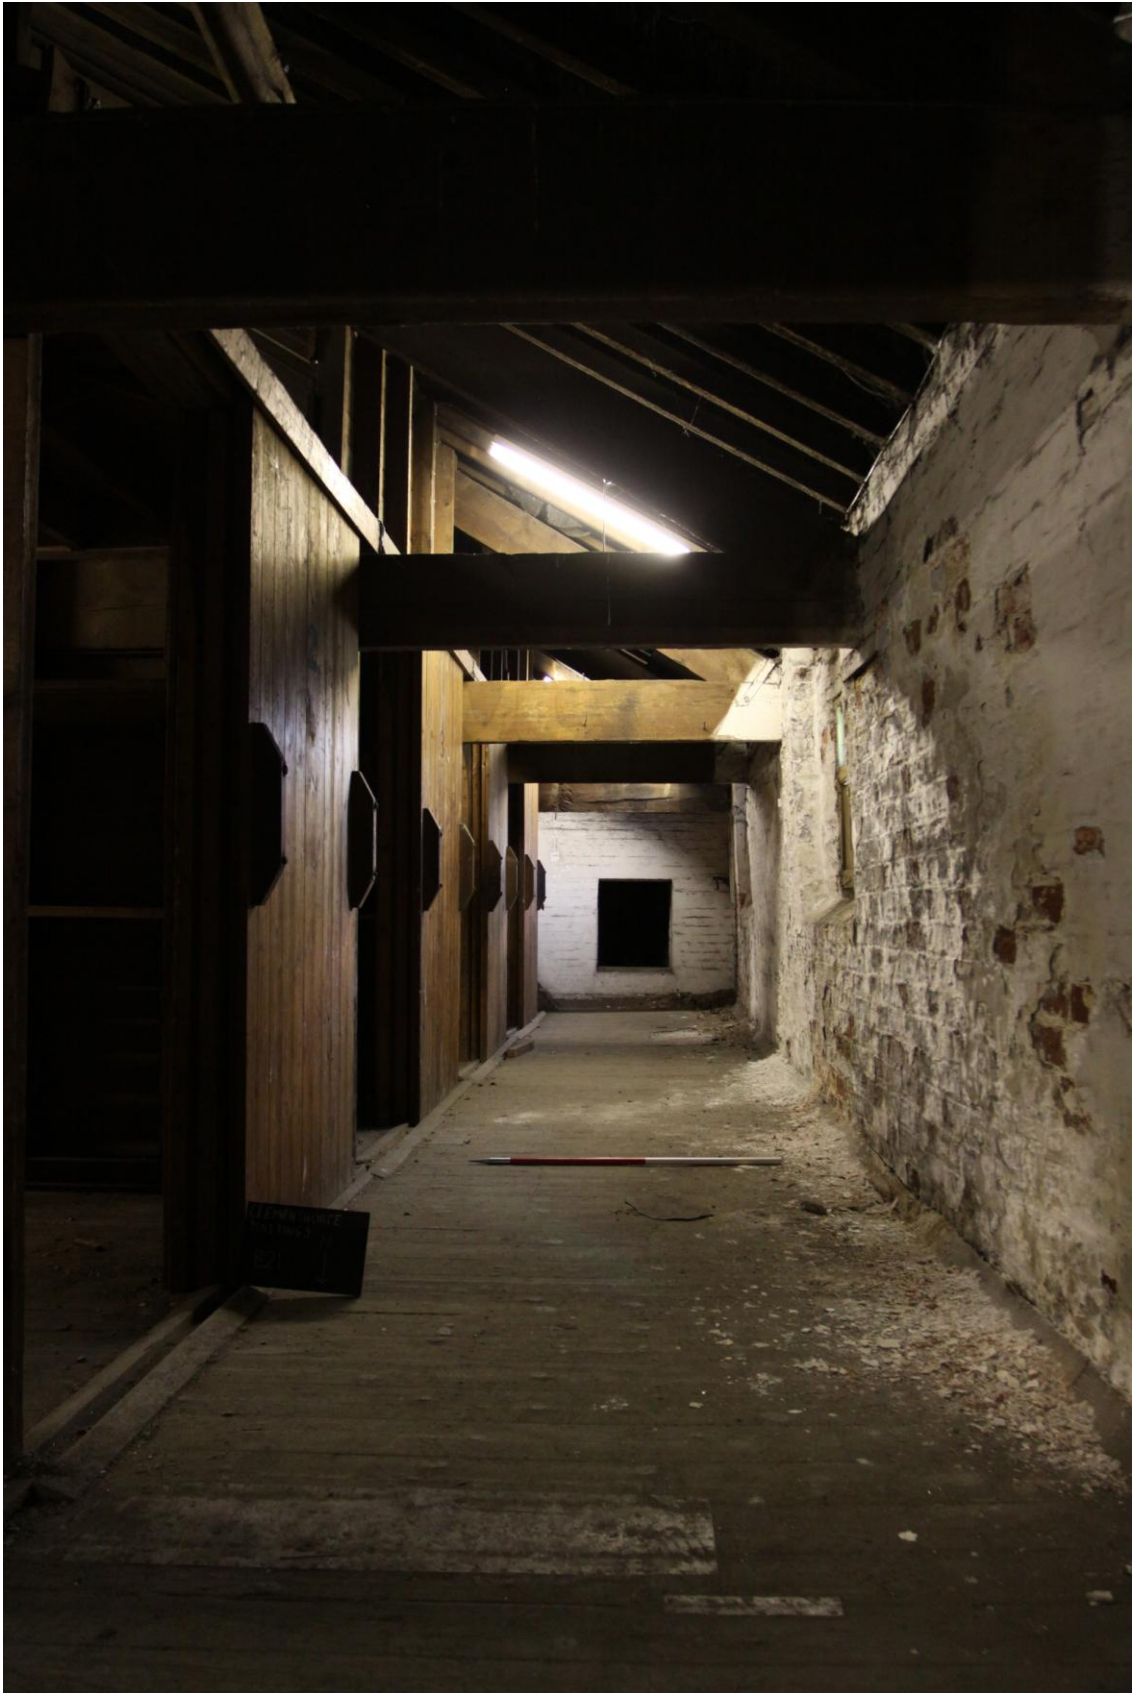
Plate 40: 2nd Floor Level, Corridor and Storage Bins (Photograph 187).

Four large, walk-in storage bins with wooden frames and wooden sliding doors are located at 2nd Floor Level. These could have been used for the storage of barley or malt (Plates 40 and 41). Inside the door frames are grooves for grain boards (Patrick 1999). The storage bins are numbered 2, 3, 4, 5. Storage Bin 1 was removed to accommodate the dressing machine. There is some graffiti to the right of the door of Bin 5 (Plate 42).

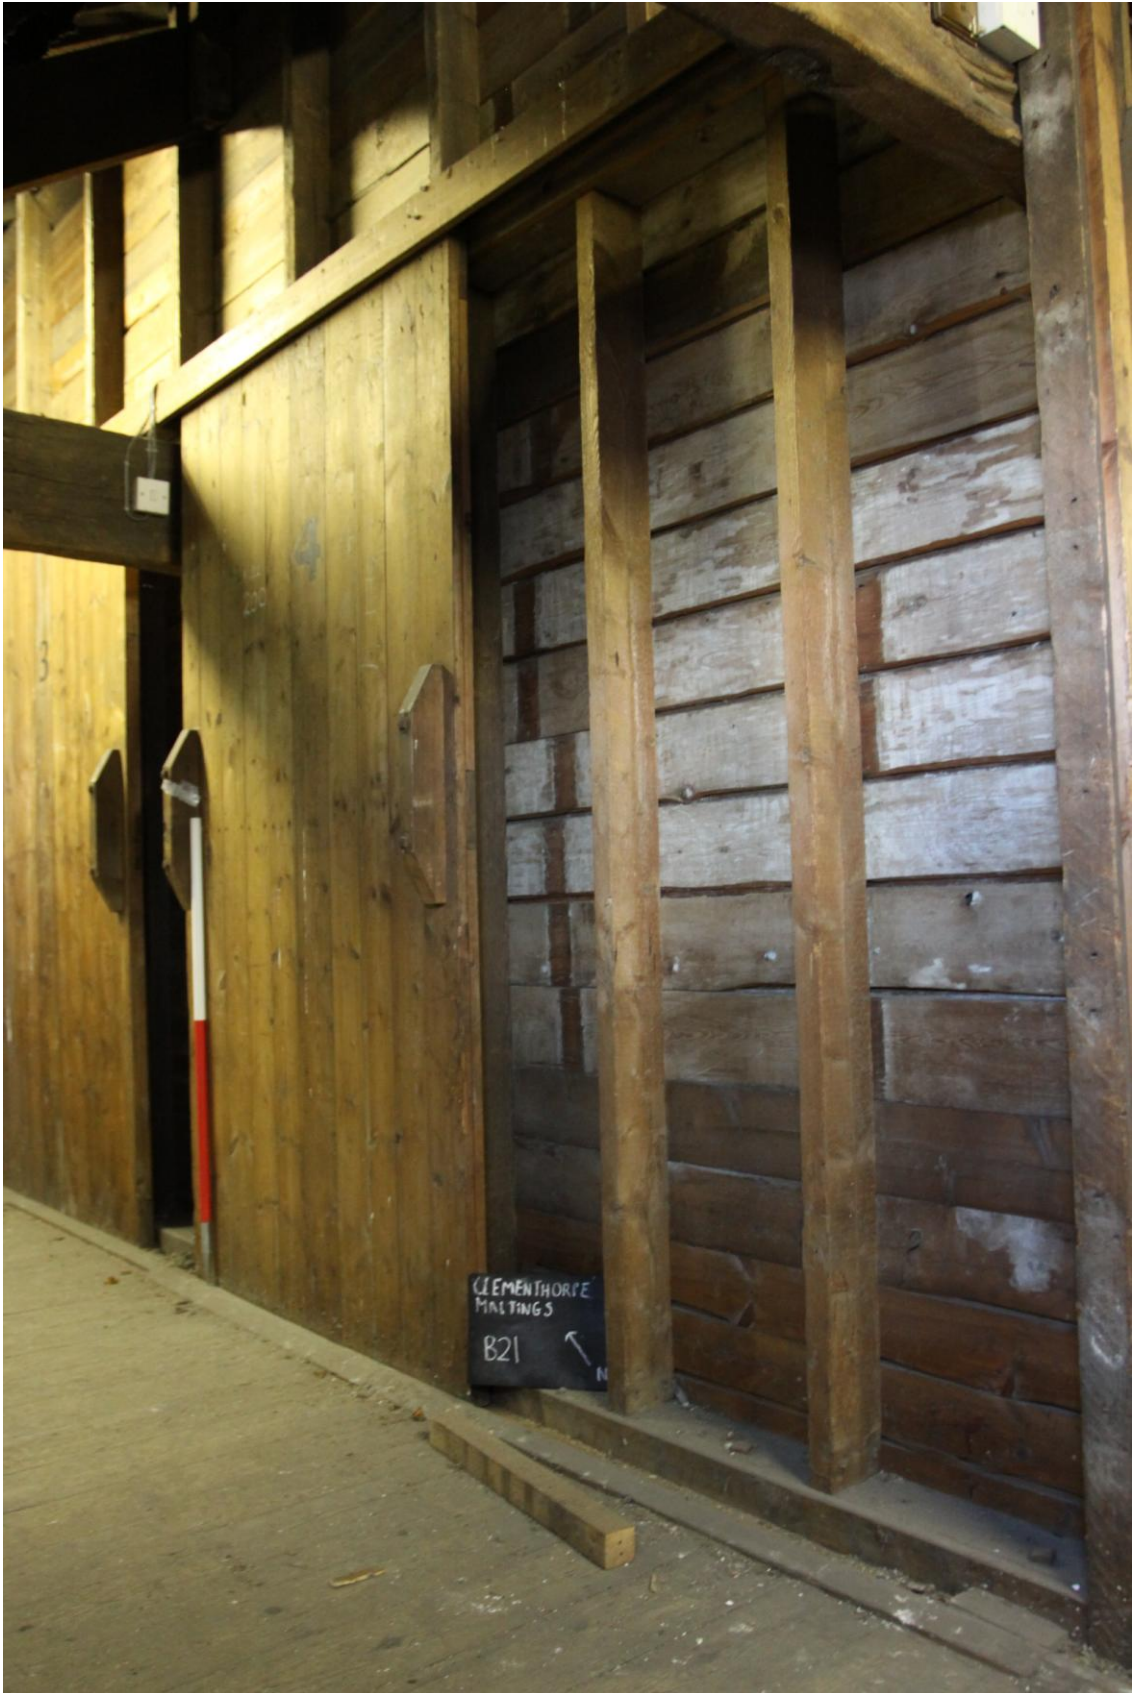
Plate 41: Storage Bins 2nd Floor Level (Photograph 192).

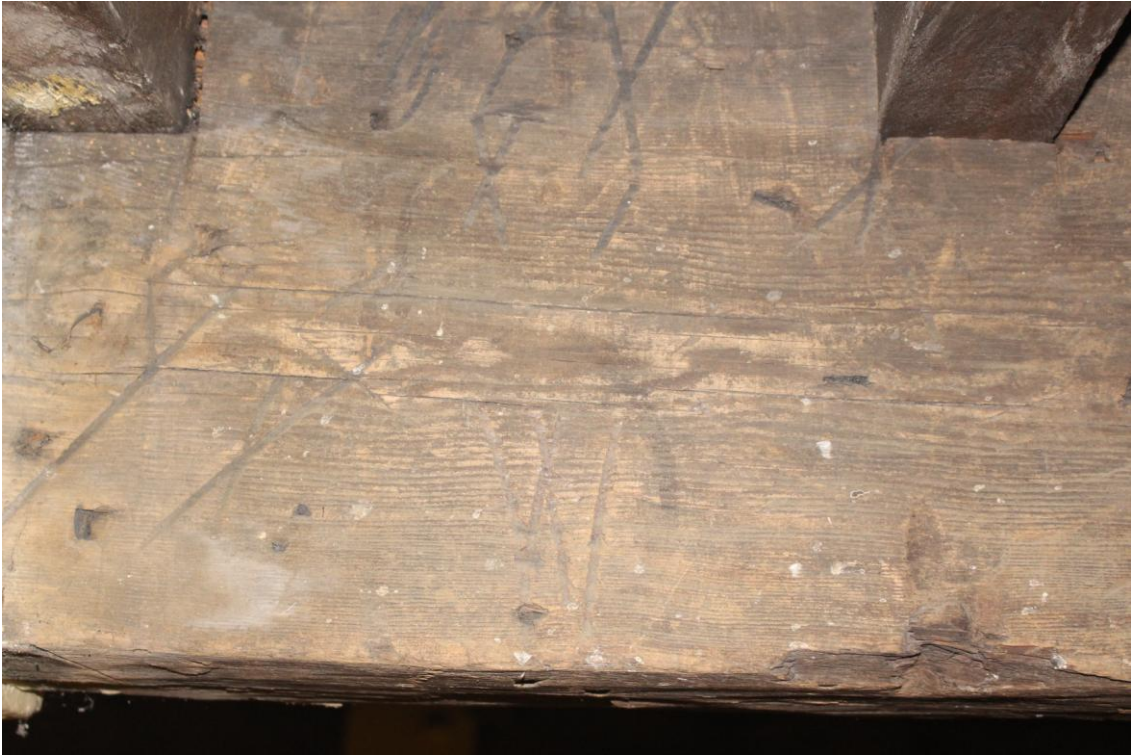
Plate 44: Baltic Timber marks to left of "W.F.No2H" (© Mark Sissons).

Painted onto one of the beams at Ground Floor Level is the mark “W.F.No2H” which probably represents “Working Floor Number 2H” (Plate 43). On the same beam are a series of Baltic Timber marks made by the shippers or importers of timber (Plate 44). At 1st Floor Level is the mark “W.F.No1H” for “Working Floor Number 1H”.

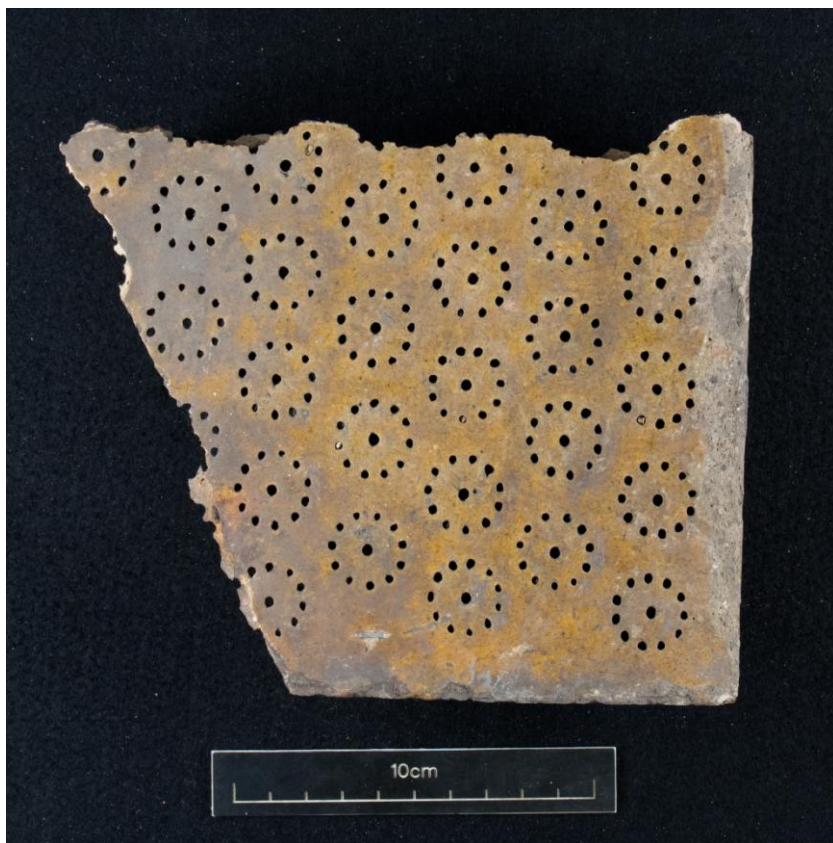
Plate 45: Kiln tile

The building has undergone a number of changes over time, including the re-building of the north elevation. An Archaeological Watching Brief in 2014 (Hunter-Mann) identified that the side walls at the north end of the building at Ground Floor Level have been thickened internally, and revealed evidence for the original quarry floor tiles below the present concrete floor. This suggested that the northern 8m of the building was altered in the 20th century. A malting kiln tile was also recovered from the trial pits at Ground Floor Level (Plates 45 and 46). This was stamped with Stanley Bros. Ltd of Nuneaton.

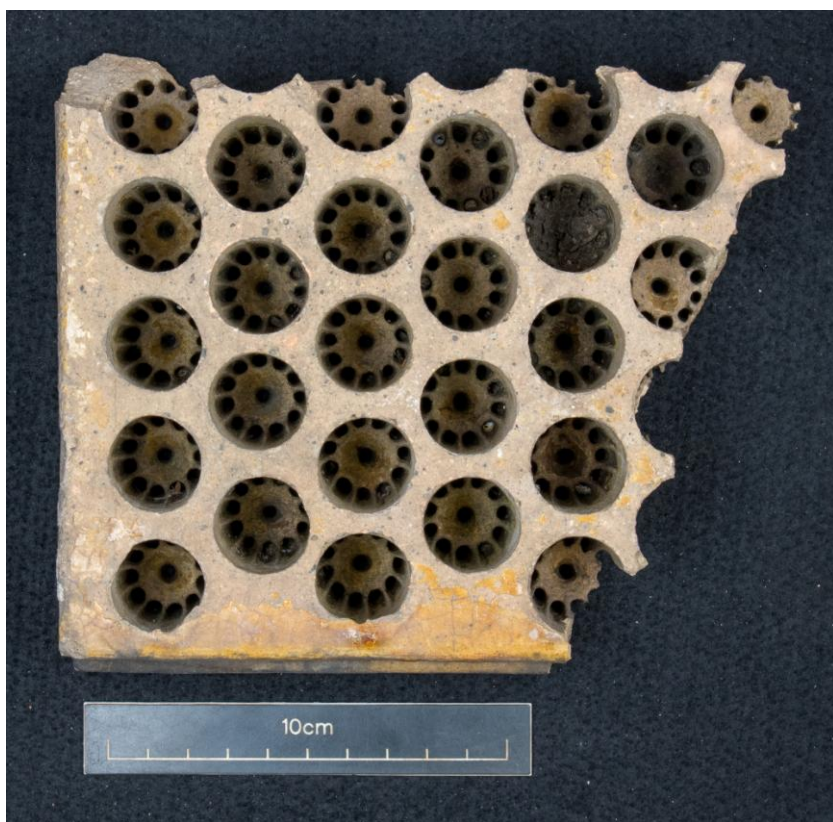
Plate 46: Kiln tile (underside).
