YORK ARCHAEOLOGICAL TRUST REPORT

SITE	AMEC Yorkshire Water Emergency Works King's Square AAI Watching Brief		
CLIENT NAME	Yorkshire Water		
YAT PROJECT #	5944	YAT REPORT #	86/2016
MUSEUM ACCESSION #	N/A	GRID REFERENCE	SE 6044 5193
PLANNING REFERENCE #	N/A	AAI OPS NOTICE #	16027

INTRODUCTION

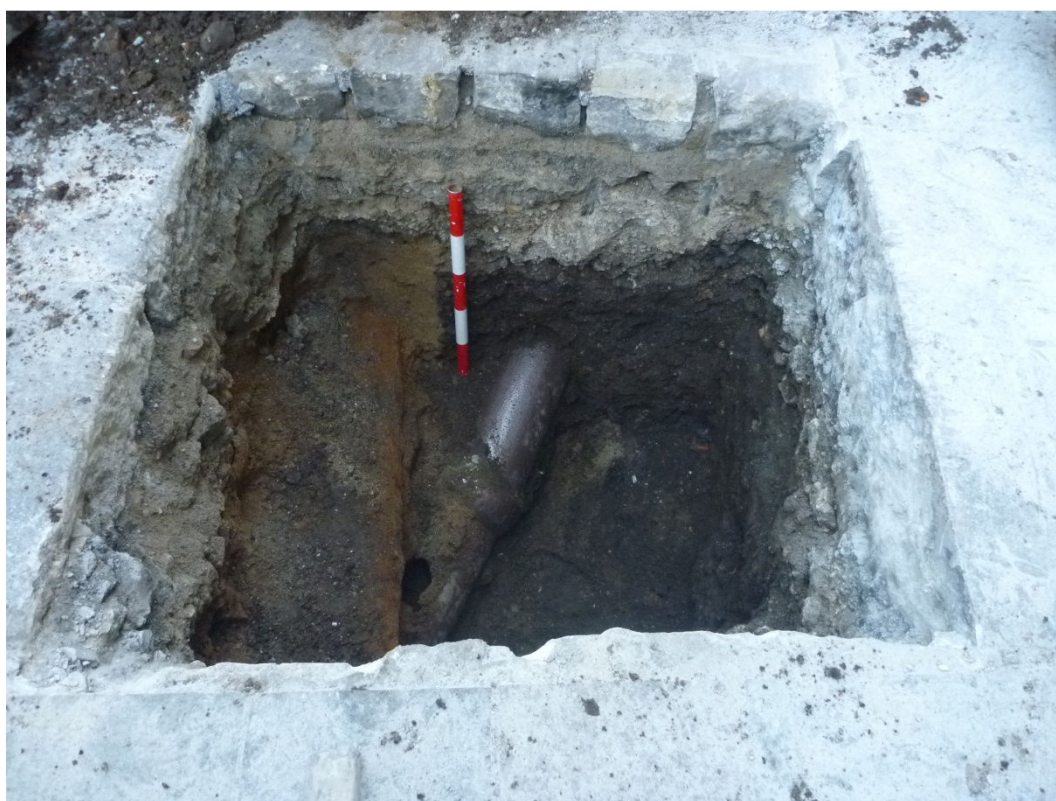
In Trench 1 the existing surface consisted of cobble sets, c.0.13m thick, resting on a bed of concrete, c.0.3m thick. Two service pipes running approximately north-south were exposed in the base of the trench. A cast iron pipe measuring c.100mm in diameter running along the eastern side of the trench was encountered at a depth of 0.56m below ground level. At a point approximately 2.5m east of the alley doorway the ceramic pipe, which was to be connected into, was exposed at 0.68m below ground level. The backfill of that pipe trench consisted of firm dark grey coarse, gritty sand with inclusions of gravel, brick fragments, sand and animal bone. That material extended across the entire western part of the trench and was clearly cut to the east by the trench containing the cast iron pipe (Plate 1). No archaeological deposits, structures or features were encountered within this part of the excavation.

Plate 1 Trench 1 showing ceramic pipe to be connected in to, facing south, 0.1m scale units

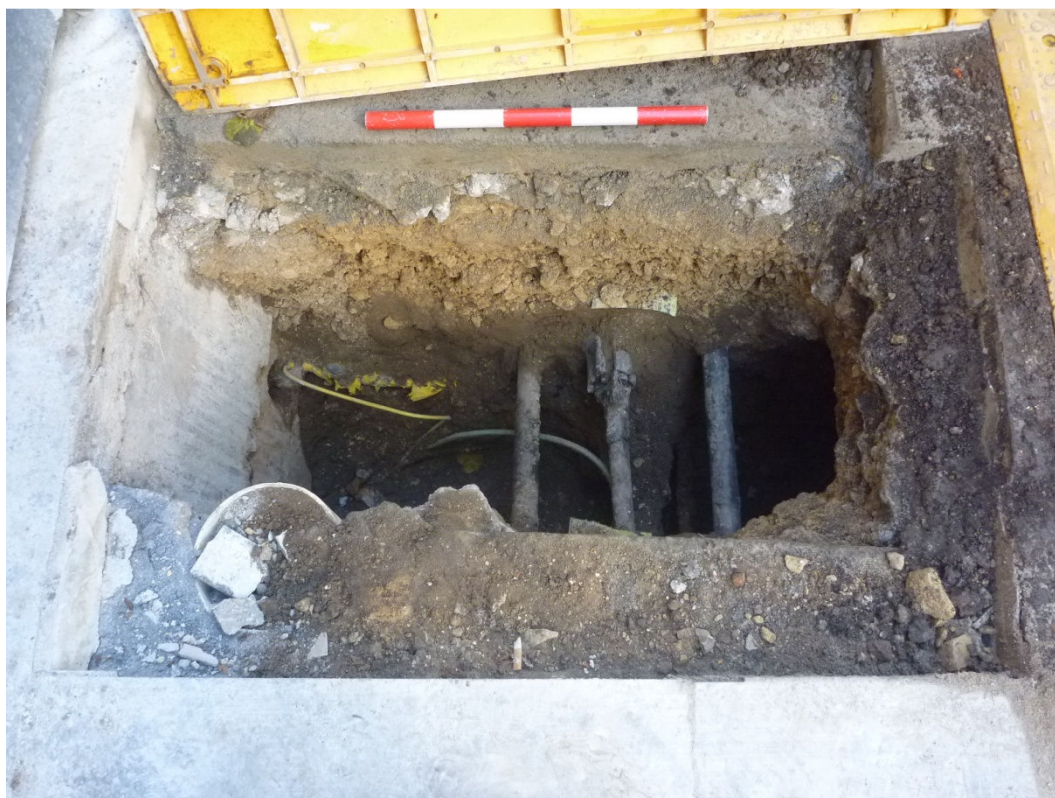
c.1.0m wide and 0.9m deep. A small area of made ground between the two parts of the trench was tunnelled through, enabling a new section of pipe to be fed through and connected to the ceramic pipe. Several recently installed power and other utility cables were exposed. No archaeological deposits, structures or features were encountered (Plate 2).

Plate 2 Trench 2, facing north, 0.1m scale units
