**ARCHAEOLOGICAL INVESTIGATIONS FOR YORK
CITY WALLS REPAIR AND RESTORATION
PROGRAMME**

ASSESSMENT REPORT

Report Number 2017/6 January 2017

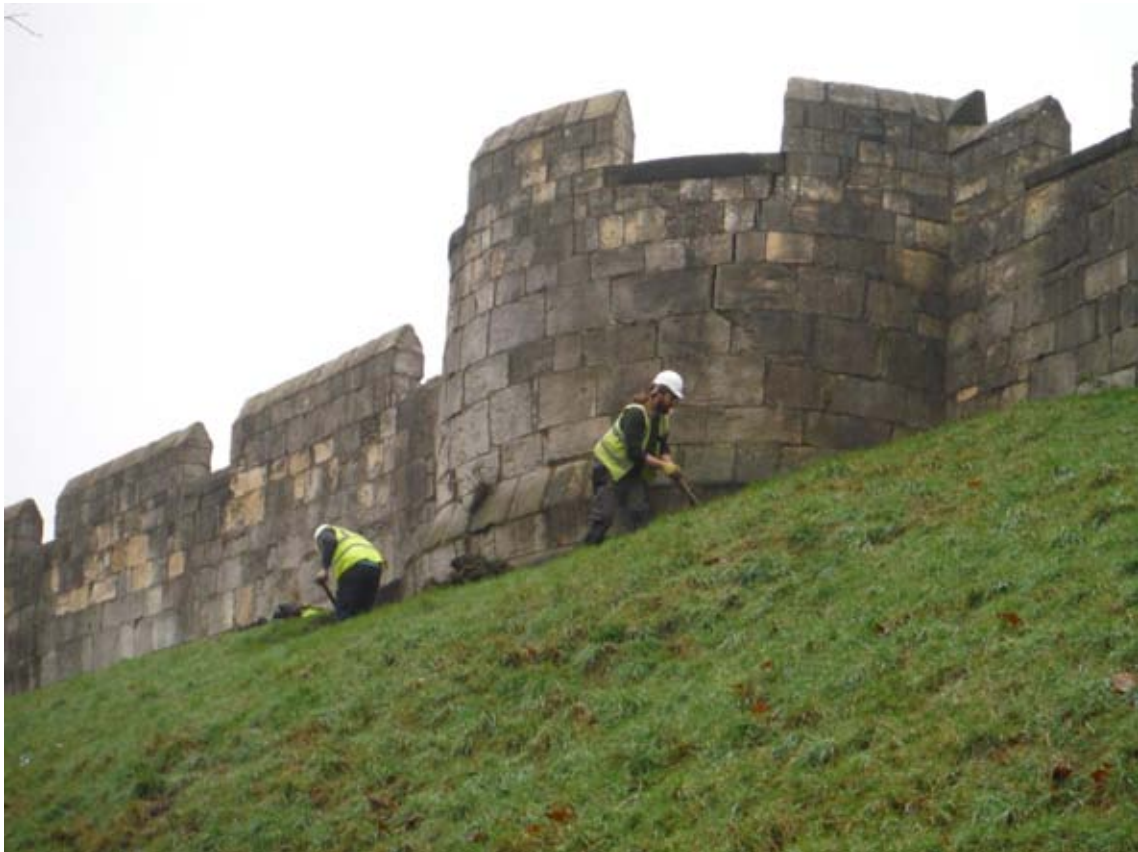
Plate 1. Excavation underway at Tower 2 (facing north-west).

Tower 2 is a semicircular structure that is 4.98m wide and projects out around 2.20m from the main wall. Although the tower is not bonded into the wall, it is believed to be contemporaneous (*ibid.*).

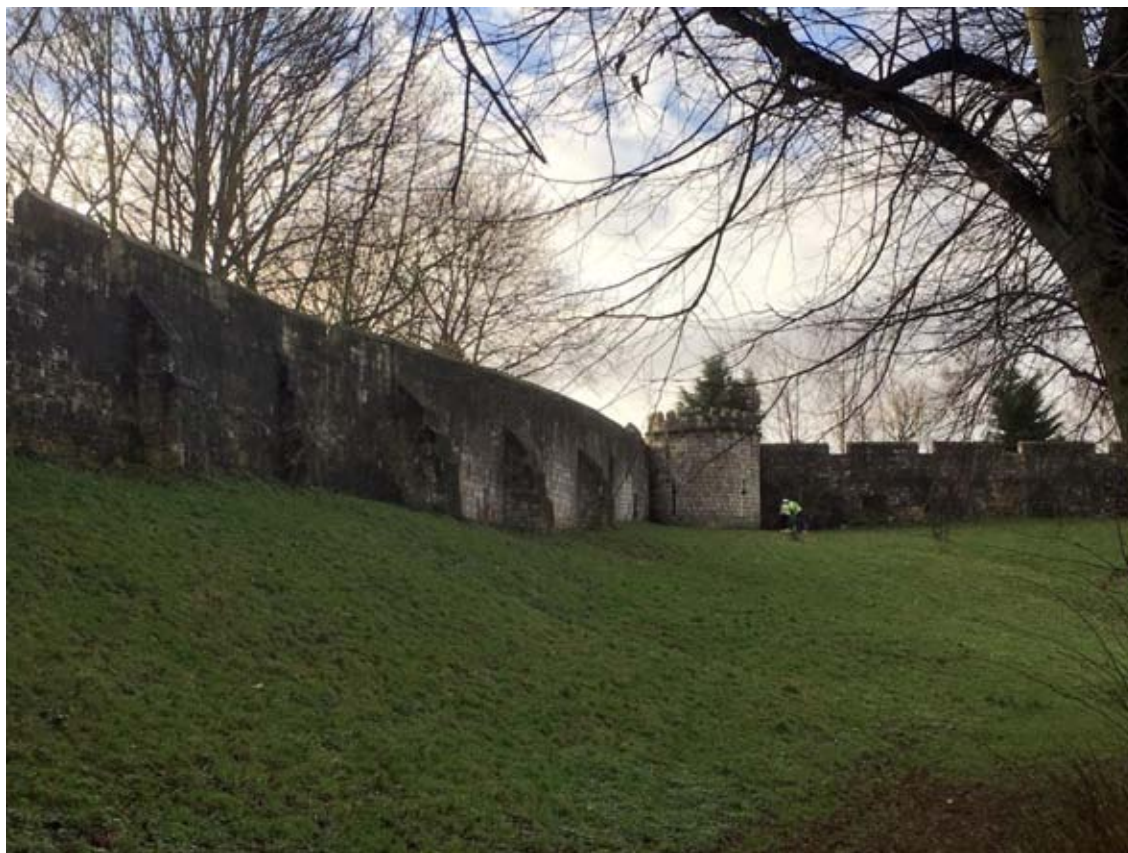
Plate 3. South-west facing view of Tower 32.

The Tower is oval in plan and occupies a point where the walls change angle (Plate 3). Measuring 6.41m in width, the exterior of the tower is almost certainly 14th century in date, although the upper string course and merlons are a 19th century addition (Plate 4). The tower is accessed from the rear where it was open to the air by 1851 when it contained the remains of a half-timbered building. The present wall walk along this stretch of the defences is supported by a much-altered series of arches of mixed 16th to 19th century date. Following 19th century restoration works, the walkway of Tower 32 itself was supported by a brick vault built in 1871 until a partial collapse led to the construction of the present concrete roof in 1950 (*ibid.*).

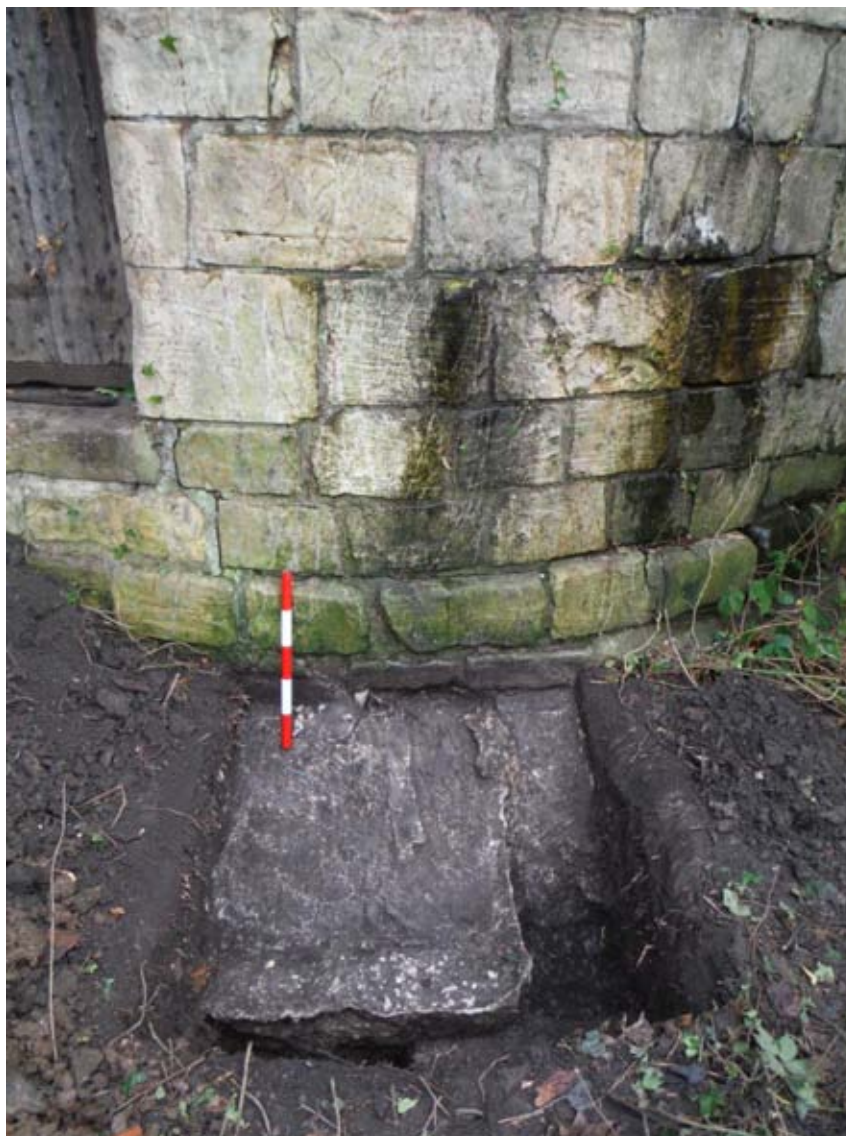
Plate 5. North-east facing view of section 2, Trial Pit 1 (0.50m scale).

Positioned to investigate a crack in the wall at the rear of Tower 32, Trial Pit 1 (Figures 3 and 5, Plate 5) measured 1.10m x 1.10m and was excavated to a maximum depth of 15.65m AOD (0.83m BGL). The earliest deposit to be encountered was a layer of firm, mid-orange brown silty clay that survived at a maximum height of 15.98m AOD (Context 101). This deposit was interpreted as the uppermost surviving layer of the rampart and dated by a sherd of pottery to the medieval period.

The stonework of the rear of the tower (Context 103, Figure 6) was exposed to a maximum depth of 16.29m AOD at which point any original footings had been removed and replaced by concrete underpinning that was most likely installed at the same time as the replacement of the roof of Tower 32 in 1950 (RCHMY Vol. 2).

Two distinct sections of sloping concrete (Contexts 102 and 105) were observed at the base of the wall, within cuts running an indeterminate distance beneath the tower and extending 0.81m outwards (Contexts 104 and 106). The discovery of two separate sections of underpinning suggests that the work was carried out in stages, with sections of the wall being undermined and reinforced with concrete which was then allowed to set prior to work commencing on the neighbouring section. It is presumed that this underpinning event was preceded by a clearance event (levelling of ground, removal of overgrowth, etc.) which was assigned the context number 107.

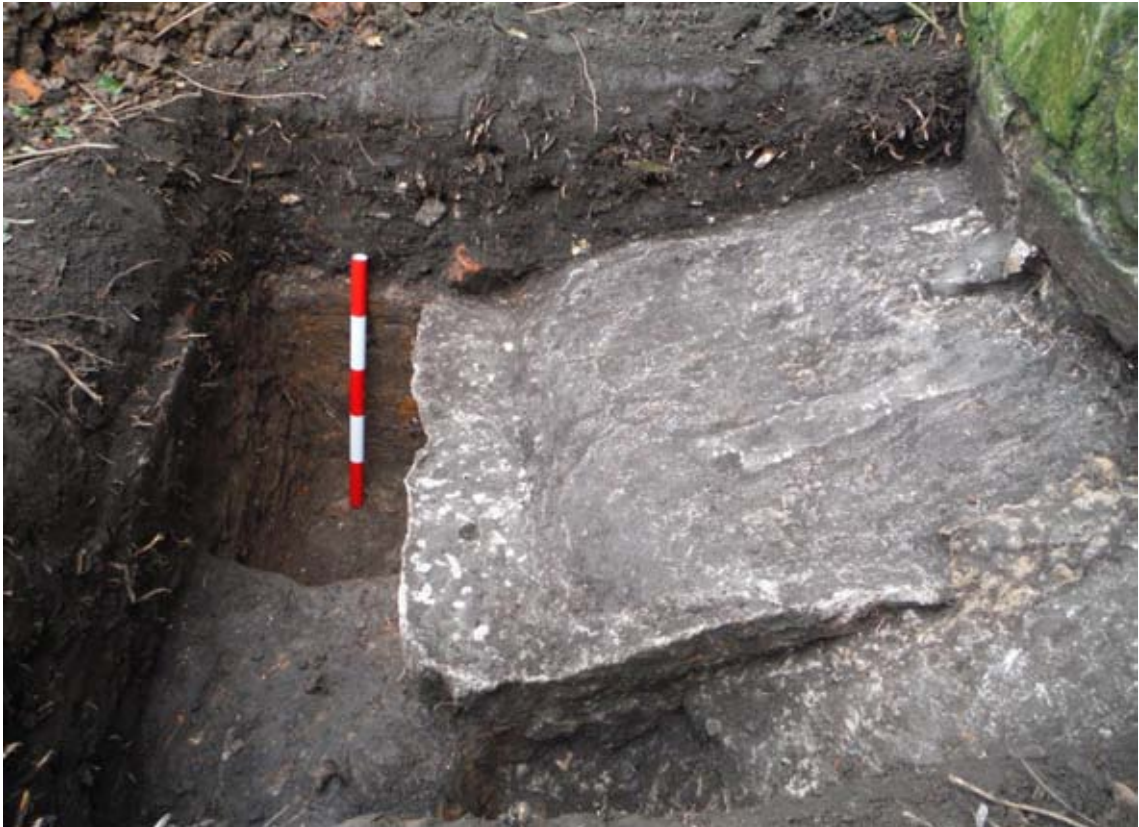
Plate 6. North-west facing view of Section 1, Trial Pit 1 (0.50m scale).

Following the underpinning, a layer of topsoil was reinstated (Context 100) which has subsequently been heavily affected by root action from surrounding vegetation (Figure 7, Plate 6).

The addition of the underpinning has removed the stratigraphic relationship between the rampart deposit (Context 101) and the wall of the tower (Context 103), although it is highly likely that the wall cuts the rampart.

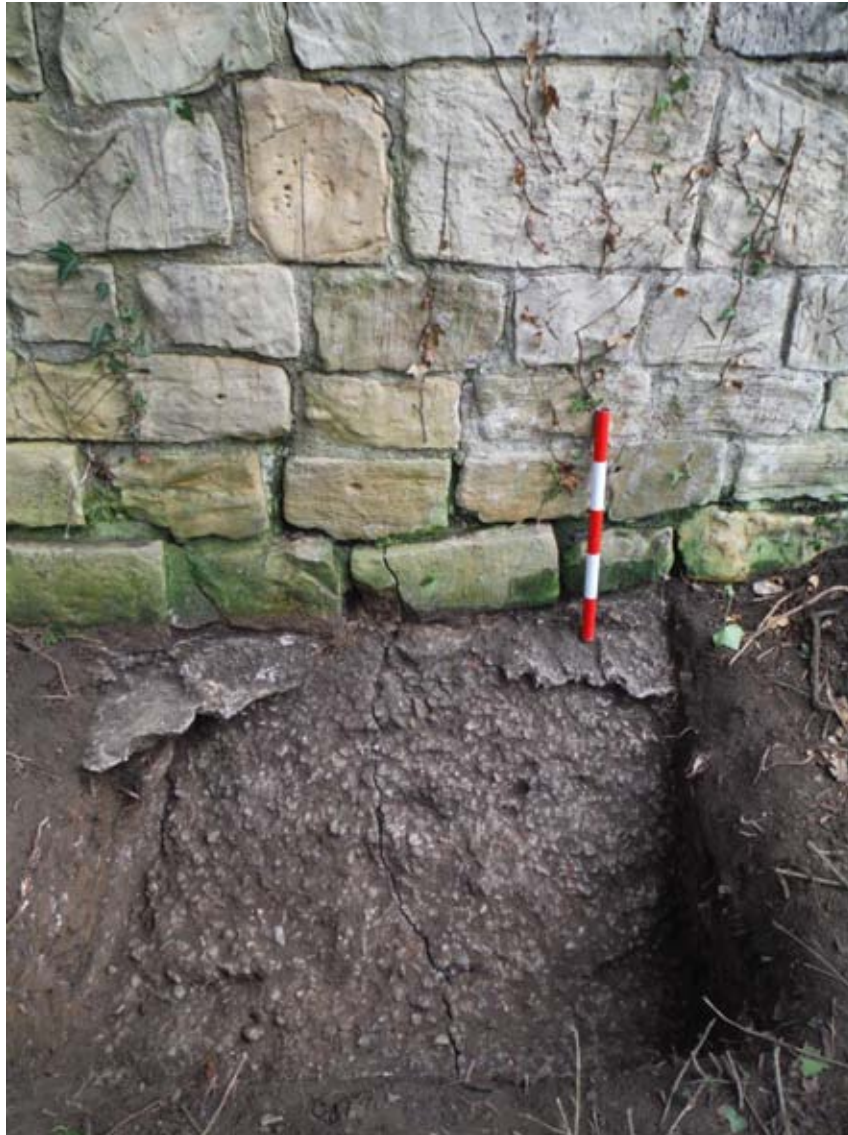
Plate 7. North-east facing view of Section 3, Trial Pit 2 (0.50m scale).

This trial pit was located against the rear wall of Tower 32 approximately 2.50m north-west of Trial Pit 1 (Figures 3 and 8), it was positioned to investigate a vertical crack running down the face of the medieval tower wall (Context 203) around the point that it is bonded to an 18th/19th century extension built to support a widened wall walk (Context 208, Figure 9, Plate 7). Trial Pit 2 measured 1.20m x 1.00m and was excavated to a maximum depth of 15.88m AOD (0.54m BGL).

The stonework of the tower (Context 203) and the walkway extension (Context 208) was exposed to a maximum depth of 16.27m AOD at which point the original footings had been removed and replaced by a single section of concrete underpinning (Context 206, Figure 10). The underpinning sloped moderately outwards from the tower wall for 1.00m and a crack visible in the elevation of wall 203 was noted to also continue through the concrete.

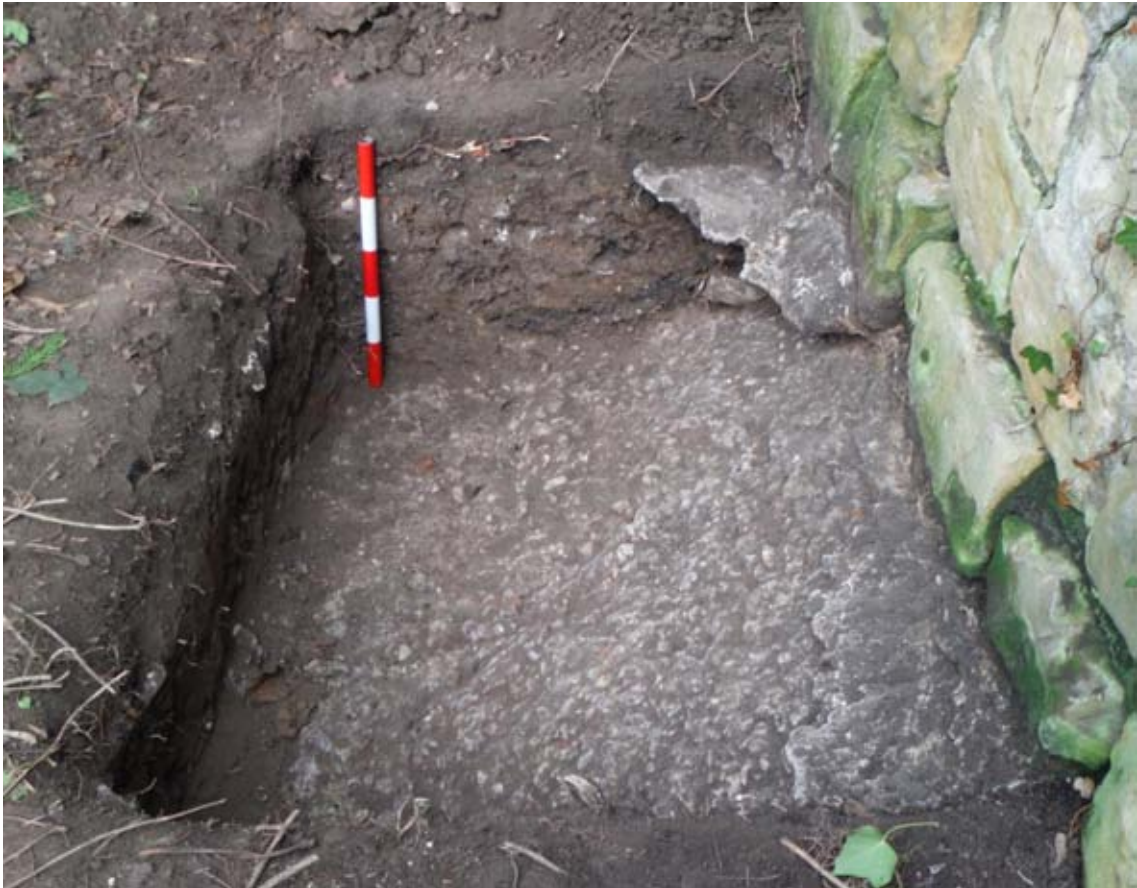
Plate 8. North-west facing view of Section 4, Trial Pit 2 (0.50m scale).

The underpinning trench (Context 207) was backfilled by two layers of mixed, rubble-rich backfill (Contexts 201 and 202) and subsequently cut by a second 20th century intrusion (Context 205). This shallow trench measured up to 0.27m in width and 0.22m in depth and was filled by a layer of limestone rubble (Context 209) and a thin layer of concrete (Context 204, Plate 8, Figure 10). This feature was interpreted as a by-product of 20th century re-pointing or maintenance of the tower and contained three sherds of re-deposited Roman pottery. The latest deposit to be observed was the present ground surface of heavily root-affected topsoil (Context 100).

As in Trial Pit 1, the underpinning event has destroyed the stratigraphic link between the rampart and the tower, although the historic evidence discussed in Section 4.3 would strongly suggest that the tower wall post-dates the rampart.

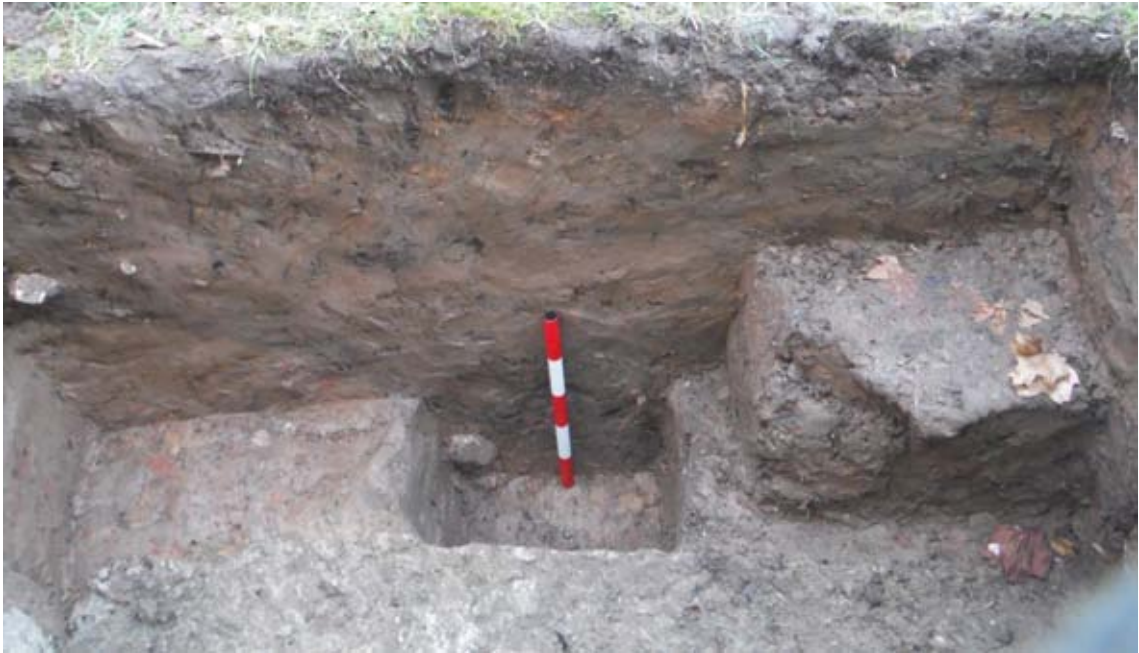
Plate 9. North facing view of Section 7, Trial Pit 3 (0.50m scale)

Trial Pit 3 was positioned on the external face of Tower 32 to investigate a crack running down the face of the stonework (Figure 3). The trench measured 1.80m x 1.10m and was excavated to a maximum depth of 15.87m AOD (1.06m BGL).

The earliest sequence of deposits observed within the trial pit was a series of six alternating layers of firm, mid-light orange brown sandy clay and firm to friable, dark-greyish brown sandy clay silt (Contexts 301, 306, 307, 310, 311 and 312, Figure 14, Plate 9). The sequence, which was interpreted as the upper layers of the medieval rampart, survived from a height of 16.95m AOD to the trial pit's maximum depth of 15.87m AOD and followed the same moderate slope to the east as the present bank. Context 312 was the earliest deposit in this sequence and contained a range of pottery including Roman domestic wares and a sherd of Stamford Ware. This would suggest an 11th century date for the deposit, although the limited sample area should be kept in mind.

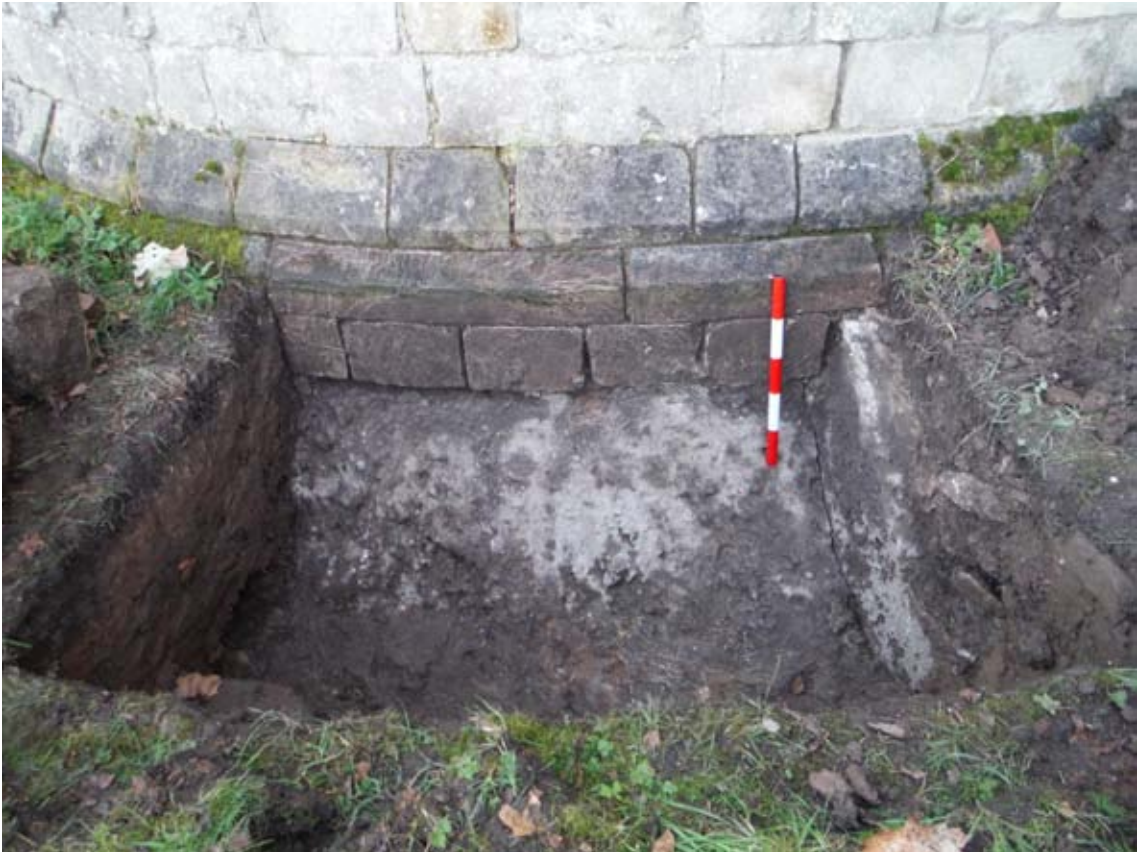
Plate 10. South-east facing view of Section 5, Trial Pit 3.

The rampart deposits were cut by two underpinning trenches (Contexts 304 and 309) which relate to the same mid-20th century repair works observed in Trial Pits 1 and 2. Both sections of concrete underpinning sloped steeply outwards from the base of the tower to a maximum width of 0.80m, although the western section (Context 303) had a maximum height of 16.87m AOD, while the eastern section (Context 308) sat much lower at 16.63m AOD (Figures 11, 12, and 13, Plates 10 and 11).

The underpinning trenches were backfilled by mixed deposits primarily of firm to friable, mid-greyish brown clay silt (Contexts 302 and 305) containing frequent large fragments of masonry as well as stone and mortar rubble and re-deposited Roman ceramics. These inclusions are likely to be evidence of the disposal of unwanted material relating to restoration works carried out at the same time as the underpinning. The quantity of discarded masonry may suggest that the tower was originally built on stone footings, although this cannot be confirmed due to the intrusive nature of the underpinning.

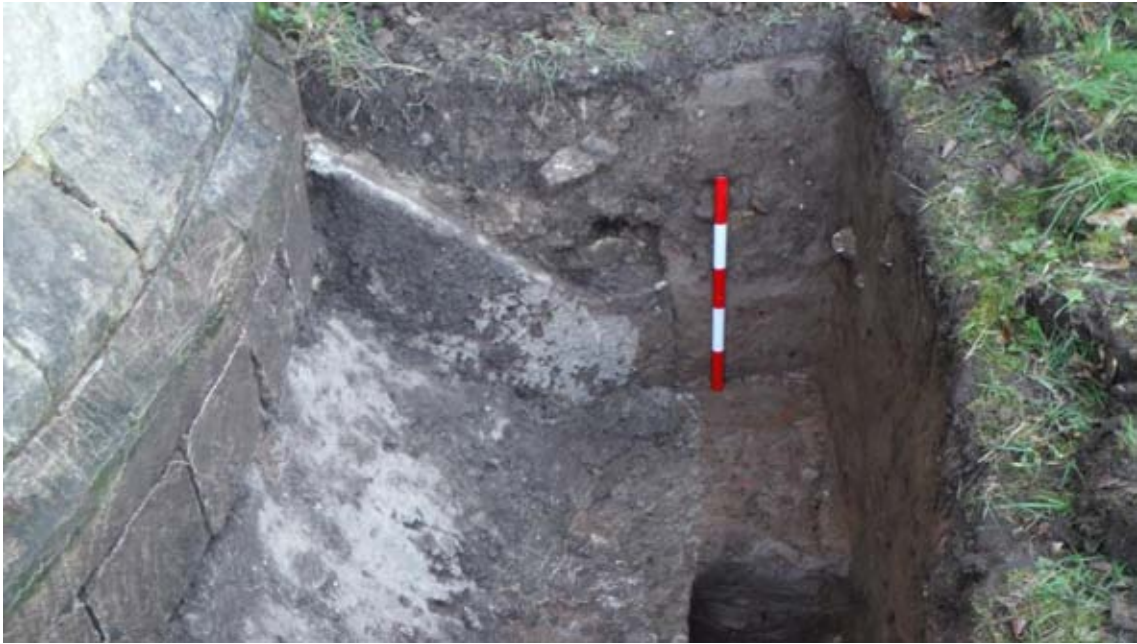
Plate 11. South-west facing view of Section 6, Trial Pit 3 (0.50m scale)

During the excavation of Trial Pit 3, it was noted that the crack in the exterior face of the tower corresponds with the change in depth of the concrete underpinning (Figure 12).

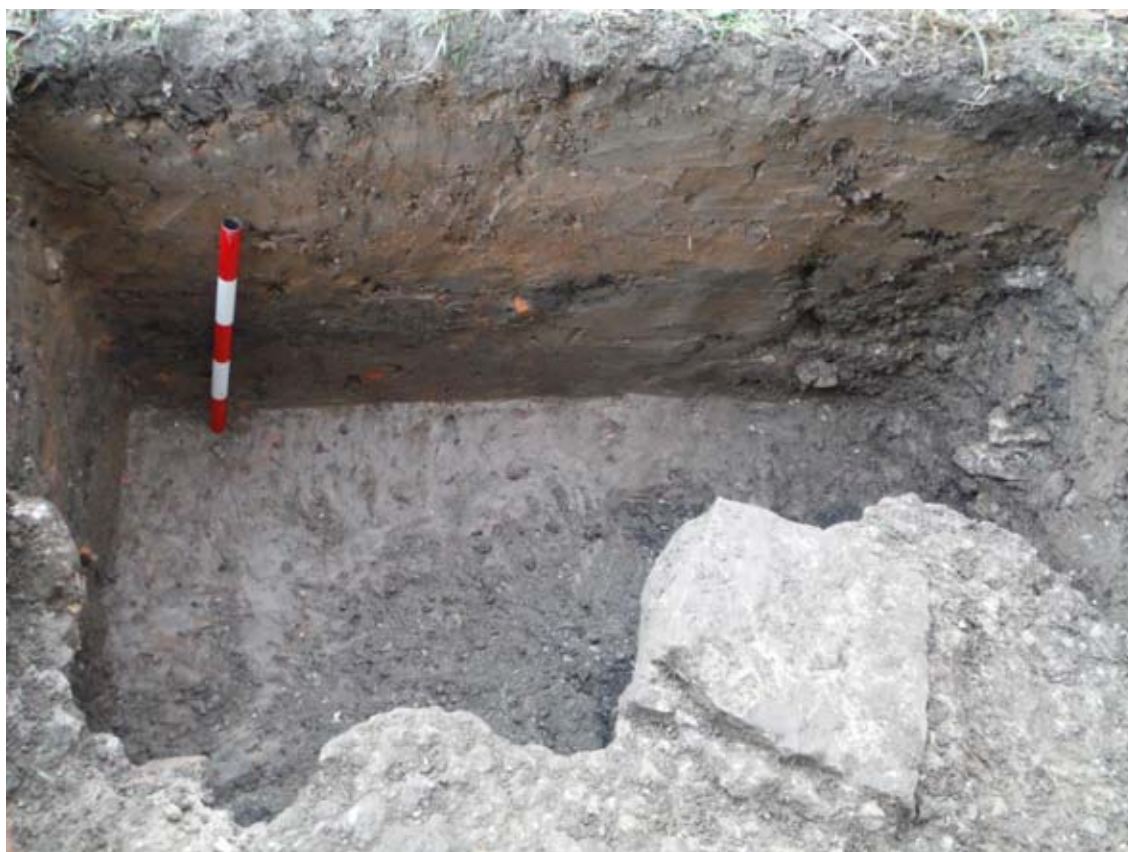
Plate 12. North-east facing view of Section 10, Trial Pit 4 (0.50m scale).

Situated on the north-eastern face of Tower 32, Trial Pit 4 was located at the base of a section of wall with several cracks (Figures 3 and 15). The trial pit measured 1.50m x 1.10m and was excavated to a maximum depth of 15.99m AOD (0.79m BGL).

A similar sequence to that of Trial Pit 3 was revealed, with the earliest observed deposits being layers of rampart make-up. The earliest of these layers comprised friable dark grey brown silty clay with orange mottling (Context 410) and survived from a height of 16.31m AOD. Context 410 was overlain by a firm, dark-grey brown silty clay (Context 409, Figure 18). In the south-west corner of the trial pit, a small pit/post hole filled with a stony fill of friable, dark brown grey silty clay sand (Context 411) was observed to cut into Context 409 (Plate 12). The pit cut (Context 412) measured 0.40m x 0.40m, was sub-oval in plan with steep sides and an irregular base.

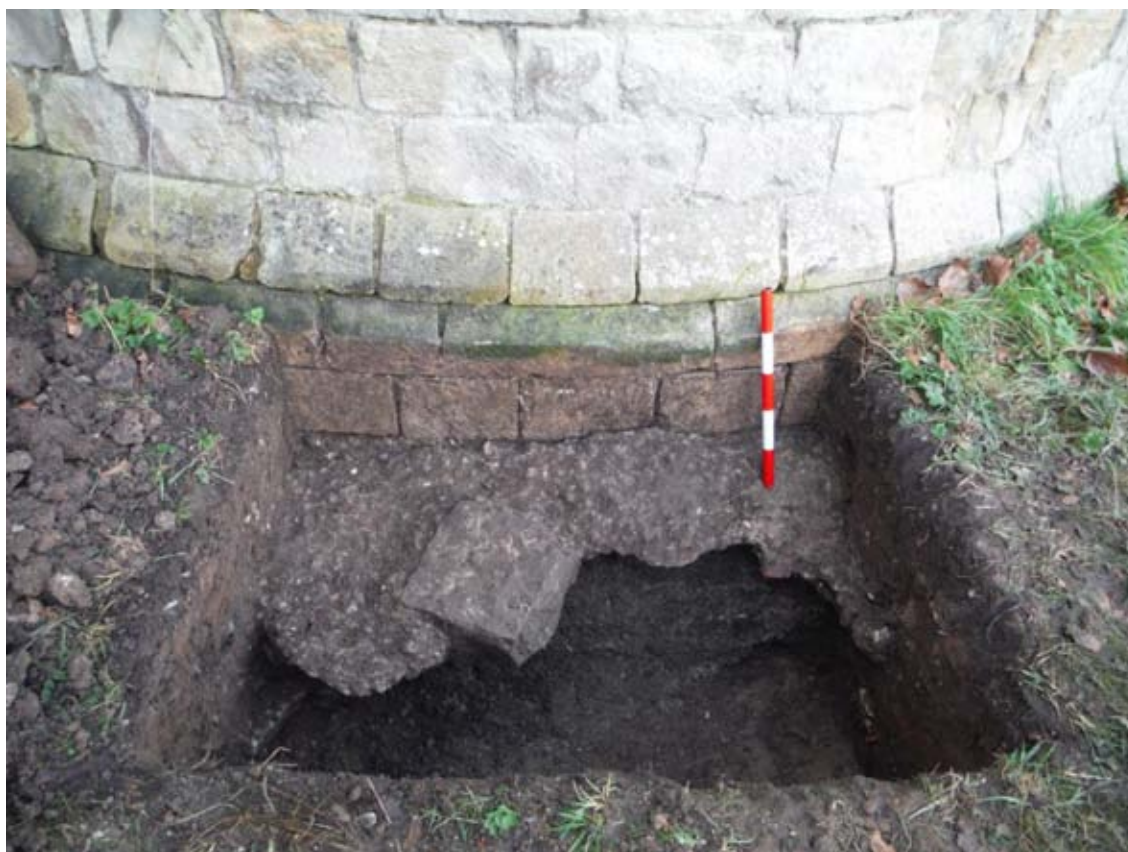
Plate 13. South-west facing view of Section 8, Trial pit 4 (0.50m scale)

As with each of the trial pits around Tower 32, Trial Pit 4 exposed the concrete underpinning that appears to have been installed in 1950. Cutting directly into the rampart layers, the underpinning cut (Context 406) mirrored the curve of the tower wall and contained a steeply sloping concrete footing (Context 404, Figure 17, Plates 13 and 14) that extended out up to 0.20m from the base of the tower (as excavated, the concrete was not fully exposed).

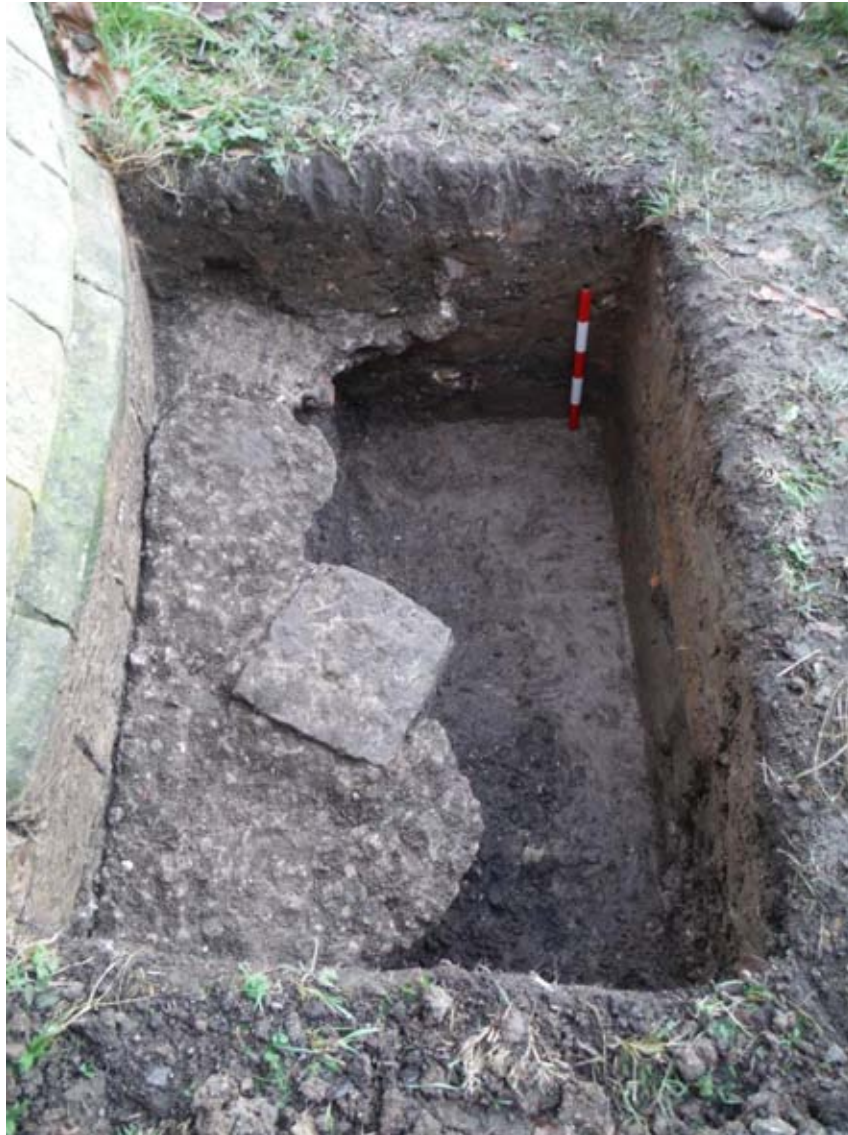
Plate 14. North-west facing view of Section 9, Trial Pit 4 (0.50m scale).

The underpinning trench was backfilled by a firm, mid-orange brown silty clay with frequent rubble and mortar inclusions (Context 405, Plate 14). A second 20th century intrusion (Context 403) was found to cut the underpinning trench backfill. Measuring up to 0.95m in width, this cut was filled by a dump of concrete and masonry deposited directly against the tower wall (Context 402) and backfilled with a rubble-rich, firm, mid-orange brown silty clay containing re-deposited ceramics ranging between Roman and medieval in date (Context 401, Figure 17). This event is likely to represent disposal of unwanted materials from 20th century restoration works. The wall of Tower 32 (Context 313) directly overlaid the initial concrete underpinning (Context 404) and survives to a depth of approximately 16.59m AOD – a more precise measurement wasn't possible as concrete dump 402 obscures the interface between the wall and underpinning.

Present day turf and topsoil was the latest deposit to be excavated (Context 400). As with all the trial pits around Tower 32, the underpinning has removed the relationship between the tower and the ramparts.

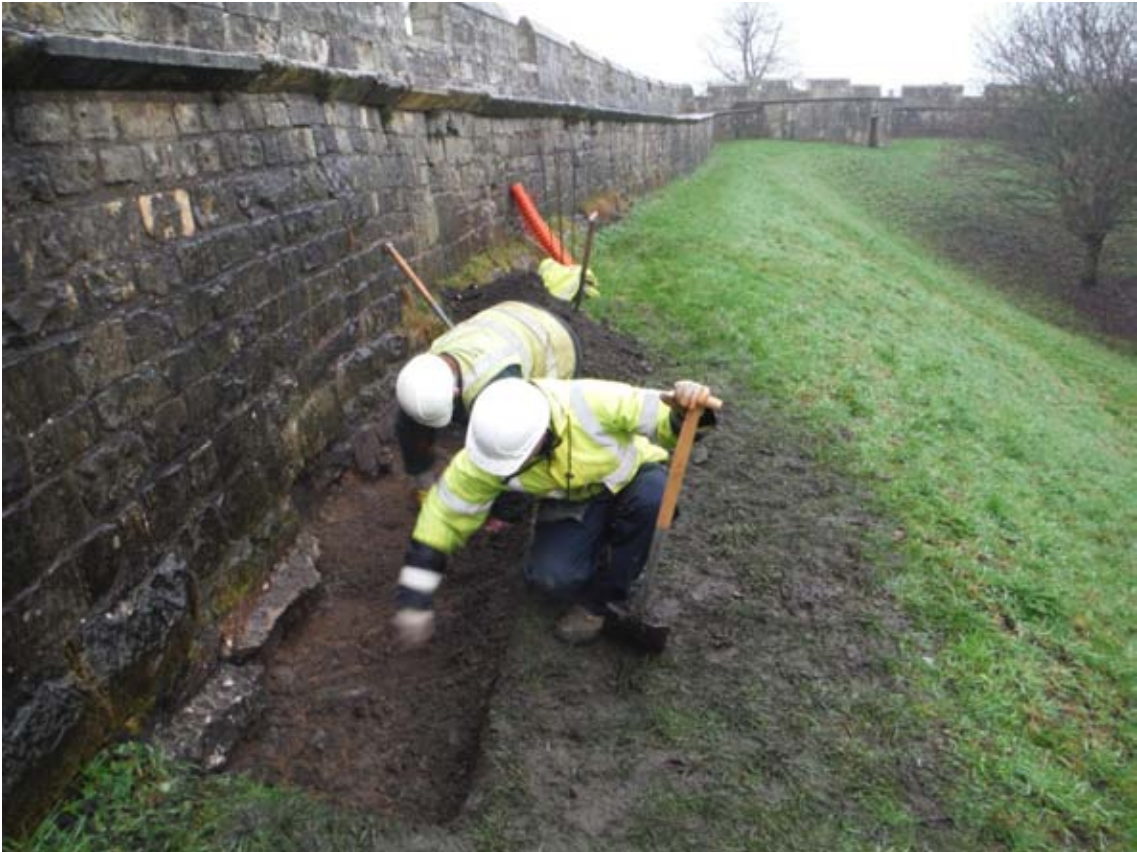
Plate 15. South-west facing image of Trial Pit 5.

Trial Pit 5 measured 3.00m x 1.00m and was excavated to a maximum depth of 19.58m AOD (0.22m BGL). It was located on the inside face of the north-east/south-west aligned wall walk at the rear of Tower 2 and aimed to investigate a crack in the walkway wall (Figures 2 and 19).

A presumed clearance event pre-dating the construction of the current walkway was assigned the context number 504. The next stratigraphic event, the construction cut for the present wall walk (Context 505), was found to be very slight, with the rampart being simply cut flat for the construction of the walkway wall (Context 501, Figure 20, Plates 15 and 16).

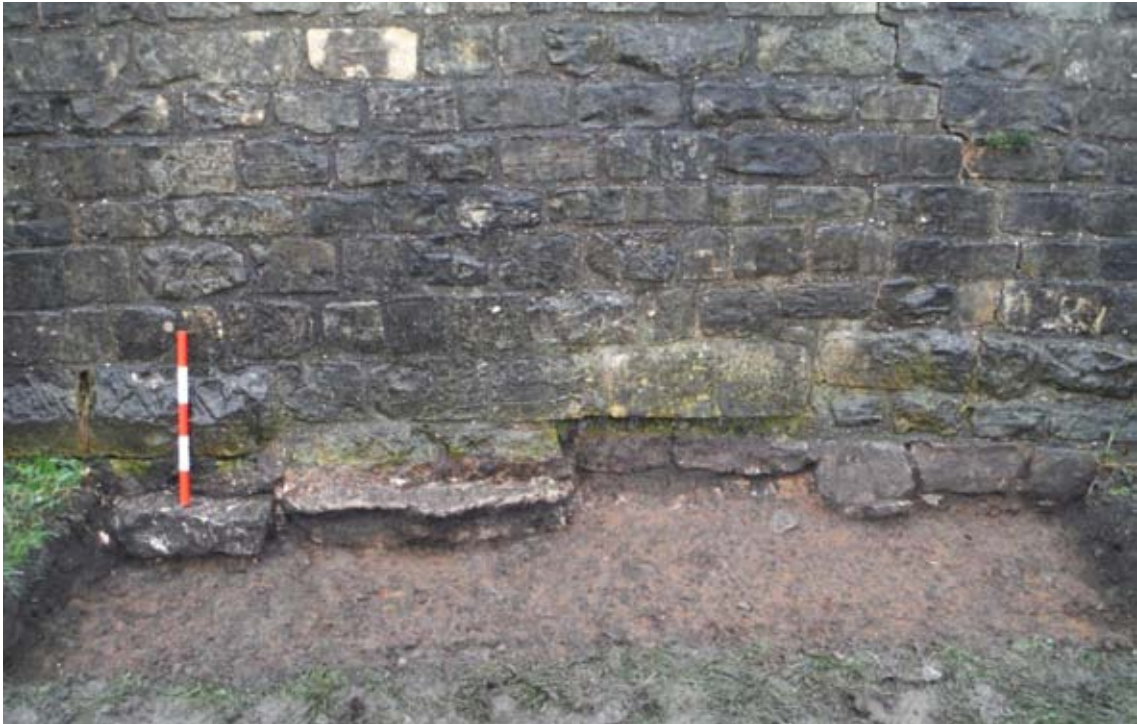
Plate 16. South-east facing view of Section 11, Trial Pit 5 (0.50m scale).

The earliest observed deposit was a firm to friable, light-orange brown silty clay that survives to a maximum height of 19.61m AOD. The deposit was interpreted as the upper layer of the medieval rampart (Context 503, Figure 20, Plate 16).

The wall was found to have no foundations and is most likely 19th century in date. A small patch of mortar was added to the face of the wall (Context 502) and may relate to re-pointing in the 20th century. The latest deposit to be observed was the present surface of turf and topsoil (Context 500) which contained a broad range of ceramics including Roman, Anglo-Norman, medieval, post-medieval and 18th century material.

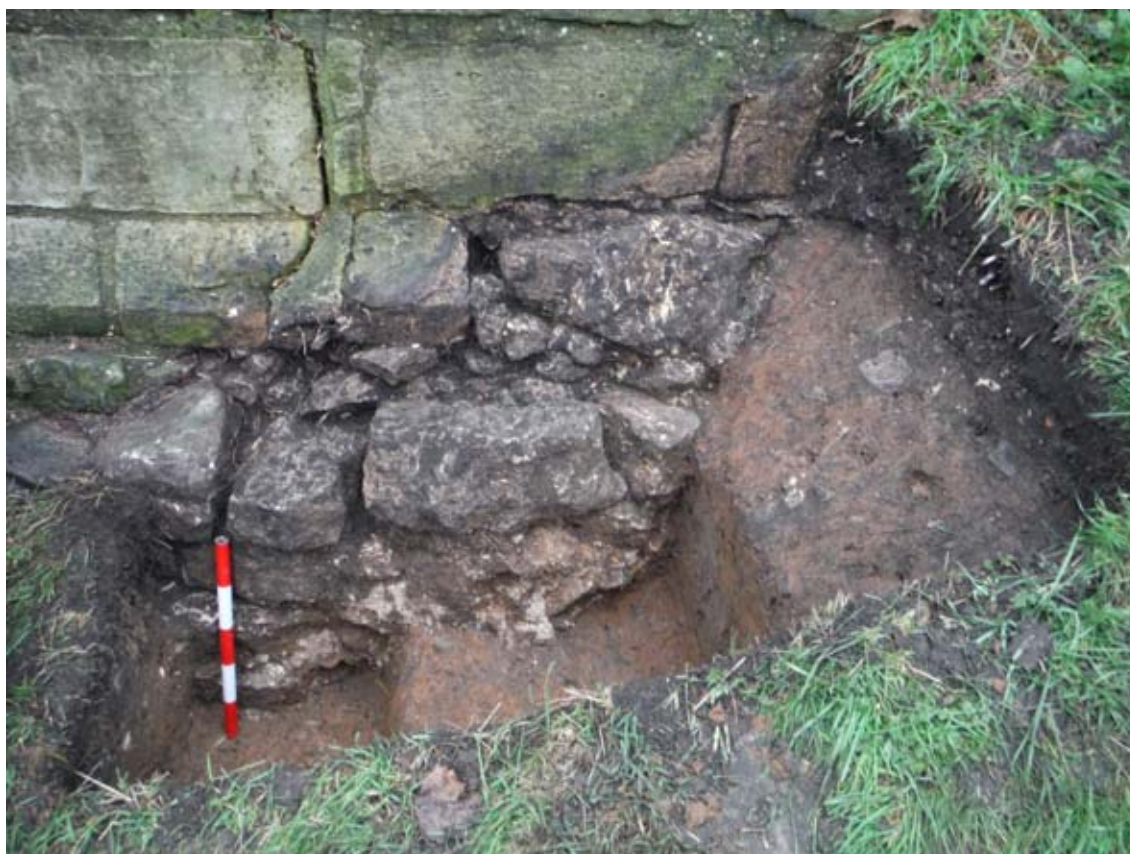
Plate 17. West facing view of Section 15, Trial Pit 6 (0.50m scale)

Positioned to investigate a crack in the outer face of Tower 2, Trial Pit 6 was situated on the east facing side of the tower. The trial pit measured 1.65m x 1.07m and was excavated to a maximum depth of 18.06m AOD (0.48m BGL, Figures 2 and 21). Due to the steep gradient of the ramparts, the trench was stepped to avoid excessive depth and maintain a safe working environment (Plate 17).

The footings for the tower wall comprised of roughly coursed angular limestone fragments measuring up to 0.50m x 0.30m x 0.20m bonded in a light grey lime mortar (Context 602). The footings were exposed to a width of 0.36m and a maximum depth of 0.75m. Close to the curtain wall, the footings were present at a height of 19.07m AOD, stepping down to 18.76m AOD following a change in the wall as it follows the downward slope of the ramparts (Figure 22, Plate 17).

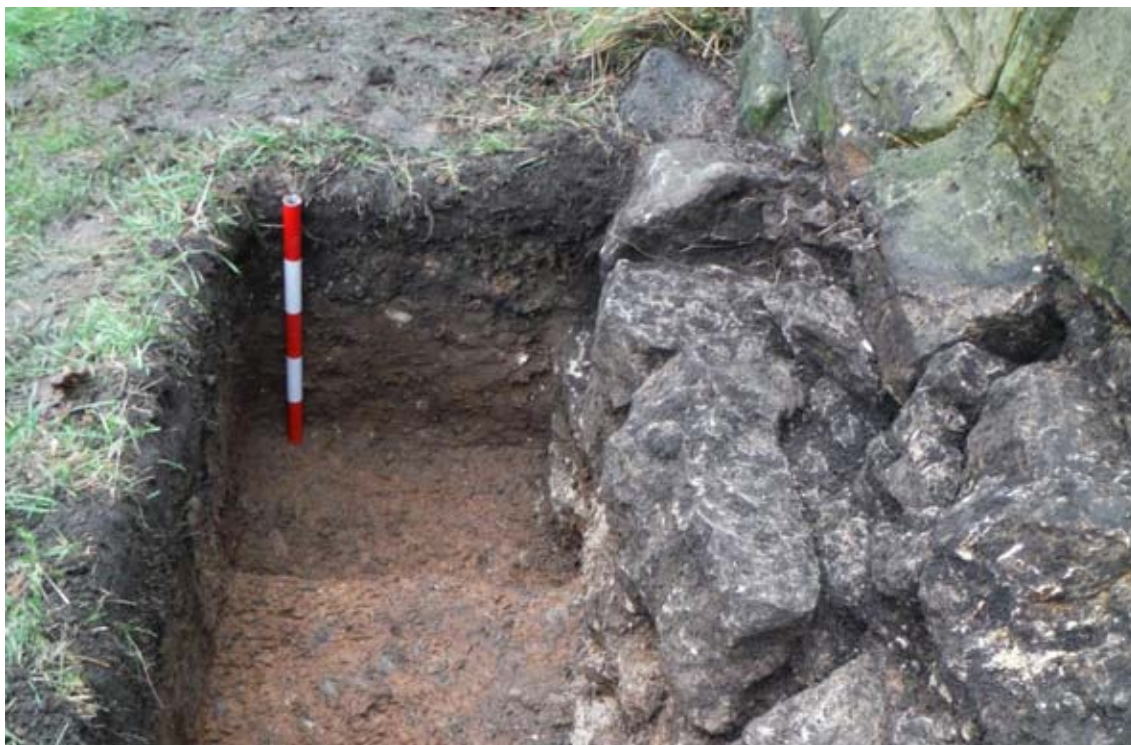
Plate 18. South facing view of Section 16, Trial Pit 6 (0.50m scale).

The rampart deposit was immediately post-dated by the curvilinear, vertical sided construction cut for Tower 2 (Context 603, Figure 23, Plate 18) which was exposed to a width of 0.36m and a depth of at least 0.55m. It was not possible to reach the base of the construction cut, which continued beyond the limit of excavation.

The wall of Tower 2 (Context 601) was built directly off of the footings and it was noted that cracks in the standing wall did not continue through the foundations. The latest deposit observed in Trial Pit 6 was the current turf and topsoil (Context 600).

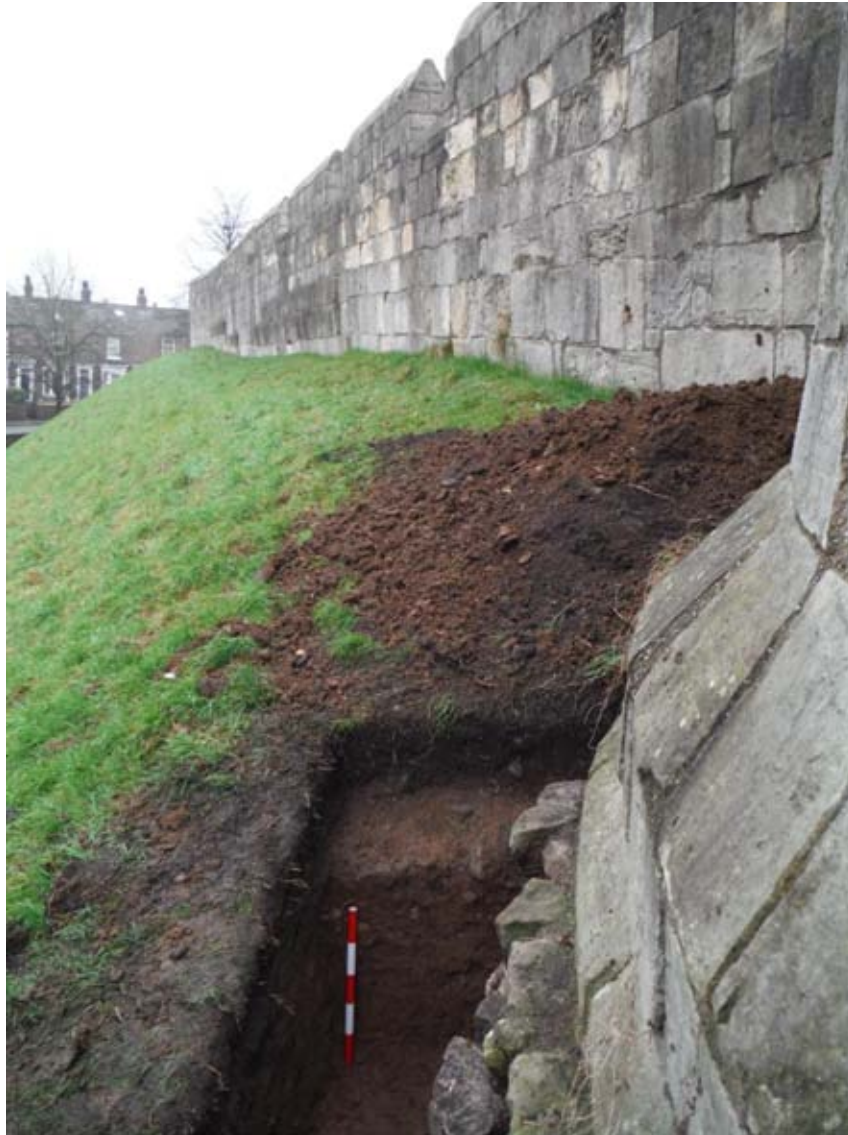
Plate 19. West facing view of Trial Pit 7 (0.50m scale).

Trial Pit 7 was positioned against the south facing side of Tower 2 where the walling exhibits numerous small cracks (Figures 2 and 24). The trench measured 1.68m x 1.06m and was excavated to a maximum depth of 17.84m AOD (0.72m BGL). Due to the steep gradient of the ramparts, the trench was stepped to avoid excessive depth and maintain a safe working environment.

Immediately post-dating the rampart deposit was the curvilinear, vertical sided construction cut for Tower 2 (Context 703) which was exposed to a width of 0.30m and a depth of at least 0.98m. It was not possible to safely reach the base of the construction cut, which continued beyond the limit of excavation.

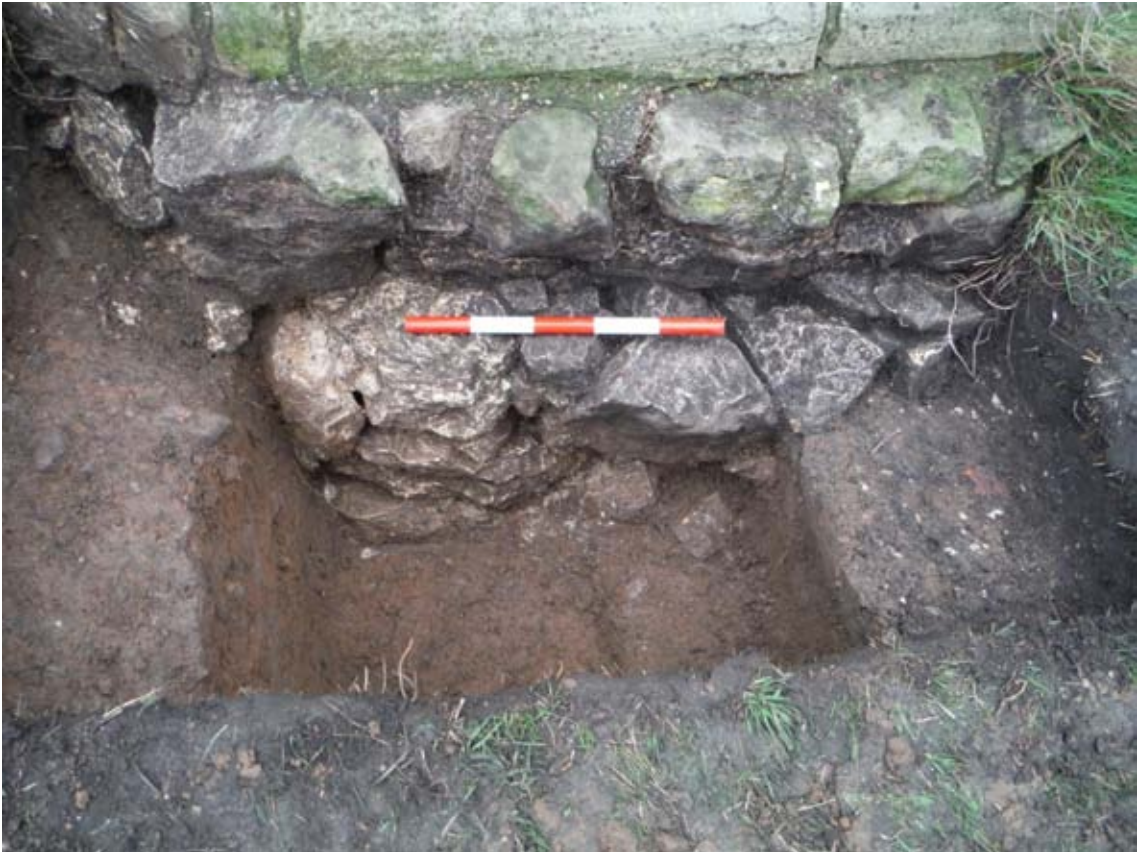
Plate 20. North facing view of Section 20, Trial Pit 7 (0.50m scale).

The footings of Tower 2 were exposed to a depth of five courses and comprised angular limestone fragments measuring up to 0.50m x 0.30m x 0.20m bonded in a light grey lime mortar. It was observed that the footings at this point were less heavily mortared than their equivalent in Trial Pit 6 (Context 602). The footings were exposed to a width of 0.30m and a maximum depth of 0.98m. The footings are present at a maximum height of 18.83m AOD, sloping down to 18.77m AOD following the downward slope of the ramparts (Figures 24 and 25, Plate 20).

The wall of Tower 2 (Context 701) was built directly off of the footings and cracks visible in the standing wall were not observed to continue into the foundations. The latest deposit observed in Trial Pit 7 was the present day surface of turf and topsoil (Context 700).

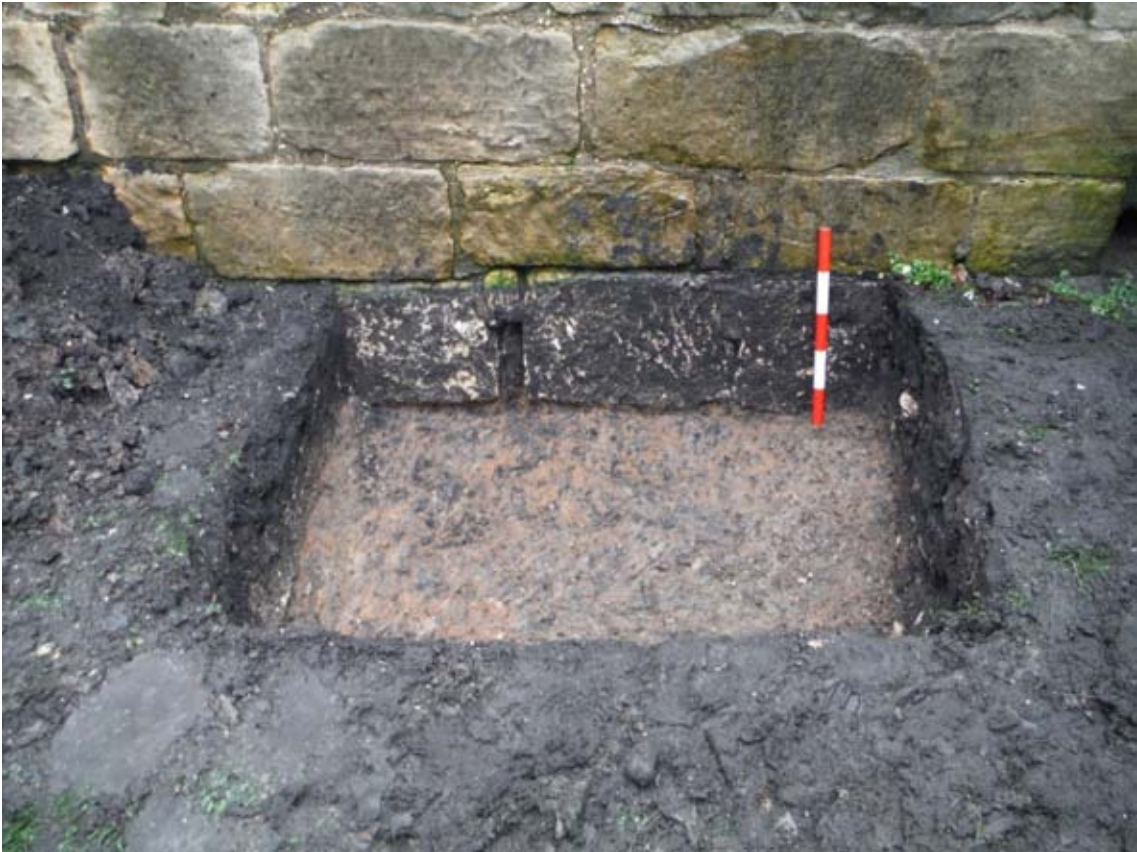
Plate 21. South-east facing view of Section 12, Trial Pit 8 (0.50m scale).

A presumed clearance event preceding the construction of Tower 39 was given the context number 803. This would have involved the removal of any redundant timber defences, clearance of overgrowth, etc. The next context to be observed was the construction cut for the tower (Context 804). Unlike Tower 2 (see sections 5.6 and 5.7), there is no evidence for a substantial cut at this point; the evidence suggests that the existing rampart (Context 802) was simply cut flat to a height of around 13.95m AOD and used as a construction platform (Plate 21).

The wall of Tower 39 (Context 801) was found to have no foundations, with good quality ashlar masonry present to the bottom course of the structure (Figure 27, Plate 21).
