**ARCHAEOLOGICAL INVESTIGATIONS FOR YORK
CITY WALLS REPAIR AND RESTORATION
PROGRAMME**

ASSESSMENT REPORT

Report Number 2017/6 January 2017

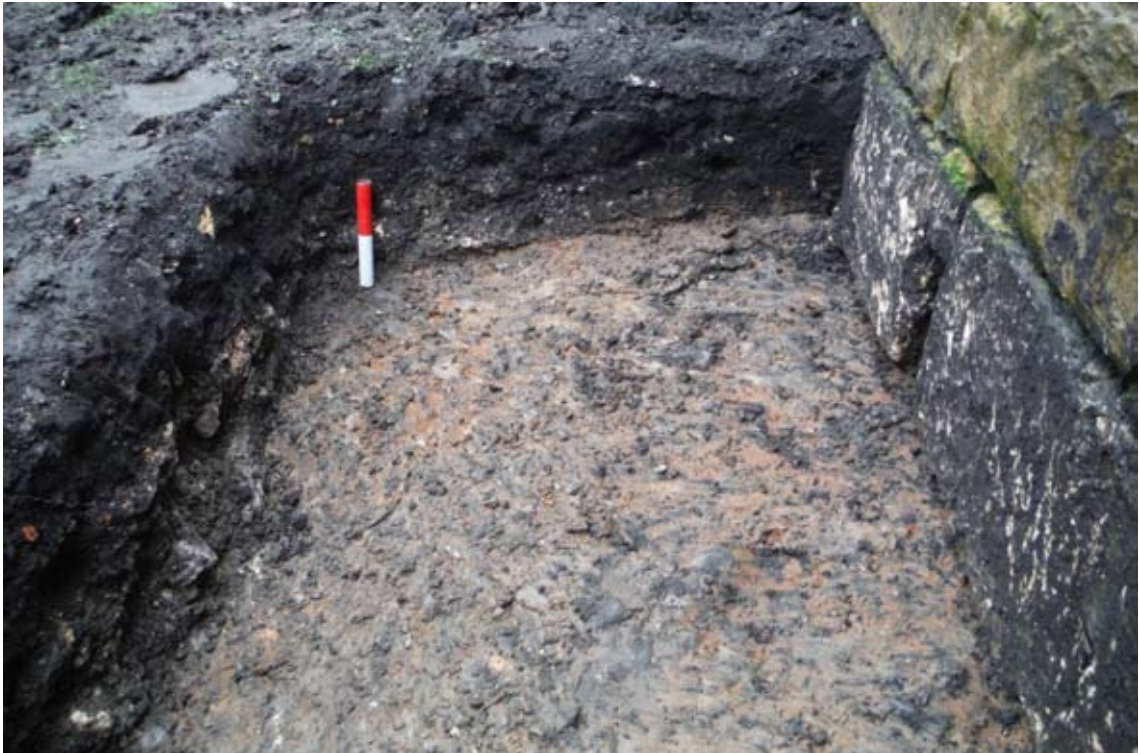
Plate 22. North-east facing view of Section 13, Trial Pit 8 (0.50m scale).

No surviving medieval or post-medieval deposits were found to post-date the structure, instead, the next context to be observed was a layer of limestone rubble and mortar dated to the 19th century by small fragments of brick (not retained, Context 805, Figure 28, Plate 22). This deposit was interpreted as a spread of construction materials relating to 19th century restoration work. The latest deposit in Trial Pit 8 was the present surface of topsoil; a heavily disturbed layer containing a large amount of early 20th century bottle glass and a small amount of post-medieval to 18th century pottery.

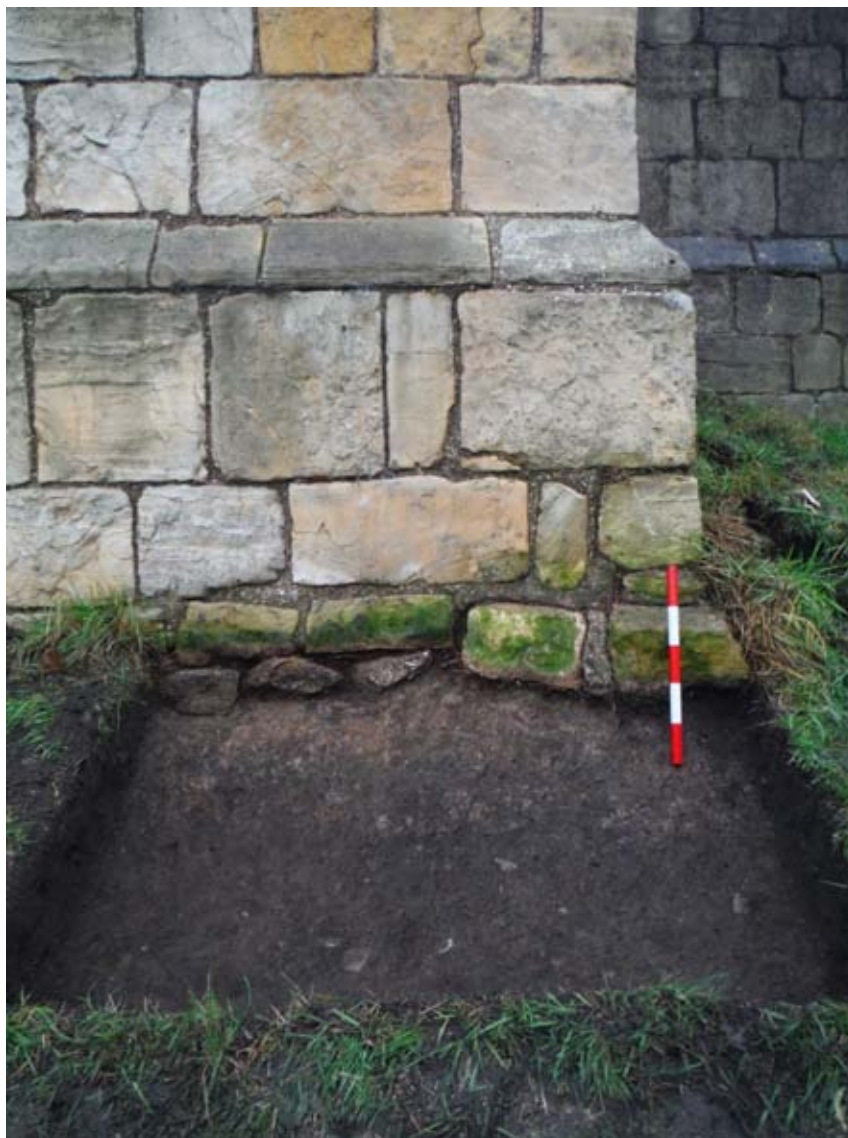
Plate 23. North-west facing view of Section 14, Trial Pit 9 (0.50m scale).

The construction cut for Tower 39 (Context 905) followed the pattern evidenced by Trial Pit 8 (see section 5.8), as no substantial cut was made into the rampart. It appears that the top of the rampart was flattened and the wall was built directly on top of it.

The exterior wall of Tower 39 (Context 901, Figure 30, Plate 23) was found to have no substantial footings. The base course of the wall comprised irregular, roughly faced masonry beneath the ashlar masonry of the extant wall and is built at a maximum depth of 13.91m AOD. The current surface of turf and topsoil (Context 900) covered much of the base course of the wall and was the latest context to be identified in Trial Pit 9.

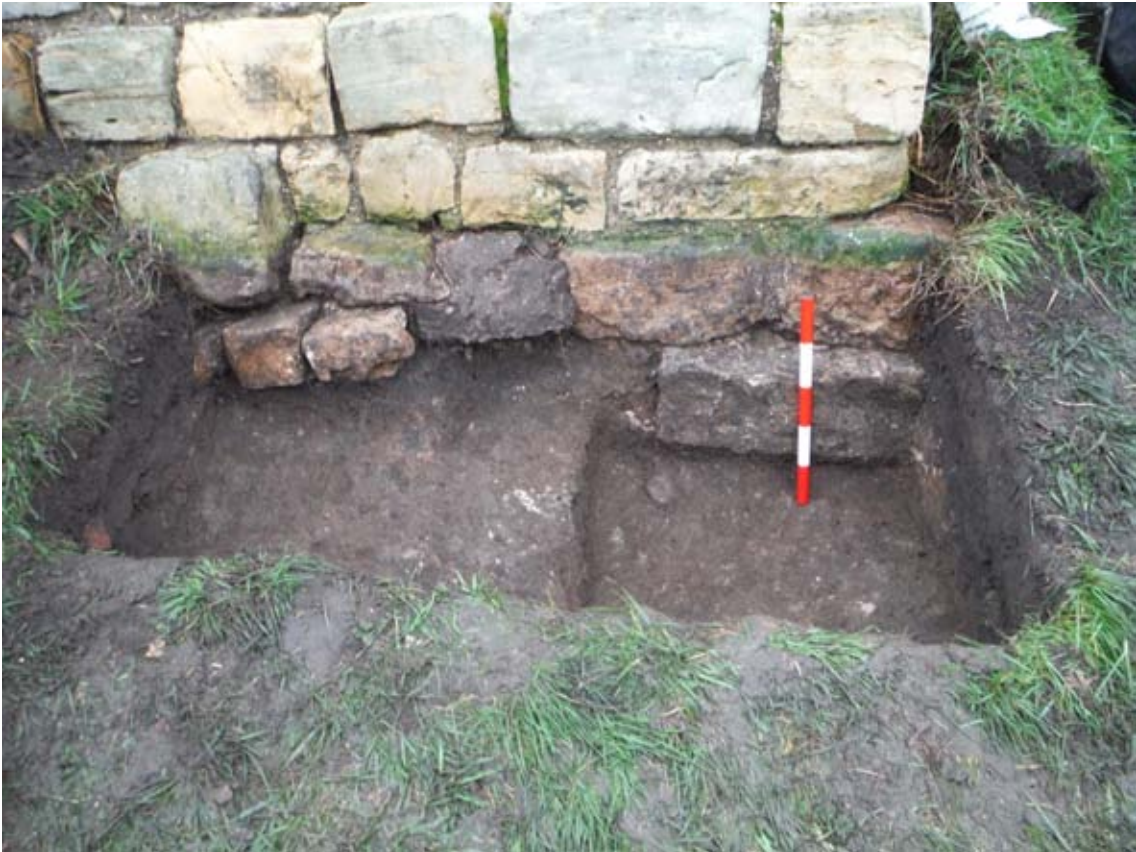
Plate 25. North-east facing view of Section 18, Trial Pit 10 (0.50m scale).

The earliest deposit observed within the trial pit was a layer of firm, mid-brownish grey sandy silt that survived from a maximum height of 11.81m AOD (Context 1004). This deposit was overlain by a layer of firm to friable, mid-orange brown silty clay (Context 1002, Figure 32, Plate 25). These deposits sloped moderately to the south-west and were interpreted as the upper layers of the medieval rampart. **FINDS DETAIL?**

The construction cut for Tower 39 (Context 1006) was the next archaeological context to be identified and followed the same pattern seen in Trial Pits 8 and 9, manifesting as a flat terrace cut into the top of the rampart as opposed to a deep foundation trench. Similarly, the tower wall (Context 901, Figures 32, 33 and 34, Plates 25 and 26) was found to have no true footings with the exception of a single additional piece of ashlar masonry at the very south-east corner set at a depth of 11.78m AOD.

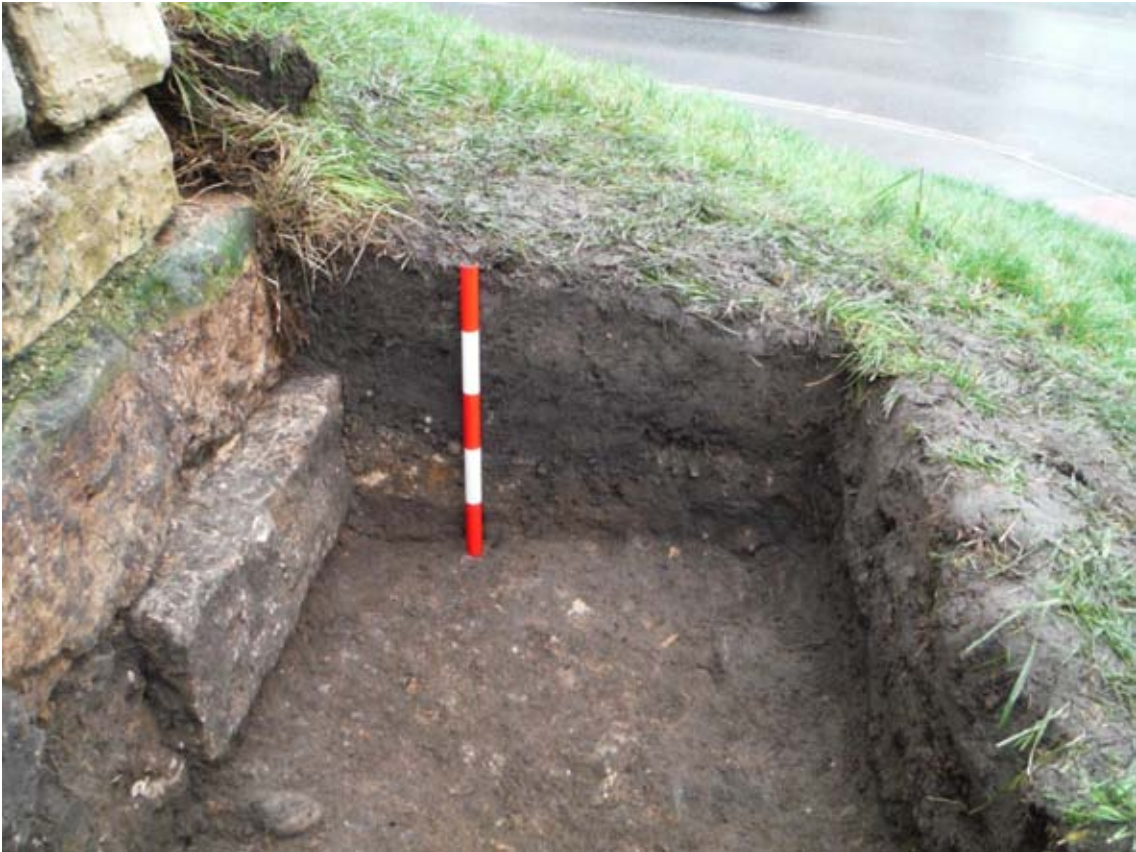
Plate 26. South-east facing view of Section 19, Trial Pit 10 (0.50m scale)

No surviving medieval or post-medieval deposits were found to post-date the tower wall. Instead, a small dump of mortar (Context 1003) and a dump of friable, dark-brownish grey clayey silt (Context 1001) were observed to have been deposited over the rampart layers and against the wall (Figures 33 and 34). Context 1001 was overlain by a patch of concrete that appears to have replaced a missing piece of masonry (Context 1007). These three contexts were interpreted as evidence of 19th/20th century repairs and restoration. The latest excavated deposit in Trial Pit 10 was the present surface of topsoil and turf (Context 1000).

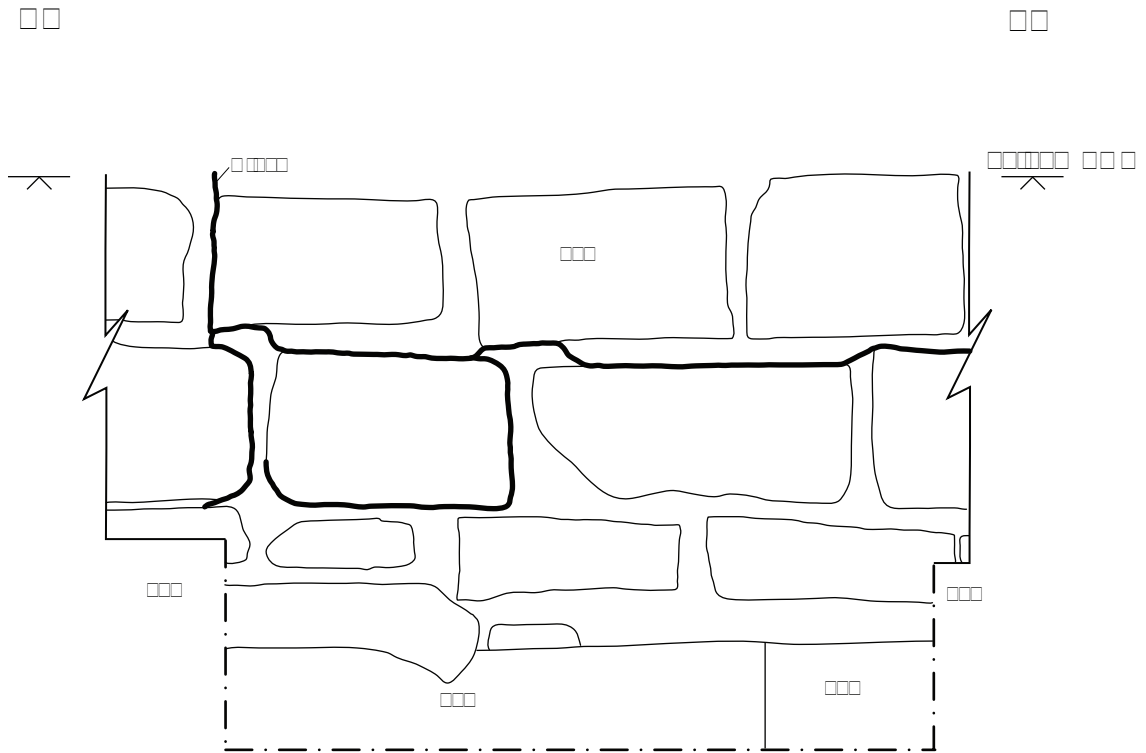
Fig. 06 South West Facing Section of Trial Pit 1 (Section 2)

The stonework of the rear of the tower (Context 103, Figure 6) was exposed to a maximum depth of 16.29m AOD at which point any original footings had been removed and replaced by concrete underpinning that was most likely installed at the same time as the replacement of the roof of Tower 32 in 1950 (RCHMY Vol. 2).

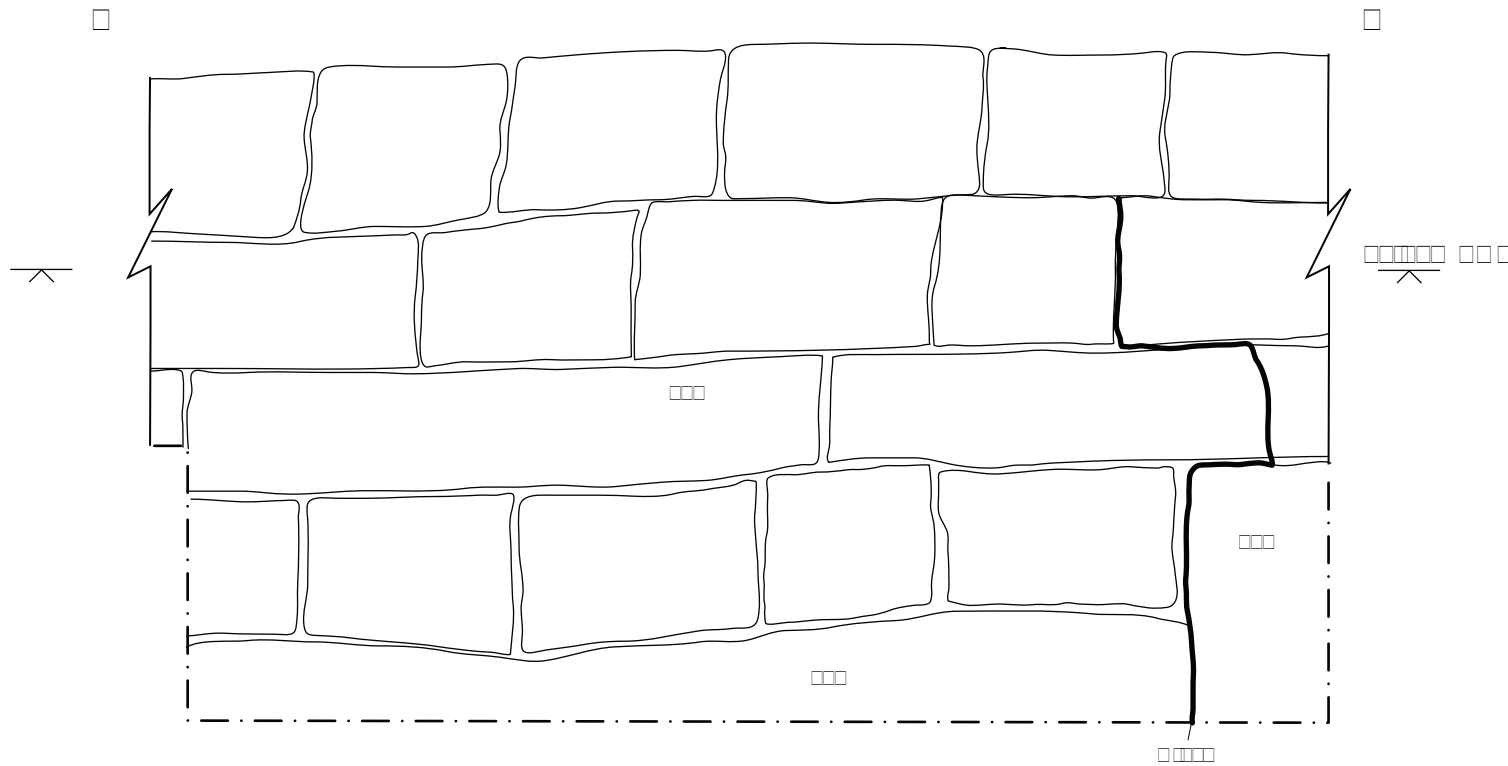
Fig. 12 North North West Facing Section of Trial Pit 3 (Section 5)

During the excavation of Trial Pit 3, it was noted that the crack in the exterior face of the tower corresponds with the change in depth of the concrete underpinning (Figure 12).
