ARCHAEOLOGICAL INVESTIGATIONS AT ST OLAVE'S CHURCH, YORK

WATCHING BRIEF REPORT

Report Number 2017/32 May 2017

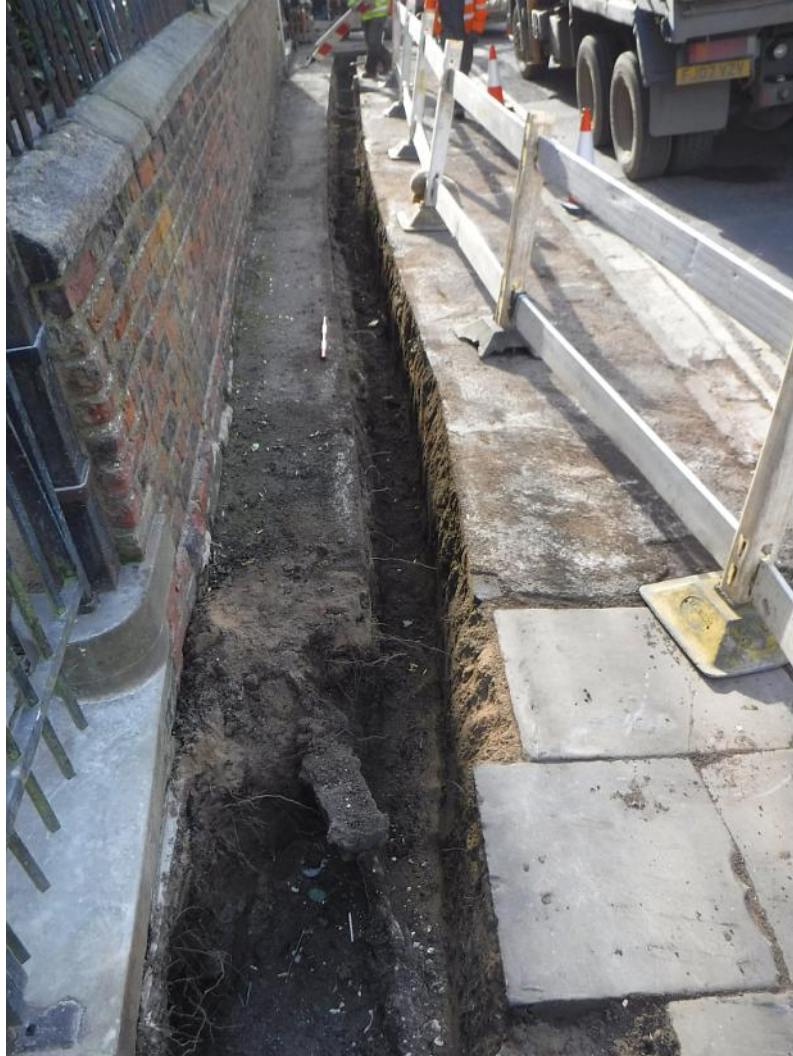
The path drainage channel was dug c.400mm wide with larger chambers at each end for work connecting and turning the drains enclosed (Plate 1). The trench ran between 500-600mm from the church wall itself. Immediately outside the gate, the north-eastern end of the trench, was c.500mm deep, and this fell to c.1m deep at the south-western end (Plate 2).

Plate 1 Drain cut along the footpath, facing southwest, scale unit 100mm

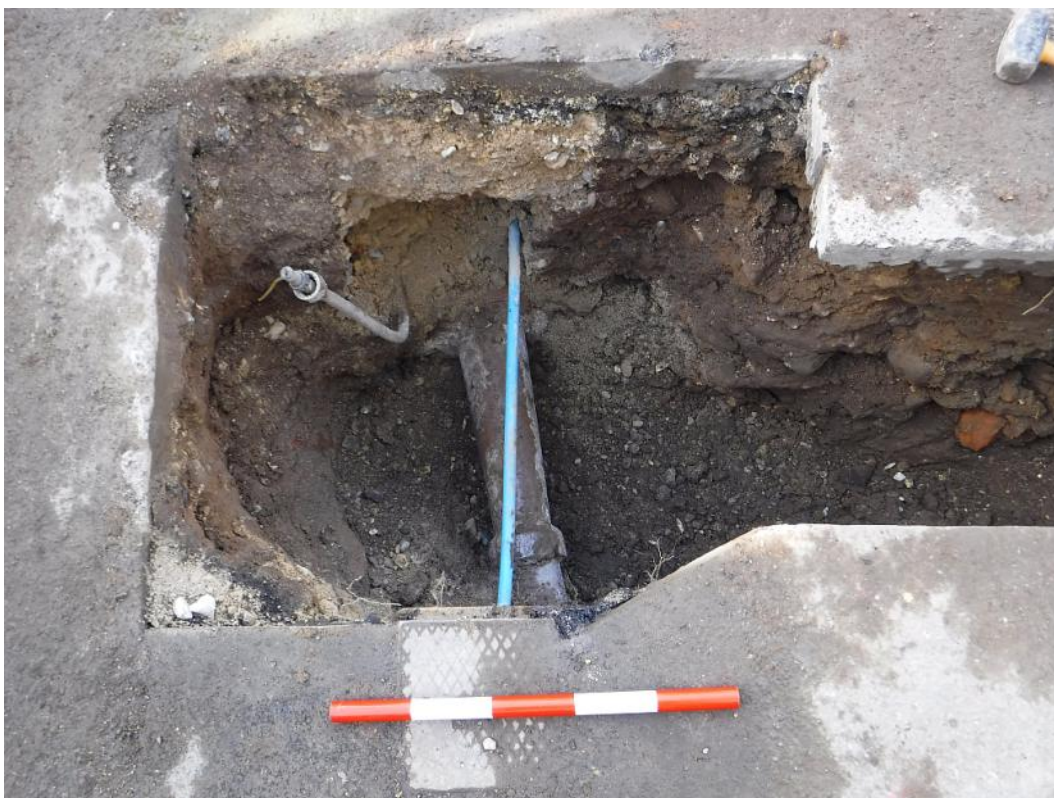
At the south-western end of the trench a small area of cobbles and rubble was observed (Plate 2). However, it was not clear if this was disturbed archaeological deposits or just backfilling from earlier drain/services installation.

Plate 2 South-western end of drain cut, facing northwest, scale unit 100mm

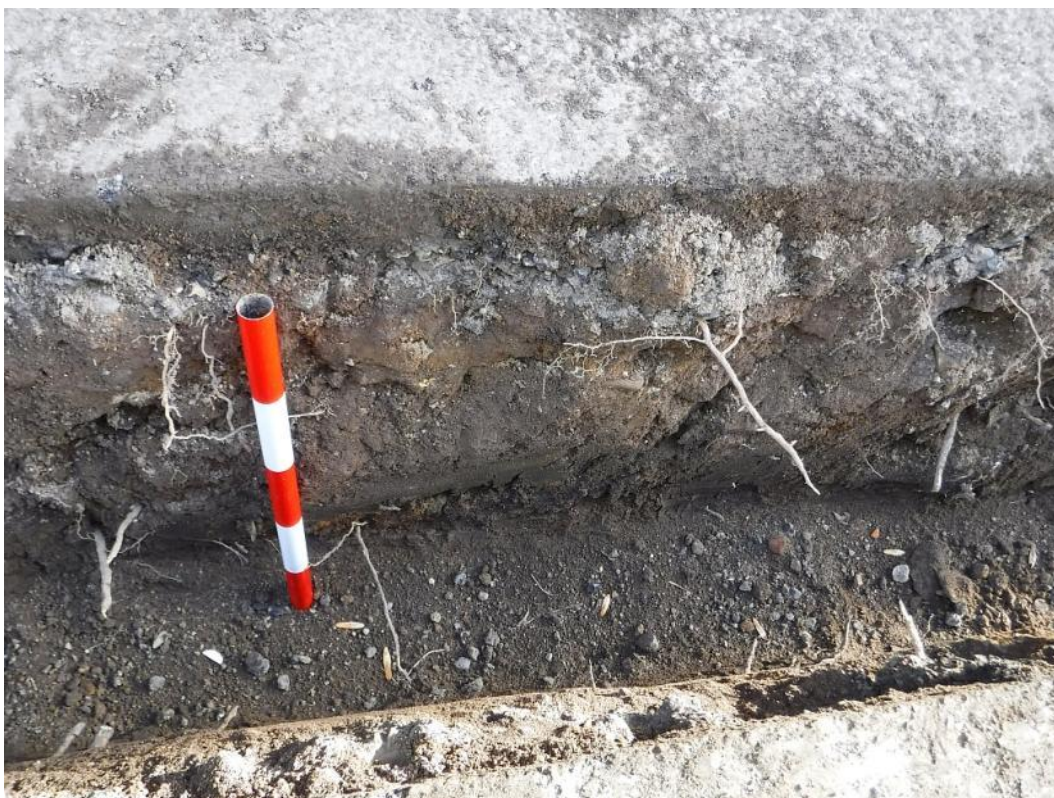
The profile (Plate 3) was typically 150mm of tarmac and base layer. Beneath this a further 200mm of disturbance and bedding for the path was present. Below this the rest of the profile was disturbed mixed deposits with hints of what may have been natural towards the base. Along the whole length of the drain run considerable root activity was present, causing further mixing of the deposits.

Plate 3 Typical drain cut profile, facing northwest, scale unit 100mm

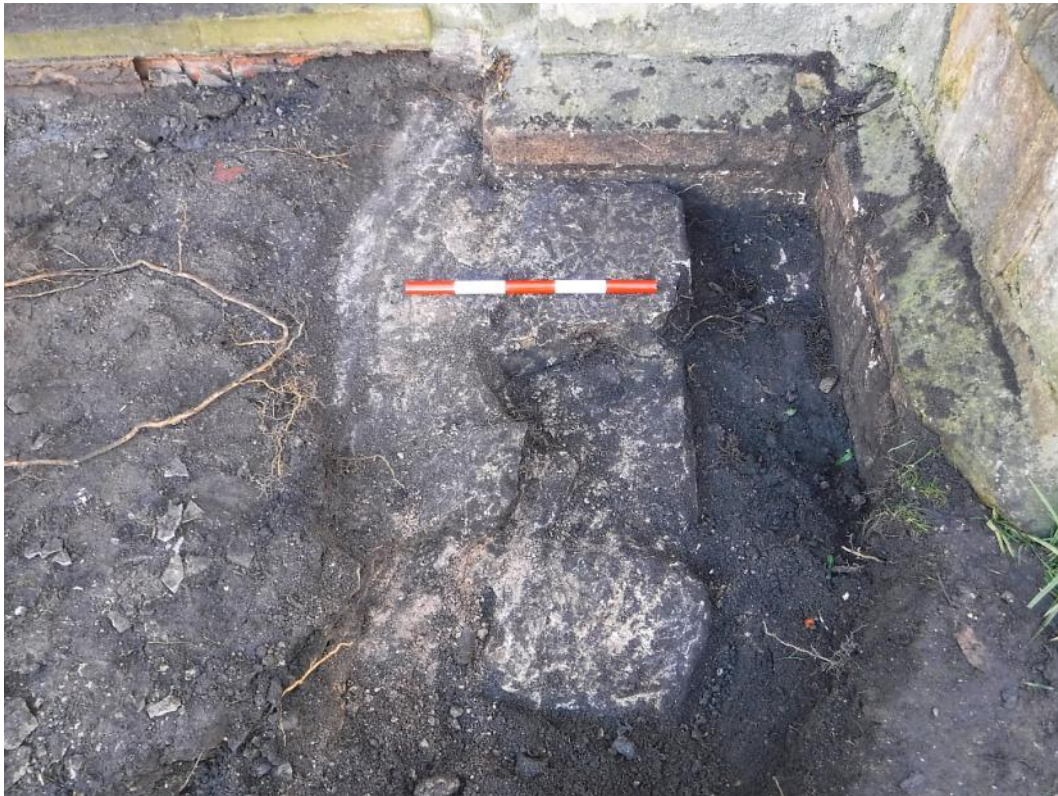
Immediately adjacent to the church wall foundations and footings for the steps and threshold were revealed (Plate 4). These were not investigated further, but perhaps dated to the 18th century renovation of the church. Material which made up a disturbance layer beneath the steps contained material from the 18th century plus small amounts of disarticulated bone.

Plate 4 Footings and foundations for steps and threshold, facing southeast, scale unit 100mm

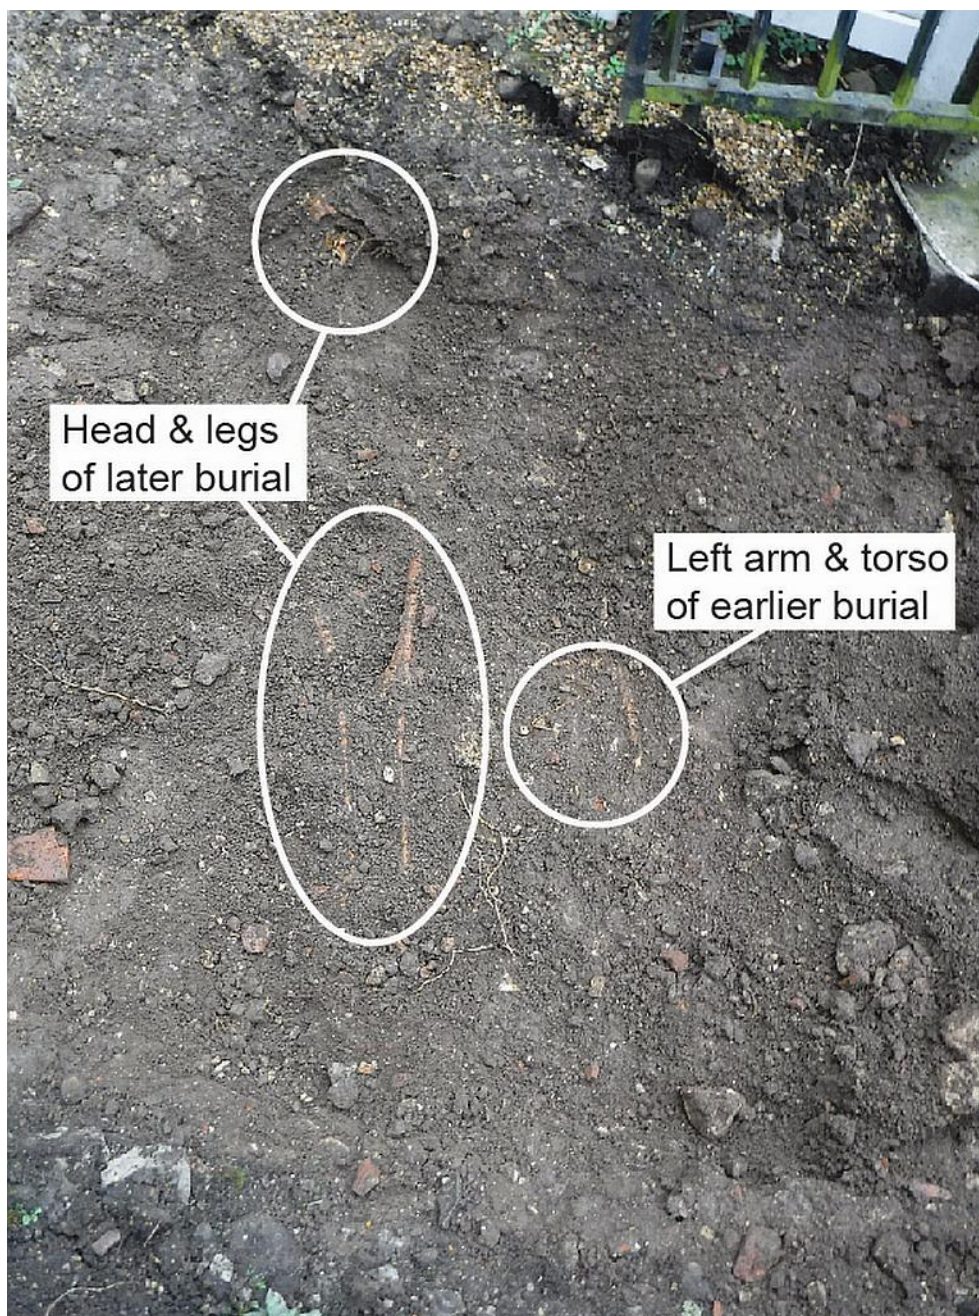
The earliest burial encountered was assumed to be medieval in date. All that survived in the area exposed was a section of the left arm and torso. This had been truncated by a later, post-medieval, burial (see below) to the south-east and the construction of the boundary wall to the north-west.

The later burial was seemingly complete and dated as post-medieval by pottery and an iron coffin handle at the north-east end. This inhumation had been slightly damaged by the installation of the earlier path, with parts of the skull and pelvis being broken. In the backfill a number of other bones had been arranged around the burial; this indicated it had been cut into earlier burials and confirming the disturbance of the earlier inhumation discussed above.

Plate 5 Medieval (right) and post-medieval (left) burials at base of ramp, facing southwest

Both burials were within 100mm of the top of the threshold stone of the gateway. Fortunately, with careful planning, it was possible to alter the design of the footing for the path so that both were left in-situ.

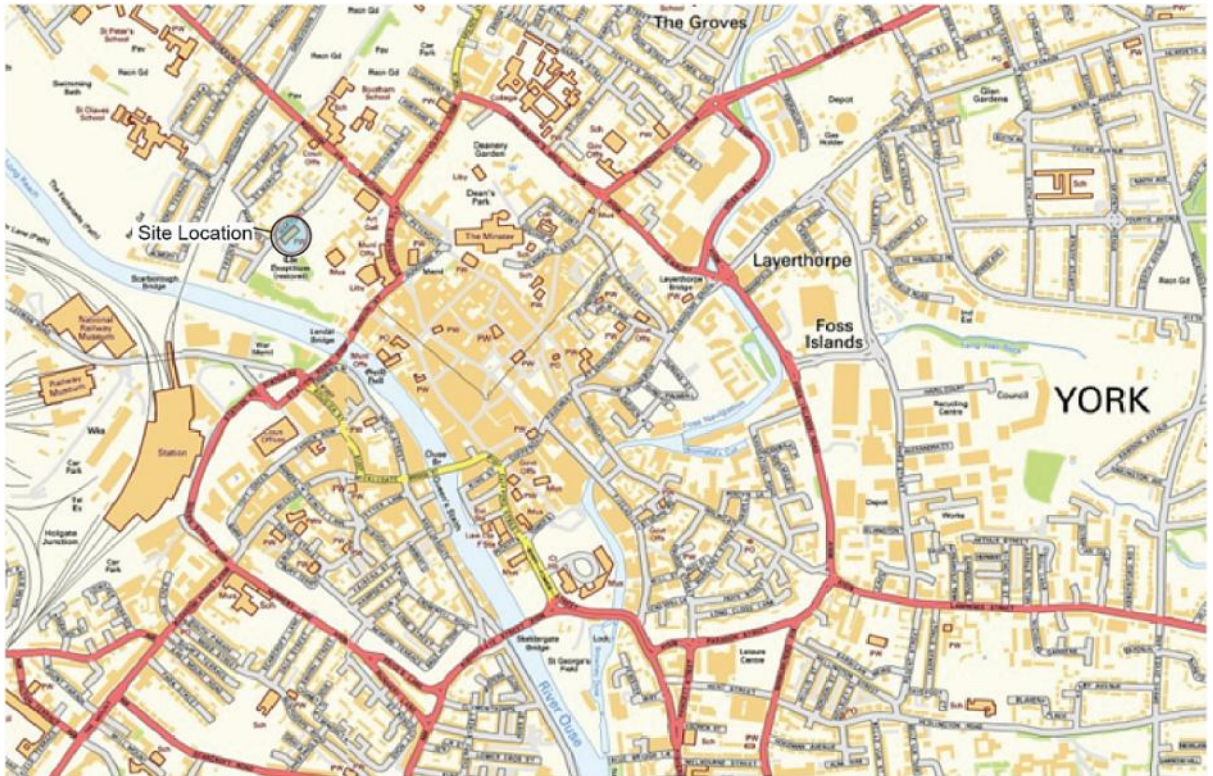
Figure 2 Works Location

The watching brief recorded any archaeological remains exposed during excavations for drains, and the alteration to the steps and a pathway/ramp (Figure 2).
