ARCHAEOLOGICAL INVESTIGATIONS AT BOOTHAM ROW GARAGE, YORK

EVALUATION REPORT

Report Number 2017/42 April 2017

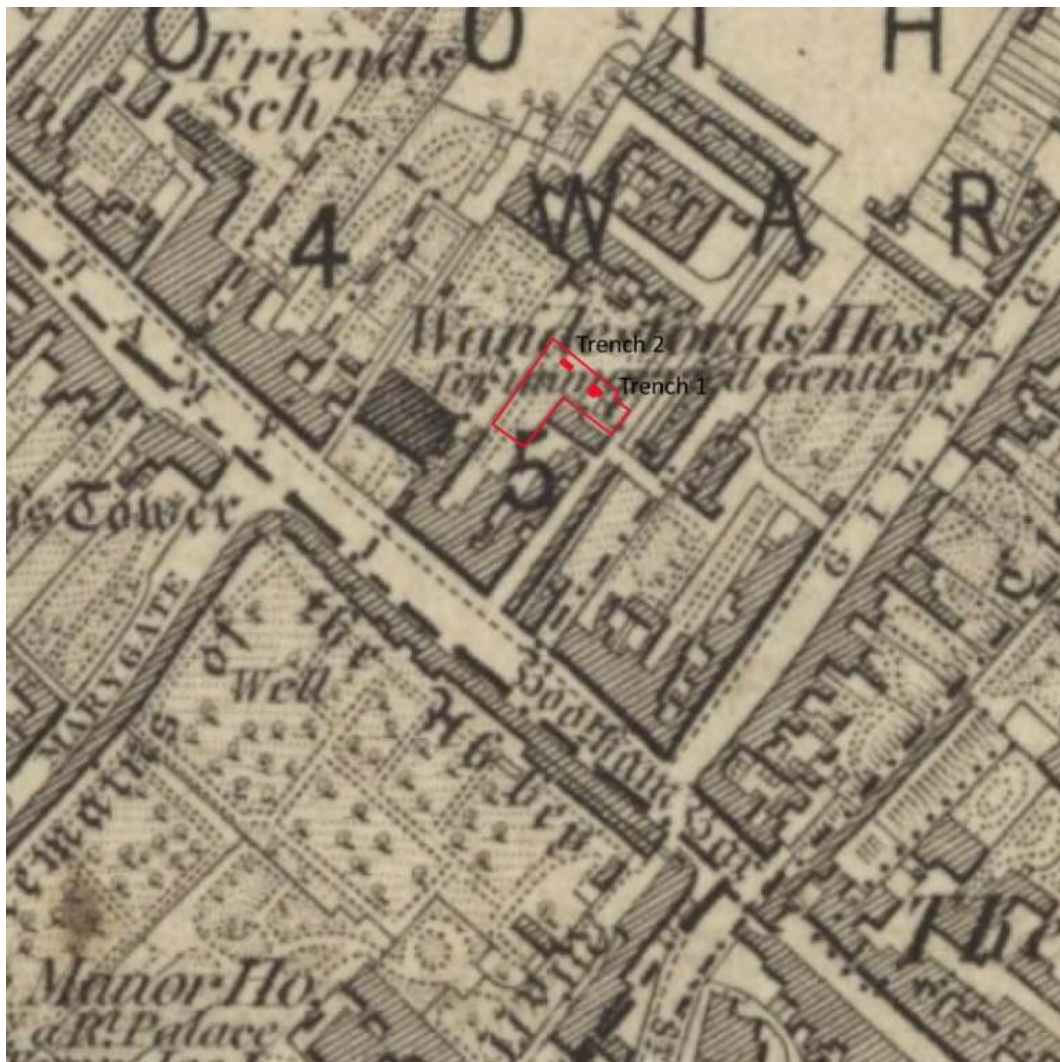
Plate 1: Excerpt from OS map published in 1853 showing trench locations

The 1853 OS map (Plate 1) shows that the majority of the proposed development area lies within gardens located behind properties fronting on to Bootham itself. It is unclear whether some of these gardens belong to the "Wandesford's House (for unmarried gentleman)" which is marked in the area.

The presence of fired clay tobacco pipe and tin glazed earthen ware suggests a date of deposition in the 18th-19th century. As such this deposit may correspond to the yards visible on the 1853 OS map (Plate 1).

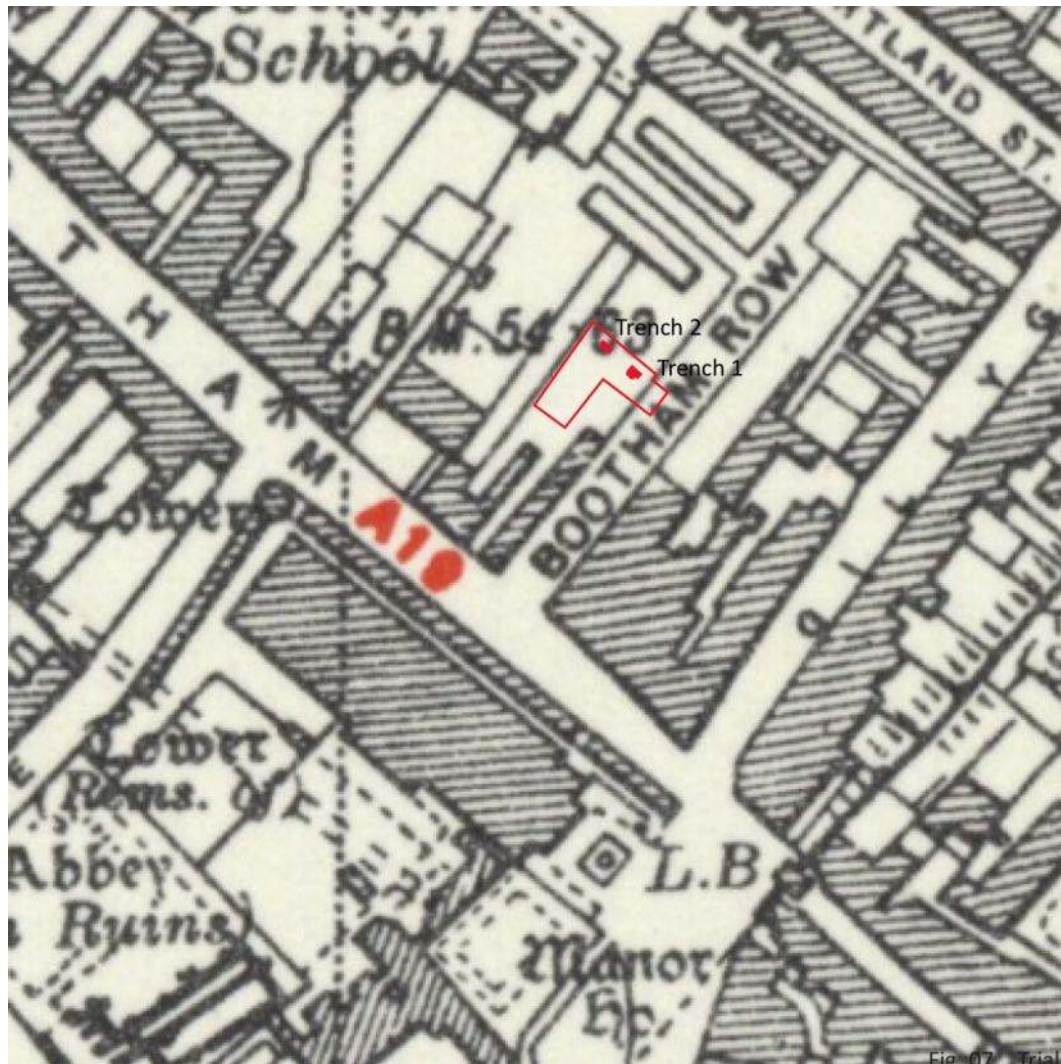
Plate 3: Excerpt from OS map published in 1946 showing trench locations

In contrast, the 1946 OS map (Plate 3) shows a great deal of alteration in the area around Bootham Row. The structure which trench 2 overlay is gone as are several more of the buildings surrounding Bootham Square (which is now a linear cul de sac). It seems that Percy Street does not exist as a separate street in 1946. It is unclear how these apparently cleared areas were then being used.

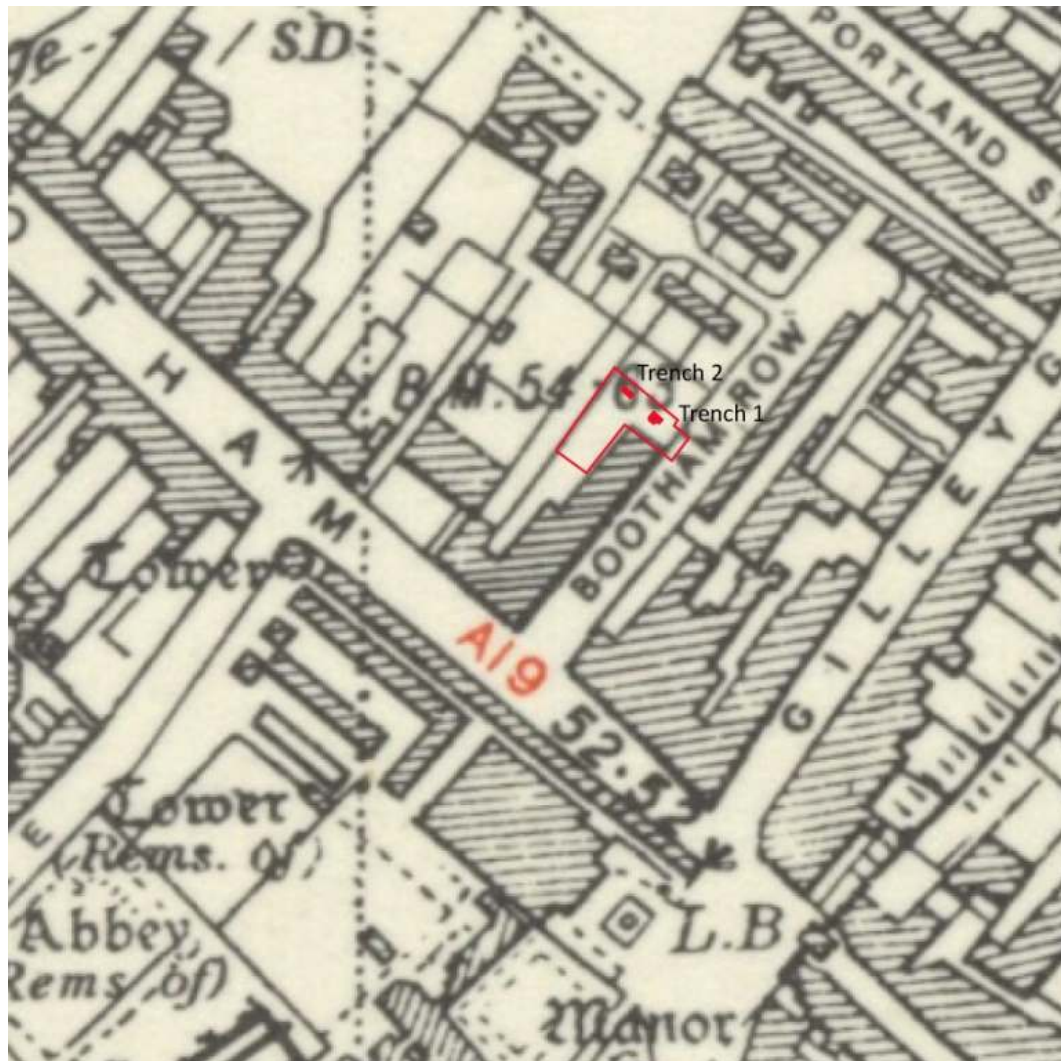
Plate 4: Excerpt from OS map published in 1952 showing trench locations

The OS map of 1952 (Plate 4) shows further development within the area surrounding Bootham Row. The range of buildings which fronted on to Bootham Row from its junction with Bootham has been extended to the north east. A row of structures appears to have been built on the opposite side of Bootham Row leaving a small access road behind them (the last vestige of Percy Street). The area behind the structures fronting on to Bootham remains unlabelled but appears to be yards.

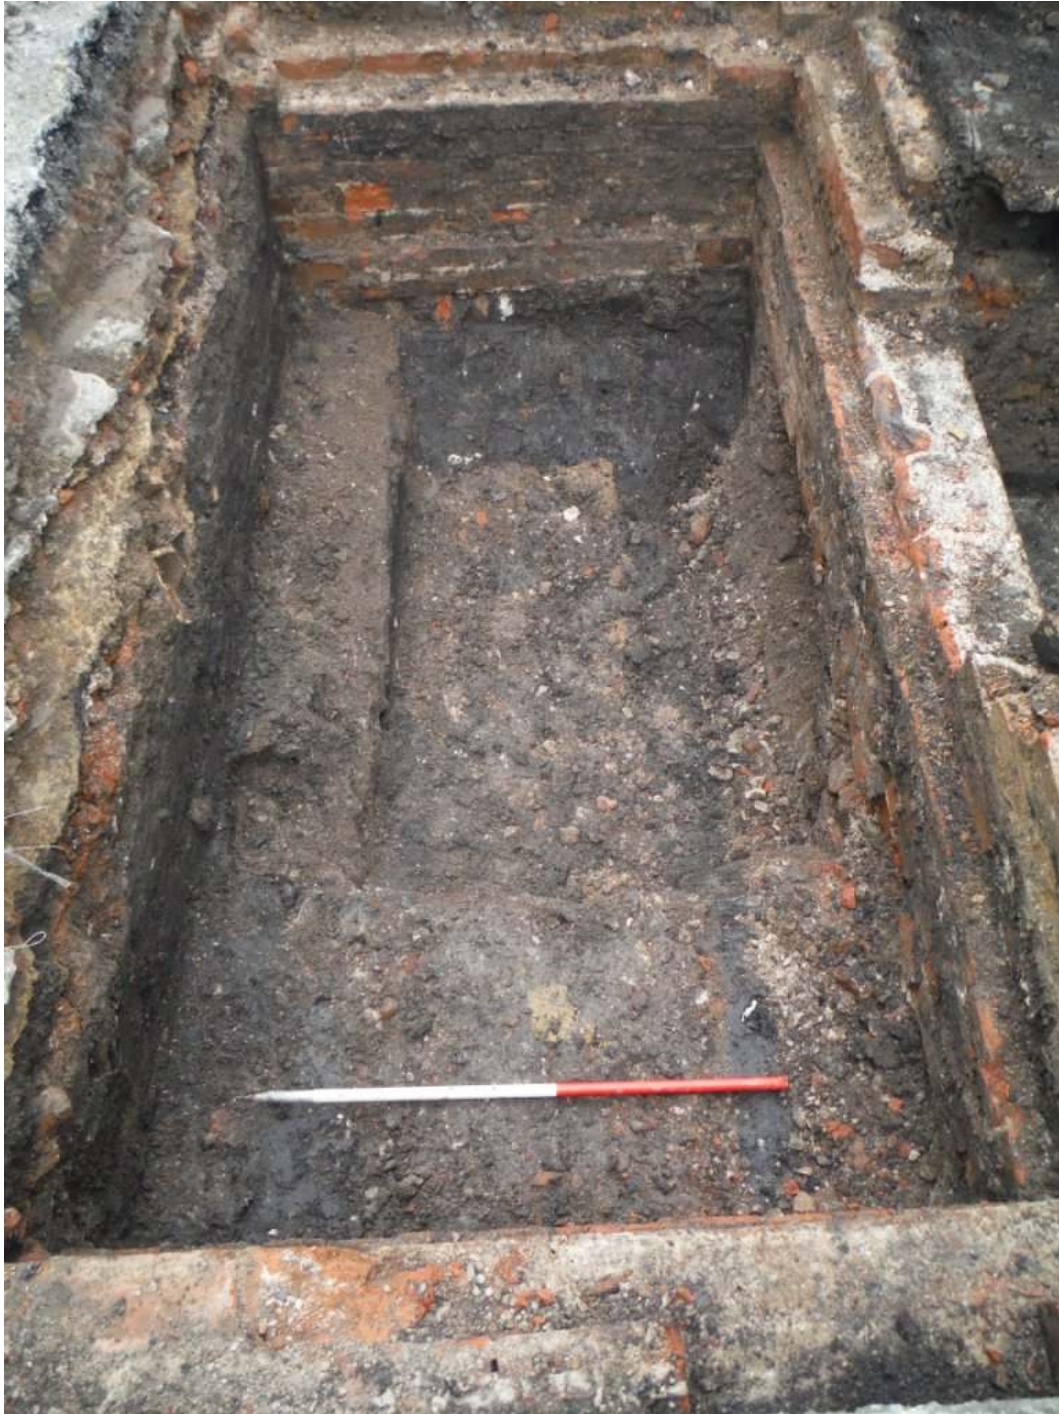
Plate 6: Trench 1, viewed from the north west.

The earliest phase of activity identified in trench 1 was characterised by a thick deposit of dark, clayey silt (contexts 1027 and 1036) which contained far less in the way of inclusions than any of the later deposits. It was truncated by a pair of linear cut features full of demolition material (Plate 6).

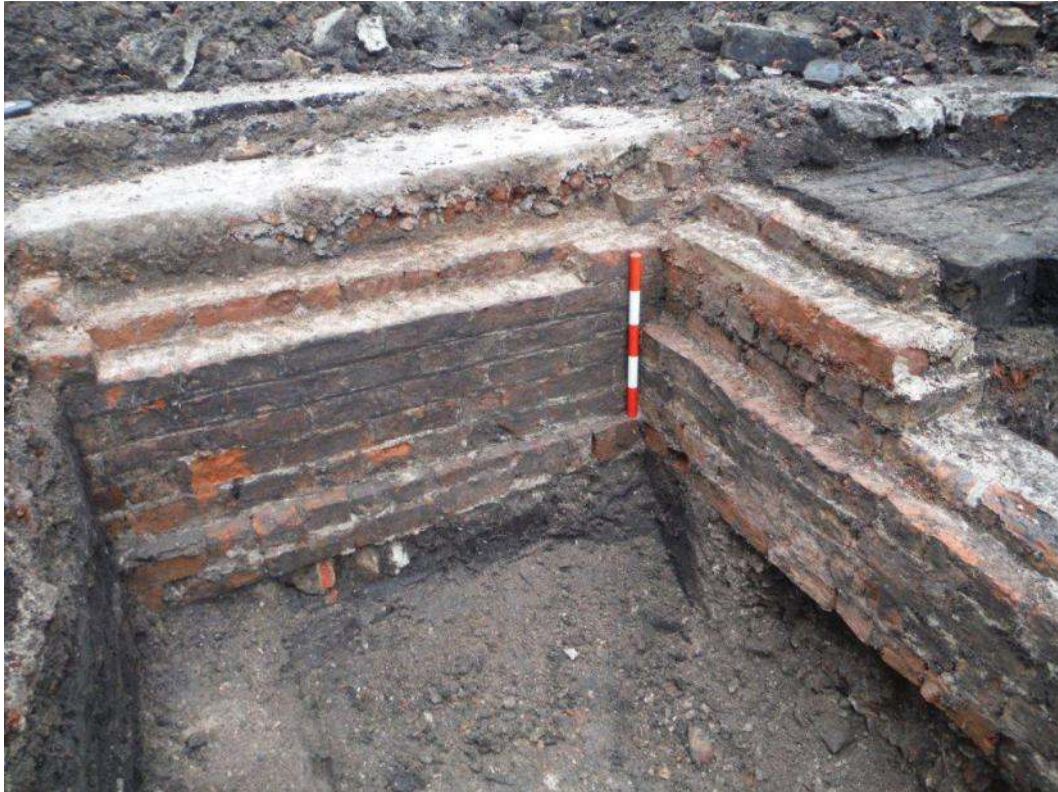
Plate 7: Wall 1031 being butted by wall 1028, viewed from the north.

1034) and was constructed from re-used bricks, some of them dating c.1750-1850. This structure was butted by the later surviving wall (Context 1028, Plate 7).

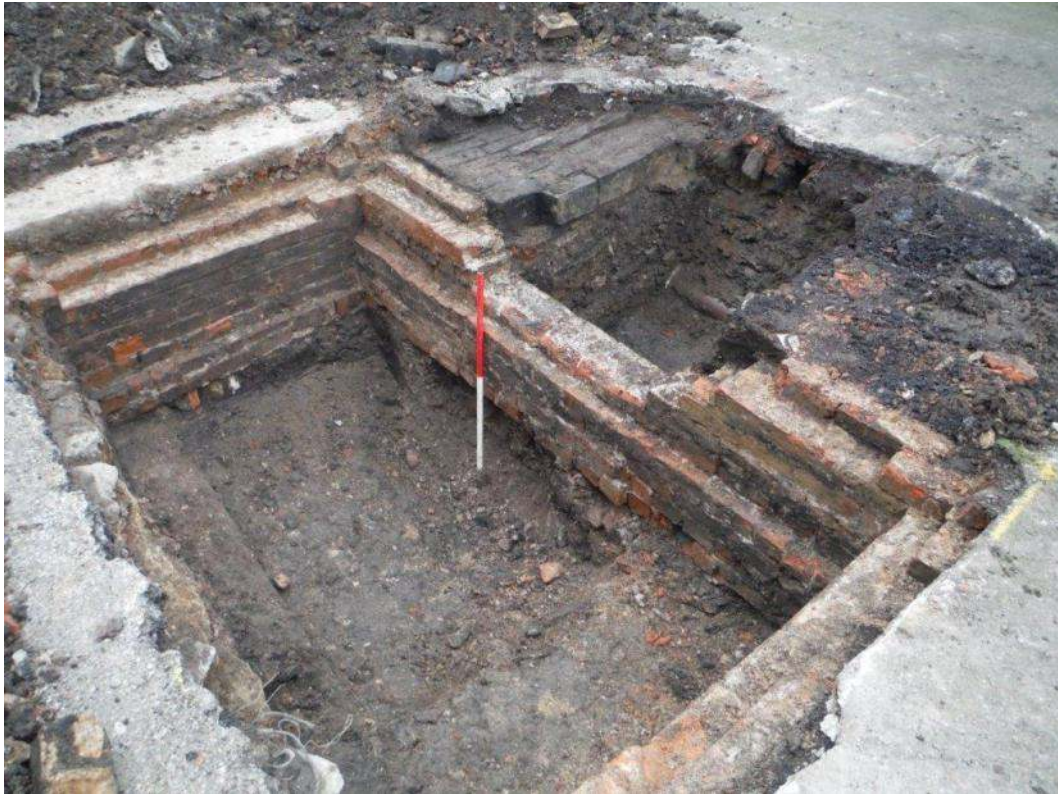
Plate 10: Brick built structure (1028) and associated stone surface (1014), viewed from the north.

This phase includes the construction of the later walls (Context 1028) which butt against the earlier wall (Context 1031). Together these formed a rectangular structure which contained a series of levelling deposits (Contexts 1003, 1004, 1008, 1009 and 1010), a service trench (Cut 1007) and a concrete surface (Context 1002). All of these elements appear to be associated with the use of this structure (Plate 10).

Outside the structure, to the south-west, it appears that a contemporary yard surface was laid. This surface was comprised of dark purplish grey stone sets (Context 1014) bedded in a sandy mortar (Context 1015). This surface overlay the construction backfill for the wall and a service trench containing a salt glazed ceramic pipe (Contexts 1018 and 1019). It seems likely that this drainage system was installed at roughly the same time as the construction of the building.

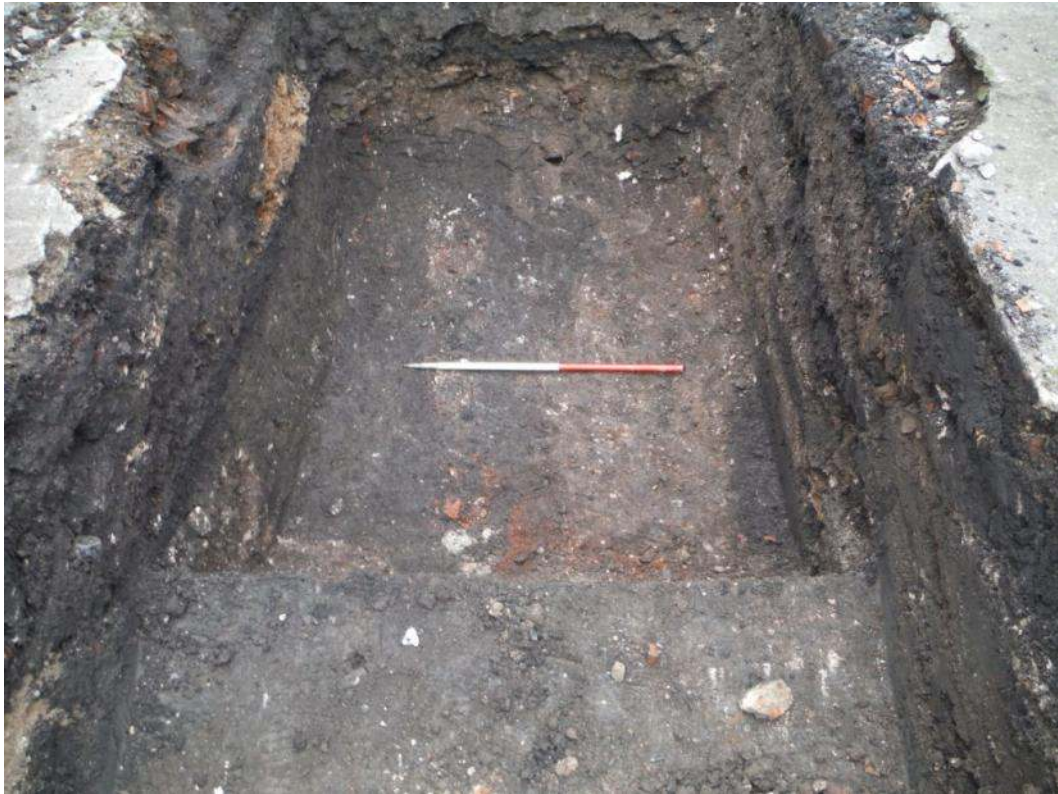
Plate 11: Trench 2, viewed from the north west

The earliest phase of activity identified in trench 1 was characterised by a thick deposit of light brown, silty clay (context 2009) which contained mortar and ceramic building material inclusions. It was truncated by a pair of linear cut features full of demolition material (Plate 11).

Both of the robber backfills were sealed by a make-up deposit (Context 2006) of dark grey, silty clay (Plates 11 and 12). This deposit appears to be a deliberate levelling of the ground immediately after the demolition of whatever the robbed structures were.
