## **ARCHAEOLOGICAL INVESTIGATION ON LAND TO THE REAR OF 27 BOOTHAM, YORK**

*EVALUATION REPORT*

Report Number 2017/54    May 2017

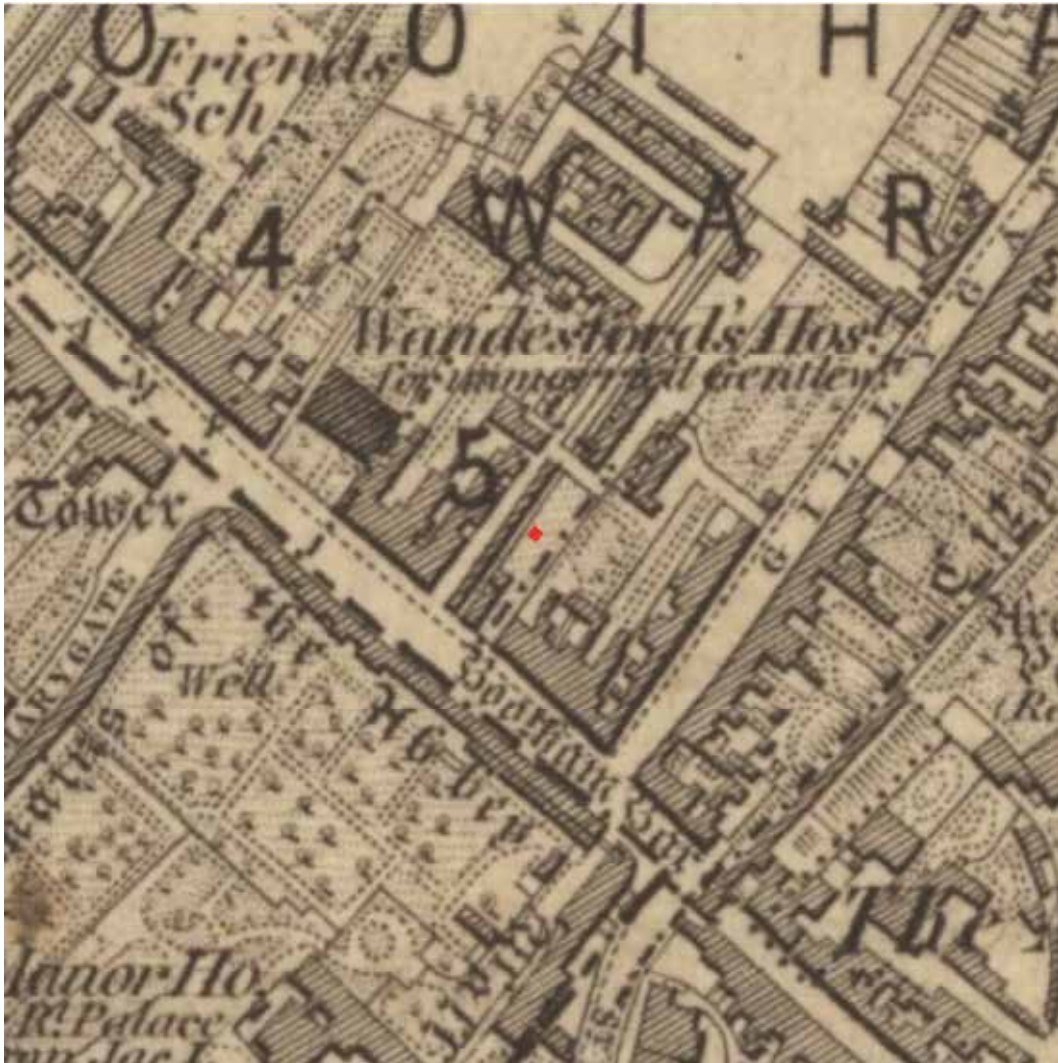
**Plate 1: Excerpt from OS map published in 1853 showing trench location**

The 1853 OS map (Plate 1) shows that the evaluation trench lies within gardens located behind a property fronting on to Bootham. A row of houses that front on to Bootham Row with gardens behind them is visible just to the north west of the evaluation trench. Large parts of the surrounding area appear to be gardens and yards for buildings fronting on to Bootham and Gillygate.

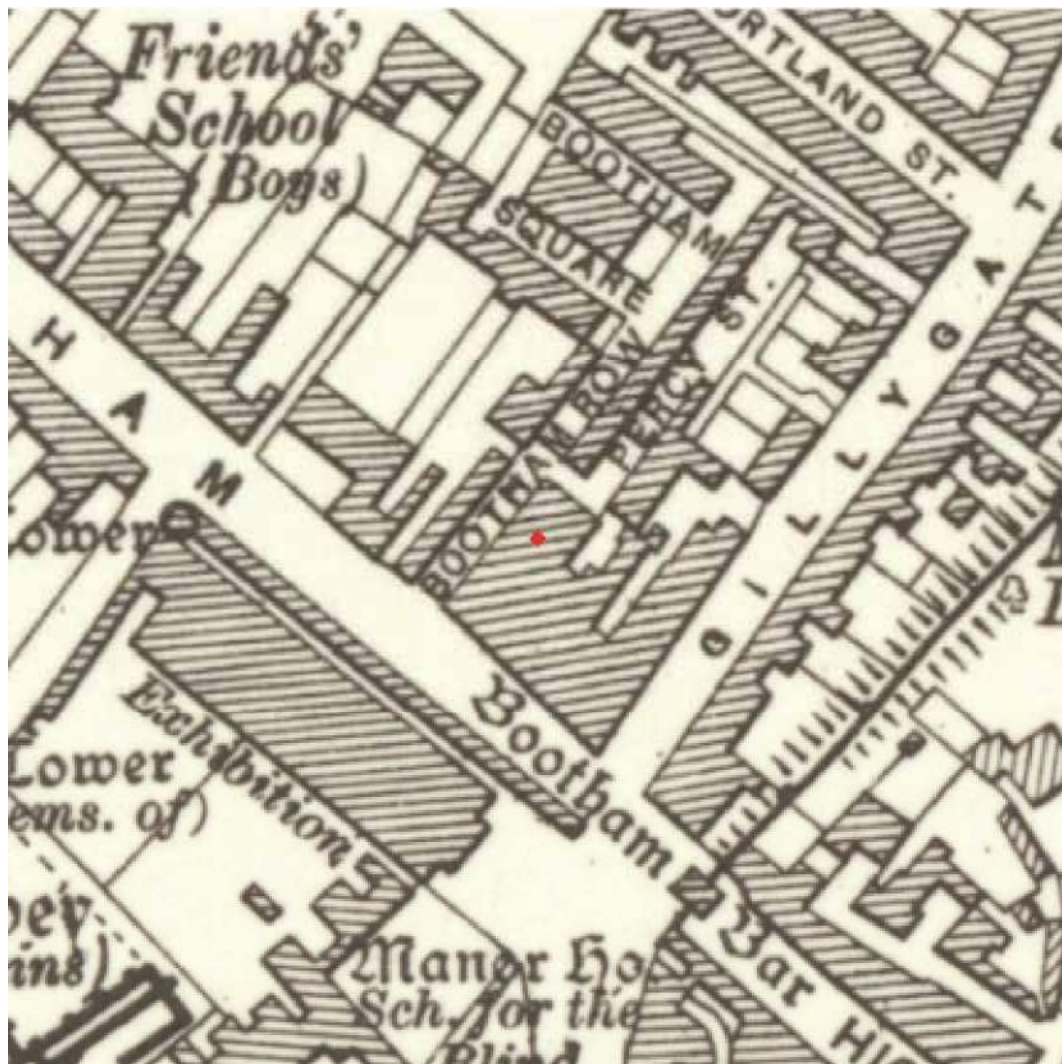
Plate 2: Excerpt from OS map published in 1910 showing trench location

The OS map of 1910 (Plate 2) shows that the area has been completely developed in the period between 1853 and 1910. The trench appears to lie within this completely developed area.

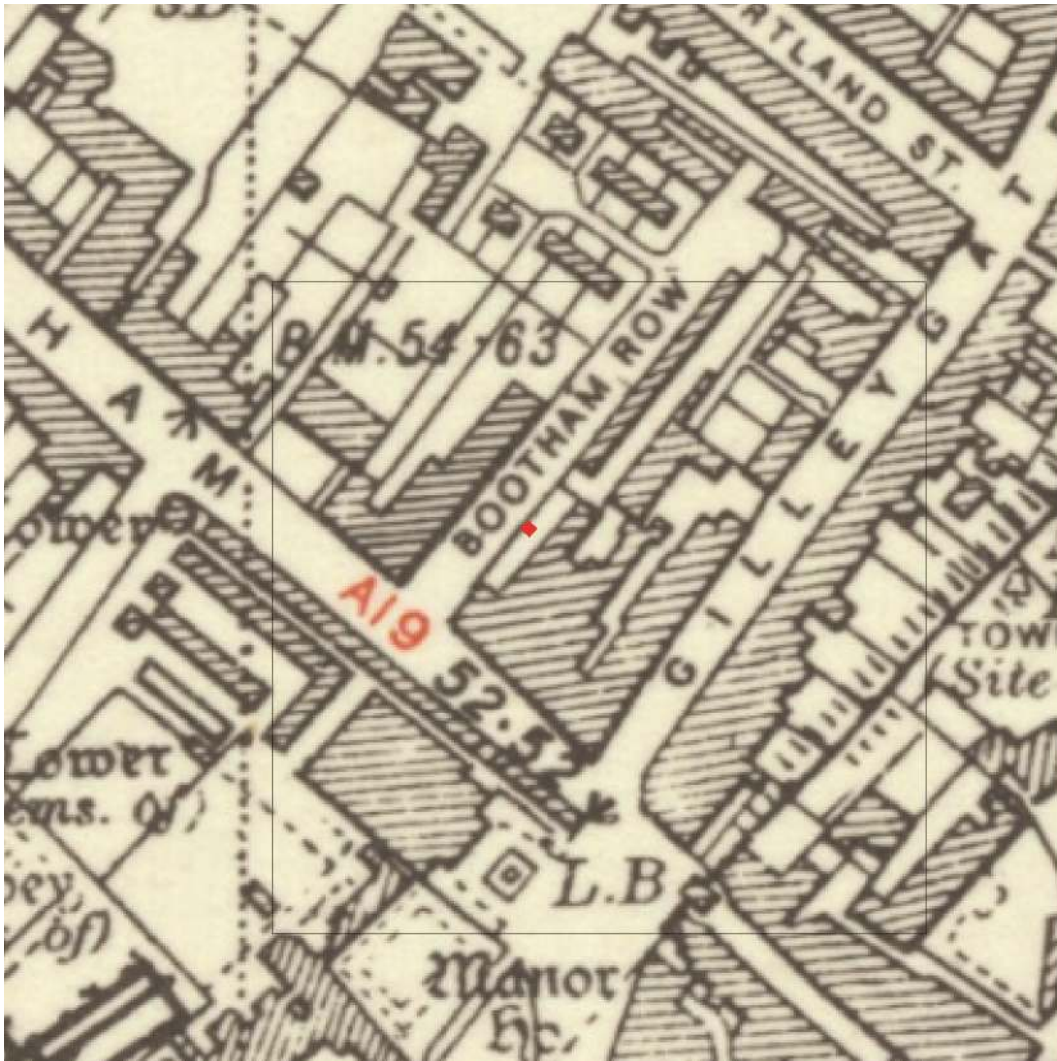
**Plate 4: Excerpt from OS map published in 1952 showing trench locations**

The OS map of 1952 (Plate 4) shows further development within the area surrounding Bootham Row. The range of buildings which fronted on to Bootham Row from its junction with Bootham has been extended to the north east. A row of structures appears to have been built on the opposite side of Bootham Row leaving a small access road behind them (possibly a reestablishment of Percy Street).

The trench appears to be overlaying a cleared space in 1952. It appears that part of the built up area it lay within has been demolished between 1946 and 1952. The layout of the remaining buildings to the south east of the trench appears to be the same.

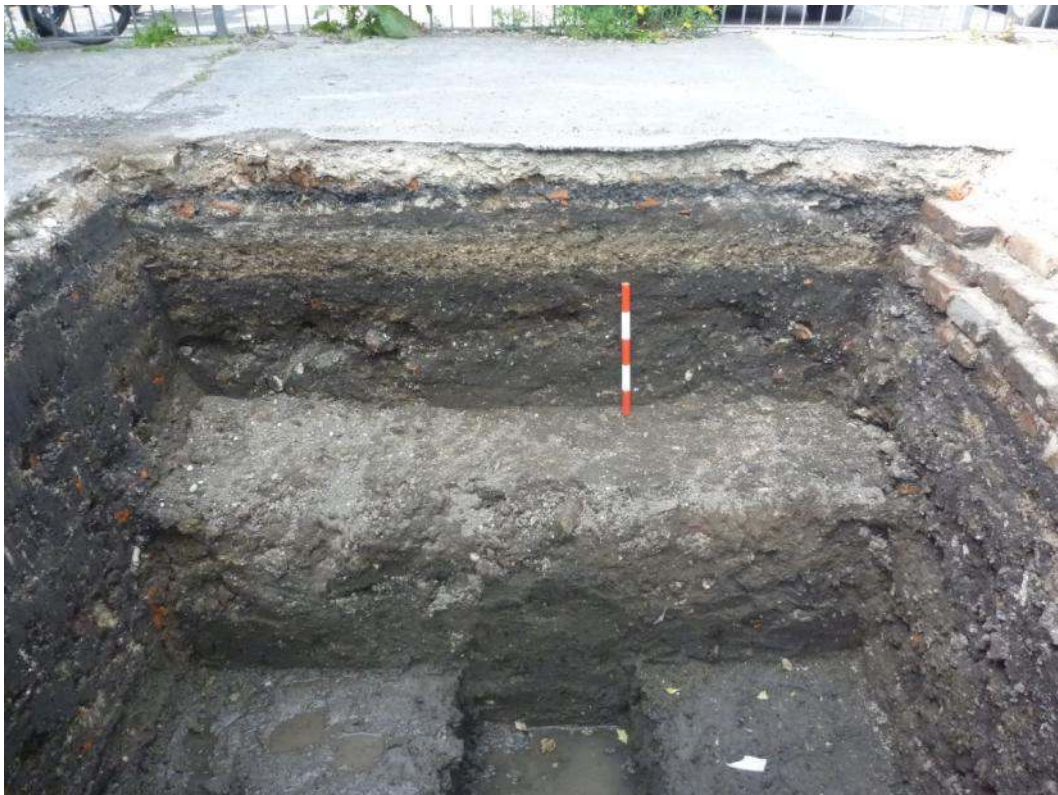
**Plate 6: Evaluation trench section viewed from the south east**

The earliest phase of activity identified in the trench was characterised by a deposit of mid brownish grey, silty clay (contexts 1010) at least 0.7m thick which contained far less in the way of inclusions than any of the later deposits (Plate 6, Figure 4).

The next phase of activity was characterised by a deposit of firm, mid brownish grey, sandy clay (context 1009) up to 0.96m thick which contained a large amount of demolished structural material in the form of CBM fragments and mortar (Plate 6, Figure 4).

These deposits included a layer of compacted white stone (context 1003), a brownish grey clayey sand containing frequent CBM fragments (context 1004) and a layer of compacted gravel (context 1005, Plate 6, Figure 4).

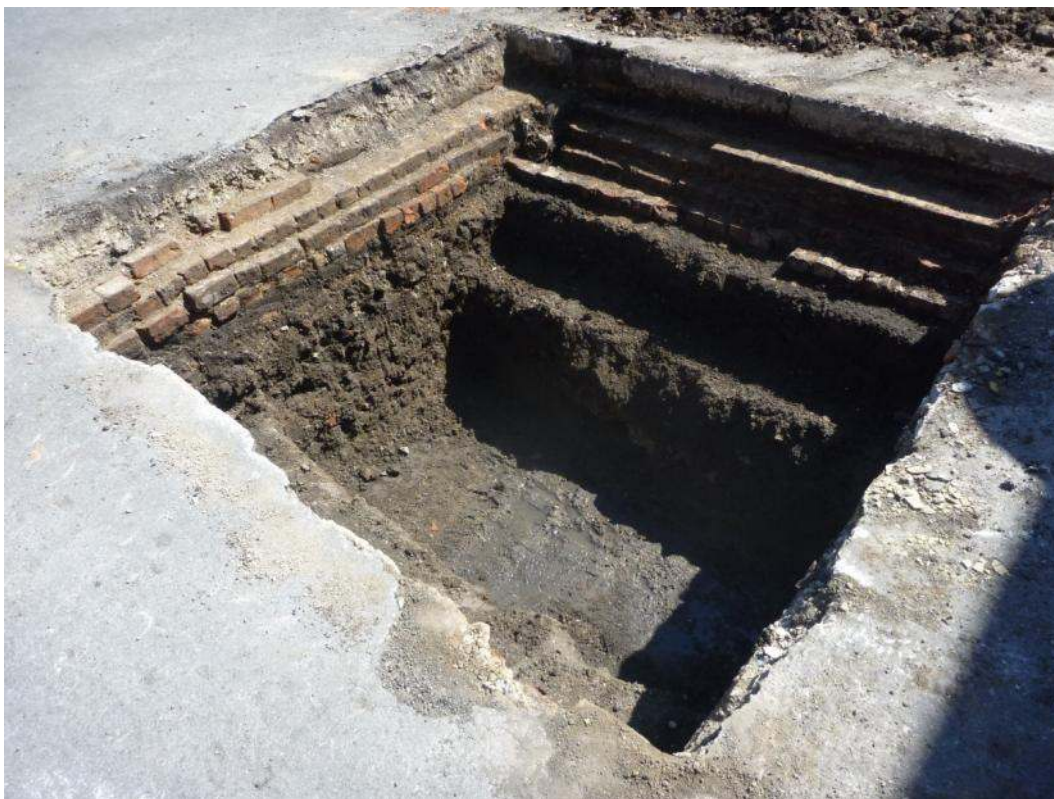
**Plate 7: Evaluation trench viewed from the west**

Two walls (contexts 1008 and 1013) were encountered which ran along both the north eastern and south eastern edges of the trench (Plate 7, Figure 3) respectively. Both walls had spread foundations and were constructed of re-used handmade bricks.

The walls appeared to be contemporary but the relationship between them could not be seen due to truncation by a salt glazed service (context 1011 and 1012). This service appeared to respect the lowest foundation course of both walls and seems likely to have been a modification during the buildings use.
