# YORK ARCHAEOLOGICAL TRUST REPORT

<b>SITE</b>	7 Cumberland Street WB		
<b>CLIENT NAME</b>	Gary Rollinson of Streamline Taxis by York Archaeological Trust		
<b>YAT PROJECT #</b>	5985	<b>YAT REPORT #</b>	2017/63
<b>MUSEUM ACCESSION #</b>	N/A	<b>GRID REFERENCE</b>	SE 60308 51567
<b>PLANNING REFERENCE #</b>	16/01217/FUL	<b>AAI OPS NOTICE #</b>	N/A

Between the 16<sup>th</sup> and 19<sup>th</sup> June 2017 a watching brief took place to record deposits revealed during the excavation of a foundation trench at 7 Cumberland Street, York (Figure 1). The foundations were for a single storey rear extension to the rear of the building, within the area formerly used as a yard.

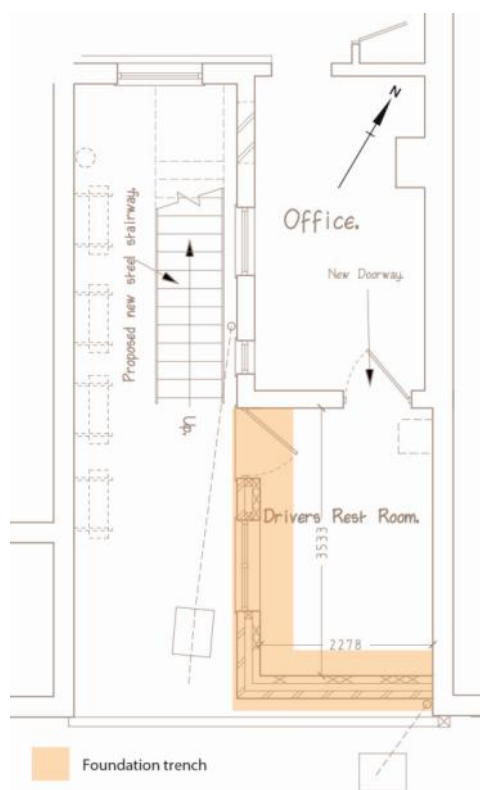
Figure 2 Works Location 1:100 (after drawing 16/01217/FUL 16-1141-2)

See Figure 2 for works location.

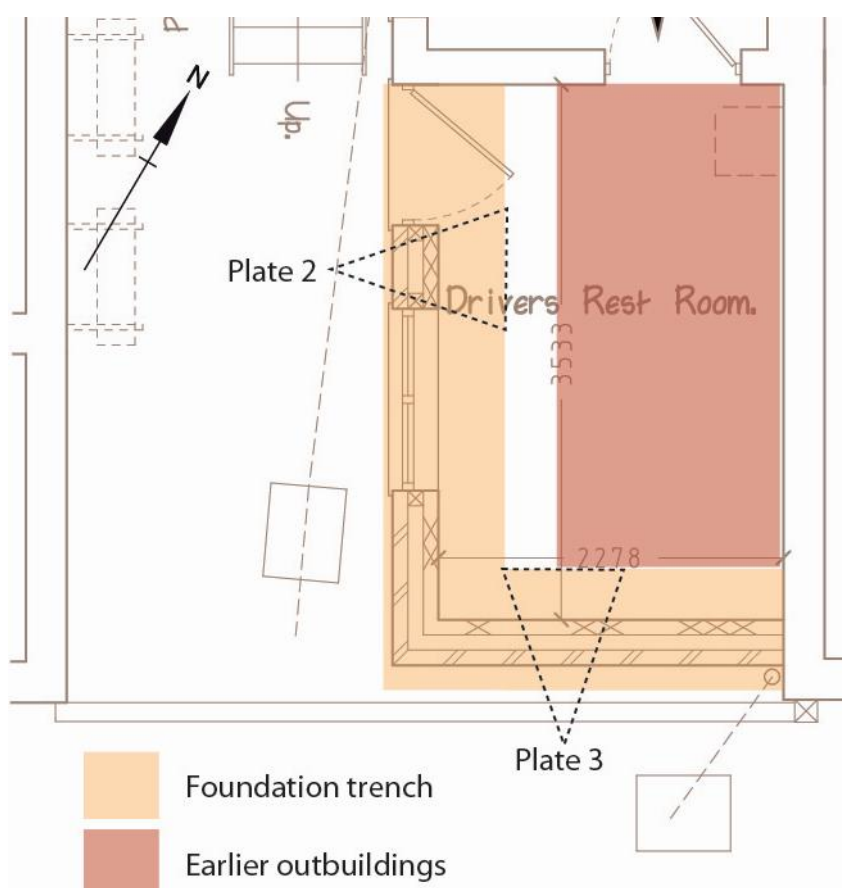
Figure 3 Results Location 1:50 (after drawing 16/01217/FUL 16-1141-2)

The location of images and other elements can be seen in Figure 3.

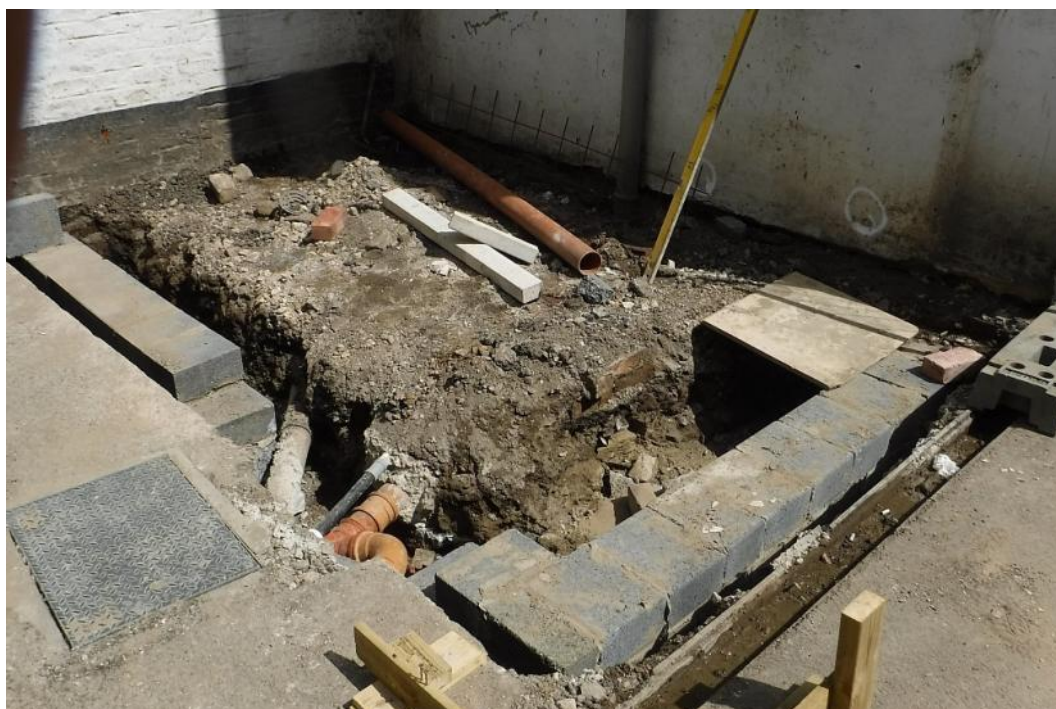
The foundation trench was approximately 800mm wide and 900mm deep (Plate 1). For the remainder of the development area ground reduction was only c.200mm, and therefore only penetrated into modern makeup deposits for the former yard.

As can be seen in Plate 1 there were also significant truncations from a rainwater and soil pipe entering an inspection chamber to the south-west of the trench.

Plate 1 Foundations, facing north

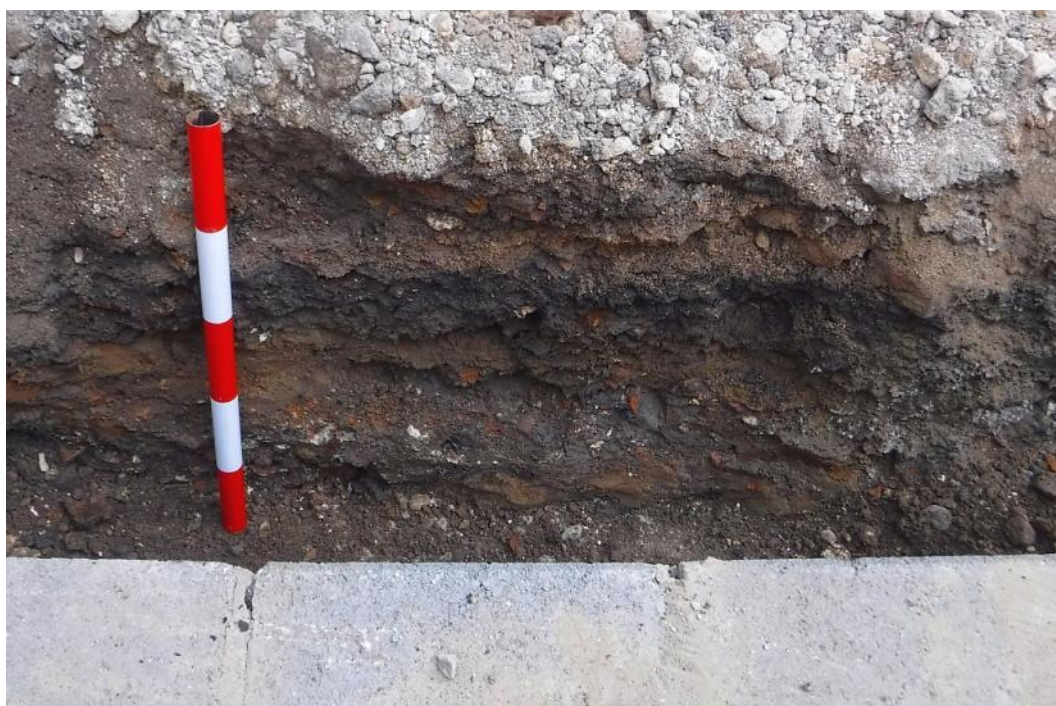
The earliest deposit encountered was seen along the south-west foundation cut, between 900 and 500mm BGL. This was firm clay with mortar and rubble, becoming more frequent towards the top (Plates 2 & 3). This was interpreted as being ground formation linked to the construction of the original buildings in this area.

Plate 2 South-west side of foundation trench, facing northeast, scale unit 100mm

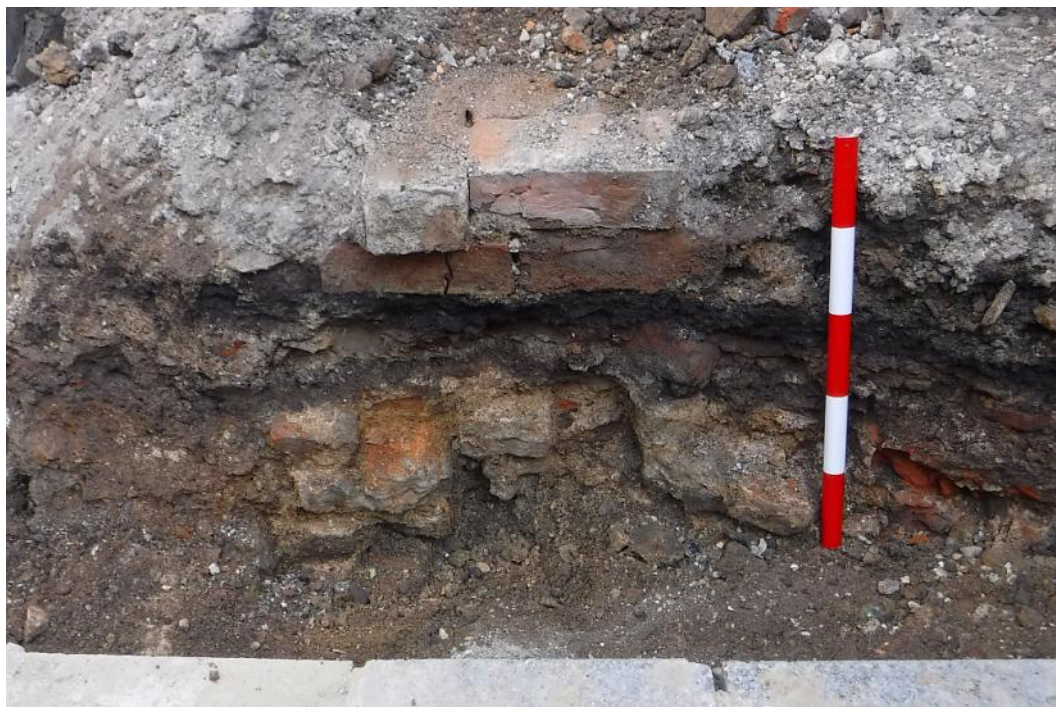
At potentially the same time this was deposited, or at least very soon afterwards, a wall footing was built. This is visible in Plate 3 and appeared to run to the north-west, on the same alignment as the current buildings. To the north-east of this footing was rubble infilling, which may have acted as the makeup for flooring within any structure. The first edition Ordnance Survey mapping of 1852 indicates outhouses or similar in this location, which would correlate with the size of bricks used in this structure.

**Plate 3 South-east side of foundation trench, facing northwest, scale unit 100mm**

On the same alignment, and in a very similar position, as the earlier wall described above, another wall was then created. This can be clearly seen in Plate 3. Again this will have related to outhouse structure in the yard and a scar from the roofing can still be seen on the extant wall to the north-west.
