YORK ARCHAEOLOGICAL TRUST REPORT

SITE	7 Cumberland Street WB		
CLIENT NAME	Gary Rollinson of Streamline Taxis by York Archaeological Trust		
YAT PROJECT #	5985	YAT REPORT #	2017/63
MUSEUM ACCESSION #	N/A	GRID REFERENCE	SE 60308 51567
PLANNING REFERENCE #	16/01217/FUL	AAI OPS NOTICE #	N/A

Between the 16th and 19th June 2017 a watching brief took place to record deposits revealed during the excavation of a foundation trench at 7 Cumberland Street, York (Figure 1). The foundations were for a single storey rear extension to the rear of the building, within the area formerly used as a yard.

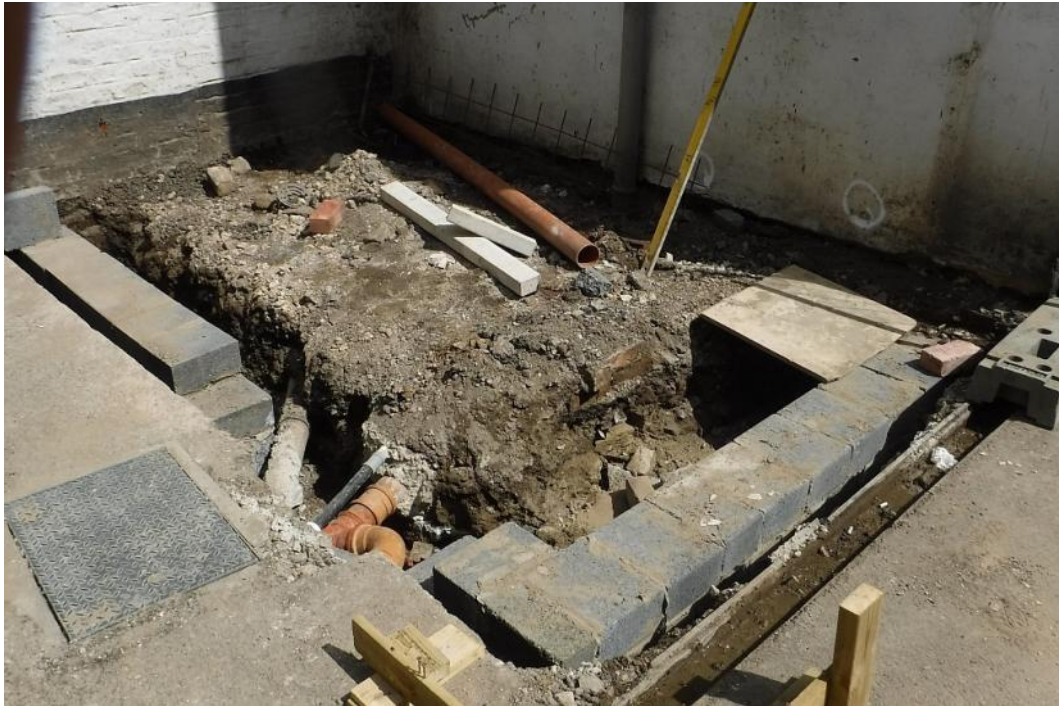
The foundation trench was approximately 800mm wide and 900mm deep (Plate 1). For the remainder of the development area ground reduction was only c.200mm, and therefore only penetrated into modern makeup deposits for the former yard.

As can be seen in Plate 1 there were also significant truncations from a rainwater and soil pipe entering an inspection chamber to the south-west of the trench.

Plate 1 Foundations, facing north

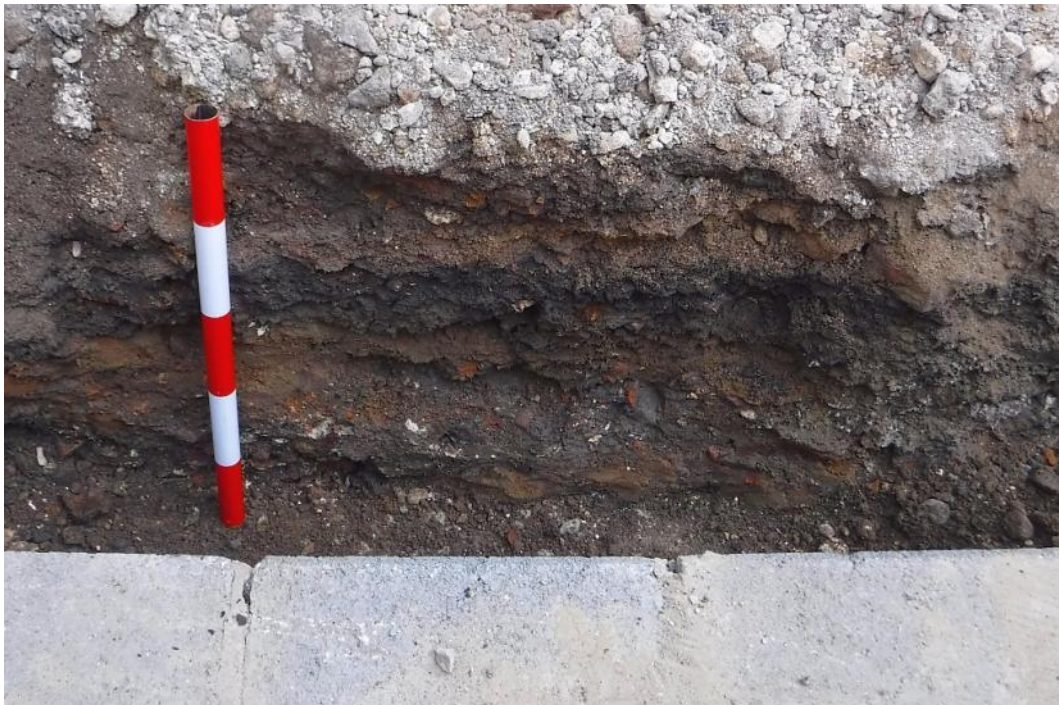
The earliest deposit encountered was seen along the south-west foundation cut, between 900 and 500mm BGL. This was firm clay with mortar and rubble, becoming more frequent towards the top (Plates 2 & 3). This was interpreted as being ground formation linked to the construction of the original buildings in this area.

Plate 2 South-west side of foundation trench, facing northeast, scale unit 100mm

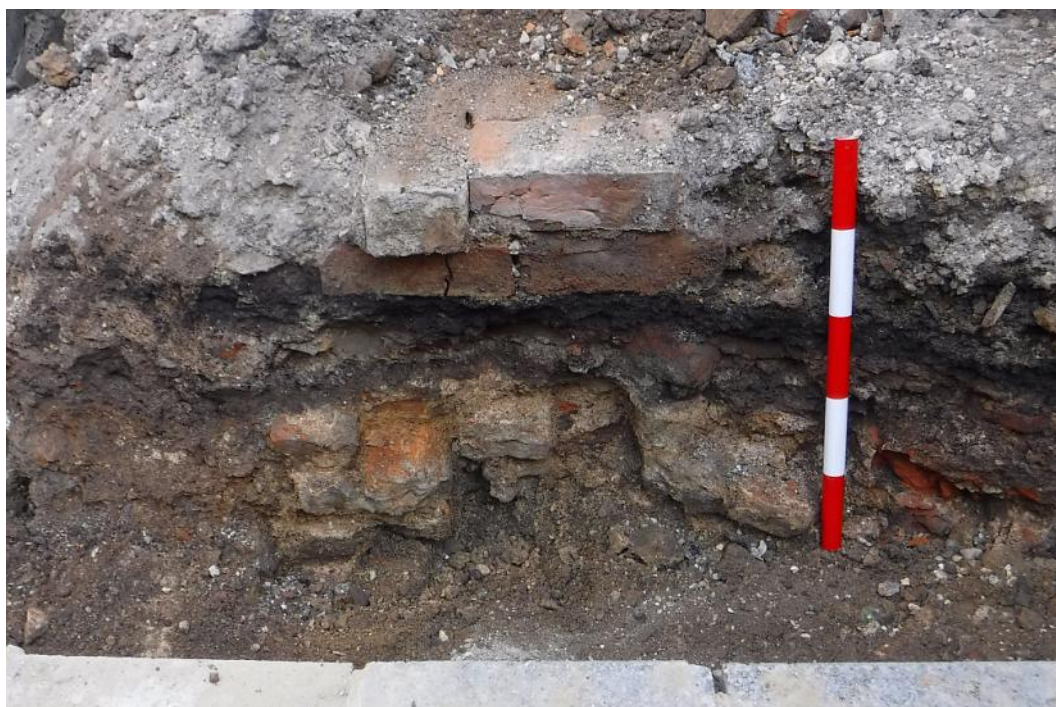
At potentially the same time this was deposited, or at least very soon afterwards, a wall footing was built. This is visible in Plate 3 and appeared to run to the north-west, on the same alignment as the current buildings. To the north-east of this footing was rubble infilling, which may have acted as the makeup for flooring within any structure. The first edition Ordnance Survey mapping of 1852 indicates outhouses or similar in this location, which would correlate with the size of bricks used in this structure.

Plate 3 South-east side of foundation trench, facing northwest, scale unit 100mm

On the same alignment, and in a very similar position, as the earlier wall described above, another wall was then created. This can be clearly seen in Plate 3. Again this will have related to outhouse structure in the yard and a scar from the roofing can still be seen on the extant wall to the north-west.
