SITE ADDRESS	Unit 3 St Maurice's Road, York					
CLIENT NAME	SMR Limited					
YAT PROJECT#	5963	5963 <b>YAT REPORT #</b> 2017/30				
MUSEUM ACCESSION #	N/A	GRID REFERENCE	SE 60620 52217			
PLANNING REFERENCE #	AOD/16/00424 & 16/01698/FUL

### Introduction

Between the 1<sup>st</sup> and 6<sup>th</sup> March 2017 a watching brief took place during the excavation of a combined utility trench in the yard and car park of Unit 3 St Maurice's Road, York (Figure 1).

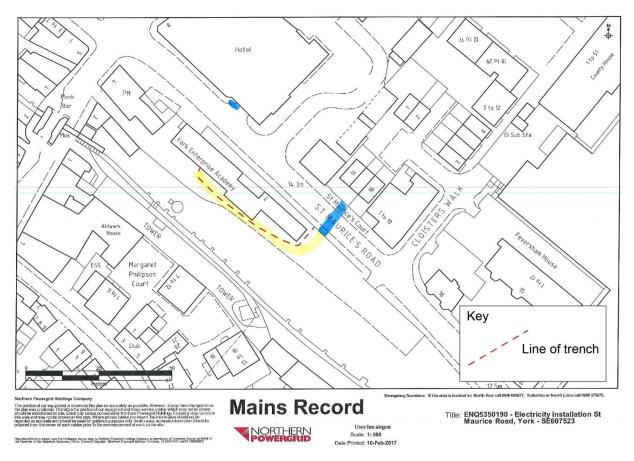
Figure 2 Works Location
After AIA ops notice 20170210103955617

The trench for the combined services was 600mm wide and 750mm deep. The tarmac and solid surfaces were cut with a Stihl saw and a hydraulic breaker was used to loosen firm deposits below. Following this trench was excavated using a small 360° tracked excavator and shovels where appropriate. See Figure 2 for works location.

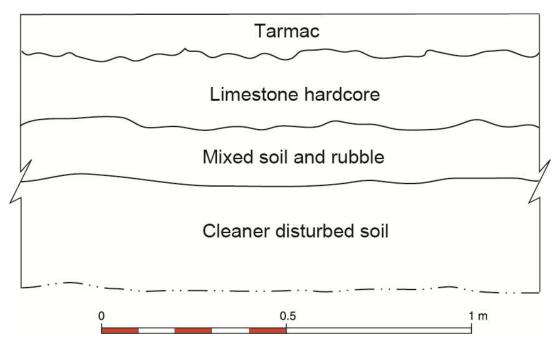
Figure 3 Representative Section

The general sequence commenced with disturbed backfill deposits in the lower 300mm of the trench, overlain by 150mm of disturbed soils and rubble. The uppermost 300mm was hardcore and tarmac for the current surfaces (Figure 3; Plate 1). Virtually the entire trench was positioned on top of existing drains and sewers, explaining the disturbed deposits.

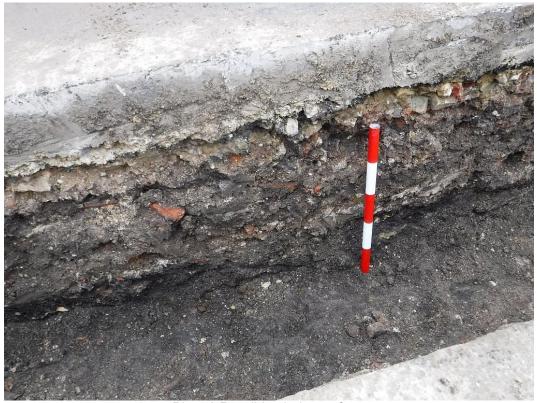
Plate 2 Possible cinder surface

In the few areas outside of previous significant disturbance there were traces of a possible cinder surface at c.700mm BGL and truncated wall stubs (Plates 2and 3).

The surface and wall stubs were both clearly 19<sup>th</sup> century or later in date and will relate to previous use and structures across the site.
