**ARCHAEOLOGICAL INVESTIGATIONS AT THE
FORMER MUNITIONS STORE, MELMERBY
INDUSTRIAL ESTATE, MELMERBY, NORTH
YORKSHIRE**

*LANDSCAPE SURVEY, BUILDING RECORDING AND
WATCHING BRIEF REPORT*

Report Number 2017/94 December 2017

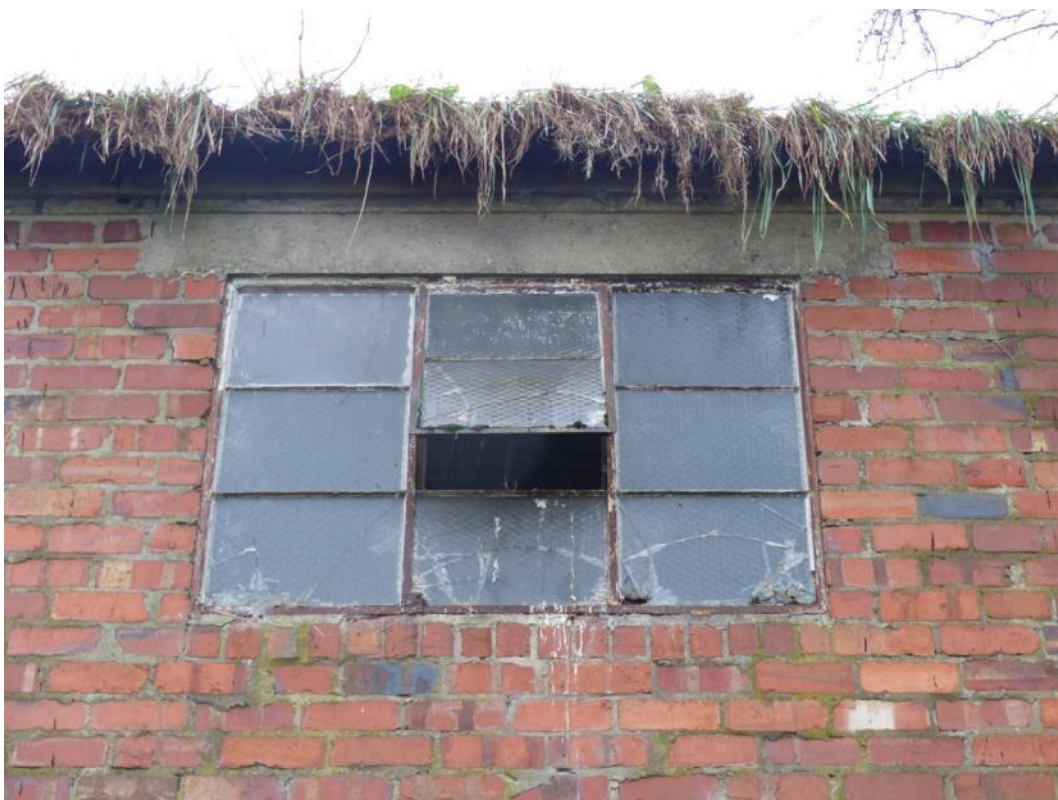
The building features thirteen windows all of the same design (Plate 2). These are all square-headed openings with nine-pane painted cast iron windows in a three by three pattern. The central and upper central panes form an awning window that can be opened outwards for ventilation. The glass in the windows is dimpled making it difficult to see in and has a wire mesh running through it making it an early type of safety glass that would break apart into small pieces and not blow into the building in the event of an impact. The windows all have concrete lintels set between the windows and the roof.

Plate 2: Detail of a window in the former munitions store, looking west

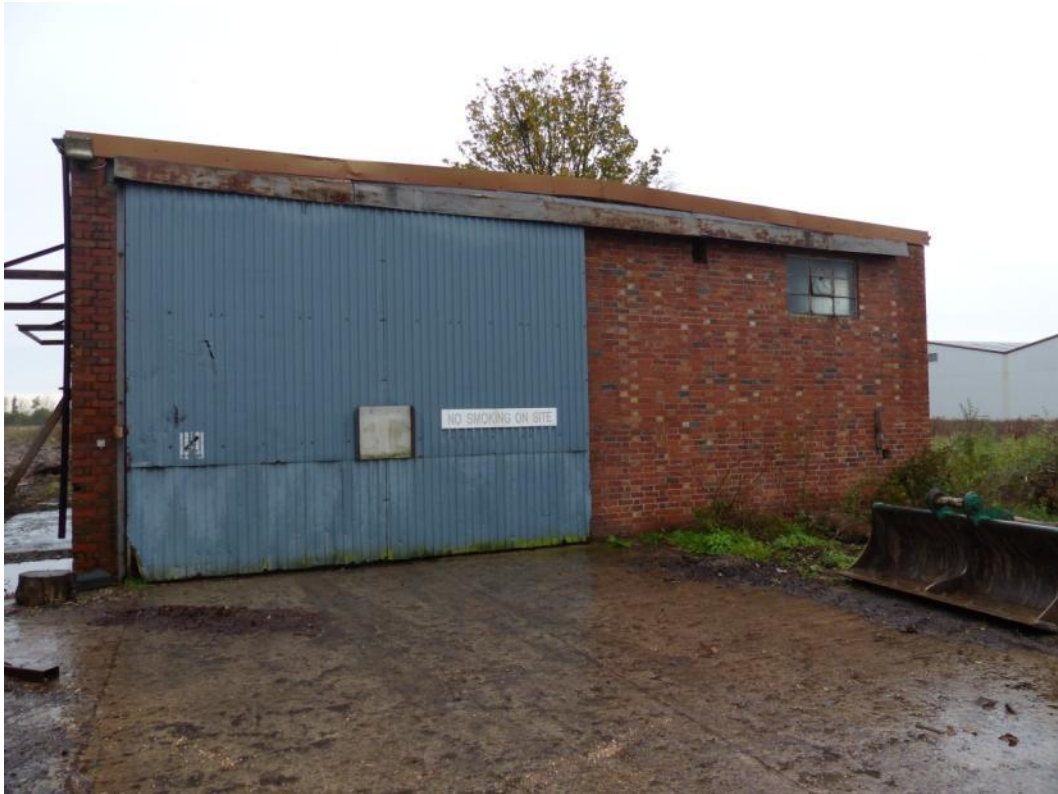
The south elevation is the front elevation and has a single large square headed door opening with a hanging sliding door. The door opening is half the width of the elevation and runs the full height of the building. The door is composed of corrugated iron and hangs on a metal runner to the top. The door appears to be a later replacement as the sides of the door opening have damaged brickwork (Plate 4), suggesting an earlier set of double doors has been removed. A single window opening is located high up on the east end of the elevation. A long metal runner sits along the roof line protecting the edge of the corrugated metal roof.

Plate 3: The south elevation of the munitons store, looking northeast

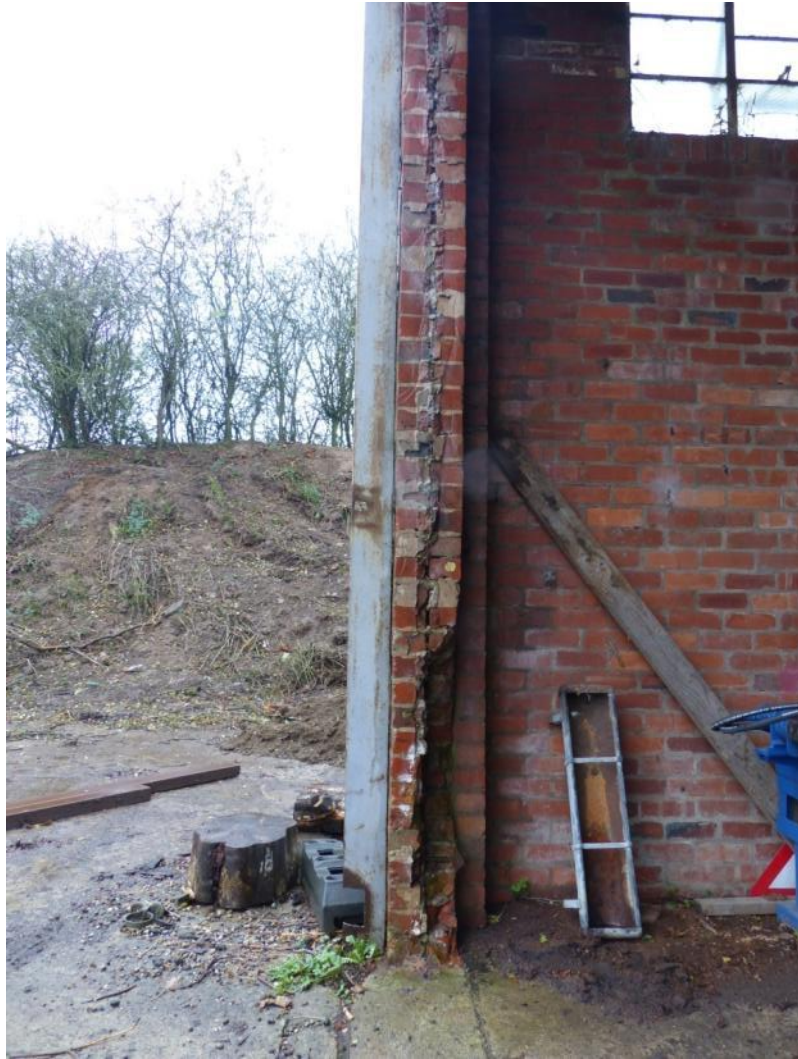
Plate 4: Damaged brickwork on the front elevation door opening, looking west

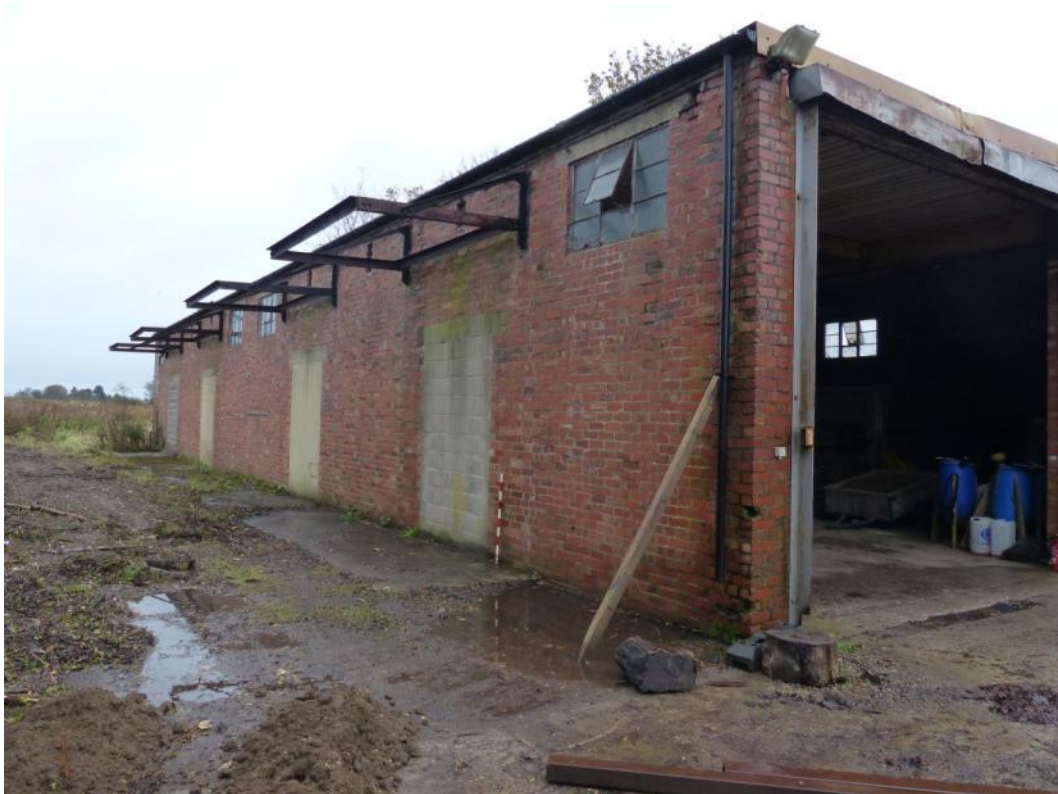
The west elevation is one of the long side elevations. This one features four square head door openings all now blocked. All four openings are blocked with concrete breeze blocks however the inner two have a skin of concrete mortar to their exterior suggesting these were blocked at different times. The door openings feature concrete lintels and on the exterior have flanking metal clips probably related to the loading munitions. Above each door are steel frame remains of canopies which would have provided cover to the loading operations. At the base of the doors running along the length of the building is a concrete walkway. Between the doors and to their sides are four windows. There are also six louvered ventilation openings just below the roof line in the bays where there are no windows.

Plate 5: The side (west) elevation of the munitions store, looking northeast

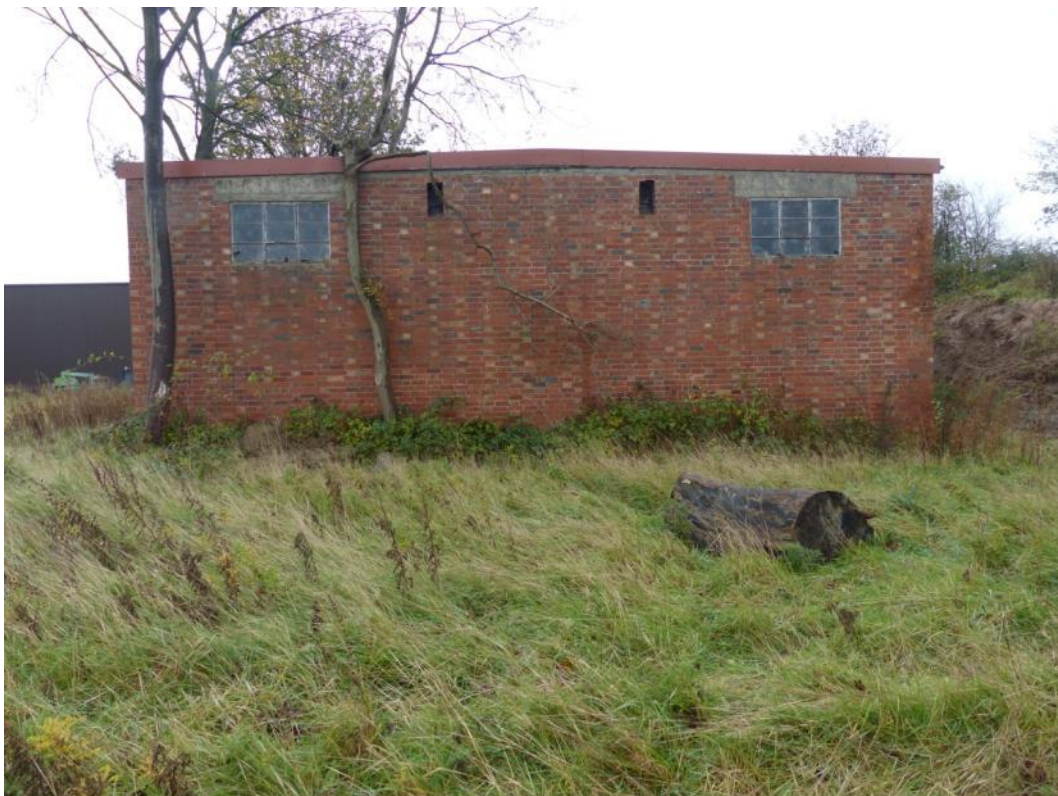
The north elevation is the rear short side of the building. It is a simple design with a window opening situated in the upper corner of each side of the elevation. Between the windows are two louvered ventilation openings evenly spaced located just under the roof line. A strip of metal protects the edge of the roof where it meets the top of the wall.

Plate 6: The rear (north) elevation of the munitions store, looking south

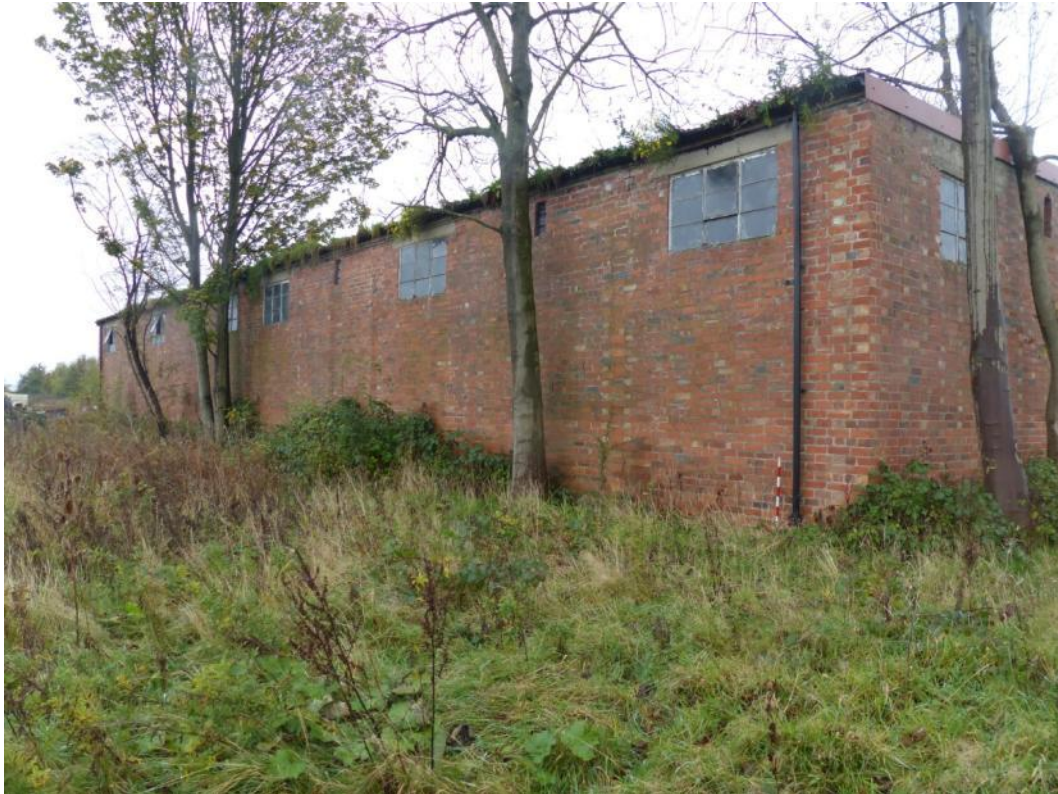
The east elevation is the long side elevation of the building opposite the loading bays, and is similar to the north elevation in design. This elevation features no door openings and has regularly spaced windows, six in total and with louvered ventilation openings between each set of windows except the central two.

Plate 7: The side (east) elevation of the munitions store, looking southwest

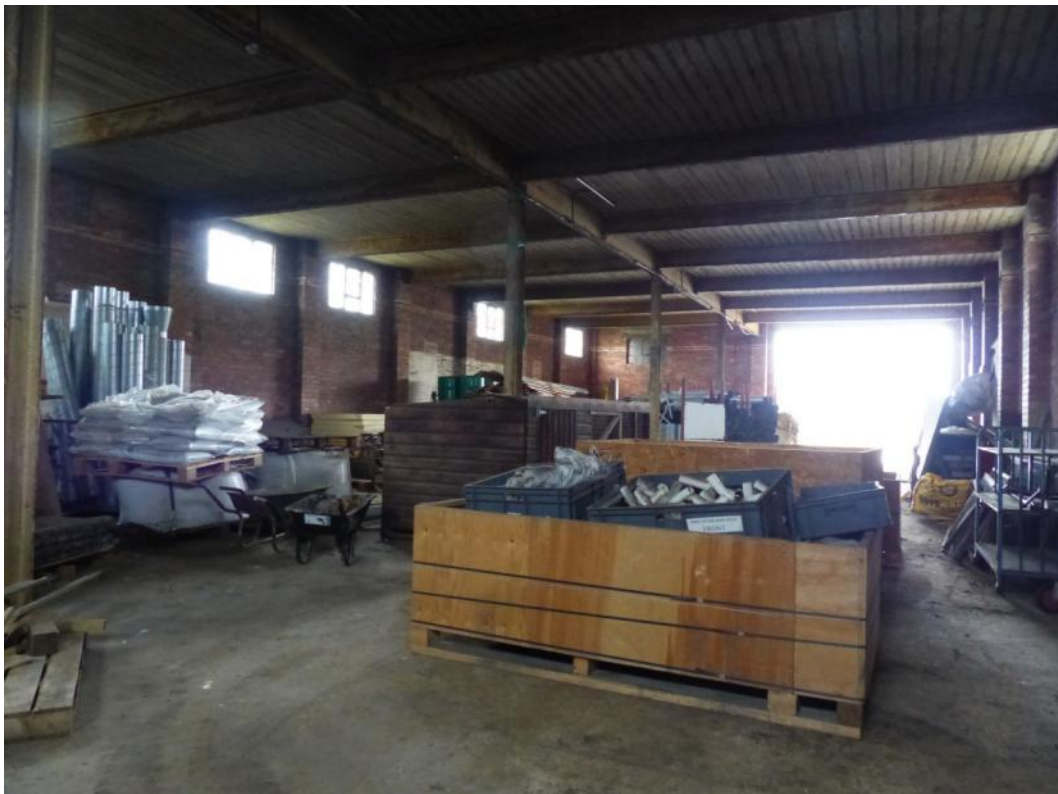
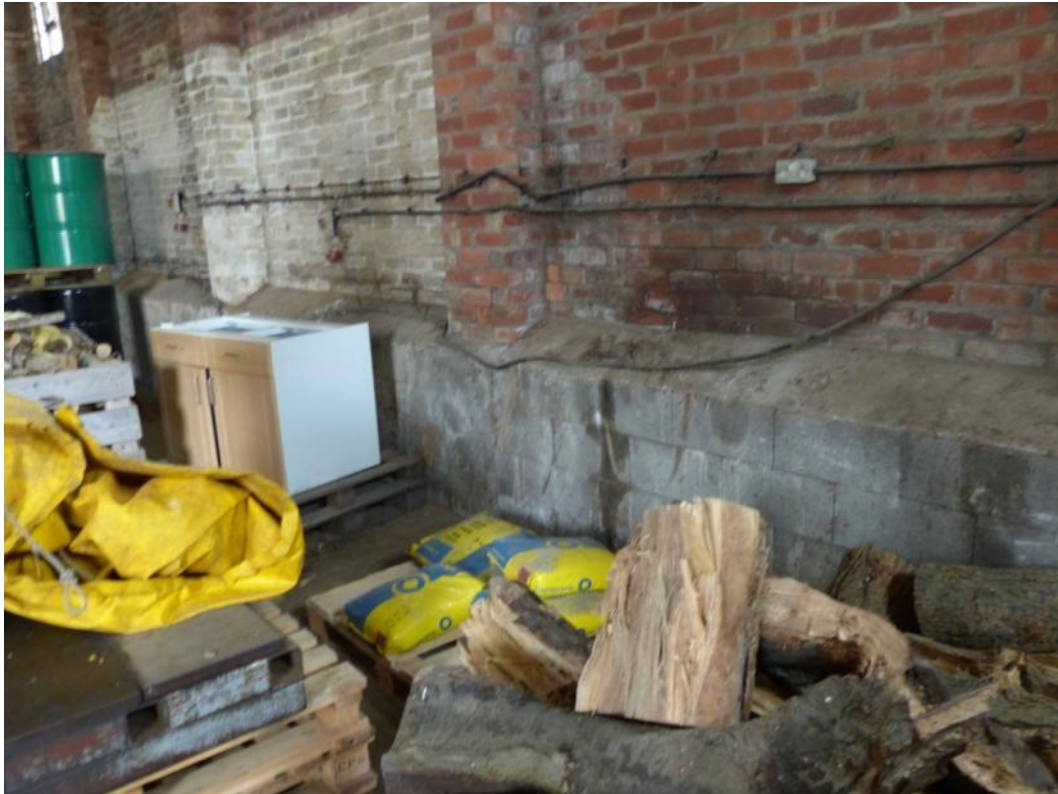
The floors are constructed of concrete which was poured after the walls and internal posts had been constructed. The interior of the walls are exposed red brick similar to the exterior. The east wall has a low concrete breeze block buttress wall added, which is 0.30m thick and 1.24m high (Plate 9), possibly added later when a weakness or water ingress to the wall was detected. Wires for outlets and lighting line the eastern wall; these were added after 1975 but no longer function (Andrew Frost pers comm.) Some paint marks could be seen along the walls of the interior possibly denoting where certain supplies were meant to be kept, though it is unclear if these are original to the munitions store or added later for the industrial estate.

Plate 8: The interior of the munitions store, looking south

Plate 9: The interior of the munitions store, looking south

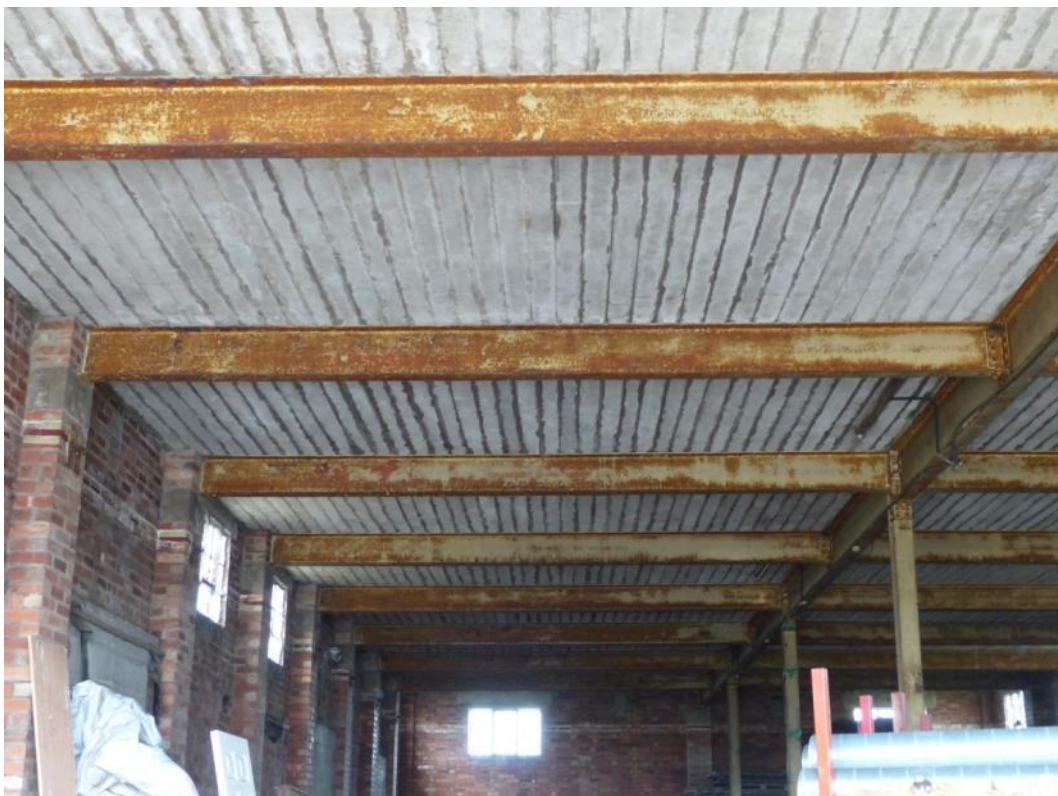
The interior features a steel frame supporting the concrete roof. The steel frame is comprised of nine I-beam posts running north-south through the middle of the building. These posts support a long line of horizontal steel I-beams creating a north-south spine with a series of "ribs" running east-west from the top of the posts to the edges of the brick walls. The walls have brick pilasters running up the inside of the walls to support the outer ends of the steel ribs and the roof (Plate 10). The steel I-beams are riveted together and each one is marked with "DORMAN LONG & Co Ld MIDDLESBROUGH ENGLAND" (Plate 11 and Plate 12).

Plate 10: The ceiling of the munitions store, looking north

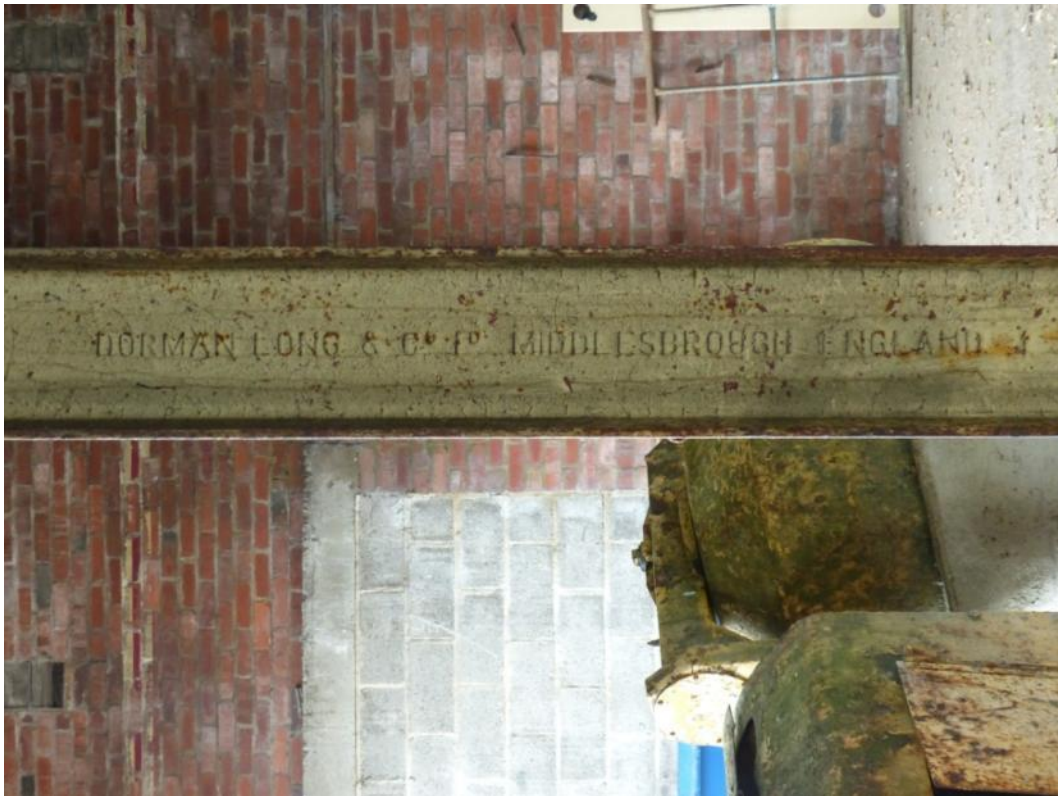
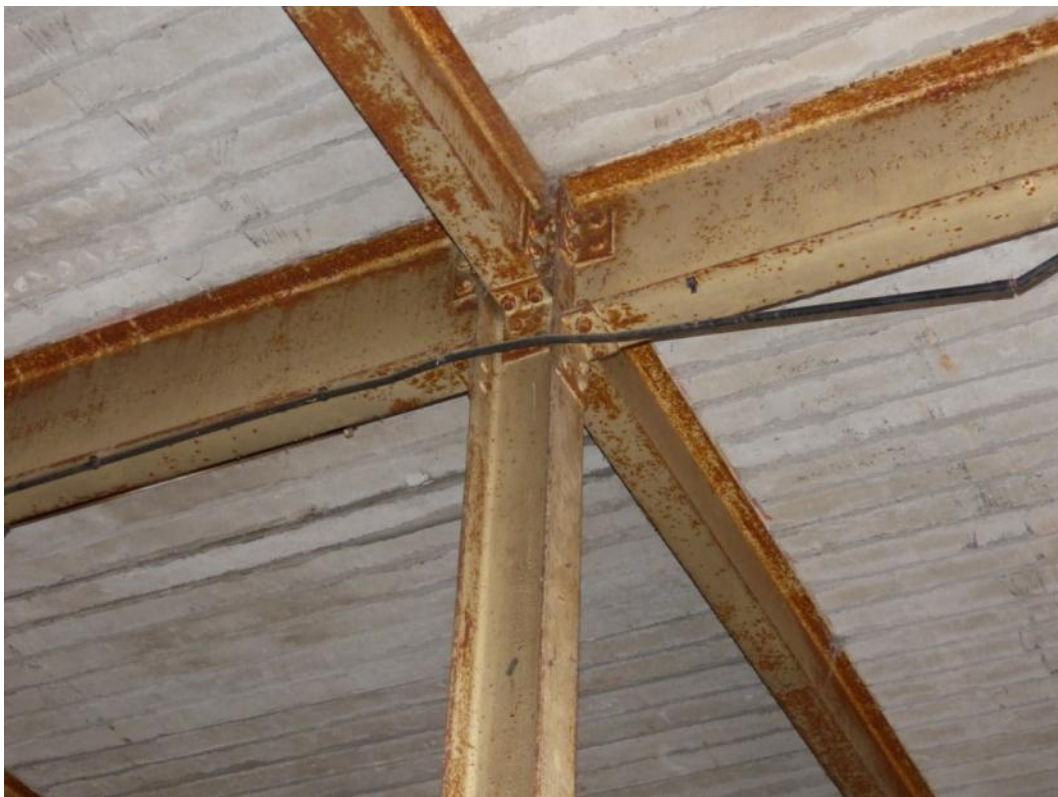
Plate 11: The raised lettering on the steel girders reading "DORMAN LONG & Co Ld MIDDLESBROUGH ENGLAND"

Plate 12: The steel I-beams showing the details of their connections, looking northeast

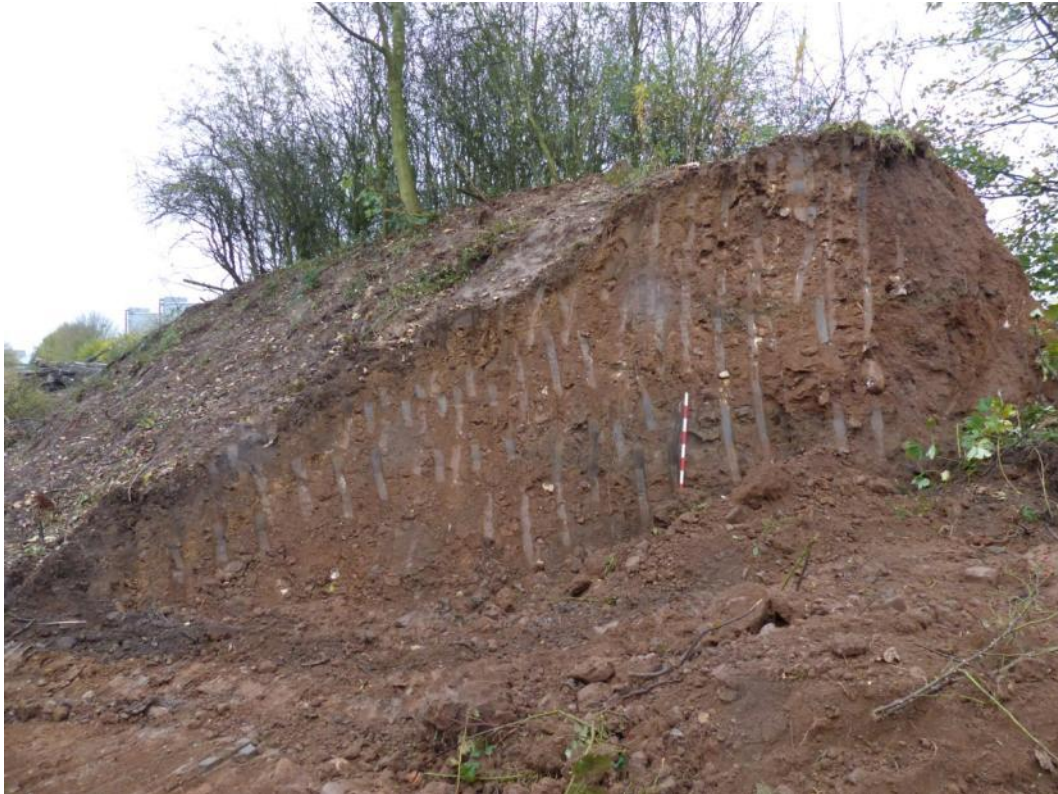
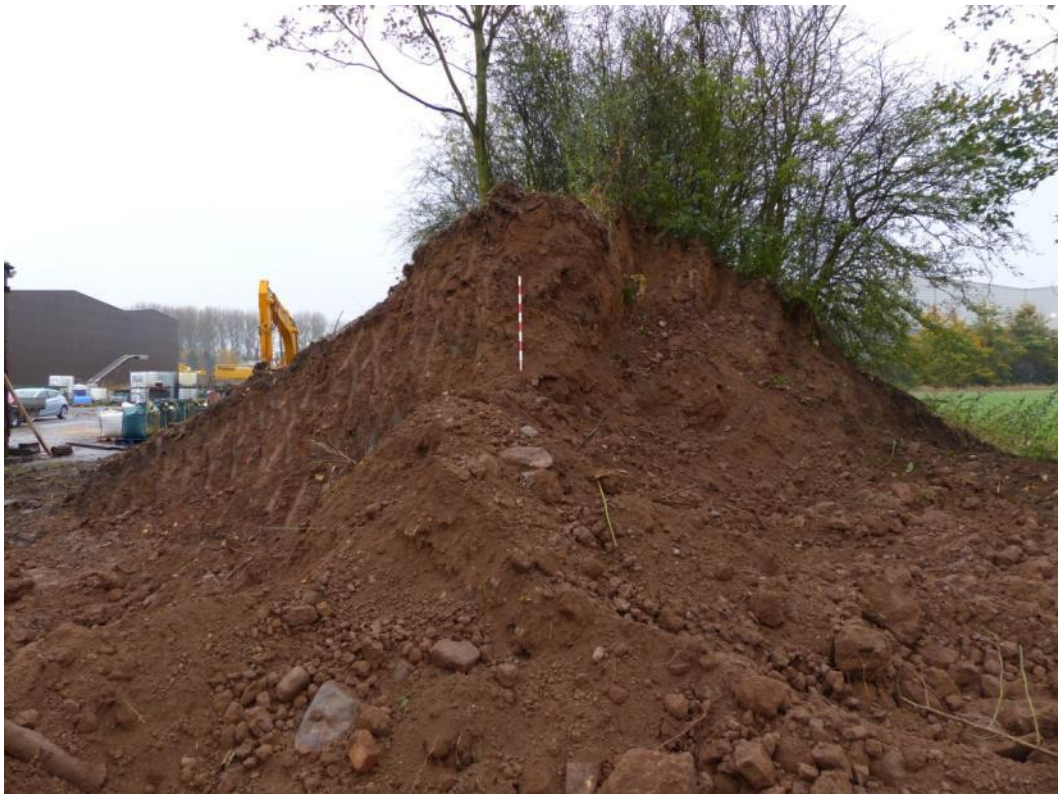
Observations during the removal of the bund indicated that it was a modern construction almost certainly added when the munitions store was built. The sections through the middle of the bund revealed a fairly homogenous dark brown clayey silt. A slightly darker humic layer had built up on top of the mound over the last 70+ years as plants and leaves decomposed on top of the bund (Plates 13 & 14).

Plate 13: Cut section through the Bund, facing south, scale unit 100mm

Plate 14: Cut section through the Bund, facing south south west, scale unit 100mm

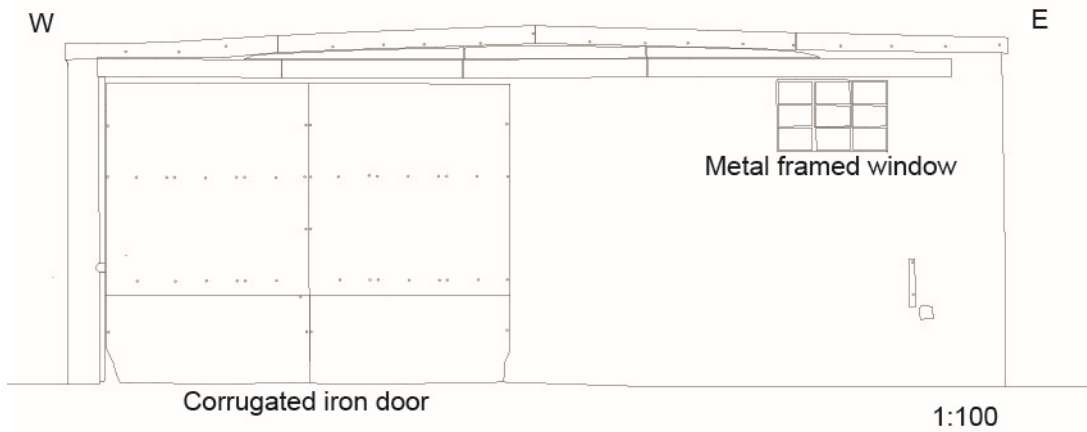
Figure 6 The front (south) elevation of the former munitions store

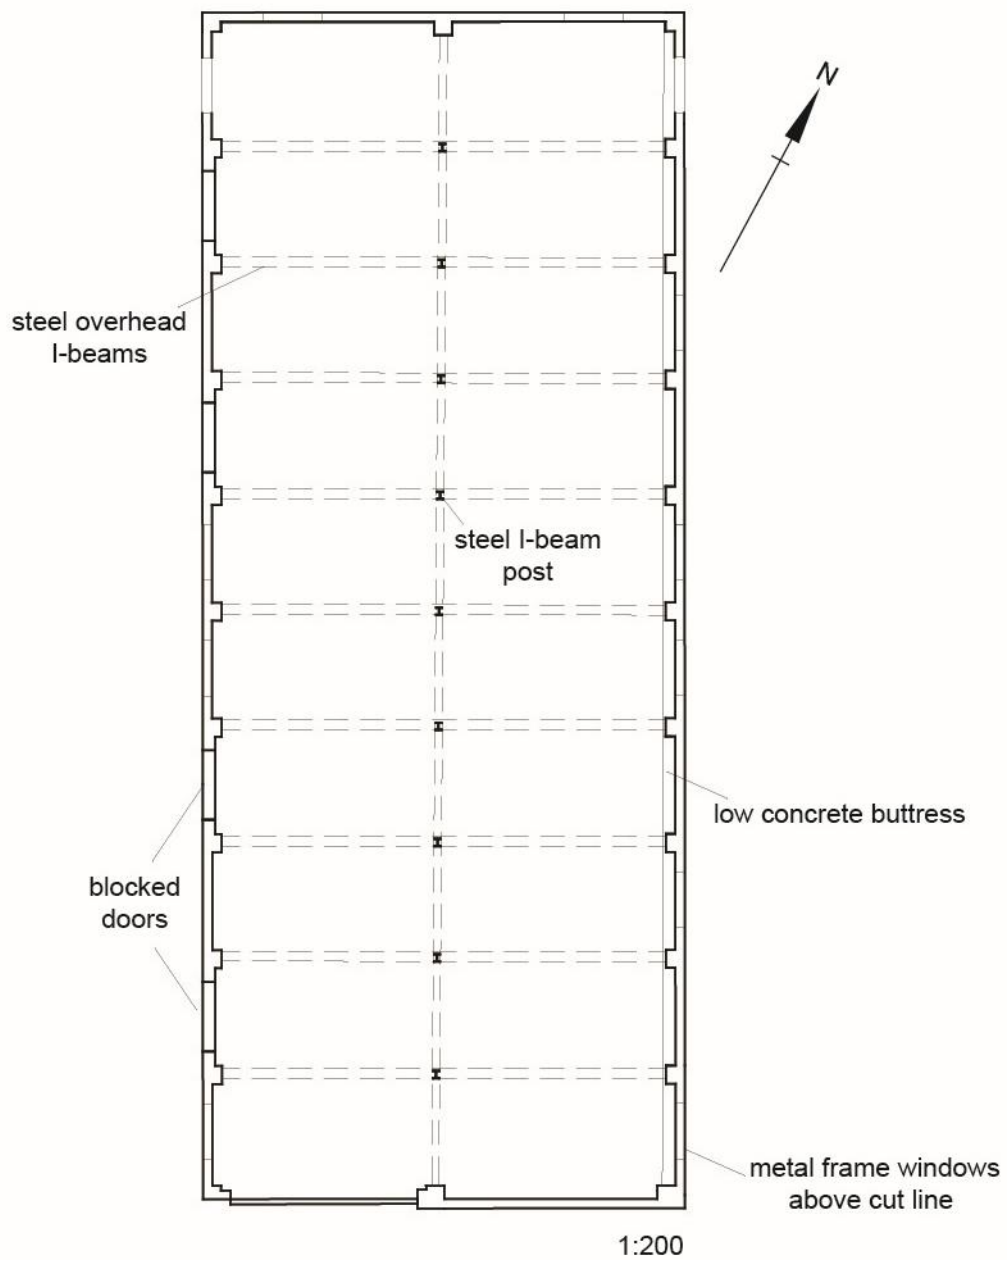
The interior of the store is accessed solely through the large single sliding door to the south elevation, due to the west elevations doors now being blocked. The interior is a single room with no internal walls.

Figure 8 Plan of the former munitions store
