Building Recording at Micklegate Bar, York

YAT Building Recording Report 2018/39 March 2018

Project Name	Micklegate Bar, Micklegate, York YO1 6JX
YAT Project No.	1126
Document Number	2018/39
Type of Project	Building Recording
Client	City of York Council
NGR	SE 59754 51470
OASIS Identifier	yorkarch1-312090

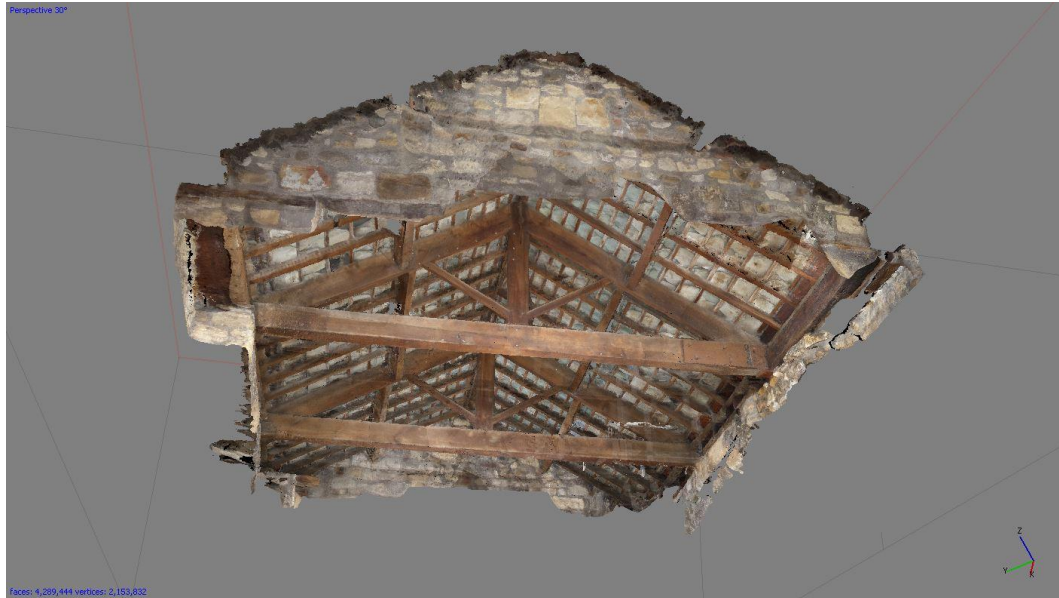
Figure 2: 3D model of internal roof space, looking north

A Level 2 Historic Building Survey was undertaken by Greg Laban on 5th July 2017. Photos of the building are shown on Plates 1-19 and views of the 3D model of the roof structure are shown in Figures 2-3.

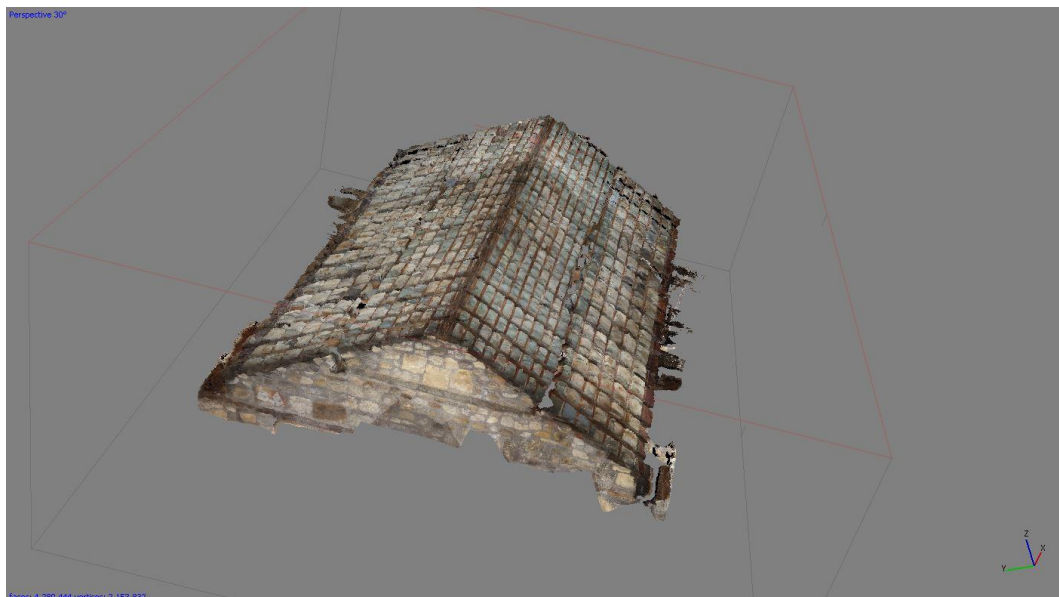
Figure 3: 3D model showing the outside of the roof, looking northwest

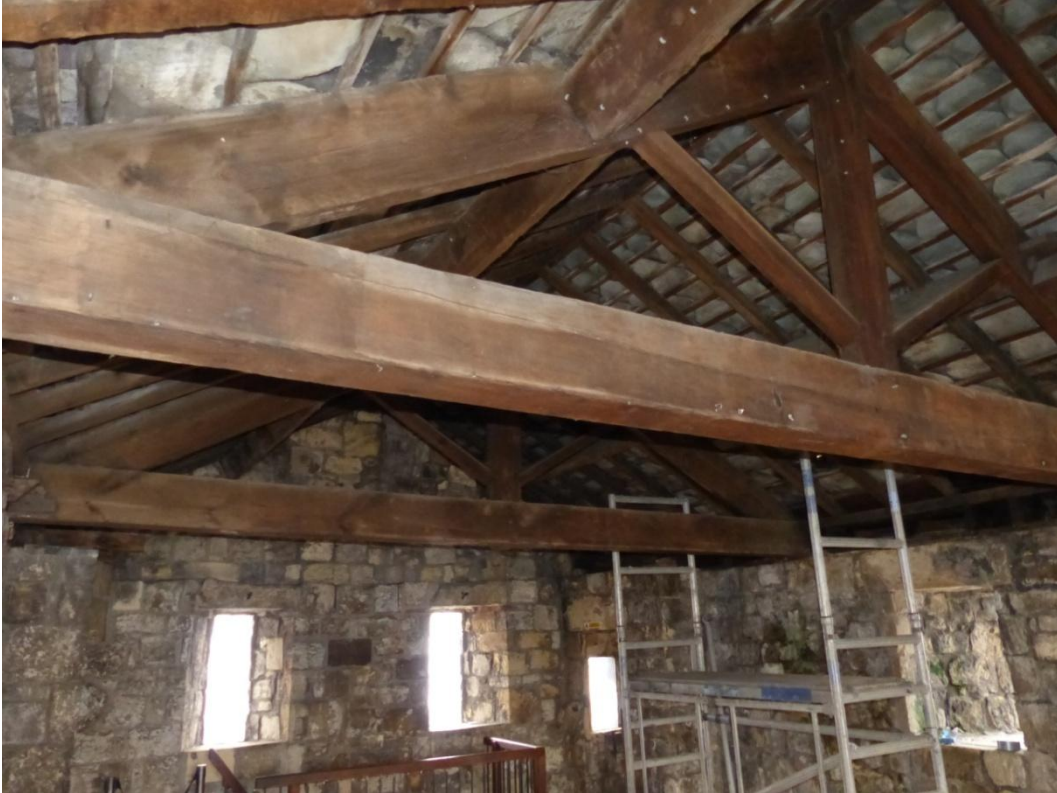
Micklegate Bar has a pitched roof composed of two king post trusses and three bays. Each truss features a king post, two struts, a tie beam and two principal rafters. The height of the roof from the base of the tie beam to the top of the ridge beam is 1.70m. The overall length of the room and the main roof is 7.80m with a width of 5.06m. All of the timbers have been treated with a dark brown stain or paint, either to make their appearance uniform or to possibly protect them from insect and water damage (Plate 1).

Plate 1 General view of the roof, looking northeast

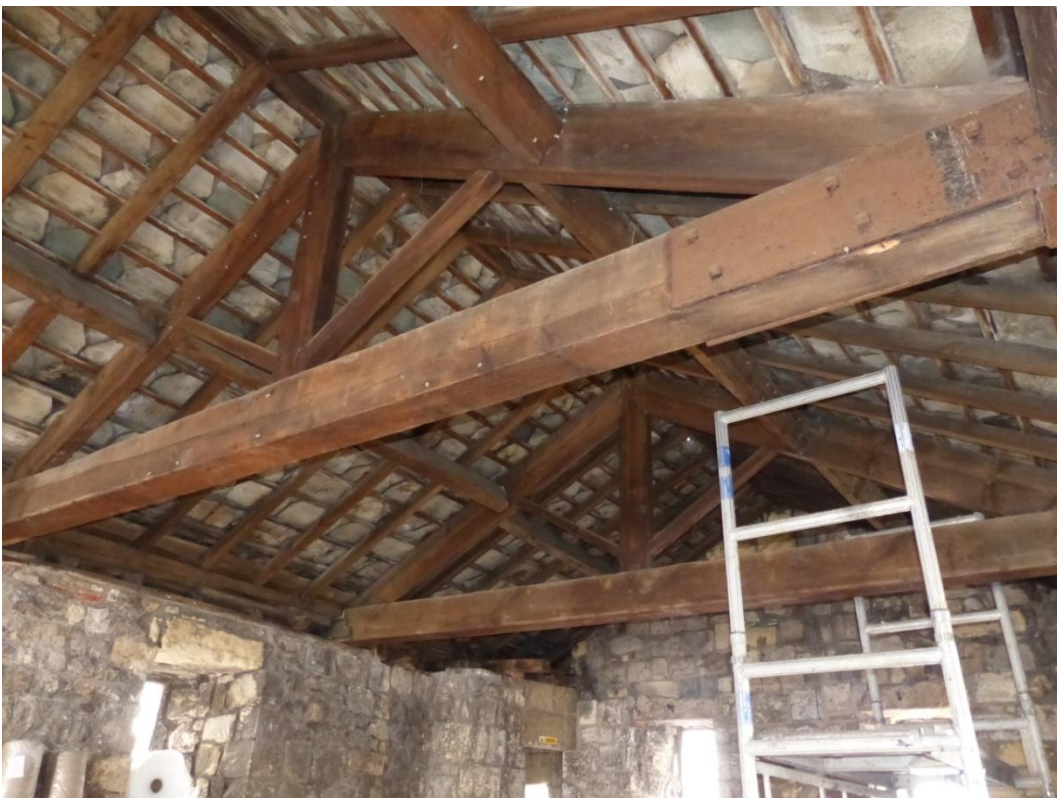
Plate 2 General view of the roof, looking northwest

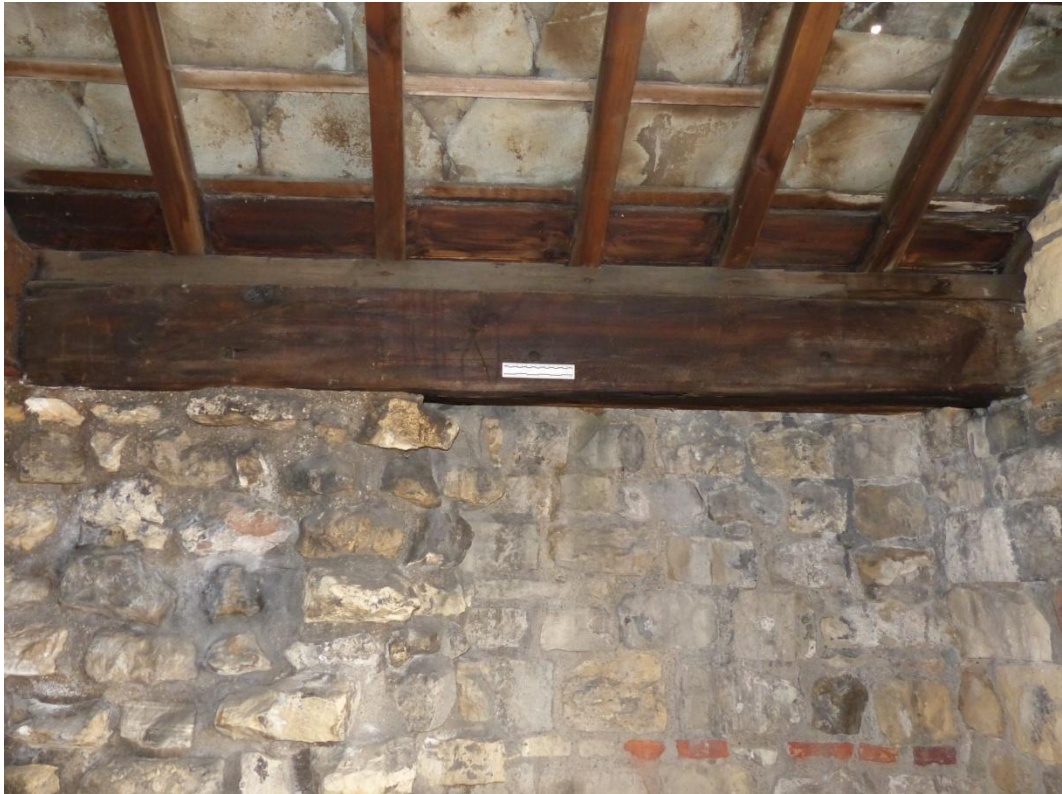
The tie beams rest on top of wall plates that sit on top of the stone walls. Additional timber beams have been added to support the wall plates along the northeast and northwest corners. These beams run over recesses in the wall caused from blocking up a chimney. The bases of the common rafters sit on a secondary wall plate or minor purlin, instead of overlapping the edge of the wall which is more common for a pitched roof. This is due to the guttering/walkway between the base of the pitches and the stone parapets sitting between the roof and the stone parapet walls. Further evidence of the guttering can be seen as a number of reused horizontal timbers sticking slightly out of the wall and into the roof space (Plate 4). These horizontal joists support the lead guttering/walkway surrounding the roof (Plate 6 and Plate 7). Timber planks on top of these joists run up the ends of the common rafters to create a slope, covered with lead flashing.

Plate 3 View of additional wall plate beam, looking west

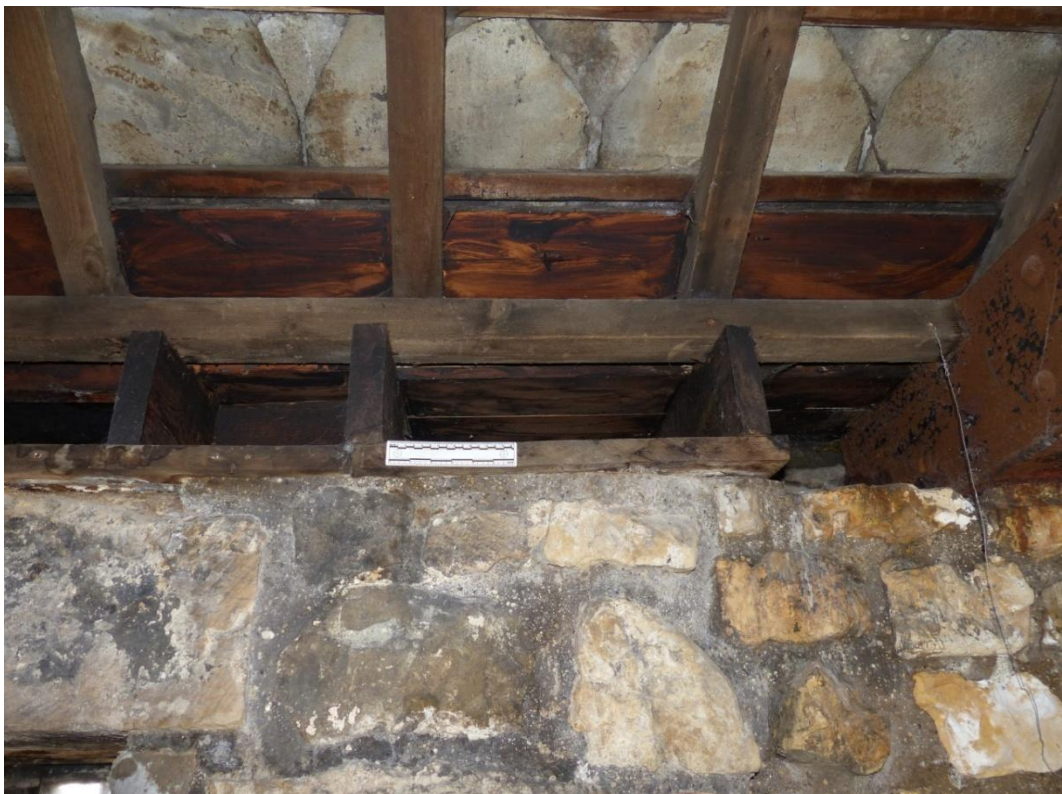
The guttering is located at the base of the roof pitches. From the interior of the building timber joists can be seen on top of the wall plates interweaving with the ends of the common rafters (Plate 4). These joists run to the east and west and make up supports for the timber planks which in turn make a flat surface for the lead flashing in the guttering. The joists appear to be a mixture of reused earlier timbers, 19th-century timbers and some modern 20th-century timbers.

Plate 4 Timber joists supporting the guttering seen below the common rafters, looking west

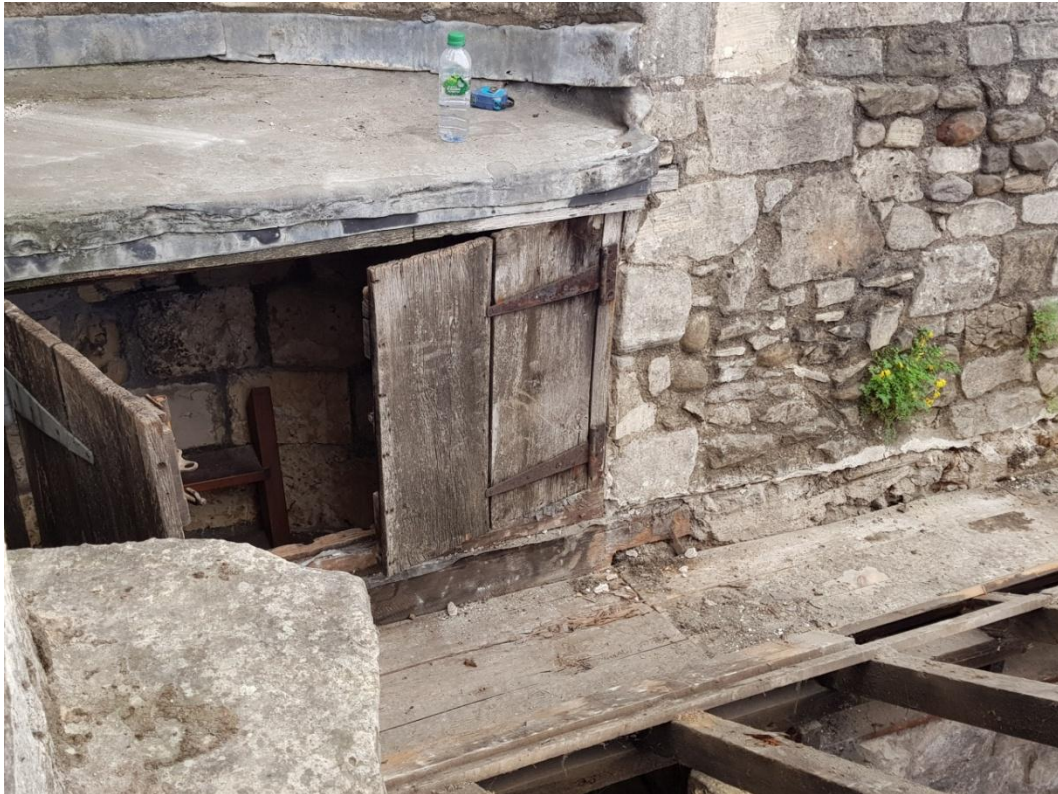
supported by a single reused timber joist. The upper portion rises above the line of the roof and has a flat timber plank roof with two timber doors opening out into the gutter area of the roof (Plate 5).

Plate 5 View of the hatch in the southwest bartizan providing access to the top of the roof and guttering, looking west

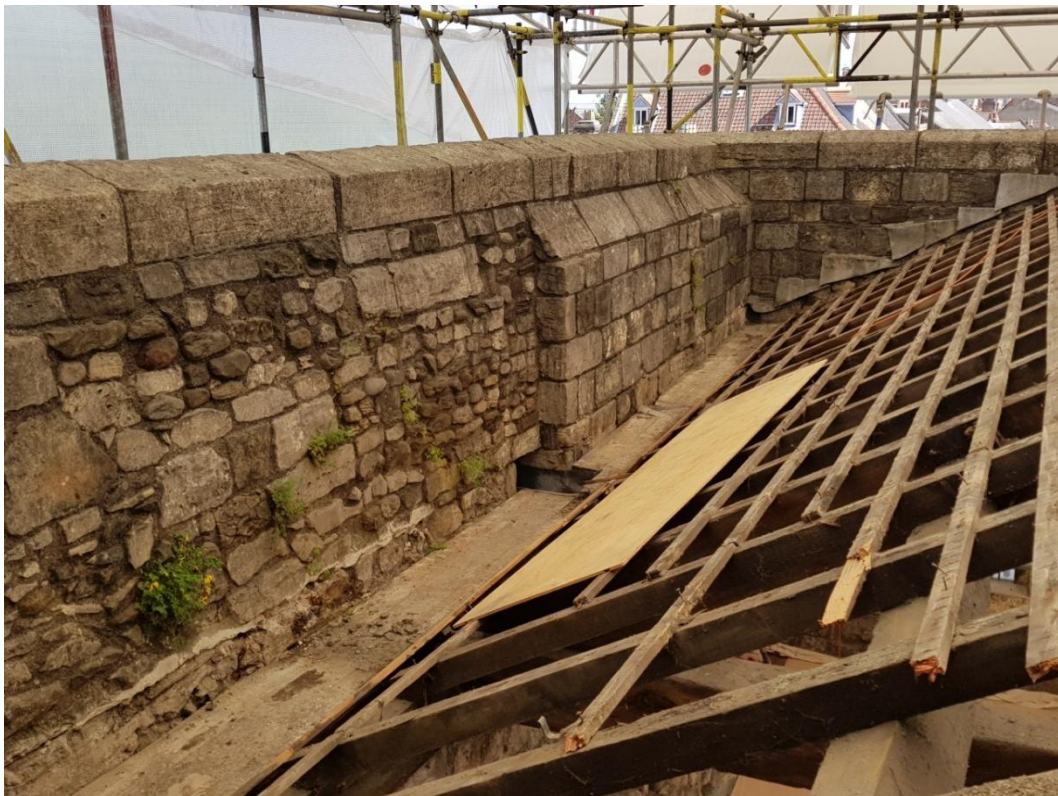
Plate 6 The guttering and battlements along the west half of the roof, looking northwest

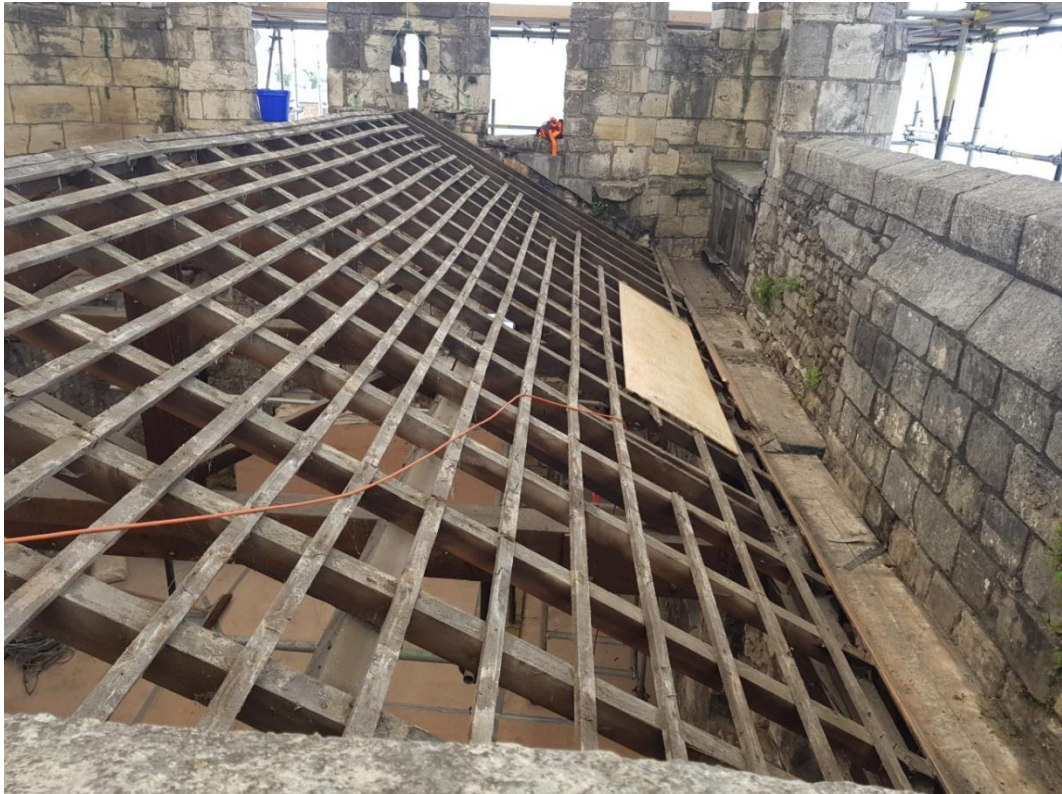
Plate 7 General view of common rafters and battens on the west half of the roof

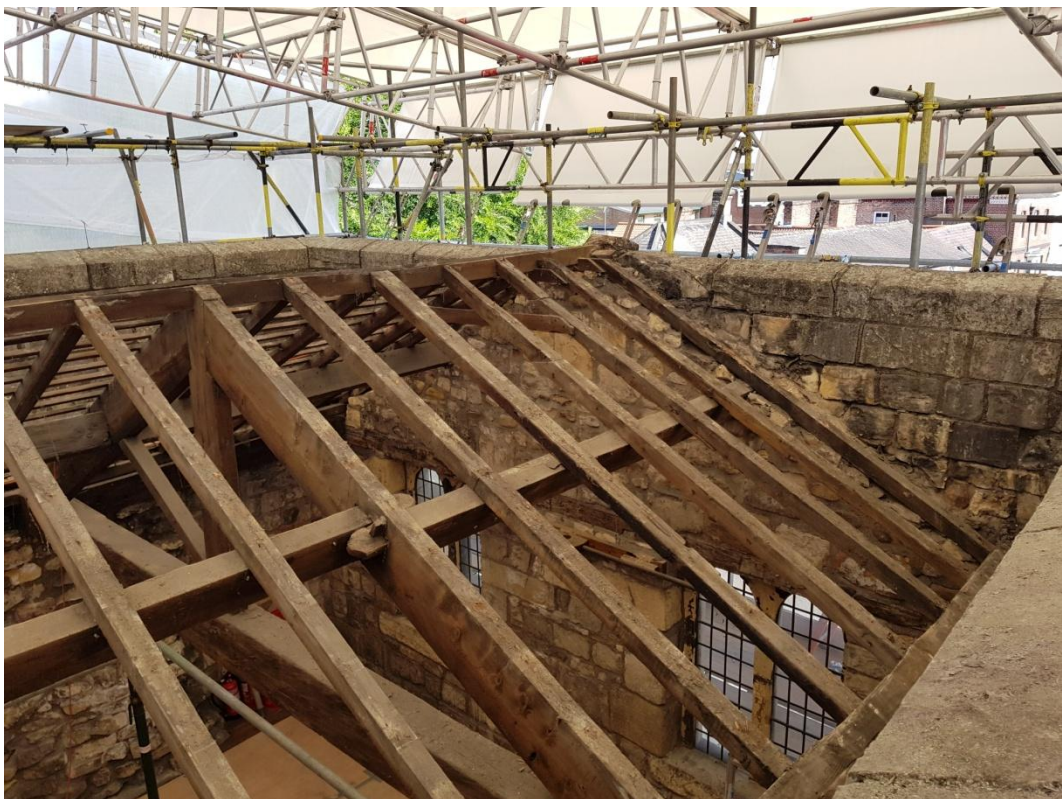
Plate 8 General view of the north half of the roof from the battlements, looking northwest

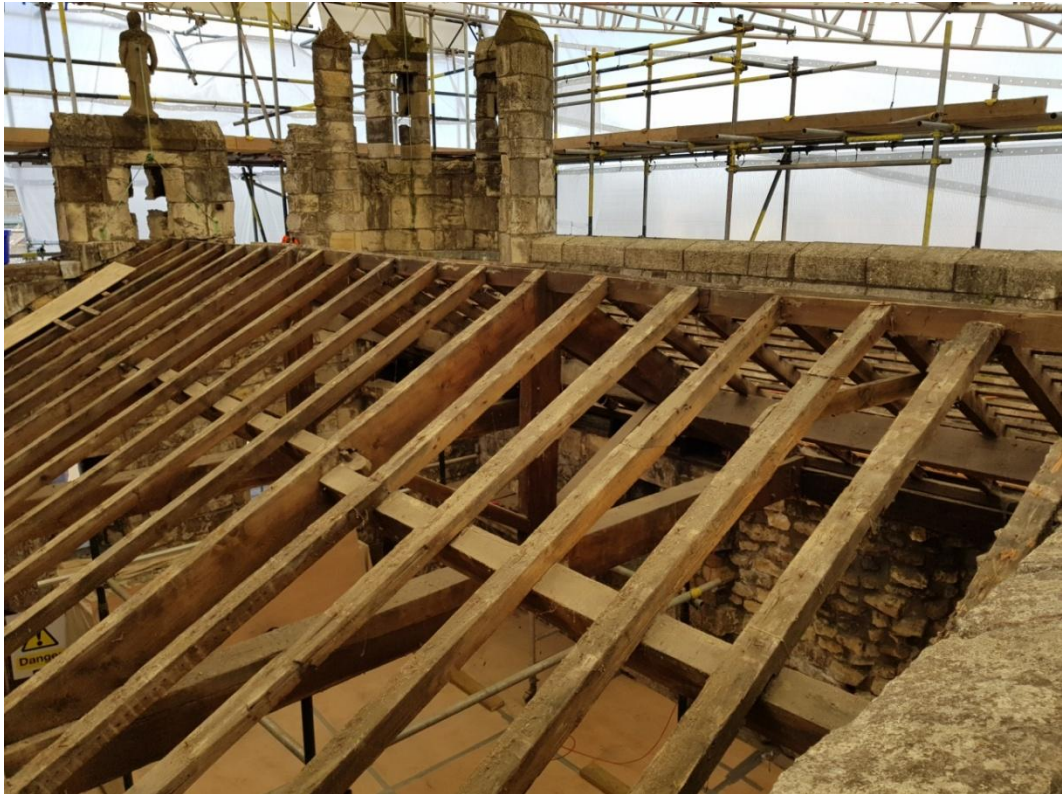
Plate 9 General view of roof from battlements, looking southeast

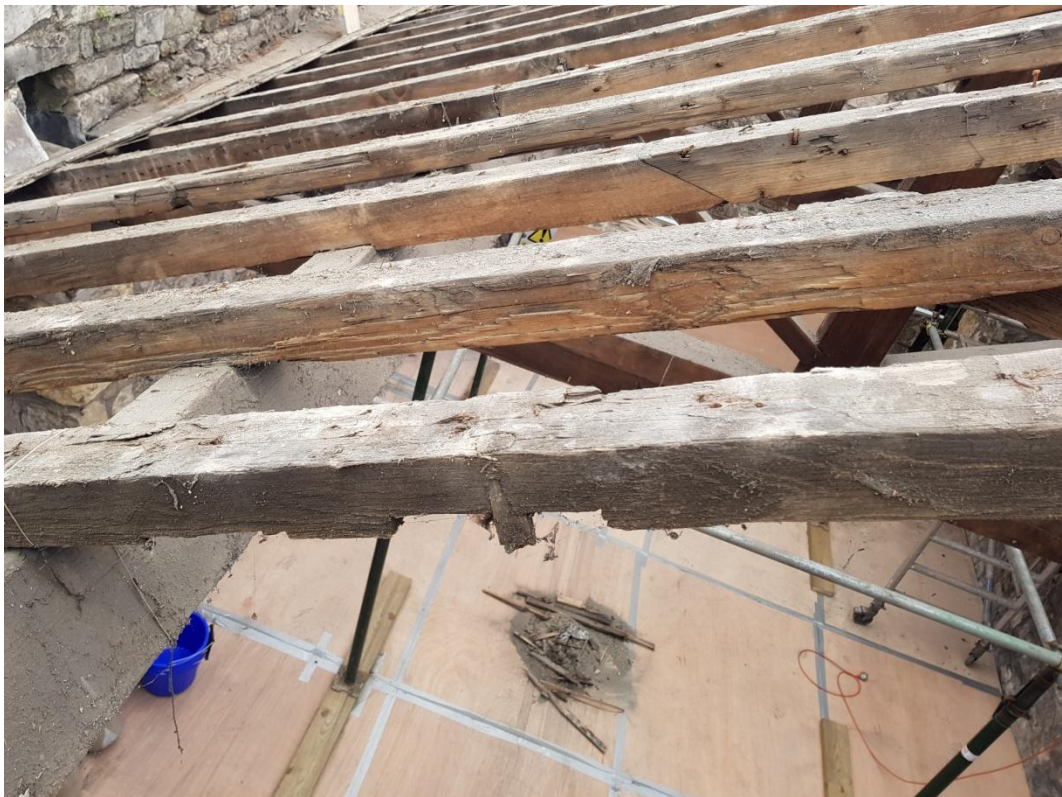
There are a total of 32 common rafters in the roof. The majority are a single piece from the ridge beam to the wall plate, with a few that are two pieces with a scarf joint hidden behind the purlin. The majority of the common rafters appear to have been added at a later date, perhaps during the mid-20th century when repair works are known to have occurred. There is a set of five common rafters in the east side of the north bay that are all reused timbers (Plate 9 and Plate 10); some have a series of empty mortises along one side, others have the scars of lathe plaster along a single side and others appear to have been scarfed together. All five show greater signs of age and wear on them.

Plate 10 Detail view of the reused common rafters in the northeast corner bay, looking south

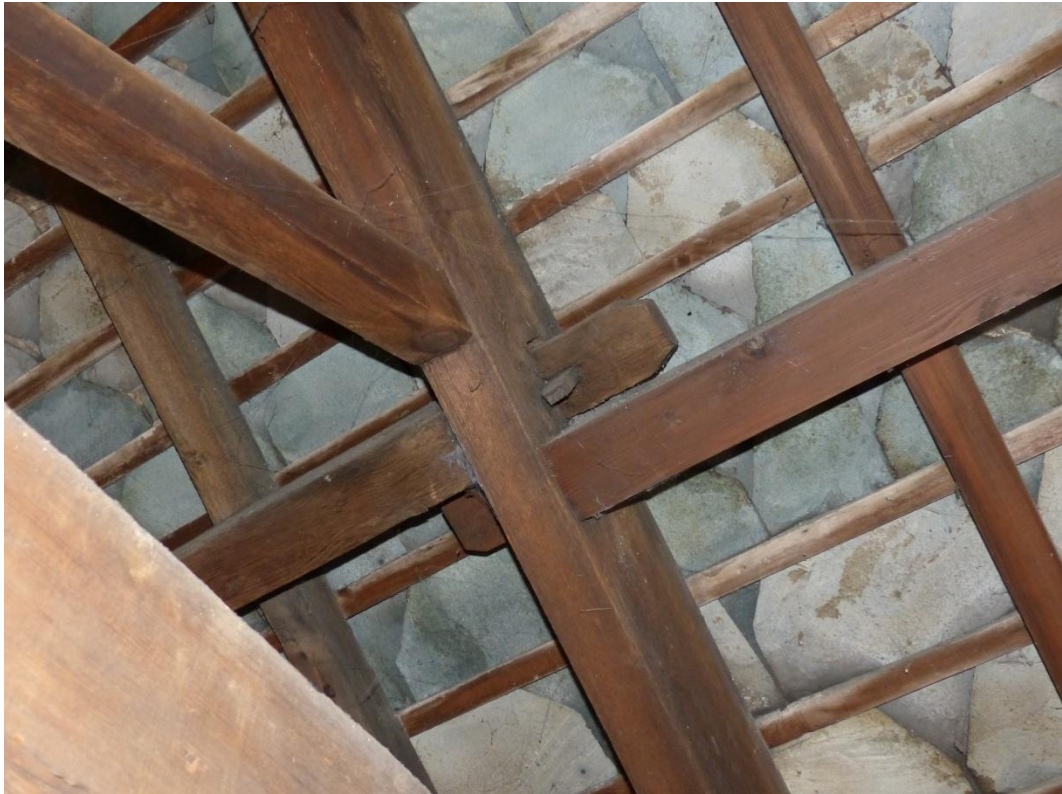
The purlin ends are staggered and overlapping with through timber tenons held with timber pegs holding them tight within the open mortises of the principal rafters (Plate 11). The purlins all appear original to the 19th-century construction with the two purlins to the east and west within the central bay appearing to have Baltic timber markings on them (Plate 16 and Plate 17). They appear scribed with a race knife and have indeterminate lettering/numbering, both sets of letters having been split by later sawing (Plate 15). This suggests the timbers were reduced further upon reaching their destination, perhaps as a result of being chosen as purlins for this building.

Plate 11 Detail view of the purlins overlapping and running through the principal rafter

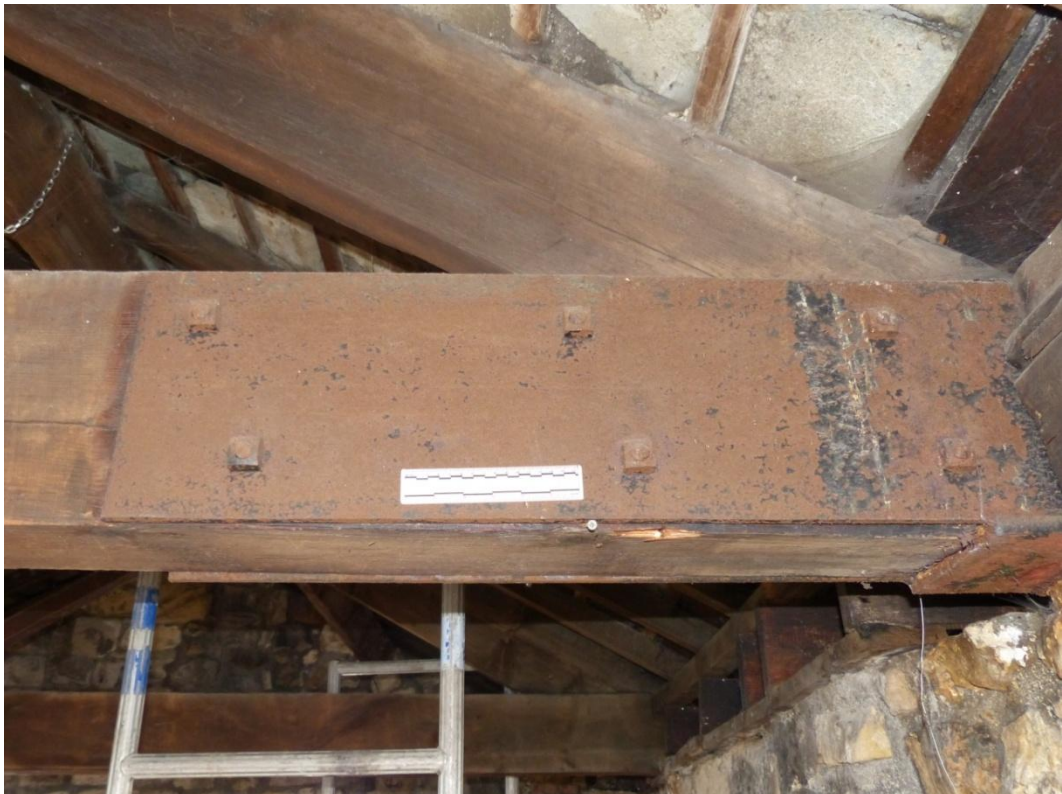
Plate 12 Detail view of the steel jacket supporting the west end of Truss 1

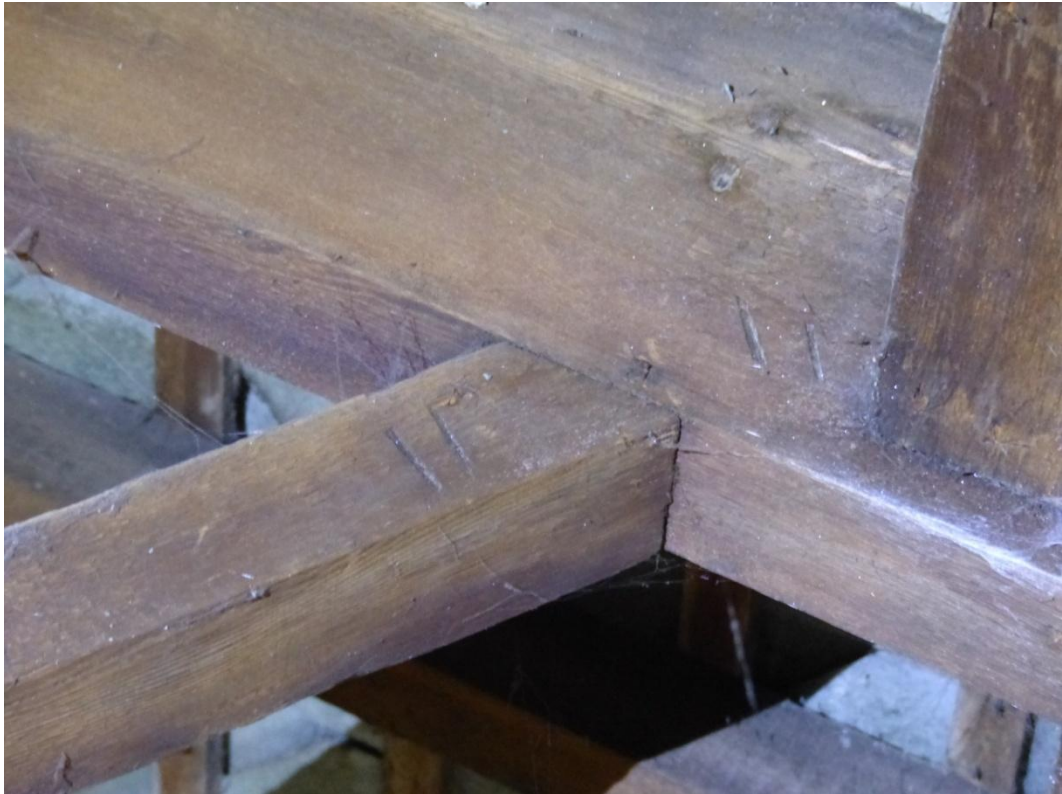
The trusses feature carpenter's marks, made with a chisel on their north faces. The marks are located where many of the main elements meet, including where the struts met the principal rafters (Plate 13) and where the principal rafters meet the tie beams. It should be noted not all expected marks were seen, but this could have been the result of dirt/dust obscuring them.

Plate 13 Detail of carpenter's marks on the Truss 2 where the strut and principal rafter meet

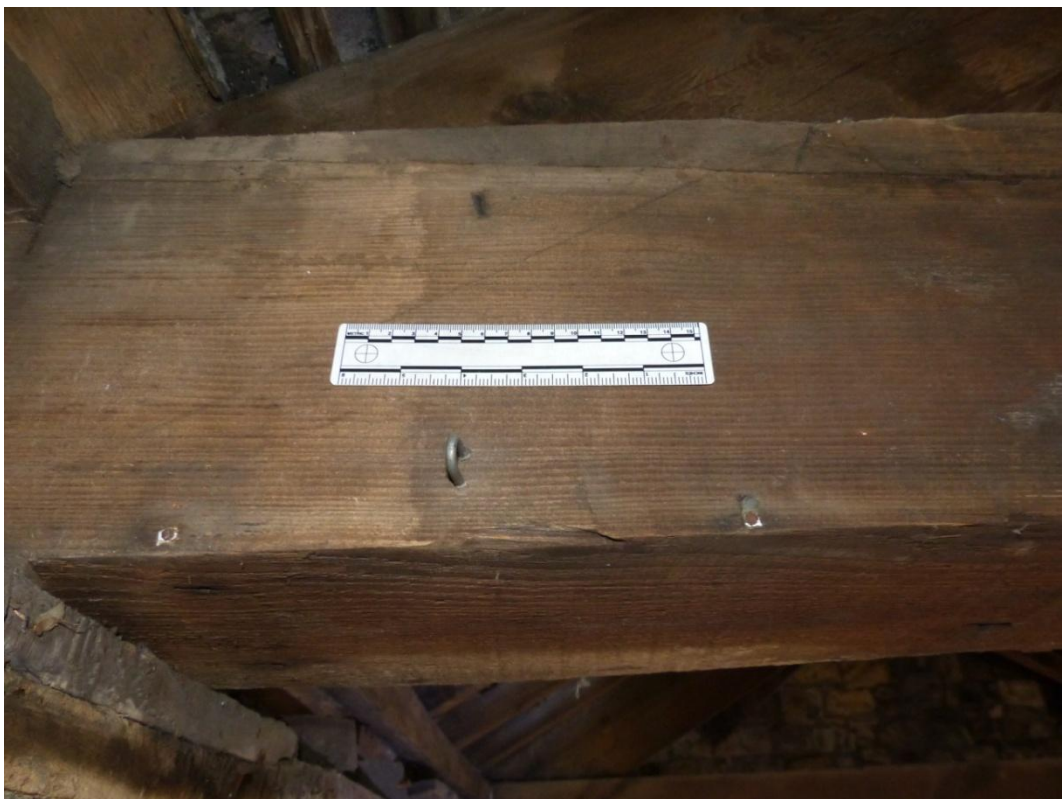
Plate 14 Detail view of the purlins overlapping and running through the principal rafter

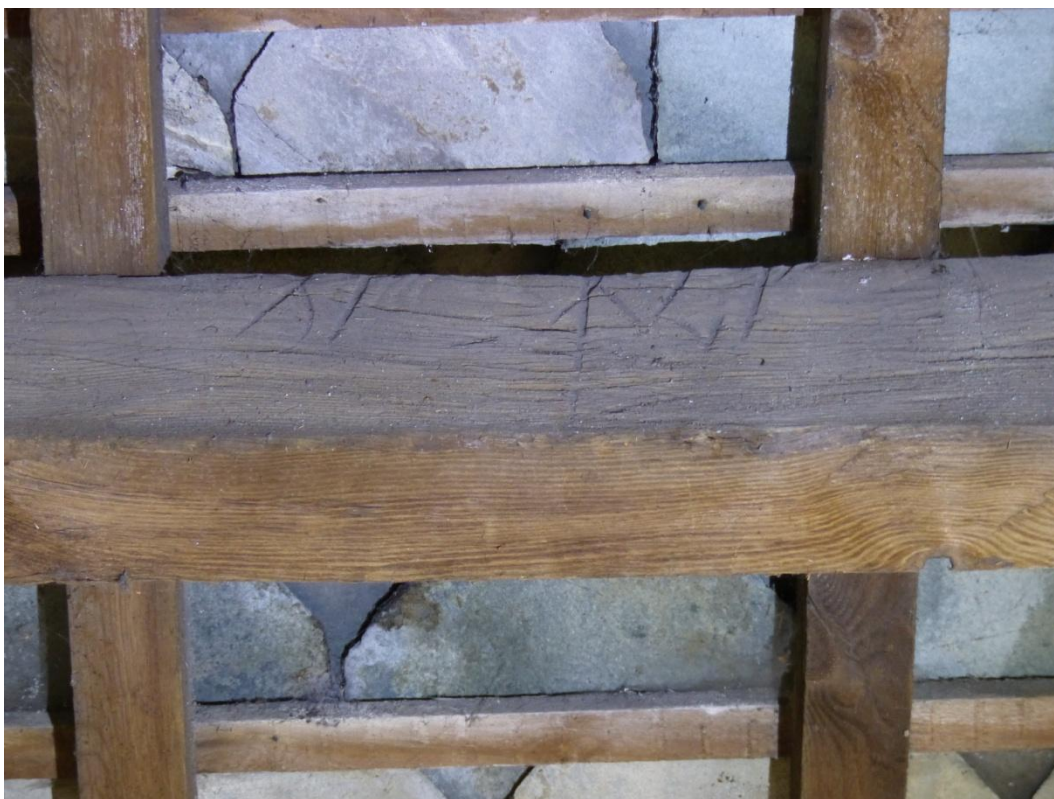
Plate 15 Detail view Baltic timber marks on the west purlin in the central bay

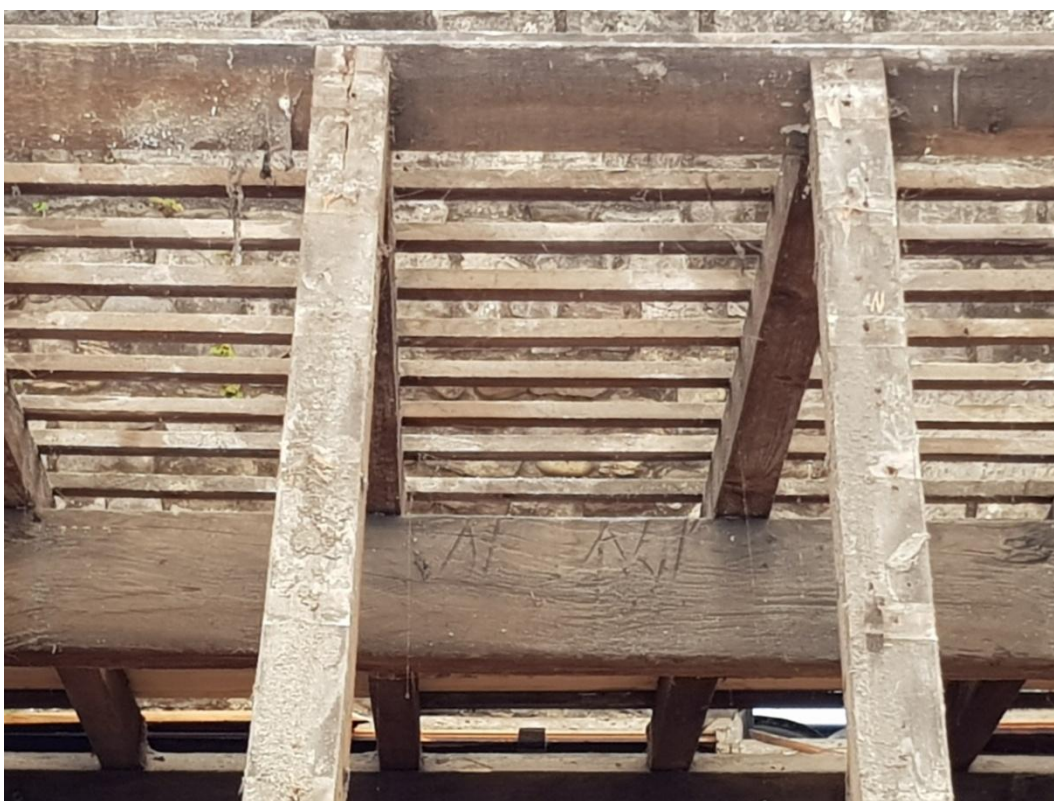
Plate 16 Detail view Baltic timber marks on the west purlin in the central bay

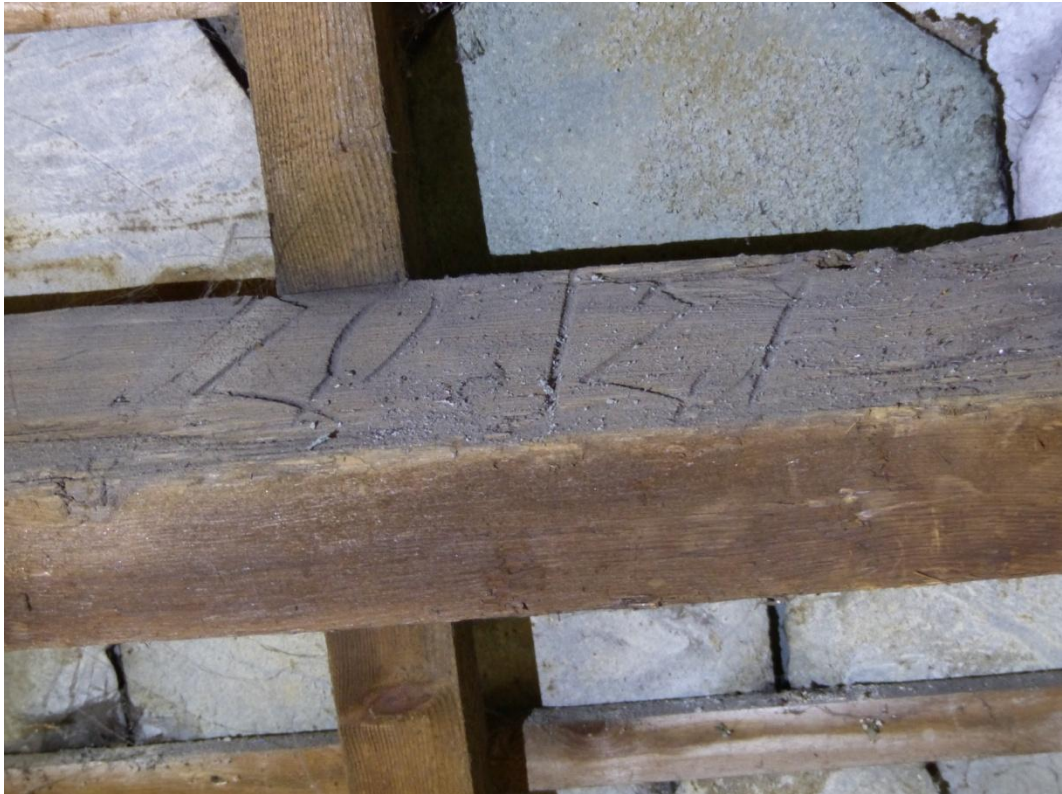
Plate 17 Detail view Baltic timber marks on the east purlin in the central bay

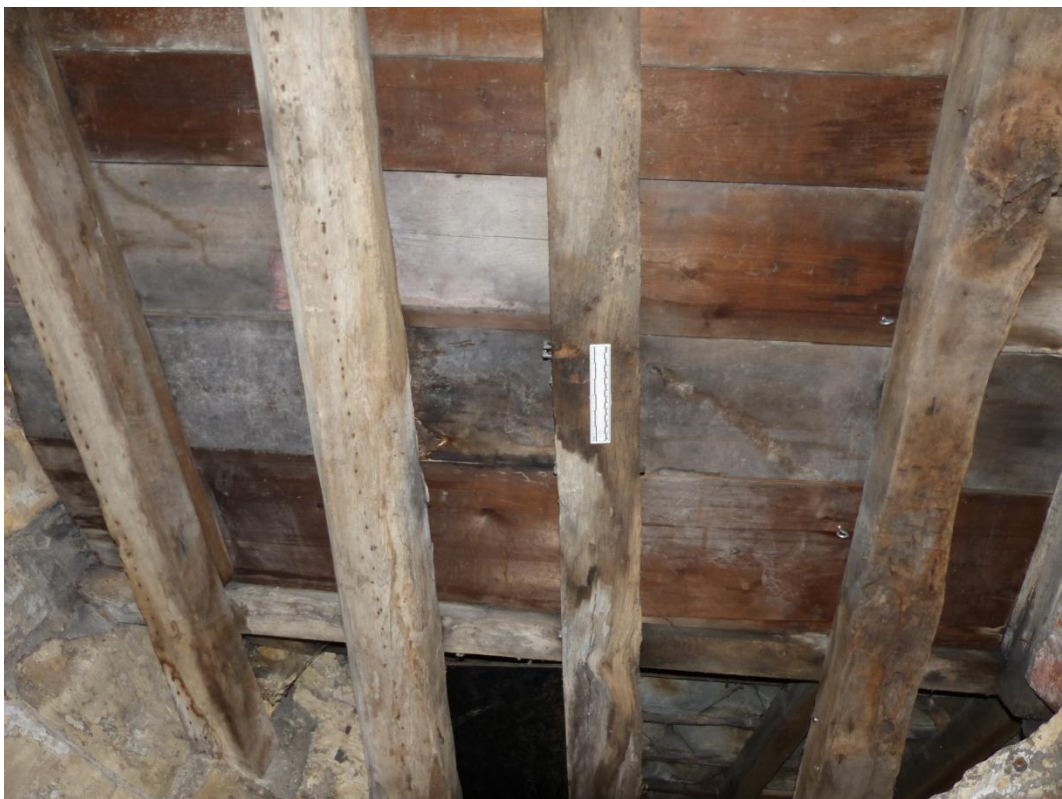
The east bartizan features four reused timber joists supporting a flat timber plank roof (Plate 18). Two of the joists have lathe nails suggesting they were originally wall studs. These timbers may have been reused from the conversion of the south elevation from timber to stone, c.1827. The west bartizan features the hatch to the top of the roof. The lower portion is

Plate 18 View of timber reused timber joist in east bartizan roof, looking up and west

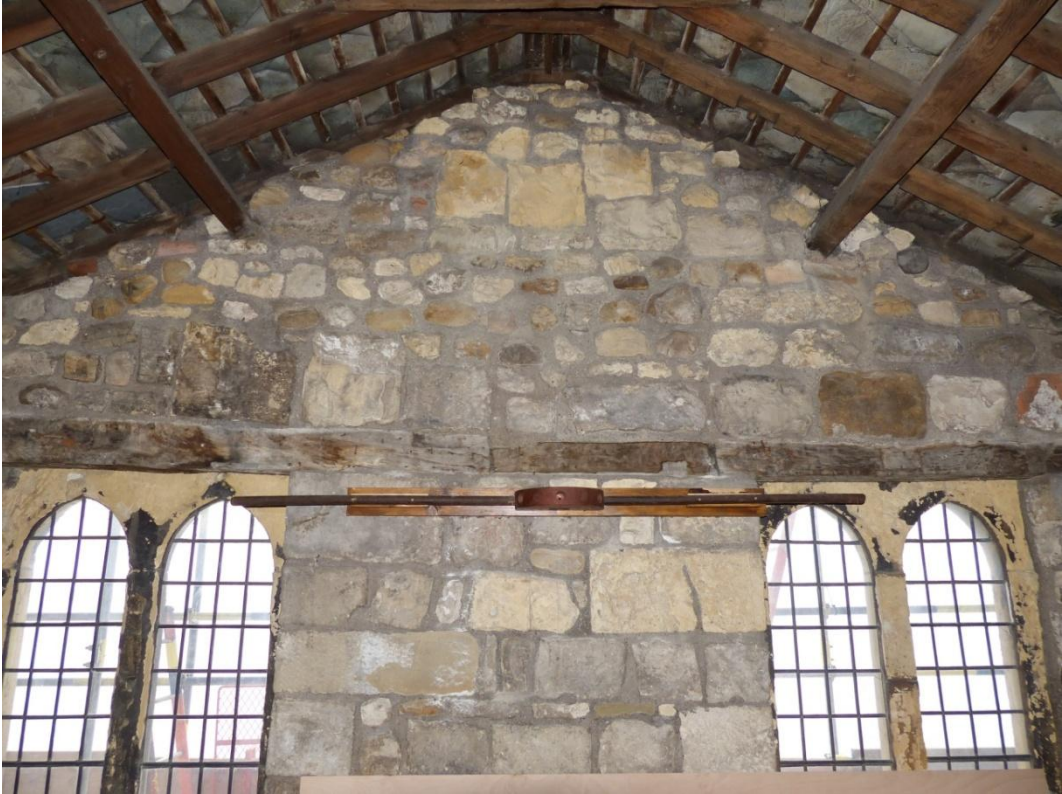
The north gable features a line of reused timbers within the stonework just above the windows (Plate 19). They don't appear to be necessary for structural support, so it may be that they were added to incorporate some of the old building into the new. They may act as a bonding layer within the stonework; however, that practice generally went out of use in the 18th century.

Plate 19 View of the north gable end incorporating reused timbers.
