SITE	York City Walls Tower 39				
CLIENT NAME	City of York Council				
YAT PROJECT#	6051	YAT REPORT #	2018/66		
MUSEUM ACCESSION #	N/A	GRID REFERENCE	SE 60696 51258		
PLANNING REFERENCE #	N/A	AAI OPS NOTICE#	N/A

INTRODUCTION

A watching brief on reinforcement works at one of the towers on York City Walls was undertaken by York Archaeological Trust on behalf of City of York Council between 25th April and 3rd May at York City Walls Tower 39, NGR SE 60696 51258 (Figure 1). The objective of the watching brief was to record any archaeological deposits or structures exposed by the ground works.

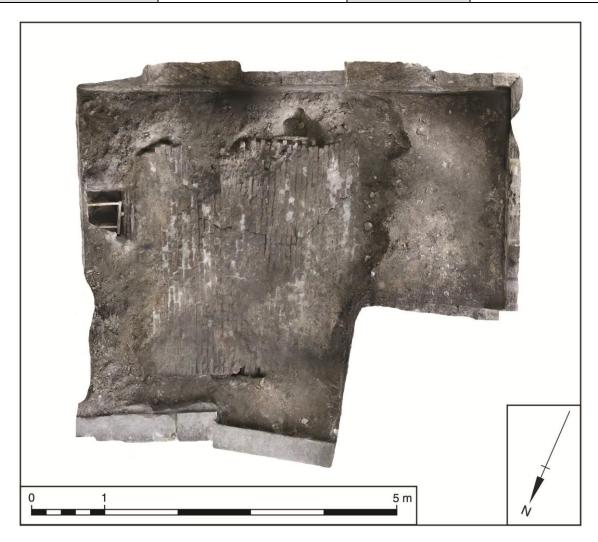
The main brick arch was located centrally on the northeast side of the tower platform and measured 3.15m x 3.12m with bricks measuring 240mm x 110mm x 53mm, suggesting a date of 16th to late 18th century. At the northeast side of the platform the stone-built chimney included a brick built section at the top. The bricks were 220mm x 105mm x 44-50mm, and thus could be late medieval or early post medieval in date. The length and width indicates post medieval, but the thickness may indicate earlier. It also indicates that the structure pre-dates the main brick arch of the tower.

Figure 3 Scaled photo of the brick arched vault on top of Tower 39

The central brick arch exposed during the first phase of works required in-situ strengthening using a limecrete pour to reinforce the sides and top of the arch. To achieve this the top of the brick arch was fully exposed as well as the sides to the level of the springer, where possible. In addition the ends of the brick arch were revealed and the brick element of the chimney to the northeast was reduced and rebuilt.

A scaled image of the main brick arch was produced and can be seen below.

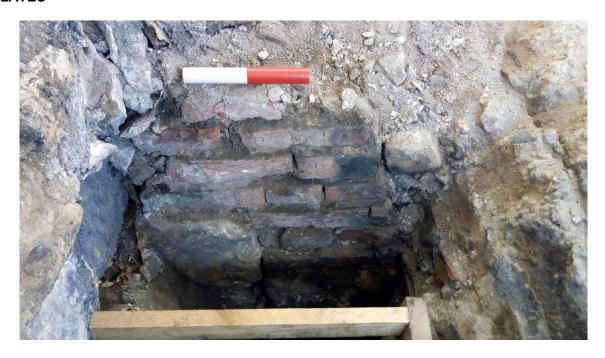
Plate 1 Upper brick section of chimney

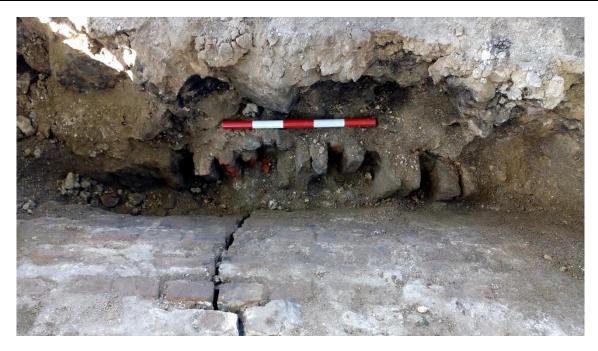
To the southwest the arch of the smaller room was made with bricks of the same dimensions as the chimney, again suggesting the structure was earlier than the main arch. Where exposed, the junction between the smaller vaulting and main section also indicated that the smaller section was earlier. The brickwork at the northeastern side was irregular and it appeared that individual bricks had been pulled out of the structure, most probably making space for the later main arch.

Plate 2 Junction of small room brick vault, at the top of the plate, with the main brick vault arch at bottom of plate
