Archaeological Investigations at
Land at Thorne Road, Sandtoft, Lincolnshire

By T. Kendall

YAT Assessment Report 2018/64 June 2018

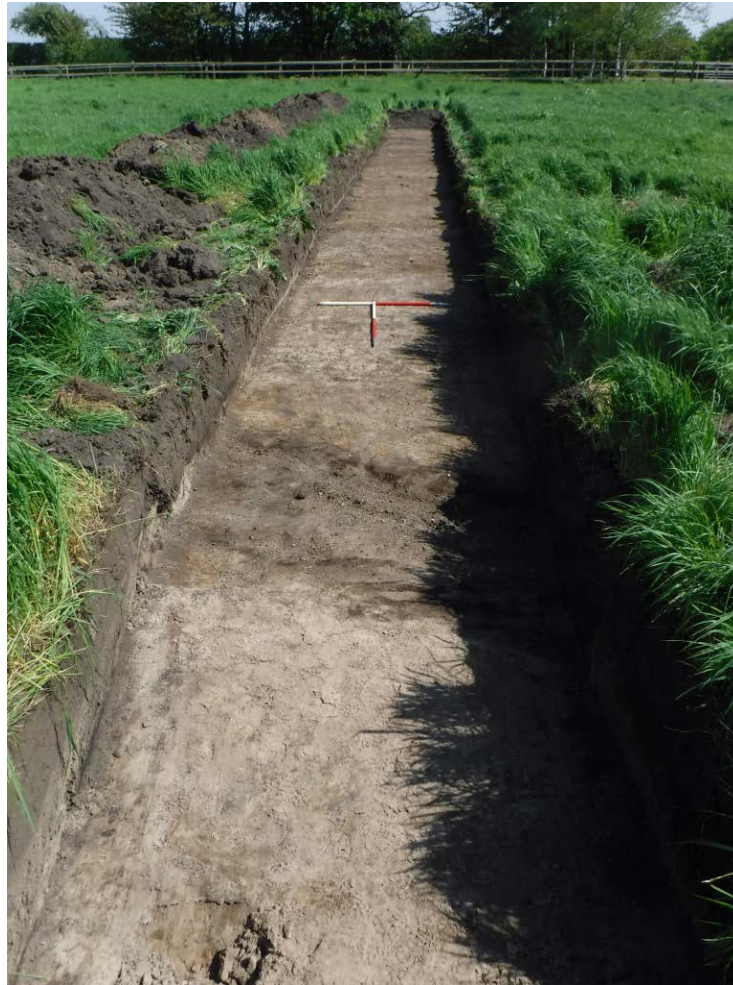
Plate 2 Trench 1, facing east, scale unit 500mm

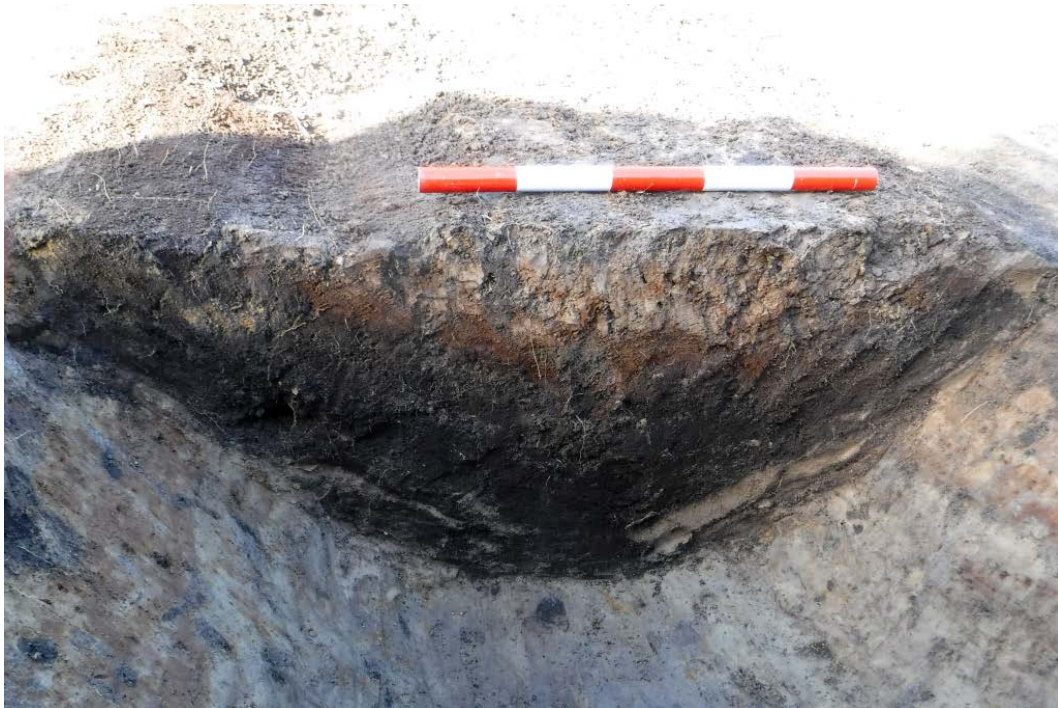
Plate 3 Ditch A (cut 1003), facing southwest, scale unit 100mm

No finds were retrieved from the feature. The origins of the uppermost clayey backfill was unclear, but may be linked to imported materials and/or the degradation of the organic materials within the upper fill.

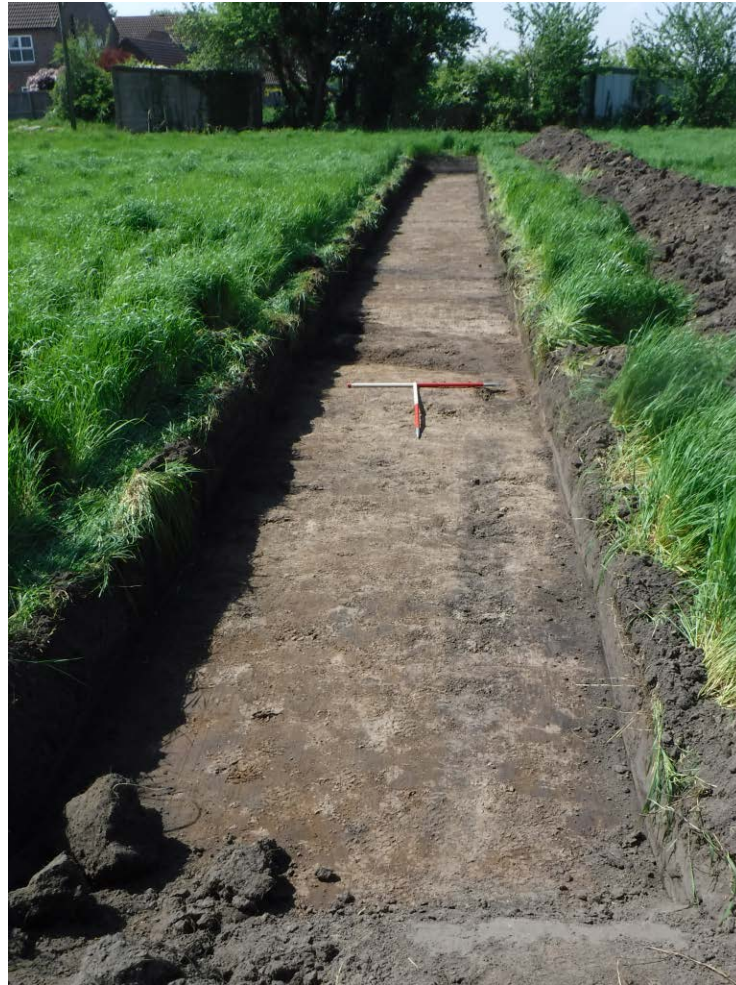
Plate 4 Trench 2, facing east, scale unit 500mm

The earliest deposit encountered within Trench 2 was natural light brown sand at c.2.0mAOD, sloping down to the west to a depth of c.1.85mAOD. The lower section to the west was also darker and may have been a more 'damp' part of the site under wet conditions.

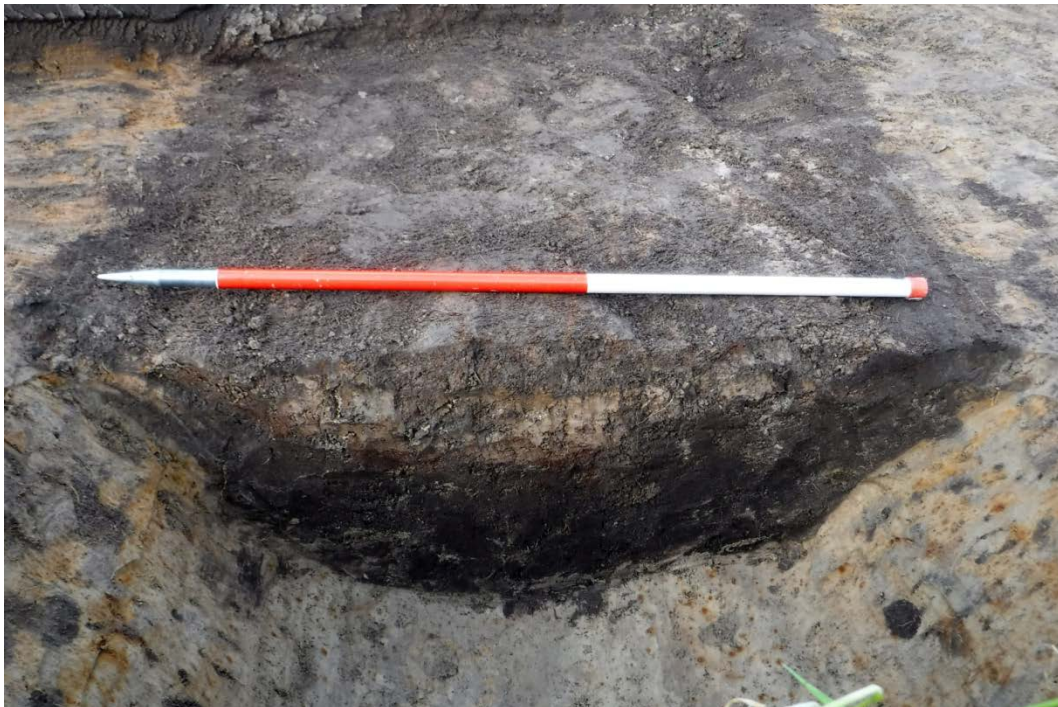
Plate 5 Ditch B (cut 2004), facing southwest, scale unit 500mm

No finds were retrieved from the feature. Again the origin of the clay in the upper backfill is unknown, but possibly linked with imported materials and/or the degradation of the organic material within.

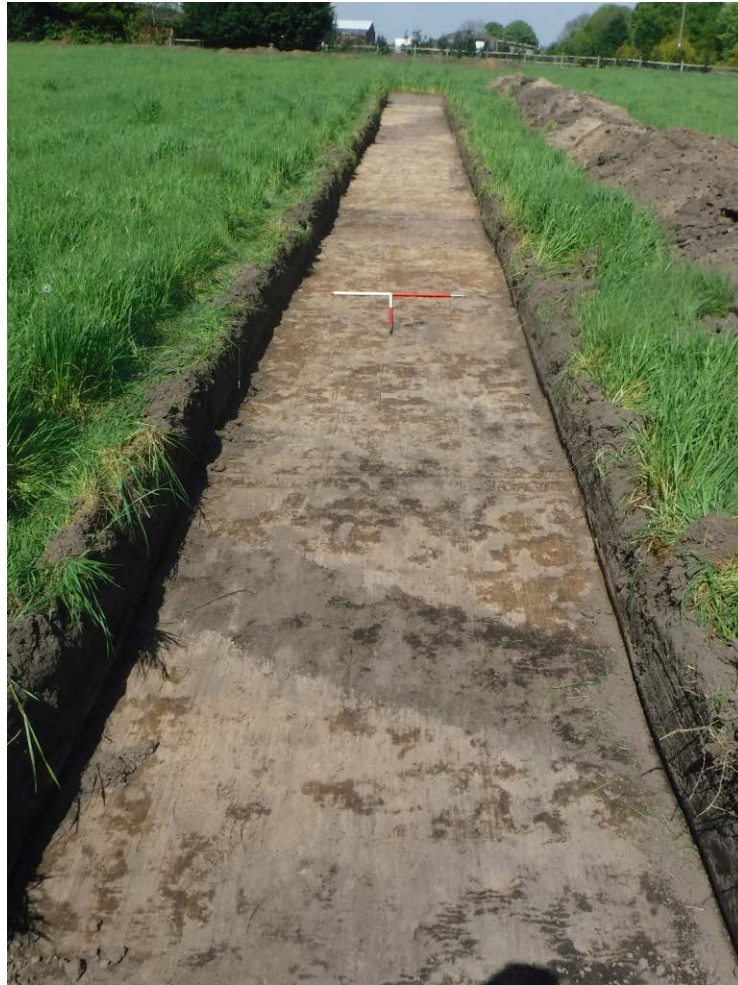
Plate 6 Trench 3, facing north, scale unit 500mm

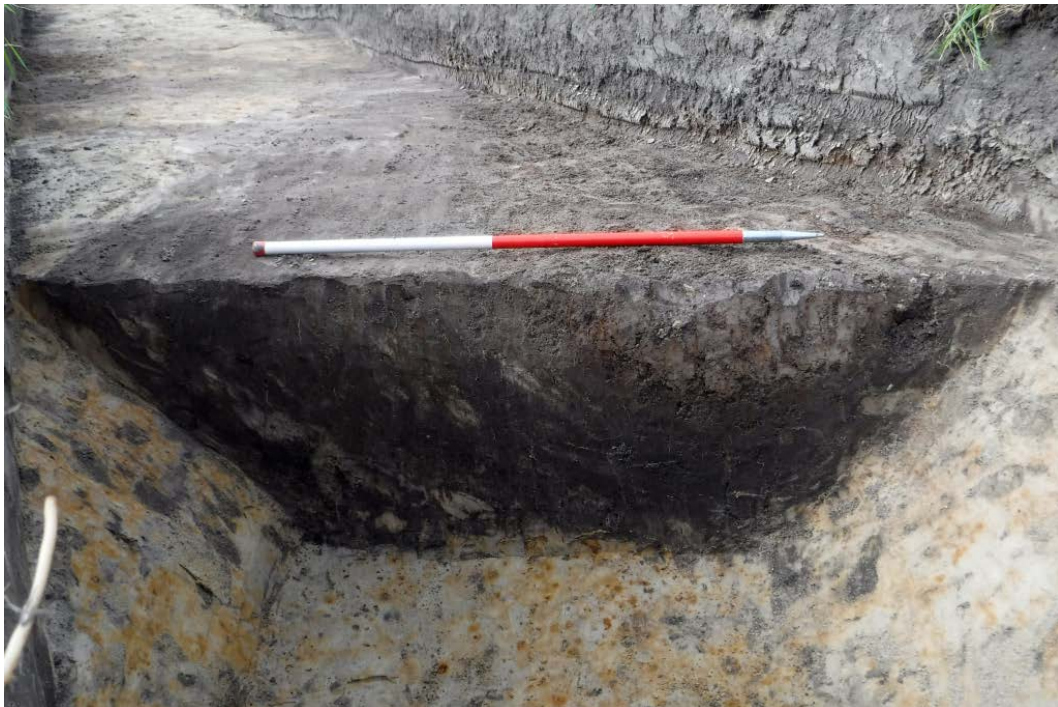
Plate 7 Ditch B (cut 3009) and possible earlier phase (cut 3012), facing southwest, scale unit 500mm

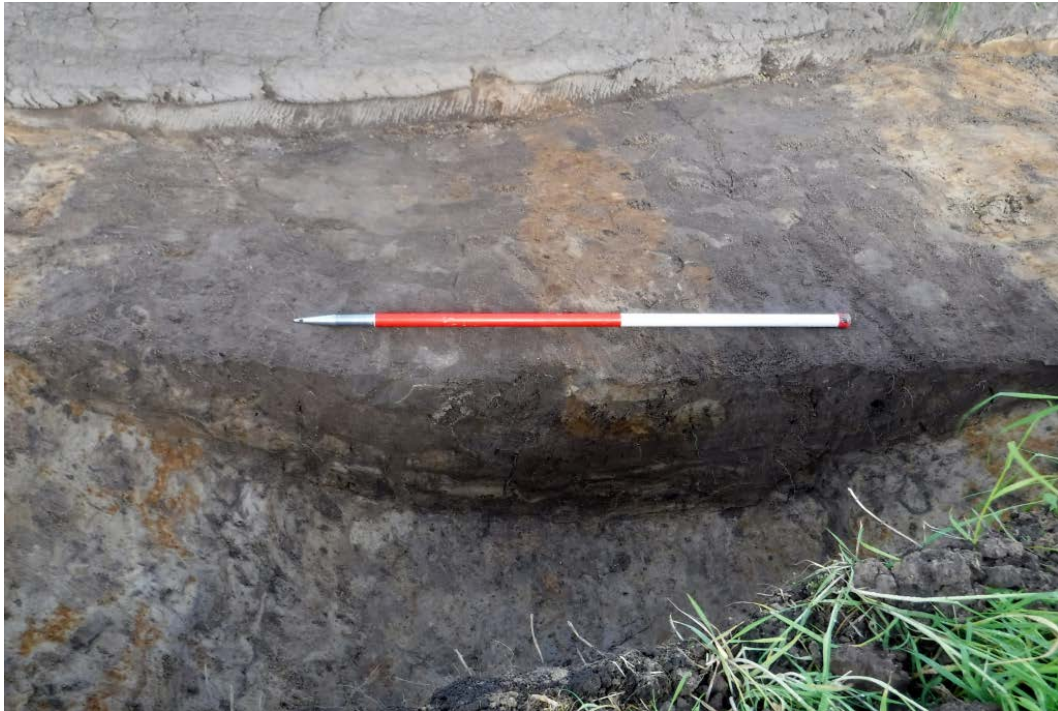
Plate 8 Ditch C (cut 3005), facing westnorthwest, scale unit 500mm

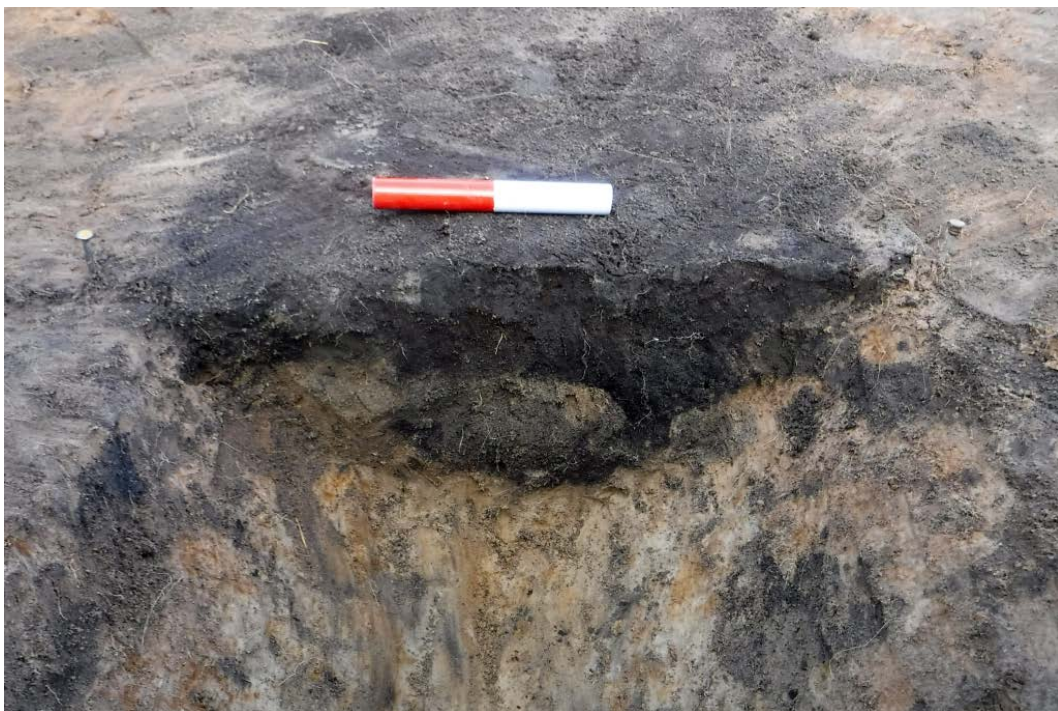
Plate 9 Ditch/gully (cut 3006), facing northwest, scale unit 100mm

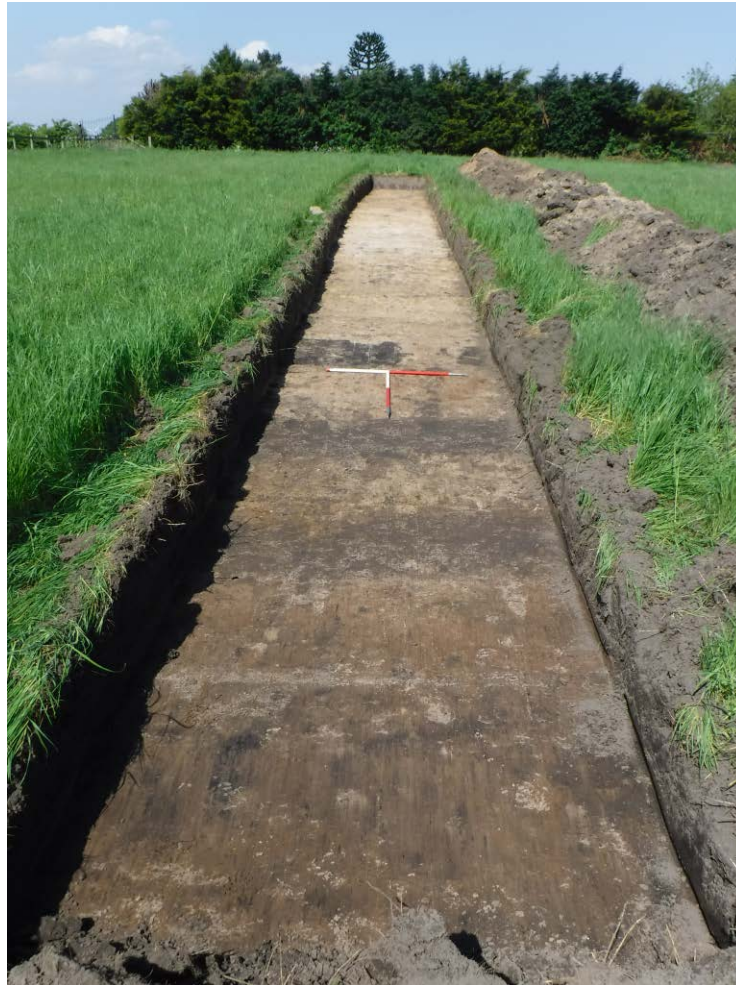
Plate 10 Trench 4, facing north, scale unit 500mm

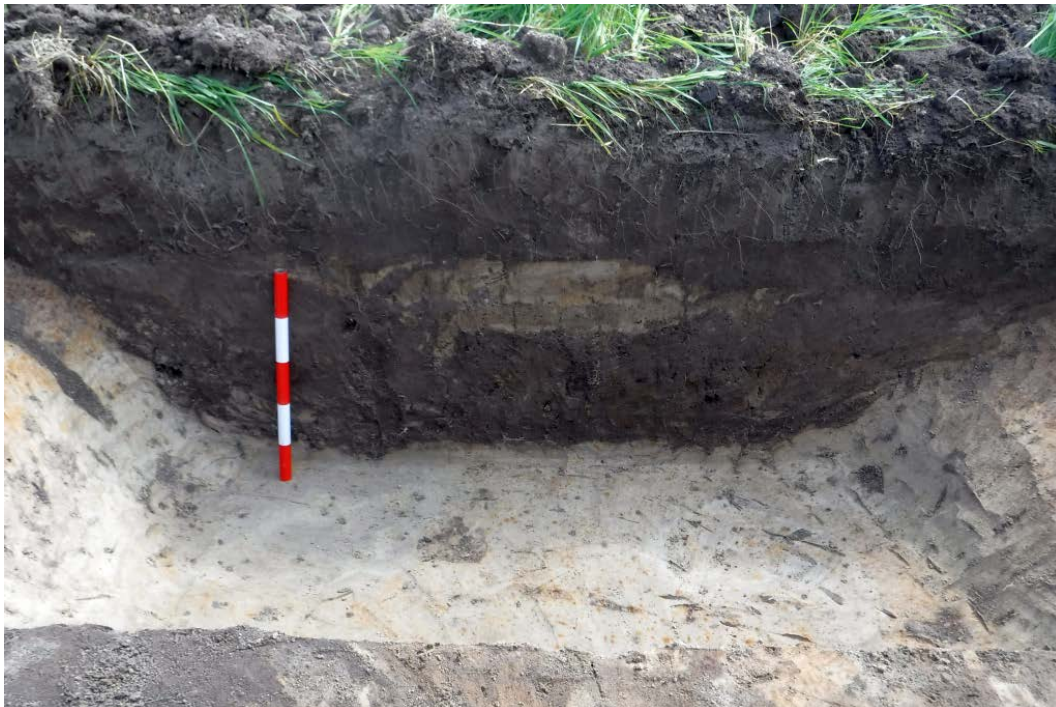
Plate 11 Ditch C (cut 4003), facing east, scale unit 100mm

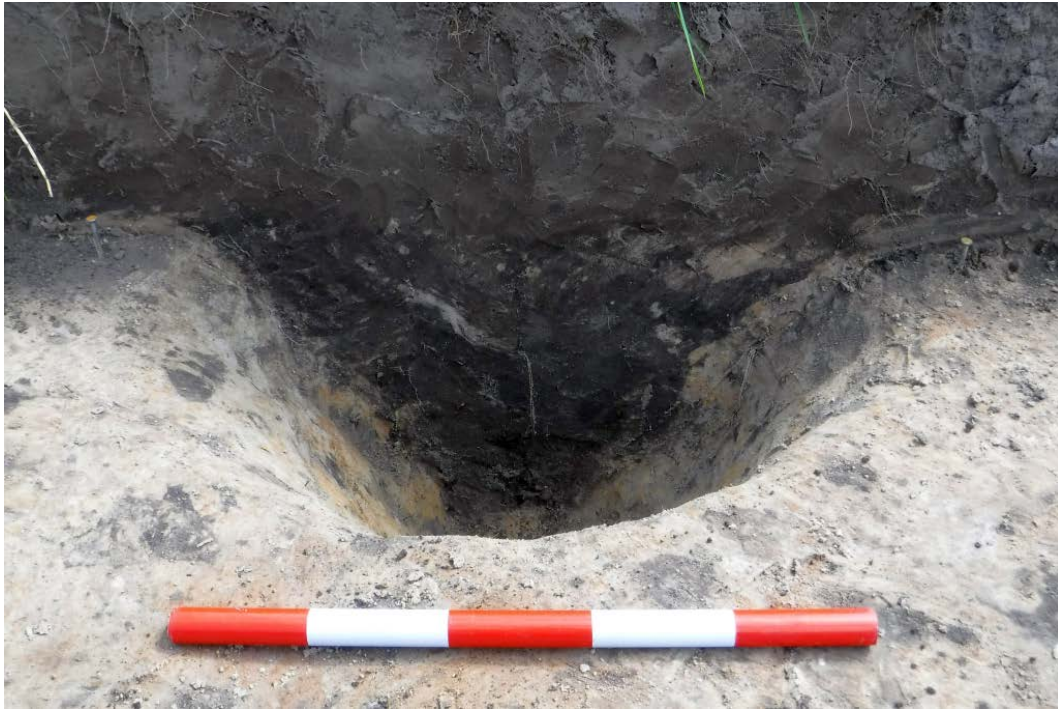
Plate 12 Ditch/gully (cut 4005), facing east, scale unit 100mm

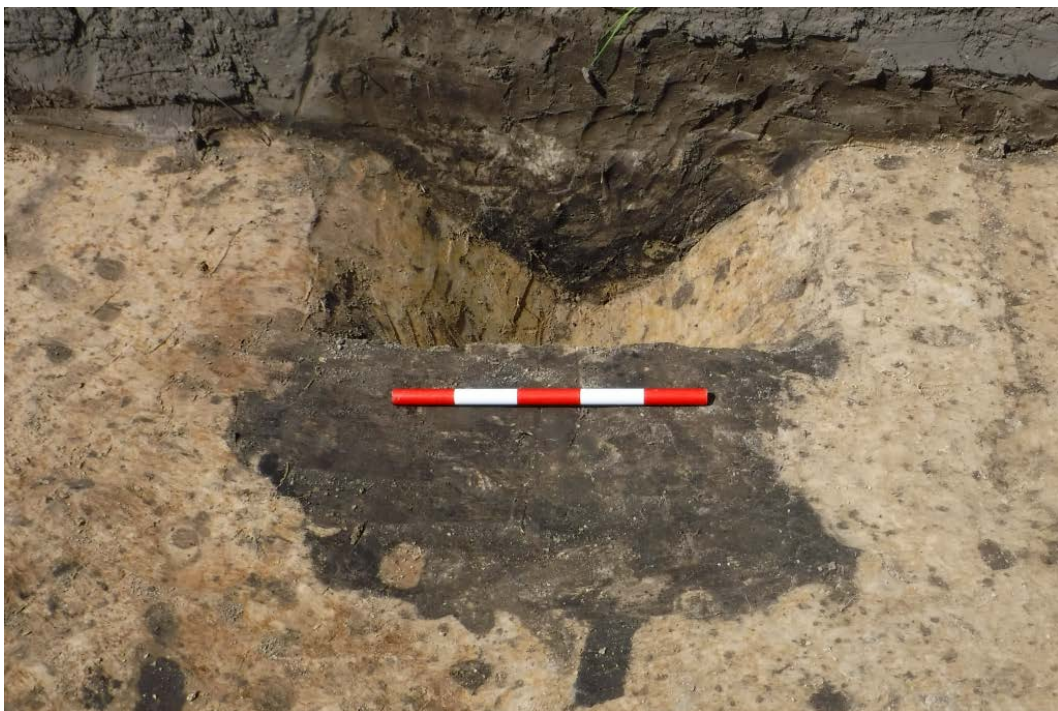
Plate 13 Ditch/gully (cut 4007), facing west, scale unit 100mm

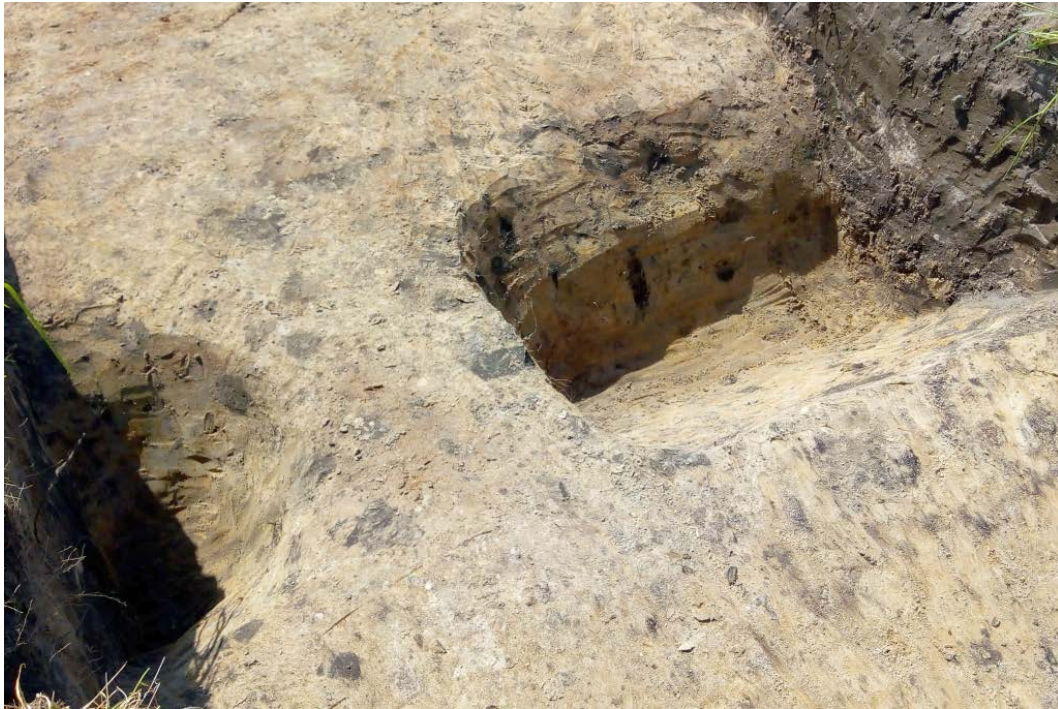
Plate 14 Possible opening/crossing between ditches (cuts 4005 & 4007) facing southwest

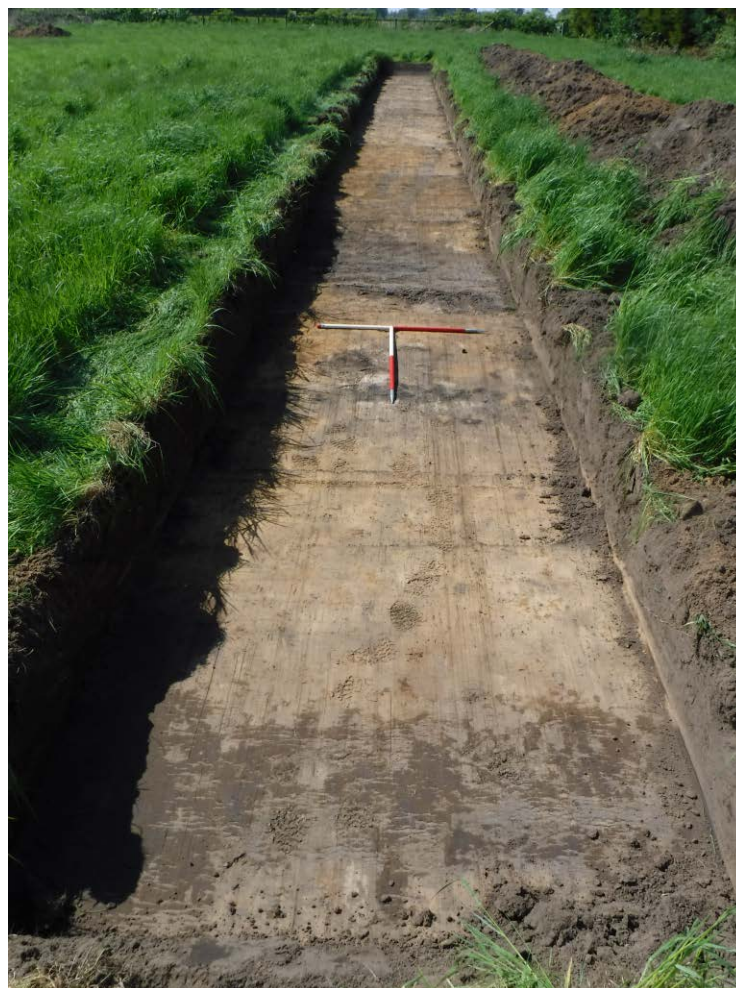
Plate 15 Trench 5, facing west, scale unit 500mm

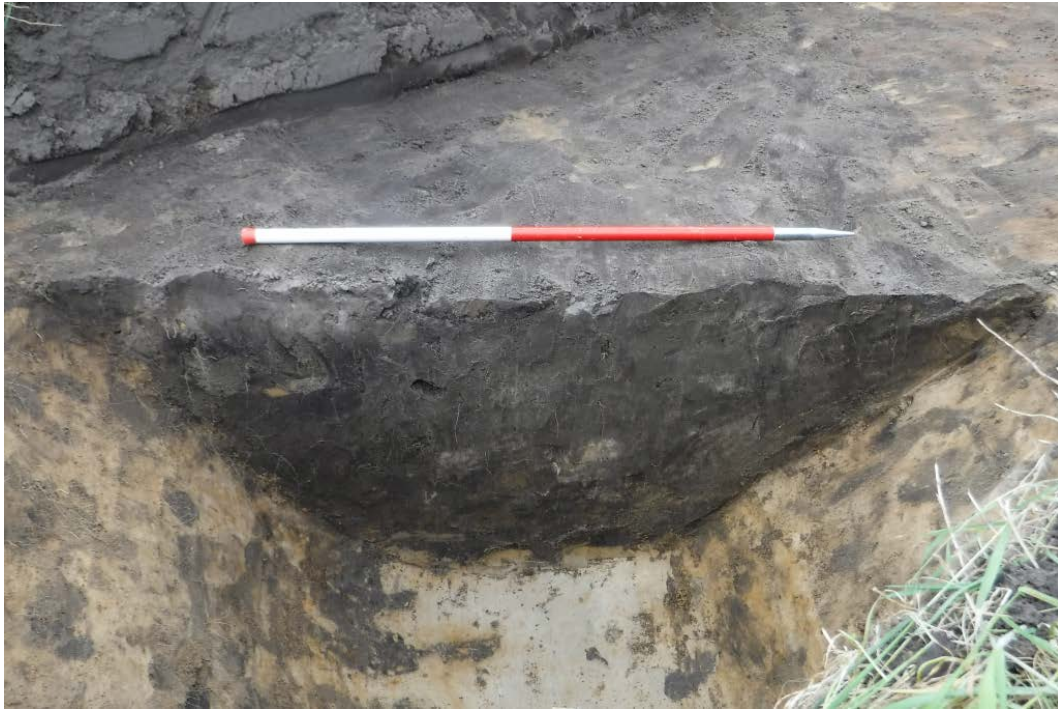
Plate 16 Ditch B (cut 5006) facing southwest, scale unit 500mm

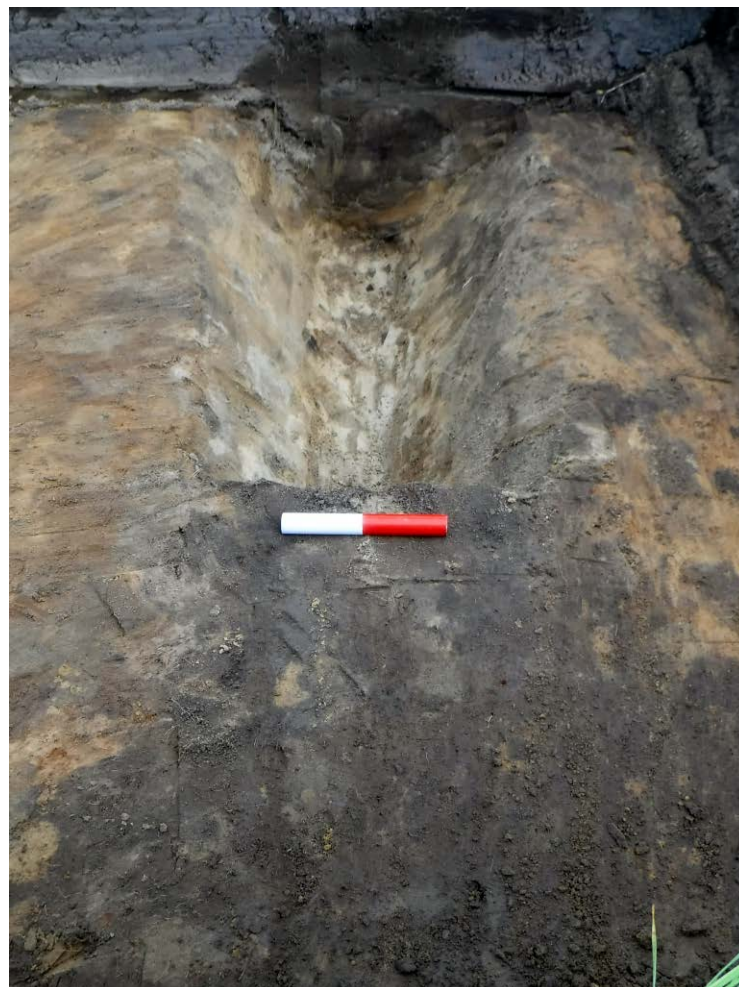
Plate 17 Ditch/Gully (cut 5003) facing north, scale unit 100mm
