ARCHAEOLOGICAL INVESTIGATIONS AT THE BLUE BICYCLE, FOSSGATE, YORK

TEST PIT & WATCHING BRIEF REPORT

Report Number 2017/113 May 2018

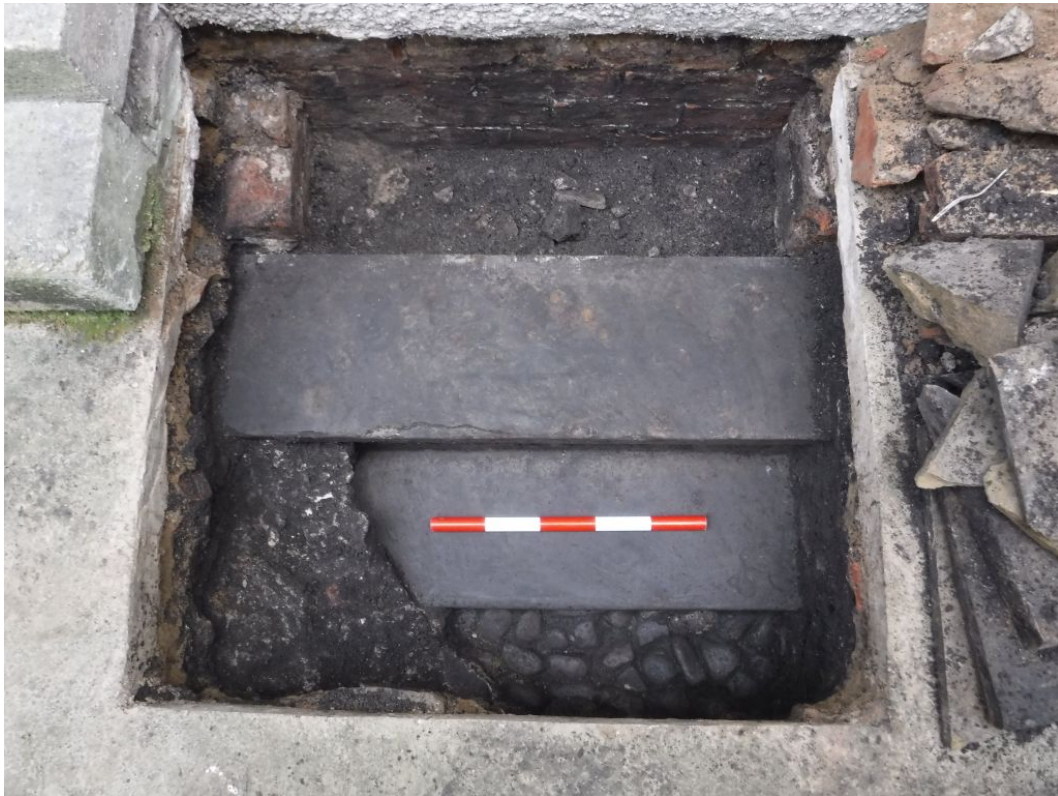
Plate 1 Test pit 1 final excavation record shot, facing north-east, scale unit 100mm

The north-east extent of the trench was bounded by a brick wall (1008), constructed from bricks measuring 230mm long and 77mm thick. The top of the wall was recorded immediately below the concrete floor surface, at c.0.06m BGL, and was visible to the top of a concrete step around 0.20m BGL. The wall was not excavated, but represented the earliest feature within the test pit.

The earliest deposit encountered was a cobble yard surface (1007), recorded at the base of the test pit at 0.56m BGL. The yard surface was made up of relatively small cobbles, with the largest cobble measuring up to 100mm in diameter. The composition of the bedding layer for the cobbles is unknown, as the cobbles were left *in-situ*. The relationship between the surface and the wall to north east (1008) was not revealed, however it is assumed that the building predated the yard.

A series of three steps (1006) were constructed on top of the yard surface (1007) and abutted the north-east wall. The steps were made up of brick support walls carrying York Stone treads and risers. Only the bottom 2 steps of treads and risers survived with the tread measuring 1000mm+ x 320mm x 53mm. The opening which the steps served was no longer visible and perhaps closed up at the same time the top step was removed.

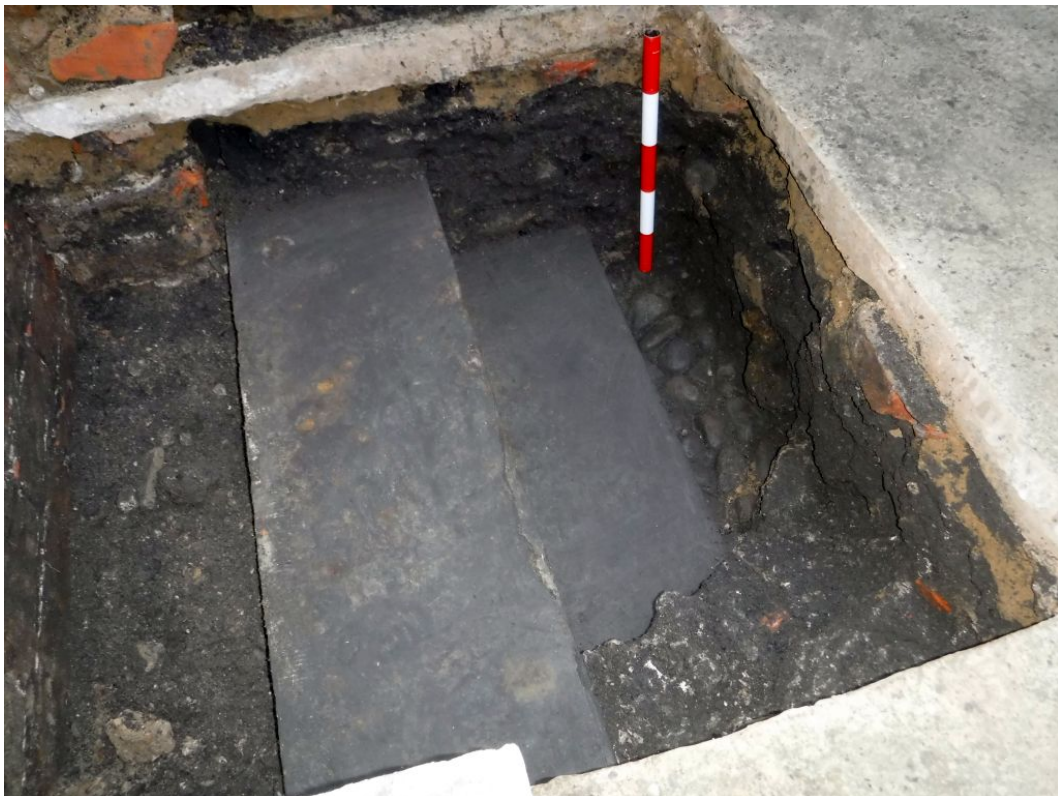
Plate 2 Test pit 1 final excavation record shot, facing south-south-east, scale unit 100mm

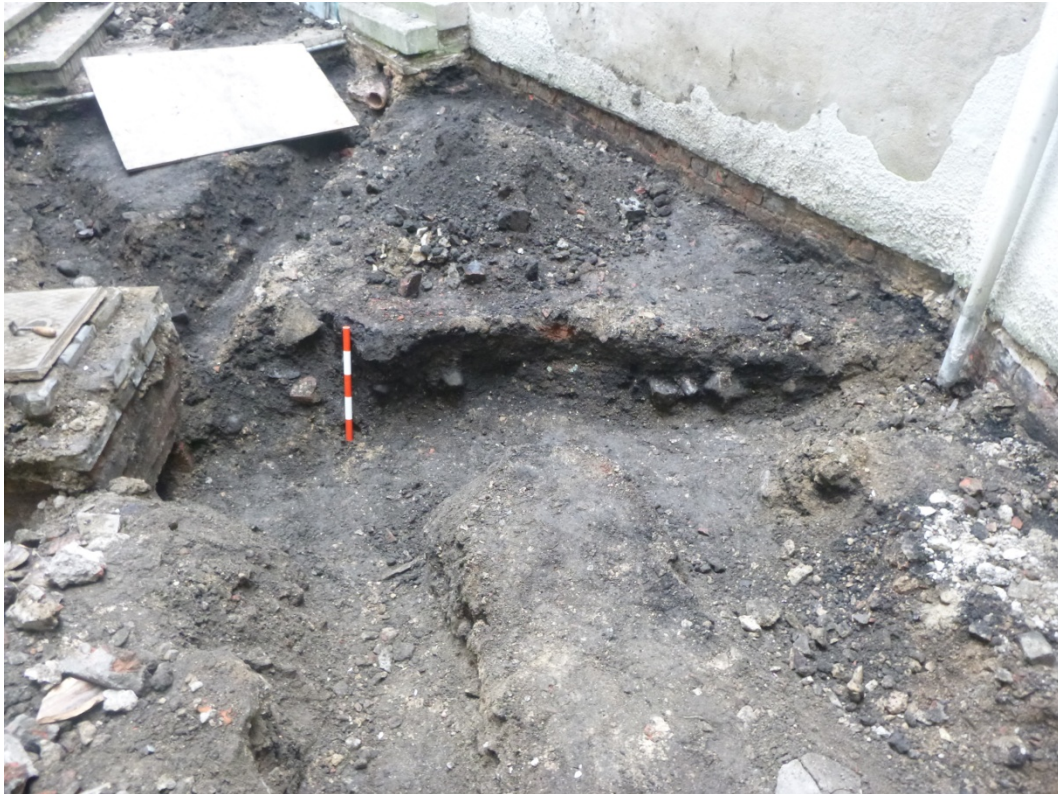
Plate 3 Lower yard after the removal of ceramic drains, facing north, scale unit 100mm

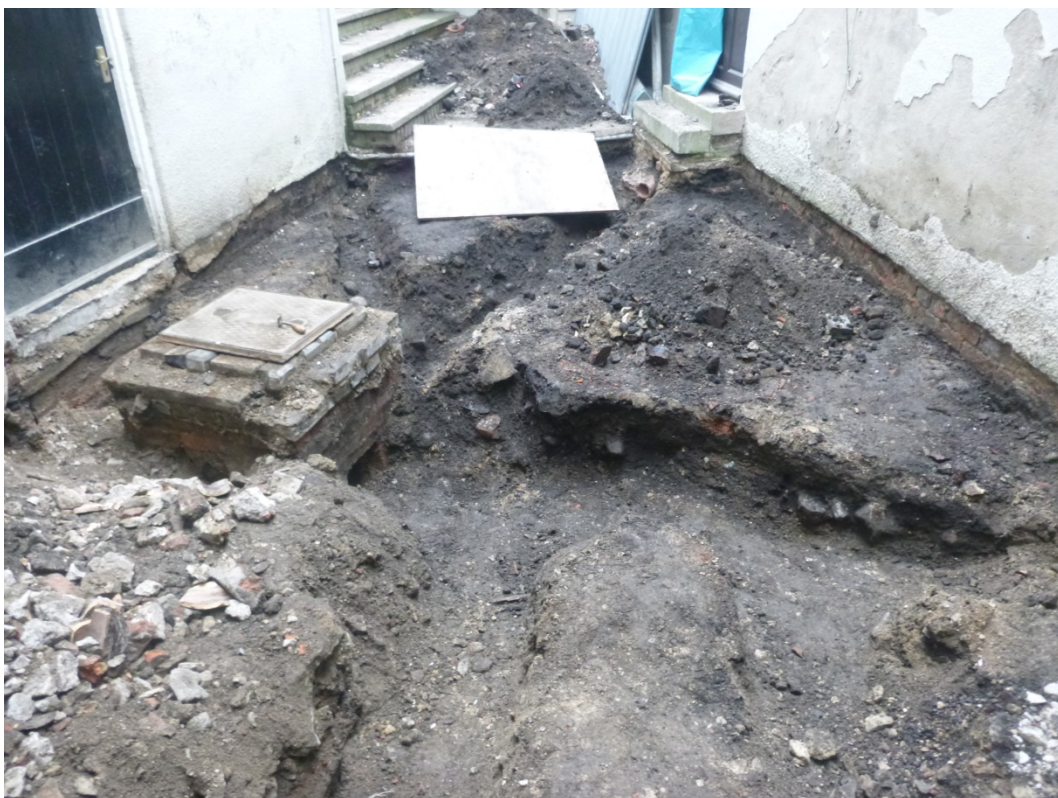
Plate 4 Lower yard after the removal of ceramic drains, facing north-west

This was followed by a series of ceramic drains that all connected to the brick chamber close to the entrance into the rear basement. (Plate 4) This was then capped by the fine sandy make-up layer for the modern concrete floor. This formed the ground level at 9.03m AOD at the southernmost corner and 9.08m AOD at the northernmost corner.

The earliest deposits encountered were associated with a series of levelling layers recorded at a depth of 8.72m AOD, set down prior to laying out the original floor level. This was then cut by a ceramic drain that ran across the centre of the room at a north-west/south-east alignment (Plate 5) that linked with the brick chamber outside the northern entrance (Plate 4).

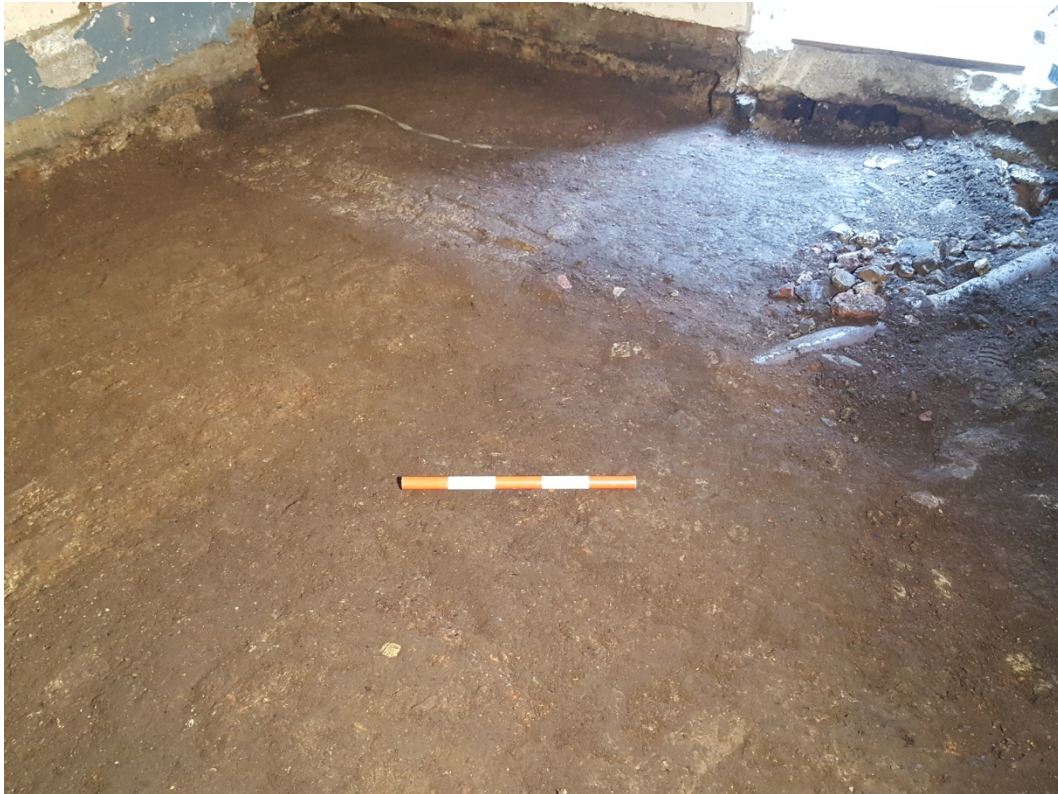
Plate 5 Rear basement after the removal of the in-situ brick floor, facing north, scale unit 100mm

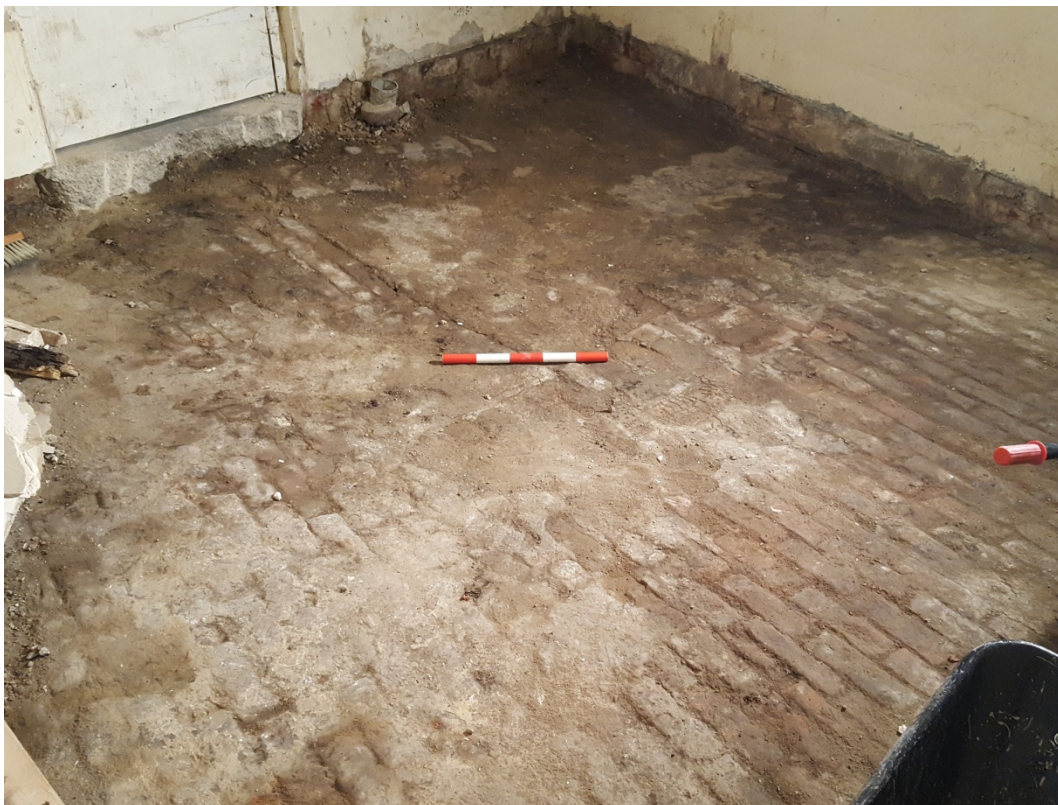
Plate 6 Rear basement revealing in-situ brick floor, facing east, scale unit 100mm

This was overlain by a brick floor constructed from bricks measuring 235mm x 105mm x 85mm and which were laid on their side as part of the original construction of the building (Plate 6). Most of the bricks were dated to the Brick Tax of the first half of the 19th century. However, there were a few that were distinguishably machine made. This suggests there were elements of later repair work, or the earlier bricks were reused for the floor during the second half of the 19th century onwards.

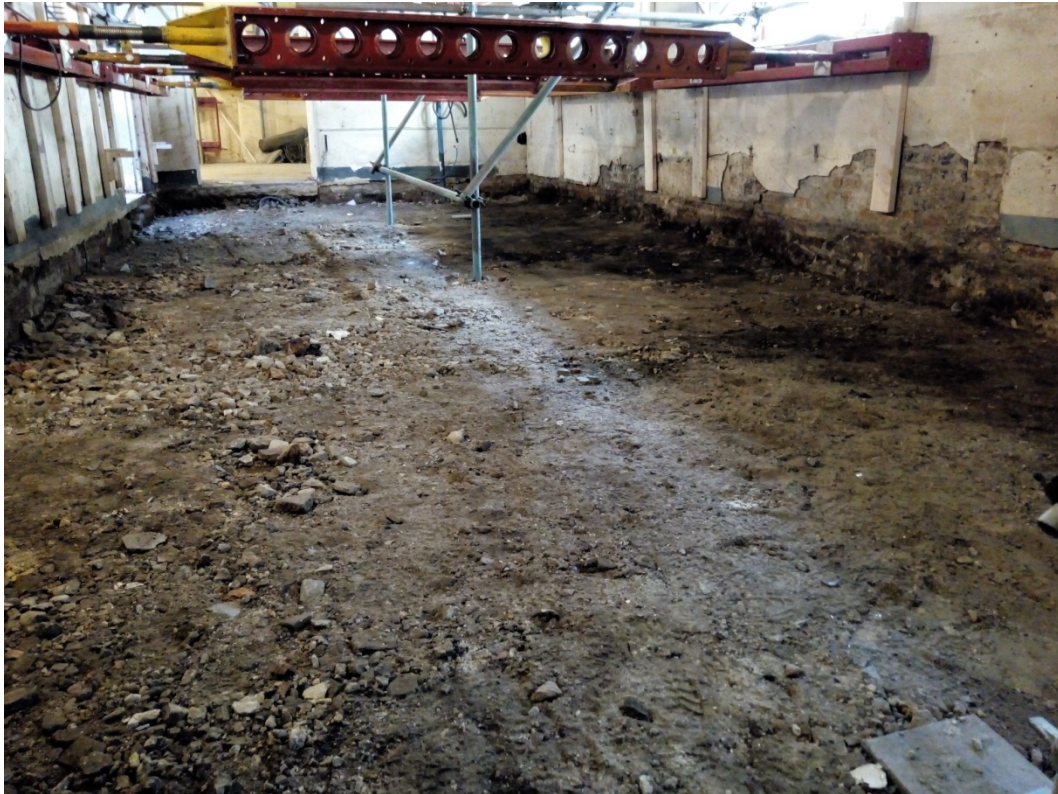
Plate 7 Main basement after ground reduction, facing east

The exposed area contained a mass fill to a depth of 350mm (Plate 7). This mass fill was typical to what is seen in late 19th century and early 20th century building before the laying of a solid floor. The material was predominantly rubble of mortar and CBM with occasional glass, pottery and bone fragments.

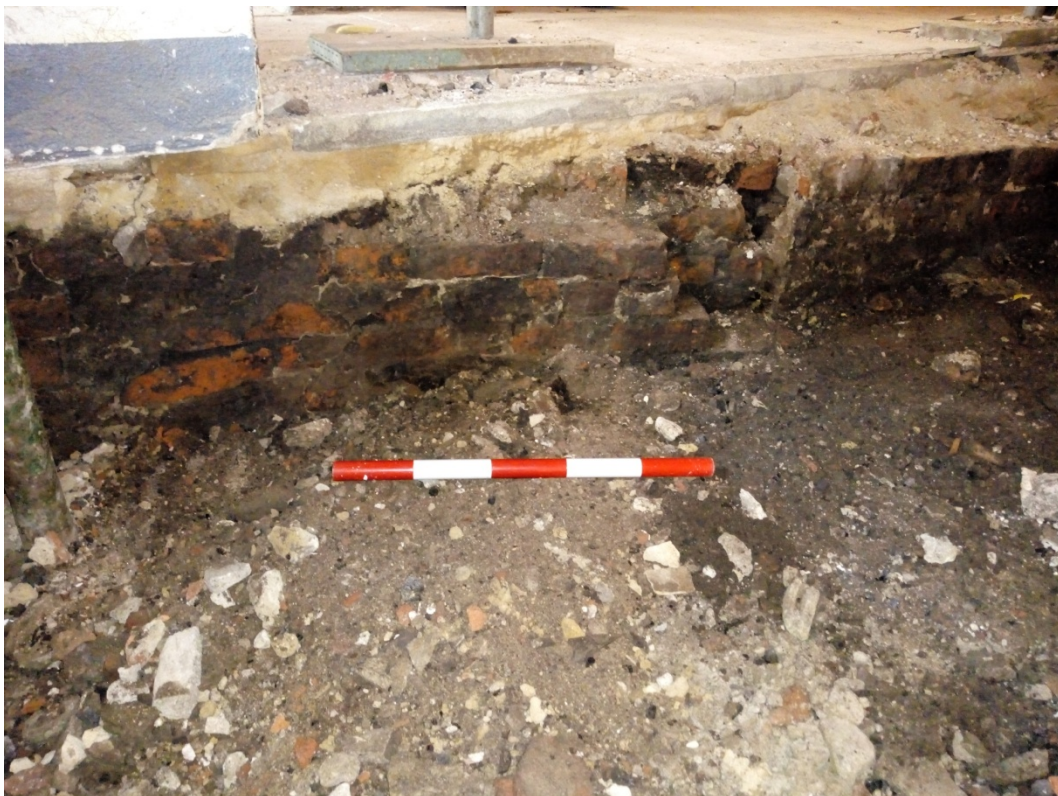
Plate 8 Shot of curved wall featured in 1852 OS map at south-west end of main basement, facing south-west, scale unit 100mm

The works revealed the lower sections of the extant walls, which were consistent with buildings of that type and date, bar the southwest limit of the partition room. The main walls contained bricks measuring 230mm x 110mm x 78mm, whilst the southwest limits of the partition room contained an earlier section of wall formed from bricks measuring 220mm x 110mm x 65mm (Plate 8) which were jointed with a thinner mortar bed. The wall itself was abutted by the southeast waterfront wall and also turned into the room slightly, with the standing building wall continuing beyond this point.

This earlier wall is visible on the 1852 first edition Ordnance Survey mapping as a boundary wall and possible small outbuilding.

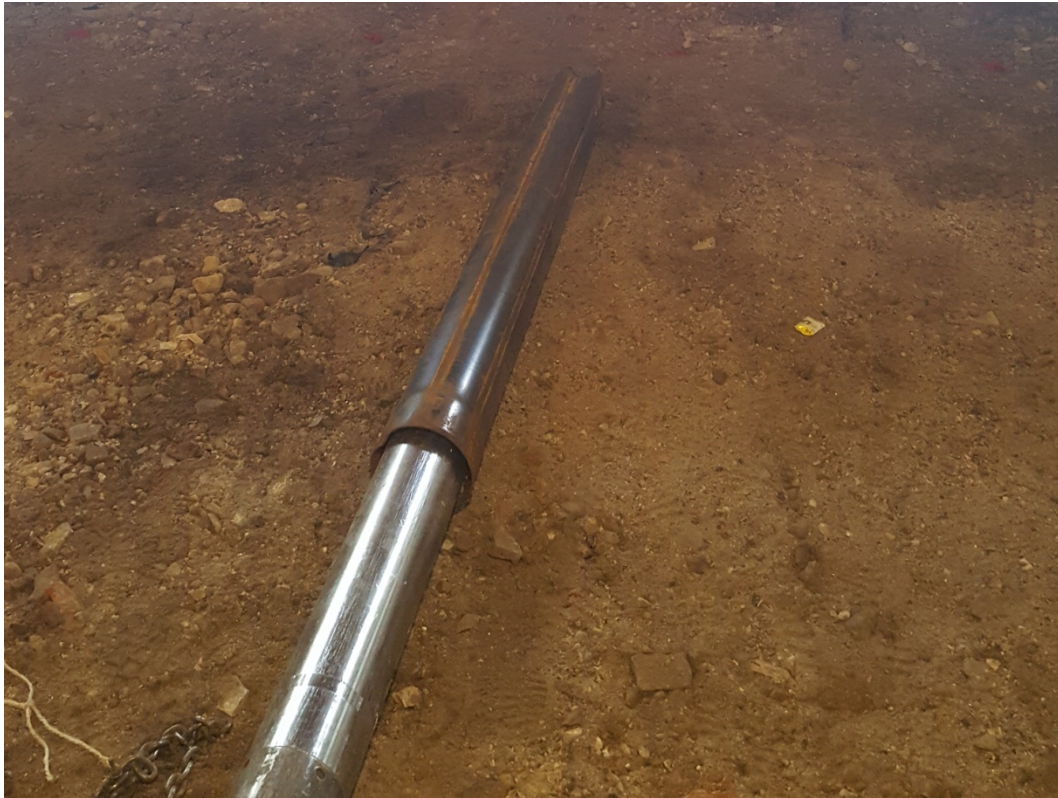
Plate 9 Shot of displacement pile prior to ground penetration

As previously mentioned in the methodology, the mini-piles involved the use of displacement rather than auguring therefore required no further monitoring apart from a sample photographic record of the displacement pile (Plate 9).

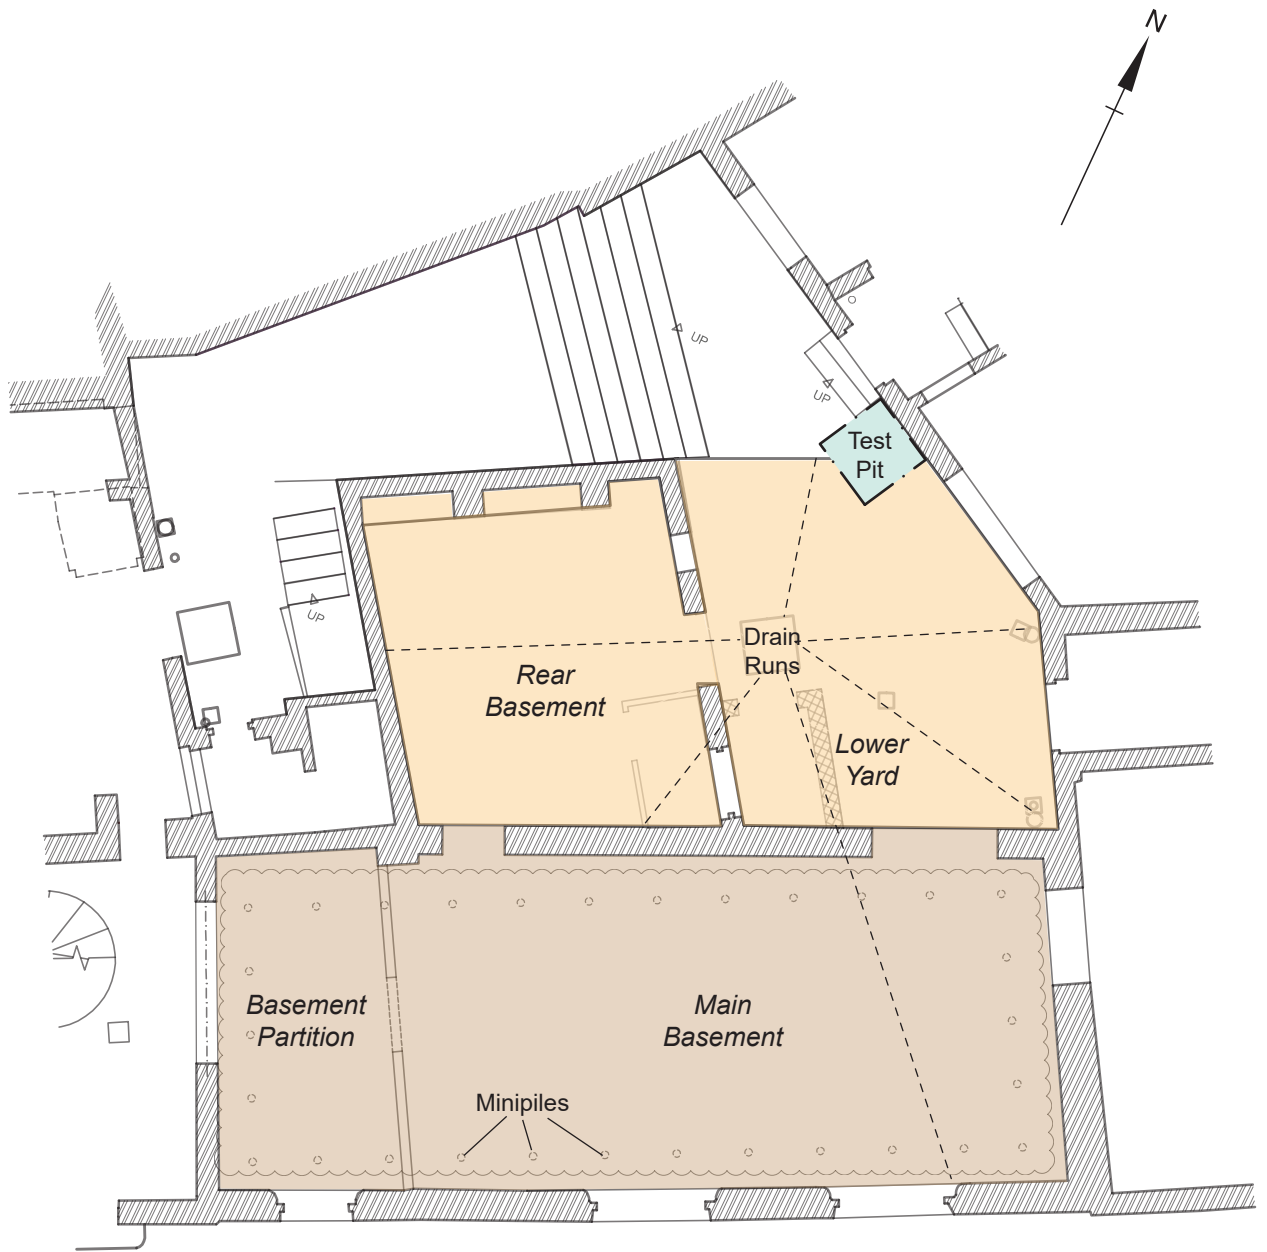
Figure 2 Works Location (after drawing no. 14297-Y-DR-014rev.T2)

A single test pit was excavated and recorded and a subsequent watching brief during engineering works was carried out (Figure 2).

Continuous monitoring of ground reduction within the lower yard, rear basement, main basement and basement partition (Figure 2) was undertaken. When it was confirmed that

5.1 As a minimum this work will comprise a continuous/comprehensive watching brief, on the excavation of all floor slabs, trenches for services and any subsequent groundworks involving excavation (Figures 2). The watching brief may be stepped down to intermittent monitoring, depending on the results, and following agreement from the Development Control Archaeologist.
