YORK ARCHAEOLOGICAL TRUST

Building Recording at 79 Fulford Street, York

YAT Building Recording Report 2018/84 June 2018

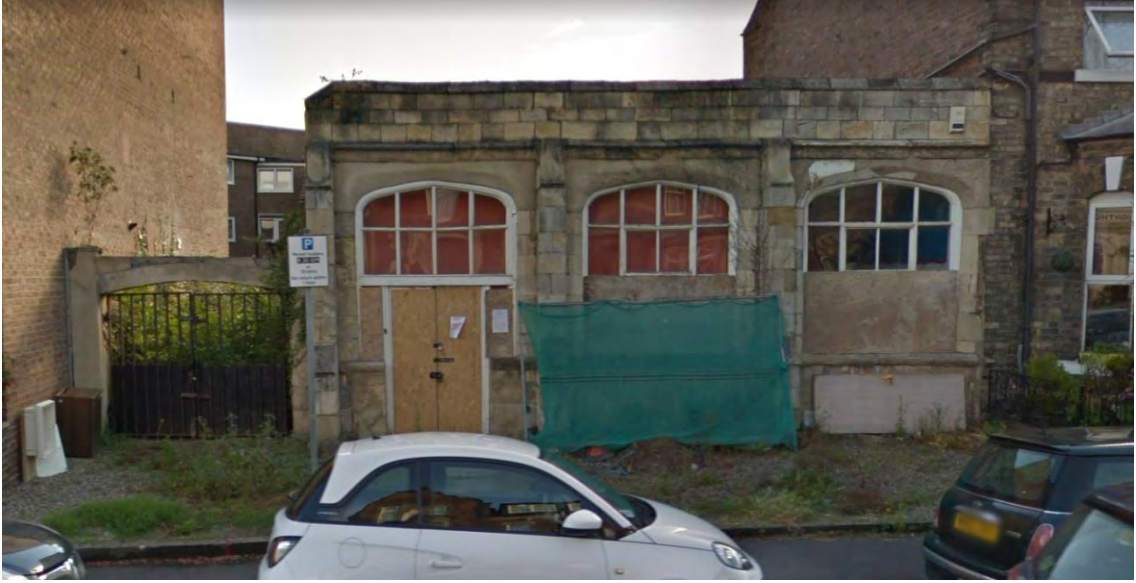
Plate 6 General view of the York Theatre Royal arcade, looking east (2017)

The frontage building consists of three bays of the original eight-bay arcade to York Theatre Royal (Plate 6). The design consists of Tudor arches, with hood mould and is surmounted by a parapet wall each divided by projecting two-stage buttress piers. The piers once featured finials however these have since been removed. The ashlar blocks are constructed of magnesian limestone bonded with a fine light grey lime mortar. The arches are now covered with a fine render covering over what appears to be damage or decay (Plate 7), visible in a few places where the render has fallen away. The two southern arch openings contain timber framed multi-pane windows, which are now heavily damaged and boarded over. The third northern arch contains a multi-pane overlight and a double-leaf timber glazed door with sidelights, these too are heavily damaged and boarded over (Plate 8). The aprons under the windows and around the door opening appear to be later additions as the earliest depiction of the arcade at the Theatre royal do not feature them. Another opening has been added to the north of the these three arches (Plate 9), it is a low segmental arched gateway, mostly rendered but with some similar stonework that may have been salvaged when the other five arches were removed. The arch holds two modern iron gate doors.

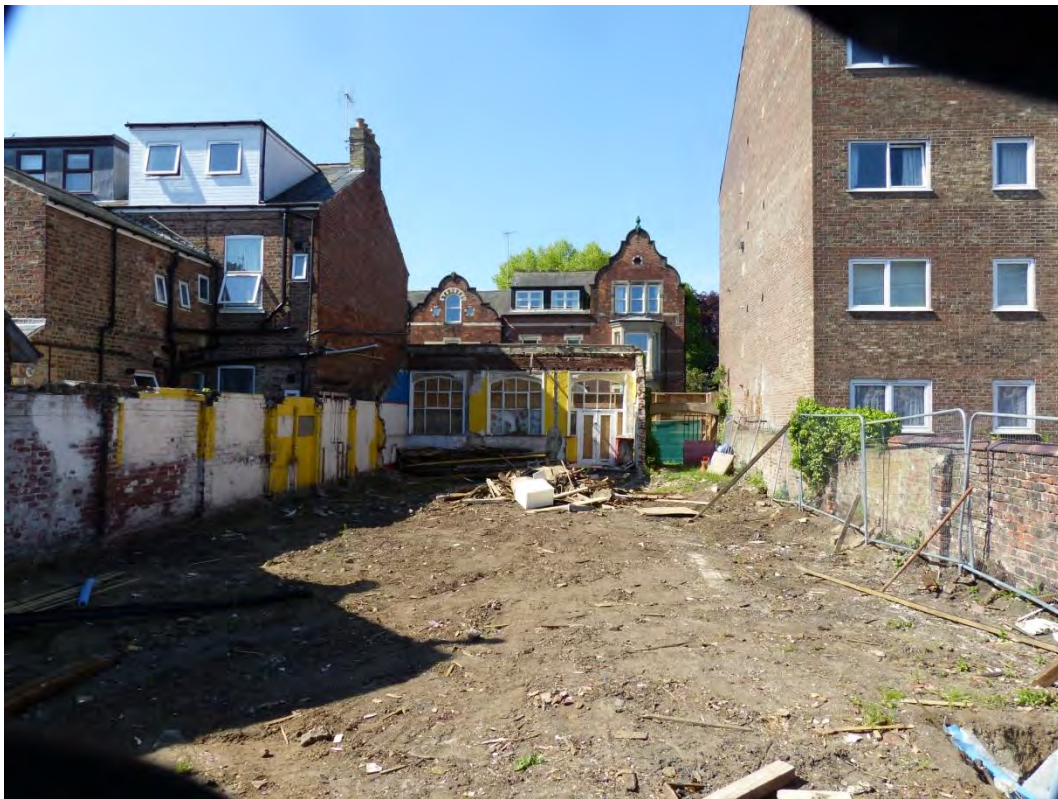
Plate 11 View across site showing empty lot between arches and coach houses, looking west

The rear of the arches are not particularly visible as they have had a building attached to them in the past, the remains of which now help stabilise the arcade (Plate 11).

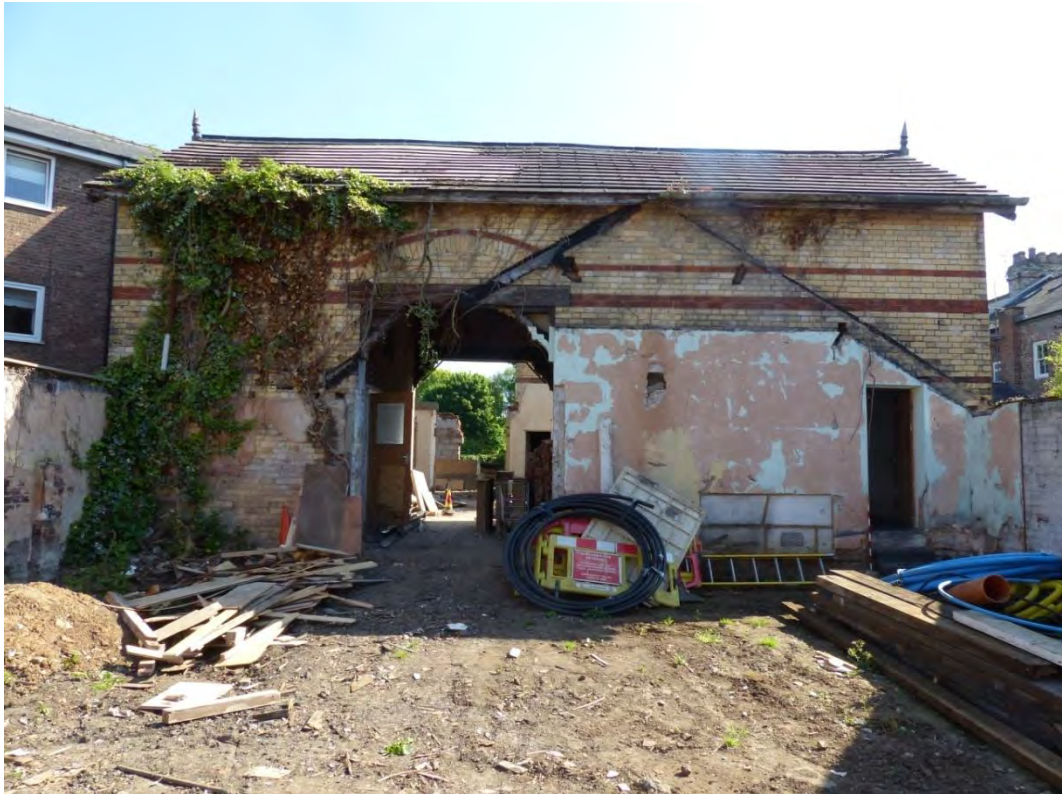
Plate 12 West elevation of the west coach house, looking east

The rear (west) elevation features two openings, a later inserted door opening to the south end of the elevation and the carriageway (Plate 12). The ground floor is rendered and the first floor features the same polychromatic effect the east elevation displays, but without the window openings. A pitched roof scar is prominent across the majority of the elevation (Plate 13), this was a long modern building attached to this portion of the building and aligned north-south down to the arches.

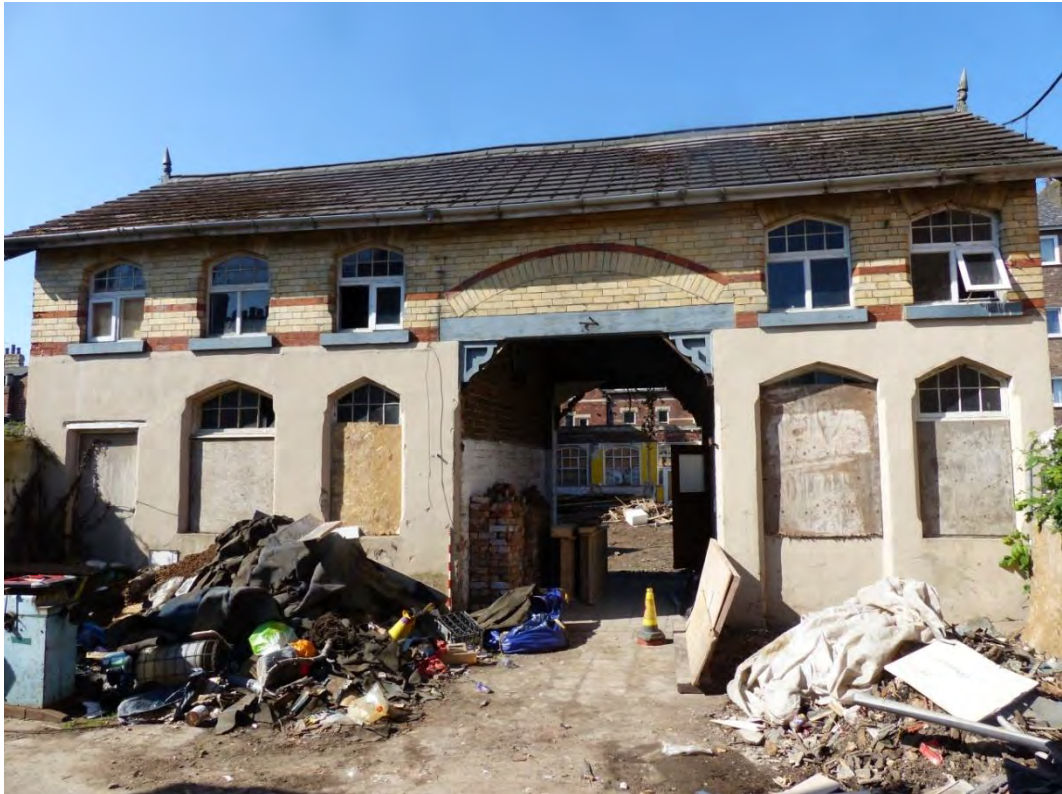
Plate 14 East elevation of west coach house, looking west

The east elevation is composed of six bays over two floors (Plate 14). Three openings to the south structure, the carriageway, and then two more openings to the north structure. The ground floor up to sill level is rendered and the first floor features yellow brick with red brick banding creating a polychromatic effect. All the window openings are similar with a Tudor arch opening and timber-framed windows with eight pane fixed overlights and hopper windows to the first floor and sliding sash to the ground floor (Plate 16). There is evidence the second

The roof features recent replacement ceramic tiles and replacement plastic guttering to the east elevation (Plate 14). The roof has original ceramic ridge tiles, timber barge boards to the north and south side elevations with decorative finials. Original timber fascia boards are located along the east and west elevations.

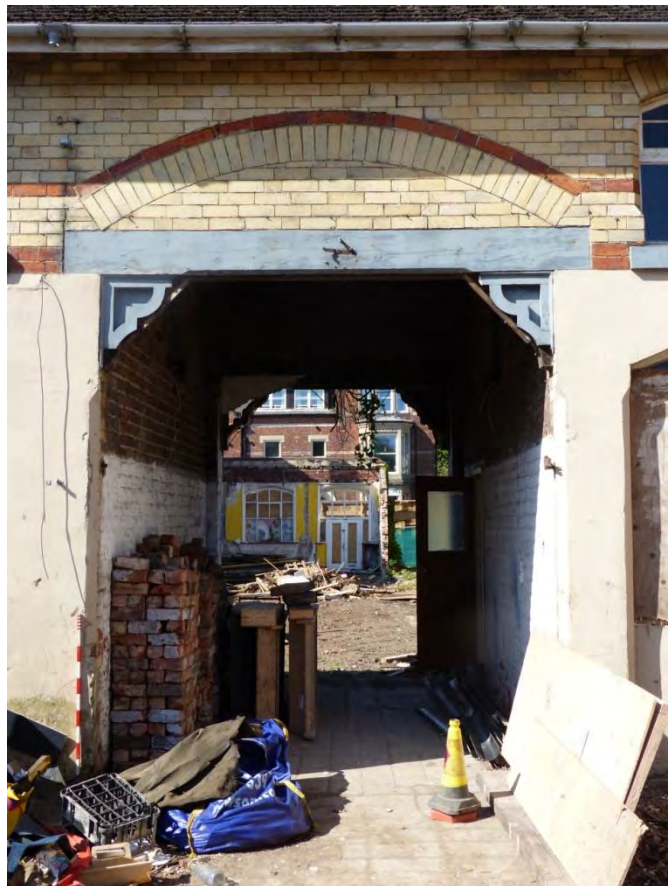
Plate 15 Carriageway through west coach house, looking west

The carriageway interior is composed of red brick with lime wash half way up the walls (Plate 15). The road through the carriageway is made of square paving stones, although these appear to be a later addition, and several spots have been replaced with asphalt. It also displays the timber rafters and purlins that make up the roof with modern sheeting protecting the underside of the roof tiles (Plate 18). There are open gaps at the base of the roof level running east west on both the north and south walls that would have originally held joists creating a flat ceiling, there is evidence of removed lathe and plaster on the remaining joists to the north and south. First floor door openings to the north and south would have provided access for delivering or receiving goods and feed from carriages entering here. Both door openings show evidence of either having been either altered or added at a later date and are both now blocked, neither with original doors.

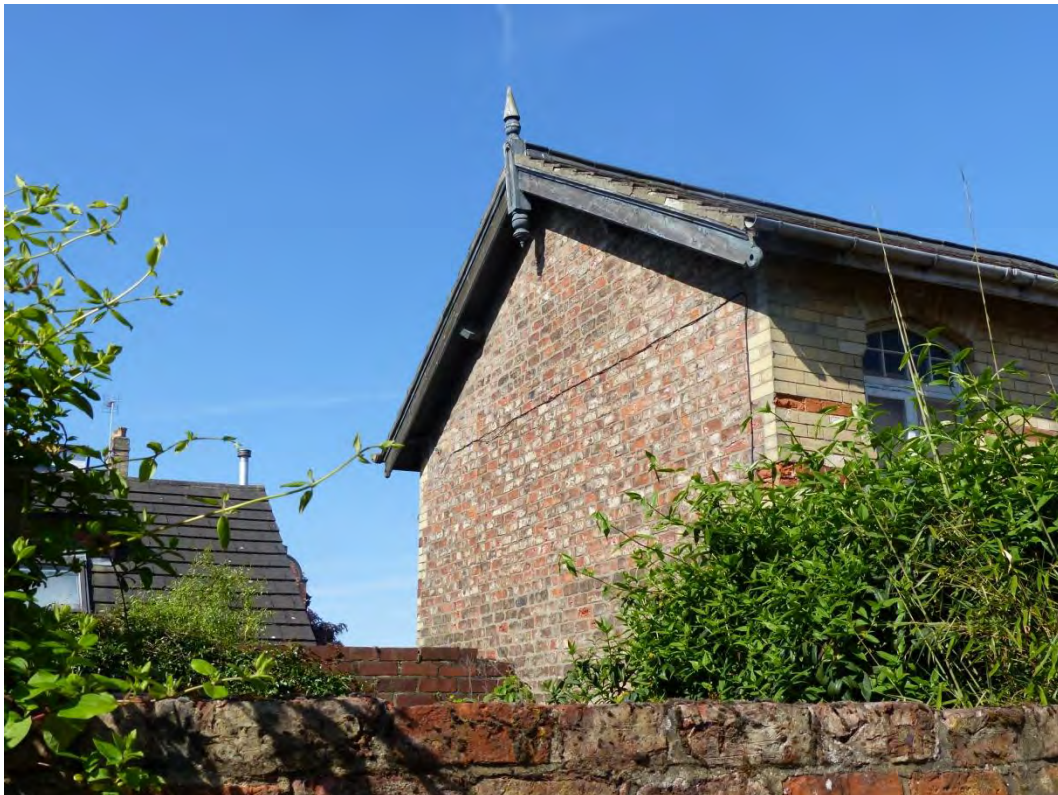
Plate 17 General view of the roof, looking north-west

The side (south) elevation has no openings and is composed solely of red brick. It features original timber barge boards and a decorative finial (Plate 17).

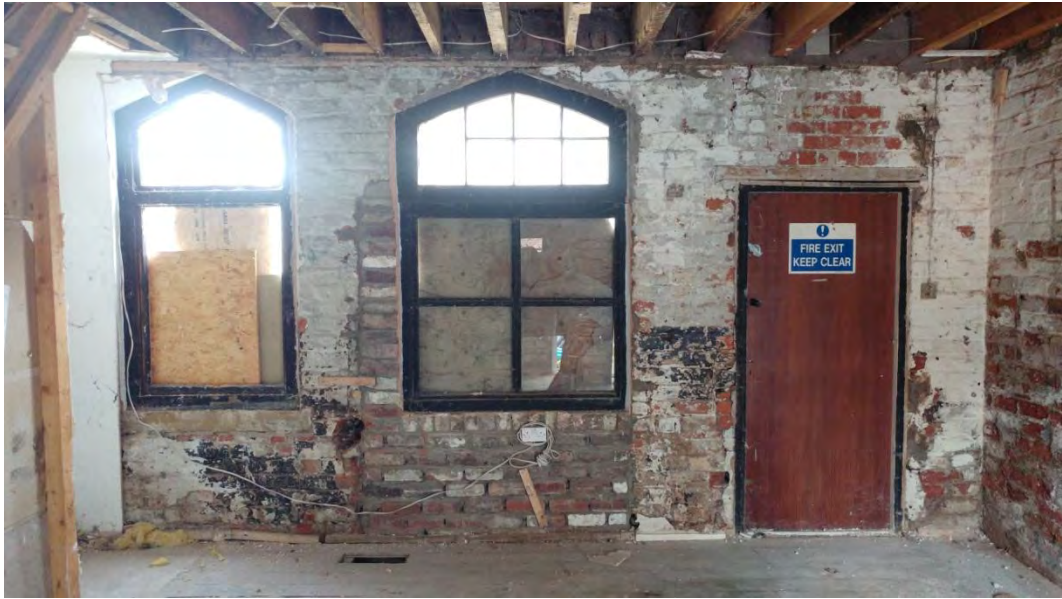
Plate 20 East wall of west coach house showing evidence of former door opening, looking east

window from the north was originally a door opening. More evidence for the original layout of the openings may be revealed with the stripping of the ground floor render. The carriage way features a large flat timber lintel with decorative timber brackets in the corners, and also a relieving segmental arch above.

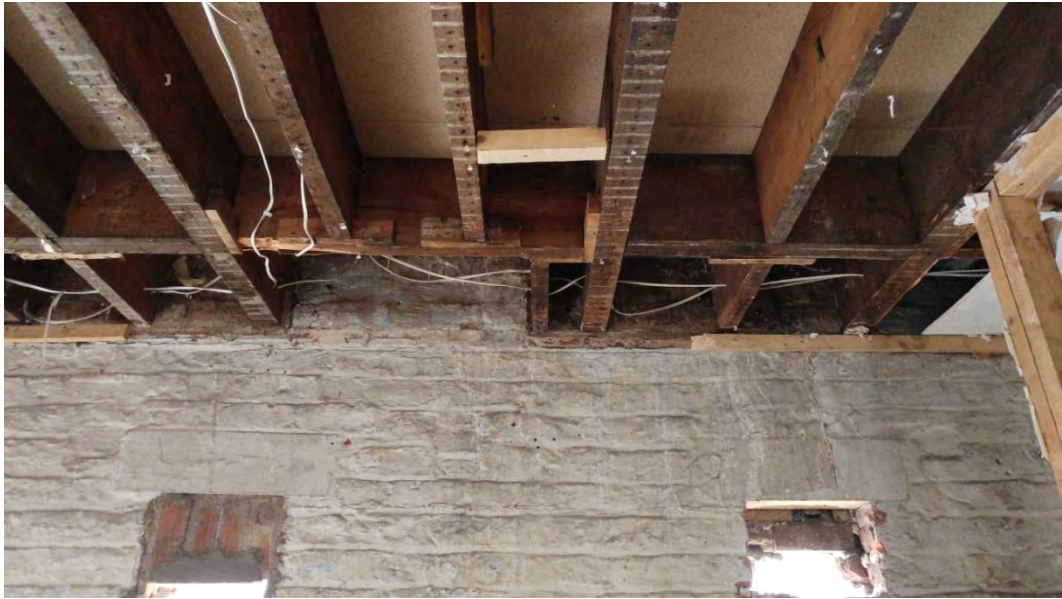
Plate 22 Possible feed drops in south room of west coach house, looking west

gaps in the joists possibly for dropping feed from the first floor into the stables below (Plate 22). An inserted set of stairs is located against the north wall and provides access to the first floor (Plate 19). The first floor features three window openings to the east wall a door leading to the loading door for the carriageway to the north wall (Plate 23). The room has a single modified queen post truss that appears to have been used in the past to divide it, most likely, into two bedrooms. The truss appears original and uses a combination of timber jointing and iron rods in its construction (Plate 24 and Plate 25). The timber rafters and purlins are all on display as plasterboard has all been removed.

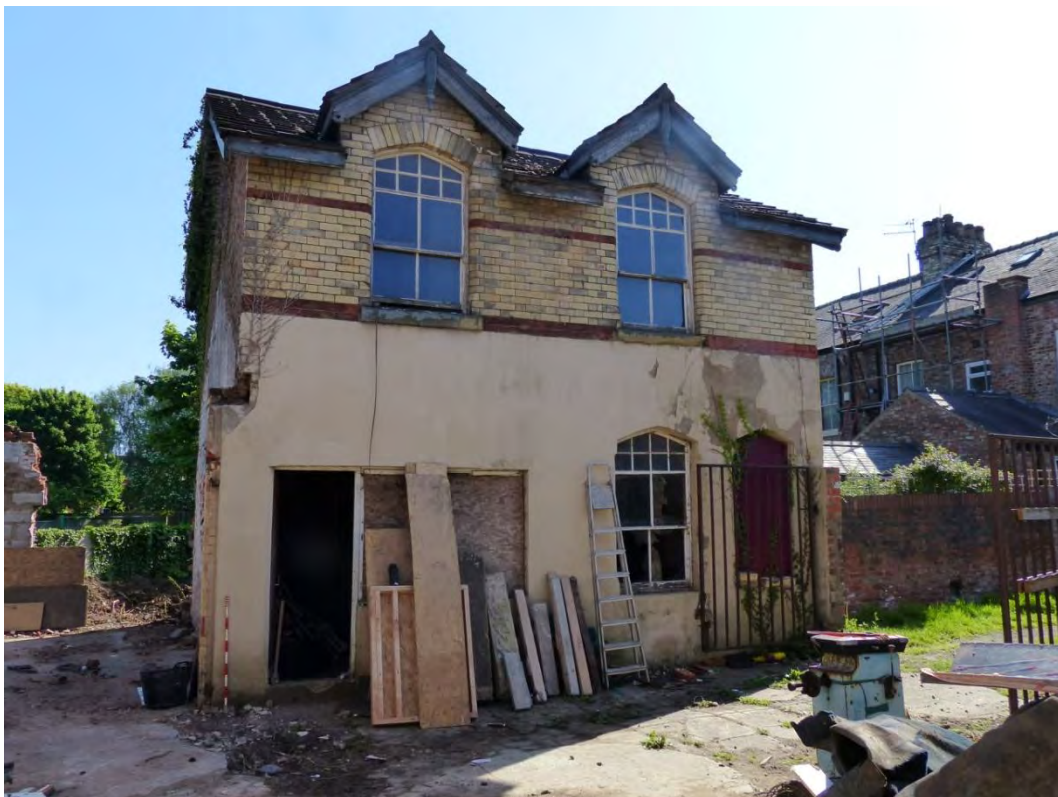
Plate 27 The front (west) elevation of the east cottage, looking south-east

The cottage is a two-bay, two-storey building, composed of red and yellow brick (Plate 27). The front (west) elevation has modern render up to sill height of the first floor. There is a later door and window opening to the north end of the elevation with the door and window now removed and boarded over. There are two other window openings to the ground floor both with timber two over two sliding sash windows with a Tudor arch design containing overlights with eight fixed panes (Plate 28). The southern window opening is thinner than the central windows and from the interior there is evidence that this was once a door opening. The first floor features yellow brick with red brick sill course and plat band. There are two half dormer window openings with original pointed Tudor arched windows similar to those on the ground floor. The dormers and around the roof feature original timber fascia boards and bargeboards, the apex of the dormer have the bottom half of finials the tops of which may have been removed.

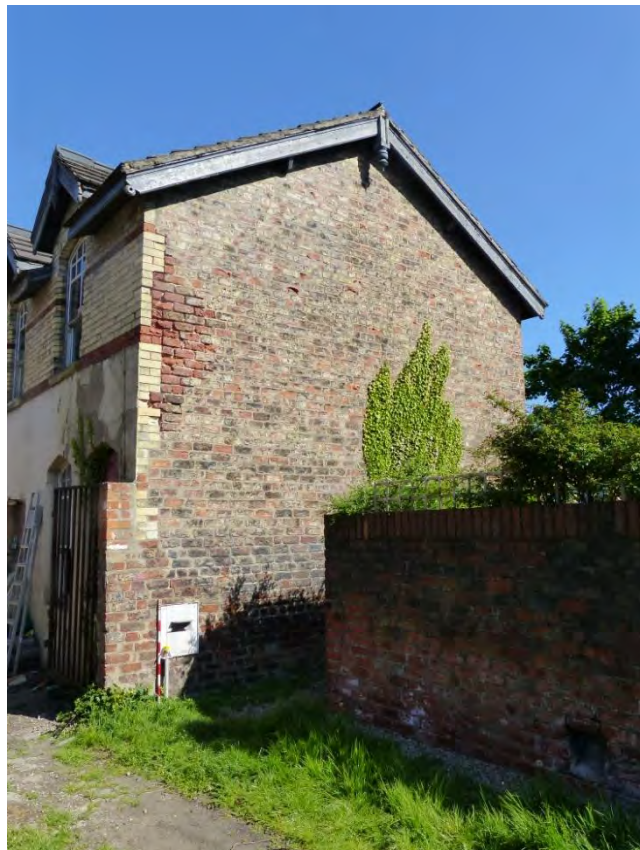
Plate 29 South elevation of eastern cottage, looking

The side (south) elevation also has no openings and is composed solely of red brick. It features original timber barge boards and a decorative finial (Plate 29).

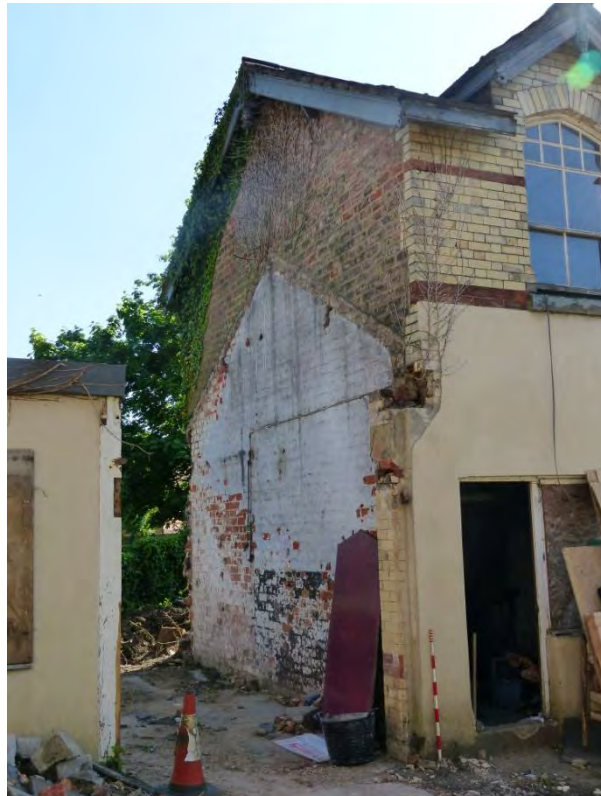
Plate 31 Side (north) elevation of coachman's cottage, looking south-east

The side (north) elevation has no openings and is composed solely of red brick (Plate 31). The scar of a formerly-attached pitched roof remains up to first floor height. The main features are the original timber barge boards and the decorative finial that has had the top removed.

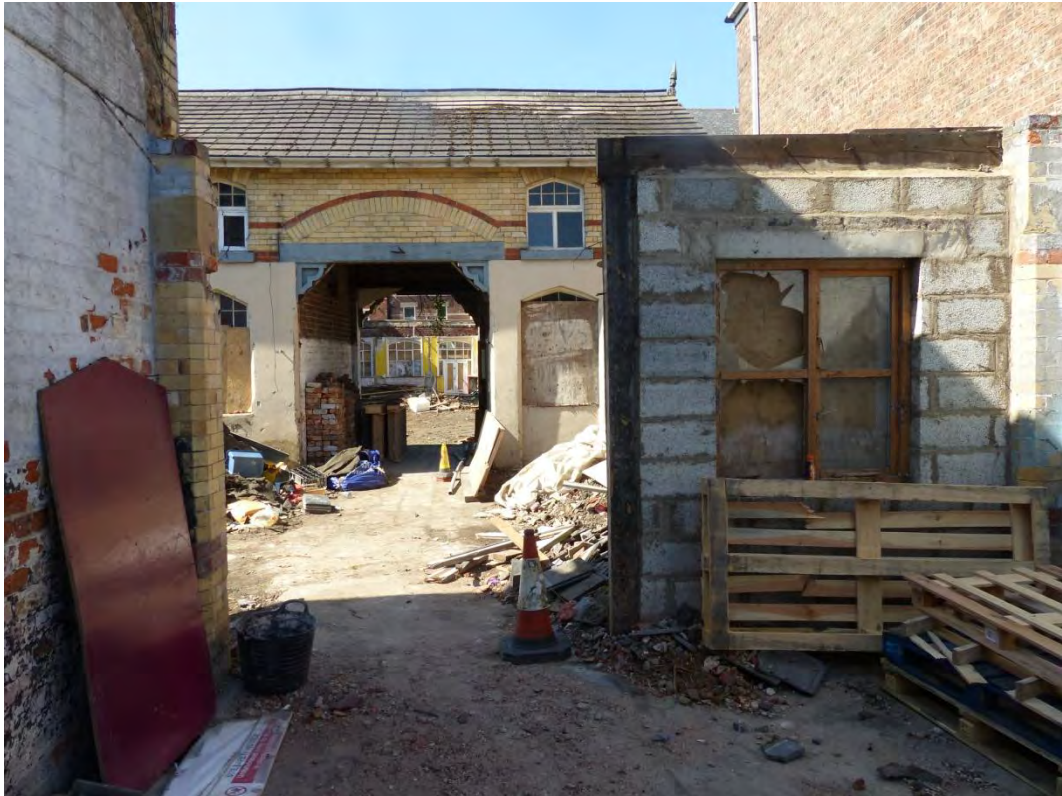
Plate 32 Partially demolished interior of carriage house, looking east

later four-pane timber window. Now mostly removed, the carriage house appears to have undergone many earlier alterations with large amounts of concrete breezeblock on display in the walls (Plate 32).

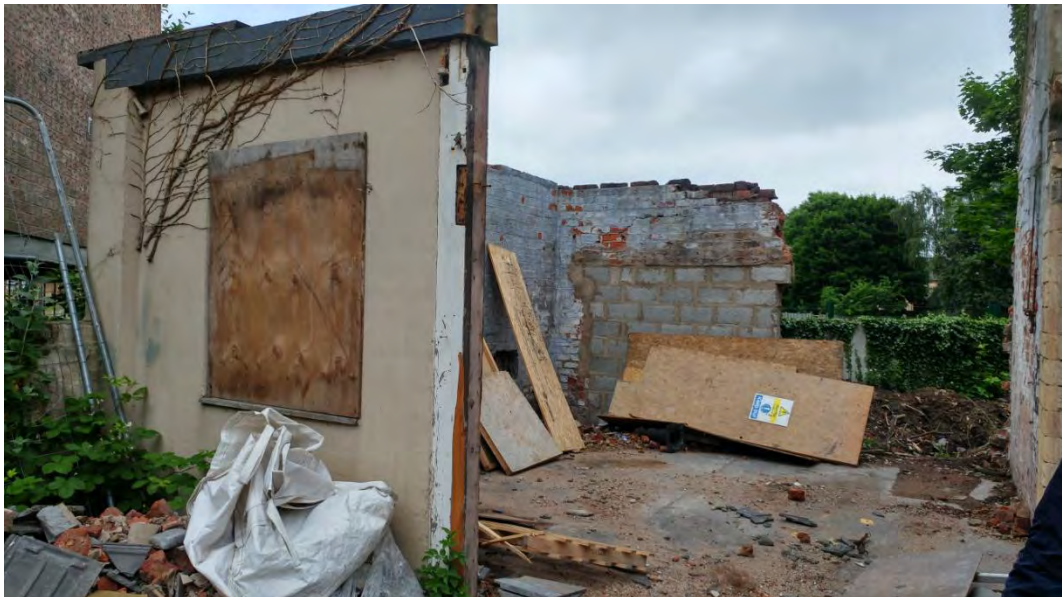
Plate 33 Partially demolished remains of carriage house, looking east

The remains of what was likely a carriage house are located to north of the cottage (Plate 33). There are large iron pintles remaining in the extant walls for a large set of double doors. The scar along the north elevation of the cottage demonstrates the height and extent of the carriage house. A single window was located in the west elevation wall with the remains of a

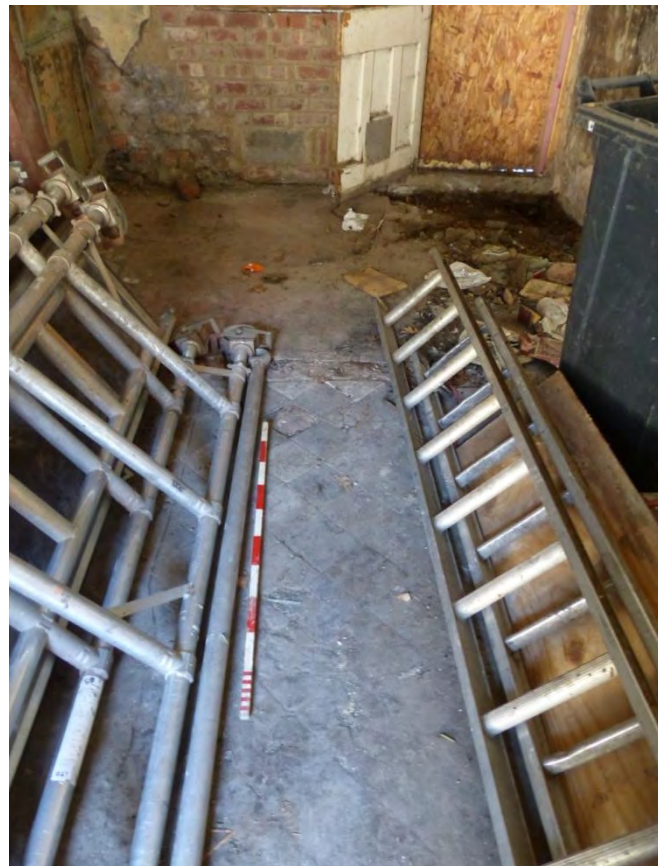
Plate 35 Detail of tiles in the ground floor north room of cottage, looking west

Entering from the modern door opening to the front elevation this north room was possibly used as a store or kitchen area although little detail remains to properly identify it (Plate 34). There are the remains of square chequerboard tiles to the floor (Plate 35).

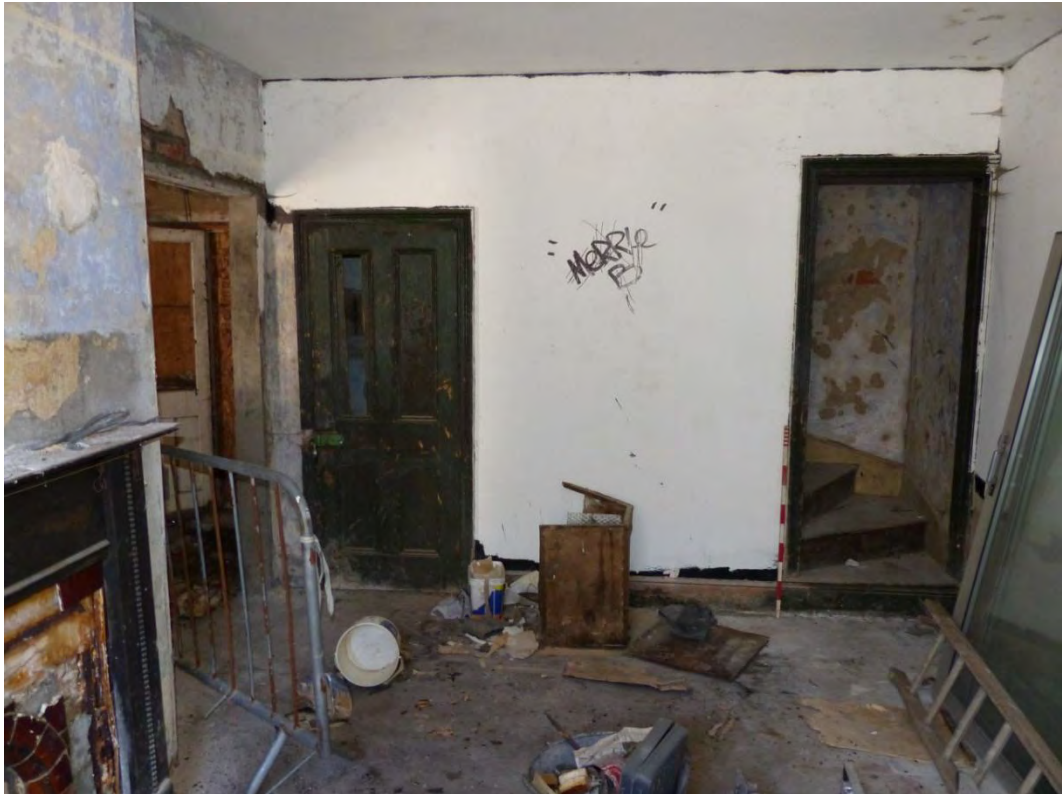
Plate 36 East wall of parlour in cottage, looking east

A large opening in the south wall leads into the parlour where the original flooring is lost and only concrete remains. Original timber skirting boards survive to the south and east walls. There is an original fireplace in the north wall (Plate 39). Evidence for a former doorway can be seen in the west wall, as previously noted. A modern piece of graffiti/ art has been located on the south wall (Plate 40). It details a personal story with photographs added intermittently to the text. The east wall features an original timber panelled door to the north which leads to the original W/C under the stairs and then onto the later addition which was also a W/C. A second opening leads up the stairs, both door openings to the east wall feature original timber surrounds (Plate 36).
