Archaeological Investigations at Northallerton Prison

YAT Assessment Report 2018/108 December 2018

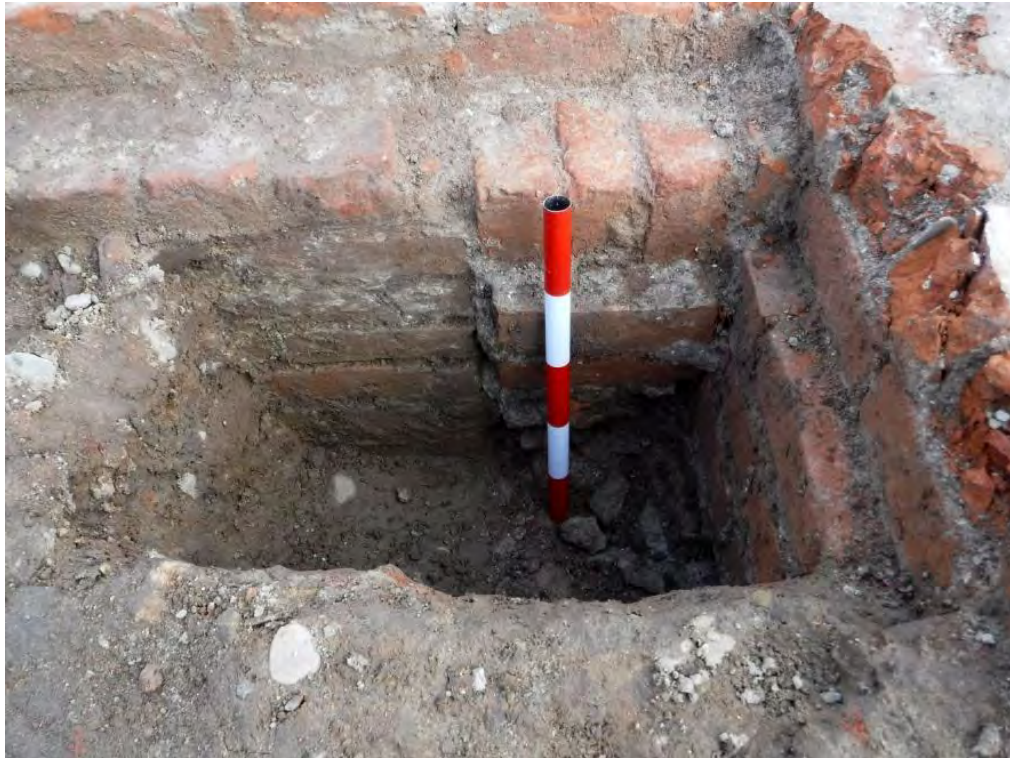
Plate 3 Section where the Early Quadrangle Wall (c1013), on the left, joins the prison wing wall (c1015), on the right, characterised by a change in brick thickness and mortar. Trench 1.

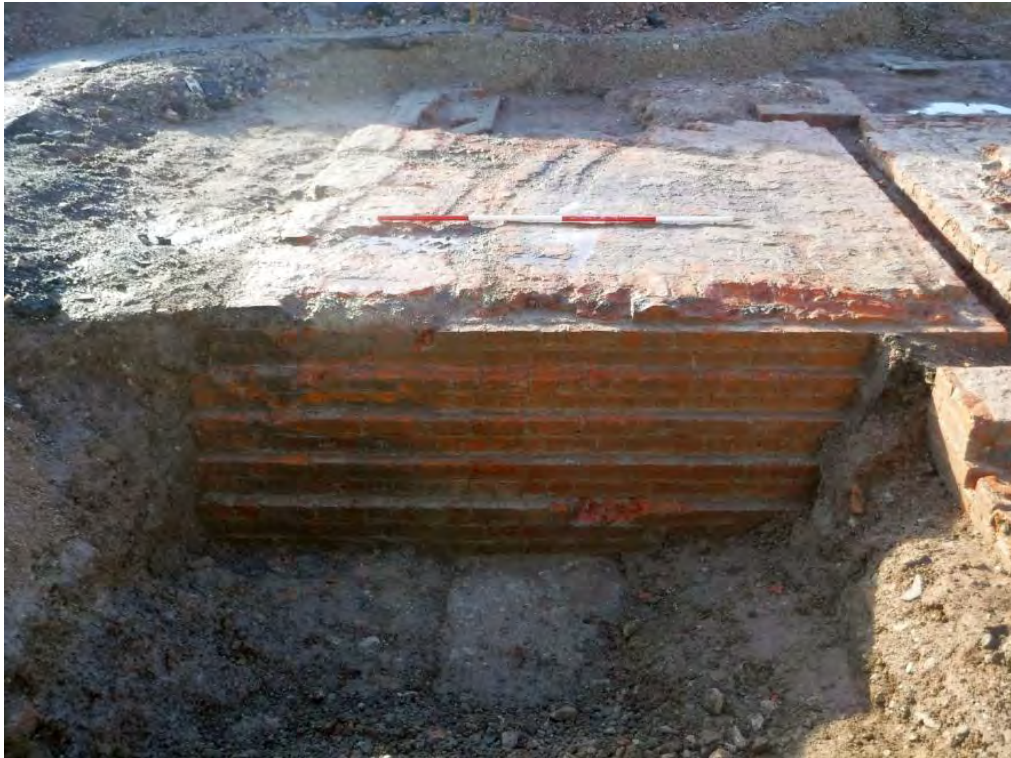
Plate 5 Chimney footing (c2012) in Trench 2. Elevation with concrete base visible

Undisturbed natural deposits were encountered at c1.68m BGL, c38.92m OD. In this case they were seen in the side of the deeper excavation revealing the foundations for the chimney. The natural (c2007) and possible buried topsoil (c2006) were similar to the orange gravelly clay natural and grey sandy clay buried soil from the same contexts in Trench 1. Natural deposits were exposed at a greater depth compared to Trench 1 due to the combination of a natural slope across the site and the location of the sondage next to the chimney footing in Trench 2 which had truncated natural.

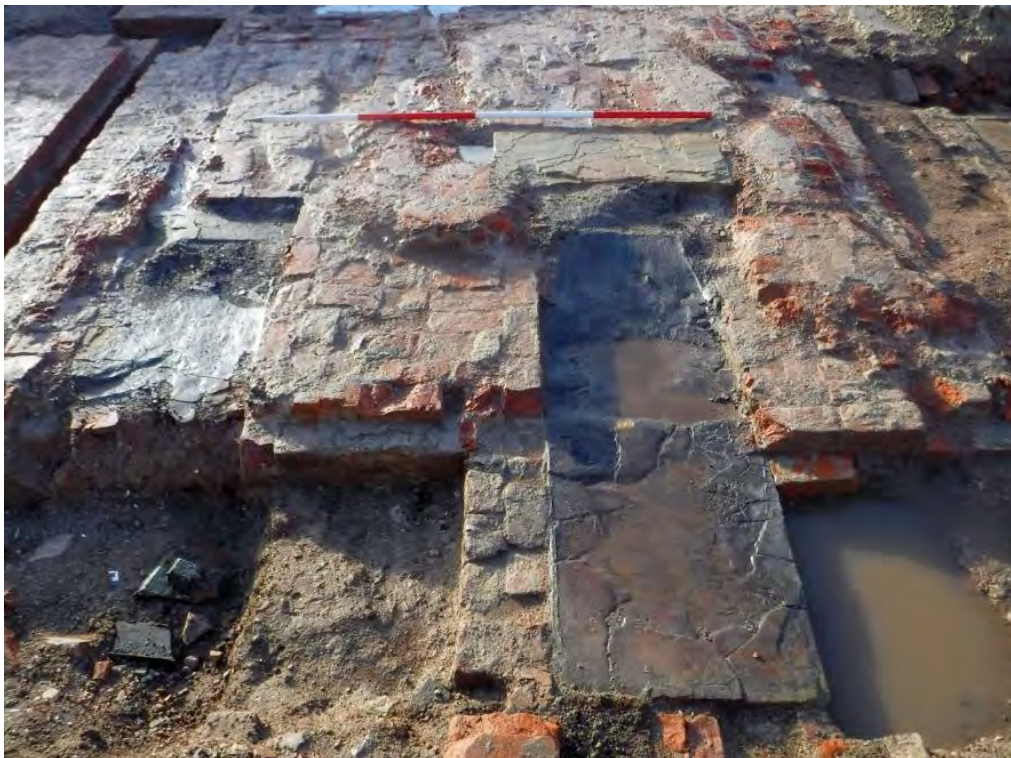
Plate 6 (c2010) and boiler use deposits (c2011) in Trench 2

2	2010	204	2005	4	Deposit. Boiler brick footing. Handmade bricks 230x110x70mm. Pale grey mortar. Large sandstone flag set into top 900x440x50mm along with two stone flues c2011. Overall dimensions 4x4m. 19 th century Cookhouse feature.
2	2011	203	2003	6	Deposit. Boiler use deposits. Aligned NNW-SSE. Friable, dark greyish black, cinder. 19 th century Cookhouse feature.
2	2012	205	2010	3	Deposit. Chimney brick footing. Handmade bricks 230x110x70mm. Pale grey mortar. Sat on 1m deep concrete foundation. Overall dimensions 4.0x4.0x1.1m. 19 th century Cookhouse feature.
2	2013	206	2011	3	Deposit. Aligned ENE-WSW. Brick wall. Handmade bricks 220x110x70mm. Pale pinkish grey mortar. Early 19 th century Smith's Shop wall.
2	2014	207	2013	2	Deposit. Brick Wall. Aligned NNW-SSE. Handmade bricks 230x110x60mm. Flemish? bond. Pale pinkish grey mortar. Early quadrangle prison wall. 18 th /19 th century. Truncated by c2013. Similar to c3009. Same as c1013.

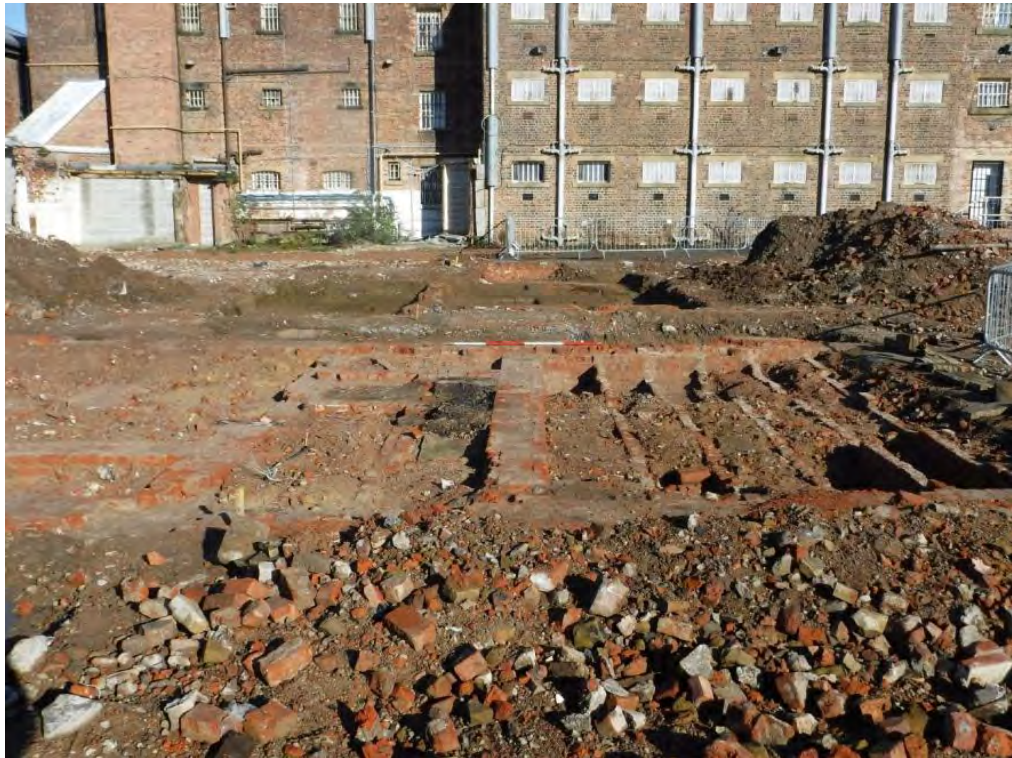
Plate 7 Overview of Trench 3

Trench 3 contains the largest continuous section of the Early Quadrangle Wall (c3009) which makes up the eastern side of the early quadrangle prison (Plate 7). The wall mirrors the truncated remains of the same wall in Trench 1 and 2. This section of the wall also fully illustrates that at certain points the wall increases from 3 courses wide to 4 courses wide; this is possibly as a form of buttressing built into the wall due to its height with mark stain visible on the standing prison wing.

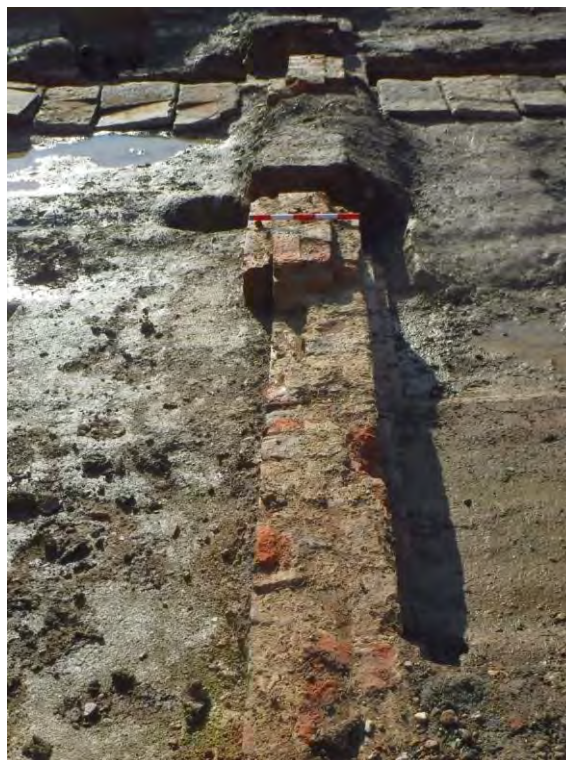
Plate 8 Early Quadrangle Wall (c3008) in the yard area of Trench 3.

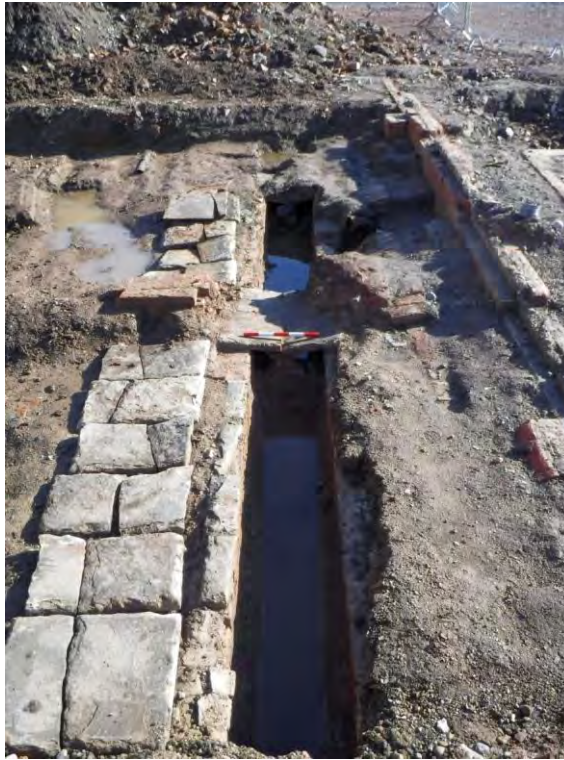
Plate 9 Culvert (c3011) in the yard area of Trench 3

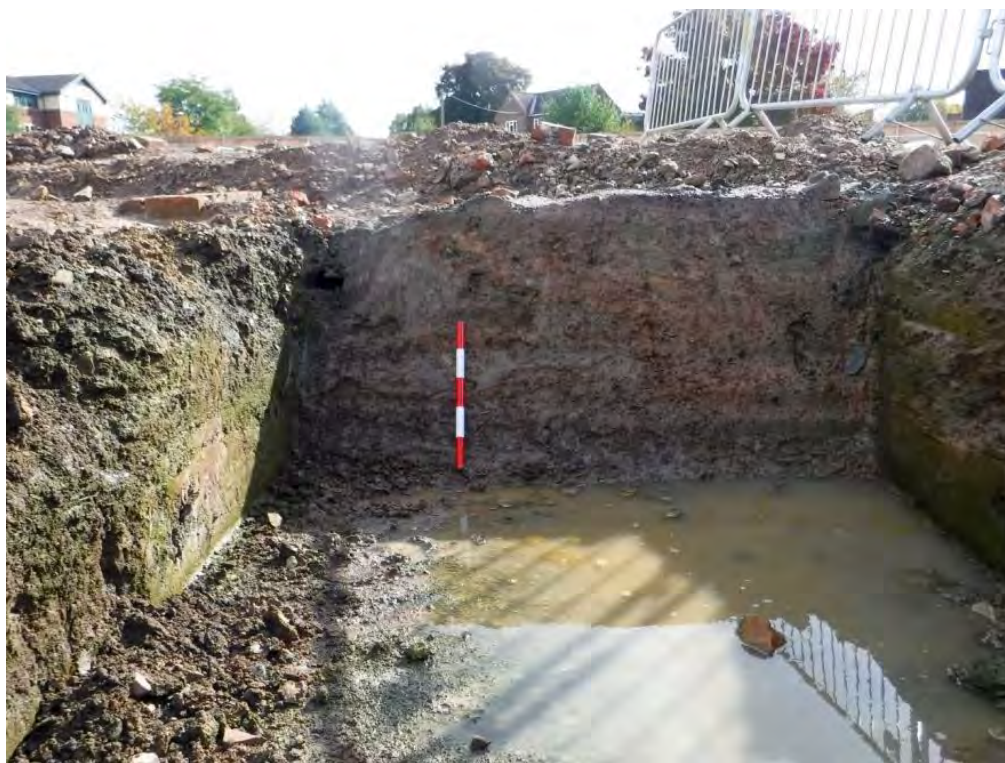
Plate 11 Section in Trench 4 sondage showing the layers of pre-prison landscaping (c4005) and the buried soil (c4006)

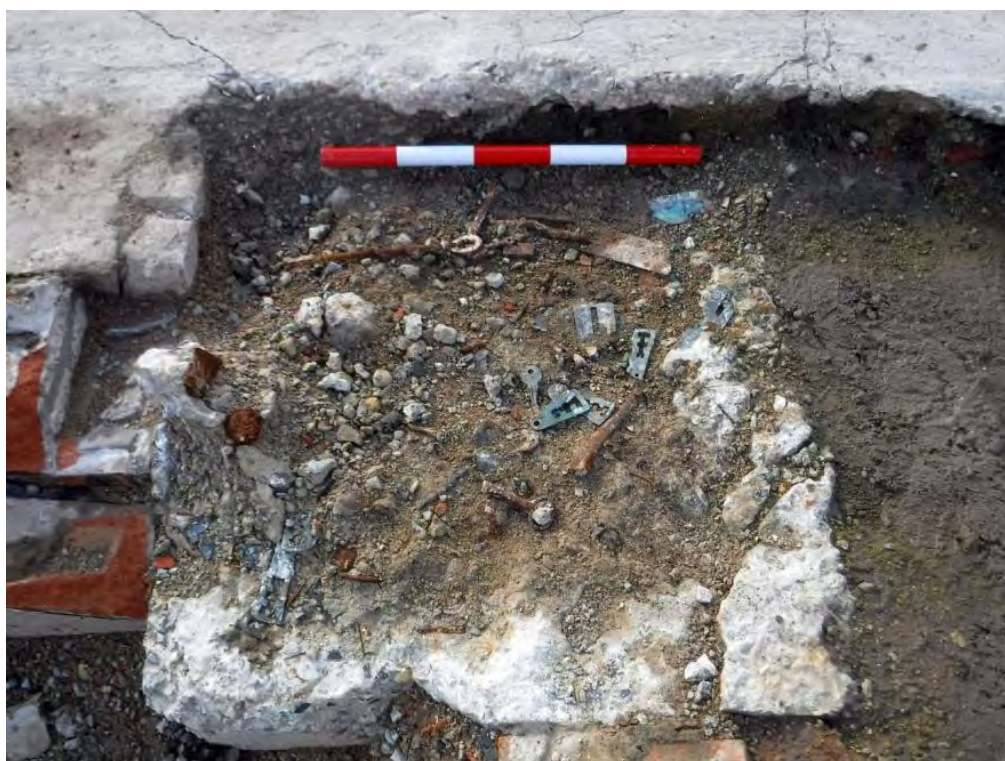
Plate 12 Keys disposed of within concrete during the early 20th century (c4004)

The modern sunken possible sump structure (c4004) was constructed to the SE of the Pump House. Largely unremarkable the structure did include a concrete foundation in its NW corner that contained a large number of discarded keys from the early 20th century period (Plates 11 and 12). Numerous explanations for this feature have come forward including a key amnesty, disposal and most likely pertains to a nationwide prison lock contract.

There is no evidence, anecdotally or through drawings and photos, of the demolition of the Pumphouse. It is likely to have fallen out of use with the treadmill as it contained a smaller version but, where the repurposed treadmill building is visible in photos from the latter half of the century, the Pumphouse had been replaced. When this occurred is unclear but when the subsequent building was constructed they disposed of the keys exposed within concrete in Trench 4.

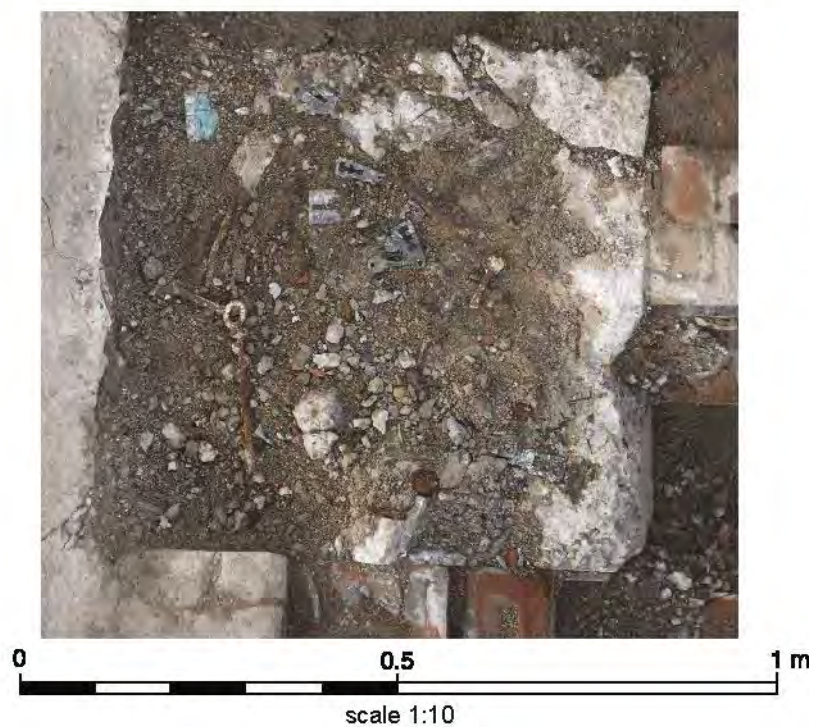
Plate 13 Image of keys produced by orthorectified photogrammetry (1:10)

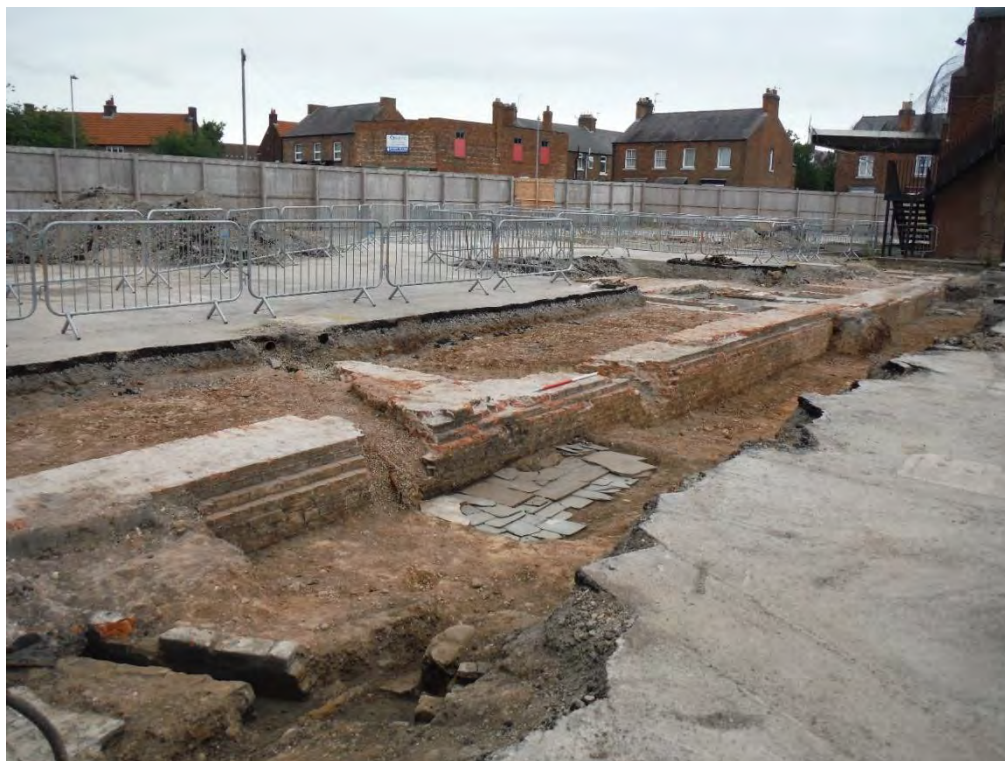
Plate 17 Main Courthouse wall c6007 with internal walls

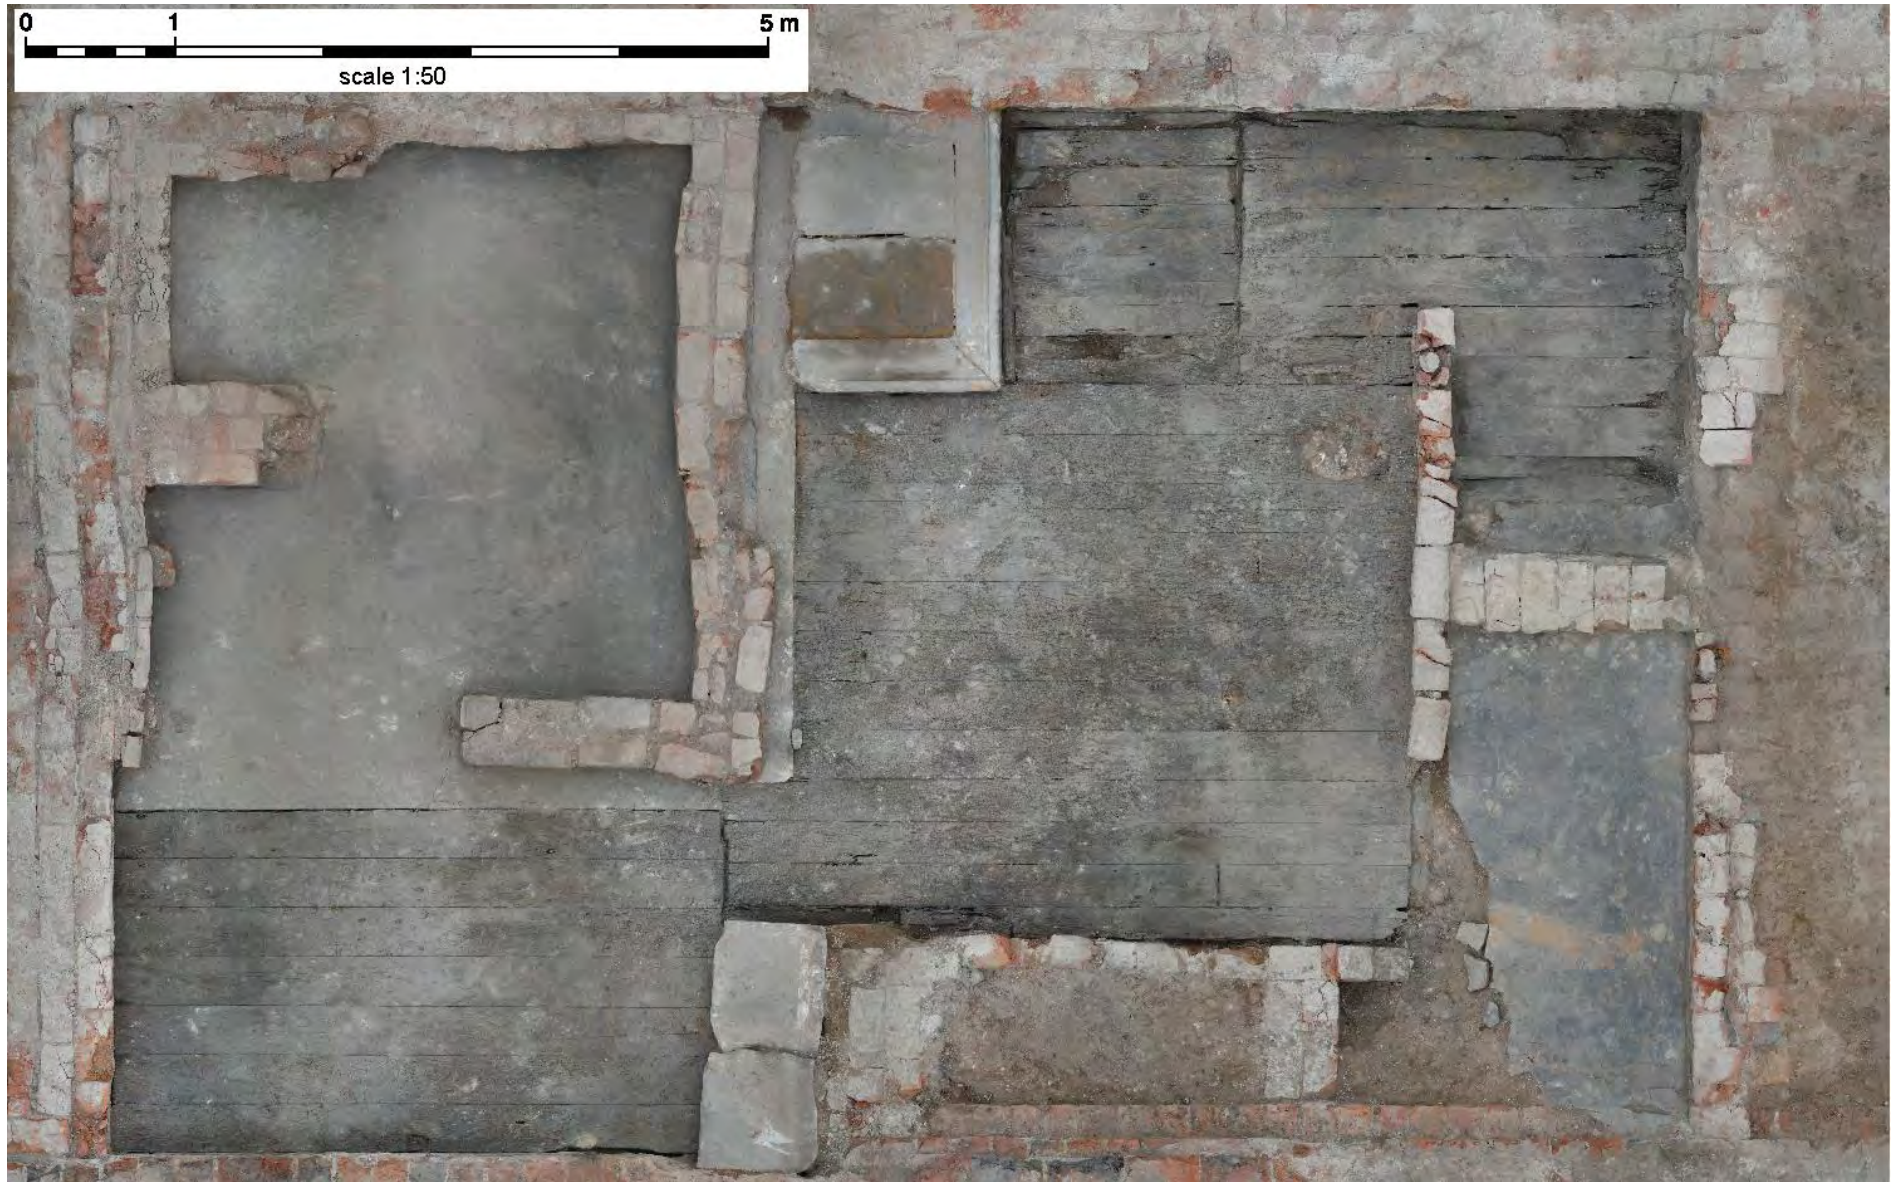
Plate 19 Image of cell area produced by orthorectified photogrammetry (1:50)

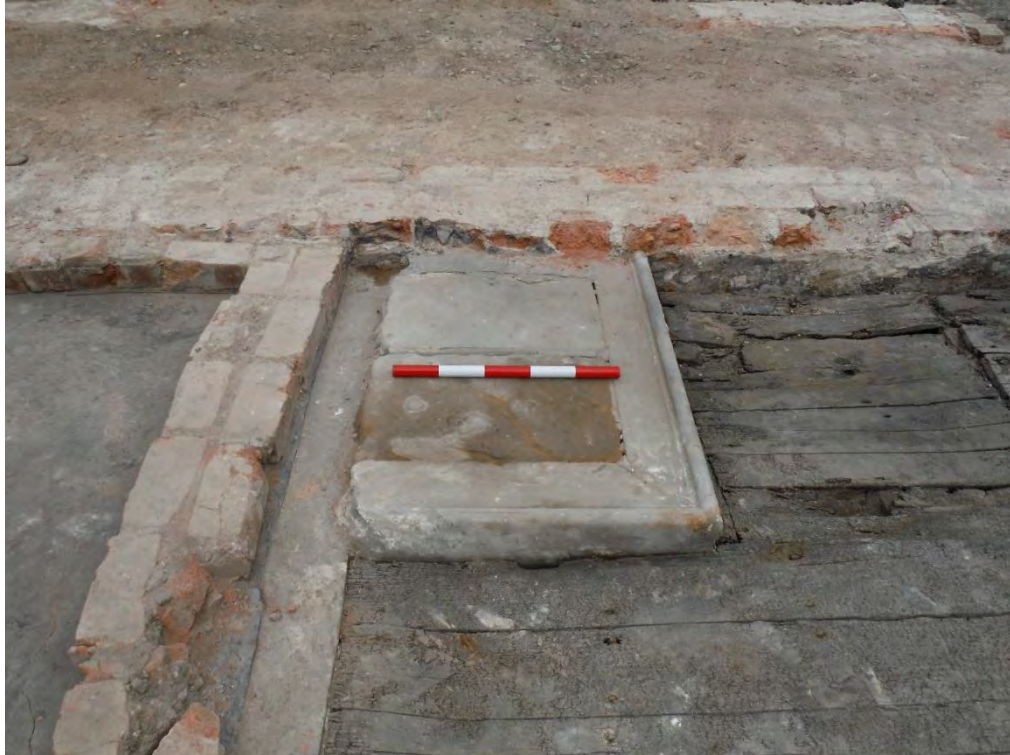
Plate 21 Reused worked stone steps as a footing or cap feature within the Courthouse cell area (c6025).

Within the cell area were deposits that appear to post-date the 1870 Ground plan. This is primarily floor alterations where staircases appear to have been removed and replaced with wooden floors and a possible footing or cap. The alteration in the south of the cell area (c6044) is possibly associated with the alteration or removal of the L-shaped staircase. The wooden floor section (c6042 and stone footing (c6025) in the north of the cell area also possibly replace a staircase. The stone footing is comprised of re-used stone steps visible in c6023 suggesting a relationship between the two alterations (Plate 20).

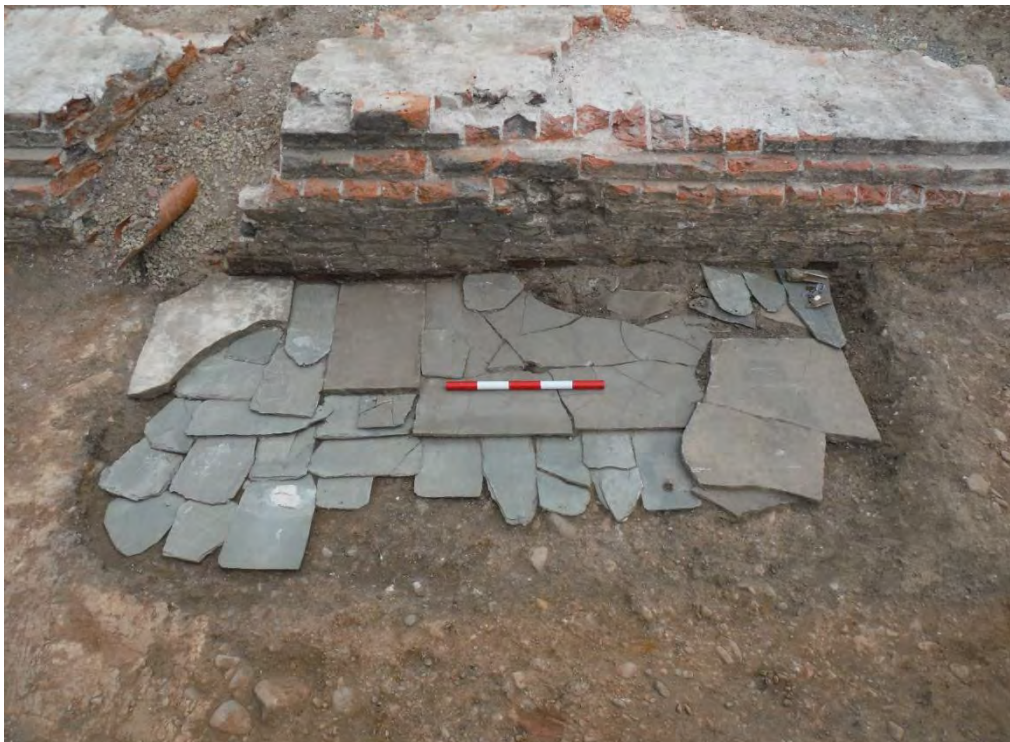
Plate 20 Sump or soak-away for the Courthouse comprised of reused slate roof tiles with visible pegholes.

Late 19th century service additions include a brick and stone culvert (c6006) at the west end of the trench which was later replaced by ceramic drain c6005 as well as two slate sumps or soak-aways (c6036 and c6040). Both sumps include a cut into Courthouse wall c6007 to accommodate the downpipe though the cut for c6040 appears to have been recut with a modern drill and refilled with concrete at a later date. The sumps are comprised of reuse slate roof tiles with peg holes and some sandstone slabs (Plate 21).

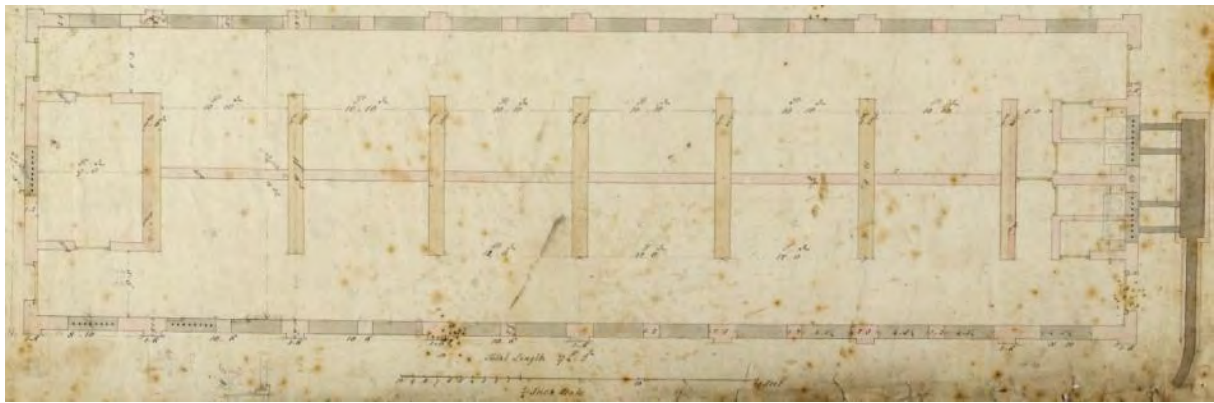
Plate 22 Detailed plan of the treadmill layout from Captain Worsely's 1849 designs for the Northallerton House of Correction

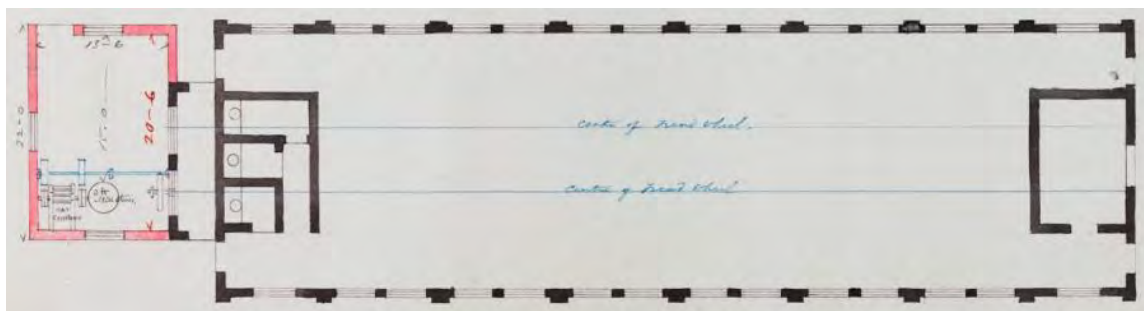
Plate 23 Detailed plan of the treadmill including the addition of the grain mill to the south. From proposed plans from 1870.

Construction of the grain mill may have caused the alterations to the toilet area, in the south of the treadmill, which has been significantly altered and disturbed (c5032, c5033 and c5042). Infilling and disturbance deposits internal and external of the treadmill indicate that the dividing walls (c5031 etc.) have been truncated in the later 19th century in the toilet area.

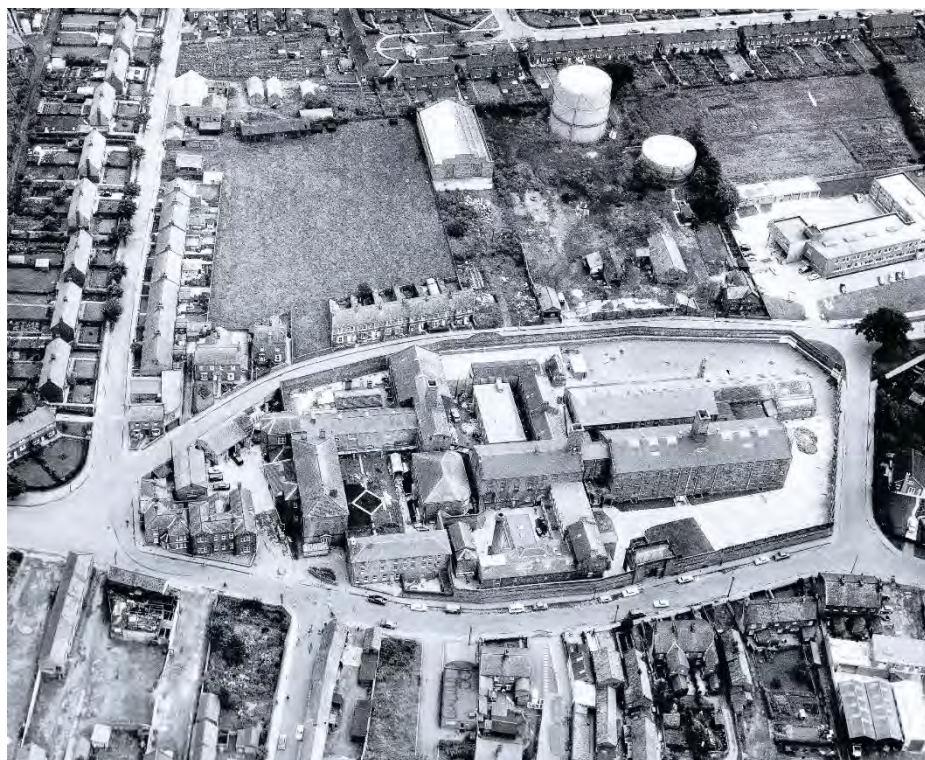
Plate 24 Aerial photograph of the prison taken in 1968. Unknown source.

The areas in Trench 3 by the late 20th century had reversed their purpose; the prison wing had been demolished and replaced with a new exercise yard while the 19th century yard was replaced with a modern wing. At one point the modern and original prison wings stood concurrently, shown in the 1968 photograph (Plate 24) and clear in archaeology where the buildings respect each other.

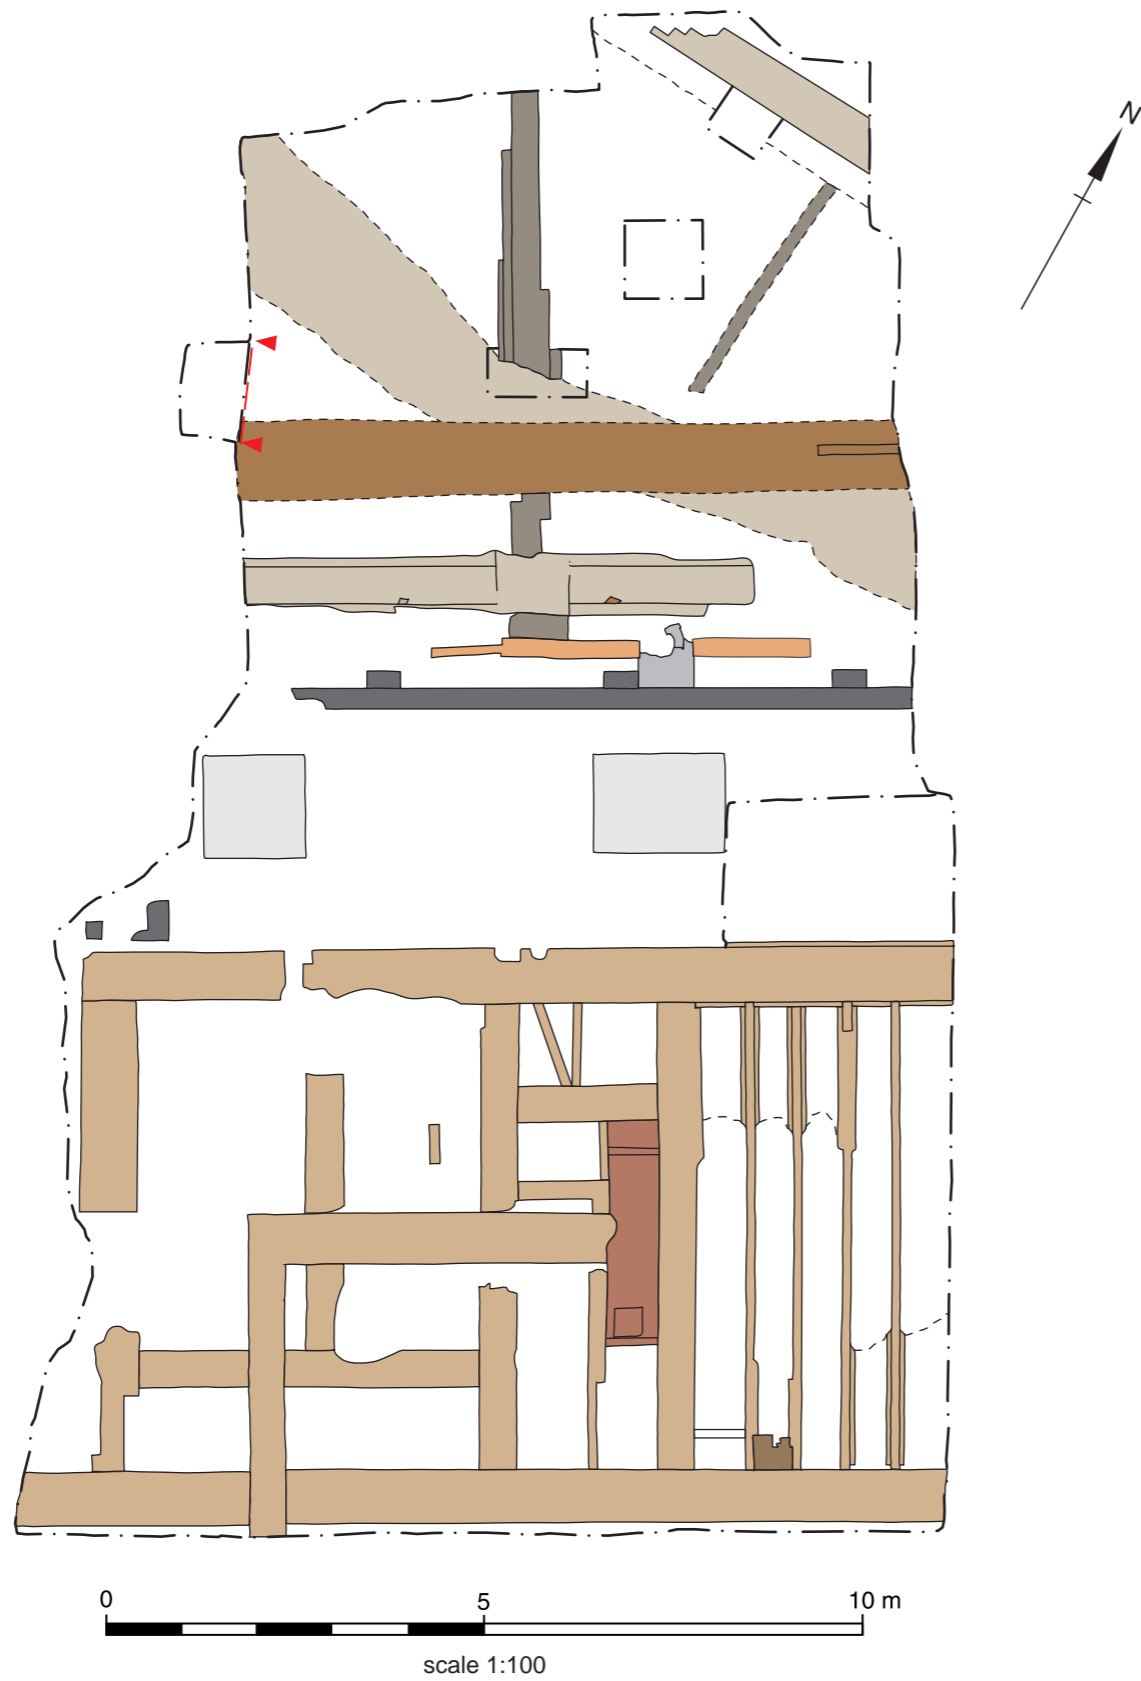
Figure 6. Trench 3

- Group 300 Modern
- Group 301 Late 20th Century Construction
- Group 302 Early 20th Century Construction
- Group 303 Late 19th Century services
- Group 304 19th and 20th Century Furnace use deposits
- Group 305 Late 19th Century Culvert, Wall & services
- Group 306 Mid 19th Century Prison Wing
- Group 307 Early 19th Century shed wall
- Group 308 Late 19th Century floor repair
- Group 309 Early Prison Construction
- ▼_▼ Trench 3 Section Location

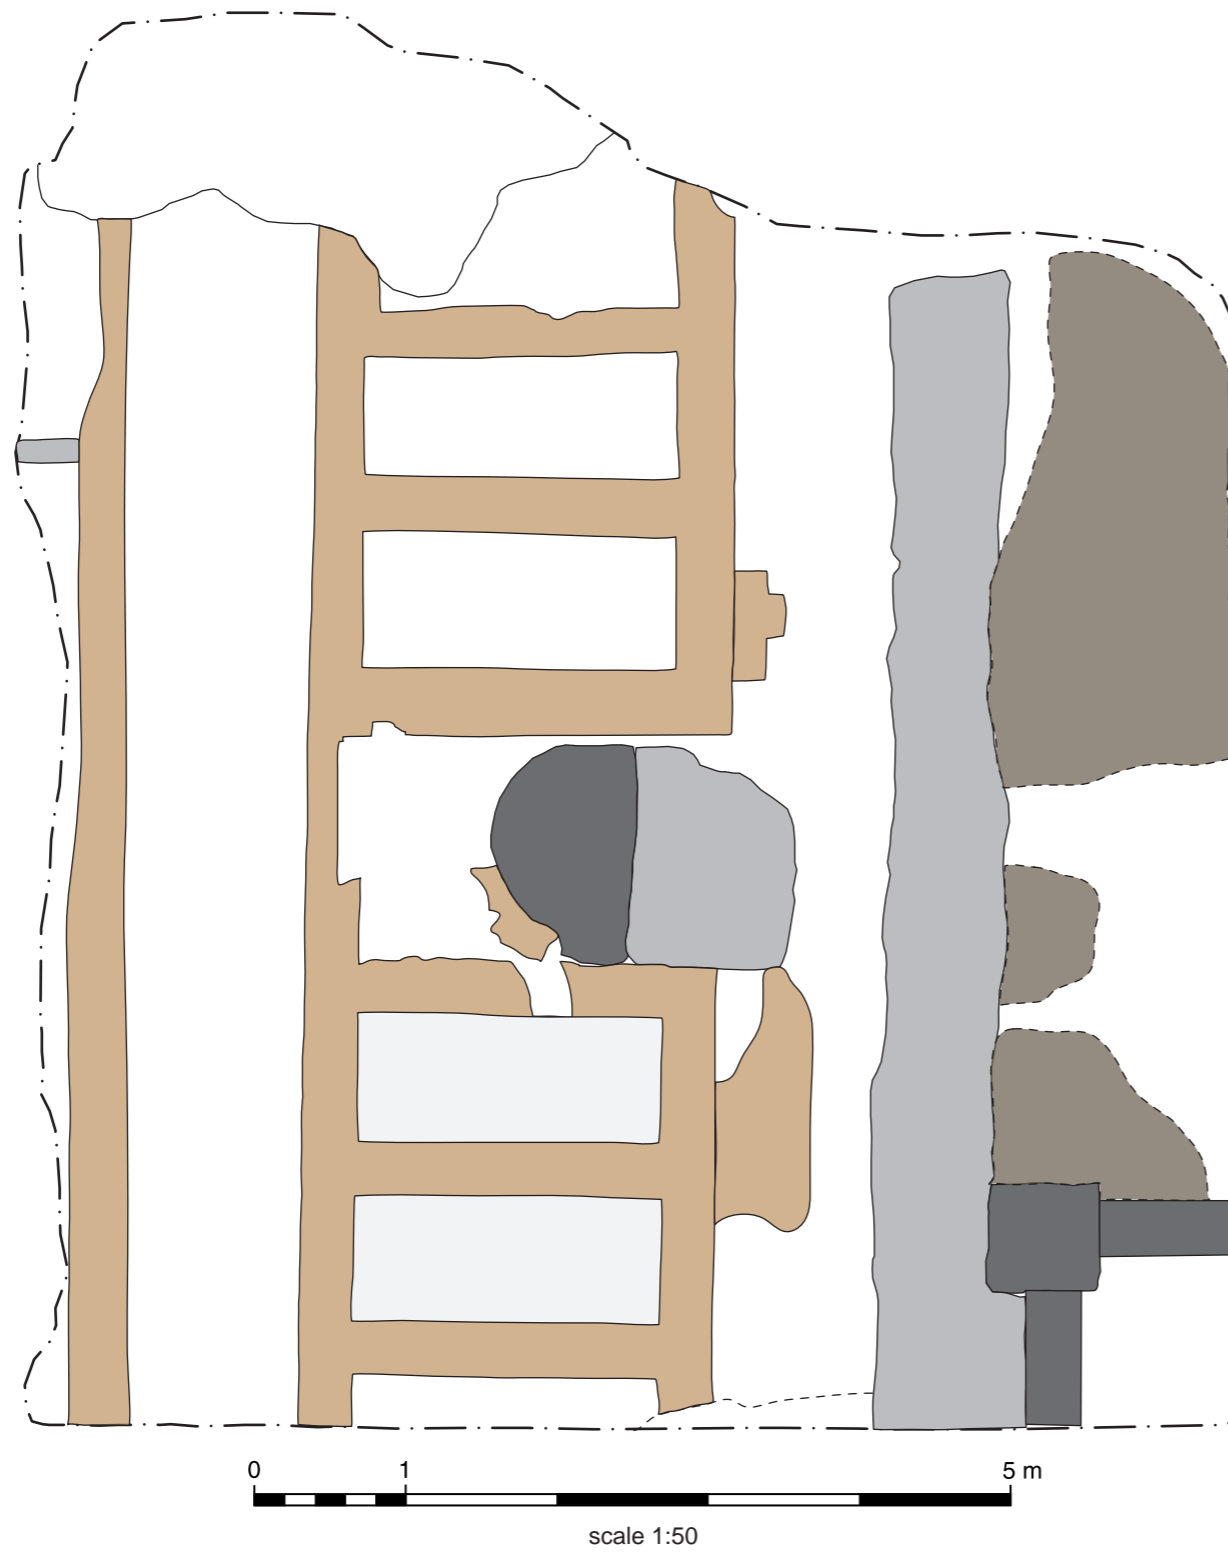
Figure. 8 Trench 4

- Group 401 Late 20th Century Construction
- Group 402 Early 20th Century Construction
- Group 403 19th Century Pumphouse
- Group 404 Late 18th Century Pre-Prison Landscaping

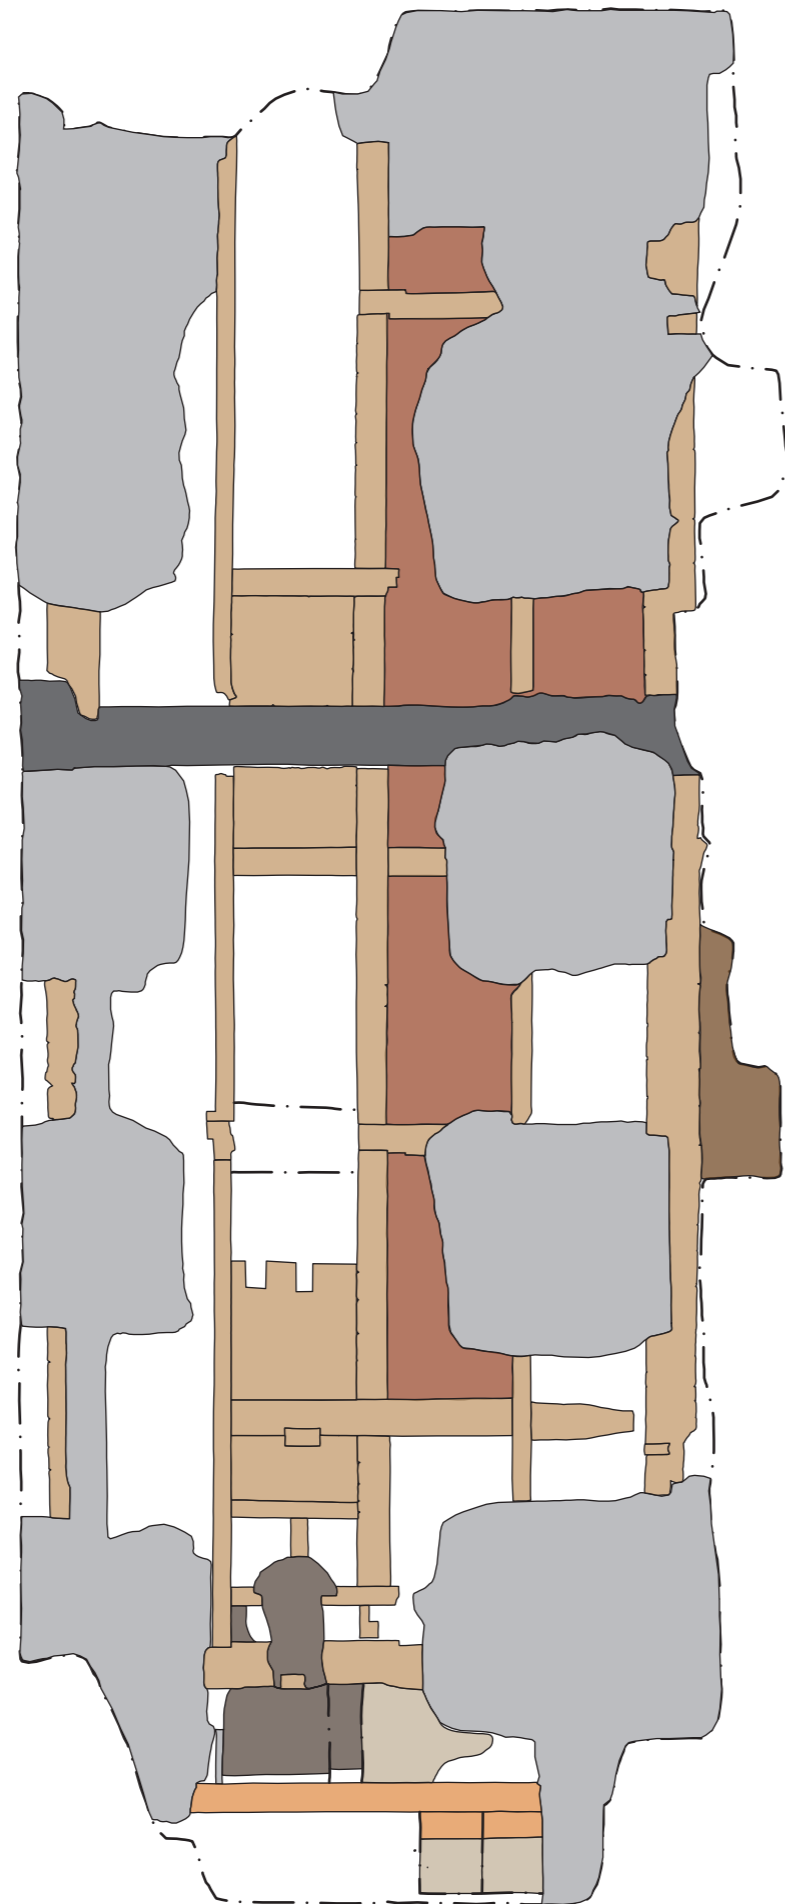
Figure. 9 Trench 5

-   Group 501 Late 20th Century Construction
-   Group 502 Early 20th Century Construction
-   Group 503 Late 19th/Early 20th Century Post-Treadmill infilling
-   Group 504 Late 19th cinder surface
-   Group 505 Late 19th Century toilet disturbance
-   Group 506 Late 19th Century Grain Mill
-   Group 507 Late 19th Century post-treadmill construction levelling
-   Group 508 Late 19th Century Treadmill

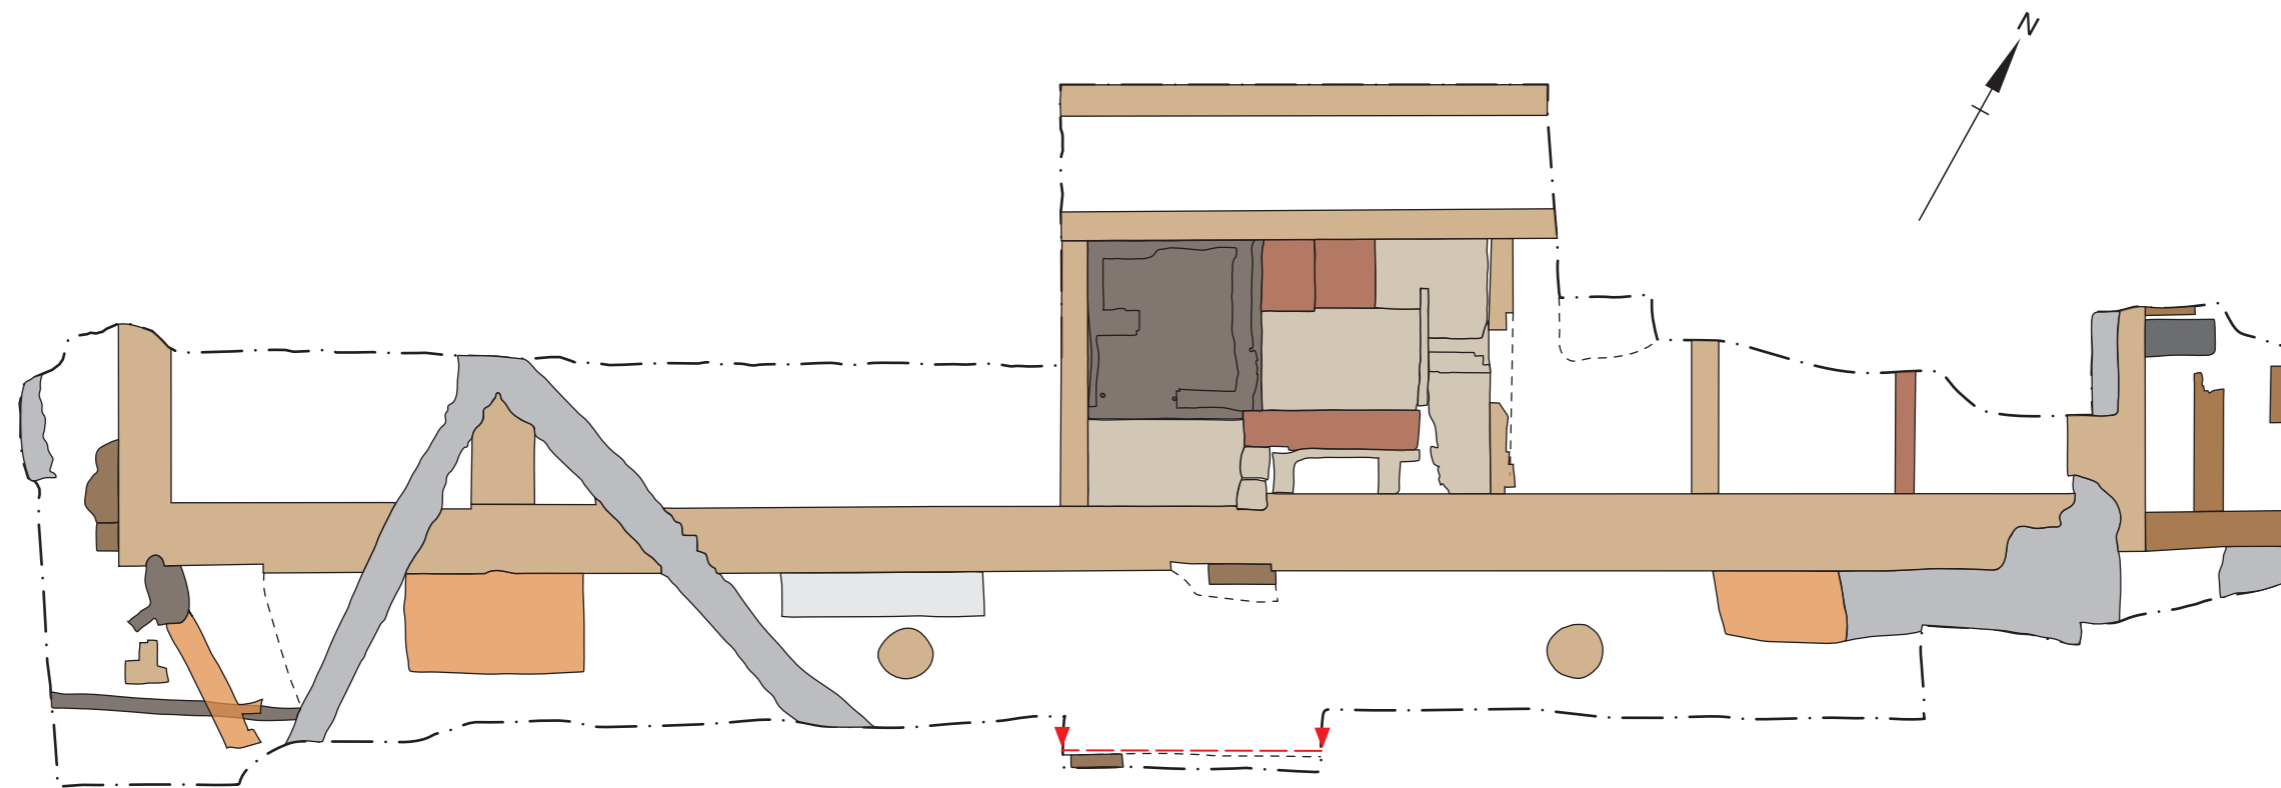
Figure. 10 Trench 6

- Key**
- Group 601 Modern Interventions
 - Group 602 Temporary Buildings and Services
 - Group 604 Ammunition Cache/dump
 - Group 605 Early 20th Century Courthouse Alterations
 - Group 606 Late 19th Century Courthouse Alterations
 - Group 607 Mid 19th Century Courthouse Service Additions
 - Group 608 Mid 19th Century Courthouse Cell
 - Group 609 Mid 19th Century Courthouse/Isolation Wing Infill
 - Group 610 External Courthouse Features
 - Group 611 Original Courthouse Wall and Construction
 - Trench 6 Section Location
