Archaeological Investigations at Northallerton Prison

YAT Assessment Report 2018/108 December 2018

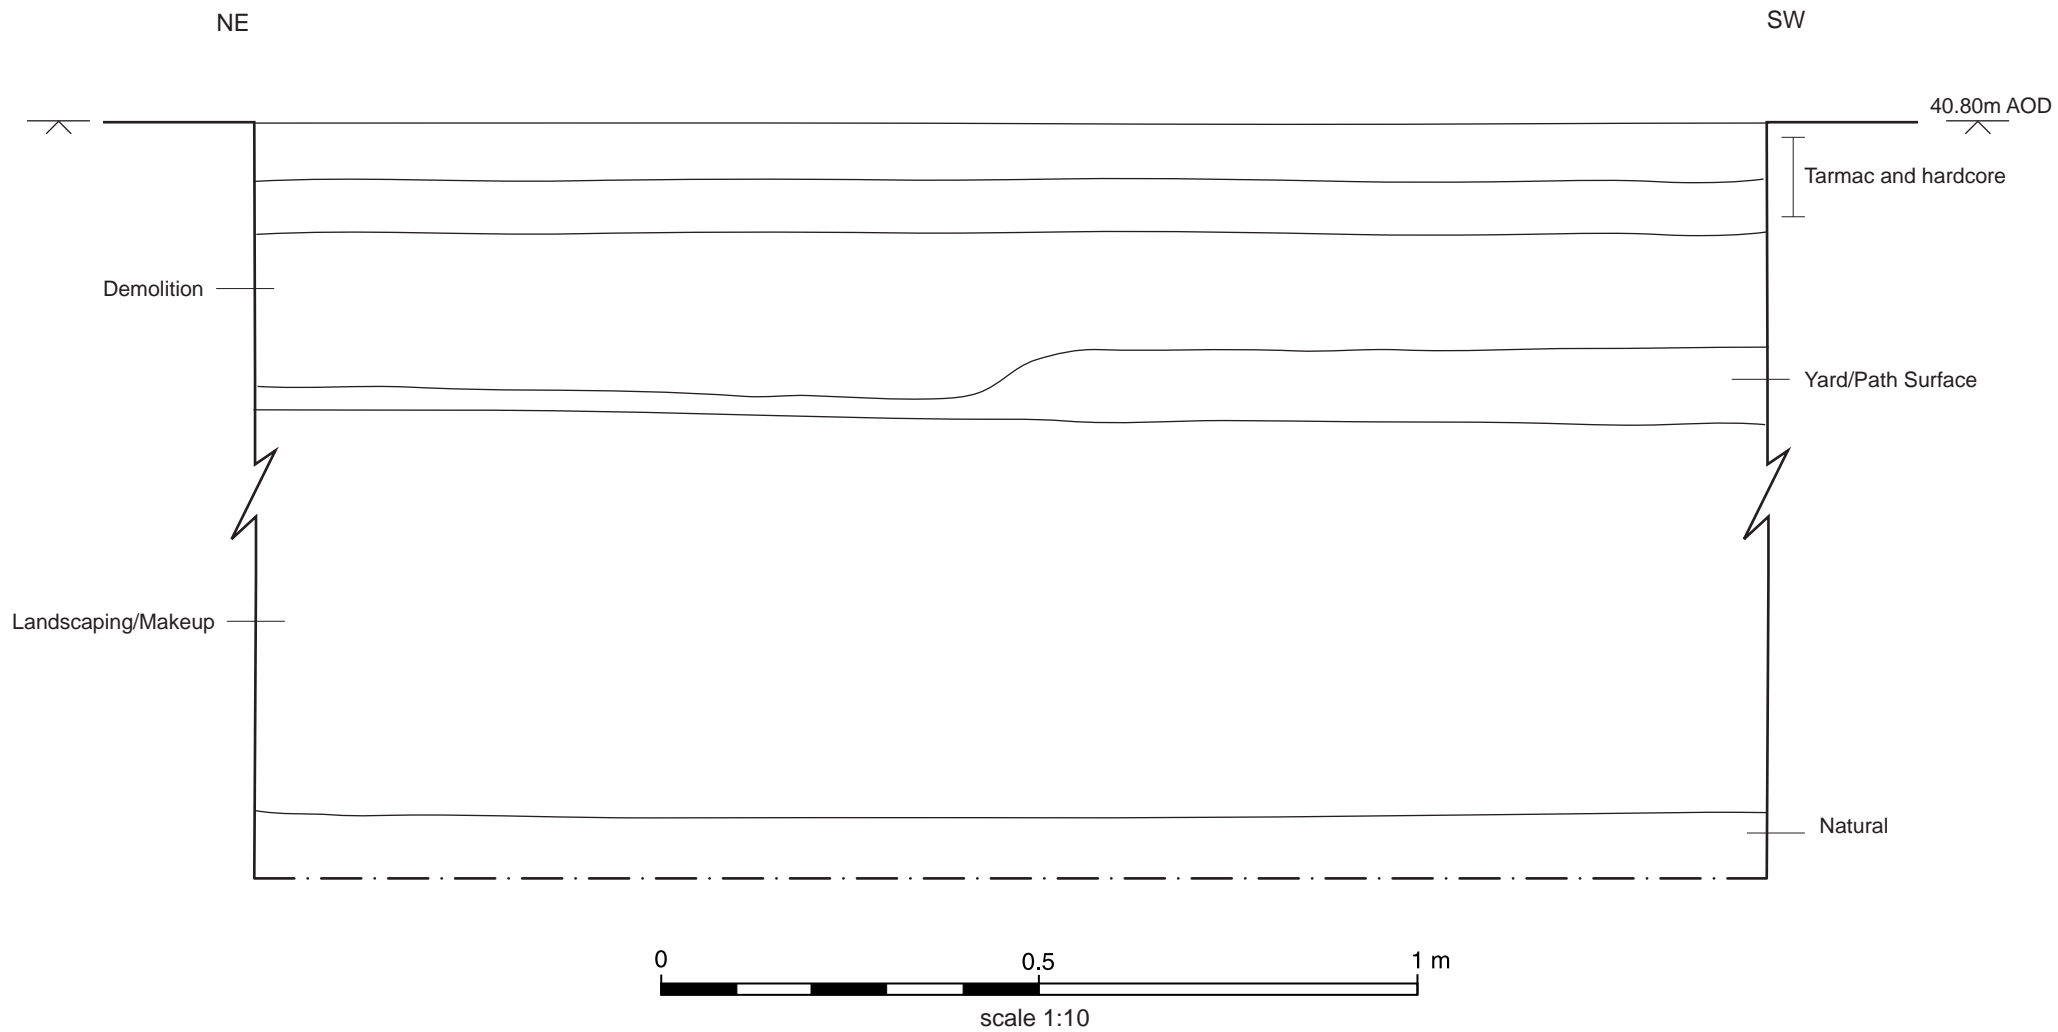
Fig. 11 Trench 6 Section with yard/path surface
