| SITE | Osbaldwick Village Green, Osbaldwick, York | | | | | |
| YAT PROJECT # | 6071 | YAT REPORT # | 2018/93 | | | |

INTRODUCTION

A watching brief on the demolition and replacement of a bridge was undertaken by York Archaeological Trust on behalf of L and K Warcup Construction Ltd. between 2nd and 3rd July 2018 at Osbaldwick Village Green, Osbaldwick, York, NGR SE 63352 51943 (Figure 1). The objectives of the watching brief were to record any archaeological deposits or structures exposed by the ground works, to investigate the structural sequence of the bridge and to ascertain whether any remains of previous crossings survived.

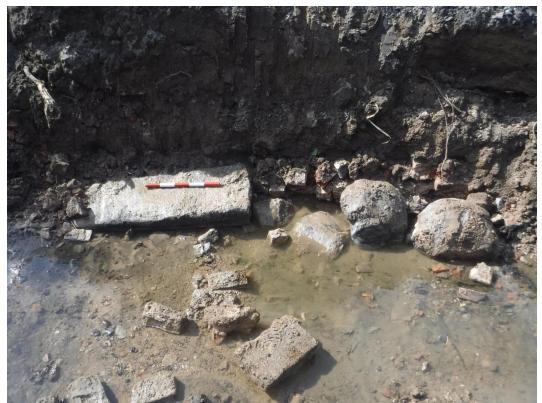
Up to present, the precise date of construction for the western bridge on Osbaldwick Village Green has been unknown. Observations during the dismantling of the structure, however, revealed two distinct phases of construction. At the limit of excavation, approximately 2m BGL, a cobble filled foundation trench (Contexts 103) was observed and dated by two sherds of pottery to the 19th century. A substantial 4.60m long, 0.50m wide footing course of large pieces of re-used medieval masonry and small boulders (up to 0.55m across) was built directly over the cobble foundation (Context 102; Plate 2). The most notable piece of masonry was a near complete medieval grave slab; unfortunately, no inscription or incised decoration was present. The significance of the stonework will be discussed in greater detail in Appendix 1.

Plate 2. South-east facing view of stone footings, including the grave slab beneath the scale (Context 102, 0.50m scale).

The brick arch of the bridge (Context 101) was built over the stone footing, spanning the approximately 1.50m width of the beck. The structure was made of slop-moulded, hand-made red brick measuring 225mm x 11mm x 65mm and bonded with a lime mortar. Many of the bricks were observed to be poorly fired, discoloured and distorted, although the bridge itself was well-built.

The bridge was clearly modified and strengthened in the late 19th/early 20th century, as the external faces of the structure were re-built using machine-made frogged brick measuring 230mm x 110mm x 70mm. These bricks were stampled 'Hartley's of Castleford' and were bonded with a gritty cement. At some point, the surface of the bridge was consolidated with reinforced concrete, over which the current rubble hardcore and tarmac surface was laid (Context 100). It is uncertain whether the reskinning and re-surfacing were a single occurrence or separate events.
