Archaeological Investigations at York Station Frontage

YAT Assessment Report 2018/116 January 2019

Between the 20th August and the 5th October 2018 York Archaeological Trust conducted a series of archaeological investigations and an archaeological watching brief during engineering ground investigations at York Station Frontage (SE 59661 51657).

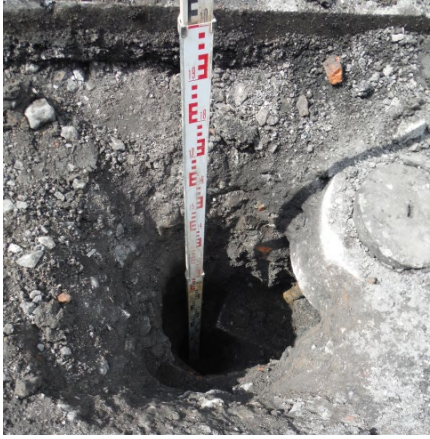
Intervention No. ATT 01	
Time/Date am 30/08/18	
Contexts / Numbers Assigned	
1100	Road surface – Tarmac
1101	Service – Electrical cable
1102	Road surface – Tarmac
1103	Road make-up - Aggregate etc.
1104	Tank/Service - Iron pipework and tank or valve.
1105	Infill/Disturbance - Friable dark grey brown, clay sand and silt. Contains brick and other rubble. Backfill around tank?
Notes	
2100mm x 1040mm and up to 1750mm deep

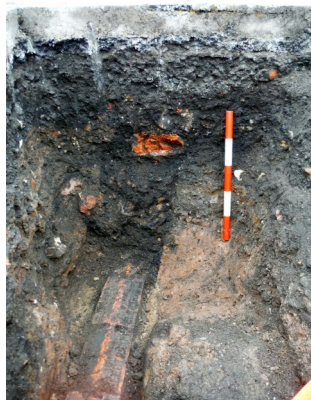
1800mm x 1000mm and up to 1200mm deep. TP 04 added to side to investigate deeper ground conditions.

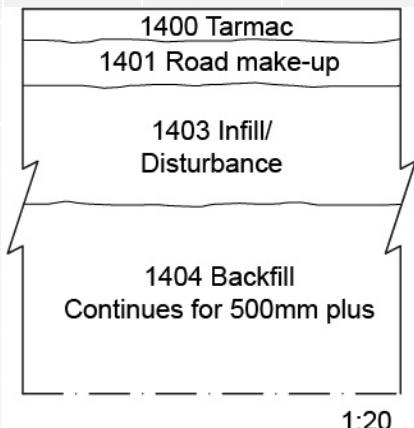
1:20

Intervention No. ATT 04	
Time/Date am 18/09/18	
Contexts / Numbers Assigned	
1400	Road surface - Tarmac.
1401	Road make-up - Aggregate.
1402	Service - 180mm gas main
1403	Infill/Disturbance - Loose, dark grey, silt and rubble etc.
1404	Service backfill? - Soft, dark grey/orange, clay silt sand with tarmac, cobbles and bricks 80mm thick
1405	Footing - Two concrete elements, 400mm and 600mm thick.
1406	Disturbance - soft, orangey brown, clay sand with cobbles and pebbles. Probably linked with concrete footings.
1407	Surface/Surface make-up - Loose, dark grey, gravel and clinker. Probably linked with railways.
1408	Disturbance - Firm, pinkish orangey brown, clay sand with pebbles, cobbles, charcoal flecks and CBM flecks.
Notes	
Two adjacent holes. 1850mm x 950mm and up to 1350mm deep plus 2050mmx950mm and up to 1500mm deep. Investigation limited by services.

1400 Tarmac
1401 Road make-up
1403 Infill/
Disturbance
1404 Backfill
Continues for 500mm plus

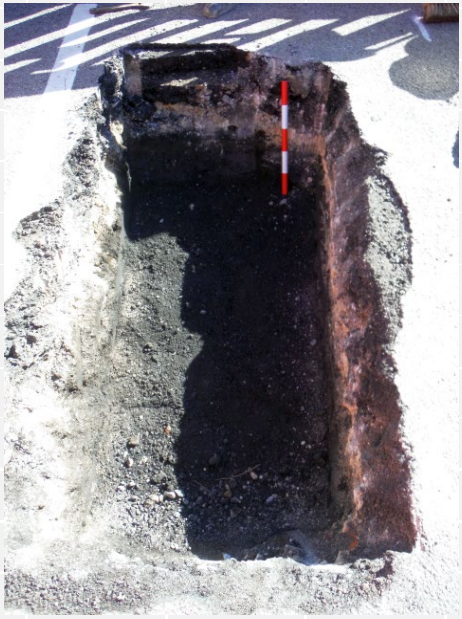
YORK ARCHAEOLOGICAL TRUST	Site Code -	
TEST PIT/BOREHOLE/WINDOW SAMPLE LOG	Project Number- 6076	
Site Name - York Station Frontage SI	Trench/Area TP 04	Sheet - 1 of 1

Intervention No. TP 04	
Time/Date am 26/09/18	
Contexts / Numbers Assigned	
2140	Road surface - Tarmac.
2141	Road surface - Tarmac.
2142	Road make-up - Aggregate etc.
2143	Infill/Disturbance - Friable, black to dark grey, gravel, clinker and other industrial materials.
2144	Surface/Surface make-up - Compact, brownish yellow, gravel with clay. Possibly linked with previous railway activities.
2145	Disturbance - Firm, pinkish orangey brown, clay sand with pebbles, cobbles, charcoal flecks and CBM flecks. May be landscaping for railway construction.
2146	Natural - Stiff, brownish orange, clay sand with cobbles and pebbles. Large cobble and boulders lower down.
Notes 1800mm x 700mm and up to c.2400mm deep.

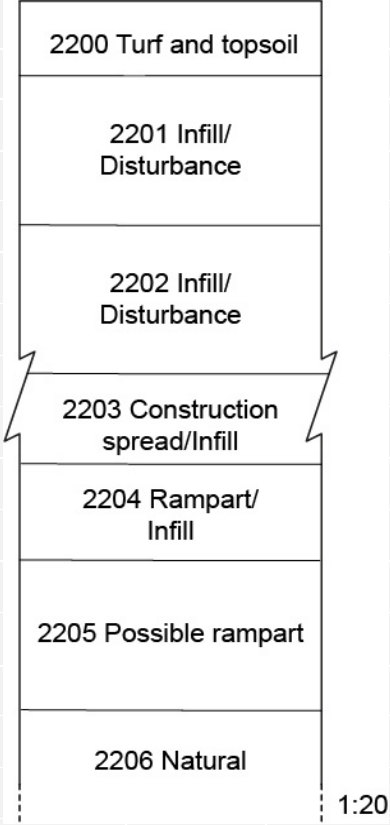
1:20

2200 Turf and topsoil

2201 Infill/
Disturbance

2206 Natural

Sealing natural were lenses of orange and yellow sands and silts (2205) which were interpreted as possible rampart deposits. Within these deposits was a part of a Roman tegula which was broken during excavation. Collectively these weighed 735g and all of this material is of 1-14th century date and in fabric R11 from the York fabric series (J. McComish pers. com.). There was also a late 4th century pottery beaker base. It may be that this was just medieval reworking of Roman materials or it could have been Roman in date. This possible rampart material was 400mm thick and went up to 1.5m BGL.

260mm was a possible construction spread of loose angular limestone fragments (2203). Both deposits together may be evidence of a medieval rampart.

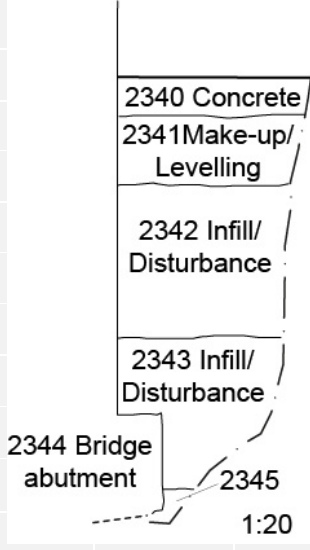
Intervention No. OP 04	
Time/Date am 12/09/18	
Contexts / Numbers Assigned	
2340	Surface - Concrete
2341	Surface make-up/Levelling - Firm, brick rubble etc.
2342	Infill/Disturbance - Friable, dark grey black, mixed clinker and industrial waste fragments.
2343	Infill/Disturbance - Friable, dark grey black, mixed clinker and industrial waste fragments with disturbed soil.
2344	Bridge abutment - Sandstone structure with stepped concrete footing projecting 130mm out and 300mm down.
2345	Disturbance/Possible natural - Firm, orangey brown, sandy clay with cobbles.
Notes	
500mm x 400mm and up to c.1380mm deep.

The earliest deposit was sandy clay with cobbles from 1.08m BGL. The bridge abutment foundation cut through this to 1.38m BGL. There was then 800mm of infill against the structure.

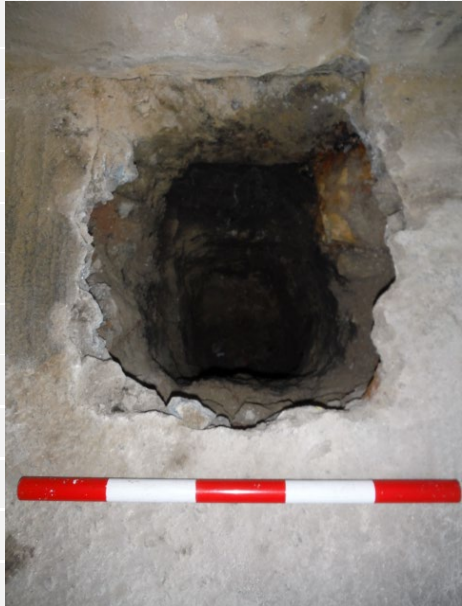
YORK ARCHAEOLOGICAL TRUST	Site Code -	
TEST PIT/BOREHOLE/WINDOW SAMPLE LOG	Project Number- 6076	
Site Name - York Station Frontage SI	Trench/Area OP 05	Sheet - 1 of 1

Intervention No. OP 05	
Time/Date pm 10/09/18	
Contexts / Numbers Assigned	
2350	Surface - Concrete = 1200
2351	Path surface - Firm, dark grey, tarmac plus rubble and aggregate make-up. = 1203
2352	Service - Cast Iron pipe plus cut and backfill.
2353	Infill/Disturbance - Firm, brownish orange, clay sand with brick rubble. = 1213
2354	Bridge abutment - Sandstone structure with stepped concrete footing projecting 130mm out and 300mm down.
2355	Disturbance - Friable, grey brown, silty sand with clay and clay lumps, shell, charcoal flecks and cbm flecks. = 1214
Notes	
700mm x 600mm and up to c.1400mm deep.	
Part of ATT 02, dug and recorded at same time.

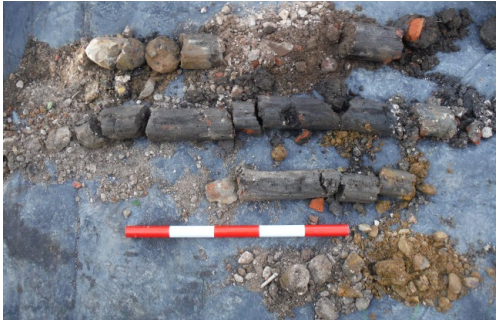
YORK ARCHAEOLOGICAL TRUST	Site Code -	
TEST PIT/BOREHOLE/WINDOW SAMPLE LOG	Project Number- 6076	
Site Name - York Station Frontage SI	Trench/Area AWS 01	Sheet - 1 of 1

Intervention No. AWS 01	
Time/Date am 22/08/18	
Contexts / Numbers Assigned	
3010	Surface - Turf and topsoil, loose dark grey brown, sandy silt.
3011	Infill/Disturbance - Soft, dark grey brown sandy silt with concrete and other rubble.
3012	Infill/Demolition possibly linked with former School - Loose, pinkish orange silt with brick and mortar rubble.
3013	Voids in column * as above?
3014	Infill/Disturbance - Firm, dark grey silt clay with some medieval tile. Again voids in the column.
3015	Voids in column
3016	Infill/Silting which may be early deposits within the ditch - Soft, grey silty clay.
3017	Void in column, column collapsed. Rubble including clay tobacco pipe fallen into sample.
3018	Natural - Loose, orange yellow, sand and gravel.
Notes	
4.35m Deep. Hand dug to 850mm.	
Multiple column collapses.

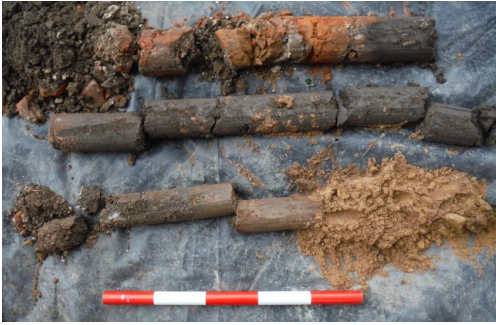
YORK ARCHAEOLOGICAL TRUST	Site Code -	
TEST PIT/BOREHOLE/WINDOW SAMPLE LOG	Project Number- 6076	
Site Name - York Station Frontage SI	Trench/Area AWS 02	Sheet - 1 of 1

Intervention No. AWS 02	
Time/Date am 22/08/18	
Contexts / Numbers Assigned	
3020	Surface - Turf and topsoil, loose dark grey brown, sandy silt.
3021	Infill/Demolition, terrace fronting Queen Street? - Loose, grey brown sandy silt with brick rubble.
3022	Infill/Demolition, as above, Queen Street? - Loose, grey brown sandy silt with larger brick rubble.
3023	Infill/Silting within ditch - Firm, brownish grey, silty clay. No visible inclusions or finds.
3024	Rampart/Natural could be part of early rampart structure or natural clay - Firm, grey to pinkish grey, clay.
3025	Natural - Loose, orange yellow, sand.
Notes	
3.8m Deep. Hand dug to 850mm.

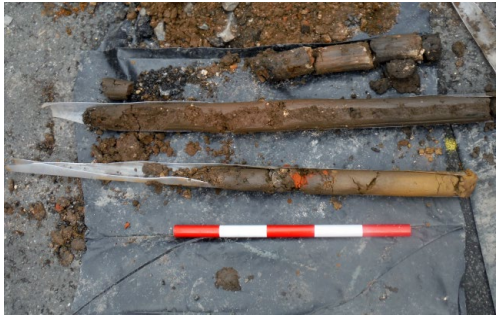
YORK ARCHAEOLOGICAL TRUST	Site Code -	
TEST PIT/BOREHOLE/WINDOW SAMPLE LOG	Project Number- 6076	
Site Name - York Station Frontage SI	Trench/Area AWS 03	Sheet - 1 of 1

Intervention No. AWS 03	
Time/Date pm 20/08/18	
Contexts / Numbers Assigned	
3030	Road surface - Tarmac.
3031	Road Make-up - Aggregate etc
3032	Infill/Disturbance - Loose, orangey brown, silt with mortar and rubble.
3033	Voids in column
3034	Disturbance, possibly earlier construction or landscaping - Firm grey or pinkish brown silty clay.
3035	Buried soil - Soft, dark grey clay silt with charcoal flecks.
3036	Voids in column
3037	Natural - Soft, yellow, slightly clayey sand.
Notes	
3.7m Deep. Hand dug to 700mm. 67mm bore column due to restriction

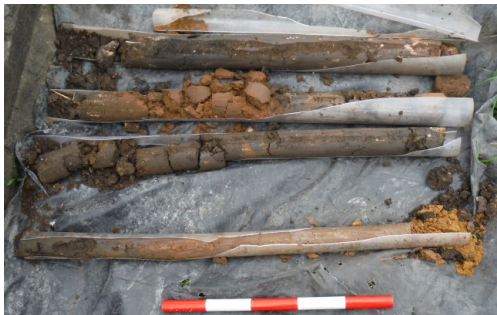
3069	Natural - Soft, yellow, sand.
Notes	
5.0m Deep. Hand dug to 1000mm.

Sketch Section / Photo	
	3060 Surface Turf & Topsoil
	3061 Infill/Disturbance
	3062 Buried Soil
	3063 Rampart/Disturbance
	3064 Rampart/Disturbance
	3065 Rampart/Disturbance
	3066 Infill/Silting
	3067 Infill/Silting
	3068 Rampart/Natural
1:20	3069 Natural

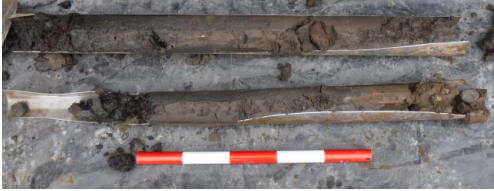
YORK ARCHAEOLOGICAL TRUST	Site Code -	
TEST PIT/BOREHOLE/WINDOW SAMPLE LOG	Project Number- 6076	
Site Name - York Station Frontage SI	Trench/Area AWS 07	Sheet - 1 of 1

Intervention No. AWS 07	
Time/Date pm 23/08/18	
Contexts / Numbers Assigned	
3070	Road surface - Tarmac.
3071	Road surface - Tarmac.
3072	Infill/Disturbance - Soft to loose, black dark grey aggregate and other 'industrial' material.
3073	Infill/Disturbance - Firm, dark grey brown, silt clay with post-medieval brick.
3074	Void in column
3075	Natural subsoil/Natural - Firm, grey stained silt clay.
3076	Natural - Firm, orangey brown, clay with pebbles
Notes	
2.9m Deep. Hand dug to 900mm.

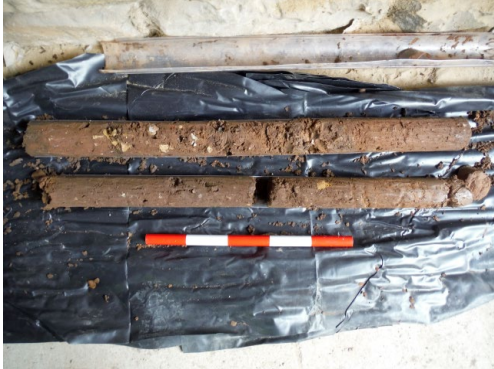
YORK ARCHAEOLOGICAL TRUST	Site Code -	
TEST PIT/BOREHOLE/WINDOW SAMPLE LOG	Project Number- 6076	
Site Name - York Station Frontage SI	Trench/Area AWS 09	Sheet - 1 of 1

Intervention No. AWS 09	
Time/Date am 14/09/18	
Contexts / Numbers Assigned	
3090	Surface - Concrete
3091	Surface make-up/Levelling - Firm, brick rubble etc.
3092	Surfaces/Disturbance - Compact, yellowy grey, stone and pebbles
3093	Infill/Disturbance - Friable, orangey brown, clay sand with rubble fragments.
3094	Disturbance - Firm, orangey brown, clay sand with cobbles, stone fragments plus medieval tile.
3095	Disturbance/Interface - Friable, yellowy brown, gravel and sand.
3096	Natural - Firm, orangey brown sandy clay with pebbles. Becomes darker grey lower down.
3097	Natural - Laminated sand and clay. *links with Hudson House inside walls.
Notes	
3.2m Deep. Hand dug to 1200mm.

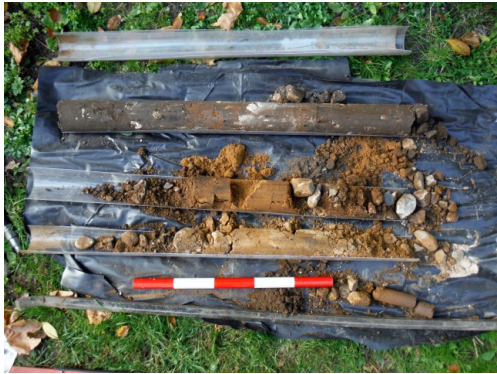
YORK ARCHAEOLOGICAL TRUST	Site Code -	
TEST PIT/BOREHOLE/WINDOW SAMPLE LOG	Project Number- 6076	
Site Name - York Station Frontage SI	Trench/Area WS 03	Sheet - 1 of 1

Intervention No. WS 03	
Time/Date pm 14/09/18	
Contexts / Numbers Assigned	
3230	Surface - Turf and topsoil, loose dark grey brown, sandy silt.
3231	Infill/Disturbance - Friable, dark grey brown, sandy silt with occasional rubble fragments.
3232	Infill/Disturbance - Firm, grey brown clay sand silt with CBM and limestone fragments.
3233	Void in column.
3234	Possible rampart - Soft, orange, sand.
3235	Possible rampart - Loose, angular stone fragments and cobbles in sand.
3236	Void in column.
3237	Natural - Soft, light orangey yellow, sand and gravel at base. Refusal, but further probe suggests natural clay below.
Notes	
c.4m Deep. Hand dug to 1000mm.

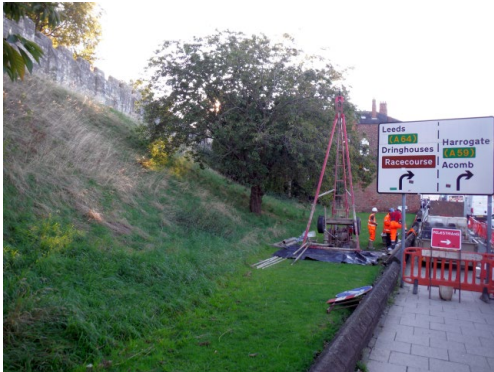
YORK ARCHAEOLOGICAL TRUST	Site Code -	
TEST PIT/BOREHOLE/WINDOW SAMPLE LOG	Project Number- 6076	
Site Name - York Station Frontage SI	Trench/Area BH 01	Sheet - 1 of 1

Natural clay sand was encountered at 3.7m BGL (11.02m OD). Immediately above the natural was a 100mm thick layer of possible rampart deposits or disturbance (3313). This was made up of loose limestone fragments in a brown silty matrix.

Intervention No. BH 01	
Time/Date am 27/09/18	
Contexts / Numbers Assigned	
3310	Surface - Turf and topsoil, loose dark grey brown, sandy silt.
3311	Infill/Disturbance - Soft, dark grey brown sandy silt with rubble. See WS 01 for more detail.
3312	Infill/Disturbance - Firm, dark grey silt clay.
3313	Possible rampart /Disturbance - Loose, limestone fragments.
3314	Natural - Firm, reddish brown clay with sand.
Notes	
4m+ Deep. Hand dug to 1200mm.

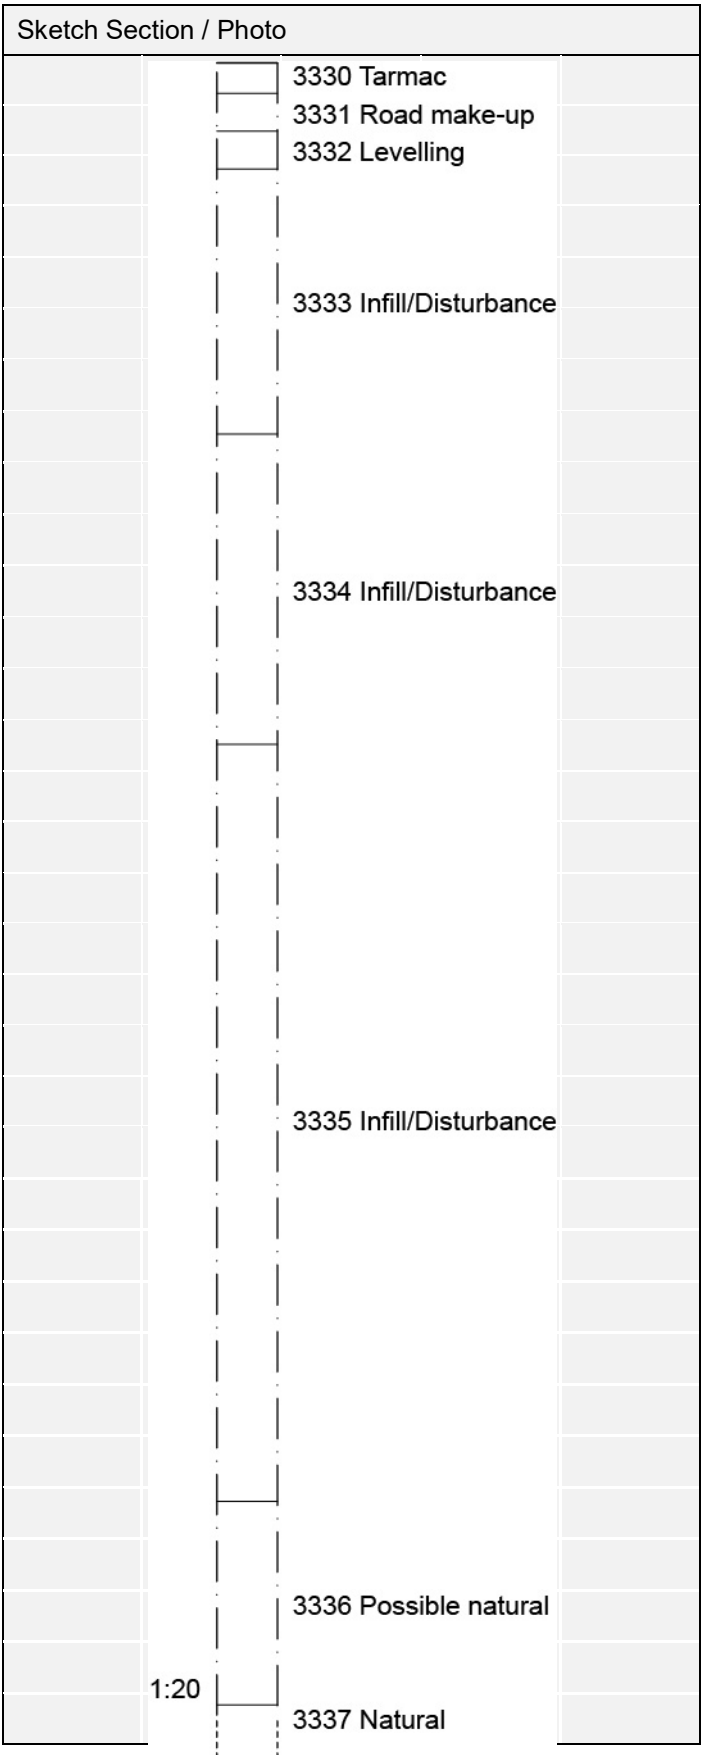
Intervention No. BH 03	
Time/Date pm 26/09/18	
Contexts / Numbers Assigned	
3330	Road surface - Tarmac.
3331	Road make-up - Aggregate etc.
3332	Levelling - Hardcore.
3333	Infill/Disturbance - Firm, grey brown, clay sand with cobbles.
3334	Infill/Disturbance - Friable, dark grey, clay sand with 19 th century brick fragments.
3335	Infill/Disturbance - Soft, dark grey black, silt sand. Possible industrial staining.
3336	Possible natural - Soft, dark grey, sand and clay layers. These were disturbed during drilling.
3337	Natural - Compact, grey, gravel.

Notes
9m+ Deep. Hand dug to 1200mm.
