Buildings to the rear of 32 Clifton, York Building Survey

YAT Report 2018/111 August 2018

A Level 2 Building Survey was undertaken by York Archaeological Trust on the 2<sup>nd</sup> August 2018 on two mid-19<sup>th</sup> century outbuildings to the rear of 32 Clifton, York. This report provides a written and photographic record of the buildings prior to their redevelopment into two residential dwellings.

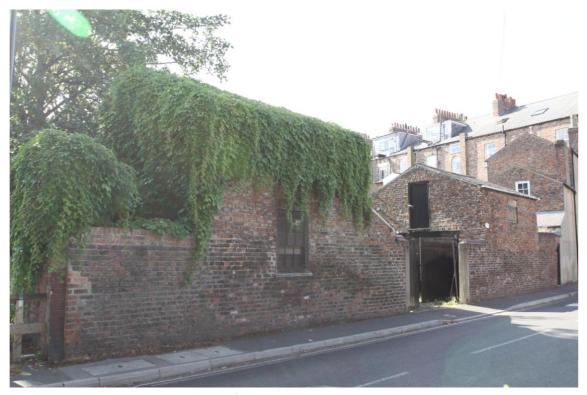
**Plate 1** View of Buildings 1 and 2, view south-east.

The outbuildings are set on the eastern side of Burton Stone Lane, their western walls forming part of the western boundary of 32 Clifton. As can be seen in Plate 1, the construction of the outbuildings post-dates the western boundary wall of 32 Clifton, being of different brick to the original boundary wall, and clearly using the original boundary wall as the lower half of the outbuildings. The outbuildings are mainly constructed of common red brick in Common Bond. Both outbuildings are detached, with Building 2 lying immediately to the north of 32 Clifton, with Building 1 further to the north. The outbuildings face each other across a courtyard, with a double gate providing access from Burton Stone Lane. Within the eastern wall of the courtyard is a single pedestrian gate providing access into the garden of 32 Clifton.

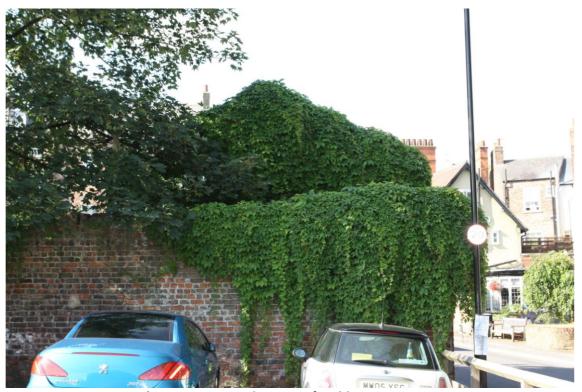
Plate 2 Western elevation of Building 1, view east

Building 1 is a two-storey 19<sup>th</sup> century outbuilding, with an open gabled slate roof. The western elevation is the most prominent as it faces Burton Stone Lane (Plate 2). Although it is not as clear as Building 2, Building 1 appears to have been constructed after the western boundary wall of 32 Clifton. The brick used in the boundary wall is of a different type to that used in the upper half of Building 1. The boundary wall extends north of Building 1. There is one window present in the western elevation of this Building 1; a Georgian sash window consisting of two three by two panes. The window has a soldier course header and a wooden lintel. The top third of this elevation is masked by ivy, but there appears to be another window in the upper storey.

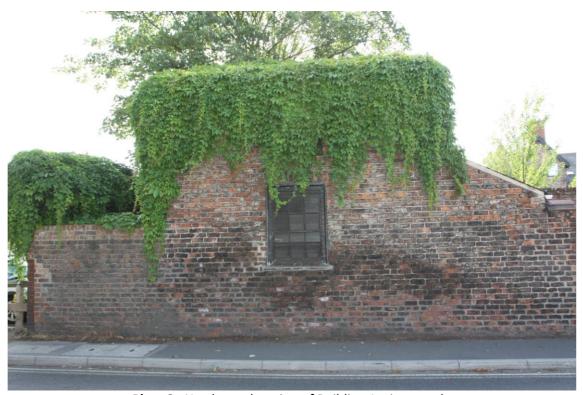
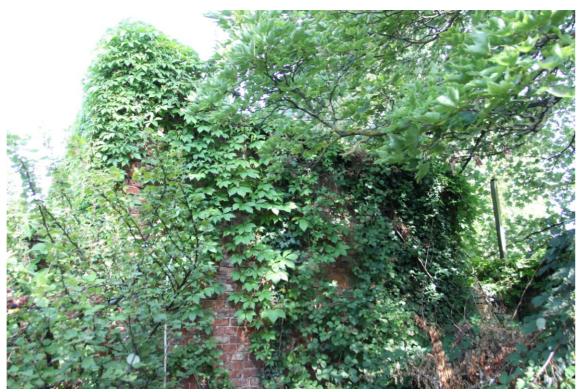
The northern and eastern elevations of Building 1 have been obscured by ivy (Plates 3–4). The southern elevation appears to be a blank wall, but there may be a door in the eastern elevation of Building 1, which can be seen from the interior (discussed below).

**Plate 3** Northern elevation of Building 1, view south.

**Plate 4** Eastern elevation, view north-west.

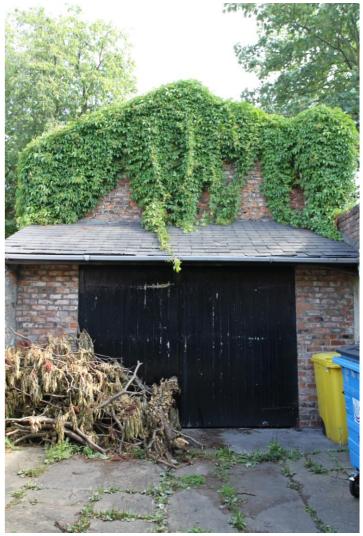
Plate 5 Southern elevation of Building 1, view north.

The southern elevation of Building 1 faces into the courtyard and is the main entrance into the outbuilding (Plate 5). A later brick extension with a single pitch slate roof has been added to create a porch with double wooden doors. This has obscured the original southern elevation of Building 1. As with the other elevations, ivy masks the upper part of the outbuilding.

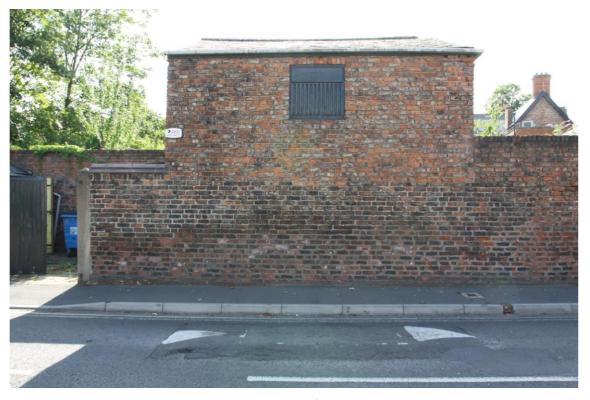
Plate 6 Western elevation of Building 2, view east.

Building 2 is a two-storey 19<sup>th</sup> century outbuilding with an open gabled slate roof. As with Building 1, the most prominent elevation is the western, facing onto Burton Stone Lane (Plate 6). The later construction of these outbuildings is clearly seen in this elevation, with the common red brick of Building 2 sitting on top of the boundary wall of 32 Clifton. A wooden shutter window with a rowlock course header and wooden lintel is present in the upper storey of this elevation.

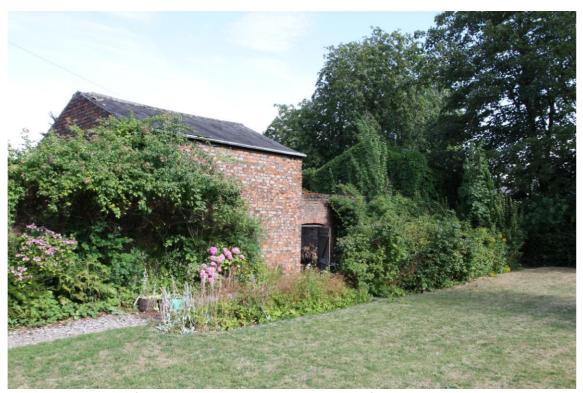
Plate 7 View of the southern and eastern elevations of Building 2, view north-west.

The southern and eastern elevations of Building 2 are partially obscured by bushes, but have no windows or doors (Plate 7).

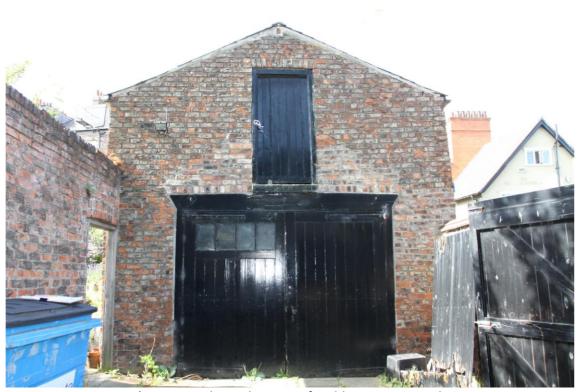
Plate 8 Northern elevation of Building 2, view south.

The northern elevation of Building 2 faces into the courtyard and is the main entrance into the outbuilding (Plate 8). This elevation has double wooden doors on the ground floor, with a four light window in the eastern door. The double doors have a rowlock course header. Immediately above the double doors is a single door into the upper storey. The single door has a lintel and a soldier course header. There is a disturbance above and to the west of the double doors, indicating that they may be a later addition to Building 2.

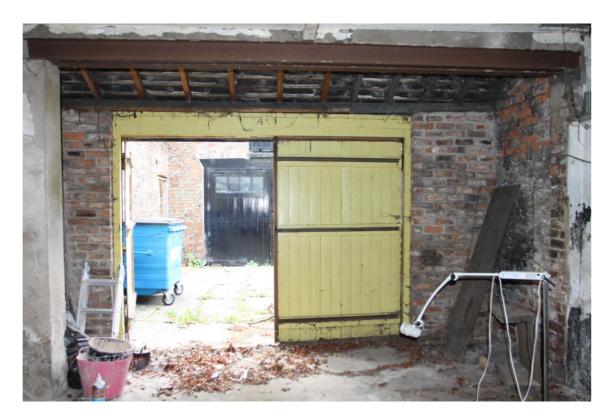
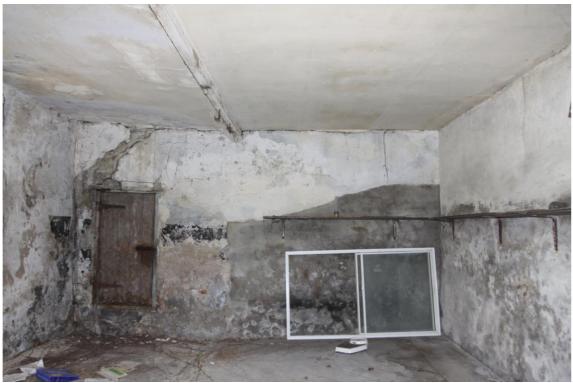
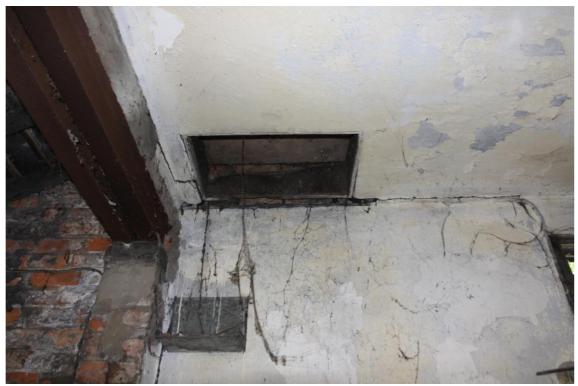
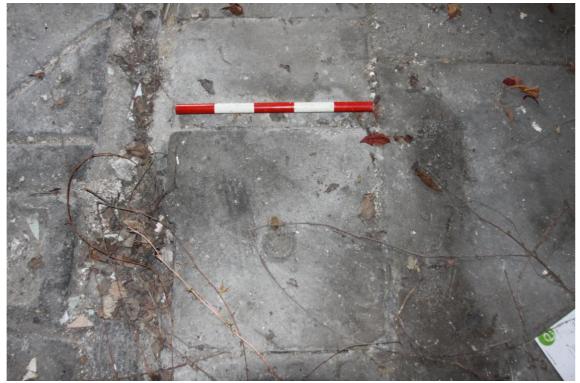
The ground floor of Building 1 consists of two rooms. The double wooden doors lead into the later single-storey porch, constructed of concrete and brick (Plate 9). Continuing through the porch is the original 19<sup>th</sup> century outbuilding (Plate 10). The walls and ceiling are plastered, with one single ceiling beam aligned north-south. In the south-western corner of the ceiling is a hatch into the upper storey, this appears to be the only access (Plate 11). In the north-western corner of the room is a wooden door that appears to lead outside, it was not possible to open it. The floor is stone, one flag has a ring set into it (Plate 12).

Plate 9 The later porch addition to Building 1, view south.

Plate 10 The interior of Building 1, view north.

**Plate 11** Access to upper storey of Building 1, view west.

**Plate 12** Stone floor in Building 1 with inset ring, view south.

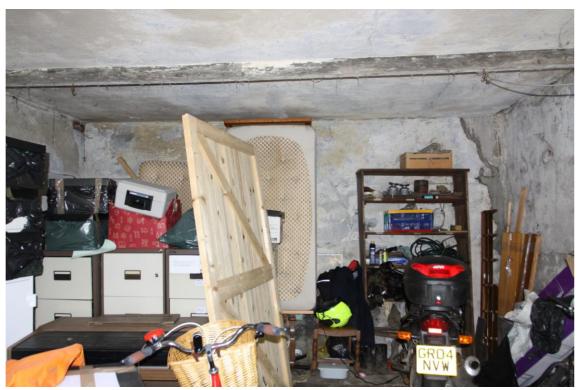
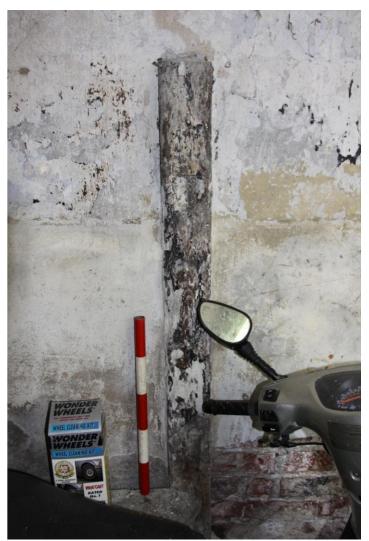
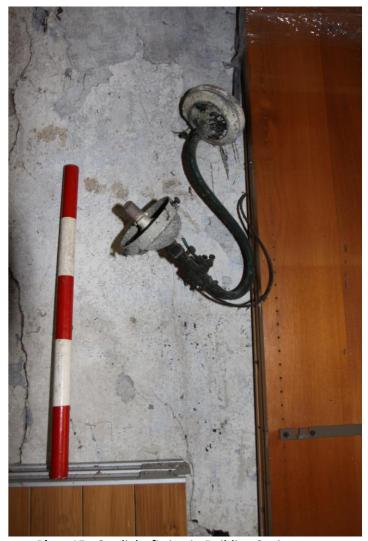
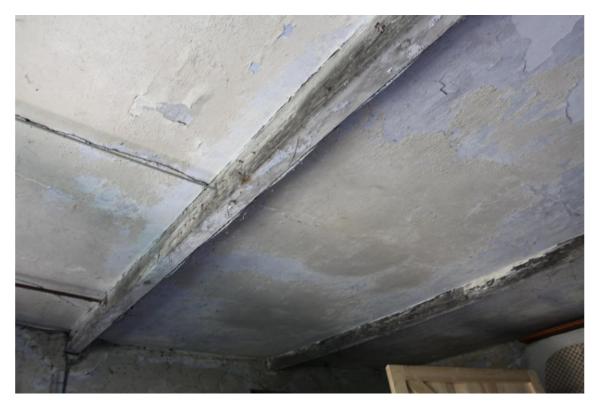
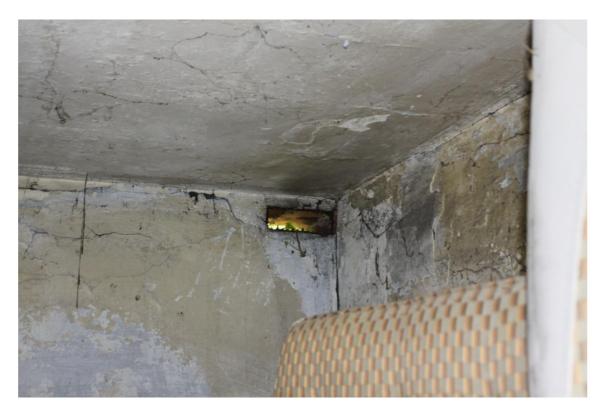
The ground floor of Building 2 consists of one room (Plate 13). The walls and ceiling are plastered, although some bricks were exposed at the bottom of the western wall next to an inset wooden post (Plate 14). To the south of this a gas light attachment was still present (Plate 15). Two wooden beams aligned west-north-west / east-south-east were present in the ceiling (Plate 16). A brick had been removed in the south-east corner to aid ventilation (Plate 17). As with Building 1, the floor was comprised of stone flags.

Plate 13 The interior of Building 2, view south.

Plate 14 Wooden post and exposed brick wall in Building 2, view west

Plate 15 Gas light fitting in Building 2, view west.

**Plate 16** Beams within Building 2, view south-east.

**Plate 17** Gap in south-eastern corner of Building 2, view south-east.
