# Archaeological Monitoring of Boreholes at 17 Mansfield Street

YAT Assessment Report 2018/174 December 2018

On the 7<sup>th</sup> December 2018 York Archaeological Trust (YAT) conducted a watching brief to monitor Geotechnical Boreholes at Simons Auto Services, 17 Mansfield Street, York, YO31 7US (SE 6093 5209).

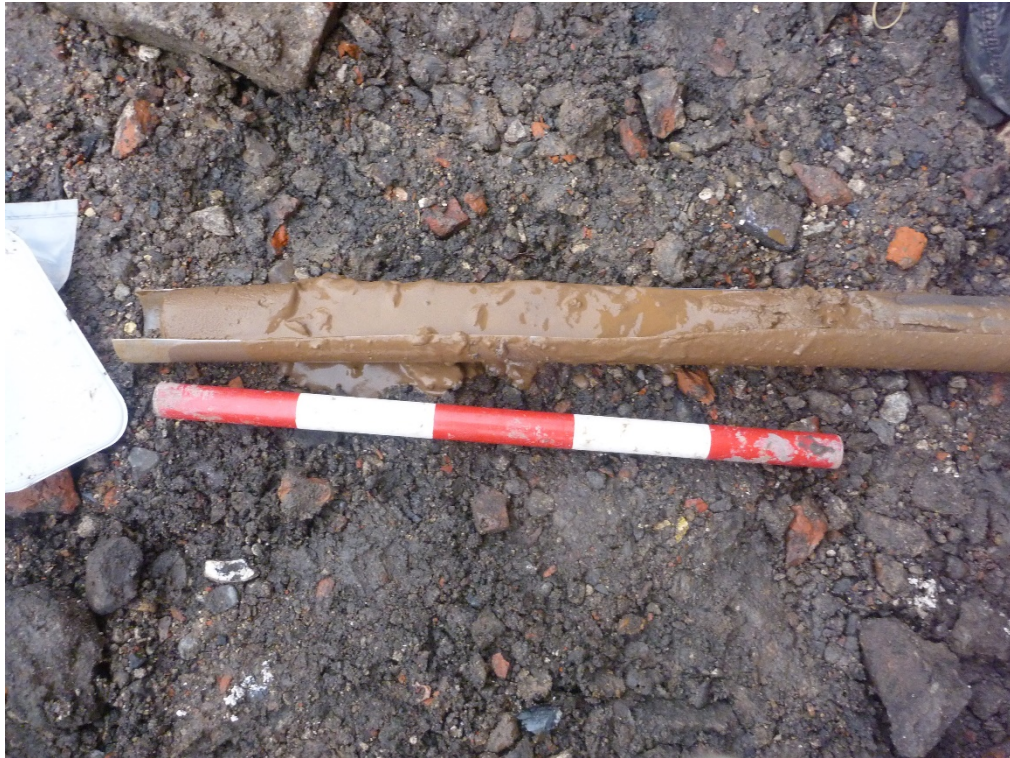
**Plate 1 Waterlogged sandy made ground deposit (C103) in BH01, at 3 to 4m BGL.**

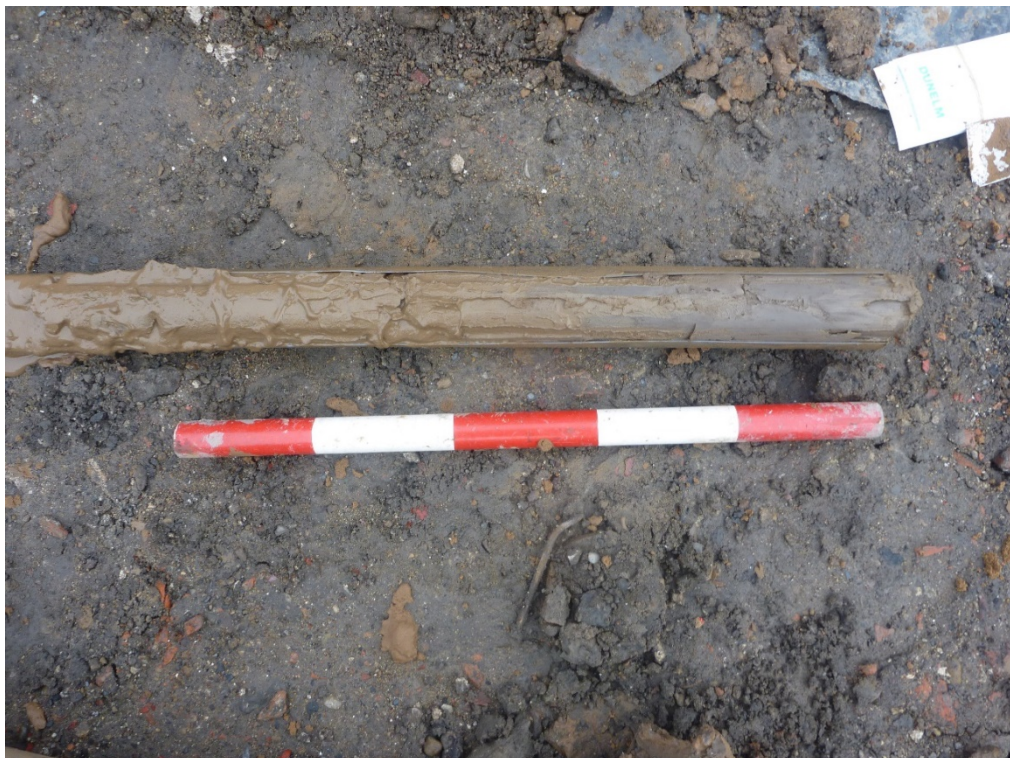
**Plate 2 Boundary between the clayey sand made ground (C203) and natural Boulder Clay (C204).  
Encountered at 4.7m BGL in BH02.**

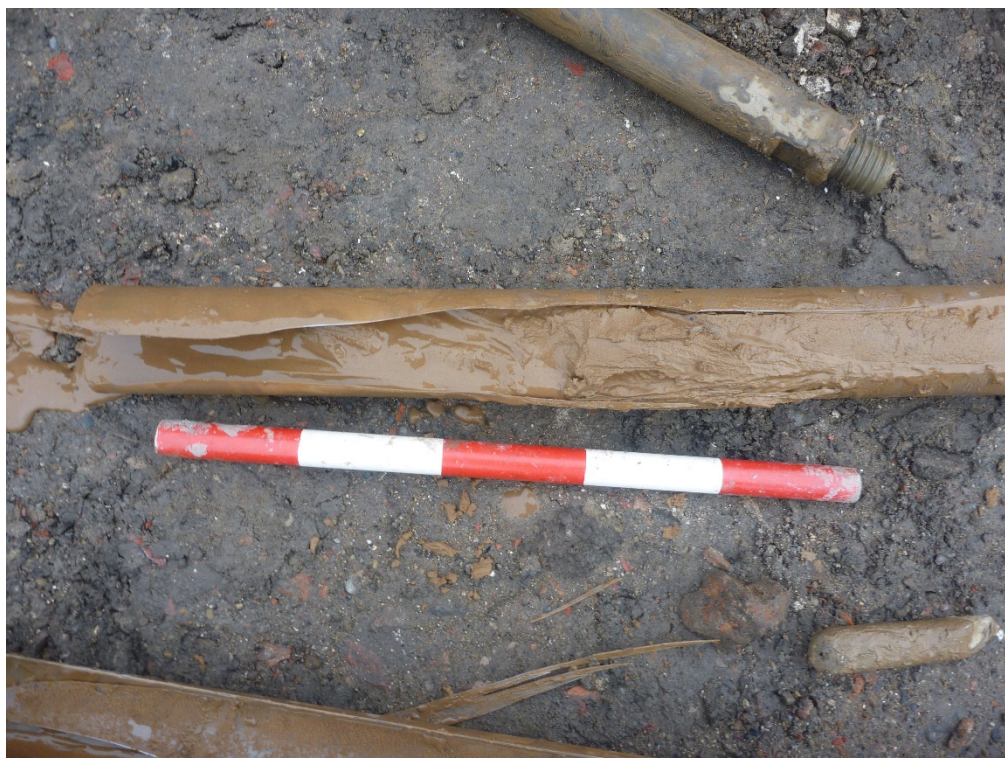
Plate 3 Clayey sand made ground deposit in BH02 (C203), same as visible in BH01, Plate 1.

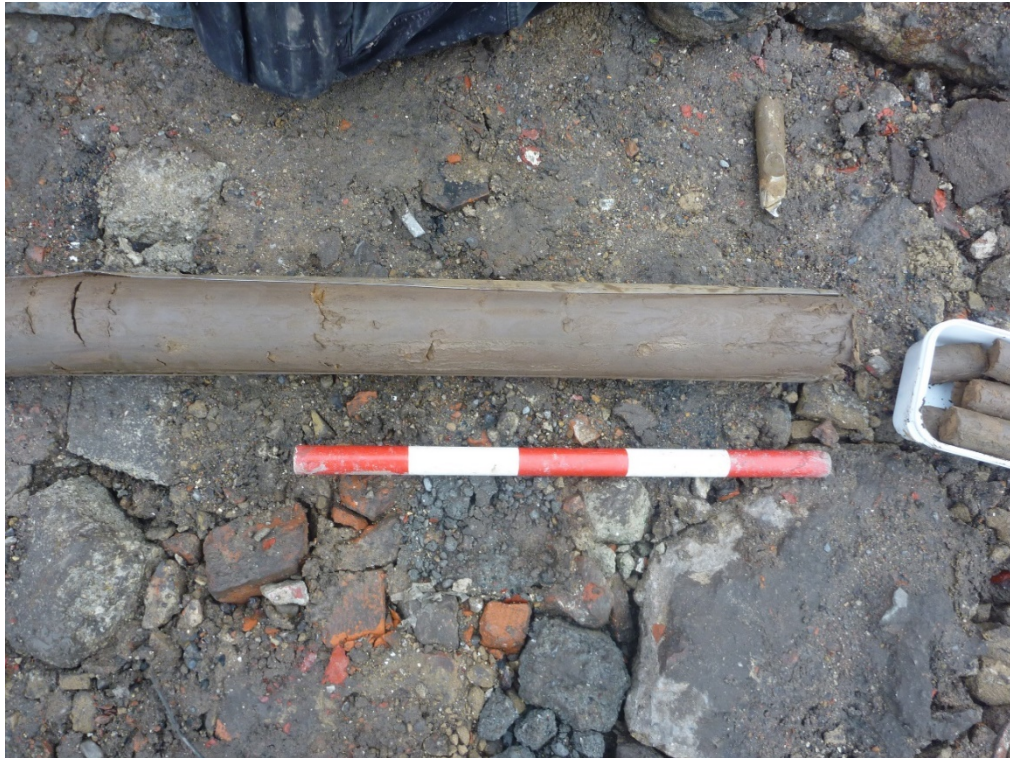
**Plate 5 Clay/sand laminates between 0.7m and 2.6m BGL in BH02.**

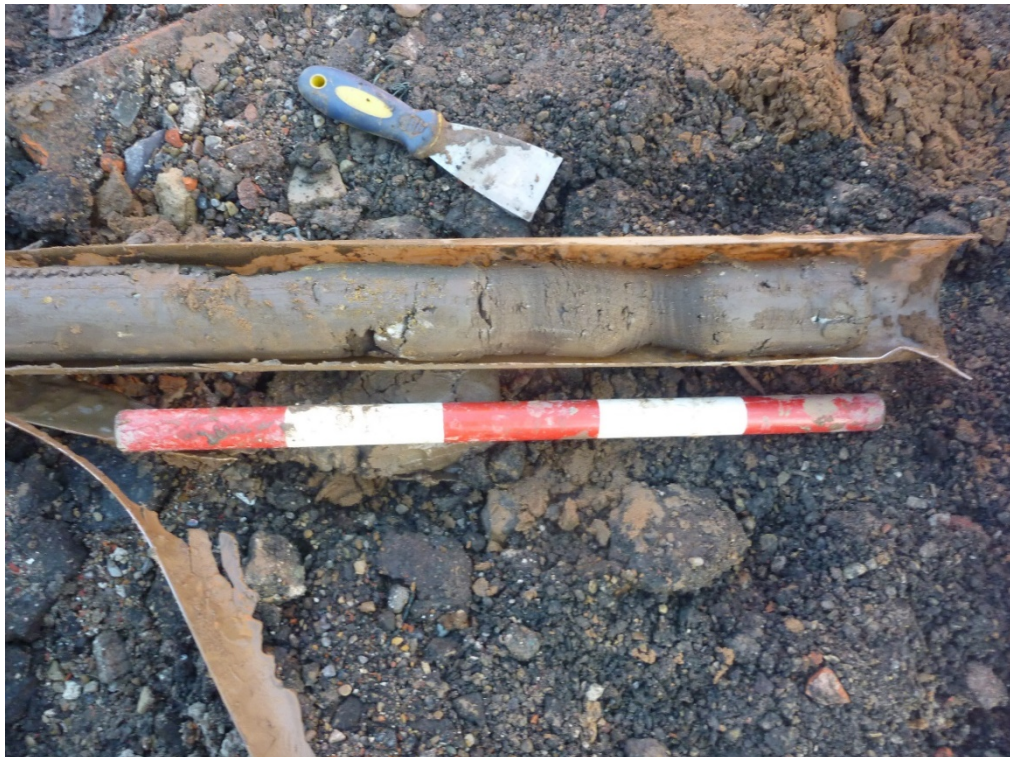
**Plate 6 Sample from between 4m and 5m BGL in BH03. Natural boulder clay.**

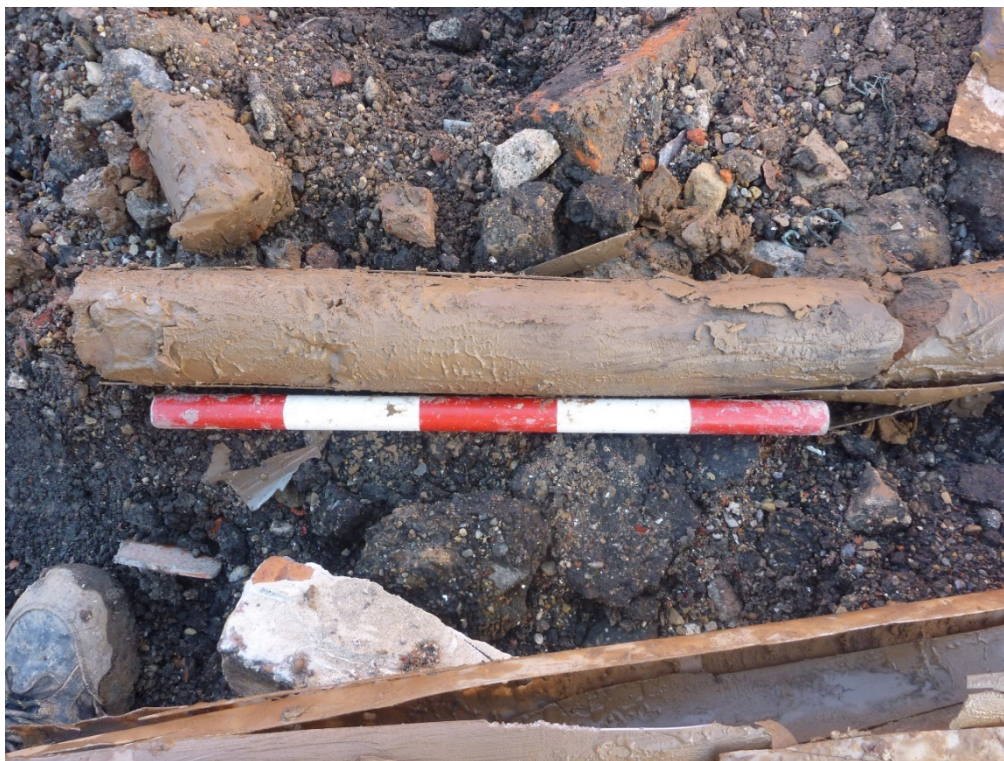
**Plate 7 Boundary between clayey sand made ground and natural boulder clay in BH03. Natural was encountered at a much shallower depth of 3.5M BGL compared to the boundary in BH02 (Plate 2).**

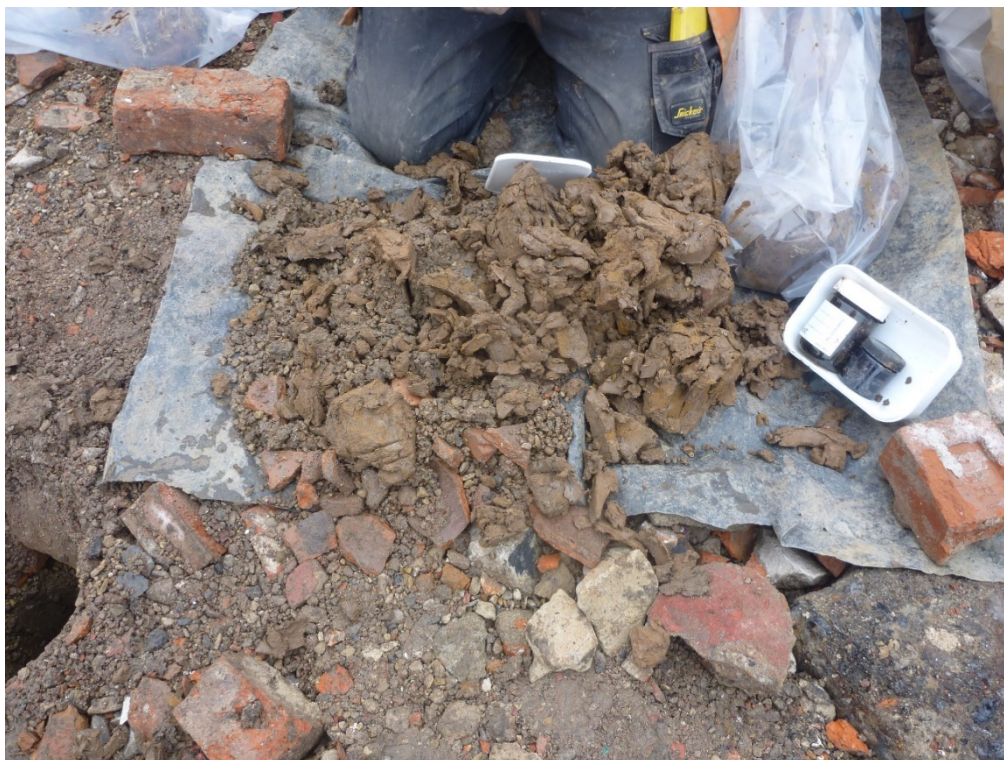
**Plate 8 First metre of BH03, hand excavated. Frequent CBM visible in rubble/demolition deposit (C300) and gravel from drain bedding material (C301).**

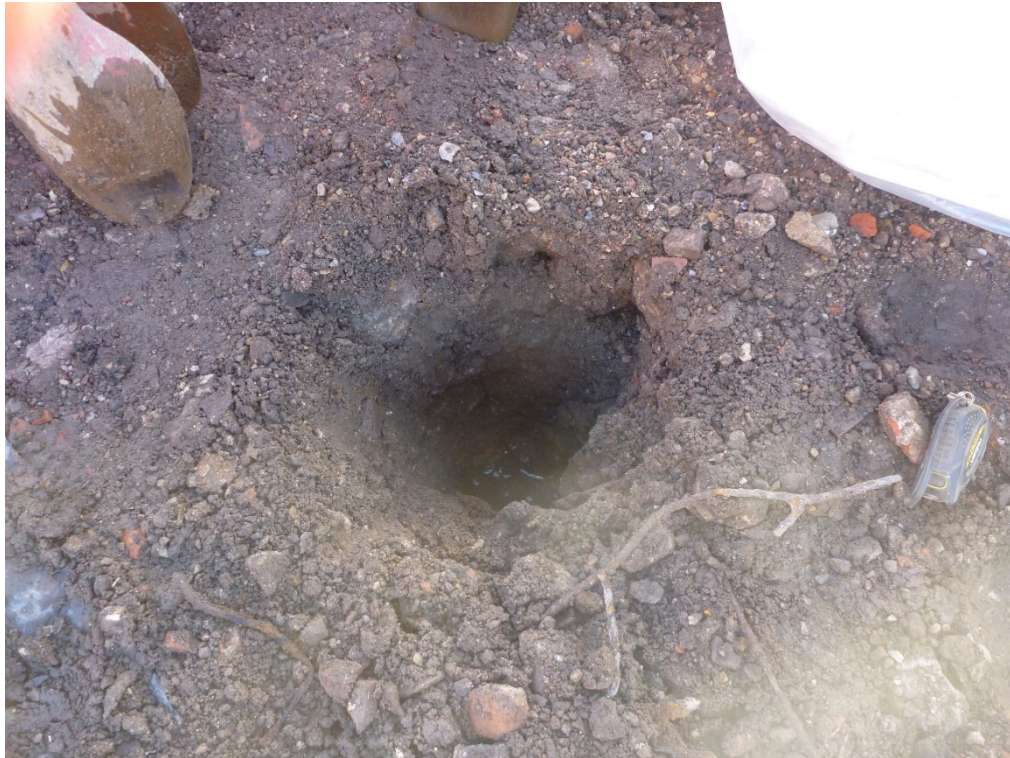
BH04, located in the south corner of the site, was hand dug to a depth of 1m before encountering an obstruction and standing water (Plate 9). The borehole was abandoned at this point to ensure the rig did not incur any damage. The only deposit encountered was the modern rubble and demolition material (c400).

**Plate 9 Hand dug test pit of first metre in BH04. Standing water where obstruction was encountered resulting in the borehole being abandoned.**
