## **ARCHAEOLOGICAL INVESTIGATIONS AT THE FORMER FIRE STATION, CLIFFORD STREET, YORK**

*UPDATED EVALUATION REPORT*

Report Number 2017/28    March 2017

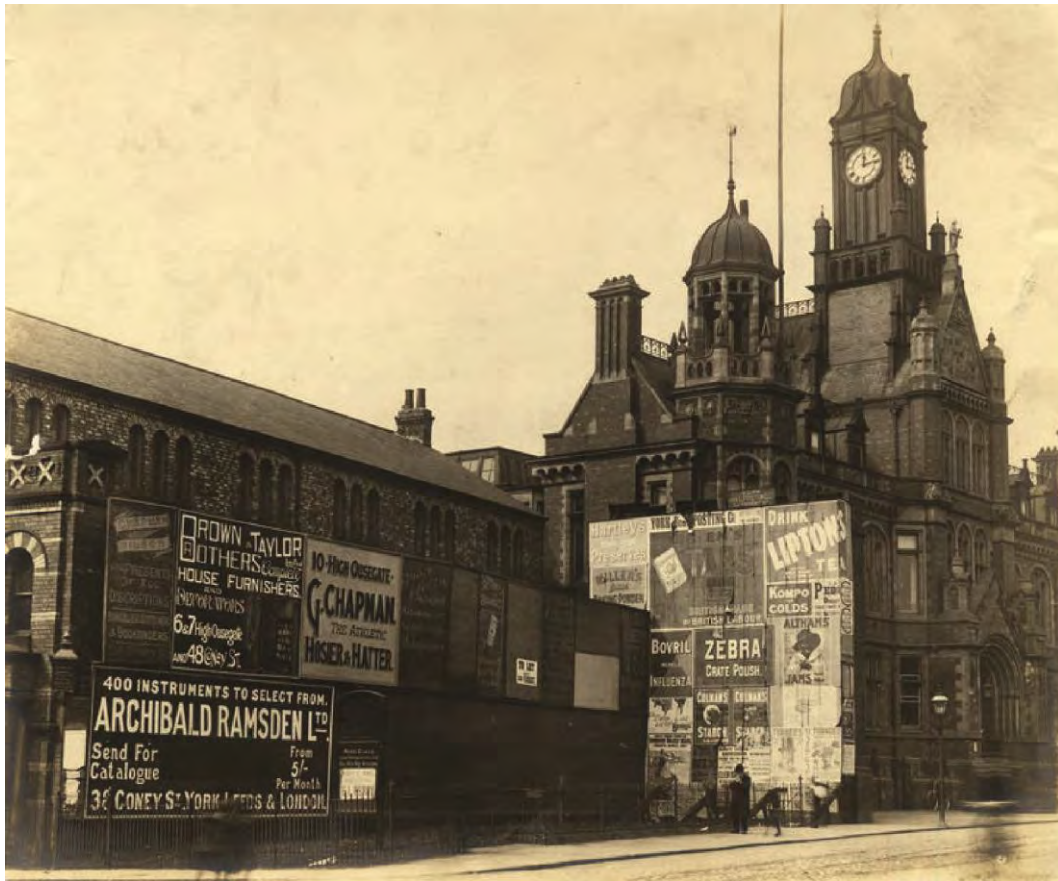
Plate 13 View of advertising hoardings along the NE aisle of Trinity Chapel (photo from city archives)

The 19<sup>th</sup> century wall observed in trench 1 is probably the aisle wall of Trinity Chapel, which was demolished when the building was converted for the fire station. 19<sup>th</sup> century pottery was recovered from the demolition deposit, 1008, but this is clearly residual as the demolition date is known to be 1935. The location of this wall can be inferred from historic photographs showing it being used for billboard posters prior to the expansion of the fire station (Plate 13).
