SITE	St Crux Parish Hall, Pavement, York				
CLIENT NAME	PR Standish Project Management				
YAT PROJECT #	N/A YAT REPORT # 2019/59				
MUSEUM ACCESSION #	N/A	GRID REFERENCE	SE 6049 5182		
PLANNING REFERENCE #	N/A	AAI OPS NOTICE #	19003

A watching brief on ground works for a replacement water pipe was undertaken by York Archaeological Trust on behalf of PR Standish Project Management on the 4th March 2019 at St Crux Parish Hall, Pavement, York, NGR SE 6049 5182 (Figure 1). The objective of the watching brief was to record any archaeological deposits or structures exposed by the ground works.

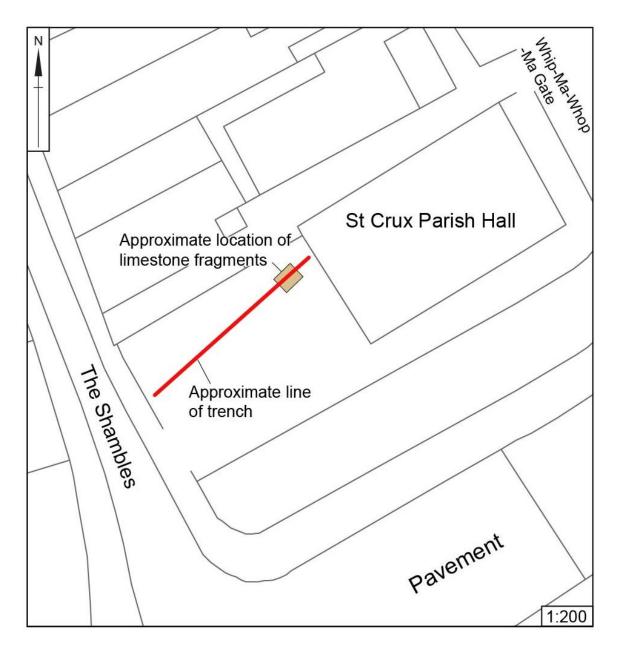
Figure 1 Site map with approximate trench and stone wall locations. Crown copyright reserved. Reproduced with the permission of OS on behalf of HMSO. Licence number 100018343

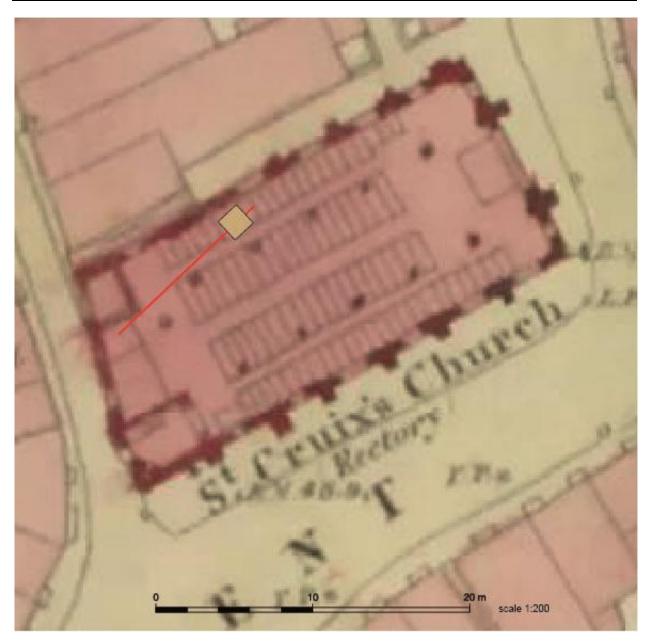
The wall appeared to be on a north-north-west / south-south-east alignment, although very little of the structure could be seen in the narrow trench. An overlay of the trench location on the 1852 OS map (Figure 2) reveals that the structure would have sat within the interior of the church, perhaps acting as a footing for one of the pillars dividing the nave and the north aisle or for some other internal dividing wall. The structure was clearly disturbed during the installation of the lead water pipe, which makes further inference difficult. Some of the stone may have been reused from earlier structures and could have some relation to the demolition of St Crux Church in the late 1880's, however the limited scope provided by these works makes this hard to clearly ascertain. Nothing else of interest was visible in the rest of the trench as the material present consisted of already disturbed ground from the installation of the earlier water supply.

Figure 2 Works location overlaid on 1852 OS map.

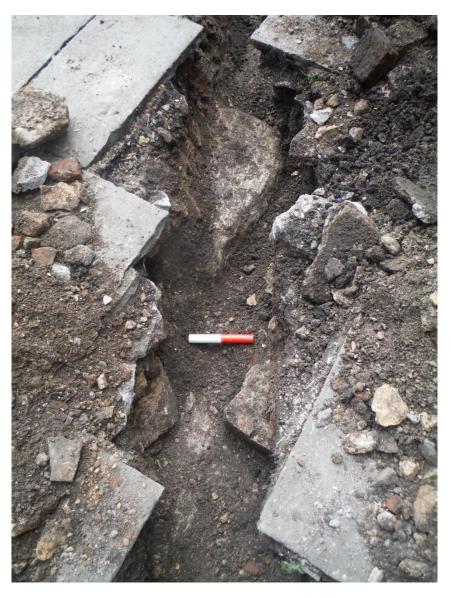
The only deposits of interest were several fragments of limestone blocks towards the north-eastern end of the service trench (See Figure 1 for approximate location). In both sections of the trench there were limestone blocks that extended beyond the limit of the excavation (Plate 1), as well as four fragments of roughly shaped blocks (Plate 2) on the spoil heap from the same area. The flagstones were approximately 60mm deep. Below the flagstones there was a deposit of friable dark brown silty sandy demolition material that extended to the base of trench except for where the limestone blocks appeared. The top of the wall was visible in the trench at 380mm below ground level, and were some 1.85m south-west of the Church Hall doors. The stone blocks visible in the trench were approximately 900mm long by 400mm wide by 70mm deep (Plates 1 and 3). The wall dimensions are not known due to the narrow window provided by the trench, although the structure was possibly as much as 400mm wide.

Plate 1 View of wall in base of trench looking south-west. Scale 20cm

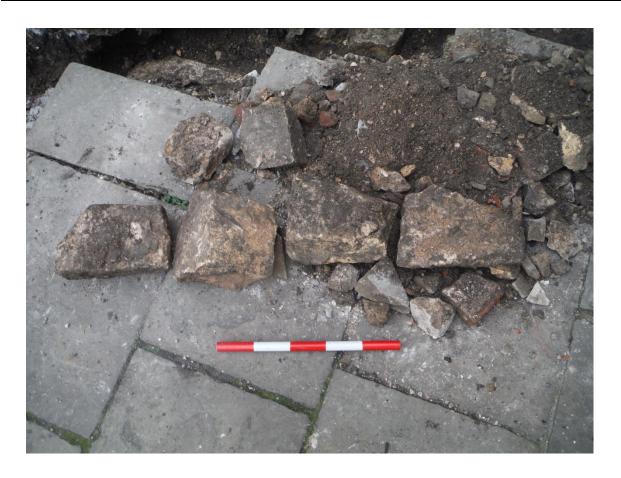
Plate 2 View of roughly shaped stone blocks from spoil heap. Scale 50cm

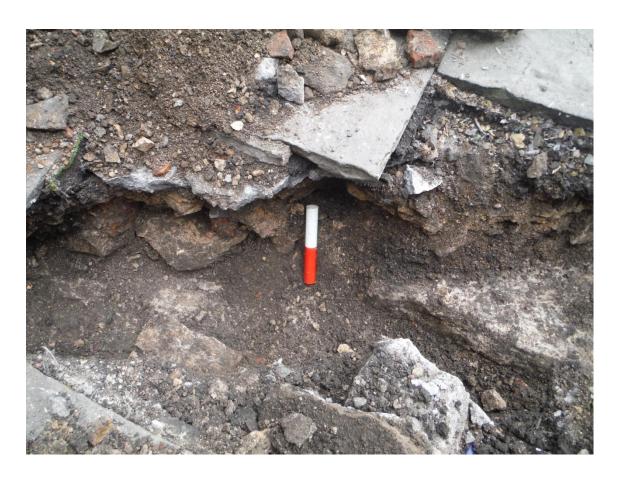
Plate 3 North-west facing trench section showing flagstones, demolition deposit and stone wall. Scale 20cm.
