212- 214 Fulford Road, York Heritage Statement and Building Recording

YAT Report 2019/94 June 2019

A Heritage Statement has been compiled for 212-214 Fulford Road, York, YO10 4DX (NGR SE 60870 50428) by York Archaeological Trust in order to establish the historical character and significance of the property, and to assess the subsequent impact of development works on the established significance. To inform the creation of this document a course of building recording was completed in June 2019. The work was undertaken for Barry Downing to help inform a planning application that is under consideration by the City of York Council (19/00462/FUL).

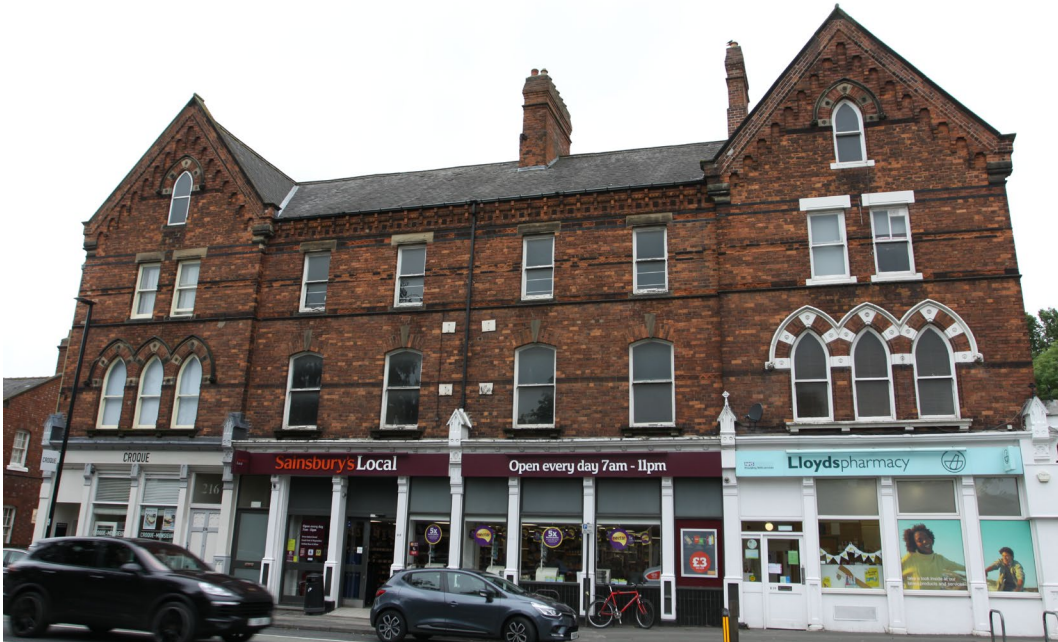
Plate 1 East facing elevation, view west

The east facing elevation is the most prominent as it fronts onto the road (Plate 1). The entrance to the property is accessed via a large rectangular glass door with door light on the ground floor, at the southern extent of the Sainsbury's Local shop frontage. Each floor consists of four bays with distinct one-over-one sash windows. On the first floor the windows are larger rectangular fenestrations with a pointed segmental arch and a corresponding brick lintel laid as a soldier course and central sandstone keystone. The windowsills, made of rectangular cut sandstone, project from base of the window and are supported by two brackets. The second-floor windows are narrower rectangular fenestrations with a horizontal sandstone lintel. The windowsills are flush with brickwork and constructed from sandstone. Other details include the chimney stack and the drain pipe which delineates the original division of properties 212 and 214.

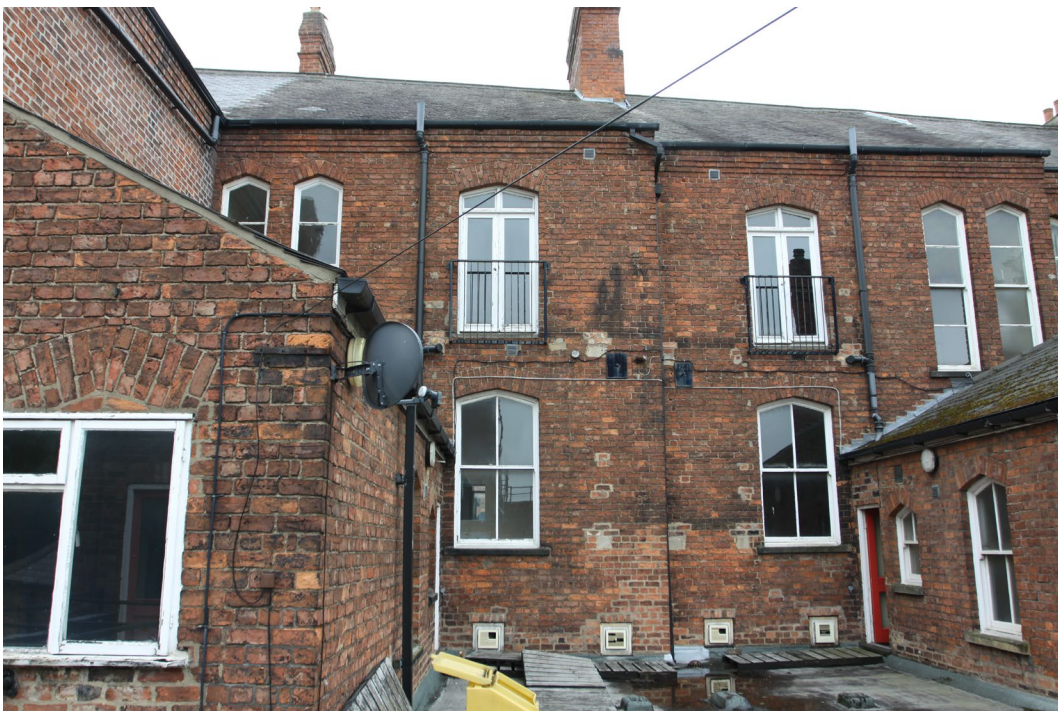
Plate 2 West facing elevation, view east

The west elevation (rear) of the building is predominantly disguised by a large chimney stack and modern construction (Plate 2). To delineate the original separation of the four terraces the elevation steps back at intervals; this is reflected in the breaks in the roof-line. It is likely that the breaks in the roof have weakened it, accounting for the damp visible in the interior. The rear elevation has also been subject to greater 20th century alteration.

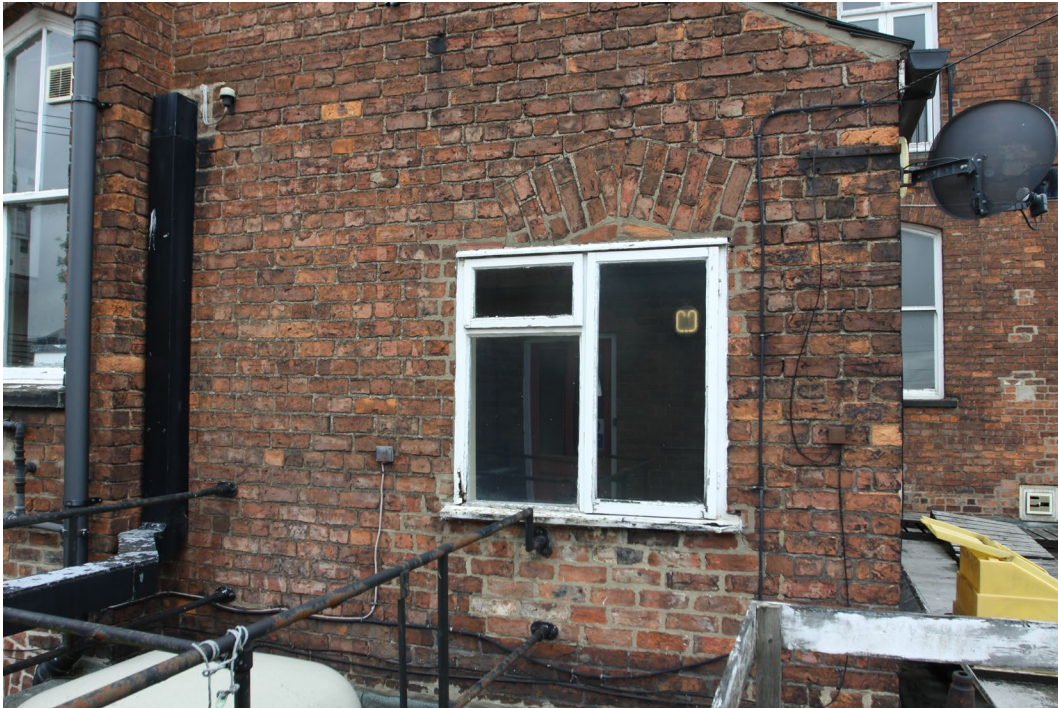
Plate 3 West elevation first floor replacement window, view east

The first floor of the building is divided into four bays with the outer bays projecting from the building proper. The central fenestrations are pointed segmental arch two-over-two sash windows with no lintel detailing. The outer fenestrations were originally both smaller pointed segmented arch two-over-two sash windows. The window of the first bay has been replaced with a rectangular wooden four-pane casement window (Plate 3). Further alterations to the wider terrace are visible here as well with a bricked-up window (Plate 4). The second floor is also divided into four bays with greater variation in fenestrations. The outer bays (1st and 4th) consist of two narrow segmented arch extended windows corresponding with the inner staircases of both properties. The 2nd and 3rd bays are rectangular French windows with an upper pointed segmental arch fanlight and a metal balustrade balconet.

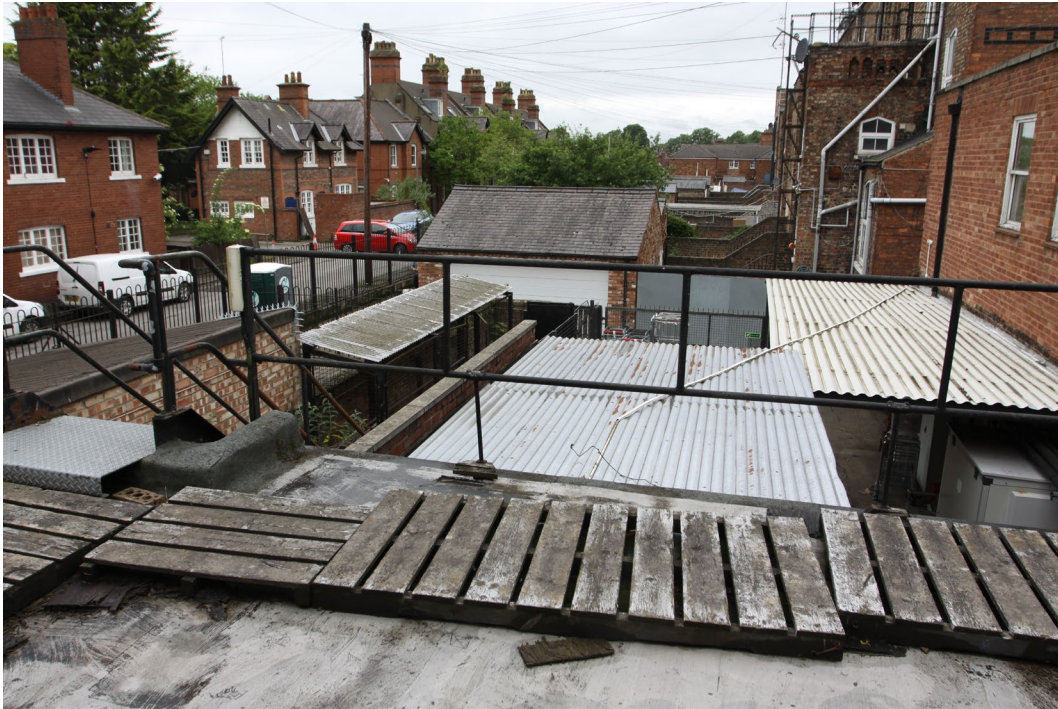
Plate 5 Roof terrace and cycle store, view south-west

The roof terrace is accessed by doors in each first-floor projection and a metal staircase leading to the cycle store to the rear (Plate 5). It consists of a flat roof made from modified bitumen with a late 20th century balustrade affixed to the edge. The modern two-storey block can also be accessed from the roof terrace (Plate 6).

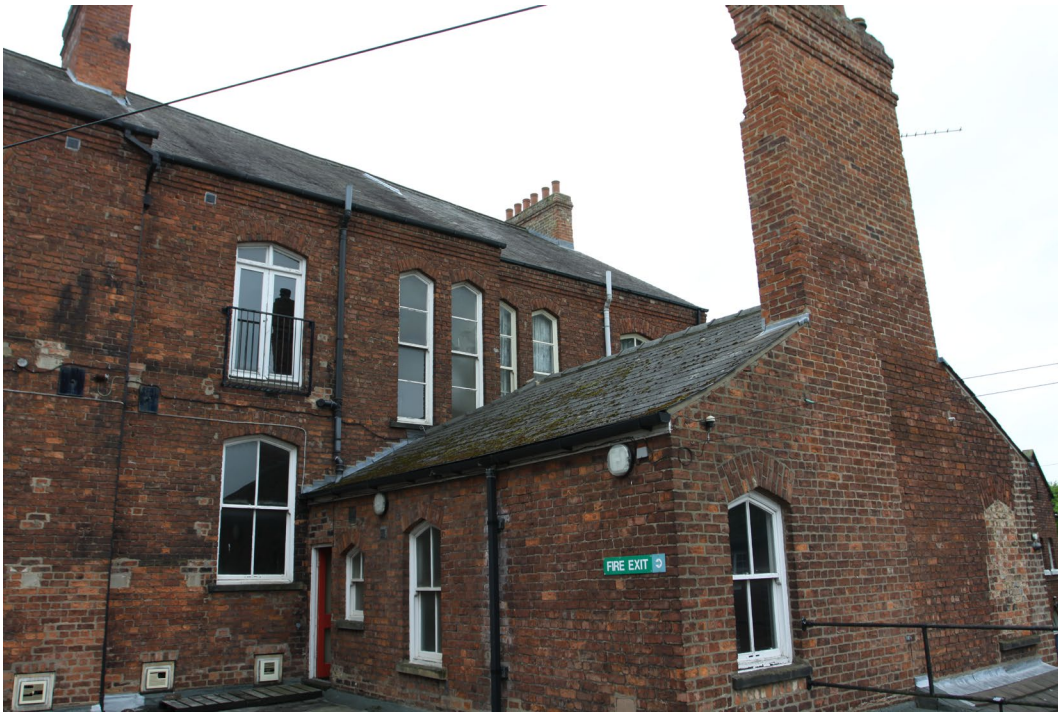
Plate 7 North facing elevation of first floor rear projection, view south-east

The north and south facing elevations of the first floor rear projections largely reflect each other with a rectangular door and two windows (three bays from left to right) (Plate 7). On the north facing elevation the windows, sash two-over-two pointed segmental arches, are the same height though the fenestration of the 2nd bay is narrower. On the south facing elevation the windows are the same typology with a variation in size with an extended outer window.

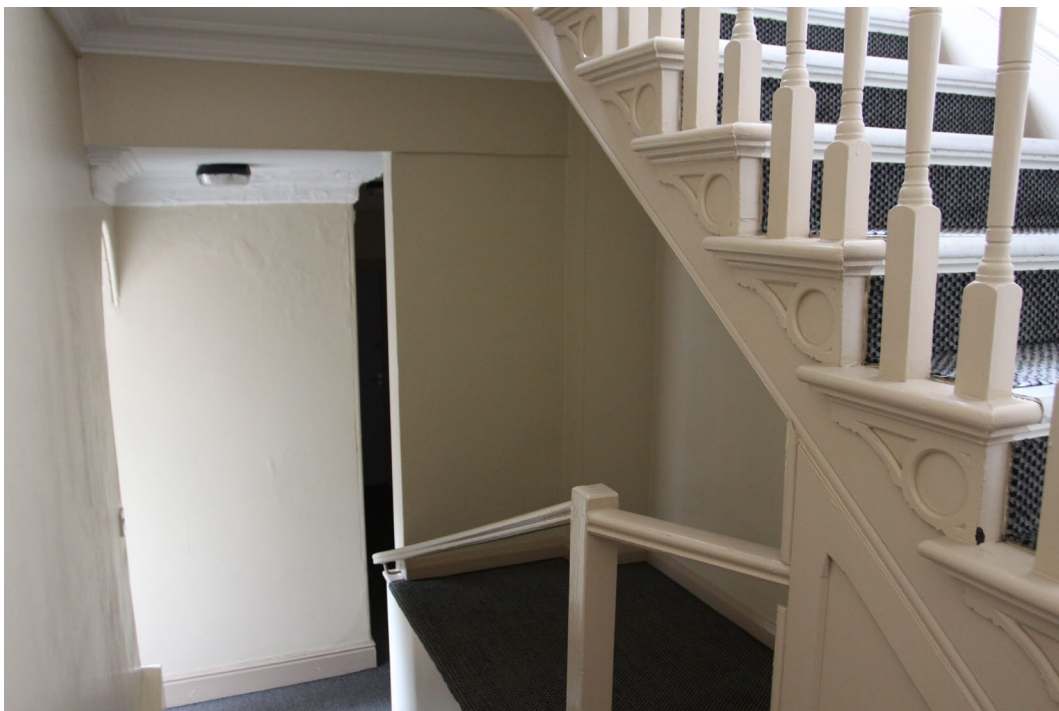
Plate 10 Stairwell in 212 Fulford Road

The entrance is accessed via the glass door of 214 Fulford Road, to the left of the Sainsbury's Local. It opens into a large corridor with high ceilings with coving and a round arch with decorative moulding supported by corbels with rosette detailing and some tracery (Plate 8). The corridor leads to an internal stairwell towards the upper floors with original moulded detailing on the newel post (Plate 9). The original ground to first floor stair in the 212 Fulford Road internal stairwell has been infilled with the creation of a small, under the stair area (Plate 10).

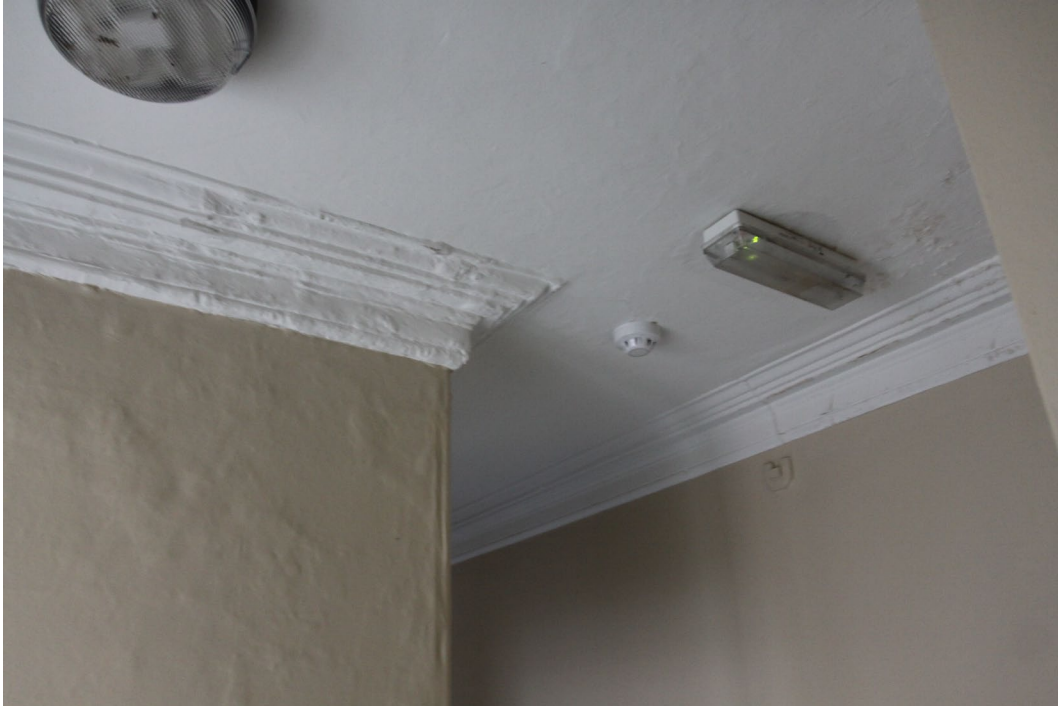
Plate 13 Damp in Bedroom 6

The flight of stairs leads to a small landing between the ground and first floor. The landing provides access to the rooms to the rear of the property and the roof terrace. In 212 Fulford Road this is accessed via the first floor landing. The rooms to the rear include a WC, bathroom and small bedroom (6 and 7); the layout is identical across the two conjoined properties (Plate 11). Both bedrooms feature sinks on the east wall and coving throughout; Bedroom 6 features a bricked-filled original fireplace on the south wall (Plate 12). Areas of damp are visible in the distortion of the coving (Plate 13) as well as mould (Plate 14).

The new designs for the buildings seek to update the student accommodation, including the addition of rooms within the current attic space, and improve the condition of the property, including repairs to the roof which is causing serious damp problems within the property. To make the scheme viable and facilitate the repairs to the roof, the rooms in the roof must be constructed and require skylights. An earlier planning application, which included a rear balcony and dormer windows in the roof, was refused as the designs were interpreted as being detrimental to the character of the property and the wider Fulford Road Conservation area. The new planning application has removed the dormer windows and balcony which has reduced the impact of the development on the significance and character of the property.

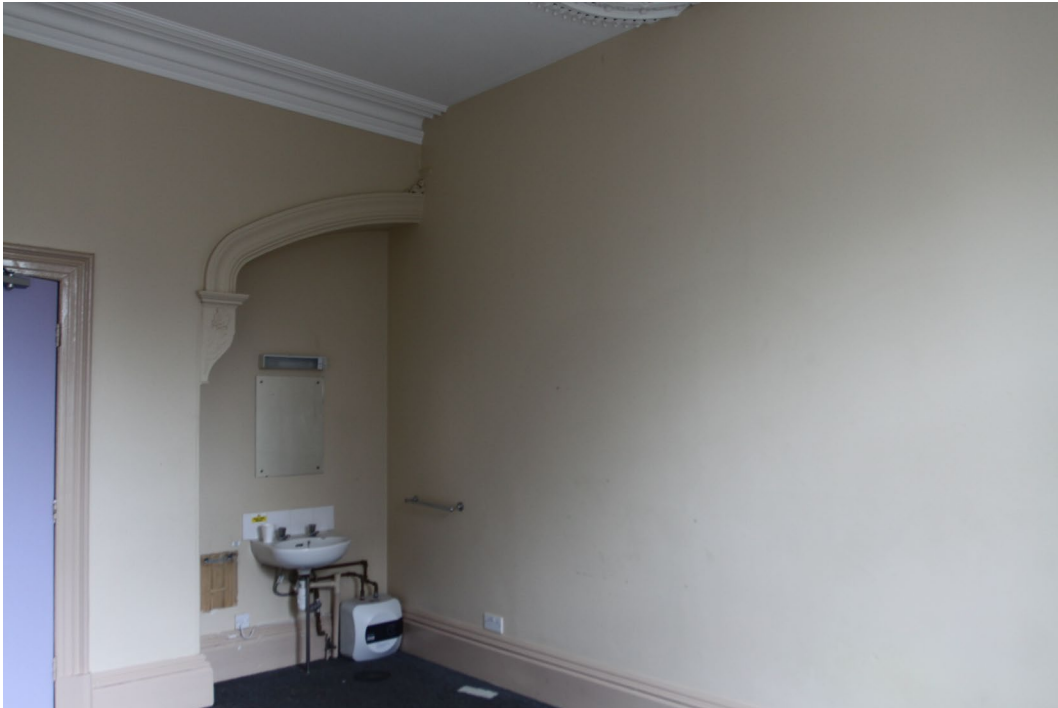
Plate 15 Bedroom 1 with dividing wall

The main rooms of the first floor show clear modern alterations to create suitable student accommodation (Plate 15). All rooms are accessed via a high-ceiling corridor which becomes wider at the original property boundary point. The four front-facing bedrooms were originally two front rooms for each of the properties. Bedrooms 1 & 2 and 3 & 4 share an alcove created by a depressed blind arch with archivolt mouldings on the western wall (Plate 16). The arch is supported by mission-style double corbels visible in each divided room. The corbels support the decorated impost from which the arch springs and feature corncicing. All mouldings feature flowers and rosettes. The edge of a keystone moulding is also visible in the rooms but has been largely disguised by the 20th century stud wall. All the rooms feature mouldings on the ceiling in the form of coving while the majority of a ceiling rose remains visible in Bedroom 1 though the dividing wall has removed one edge (Plate 17). All the rooms are equipped with sinks attached to the west wall and small wooden sills below the sash windows. Bedrooms 2 and 3 feature fireplaces with wooden surrounds on the north and south walls respectively, sharing a flue (Plate 18).

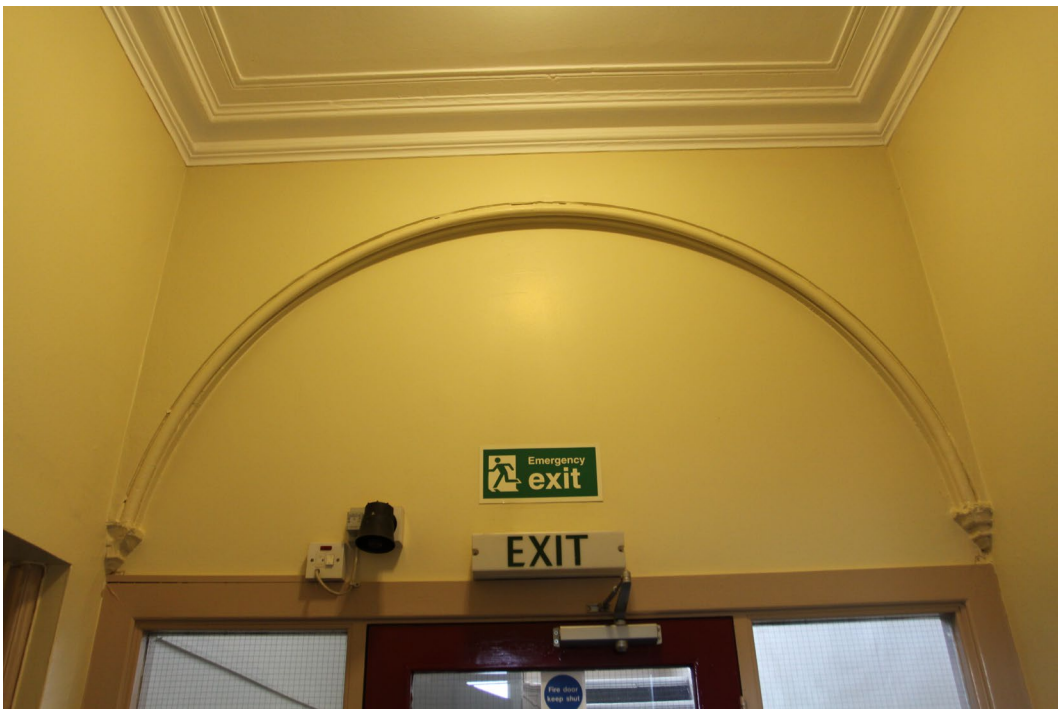
Plate 20 Stairwell leading to second floor

The stairwells leading to the second floor are accessed via rectangular doorways with flanking side lights in both 212 and 214 Fulford Road. The doorways have been altered during the late 20th century conversion to student accommodation and the original shape of the openings are visible as infilled round arches supported by corbels (Plate 20). Simple circular mouldings are

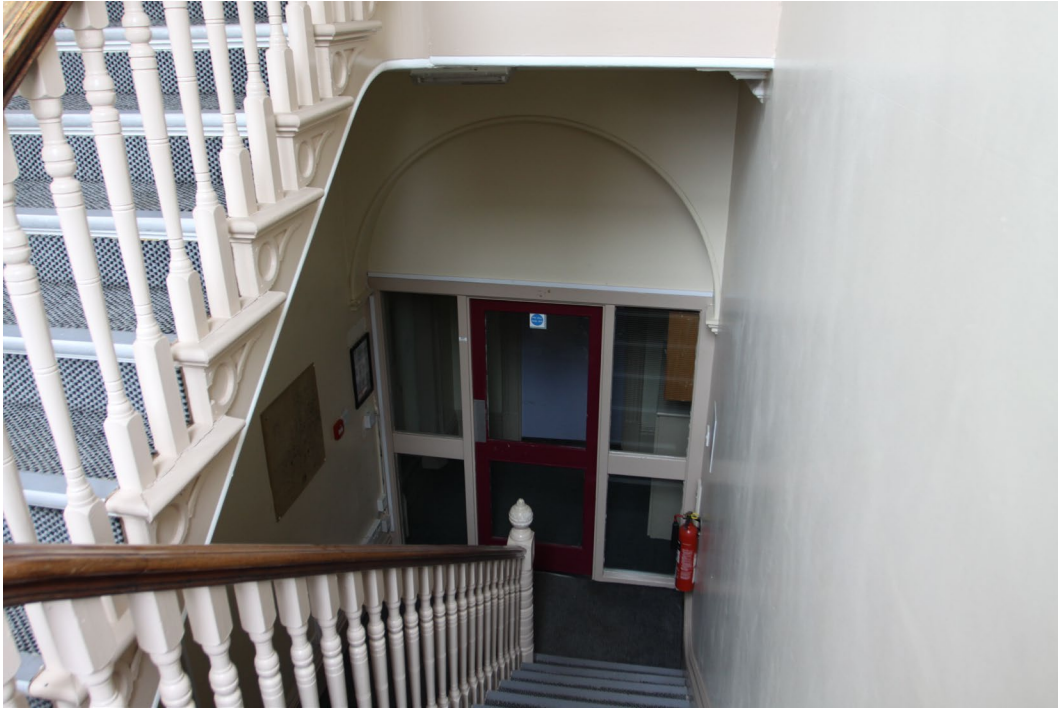
Plate 21 Staircase between first and second floors

also visible on the stairs themselves with modern wooden bannisters (Plate 21). At the top of each stairwell is a further door with side lights.

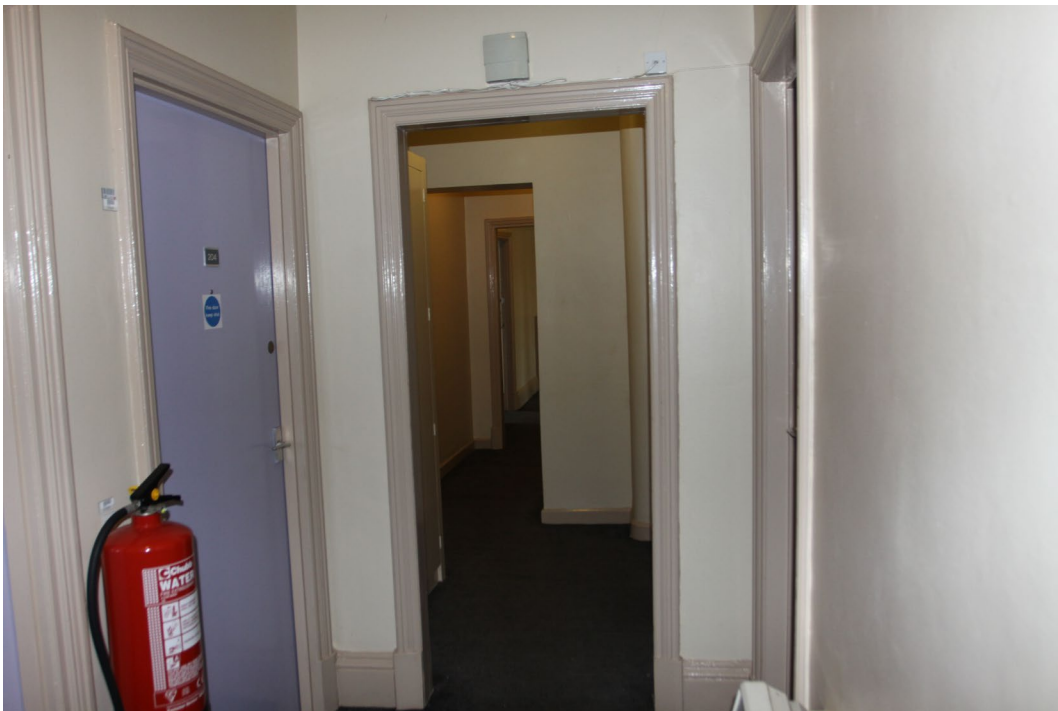
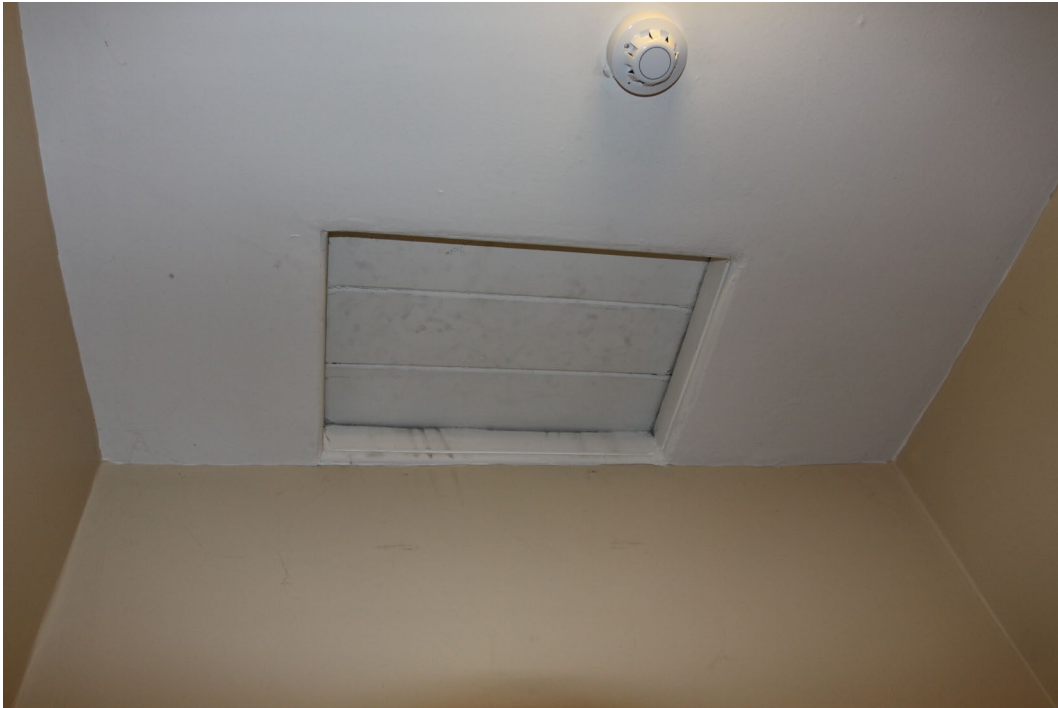
The second floor reflects the alterations to the layout visible on the first floor; the larger original rooms have been divided in order to create more individual rooms which are accessed from a central corridor which bridges formal plot boundary between 212 and 214 Fulford Road. At the north end of the corridor a small closet has been added. Two small opening in the centre of the corridor ceiling grant access to the attic space (Plate 22 and 23).

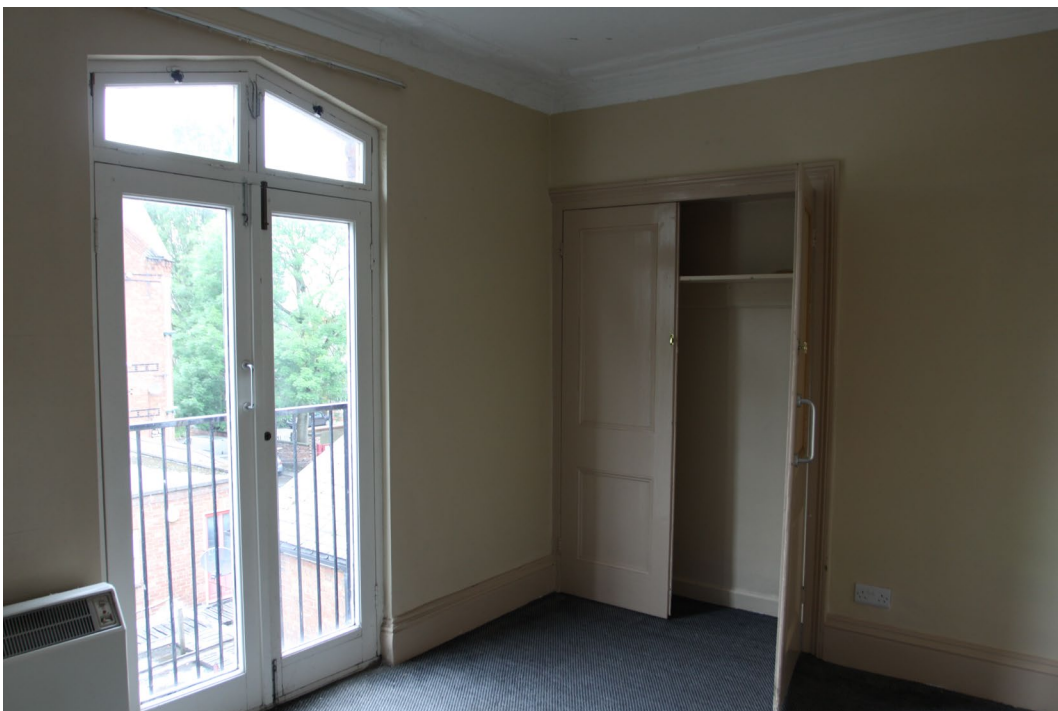
Plate 26 Bedroom 12

The front facing rooms do not feature the same amount of enriched mouldings as the first floor. This indicates that in the dwellings original form these rooms were private compared to the first floor reception rooms. The height of the ceiling on the second-floor is also lower than the first floor. Each room features a sink attached to the stud wall dividing the bedrooms while Bedrooms 9 and 10 each have a wooden surround fireplace, sharing a flue (Plate 24 and 25). The rear-facing rooms have also been altered with a kitchen, bathroom and WC added. The Bedrooms, 12 and 13, are near identical to each other with both featuring a sink and rear-facing French windows with a balconet; bedroom 13 is slightly larger (Plate 26).

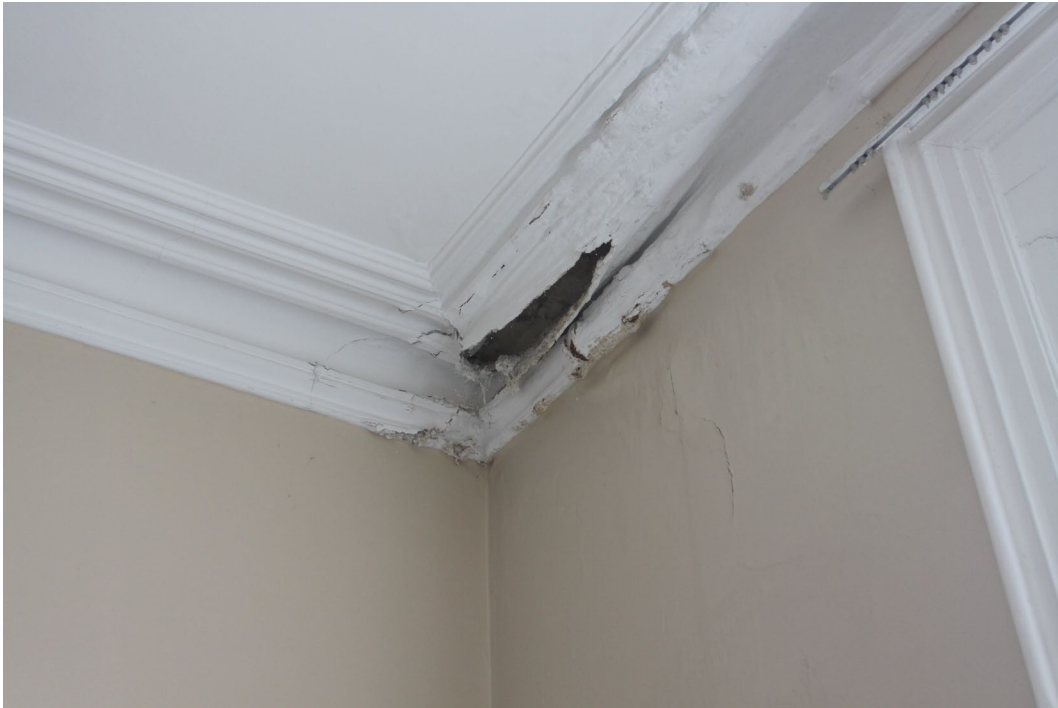
Plate 27 Bedroom 4 damp

Areas of damp have been identified in numerous areas on the first and second floors of the property, particularly in the high ceilinged corners of the rooms and in the coving. In Bedroom 4 the mouldings had deteriorated to the point of collapse (Plate 27).

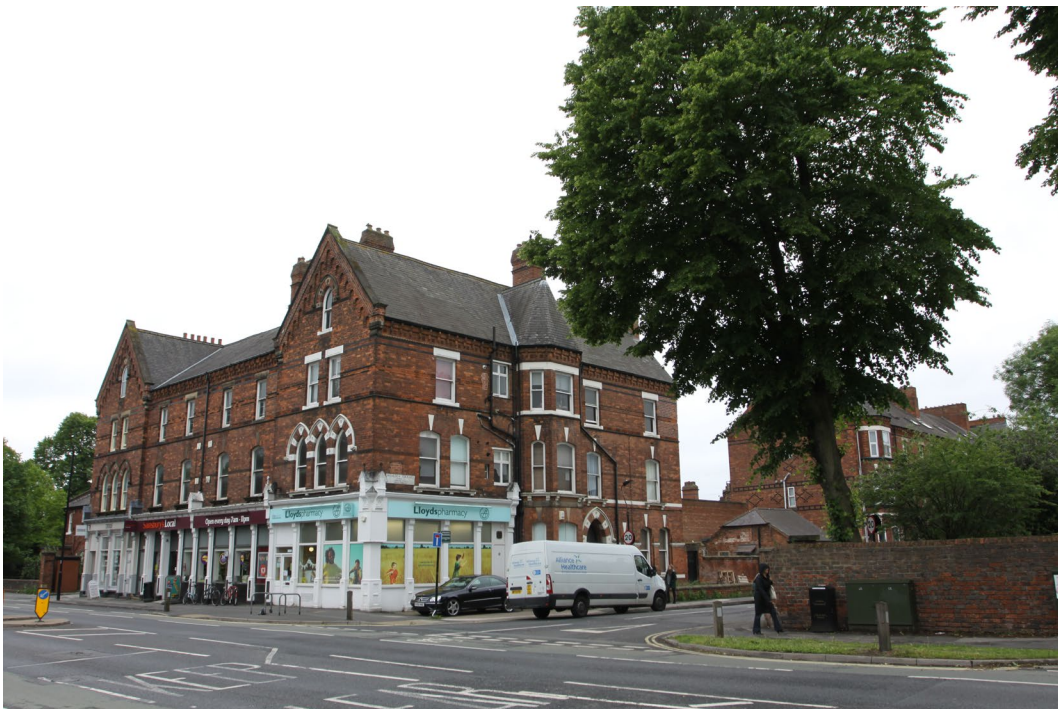
Plate 30 View of 212-214 Fulford Road, with roof lights visible along Wenlock Terrace, view south-west

The exterior alterations are more noticeable with the character of the building and area. The addition of new windows with double-glazing are being kept in the exact style of the original fenestrations, which have visible wear, and should improve the appearance of the more prominent front façade. The roof lights are necessary for the attic conversion and, in turn, the viability of the development as a whole. They are conservation roof lights, to be kept flush with the roof line, and reflect the size of the windows in front and rear façade. Views of the rear roof lights are disguised by the shape of the building, modern additions and the chimney stack. A roof light has also already been installed on neighbouring terrace 210 Fulford Road, visible from both the roof terrace and Ordnance Lane (Plate 28). There will be views of the front roof lights from various points on Fulford Road; however, the height of the building will partially disguise the fenestrations from immediately in front of the property while views from further away are partially hidden by the gable ends of the end-terraces and foliage of trees (Plate 29). These views also clearly show non-conservation roof lights on the front Gothic Revival façades of Wenlock Terrace (Plate 30). Smaller Victorian villas fronting onto Fulford

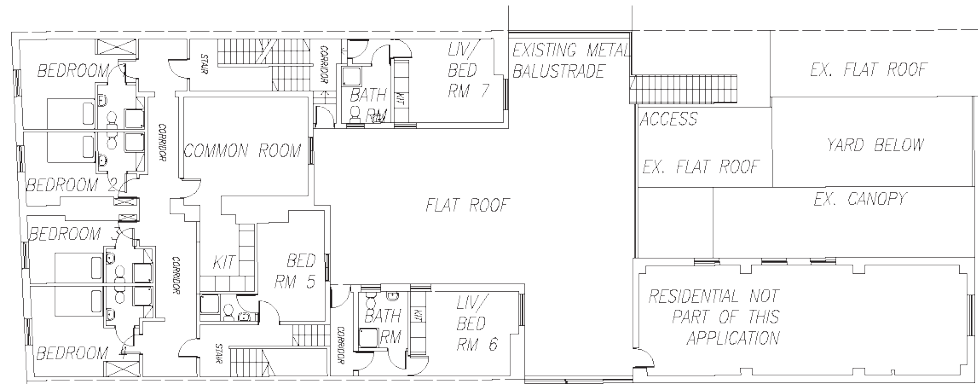
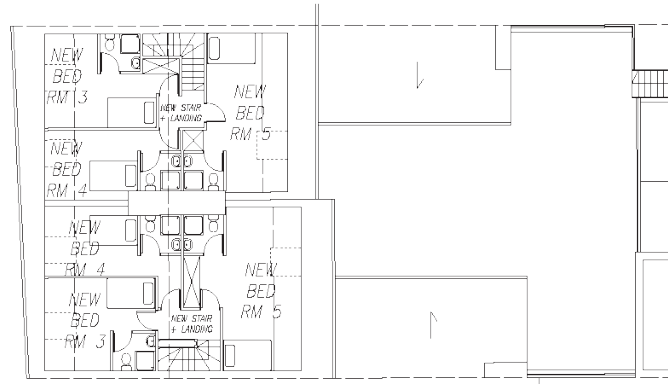
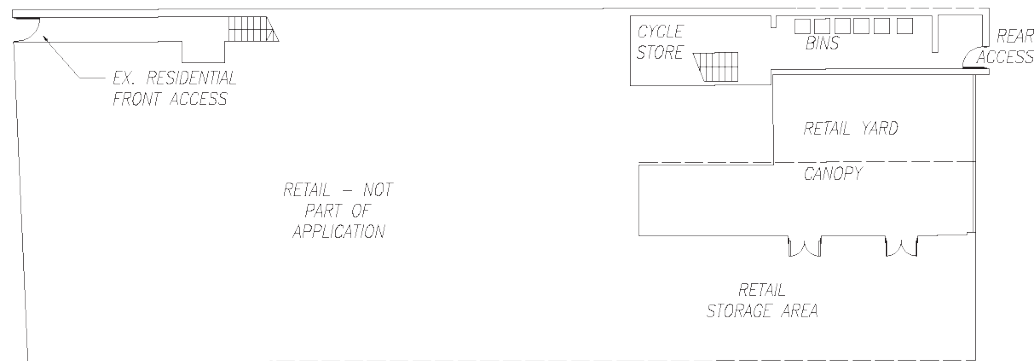
Figure 11 Proposed building alterations

Please see the architects plans and documents for construction details (Figure 11). Further impacts may be identified as the plans progress.
