Archaeological Investigations at York Central Phase 1 Infrastructure GI

By Toby Kendall

YAT Watching Brief Report 2018/181 March 2019

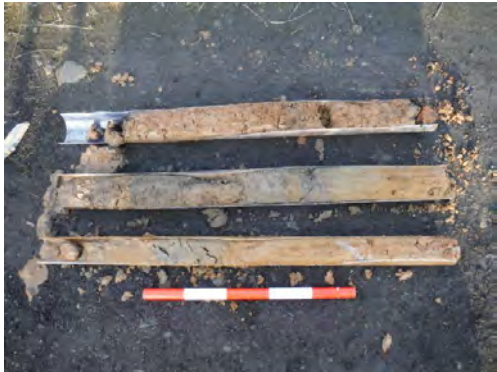
YORK ARCHAEOLOGICAL TRUST	Site Code -	
TEST PIT/BOREHOLE/WINDOW SAMPLE LOG	Project Number- 6104	
Site Name - York Central Phase 1 Infrastructure GI	Trench/Area WSA 403	Sheet - 1 of 1

Intervention No. WSA 403	
Time/Date pm 15/11/18	
Contexts / Numbers Assigned	
1030	Track base - Loose, black, clinker.
1031	Landscaping/Disturbance - Soft, brownish orange, pebbly sandy clay with clinker.
1032	Landscaping/Disturbance - Soft brownish orange, pebbly sandy clay with clay patches.
1033	Landscaping/Disturbance - Loose, dark grey, clinker with brick etc rubble.
1034	Buried soil - Soft, grey brown, silty sand.
1035	Subsoil - Soft, brown grey, silty sand.
1036	Natural - Soft, yellowy brown orange, sand.
Notes	
4m Deep. Hand dug to 1200mm.

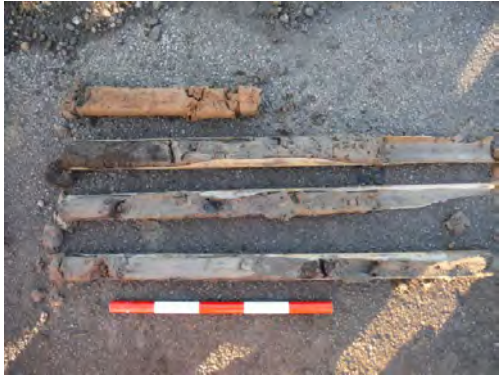
YORK ARCHAEOLOGICAL TRUST	Site Code -	
TEST PIT/BOREHOLE/WINDOW SAMPLE LOG	Project Number- 6104	
Site Name - York Central Phase 1 Infrastructure GI	Trench/Area WSA 406	Sheet - 1 of 1

Intervention No. WSA 406a	
Time/Date am 27/11/18	
Contexts / Numbers Assigned	
1060	Surface/Disturbance - Friable, brown, silt plus debris.
1061	Surface - Degraded tarmac.
1062	Make-up - Loose, ballast and clinker.
1063	Landscaping/Disturbance - Mixed deposit, friable, brownish orange, clay sand and clinker/ballast.
1064	Landscaping/Disturbance - Soft, brownish orange, clay sand. Possibly disturbed laminated.
	Void in column.
1065	Buried soil - Soft, light grey brown, sand silt with occasional pebbles. Possible gleying/waterlain.
1066	Silting/Waterlain - Firm, brown, organic clay.* Sampled.
	Void in column.
1067	Silting/Waterlain - Soft, brownish grey, sandy silt.* Sampled.
1068	Natural - Firm, light grey, clay.
	Void in column.
1069	Natural - Soft, grey, clay. Lower down firm, grey, silt.
Notes	
5m Deep. Hand dug to 1200mm.	
Moved because of obstructions.

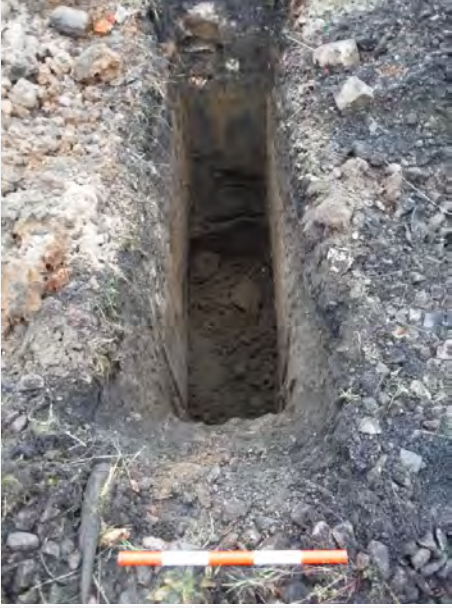
YORK ARCHAEOLOGICAL TRUST	Site Code -	
TEST PIT/BOREHOLE/WINDOW SAMPLE LOG	Project Number- 6104	
Site Name - York Central Phase 1 Infrastructure GI	Trench/Area TP 405	Sheet - 1 of 1

Intervention No. TP 405	
Time/Date pm 20/11/18	
Contexts / Numbers Assigned	
3050	Track base - Loose, dark grey/black, ballast, clinker and rubble.
3051	Landscaping/Disturbance - Soft, brownish orange, clay sand with cobbles.
3052	Buried soil - Soft, slightly brownish grey, sandy silt.
3053	Natural - Soft, brownish orange, sand with clay towards base.
Notes 2700mm x 600mm and up to 3500mm deep. Aligned northwest-southeast. Excavation stopped due to collapsing.

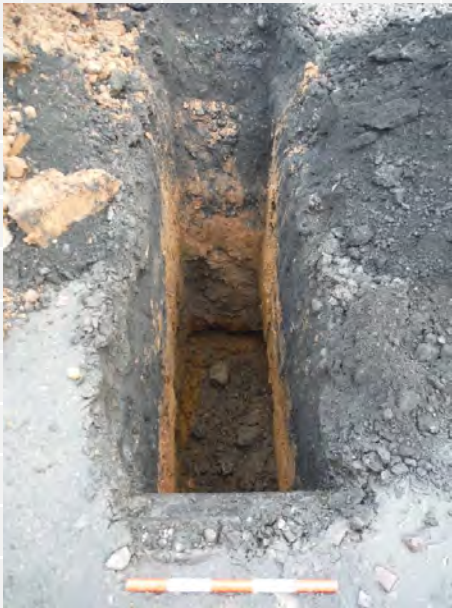
YORK ARCHAEOLOGICAL TRUST	Site Code -	
TEST PIT/BOREHOLE/WINDOW SAMPLE LOG	Project Number- 6104	
Site Name - York Central Phase 1 Infrastructure GI	Trench/Area TP 406	Sheet - 1 of 1

Intervention No. TP 406	
Time/Date pm 21/11/18	
Contexts / Numbers Assigned	
3060	Track base - Ballast over loose, black, clinker.
3061	Landscaping/Disturbance - Friable, brownish orange, sandy clay with pebbles and cobbles.
3062	Natural - Friable, yellowy orange, pebbles and sand with cobbles.
Notes	
2800mm x 600mm and up to 3300mm deep.	
Aligned northwest-southeast.

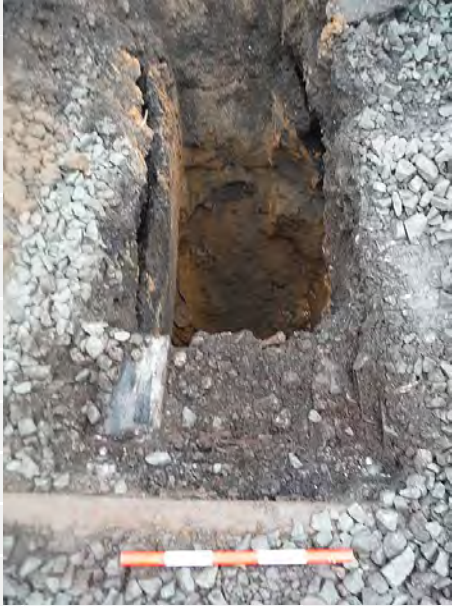
YORK ARCHAEOLOGICAL TRUST	Site Code -	
TEST PIT/BOREHOLE/WINDOW SAMPLE LOG	Project Number- 6104	
Site Name - York Central Phase 1 Infrastructure GI	Trench/Area TP 408	Sheet - 1 of 1

Intervention No. TP 408	
Time/Date pm 20/11/18	
Contexts / Numbers Assigned	
3080	Track base - Ballast over loose, black, clinker.
3081	Landscaping/Disturbance - Friable, orange, cobbly sand with clinker lenses.
3082	Buried soil - Soft, brownish grey, silt sand with medieval tile and animal bone.
3083	Natural - Friable, brownish orange, clay sand.
Notes	
	2300mm x 600mm and up to 4300mm deep.
	Aligned northeast-southwest.

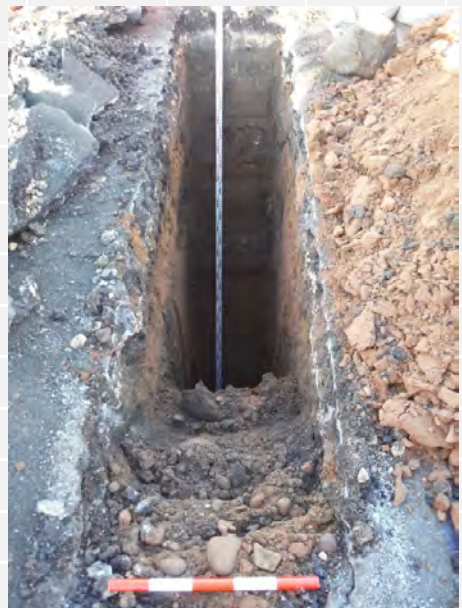
YORK ARCHAEOLOGICAL TRUST	Site Code -	
TEST PIT/BOREHOLE/WINDOW SAMPLE LOG	Project Number- 6104	
Site Name - York Central Phase 1 Infrastructure GI	Trench/Area TP 409	Sheet - 1 of 1

Intervention No. TP 409	
Time/Date am 10/12/18	
Contexts / Numbers Assigned	
3090	Surface - Tarmac.
3091	Surface make-up - Hardcore.
3092	Construction Spread - Mixed deposit, soft, brown orange, sand and loose, greyish yellow, coarse sand. Plastic duct at 1.65m BGL at northwest edge of pit linked with this activity.
3093	Landscaping/Disturbance - Soft, brownish pink clayey sand with cobbles.
3094	Buried soil - Soft, brownish grey, sandy silt with charcoal and coal flecks. Darker and slightly organic to the base.
3095	Natural - Soft, brownish orange, sand with clay patches higher up.
3096	Unknown - Soft, slightly brownish white, unknown material flecks. Seen in pit edge at c.2.5m BGL.
Notes	
3300mm x 600mm and up to 4000mm deep.	
Aligned northwest-southeast.

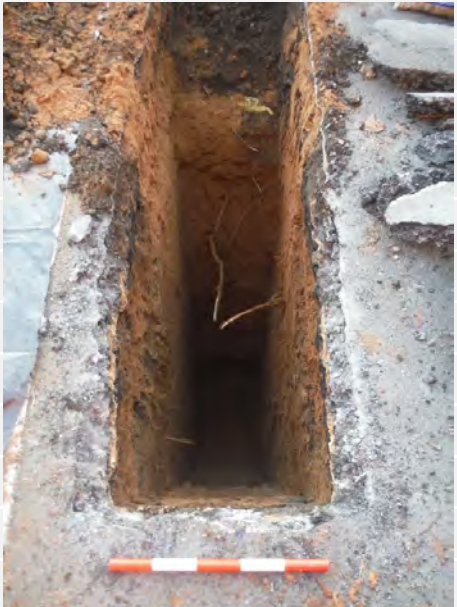
YORK ARCHAEOLOGICAL TRUST	Site Code -	
TEST PIT/BOREHOLE/WINDOW SAMPLE LOG	Project Number- 6104	
Site Name - York Central Phase 1 Infrastructure GI	Trench/Area TP 410	Sheet - 1 of 1

Intervention No. TP 410	
Time/Date pm 10/12/18 12/12/18	
Contexts / Numbers Assigned	
3100	Surface - Tarmac.
3101	Surface make-up - Hardcore.
3102	Service - Yellow plastic pipe in cut with backfill
3103	Construction spread - Friable, black, clinker.
3104	Landscaping/Disturbance - Loose, brownish orange, coarse sand with pebbles.
3105	Landscaping/Disturbance - Stiff, greyish light brown, clay with coal flecks.
3106	Natural - Laminated, orange brown, sand, and light brown, clay.
Notes	
2800mm + 800mm x600mm and up to 3800mm deep.	
Aligned northeast-southwest.	
Extended to northeast to avoid service.

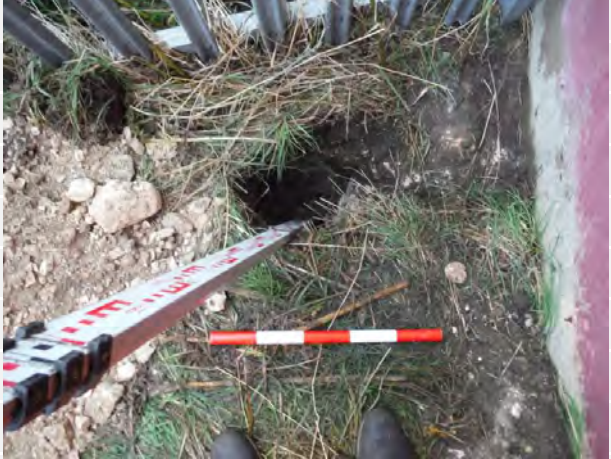
YORK ARCHAEOLOGICAL TRUST	Site Code -	
TEST PIT/BOREHOLE/WINDOW SAMPLE LOG	Project Number- 6104	
Site Name - York Central Phase 1 Infrastructure GI	Trench/Area TP 418	Sheet - 1 of 1

Intervention No. TP 418	
Time/Date pm 23/11/18	
Contexts / Numbers Assigned	
3130	Surface/Made ground - Friable, brownish grey, silt clay.
3131	Infill - Hardcore.
Notes	
300mm square and up to 1200mm deep. All hand dug.	
Deposits up to retaining wall structure.

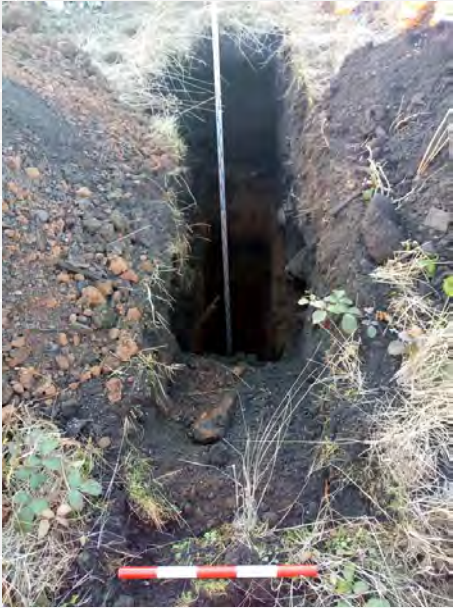
YORK ARCHAEOLOGICAL TRUST	Site Code -	
TEST PIT/BOREHOLE/WINDOW SAMPLE LOG	Project Number- 6104	
Site Name - York Central Phase 1 Infrastructure GI	Trench/Area TP 420	Sheet - 1 of 1

Intervention No. TP 420	
Time/Date pm 13/11/18	
Contexts / Numbers Assigned	
3200	Track base - Loose, black, clinker with larger fragments towards the base.
3201	Landscaping/Disturbance - Soft, brownish orange, clay sand.
3202	Landscaping/Disturbance - Loose, purple dark grey, clinker.
3203	Natural/Landscaping/ Disturbance - Friable, orangey brown, clay sand with cobbles and pebbles.
Notes	
	3400mm x 600mm and up to 4500mm deep.
	Aligned east-west.

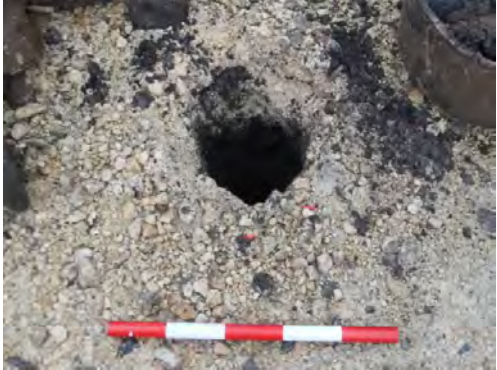
YORK ARCHAEOLOGICAL TRUST	Site Code -	
TEST PIT/BOREHOLE/WINDOW SAMPLE LOG	Project Number- 6104	
Site Name - York Central Phase 1 Infrastructure GI	Trench/Area BH 401	Sheet - 1 of 1

Intervention No. BH 401	
Time/Date pm 23/11/18	
Contexts / Numbers Assigned	
4010	Surface - Hardcore
4011	Landscaping/Disturbance - Friable, dark brownish grey, clayey silt.
4012	Buried soil - Soft, brownish grey, silt clay.
4013	Natural - Friable, reddish orange, sand.
Notes	
10m+ Deep. Hand dug to 1200mm.

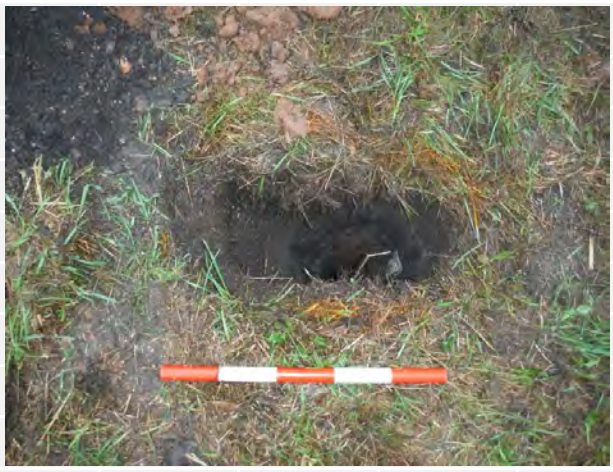
Intervention No. CPTU 401	
Time/Date am 22/11/18	
Contexts / Numbers Assigned	
5010	Surface/Made ground - Turf and topsoil, friable, black, silt.
5011	Disturbance/Made ground - Friable, black, clinker and silt.
5012	Landscaping/Disturbance - Soft, brownish orange, clay sand.
Notes	
200-300mm Diameter. Hand dug to 1200mm.

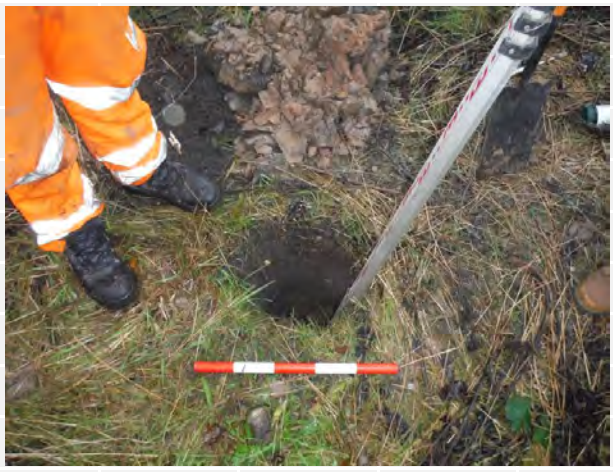
YORK ARCHAEOLOGICAL TRUST	Site Code -	
TEST PIT/BOREHOLE/WINDOW SAMPLE LOG	Project Number- 6104	
Site Name - York Central Phase 1 Infrastructure GI	Trench/Area CPTU405	Sheet - 1 of 1

Intervention No. CPTU 405	
Time/Date am 22/11/18	
Contexts / Numbers Assigned	
5050	Surface - Turf and topsoil, soft, brownish black, silt.
5051	Landscaping/Disturbance - Firm, greyish orangey brown, clay.
5052	Natural - Firm, orangey brown, clay with sand bands.
Notes	
200-300mm Diameter. Hand dug to 1200mm.

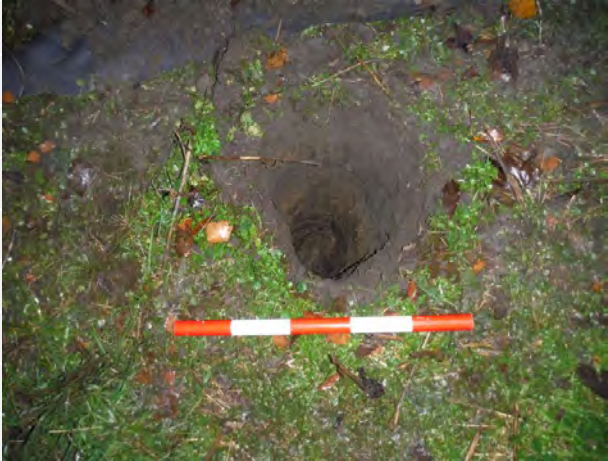
YORK ARCHAEOLOGICAL TRUST	Site Code -	
TEST PIT/BOREHOLE/WINDOW SAMPLE LOG	Project Number- 6104	
Site Name - York Central Phase 1 Infrastructure GI	Trench/Area CPTU406	Sheet - 1 of 1

Intervention No. CPTU 406	
Time/Date pm 22/11/18	
Contexts / Numbers Assigned	
5060	Surface - Turf and topsoil, soft, dark brown grey, clay silt.
5061	Subsoil - Soft yellowy grey brown clay. Probably reworked/disturbed.
5062	Natural - Firm, yellowy grey brown, clay.
Notes	
200-300mm Diameter. Hand dug to 1200mm.

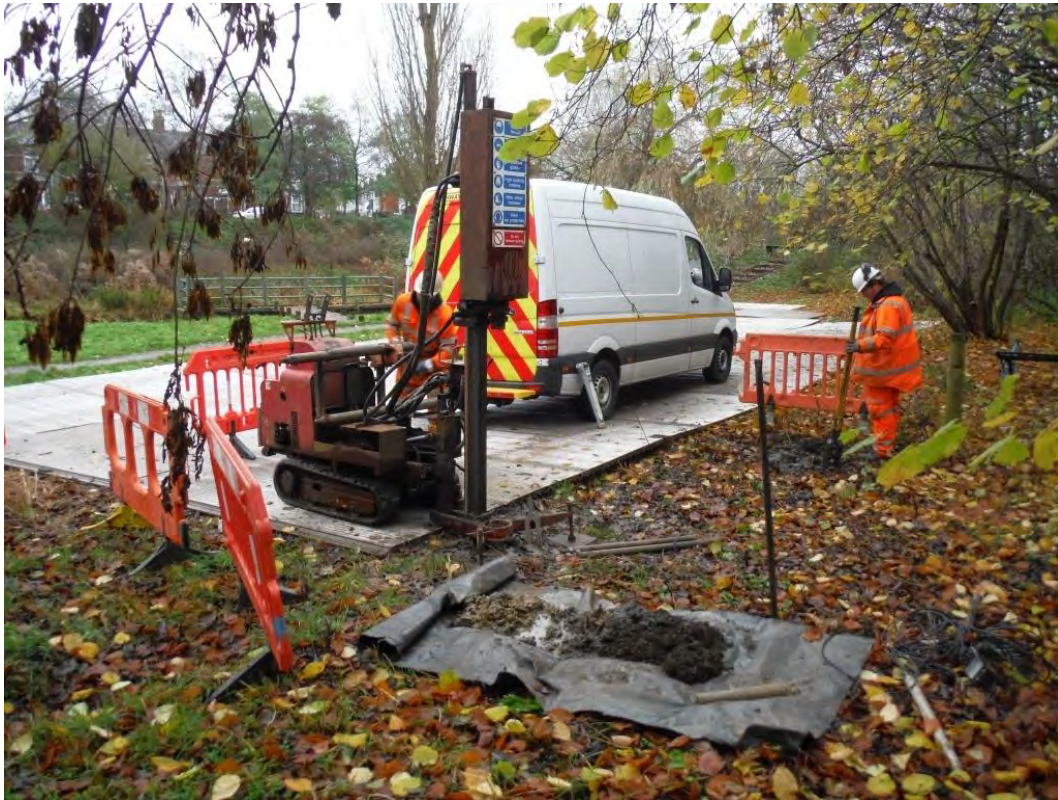
Plate 1 WS402 facing southeast

Plate 1 Shows WSA401 during excavation. This was typical of the methodology across the site as well as the specific conditions encountered at the southern end of Millennium Green.
