# YORK ARCHAEOLOGICAL TRUST

<b>SITE</b>	Wall to the rear of 10 Precentor's Court, York		
<b>CLIENT NAME</b>	CYC		
<b>YAT PROJECT #</b>	6081	<b>YAT REPORT #</b>	2019/162
<b>MUSEUM ACCESSION #</b>	N/A	<b>GRID REFERENCE</b>	SE 60160 52254
<b>PLANNING REFERENCE #</b>	19/01434/FUL	<b>AAI OPS NOTICE #</b>	N/A

## INTRODUCTION

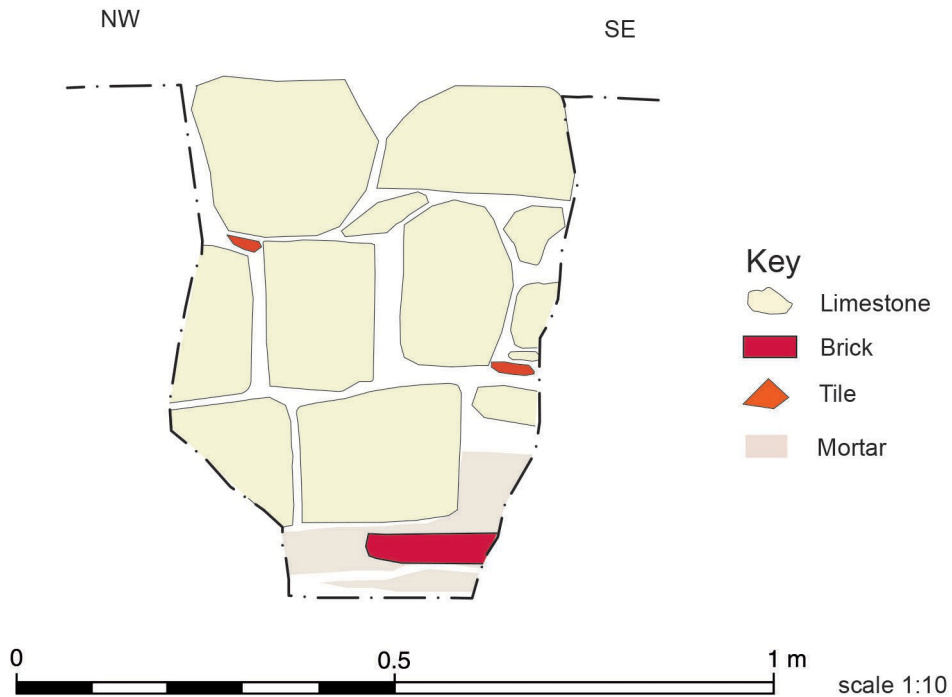
**Figure 2** Wall elevation (July 2018)

Below ground level, the wall was comprised of large limestone blocks, squared and in a random course. The stones measured between 0.21m x 0.15m and 0.24m x 0.21m. A single brick was seen within the wall at the base of the trial pit, measuring 0.15m x 0.10m. The bonding material of the wall was hard to determine as the mortar had recessed or been raked out. Above ground level the rear wall had been rebuilt and strengthened, evidenced by the presence of brickwork and concrete mortar.

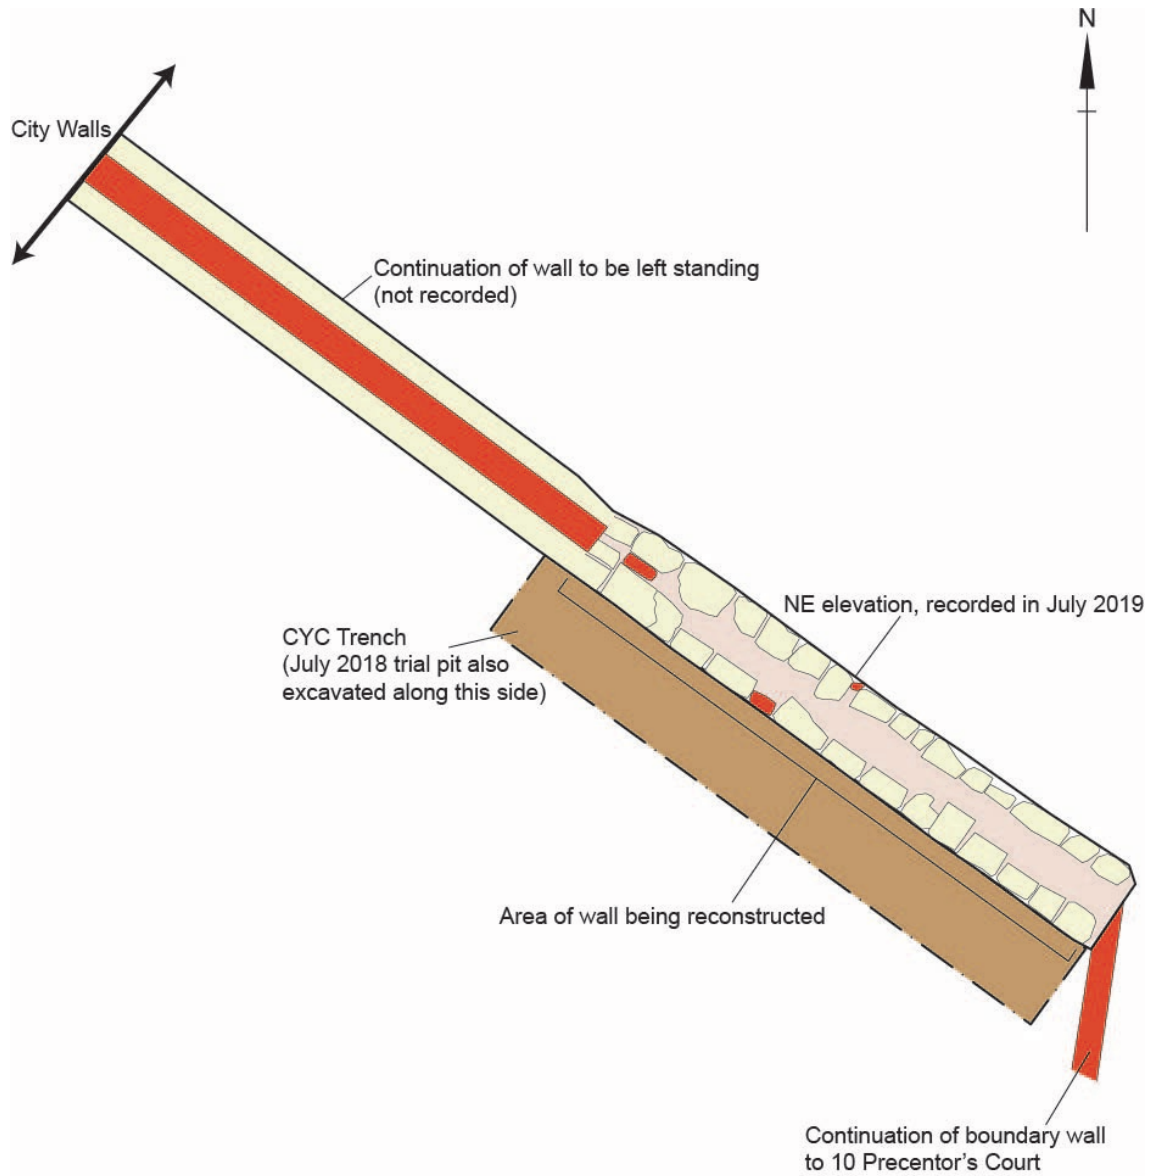
**Figure 3** Illustration showing October 2019 scheme of works

In the October 2019 scheme of works (Figure 3), a trench at the back (south-west face) of the wall was hand excavated into the bank to a maximum depth of 1.5m below ground level in order to facilitate the safe deconstruction and subsequent reconstruction of the wall. The trench excavated alongside the south-west face was approximately 4.65m long by 0.65m wide by 1.5m deep. The south-west face was barely visible prior to the commencement of the October 2019 phase of works. It was only possible to sketch the top two courses of masonry on the south-west face as the lower courses of stone were dismantled in conjunction with the deepest part of the trench excavation, due to safety concerns. Notes, a measured sketch and digital photographs were taken of the top courses of masonry (Plate 3) and the trench section. Above the masonry there had been multiple courses of post-medieval brickwork, however that section was dismantled prior to archaeological observations, and will match the same brickwork as was recorded on the north-east face during the July 2019 works.

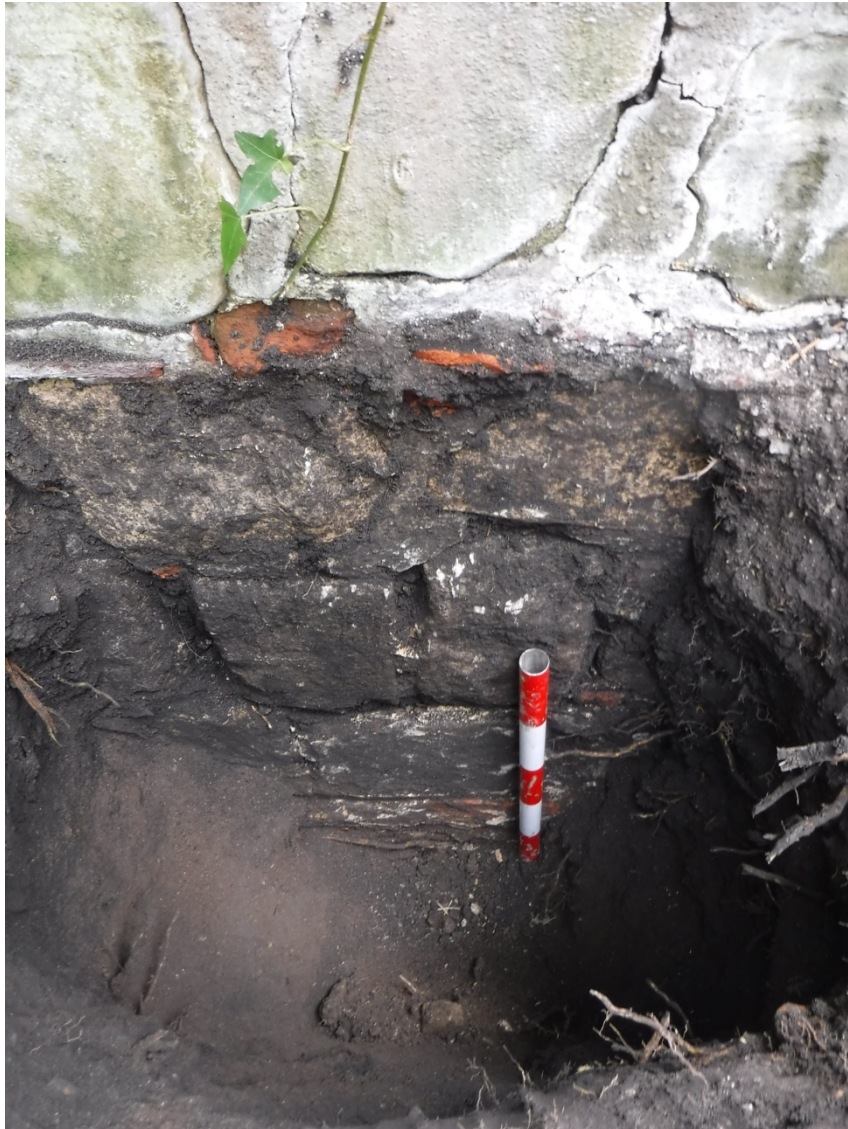
**Plate 1** View of south-west facing wall (July 2018)

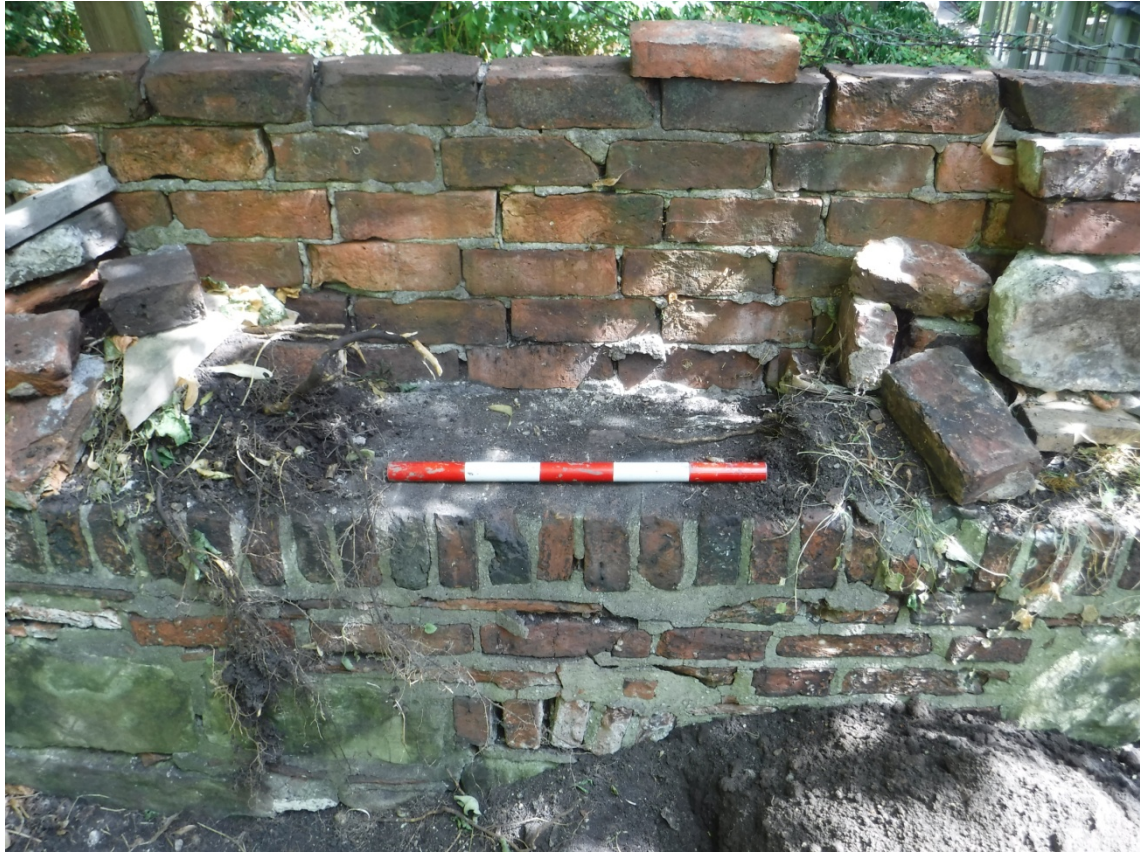
**Plate 2** View north-east of later additions to the wall (July 2018)

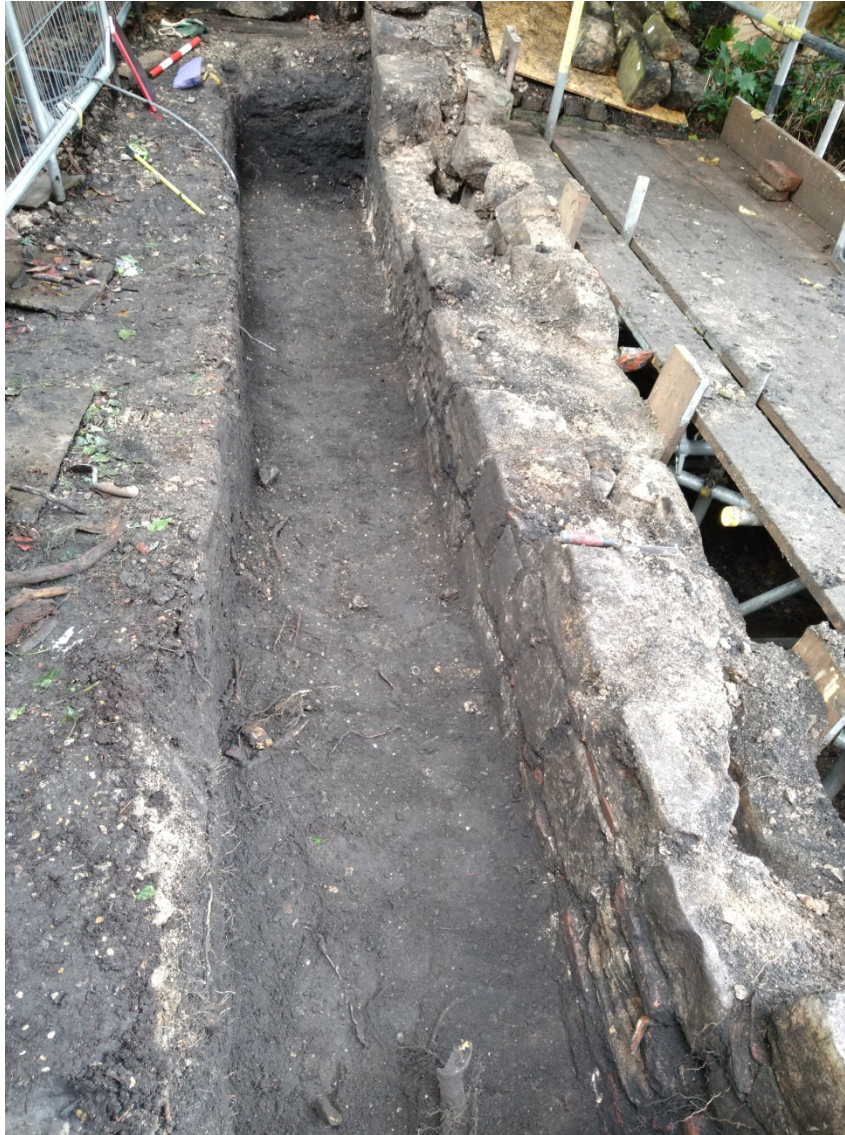
**Plate 3** View looking north-east across the wall. The visible wall face is the south-west facing elevation. The CYC trench runs the length of this section of wall.

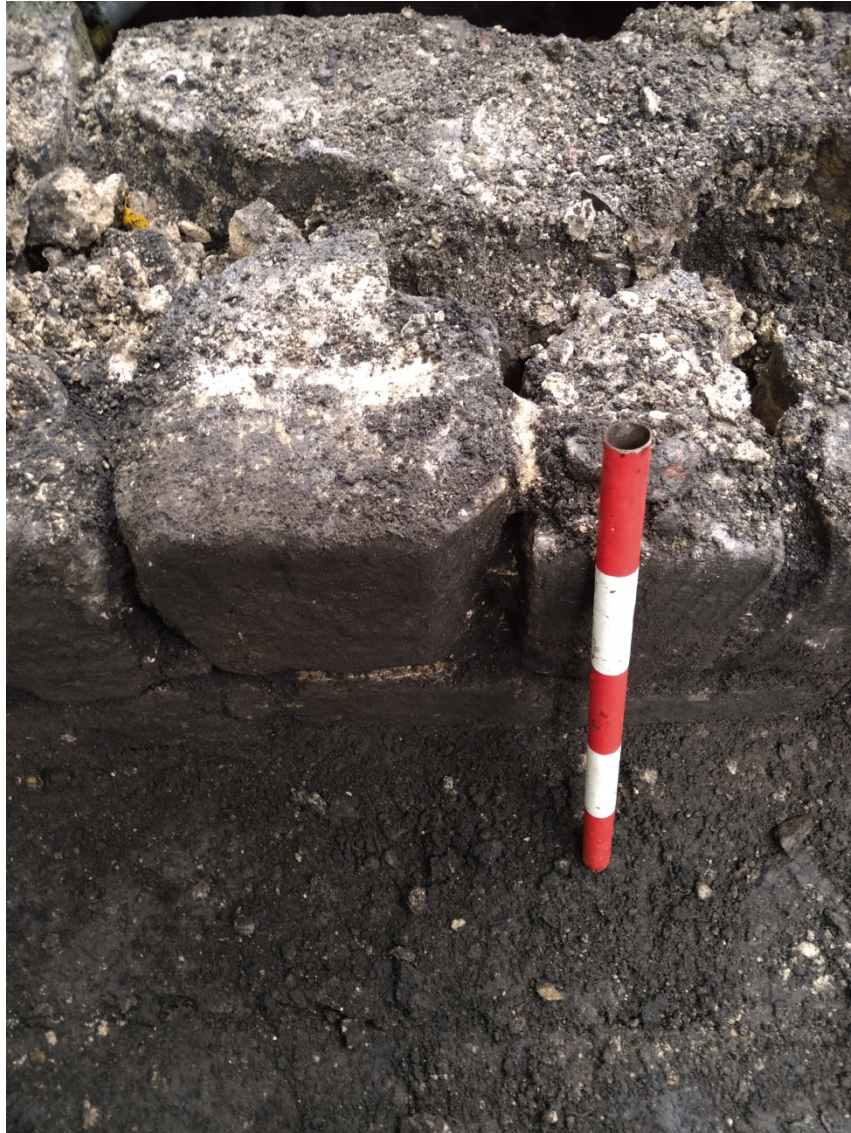
The October 2019 works expanded on what was found in 2018. On the wall itself, the bonding material appeared to be a pale yellowish-grey lime-rich mortar. As evidenced in the 2018 and July 2019 observations the lower portion of the wall was made up of large blocks of masonry, some of which were reused from the medieval period or later. There was more post-medieval brick and tile infilling in places. Two architectural fragments (Plates 4 and 5) were visible in the south-west face of the wall, and one smaller worked fragment came from the infilling between the south-west and north-east courses of stonework (Plate 6).

**Plate 4** One of three architectural fragments visible in the south-west face of the wall

Nothing of interest was found during the 2019 excavation of the trench along the south-west side of the wall. The material exposed was no earlier than 18<sup>th</sup> century in date, although it contained some residual earlier finds. Whilst the architectural fragments exposed during this stage of works were likely to be of a medieval date, they had clearly been reused when the wall was first constructed in the 18<sup>th</sup> century. These fragments were retained by the CYC stonemasons as they will be used when the wall is rebuilt.

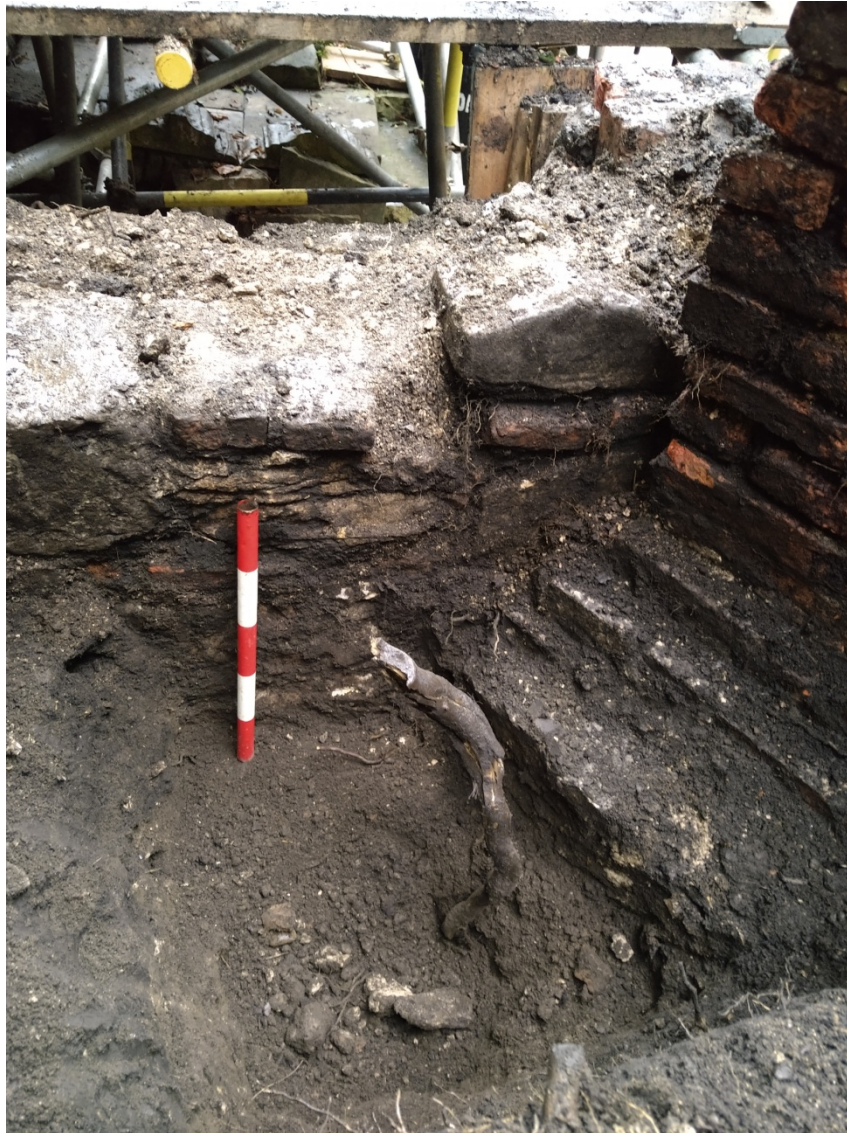
**Plate 5** The second of three architectural fragments (top right) visible in the south-west face of the wall

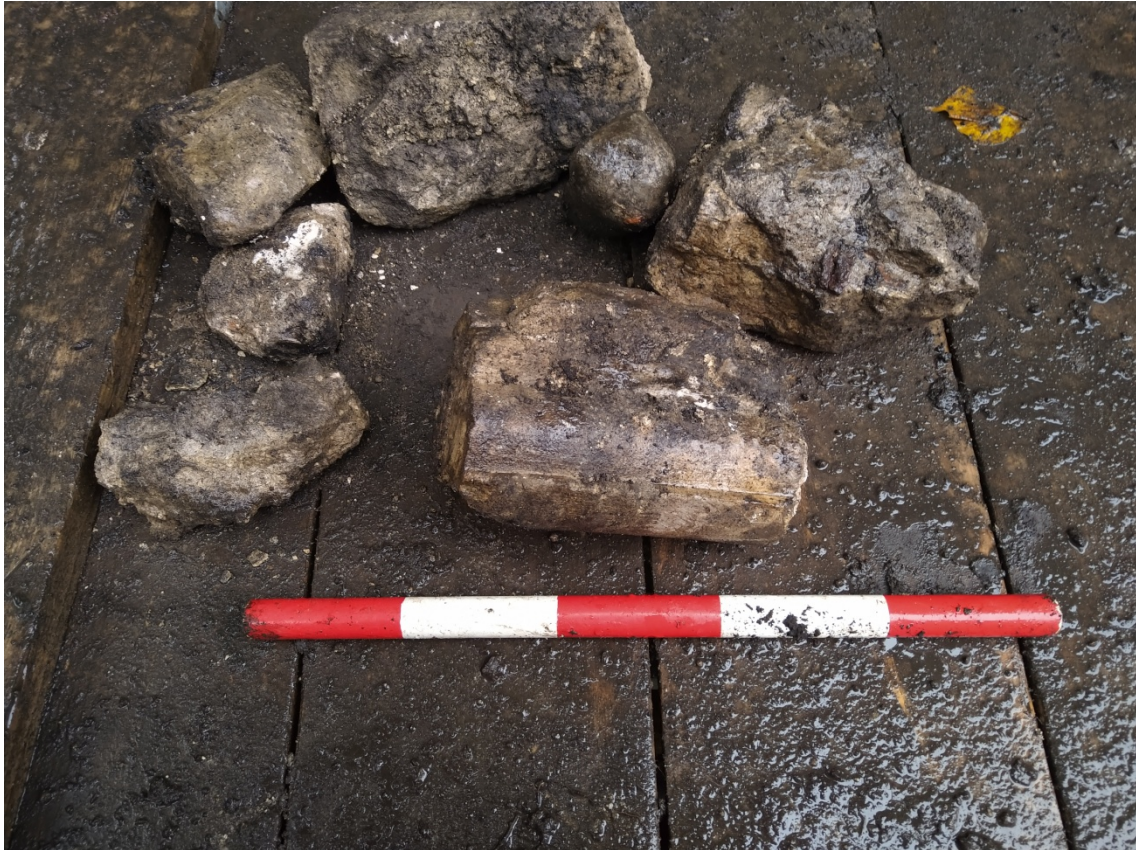
**Plate 6** The third architectural fragment from the south-west side of the wall. This piece came from the wall core.

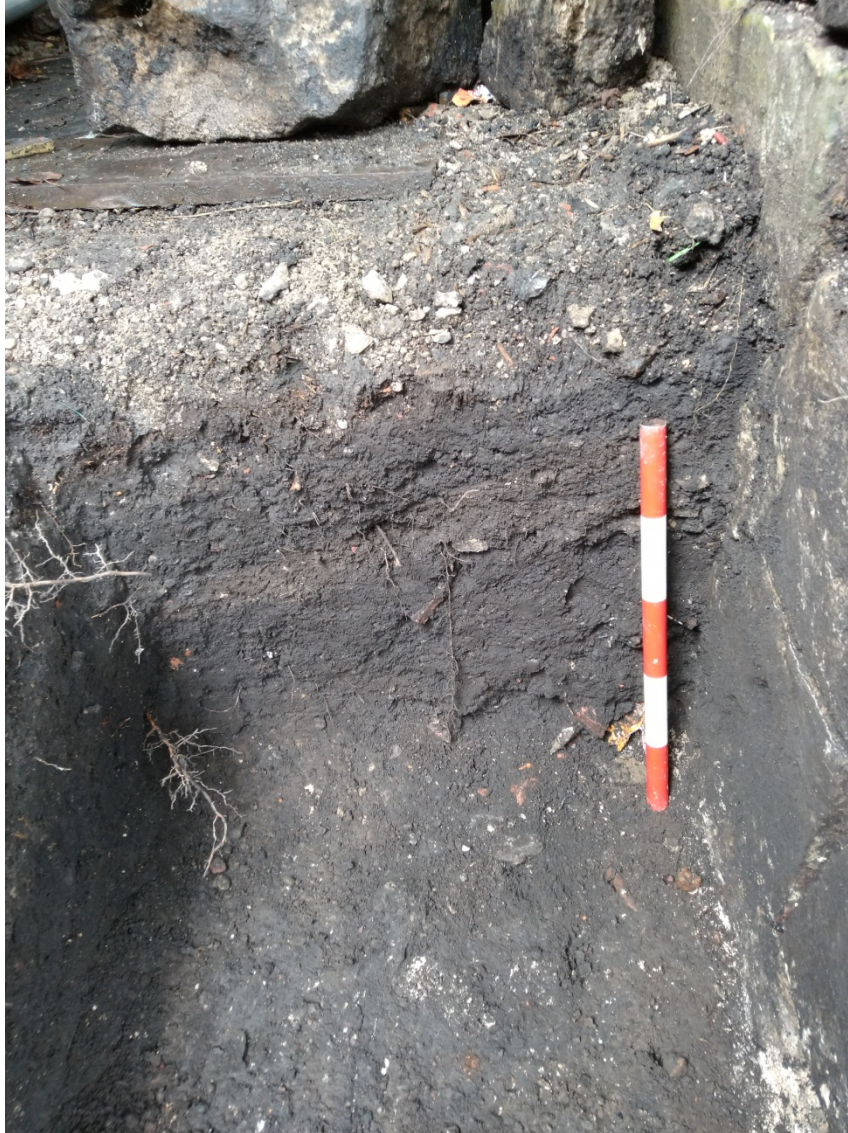
The section of the trench revealed several layers of friable to loose dark grayish-brown sandy silt that was heavily disturbed by both rooting and burrowing (Plate 7). The soil contained moderate amounts of post-medieval – modern pottery, brick and tile fragments, and occasional fragments of animal bone. A residual piece of possible Cistercian pottery was recovered from the section but was not retained. It appeared that any earlier archaeology was beyond the limit of excavation of this scheme of work and probably heavily disturbed. No deposits associated with the walls or ramparts were encountered during the works.

**Plate 7** South-east facing section adjacent to the wall (the south-west face of the wall is visible in the right of this plate).
