Archaeological Investigations at Carpetright, Layerthorpe, York

YAT Evaluation Report 2019/111 July 2019

Project Name	Carpetright, Layerthorpe, York
YAT Project No.	6135
Document Number	2019/111
Type of Project	Evaluation
Client	CBRE
Planning Application No.	N/A
NGR	SE 60902 52096
Museum Accession No.	Pending
OASIS Identifier	Yorkarch1-363203

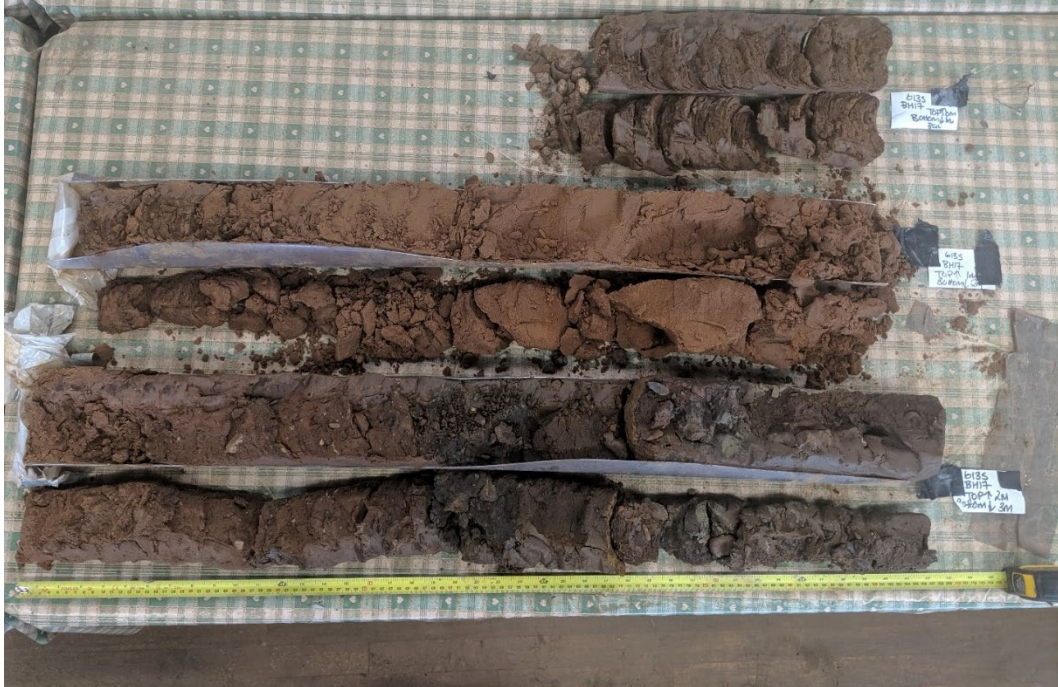
Plate 1 Cores (bottom to top, left to right) 0.65m to 3m

The deepest deposit encountered comprised a stiff, dark red grey, silt clay with occasional gravel, representing the Vale of York Formation. This deposit was recorded between 2.80–7.00m BGL, (7.47m–3.27m AOD) which was then overlain by a red-brown, silt clay with

occasional gravel 0.58m thick. This likely represents the weathered upper surface of the Vale of York Formation. This in turn was overlain by a laminated silt sand deposit which trended into a fine structureless sand between 1.00m and 2.00m BGL (9.27m-8.27m AOD). This was then sealed by a laminated dark grey brown silt clay sand, 0.65m–1.40m BGL (9.62m-8.87m AOD), representing the alluvial deposition at the site.

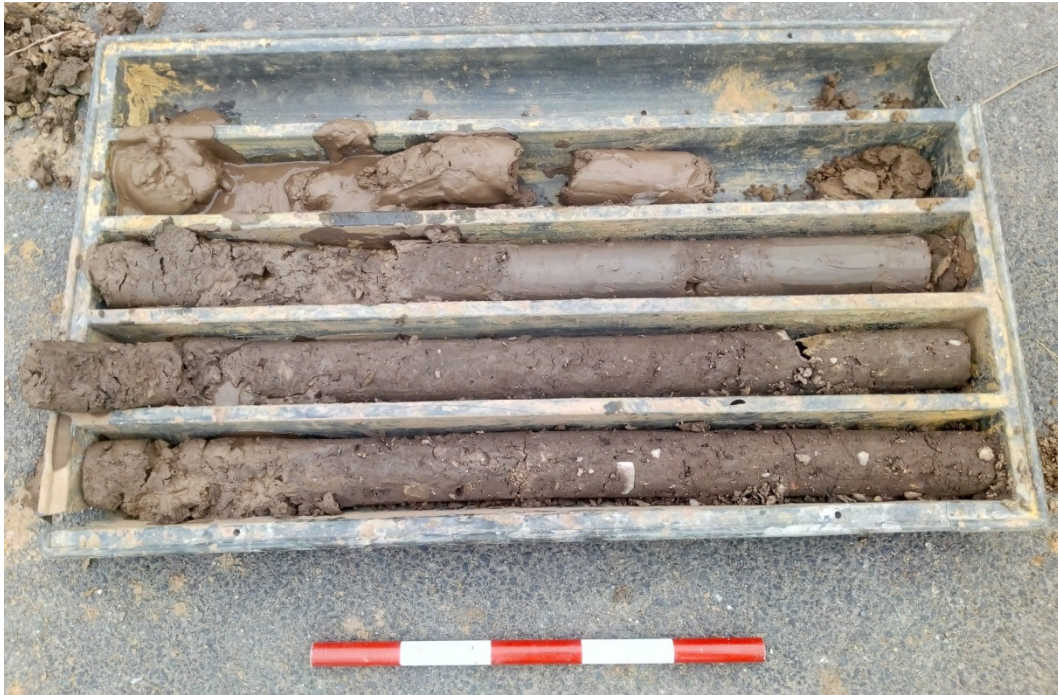
Plate 2 Cores (bottom to top) 5m–6m, 6m–7m, 7m–8m & 8m–9m. Contexts (bottom to top, left to right) C1811, C1812, C1813, C1814, C1815 & C1816. Scale 0.5m

Till deposits were observed from 2.81m BGL (7.45m AOD). The earliest deposit was a soft, very wet, mid-orange brown, sand (C1816), recorded at 8.18m BGL (2.08m AOD). Above this were deposits of mid brown boulder clay (C1813 & C1815) interspersed with laminations of silty clay (C1814) which contained occasional rounded pebbles and flecks of sandstone. A thick deposit of stiff, mid-grey brown, clay (C1809–C1812) extended from 2.81m BGL to 7.45m BGL (7.45m-2.81m AOD). The top of the clay deposit (C1809) contained occasional flecks of red sandstone, gravels of very small sub-angular pebbles and sand lenses. From around 4.70m BGL (5.56m AOD) (C1810) onwards the deposit became darker and more compacted, and from 5.00m BGL (5.26m AOD) (C1811) it became increasingly wet with lenses of sand. From 5.25m BGL (5.01m AOD) the clay (C1812) became more sterile, with fewer incidences of gravel and sandstone.

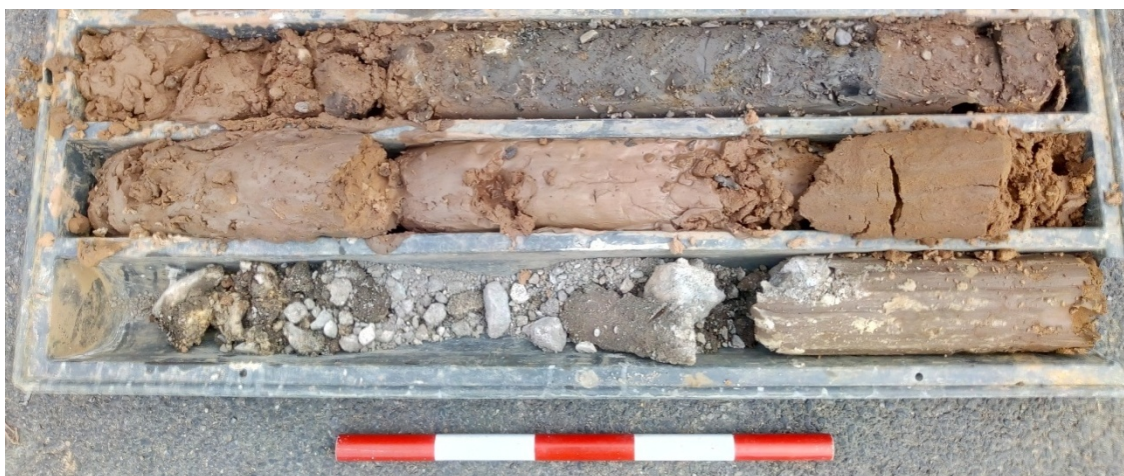
Plate 3 Cores (bottom to top) 0m–1m, 1m–2m & 3m–2m. Contexts (bottom to top, left to right) C1803, C1804, C1805, C1806, C1807, C1808 & C1809. Scale 0.5m

Made ground formed consisting of mid- to dark grey, clay (C1808–1807) containing occasional small pebbles, limestone and sandstone was recorded at 2.35m BGL (7.91m AOD). This was, in turn, overlaid by a series of redeposited clay made ground deposits (C1804–1806), the top of which was recorded at 0.66m BGL (9.60m AOD). The earliest of these deposits comprised mid-brown, wet, coarse sand with small to medium cobbles (C1806), recorded at 2.20m BGL, 8.06m AOD. This was overlaid by a mid-brown clay and clayey sand (C1805; 1m BGL, or 9.26m AOD) and stiff, brown clay (C1804).

Modern made ground (C1803), levelling (C1802) and surface deposits (C1801) made up the top metre of soil below the current ground level.

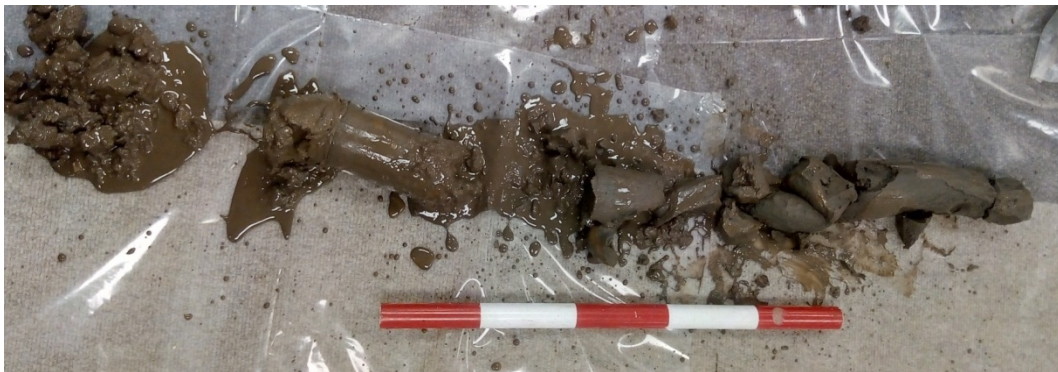
Plate 4 Borehole 6, Core 4m–5m, contexts (left to right) C6007 & C6008. Scale 0.5m

The earliest deposit recovered in both boreholes was glacial till (C5008 and C6009), recorded at depths between 5.20m BGL (5.20m AOD; BH5) and 6.00m BGL (4.39m AOD; BH6). Above this laid a deposit of very dark to mid grey, very soft, silty alluvial clay (C5.7 and C6.8), the top of which was recorded at 4.73m BGL (5.67m AOD) in BH5 and 4.50m BGL (5.89m AOD) in BH6.

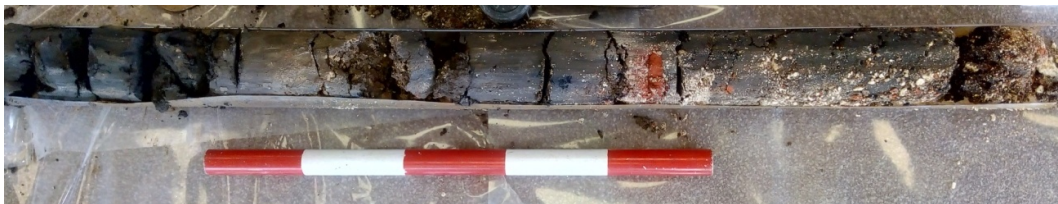
Plate 5 Borehole 5, core 2m–3m, showing very dark grey redeposited alluvial clay C5006 to far left of core, scale 0.5m

Mid- to very dark grey alluvial silty clays containing small fragments of crushed CBM and mortar (C5006 and C6007) were recorded above the till deposits. This material was very similar to the deeper alluvial deposits. However, the presence of building material within the clay suggests disturbance of the alluvium, potentially by human activity. The tops of these deposits were recorded at 2.73m BGL (7.67m AOD) in BH5 and 3.42m BGL (6.97m AOD) in BH6. None of the CBM recovered was large enough to date the deposits.

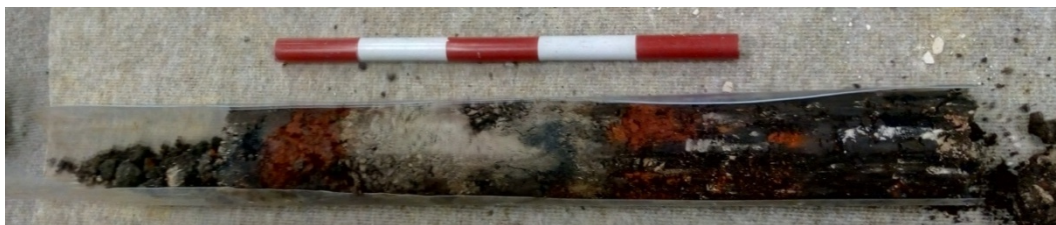
Plate 6 Borehole 6, core 1m–2m, contexts (left to right) C6004 & C6005. Scale 0.5m

Above the redeposited alluvial clays were a series of made ground/demolition deposits consisting of mid-grey clay (C5005 & C6006) and black clayey silt/silty clay (C5004, C5003, C6005 & C6004) containing frequent mortar and CBM fragments with rare occurrences of oyster shell, coke/cinder, crushed concrete and ash. The tops of these deposits were recorded at 1.24m BGL (9.16m AOD) in BH5 and 1.27m BGL in BH6 (9.12m AOD). The deposits likely date from the development of the site in the early 19th–late 20th century.

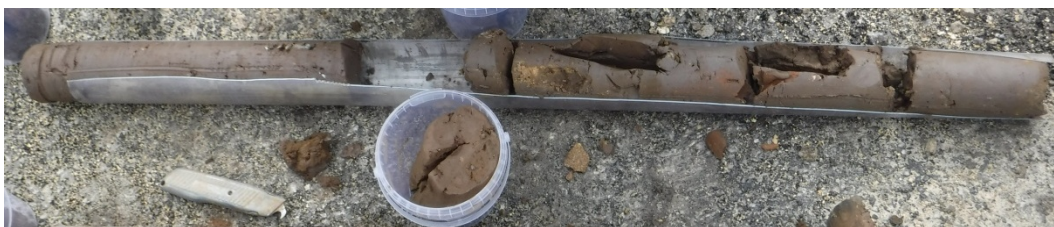
Plate 7 Core 3m–4m, context C7006

The earliest deposit recorded was a mid-brown clay (C7006), the top of which was at 2.28m BGL (8.09m AOD).

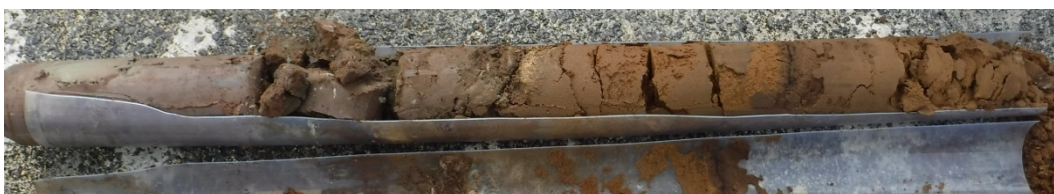
Plate 8 Core 1m–2m, contexts (left to right) C7005 & C7004

Above this was a series of modern made ground deposits, likely the back fill from when the petrol tank was removed. The earliest of these deposits comprised a stiff, mid-grey brown clay (C7005) containing small fragments of sandstone and small angular pebbles, along with rare fragments of CBM. The top of this deposit was recorded at 1.52m BGL (8.85m AOD). Above C7005 was a loose, clean, mid-orange brown sand (C7004), the top of which was recorded at 0.75m BGL (9.62m AOD). The latest of these made ground deposits was a stiff silty clay (C7003) which contained occasional small flecks of CBM and had an odour of hydro-carbon. The top of this deposit was recorded at 0.60m BGL (9.77m AOD).

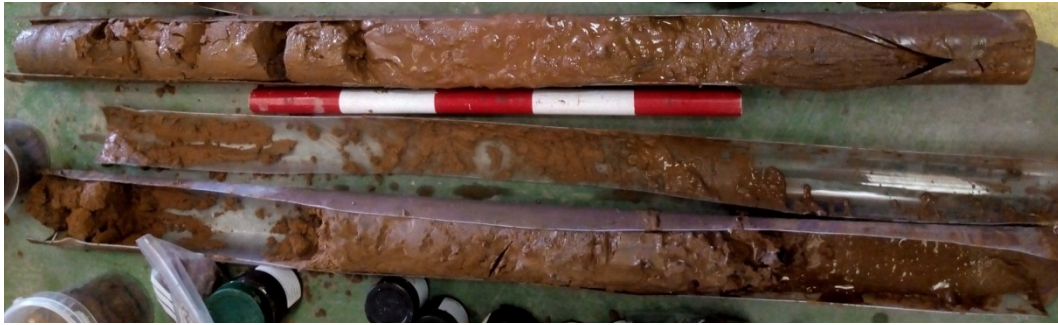
Plate 9 Cores (bottom to top) 3m–4m & 4m–5m. Contexts (bottom to top, right to left) C9005, C9006 & C9007. Scale 0.5m

The borehole reached clay deposits (C9005) at 1.50m BGL (8.96m AOD). The earliest deposit reached was a stiff, grey brown clay (C9007), which contained a lense of sand, the top of which was recorded at 4.65m BGL (5.81m AOD). Above this was a mid-orange brown fine sand (C9006), present from 3.66m BGL (6.80m AOD), which in turn was overlaid by a thick, mid-brown clay deposit (C9005) which contained frequent thin silt laminations. Water breached the core at 3m BGL (7.46m AOD).

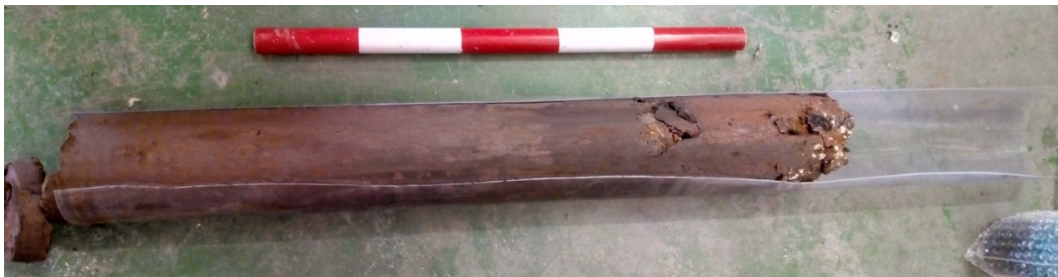
Plate 10 Core 1m–2m, contexts (right to left) C9004 & C9005. Scale 0.5m

A layer of modern made ground formed from a wet and soft mid-brown silty clay (9004) containing frequent fragments of CBM, coke, tarmac and mortar overlaid the naturally lain deposits at 1.20m BGL (9.26m AOD).

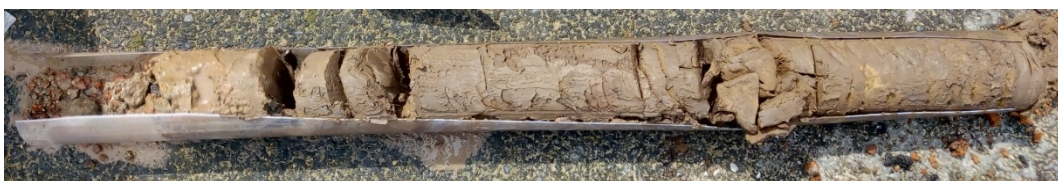
Plate 11 BH10, core 1m–2m, context C1004

Deposits of clay (C1107 & C1204), sand (C1106) and silty clay with silt and sand laminations (C1004, C1105 & C1203) were recorded from 0.64m BGL (9.55m AOD) (BH11) in the centre of the car park, and to 1.55m BGL (8.81m AOD) (BH12) in the north-west corner.

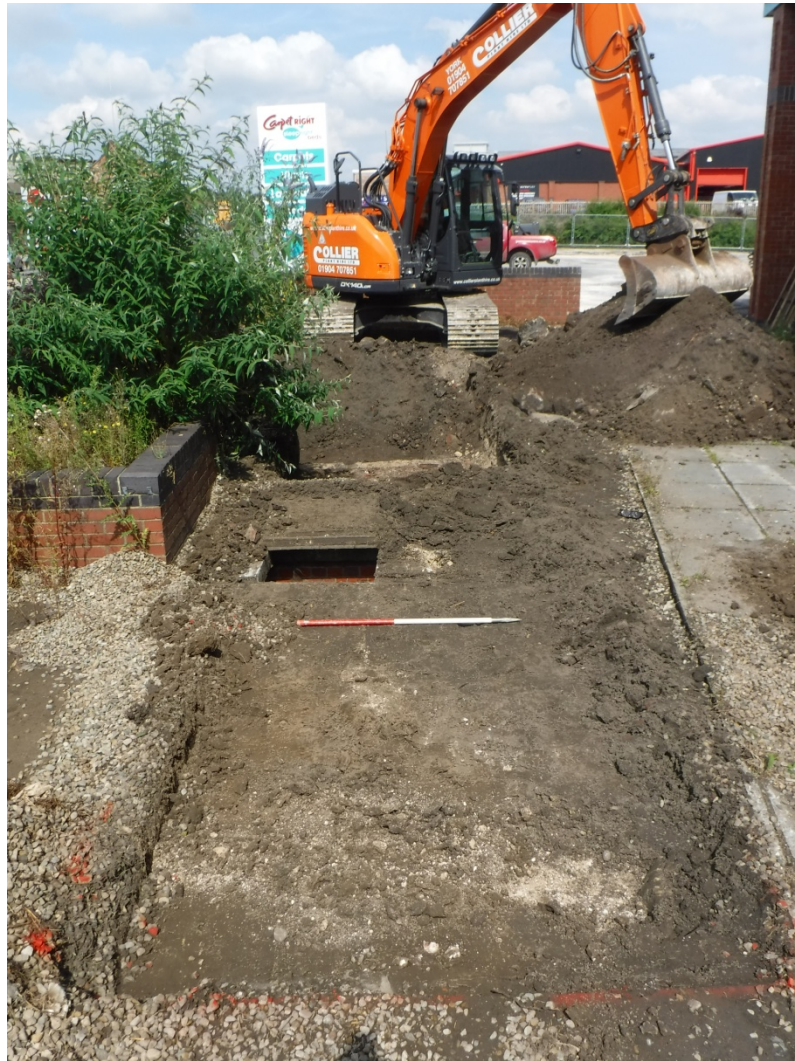
Plate 12 Trench 2, view north-east showing brick-lined inspection chamber to the left, scale 1m

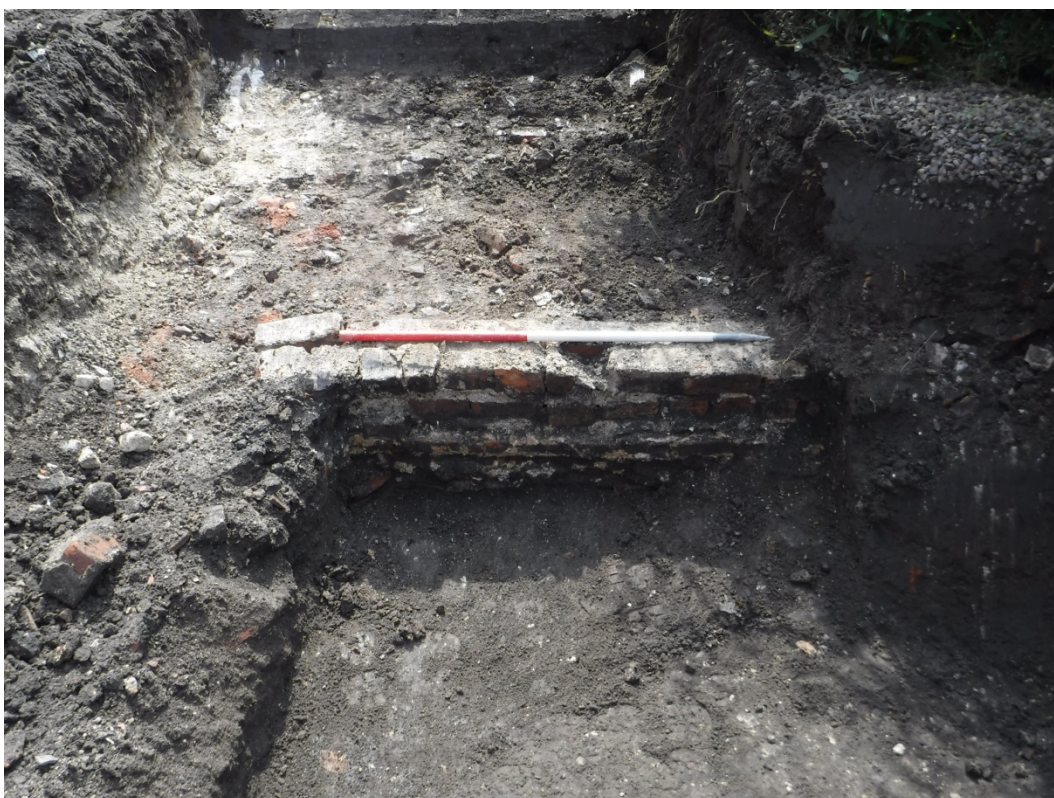
A thick deposit of mid to dark grey silt (C203) containing inclusions of medium stones, CBM fragments and mortar flecks was recorded butting up to the wall C204. Pottery sherds dating to the late Victorian period were observed and then discarded on site. The deposit was recorded at 0.60m BGL (9.65m AOD) and extended deeper than the bottom of the trench at 1.10m BGL (9.15m AOD).

Plate 13 Trench 2, view south-west, showing wall C204, scale 1m

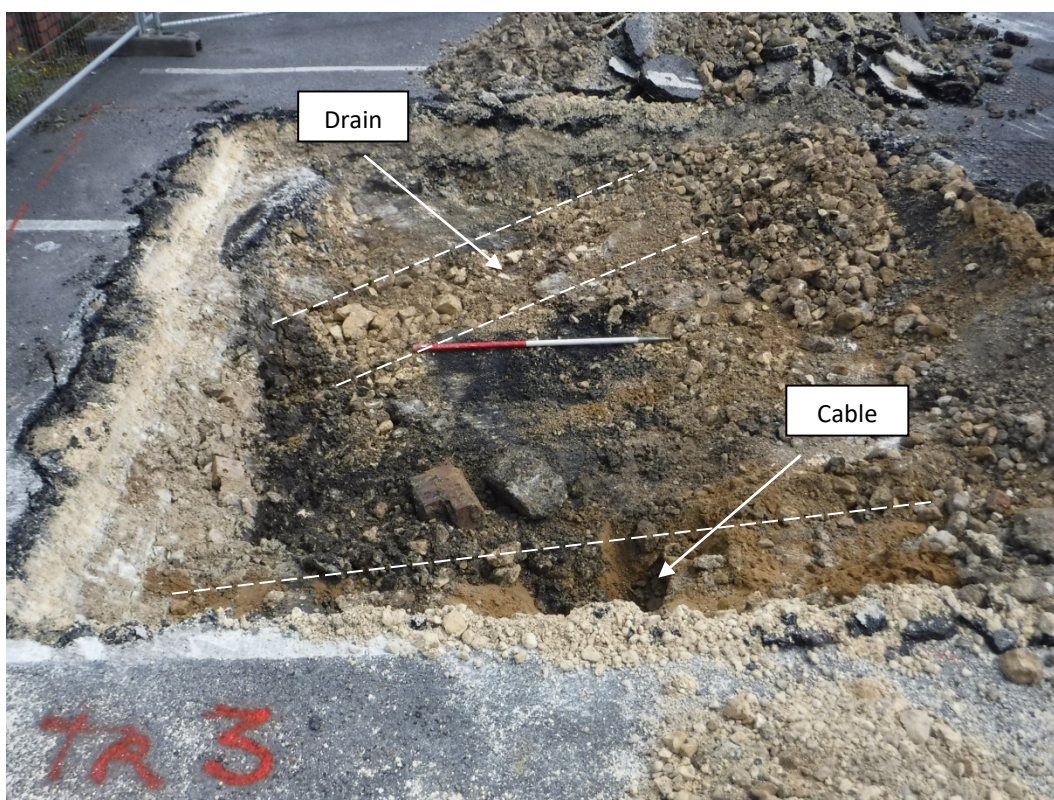
Plate 14 Trench 3, view east, showing cable and drain cut, scale 1m

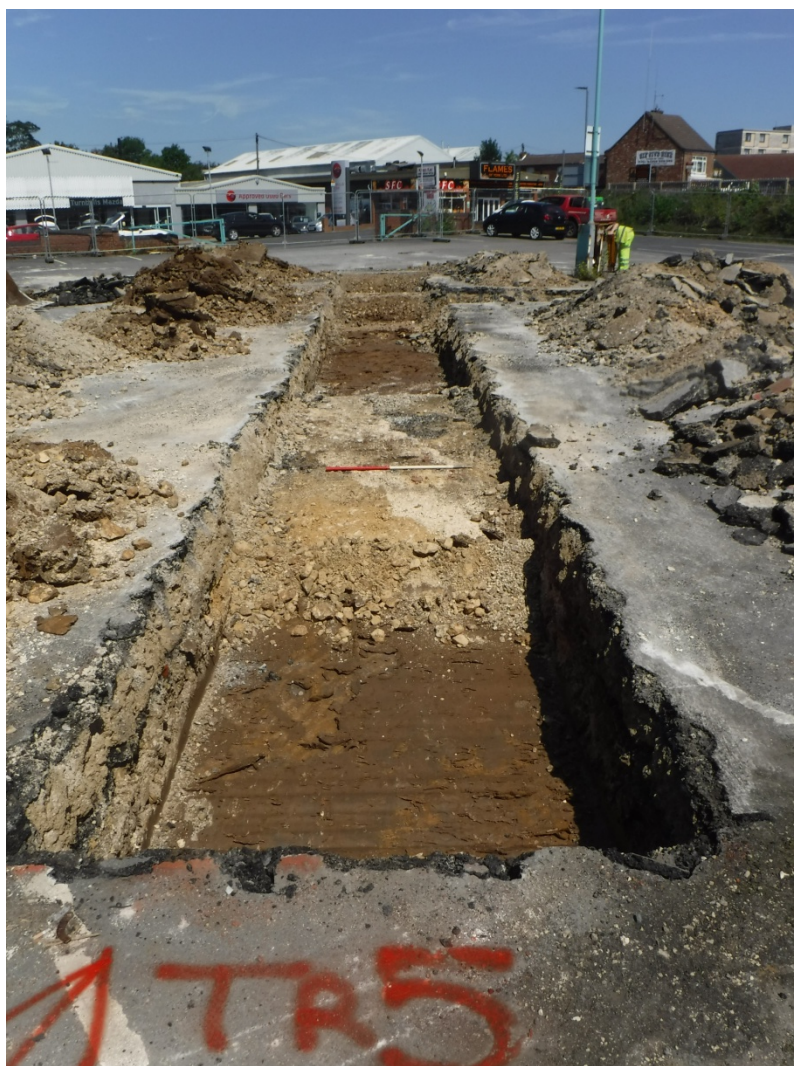
Plate 15 Trench 5, view north, showing natural brown clay C505, scale 1m

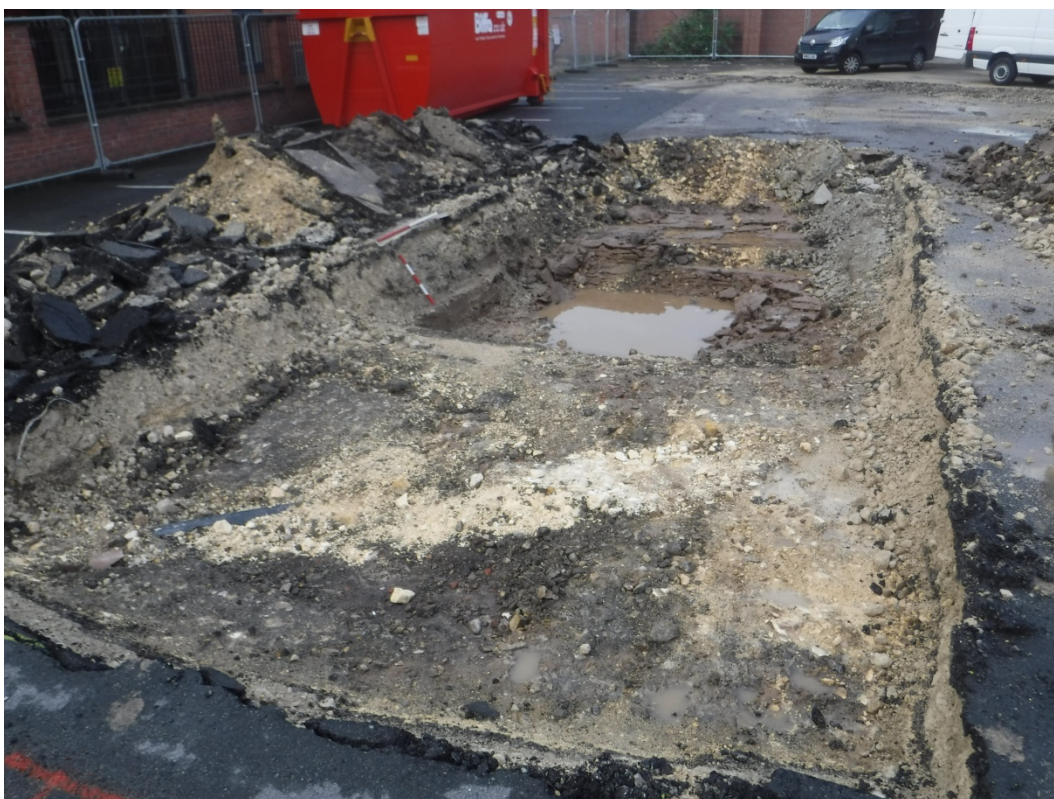
Plate 17 Trench 6, view south, showing natural clay at southern end of trench and cable in foreground.
Water present after rain

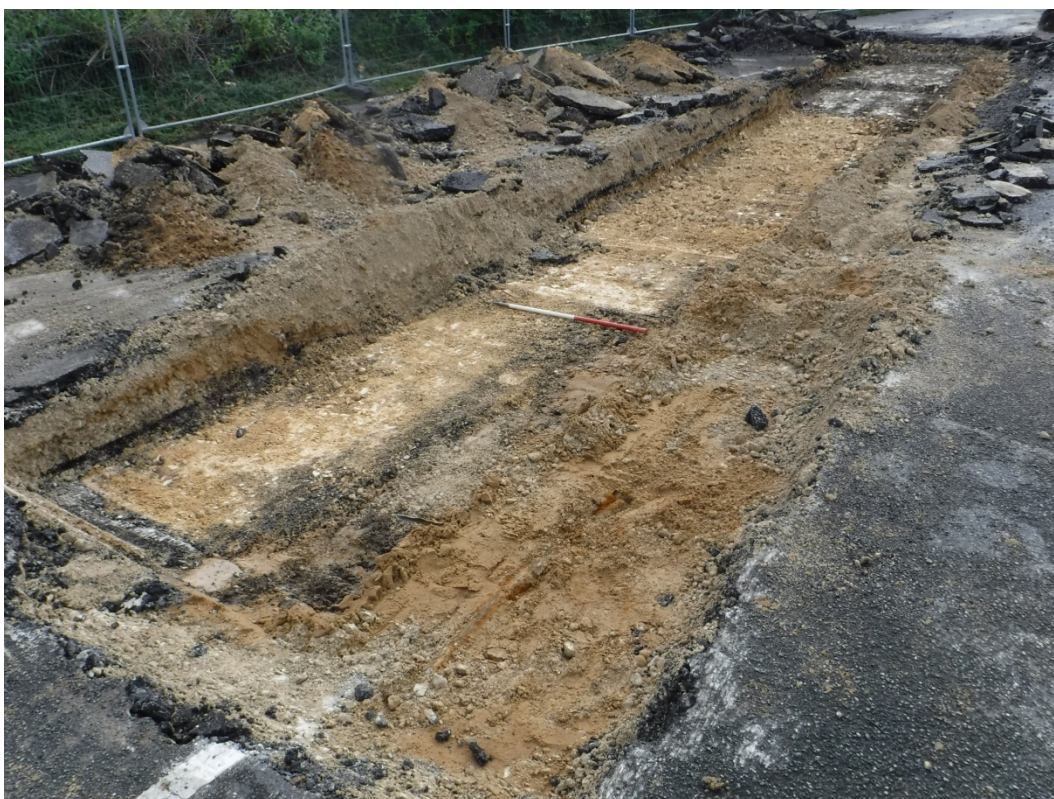
Plate 19 Trench 7, view south-east, showing cable running along length of trench, scale 1m

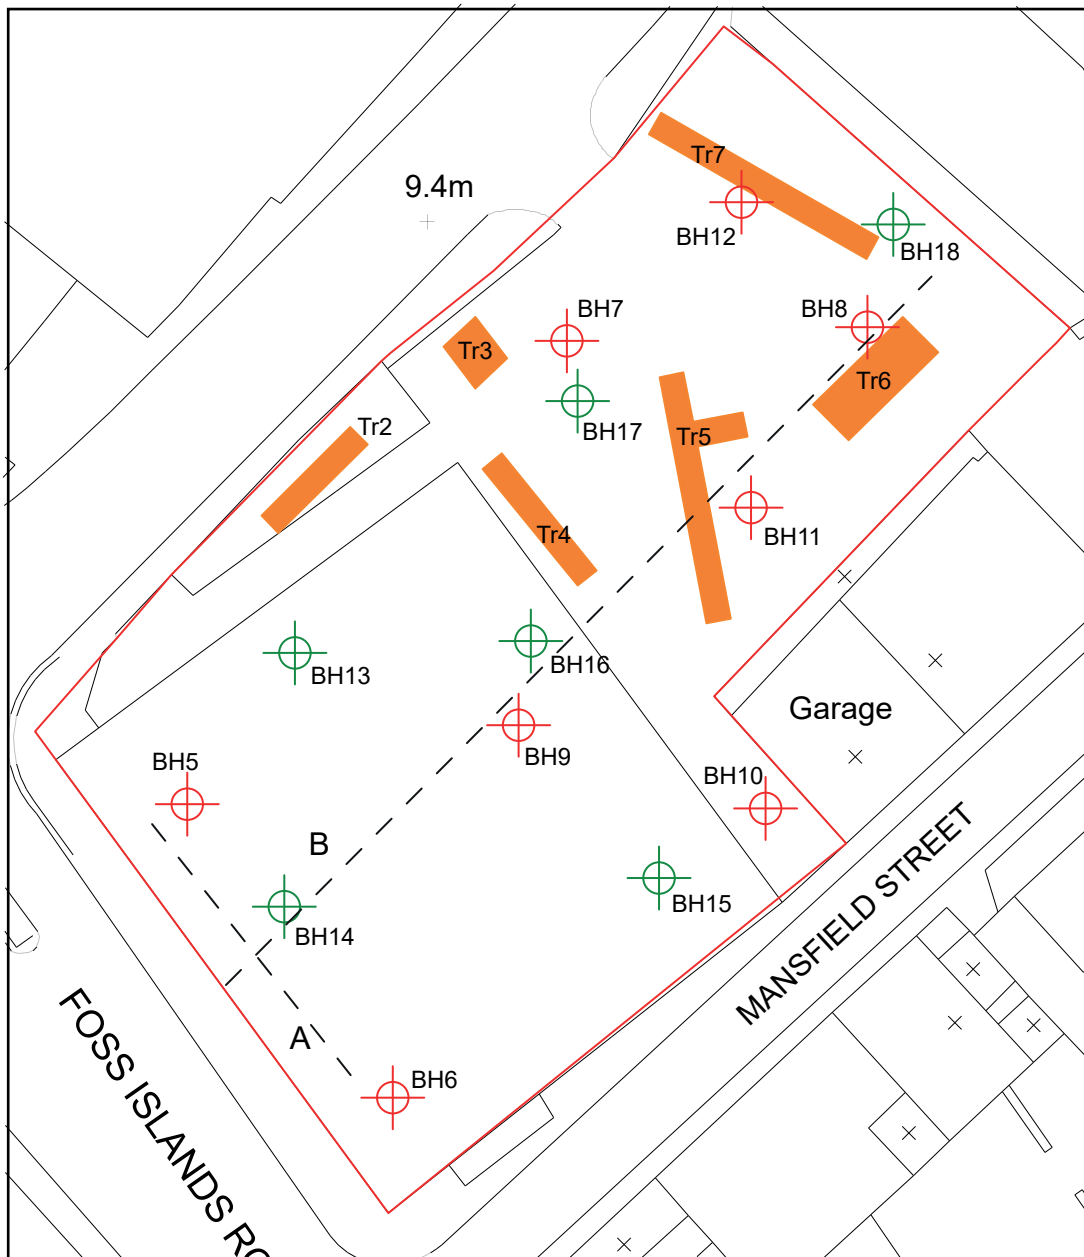
Figure 2 Works Location

The works initially involved the excavation and recording of six evaluation trenches and the monitoring of six archaeological boreholes and seven geoscience boreholes (Figure 2).

A total of six archaeological boreholes (BH's 13–18) and eight geotechnical boreholes (BH's 5–12) were drilled using a windowless sample rig and monitored by the attending archaeologist. The positioning of the boreholes was designed for optimal coverage across the site. The boreholes were positioned as shown on Figure 2.

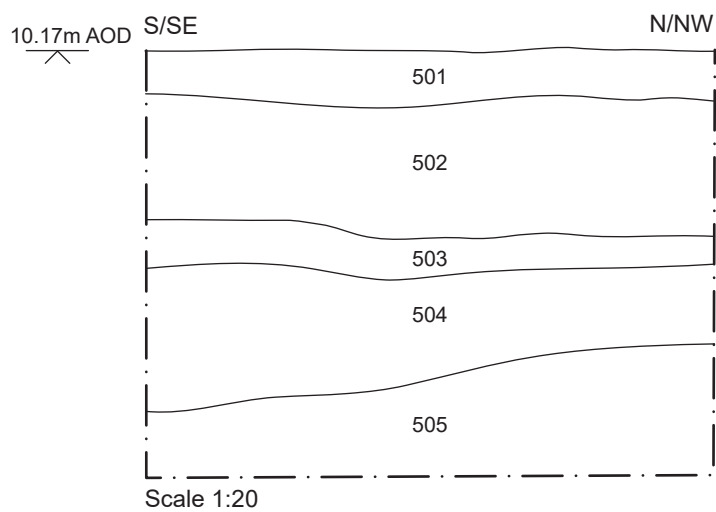
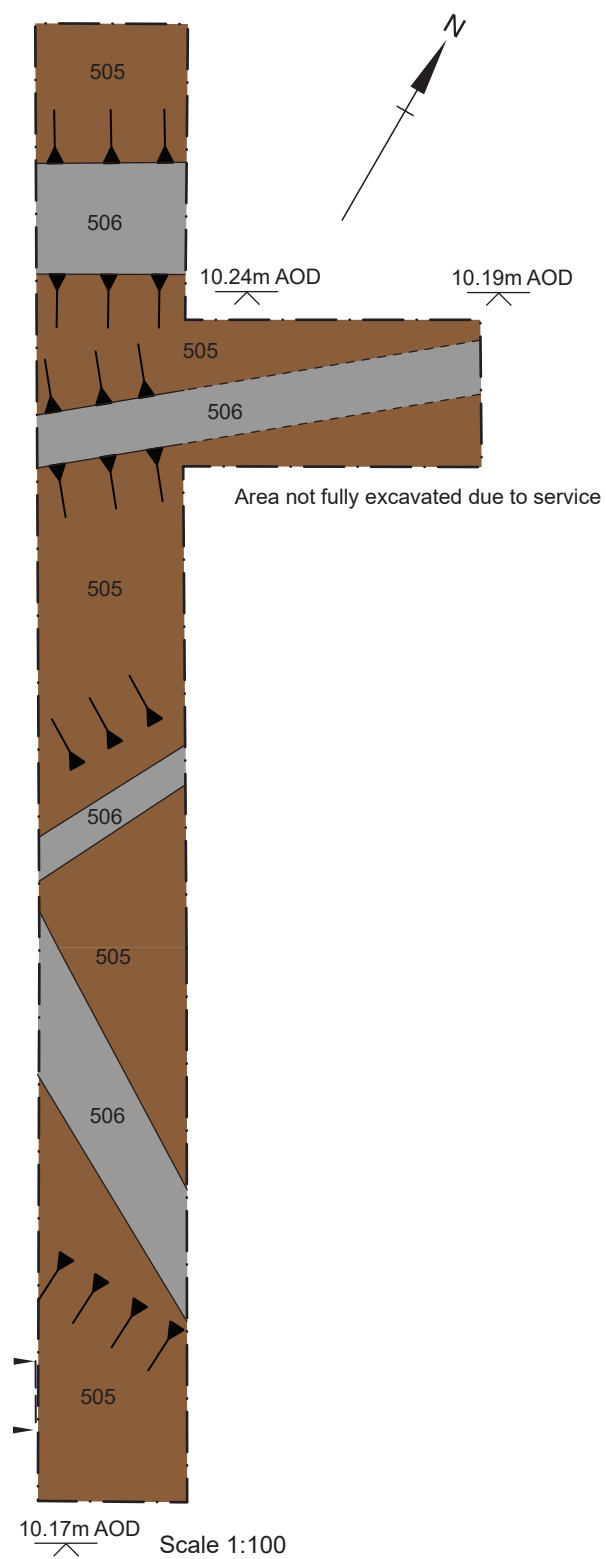
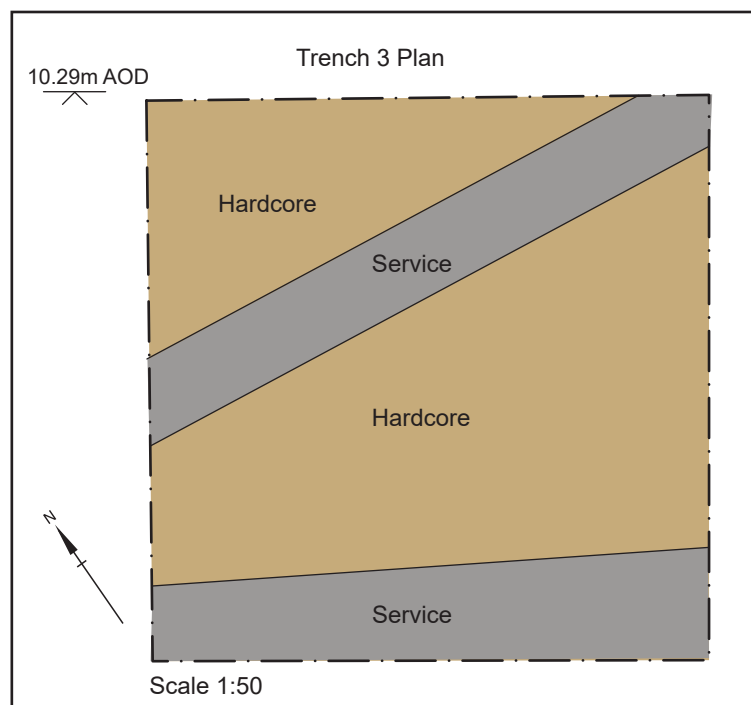
Figure 4 Trench 3 Plan and Trench 5 plan and Section

Trench 5 Representative Section. E/NE Facing.

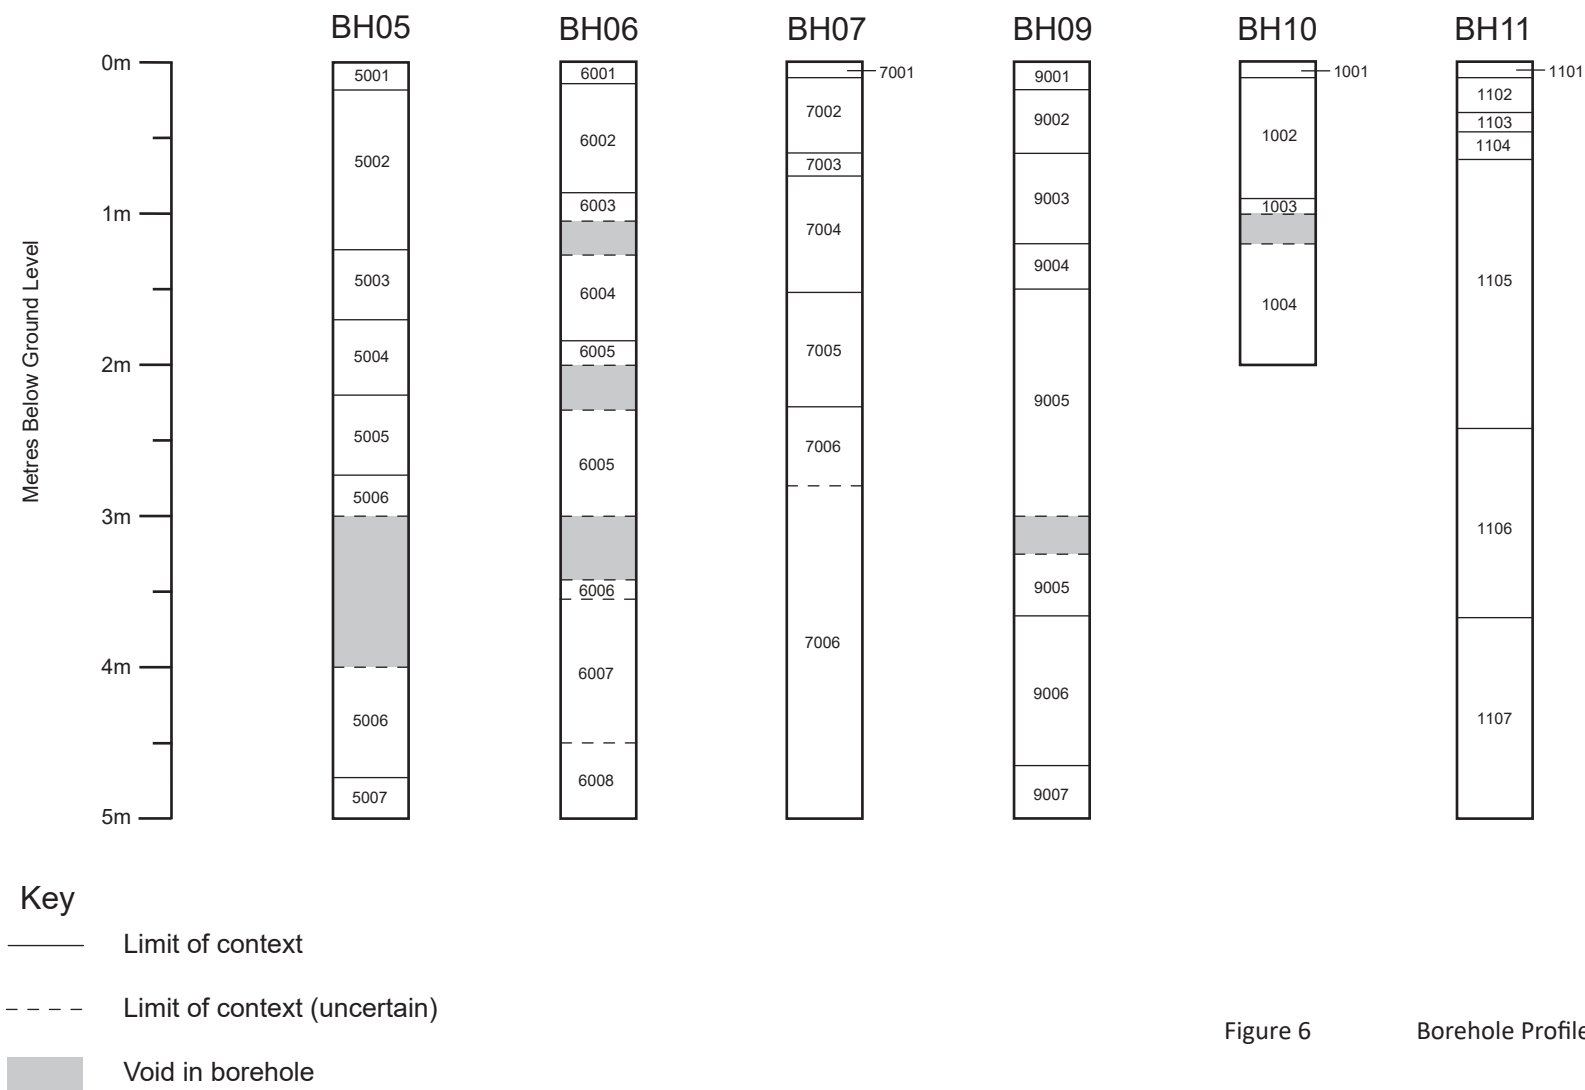
Figure 6

Borehole Profiles BH's 5-11

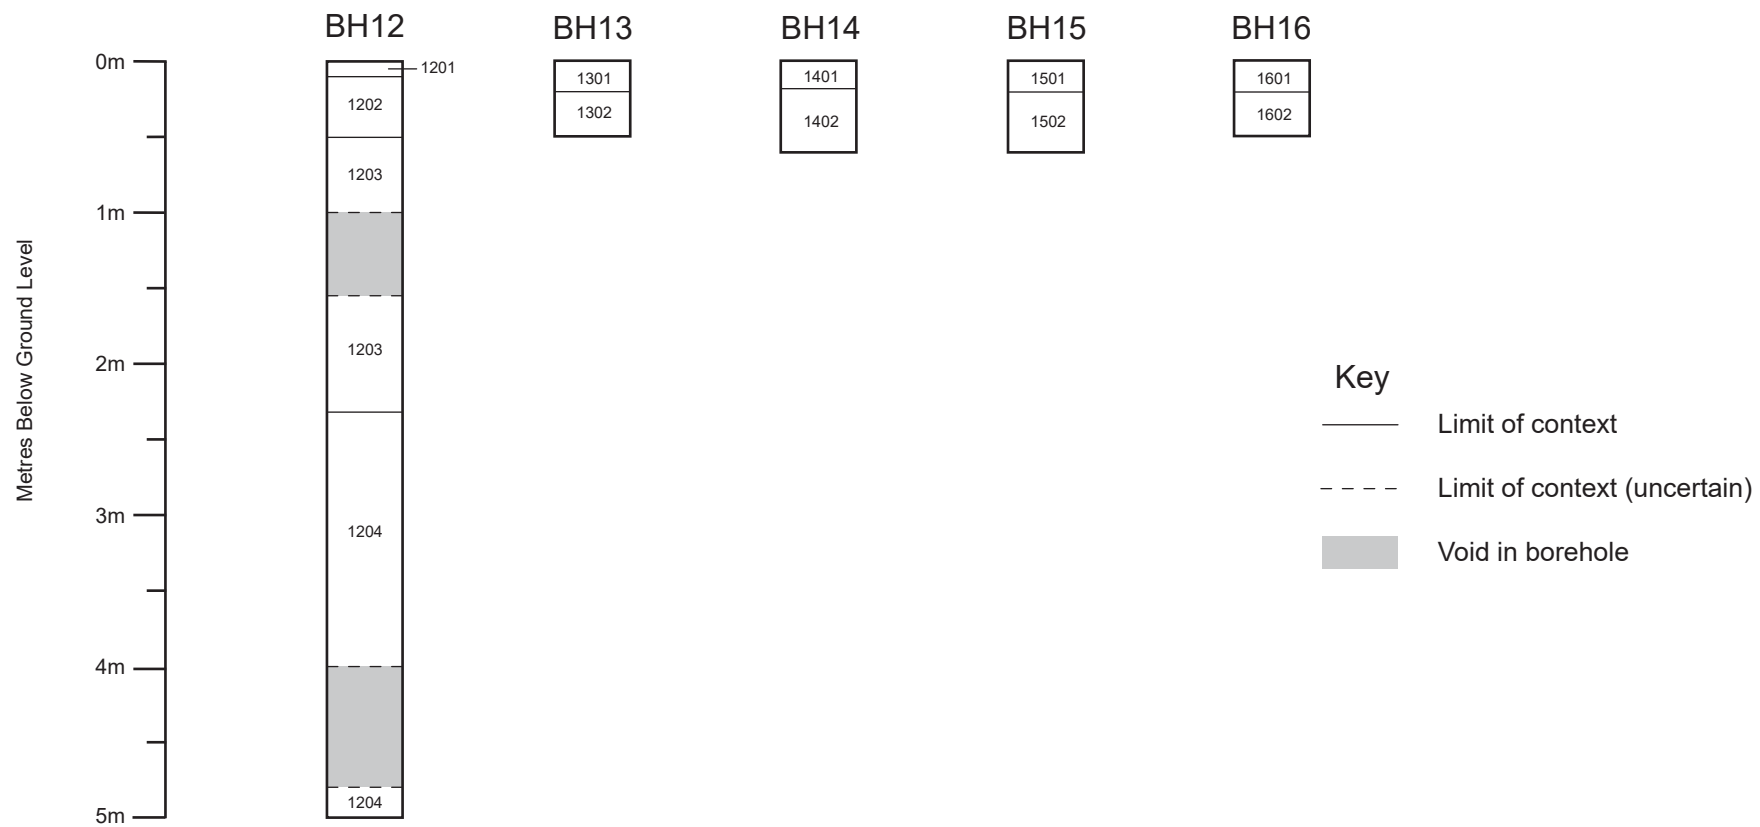
Figure 7

Borehole Profiles BH's 12-16

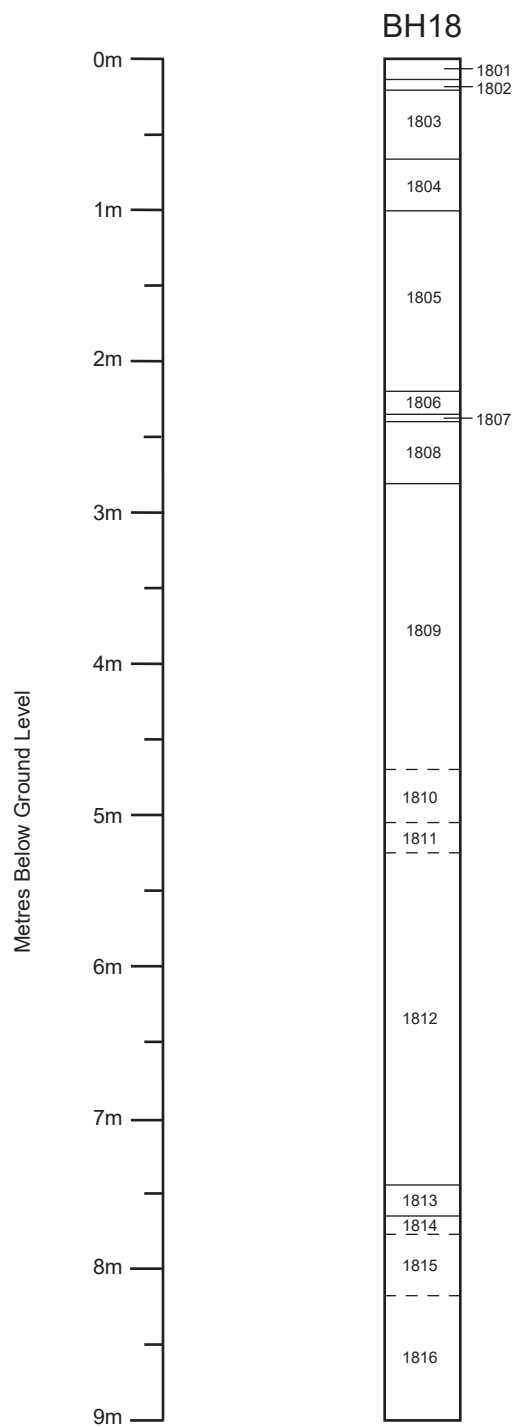
Figure 8

Borehole Profile BH18

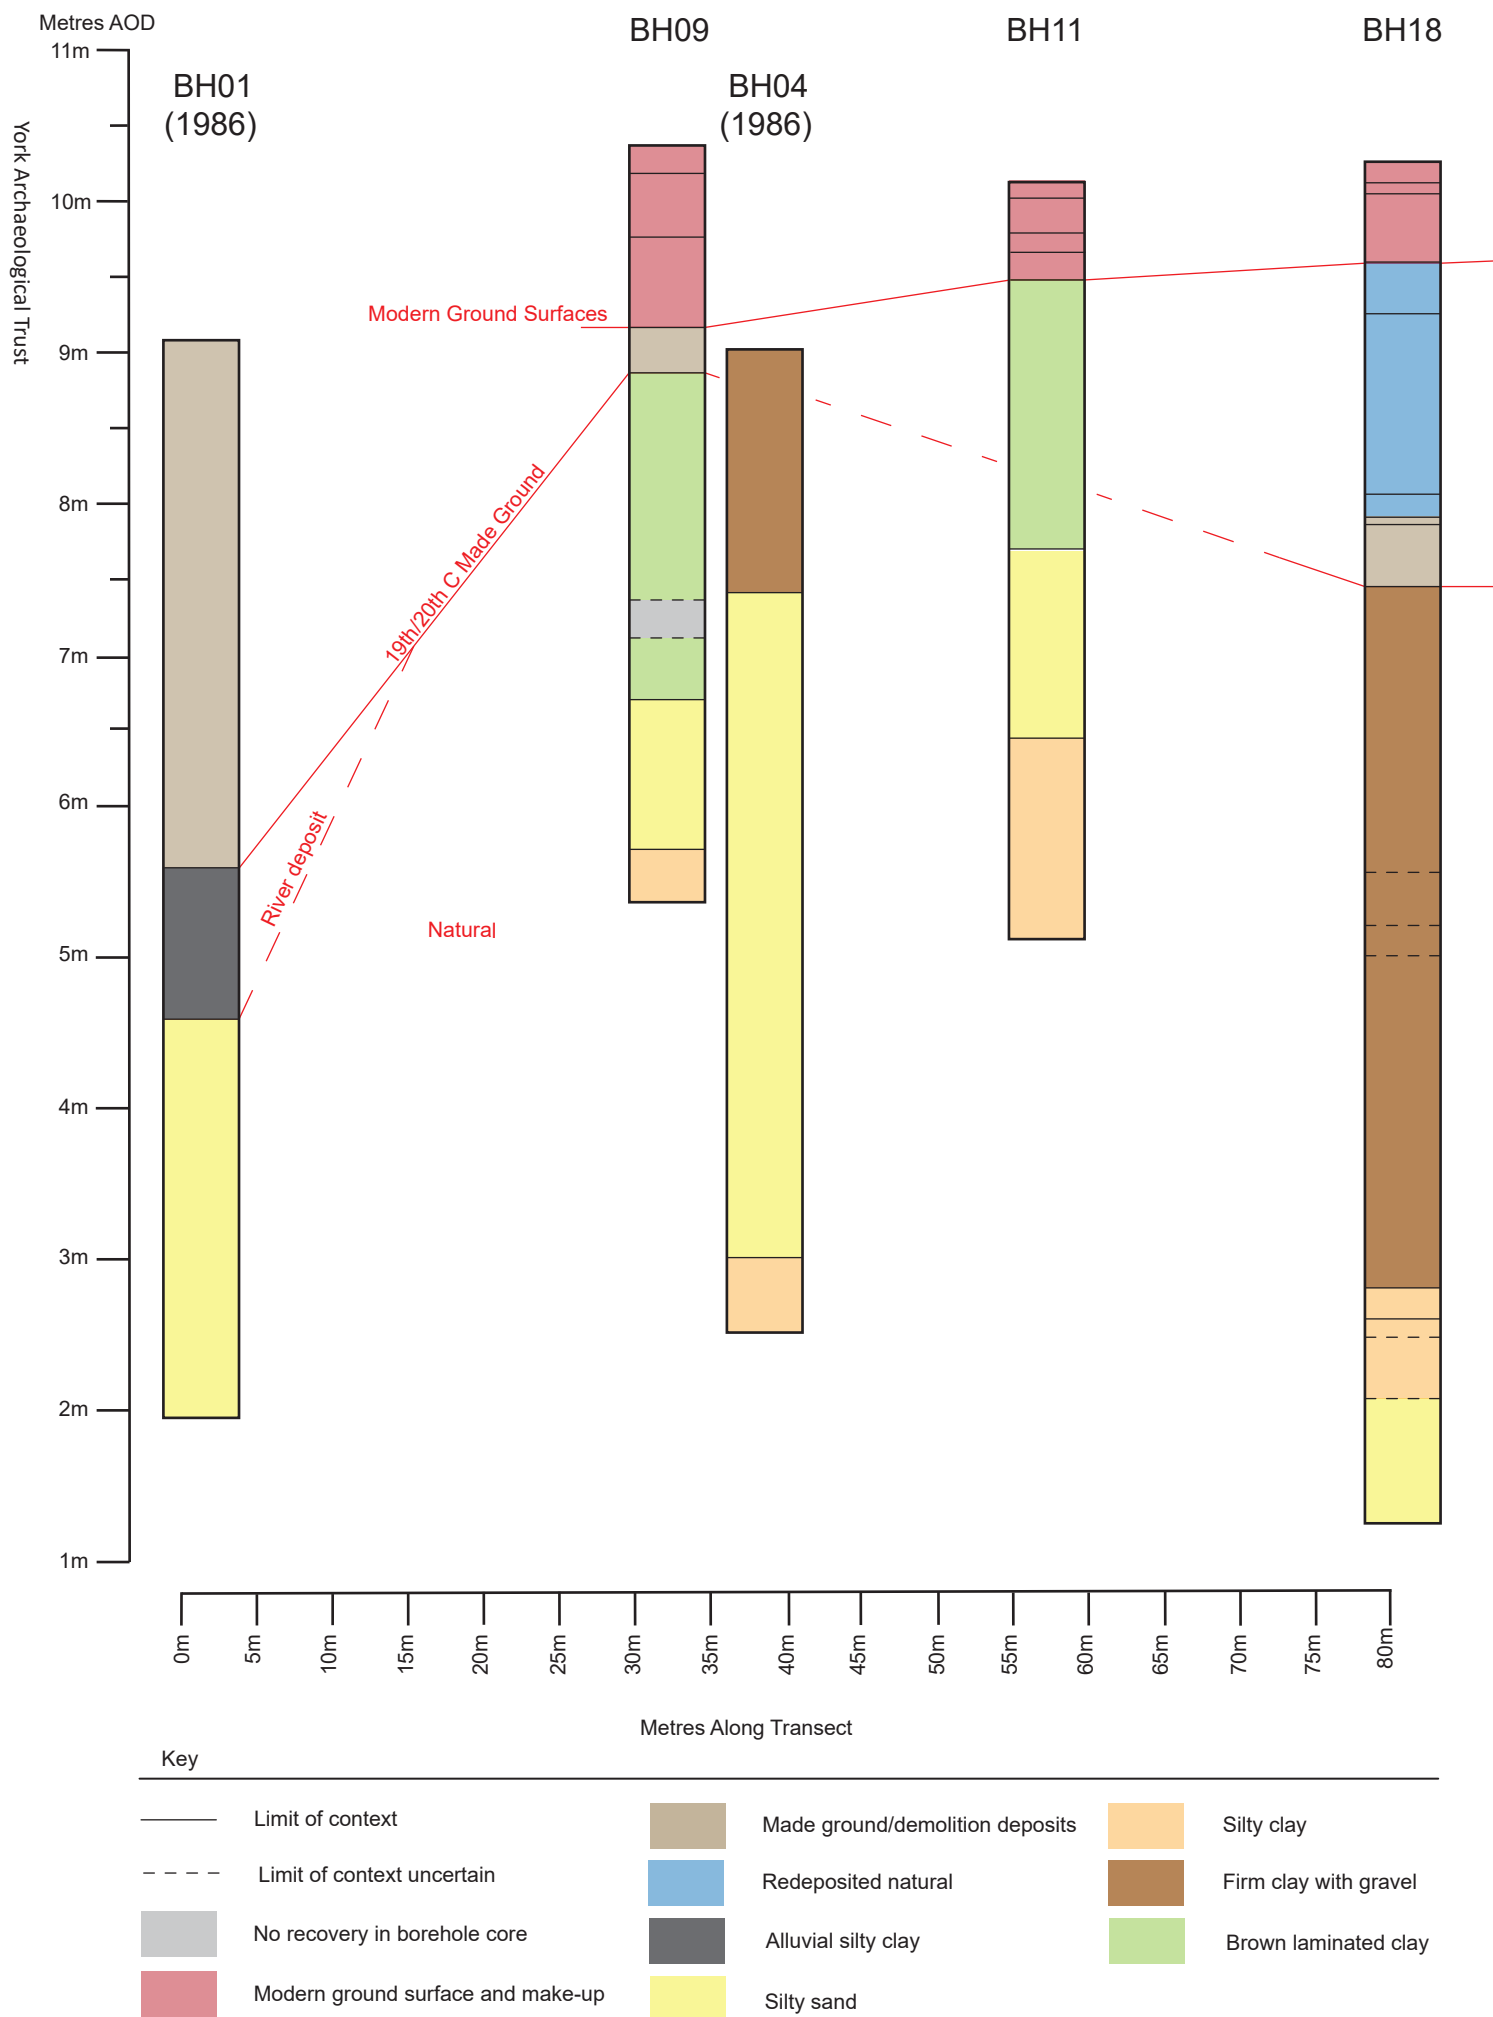
Figure 10

Transect B Deposit Model
