Desk Based Assessment and Borehole Monitoring Report for Former BHS store, 44 Coney Street/11-13 Feasegate, York

YAT Desk Based Assessment Report 2019/131 October 2019

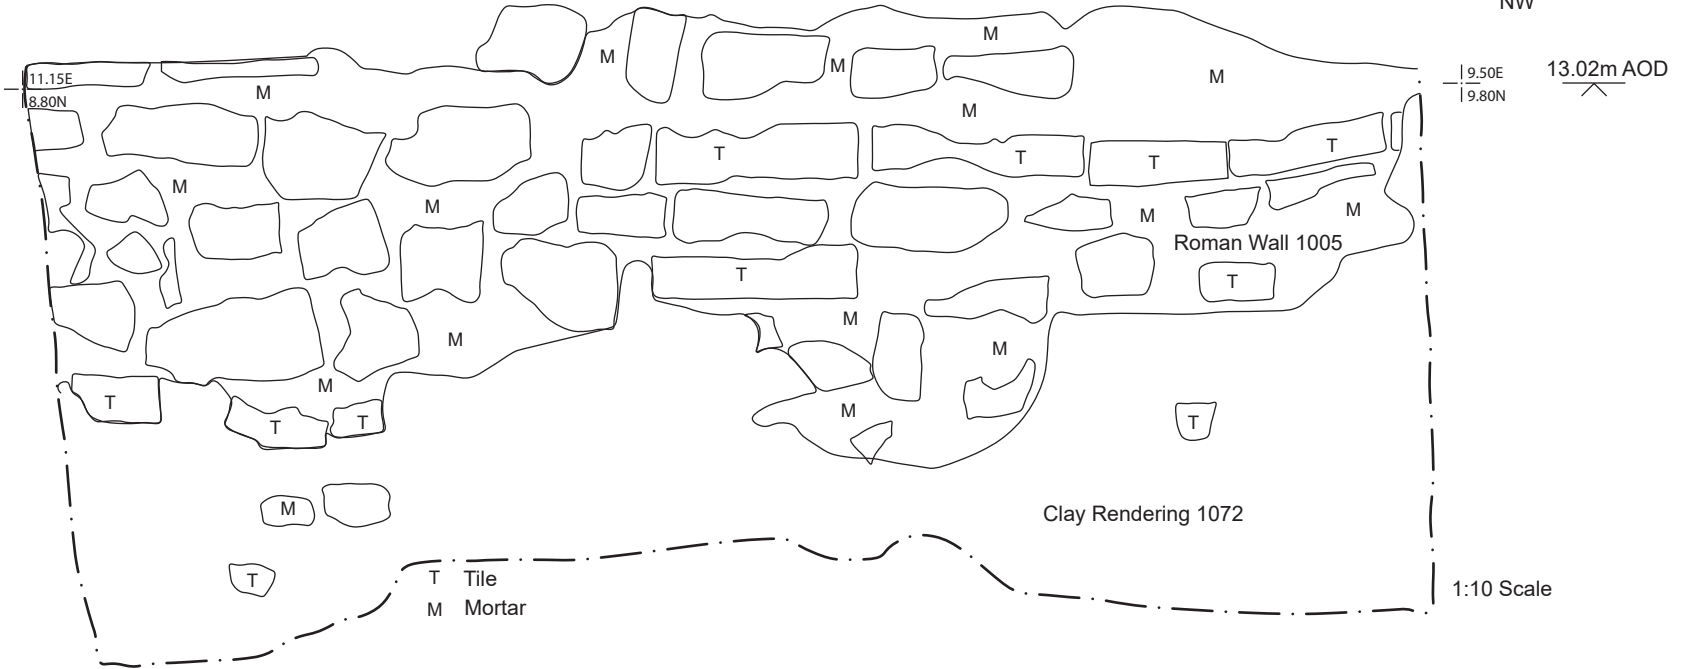
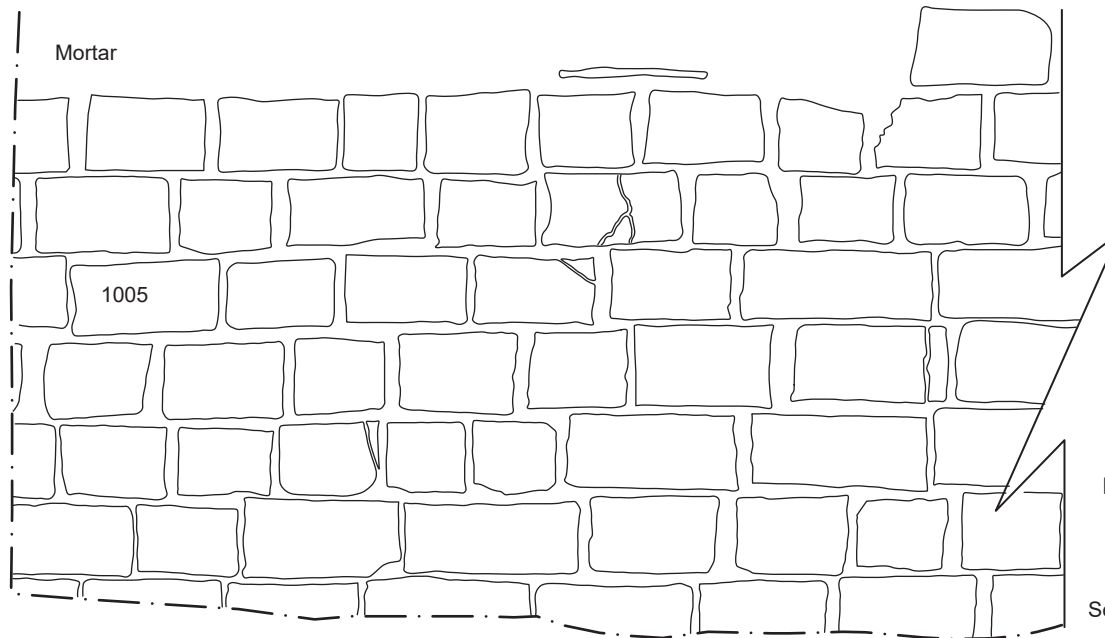
Figure 4 Section drawings of Fortress wall 1005 (YAT 1998)

SW Facing Elevation of Wall 1005

Note all stone is Limestone

8.3 1998 BHS, Feasegate (HER Map No. 10; Figures 4 and 5)

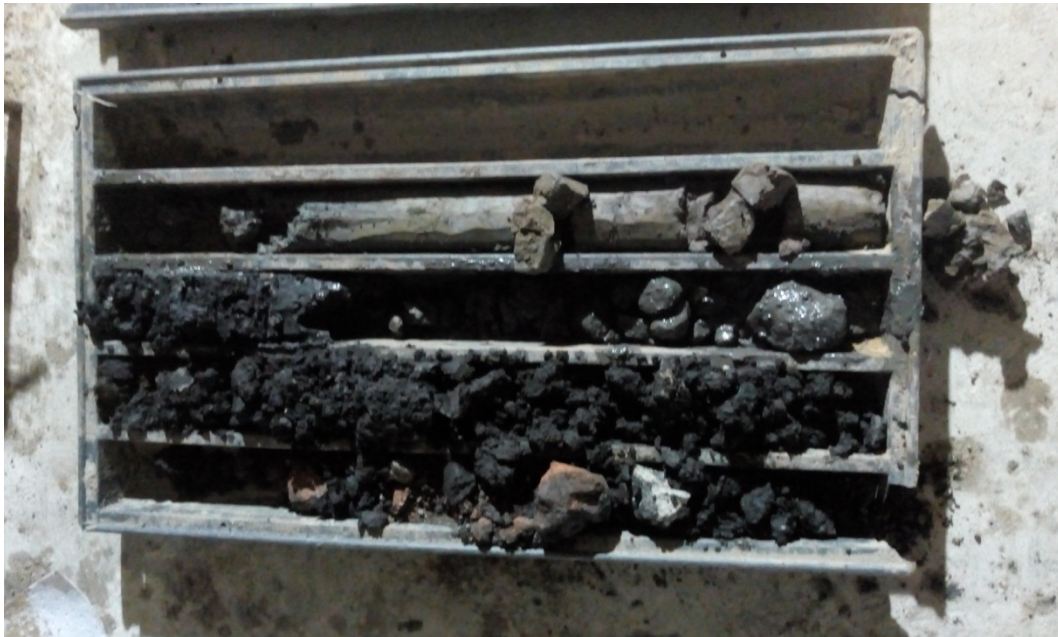
Plate 1 Borehole 1 (l-r, bottom to top) cores 0m to 4m

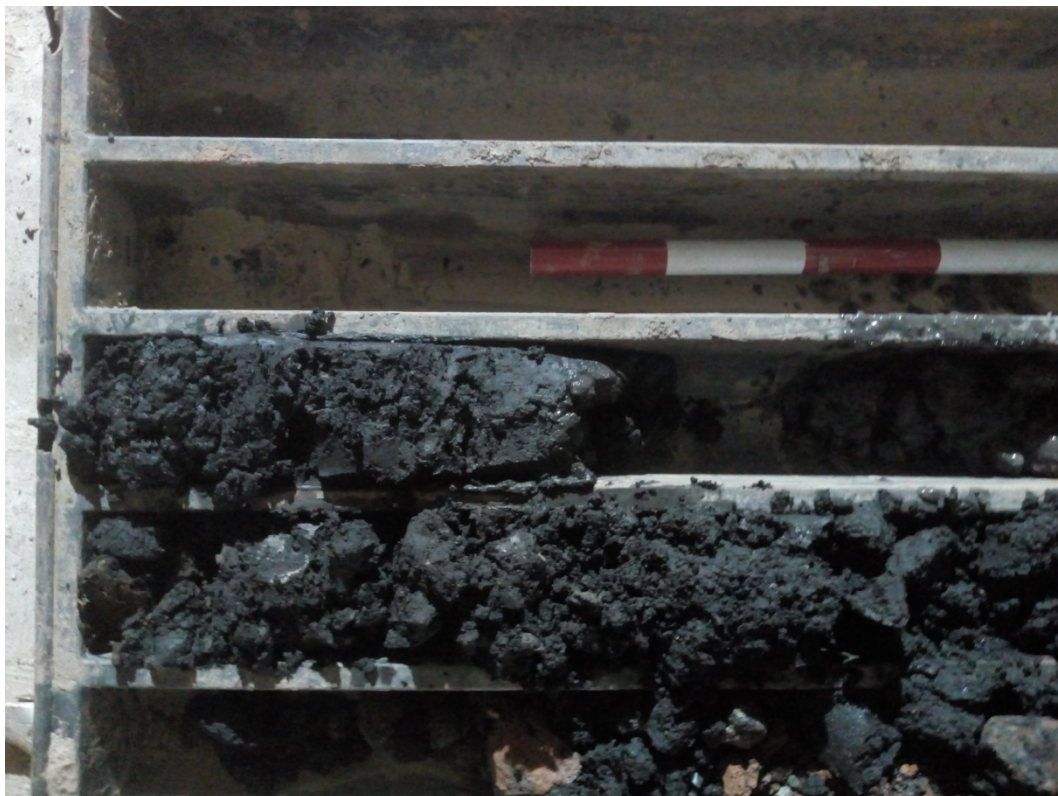
Plate 2 Borehole 1 Organic rich silty clays

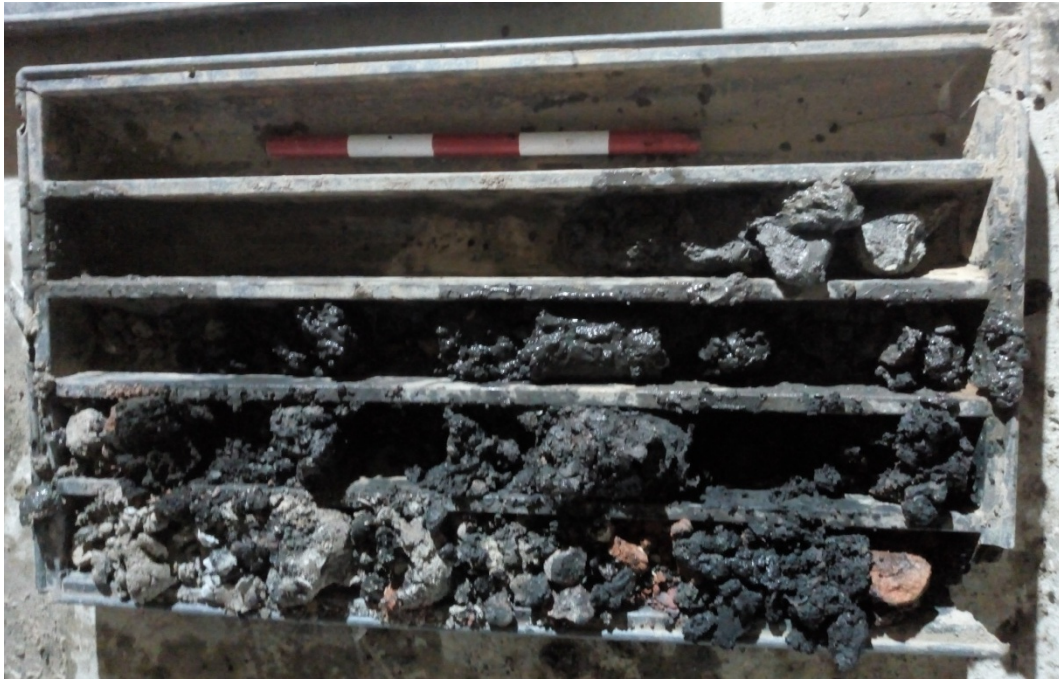
Plate 3 Borehole 2 (l-r, bottom to top) cores 0m-4m

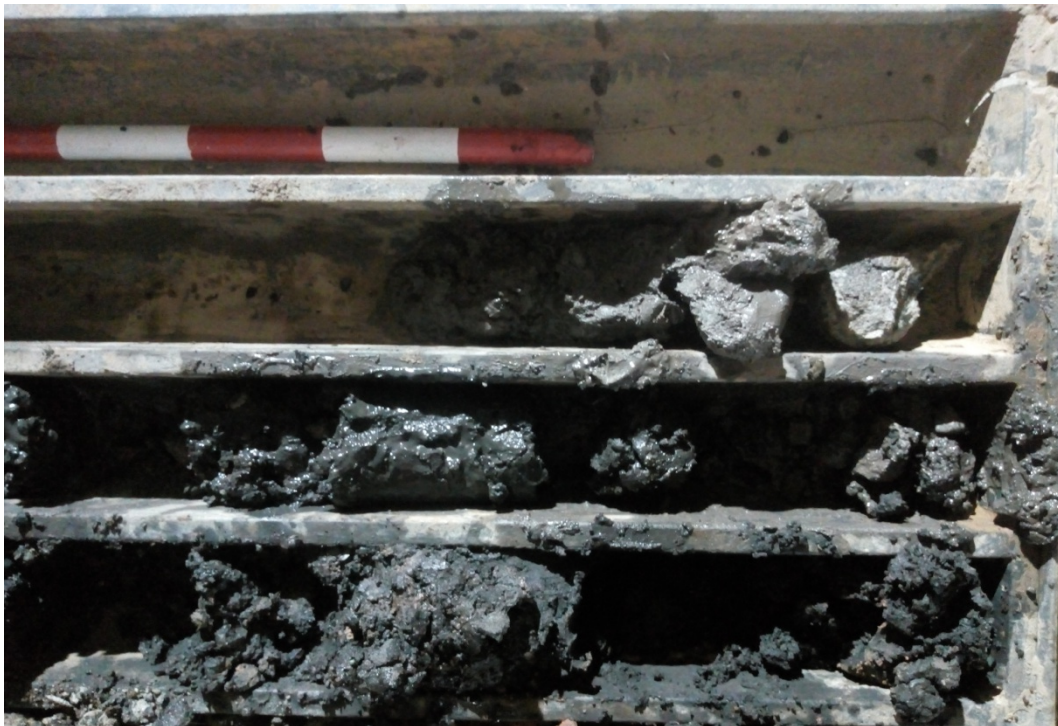
Plate 4 Borehole 2 possible Roman cobbled road (top right) and organic clays (bottom)

Across all boreholes this level represents a possible Roman road, as loose pebbles and cobbles set in a wet, soft silty grey clay and mortar, were present between 9.69m-11.04m AOD. The lack of the compaction you would normally expect with a Roman road may be due to the fact that the water level seems to have settled at this depth, thus loosening and softening the surrounding clay and mortar.

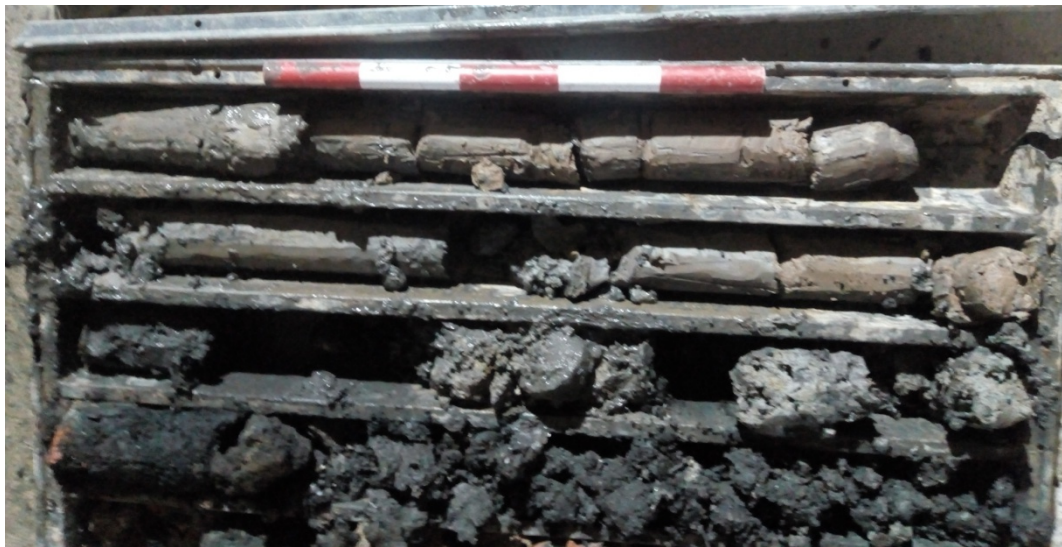
Plate 5 Borehole 3 (l-r, bottom to top) cores 1m-5m

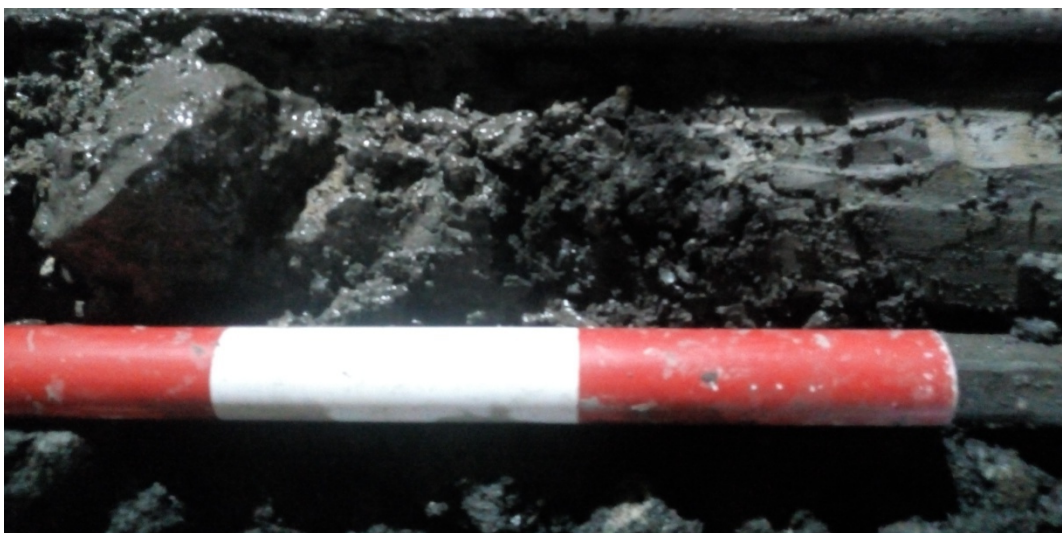
Plate 6 Borehole 3 organic deposit beneath cobbled road

In Borehole 3 an organic rich layer containing small fragments of wood was present at 10.79m AOD, between the Roman road deposit above and the green grey silty clay below. No finds were recovered from these deposits; however, the layer of cobbles match the description of the cobbled surface found during the works in the 1950's.
