Building Recording at 77-79 Micklegate, York

YAT Building Report 2019/136 September 2019

On the 12th September 2019 a programme of Building Recording was undertaken by York Archaeological Trust at 77- 79 Micklegate, York, YO1 6LJ (SE 59900 51600).

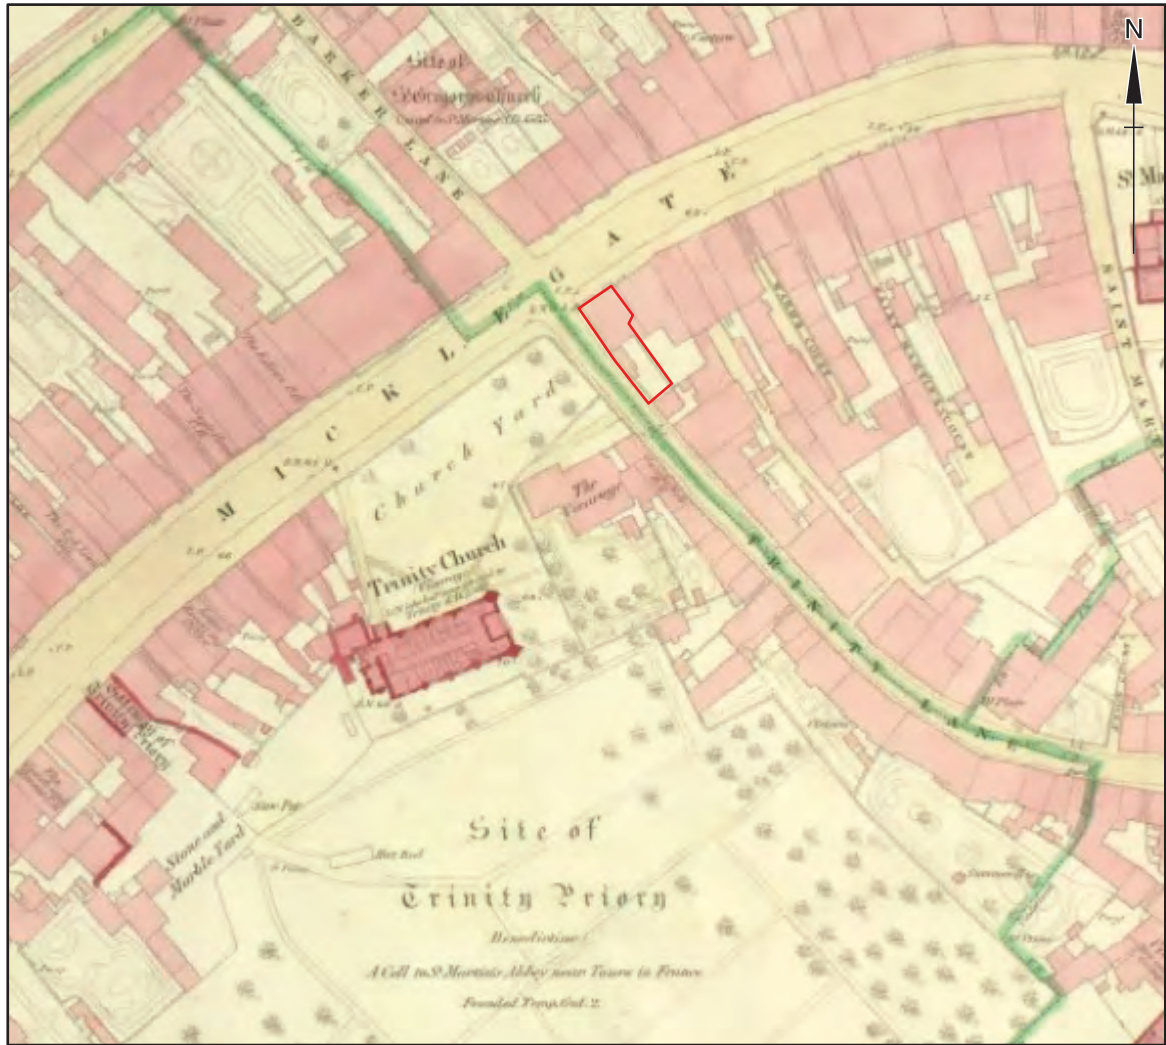
Figure 4. Map with site location outlined in red.
(York OS 1852)

Baine's 1822 Town Plan is the first major survey that features 77-79 Micklegate (Figure 3). The plan illustrates the original rectangular building with a small number of out buildings to the rear. Both the 1852 and 1892 OS Maps illustrate a small rectangular building to the rear which is potentially the rear ground floor addition (Figure 4 and 5). The 1892 plan also shows the extension attached to a further structure at the end of the plot; in the 1907 OS Map there is a space between the extension and rear building (possibly what is now an open-front garage) (Figure 6). The 1907 map is also the first clear illustration of the current extent of the property.

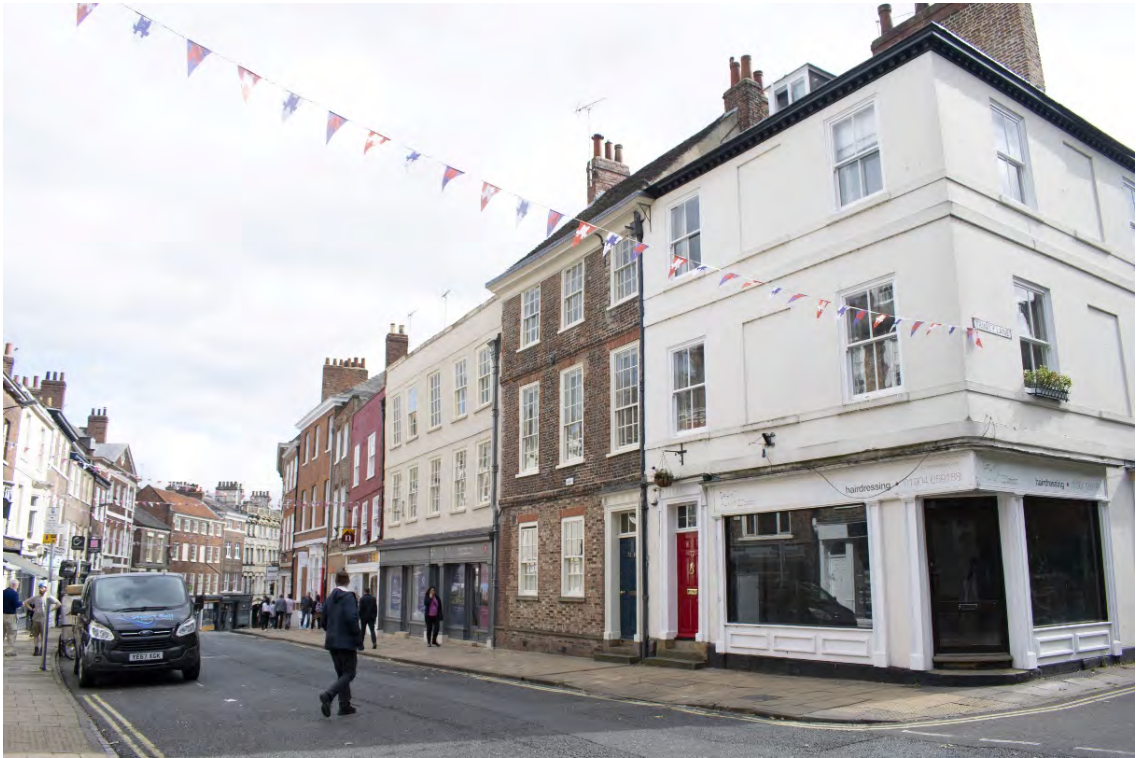
The property fronts onto Micklegate to the northwest and Trinity Lane to the southwest. Its location on the corner of Micklegate and Trinity Lane is a prominent location on a street with a high historical significance (Plate 1). Micklegate is a major thoroughfare into the city with views of the property from the north and south of the street. The architecture of Micklegate is characterised by 18th and 19th century three-storey terraces in the Georgian style. The property also sits opposite the Holy Trinity Church precinct with a 15th century church hall.

Plate 1 The property with views down Micklegate, looking southeast.

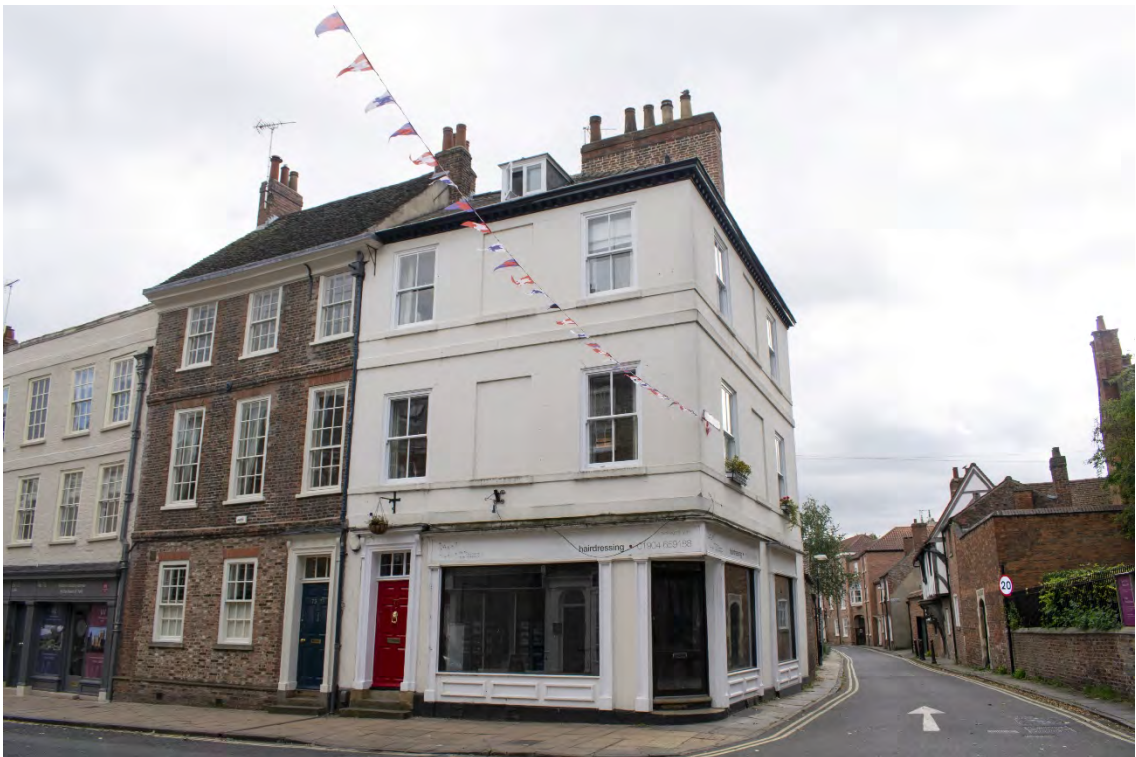
Plate 2 North facing elevation fronting onto Micklegate.

The northwest elevation fronts onto Micklegate (Plate 2). The ground floor consists of two bays. The first bay features a recessed doorway accessed by stone steps and threshold. The doorway is comprised of narrow pilasters with a triglyph frieze and a moulded cornice hood supported by fluted console brackets. The second bay features a large display window which form the main component of the storefront. The window surrounds share similar features to the original doorway and are comprised of square-based pilasters with corniced panelling supporting an undecorated panelled frieze with corncing. The panel below the window features projecting rectangular moulding.

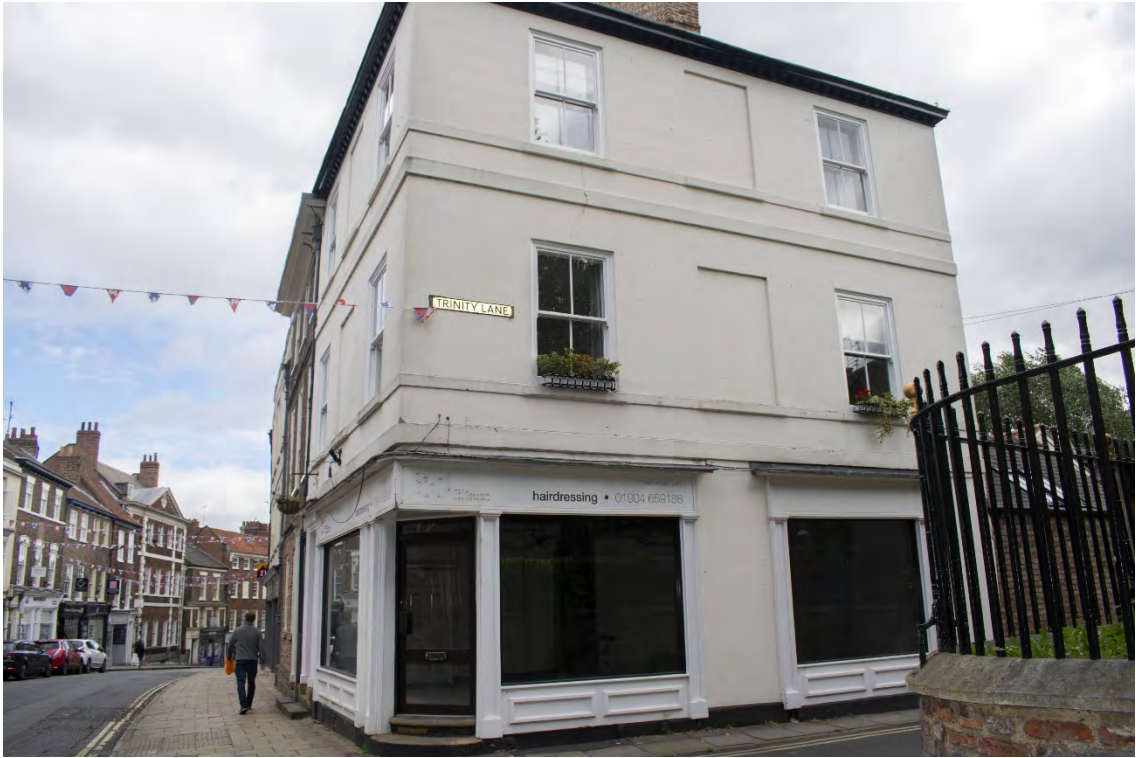
Plate 3 West facing elevation fronting on to Trinity Lane.

The retail unit is accessed by a canted corner door which has altered the rectangular shape of the ground floor by recessing the doorway (Plate 3). The original shape of the building is visible in the triangular hood that over hangs the door. The door is comprised of metal and is hinged.

It features a lower and upper panelled light. A rectangular fanlight is visible above. The door is accessed by a curved stone step and threshold.

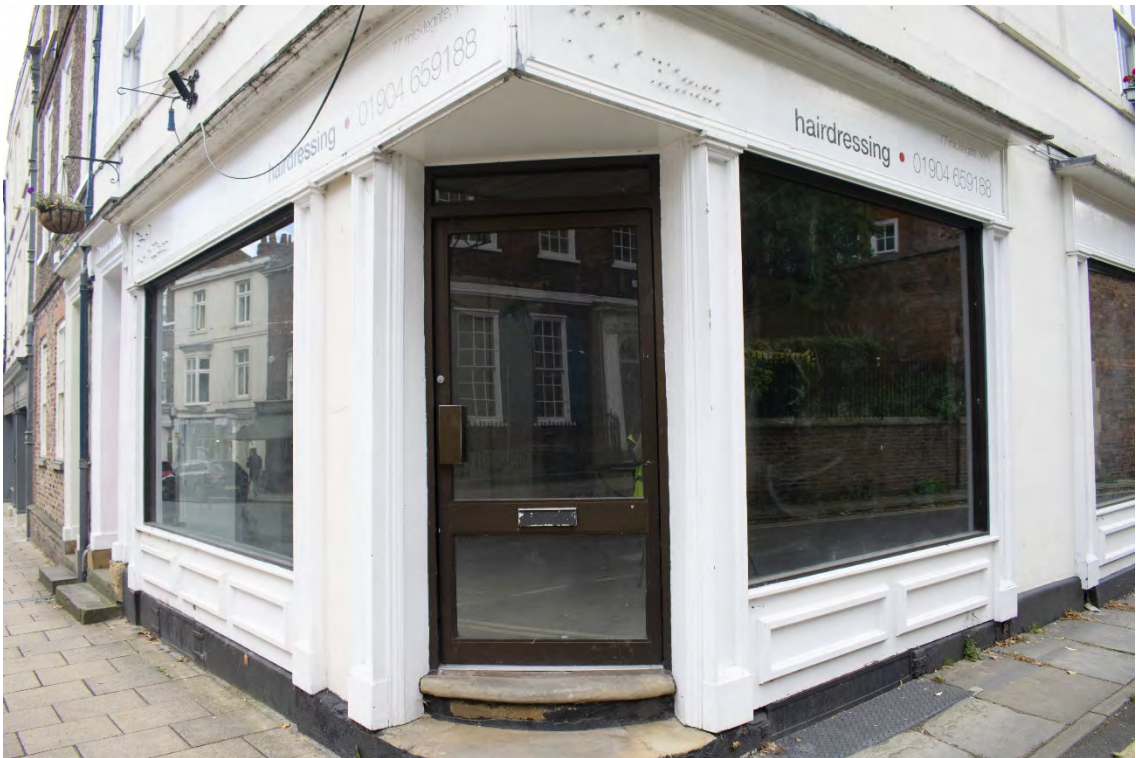
Plate 4 Canted corner door, mid-20th century addition.

The southwest elevation is nearly identical to the northwest elevation (Plate 4). The most significant difference is on the ground floor where the two bays are both occupied by storefront display windows (Plate 5). The feature and form of the fenestrations are identical to the storefront on the northwest elevation. Further to the south east the brick ground extension is visible with pitched roof and two skylights.

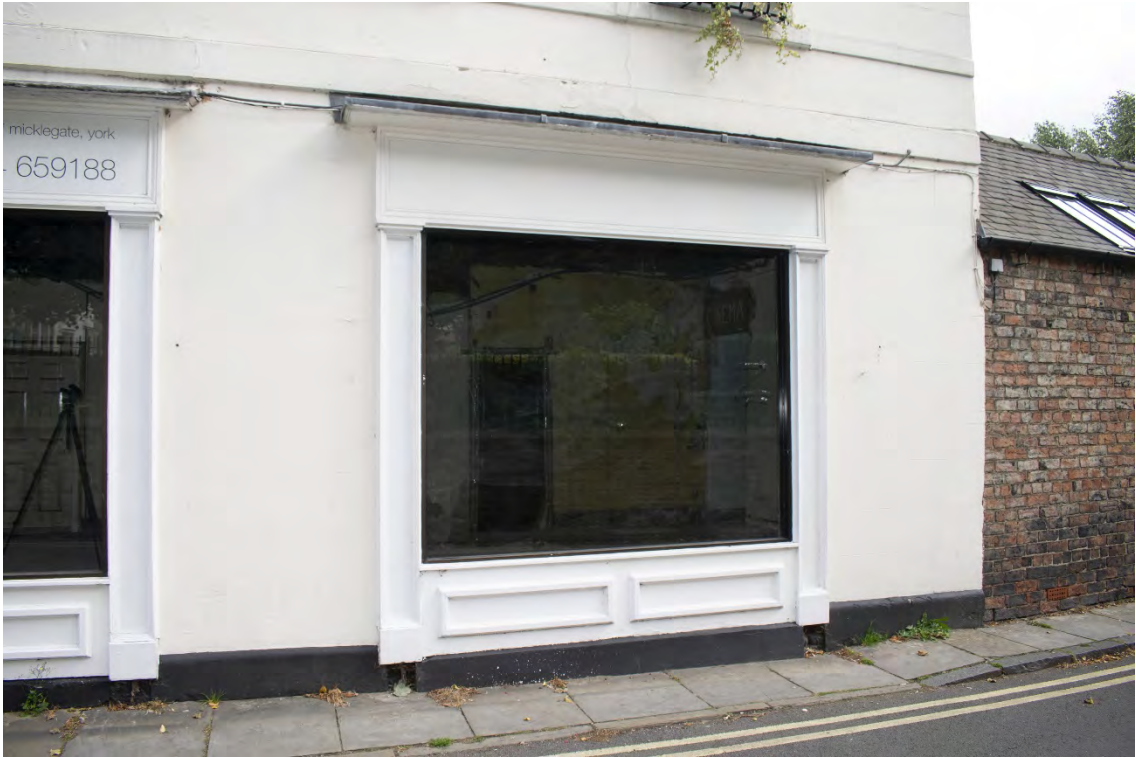
Plate 5 Example of shop frontage style on west facing elevation.

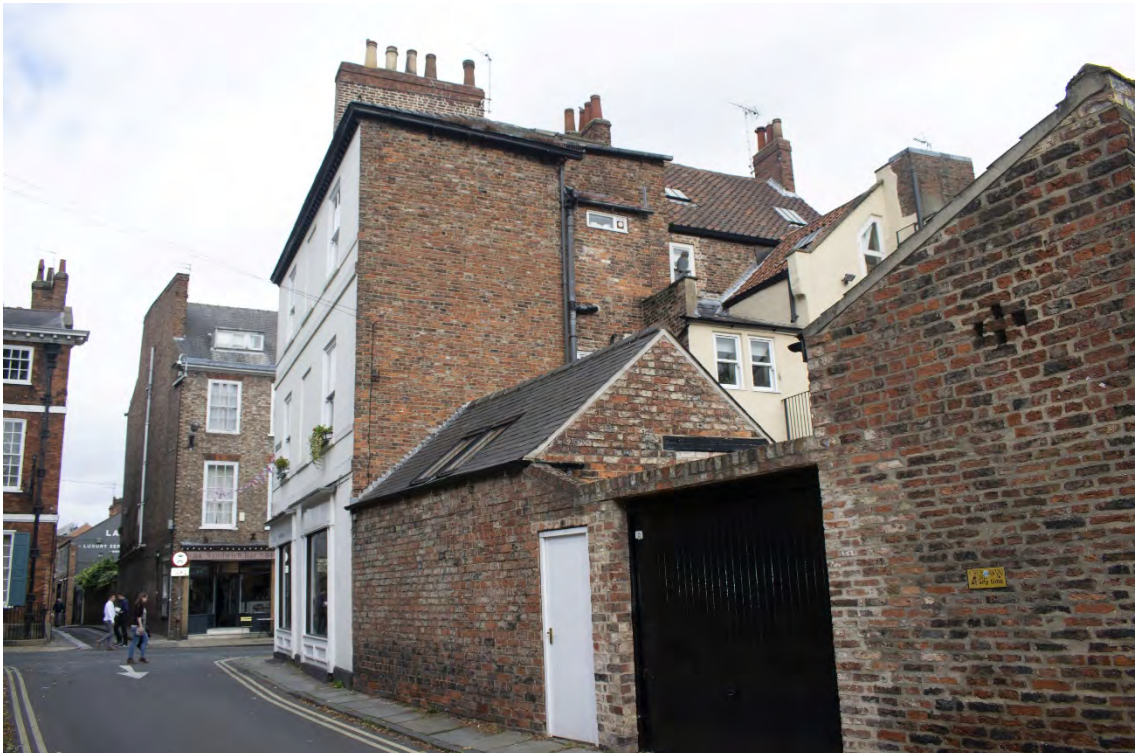
Plate 6 South facing elevation including rear elevation.

The rear elevation, facing south east, is largely absent of windows (Plate 6). A few small casement windows are visible on the upper floors but these are later additions. The rear ground floor extension features a gable end with a doorway and infilled window (Plate 7 and 8). Both the window and door feature flat cement lintels. The window sill is composed of curved corbel decorative bricks.

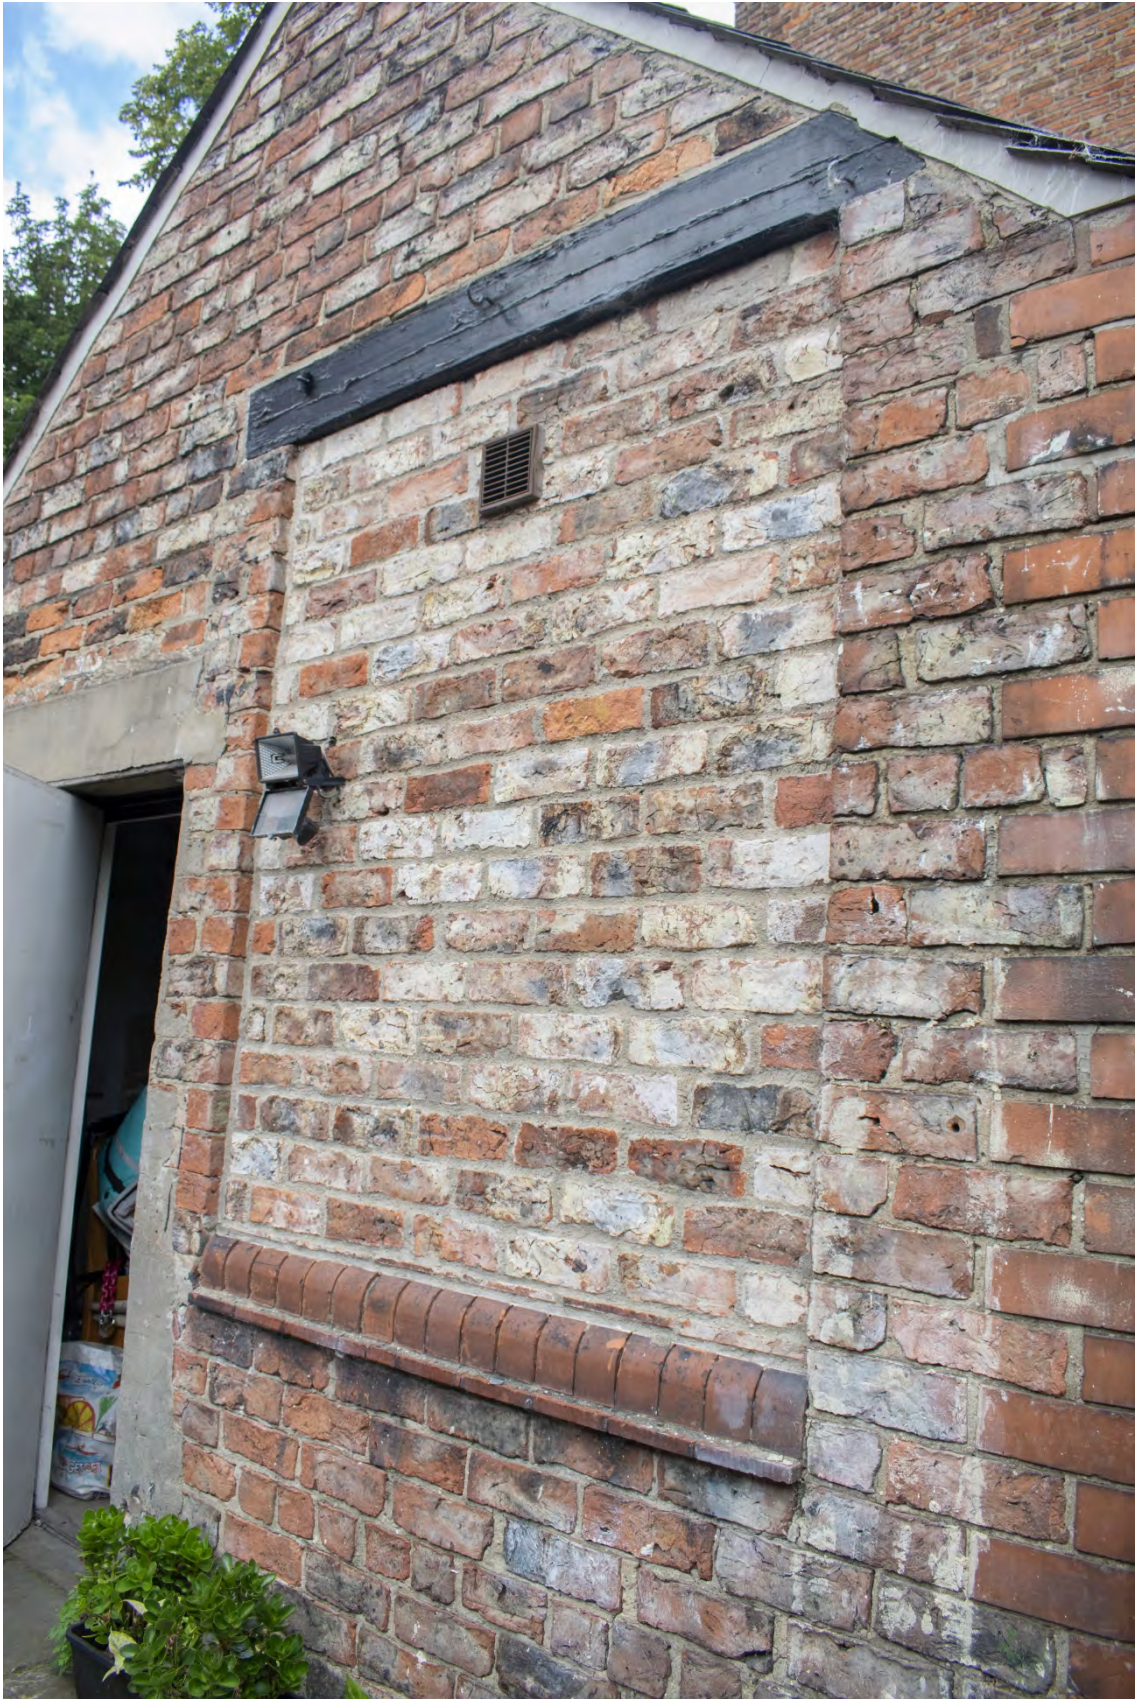
Plate 7 Infilled window in the rear extension.

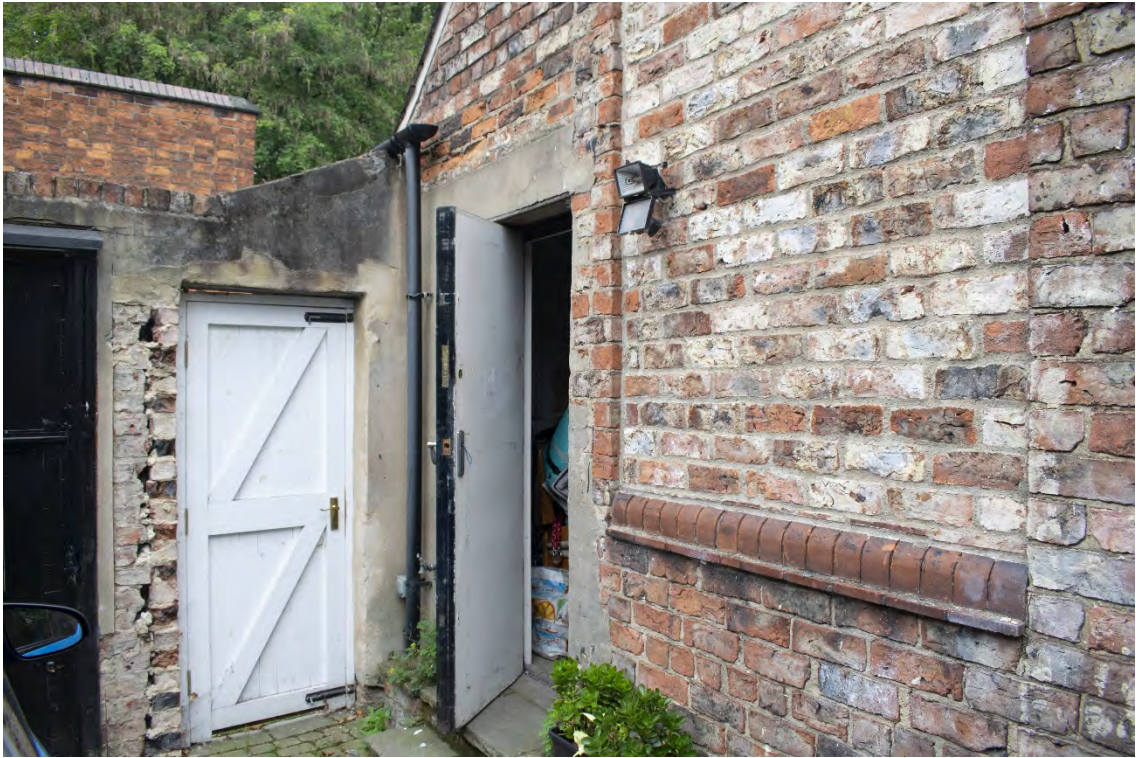
Plate 8 Rear door and infilled window with decorative brick sill.

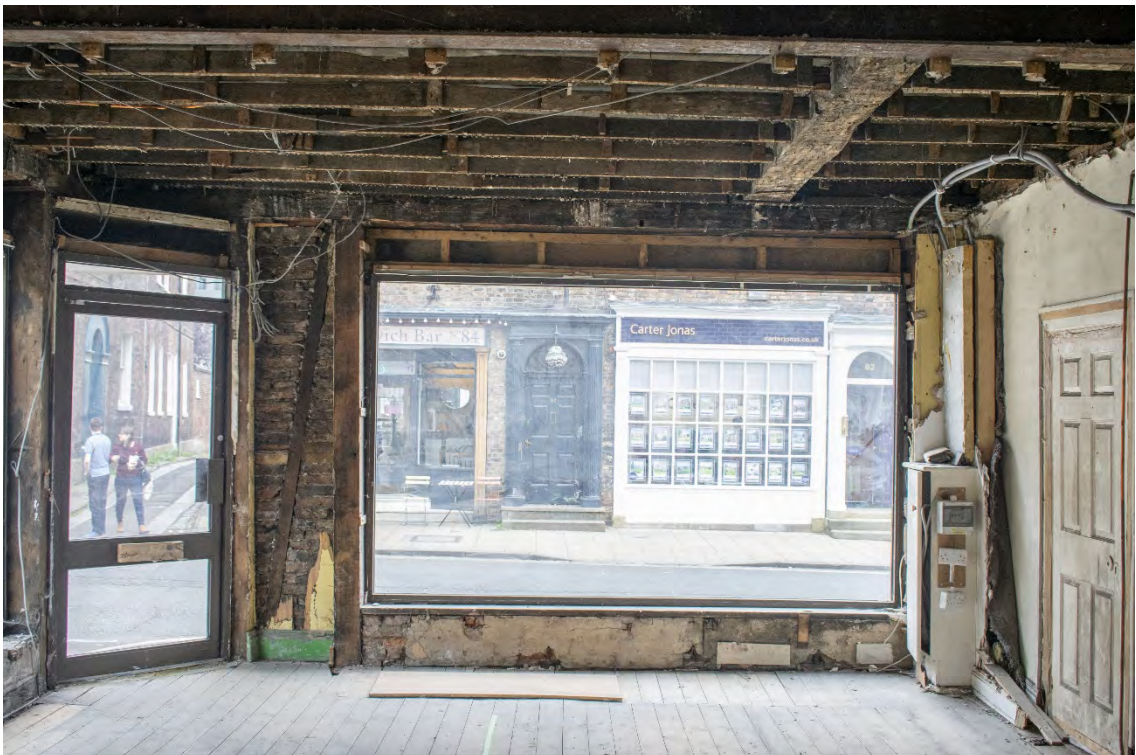
The front room has a number of original features but has been altered significantly throughout the 19th and 20th century. The north wall is dominated by the large display window (Plate 9). The window is supported by a large timber on the western side. Between the window and the original timber ceiling is an internal wooden structure consisting of a small joist and supports. The window sill consists of a thin plank of timber. Below the sill is a section of original brick with some surviving plaster.

Plate 9 North wall and interior display window.

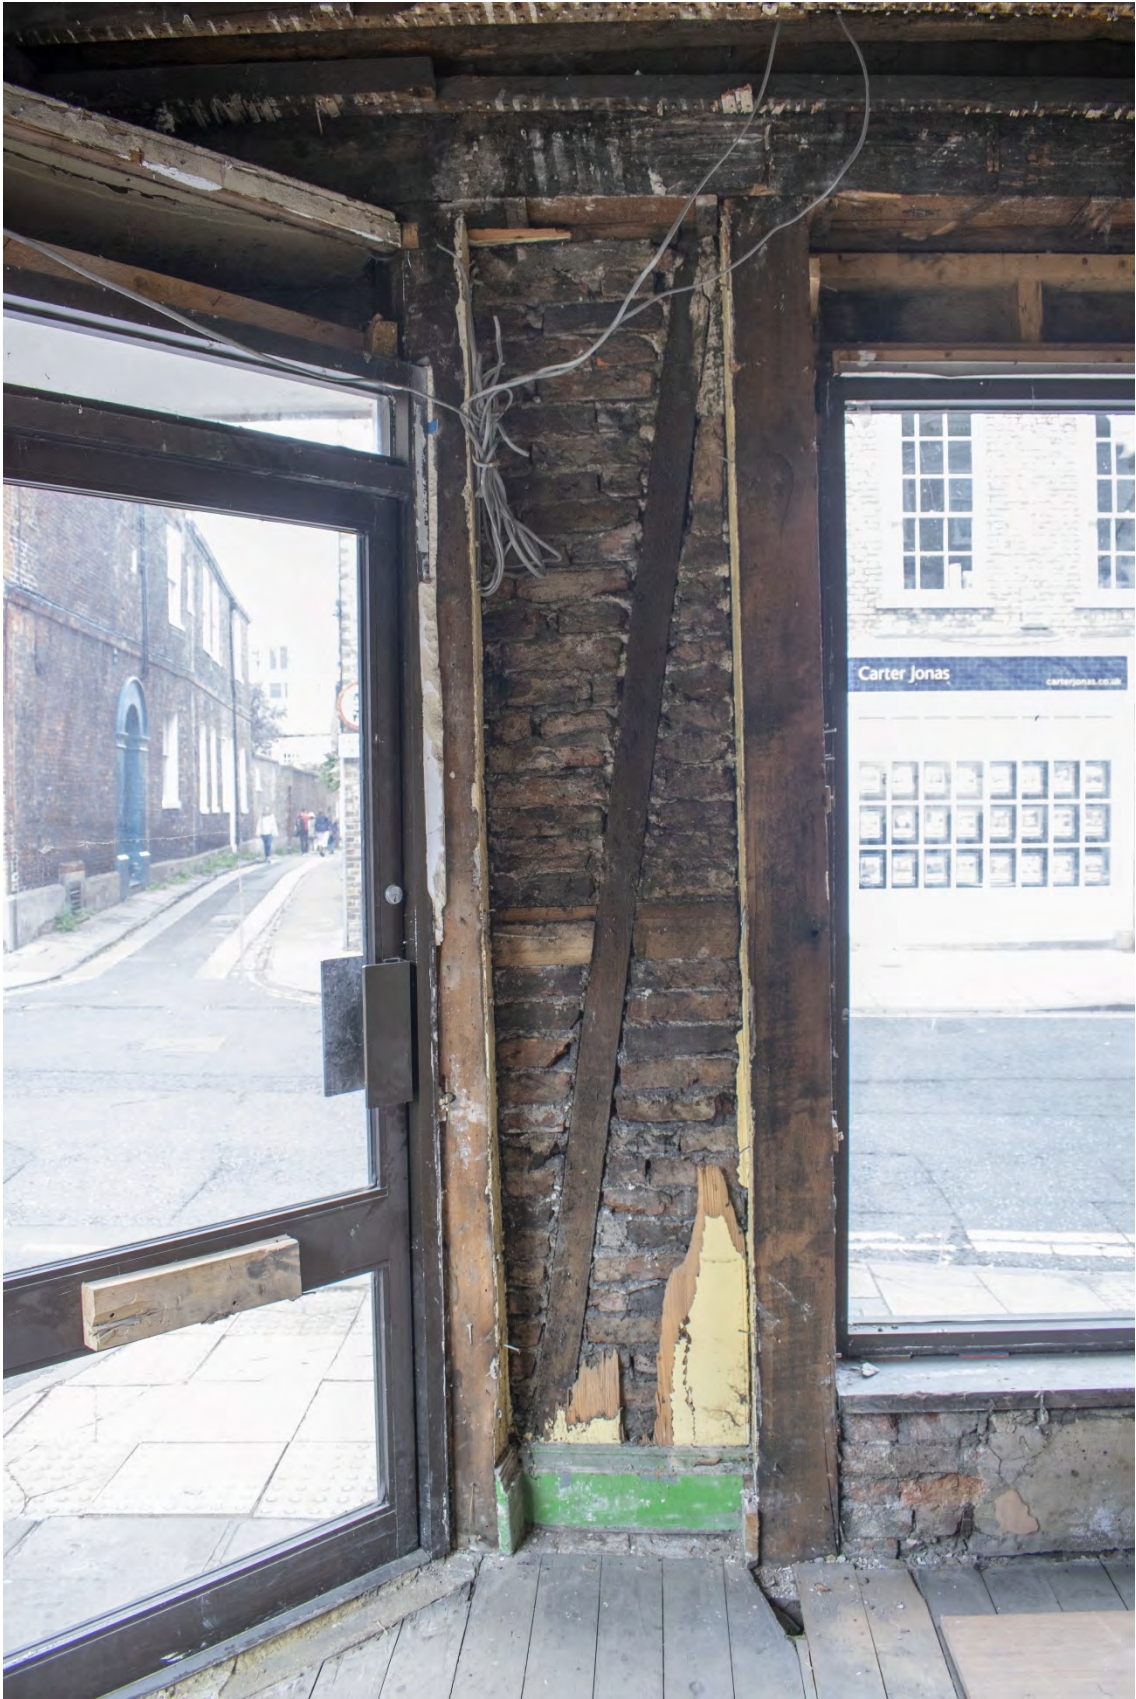
To the west of the window a small recessed area survives which exposes the original timber structure (Plate 10). This included timber posts and brace with brick infilling. At the base of the wall is a section of surviving skirting board (Plate 11). At the return of the north wall and east wall a small section of the interior lath and plaster internal wall structure remains. At the top of the north west wall is a large support beam original to the construction.

Plate 10 Recessed section of wall with exposed brick with timber brace. Original skirting detail.

A number of small sections of original skirting board have survived behind the internal retail structure. The style of the surviving skirting board is intended to be used as part of the new residential dwelling. No original cornices were encountered during the works and appear to have been removed prior to the most recent shop fitting. The door towards the rear of the front room is intended to be blocked again but will remain visible in the entrance corridor for the upper floors. The floor has been frequently altered and is suffering from subsidence in the southwest and northeast corners; works are intended to replace the floor under the supervision of an archaeological watching brief. The large display windows will be replaced with windows which match the openings in the first floor, which will improve the aesthetic appeal of the ground floor in respect to the historical 18th century character of the Micklegate area and restore the property to its original aesthetic. The location of the windows has been indicated by lintels exposed during the stripping works.

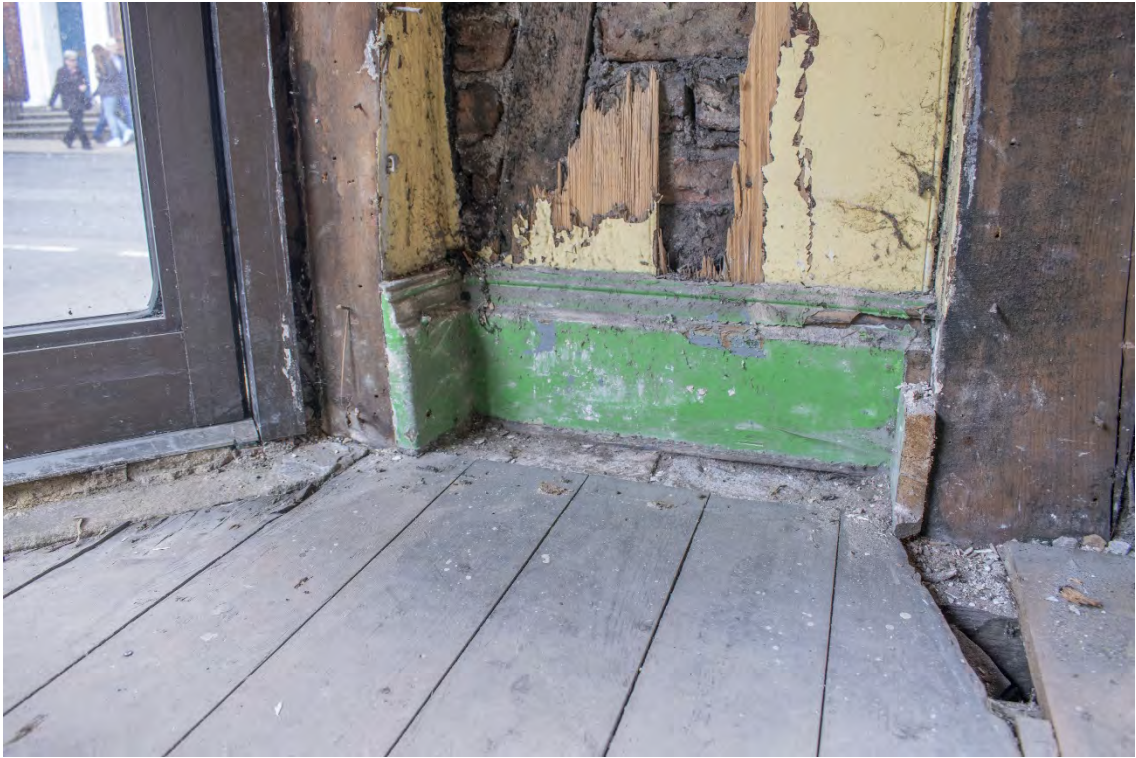
Plate 11 Original skirting detail.

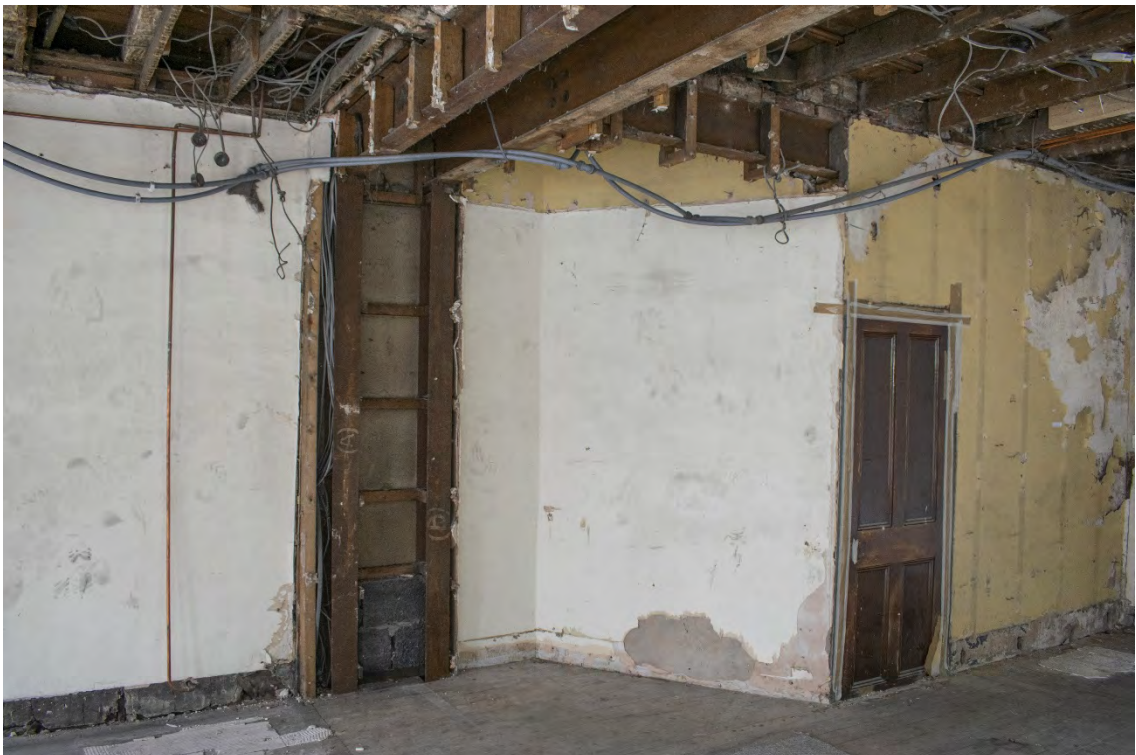
The east wall is an internal wall separating the entrance hall from the retail unit (Plate 12). The shape of the wall alters towards the centre of the room where the room narrows and is indicative of the original layout when the rear area was a separate reception room. A small cupboard is attached to the wall on the left and behind a small section of the internal retail wall survives. At the base of the wall a section of skirting board associated with the internal structure survives in front of a section of the original skirting board. There are two panelled doors in the wall, one in the wider area of the room, one in the narrower area. The first door is original to

Plate 12 East wall with steel beams and re-opened interior doorway.

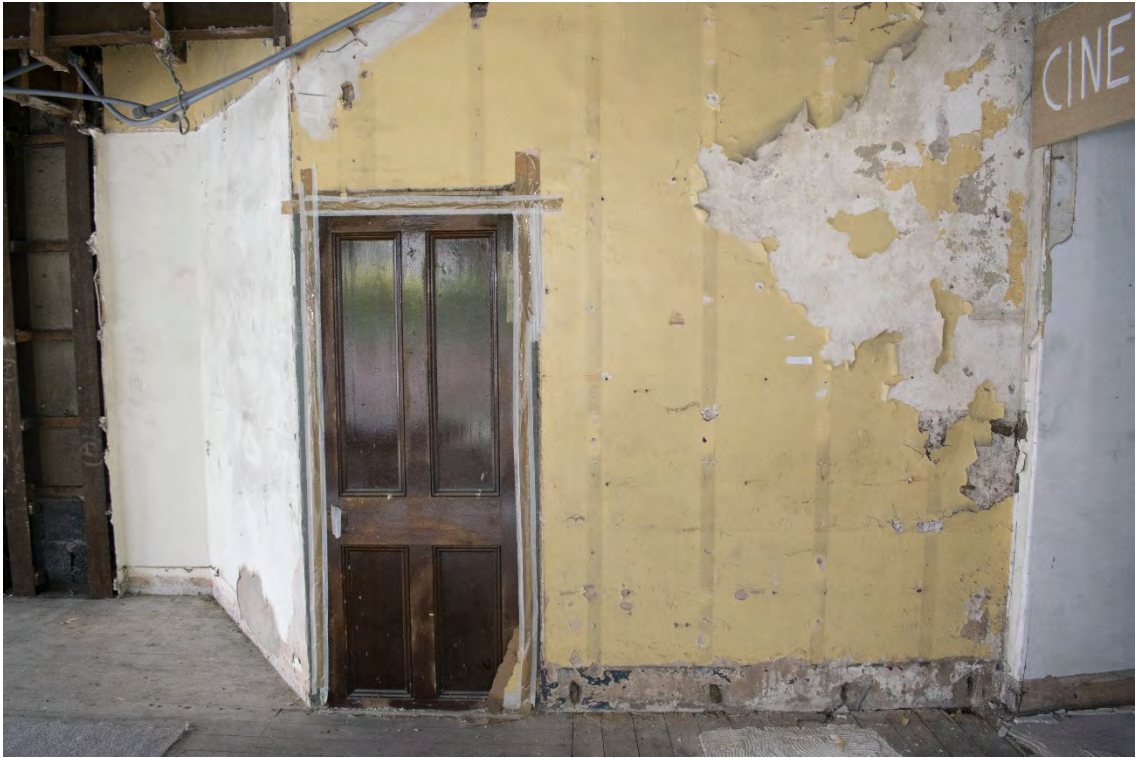
the building with a corniced door surround; the second door is simpler with a narrow door surround. The second door was encountered during the stripping of the room and had been previously infilled, likely when the two rooms were joined (Plate 13) (Heritage Statement; 2019); it has been restored to a doorway. The remains of the original skirting board height are visible as a scar in the wall paint. The centre of the wall, as with the southwest elevation, is dominated by the two vertical I-beams and steel support I-beams (Plate 14). The beams are the result of alterations that removed a central dividing wall from the ground floor. Typical 18th century dwellings feature two reception rooms on the ground floor, these have been combined into one at 77-79 Micklegate. The posts have been infilled with a small amount of breeze blocks at the base of the wall with cement mortar infilling the majority of the cavity. A further steel I-beam supports the east wall on a north/south alignment to the rear of the room (Plate 15).

Plate 13 East wall with interior doorway and skirting board scarring.

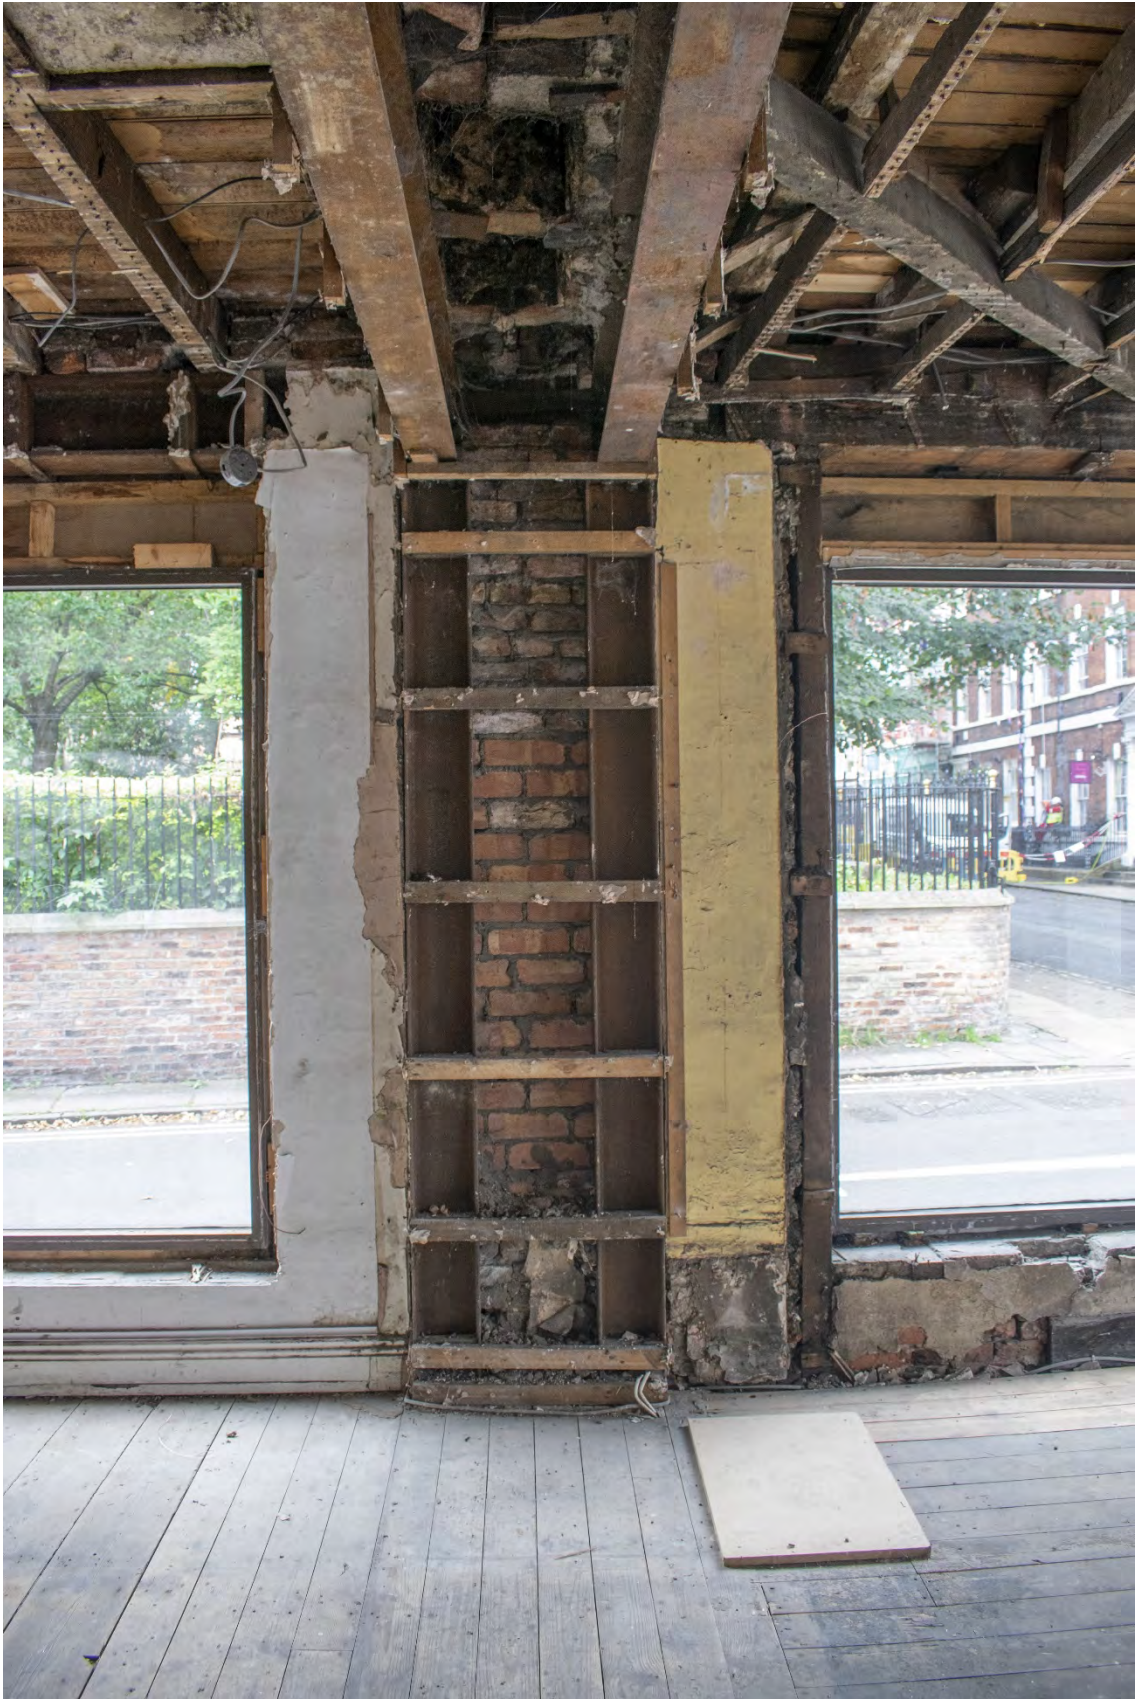
Plate 14 Structural steel beams replacing original dividing wall.

The remains of the dividing wall in the front room were exposed during the stripping of the interior which revealed it had been replaced by two large steel I-beams. Structural steel did not become common until the late 19th century at the earliest, suggesting that the removal of the dividing wall was a later alteration to the property and did not occur during the initial conversion into a shop. The design of the new residential dwelling has been altered to reflect the discovery of the original partition wall alignment and the depth of the wall is to be reflected as a built-in wardrobe in the bedroom.

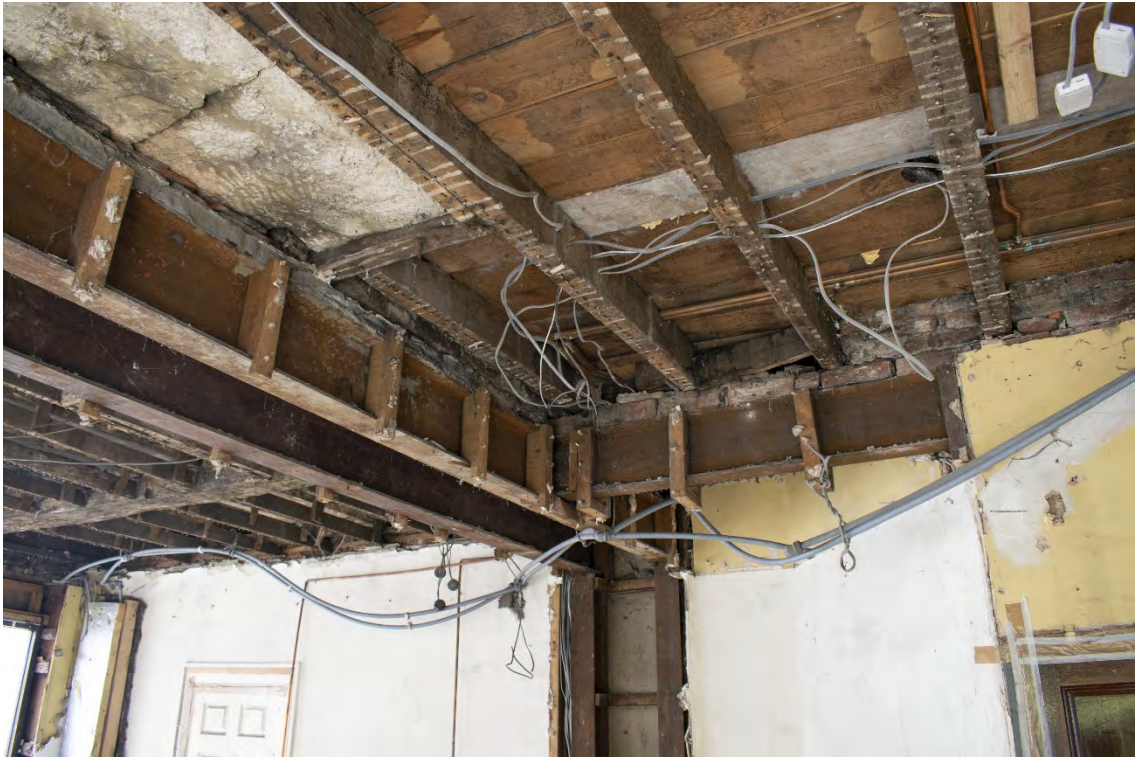
Plate 15 Structural steel beams aligned east/west and north/south.

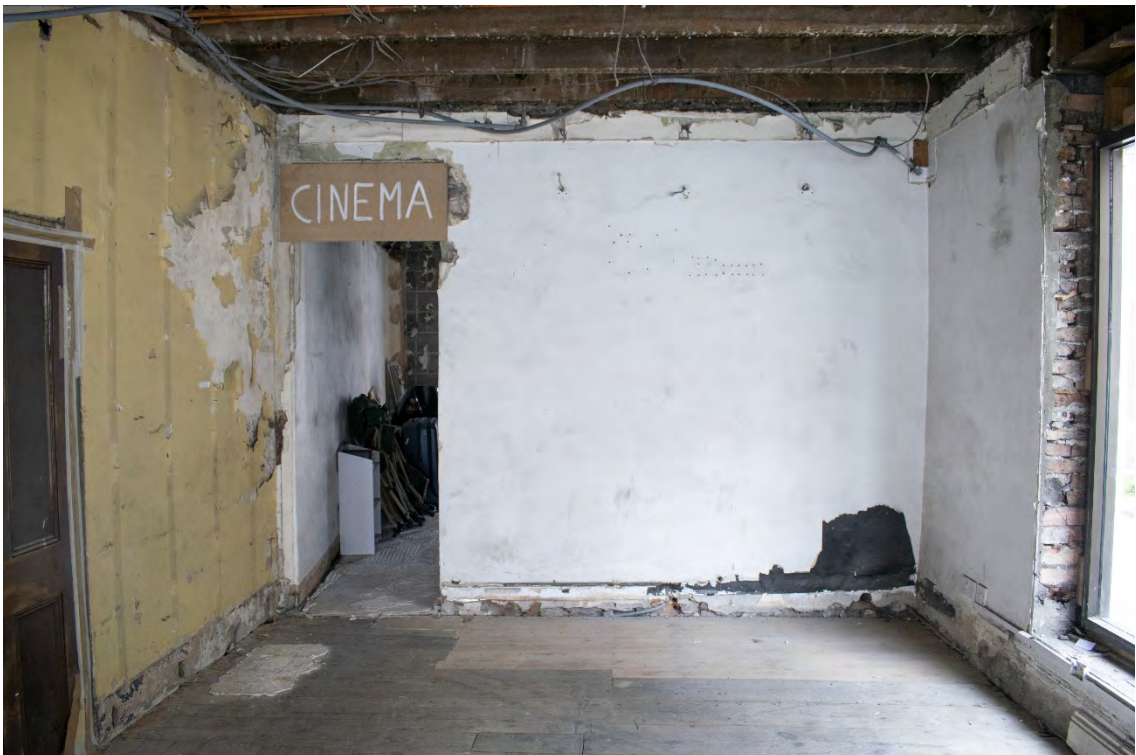
The south wall features an opening on the left which accesses the 19th century extension to the rear (Plate 16). A significant amount of subsidence in the floor is visible in the southwest corner of the room, against the south wall. New timber planks have been installed in the area but the floor has continued to drop up to 100mm in the corner (Plate 17).

Plate 16 South wall with opening to rear extension.

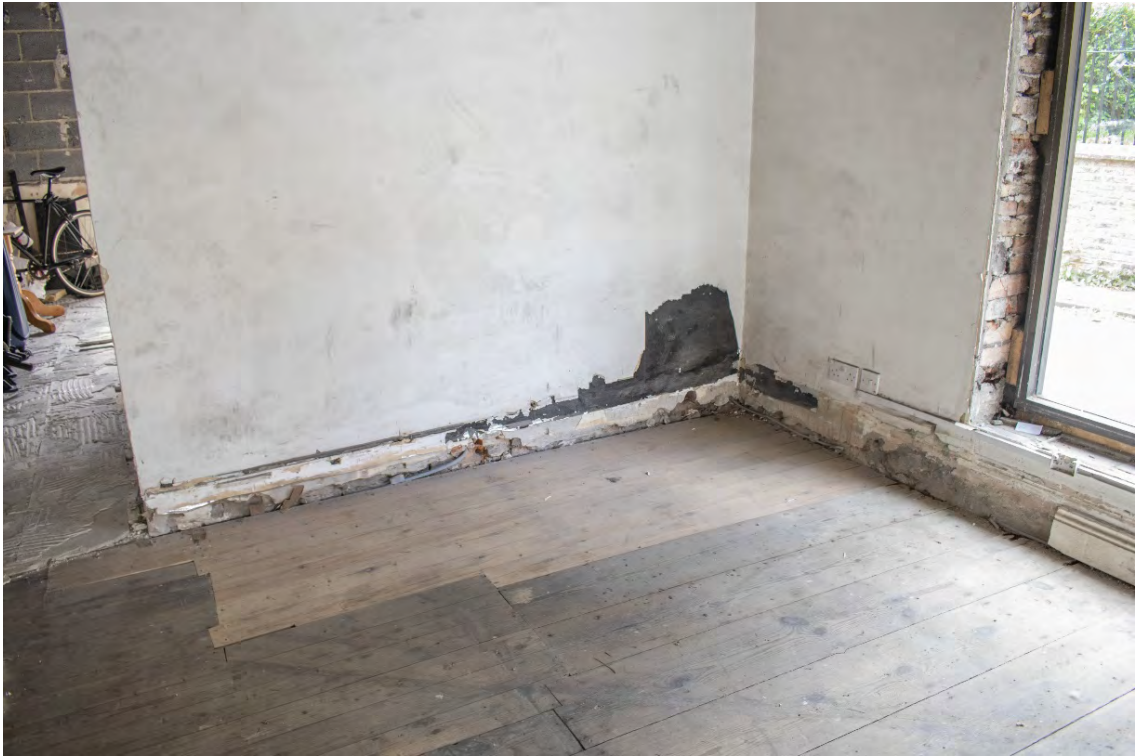
Plate 17 Floor alteration and subsidence.

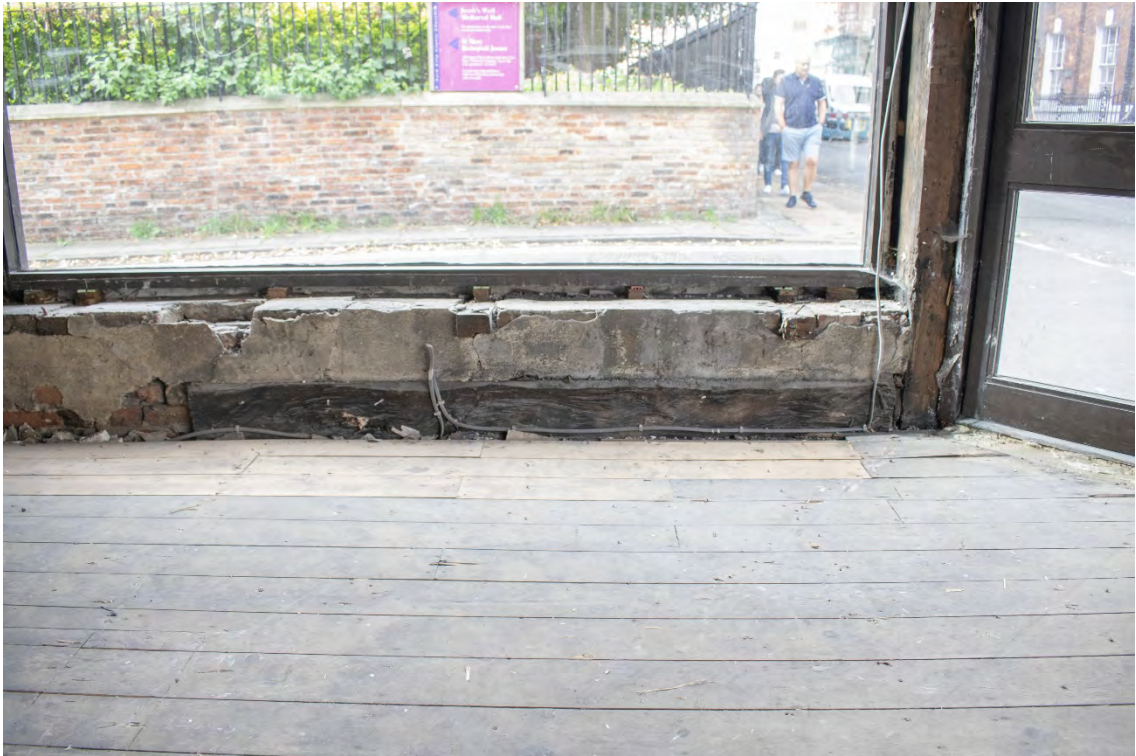
The west wall features two large display windows similar to that of the north wall and steel posts where the original dividing wall for the reception rooms has been removed (Plate 18). Between the steel posts a section of brick work has been exposed as well as rubble infill. Above the left display window, the support beam is steel not timber, reflecting an identical beam running parallel in the east wall. The structure around the right window is timber with a wooden threshold exposed at the base of the wall near the canted corner doorway (Plate 19).

Plate 19 Original timber threshold beneath display window.
