Building Recording at 77-79 Micklegate, York

YAT Building Report 2019/136 September 2019

On the 12th September 2019 a programme of Building Recording was undertaken by York Archaeological Trust at 77- 79 Micklegate, York, YO1 6LJ (SE 59900 51600).

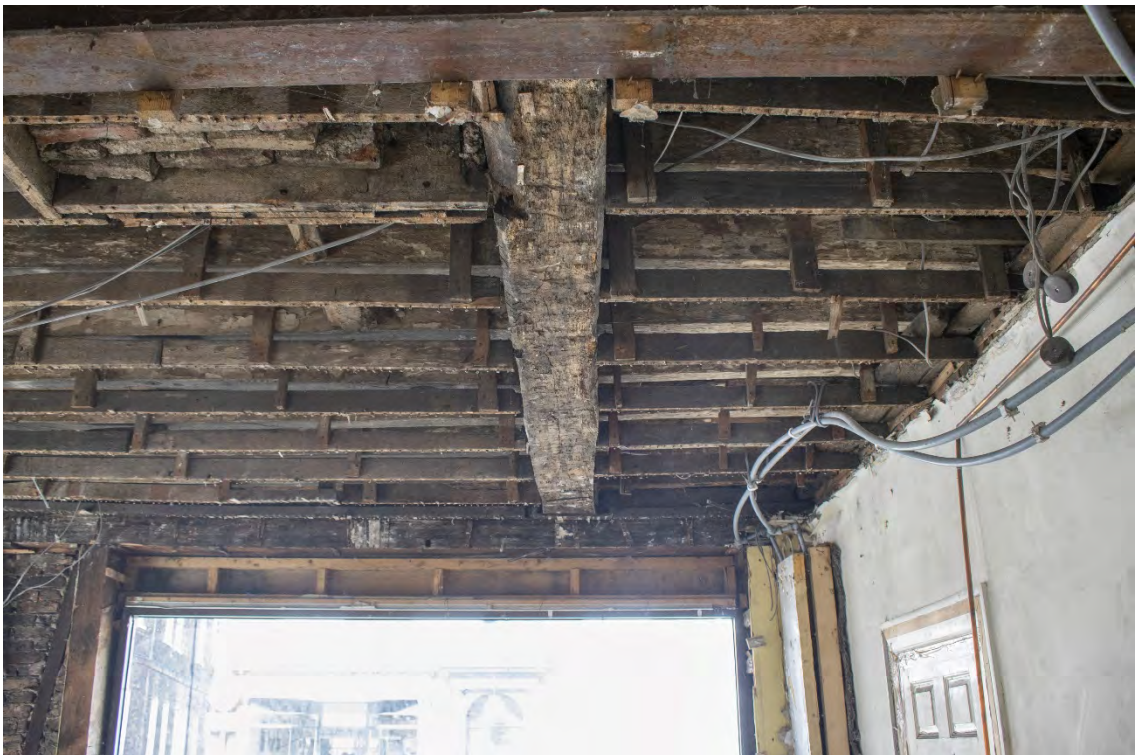
The sub-ceiling structure of the ground floor has been largely removed during the works and the timber joist floor for the upper level has been exposed (Plate 20). A large beam supports the floor above, aligned north/south and 300mm wide. The joists, aligned east/west, are 150mm wide and occur at 500mm intervals. This is shown on Figure 7, supplied by the client.

Plate 20 Original beam and joist timber floor with remains of lath-and-plaster timber sub-ceiling.

The lath-and-plaster ceiling likely dates from the conversion of the property to a shop in the early to mid-19th century. The hangers associated with the ceiling are only present in the front of the room so indicate that the partition wall between the reception rooms was still present when the ceiling was installed. There has been deterioration in the wooden hangers, particularly in the planks towards the west wall display window. In order to retain the remains of the lath-and-plaster sub-ceiling structure the client intends to create a single cavity space between the ceiling and floor above with insulation, fireproofing and the requisite services. This will ensure that the new dwelling is fireproofed and insulated while also retaining the remains of the historic lath-and-plaster ceiling structure associated with the shop conversion.

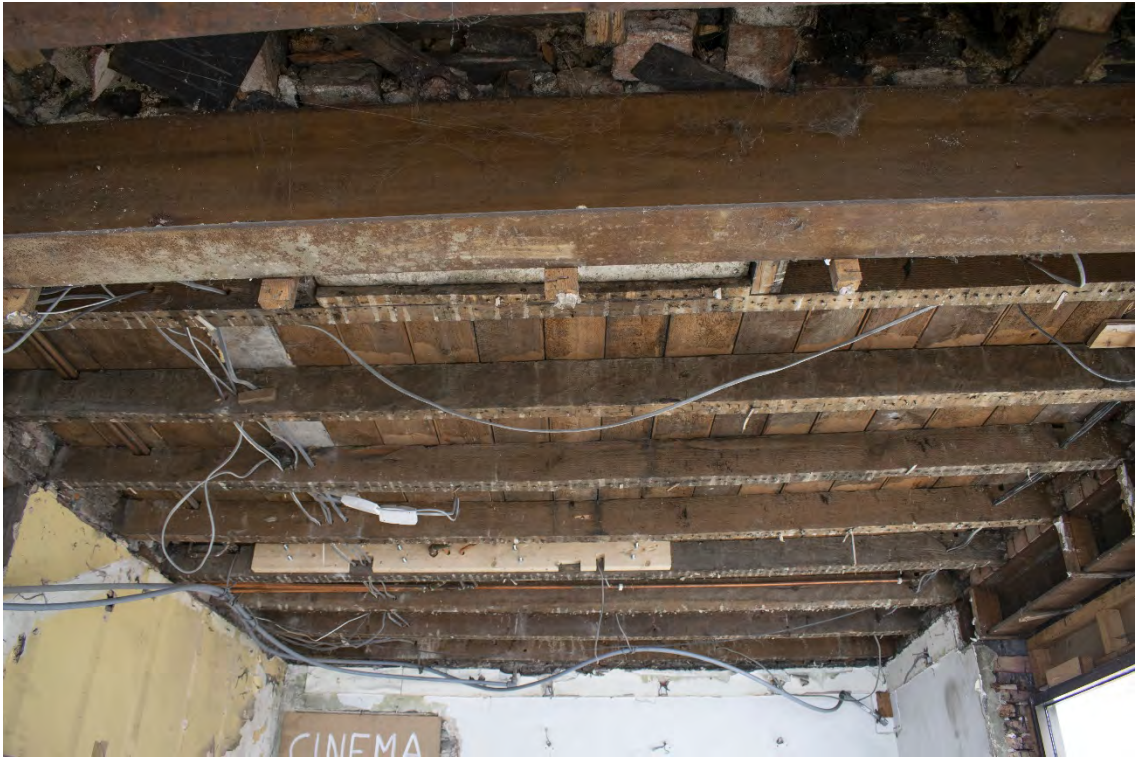
The remains of a suspended lath-and-plaster ceiling are visible in the form of hangars affixed to the timber floor joists by timber brackets. The hangars do not appear in the rear of the open-plan main room which was a separate reception room in the original 18th century layout. Nails and staining potentially associated with a lath-and-plaster ceiling are visible on the joists in the rear of the room though the ceiling itself has been removed (Plate 21); it is possible that this is the remains of the original ceiling structure whereas the hangers in the front of the room are part of alterations that occurred during the conversion to a shop. The hangers are irregular shaped and vary from 30mm to 50mm wide. Nail and plaster staining are visible on a majority of the hangars. A number of the smaller hangers have deteriorated as well as the end of a significant proportion of the larger planks (Plate 22).

Plate 21 Rear ceiling and floor structure.

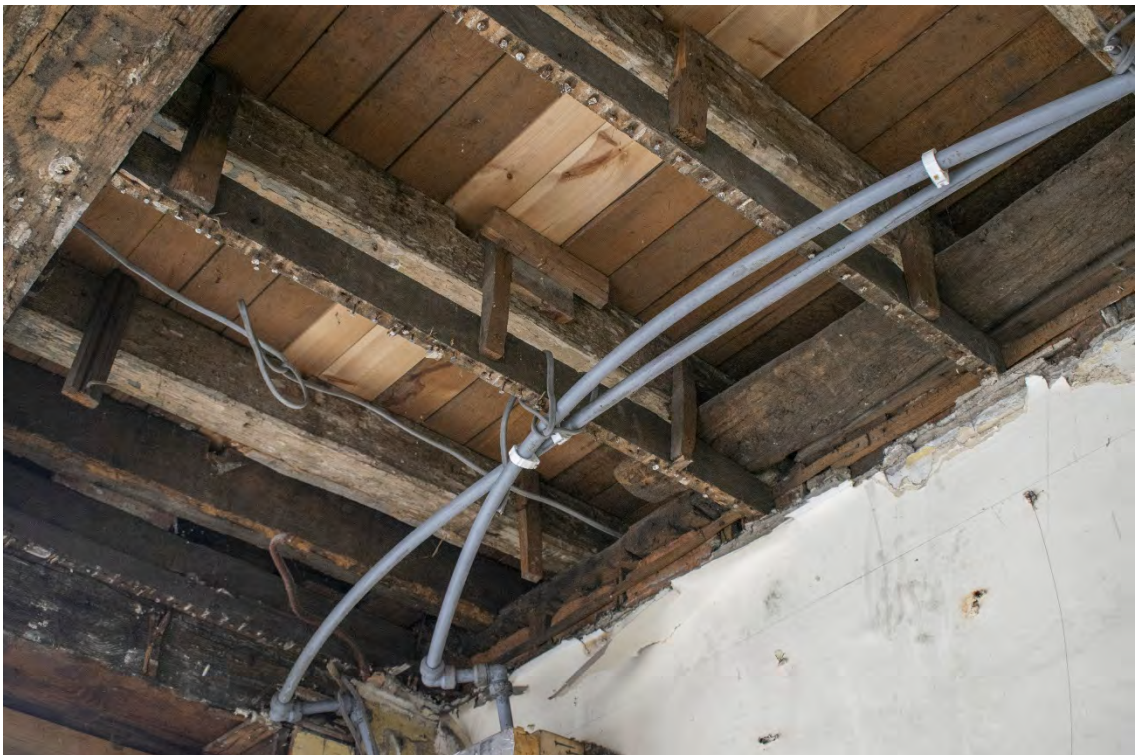
Plate 22 Detail of lath-and-plaster hangers and deterioration of plank ends.

In conclusion 77-79 Micklegate is a fairly typical late 18th century end-terrace which has had extensive alterations throughout the 19th and 20th centuries in order to facilitate the use of the ground floor as a commercial entity. Initial conversion of the property in the mid-19th century retained a large proportion of the original layout of the ground floor which remained as two separate rooms with the addition of the lath-and-plaster ceiling. Further alteration in the late 19th and early 20th century saw the removal of the partition wall to create a larger ground floor space as well as the addition of the large display windows and canted corner door. The works should return the original appearance of the property externally while returning the interior to the original layout. The remains of the mid-19th century lath-and-plaster ceiling will be protected within a new ceiling structure as a significant amount of the hangers have deteriorated.

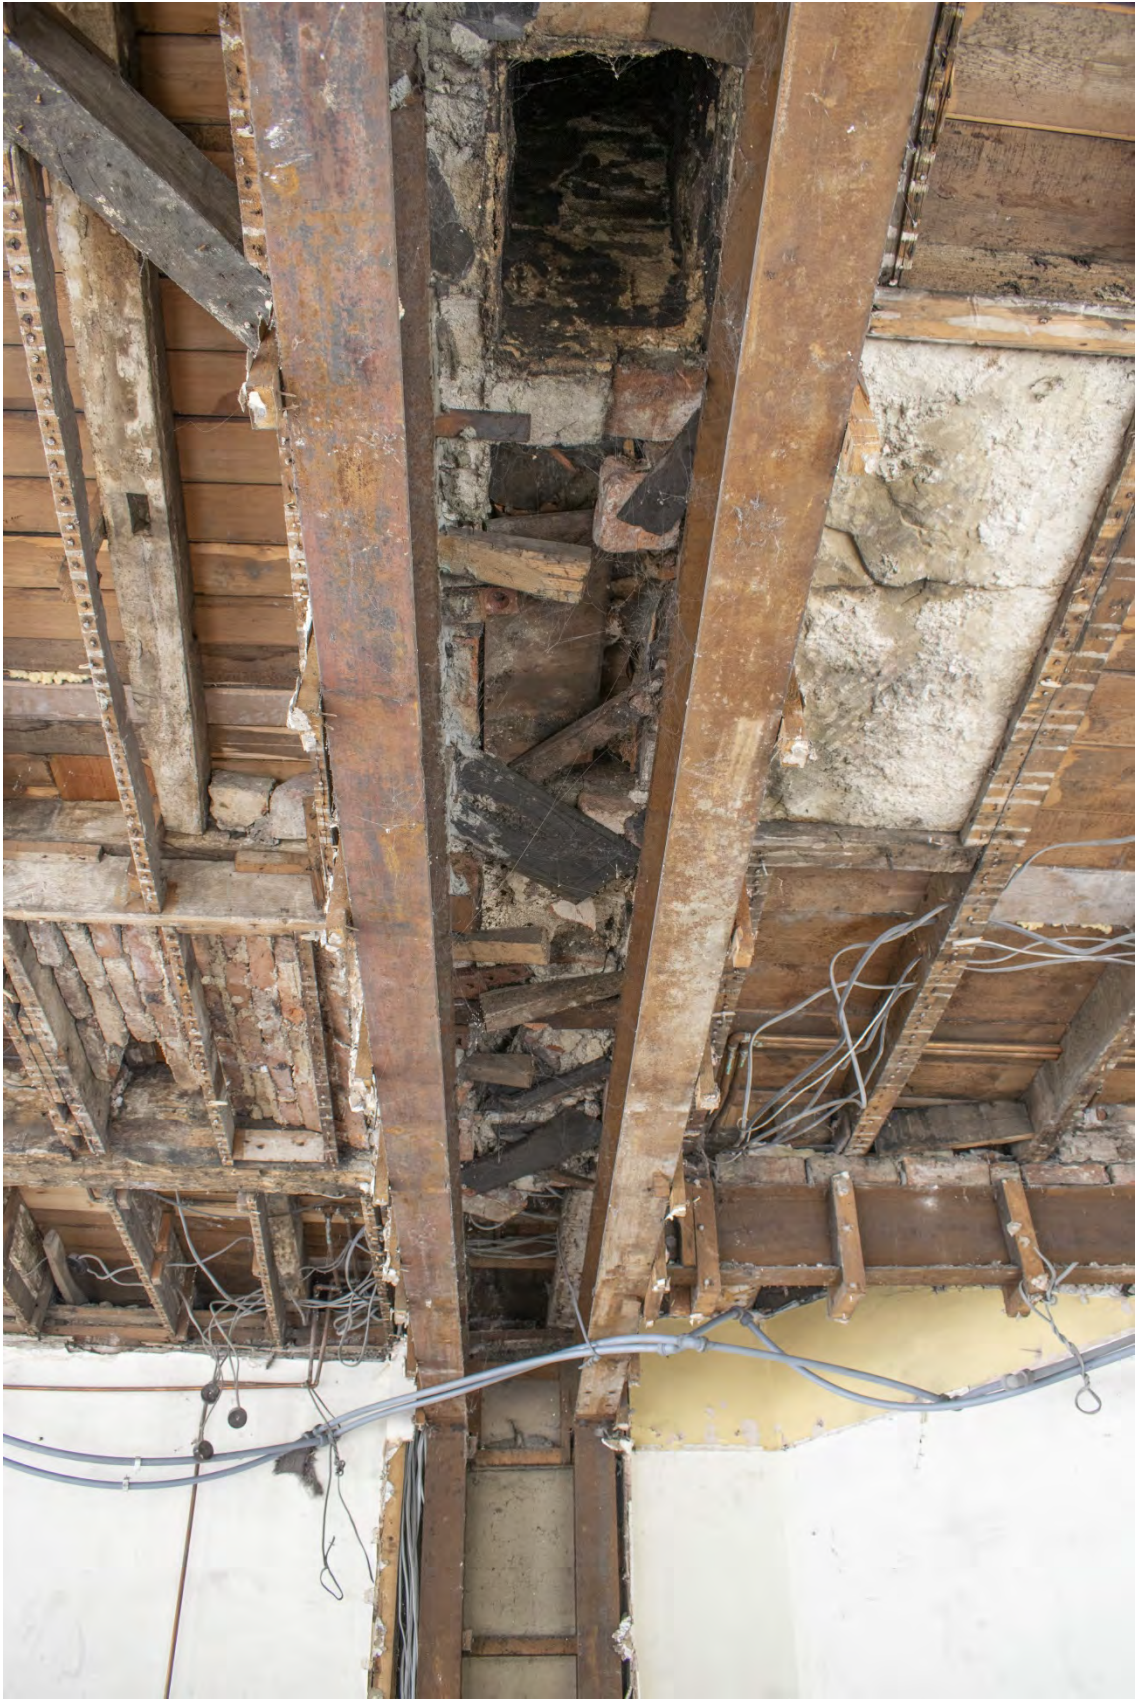
In the centre of the ceiling, where the dividing wall was removed and replaced by two steel support I-beams, the remains of a fireplace is visible (Plate 23). A stone hearth and brick flue, corresponding with the chimney stack for the rear room, were exposed during the removal of the lath-and-plaster ceiling, as well as rubble associated with a fireplace. This included a decorated metal fireback wedged between the support beams (Plate 24). A diagonal joist above the right display window supports the chimney flue (Plate 25). To the left was the remains of a further brick chimney for the front room which has been supported and repaired by a number

Plate 23 Chimney stone hearth and flue.

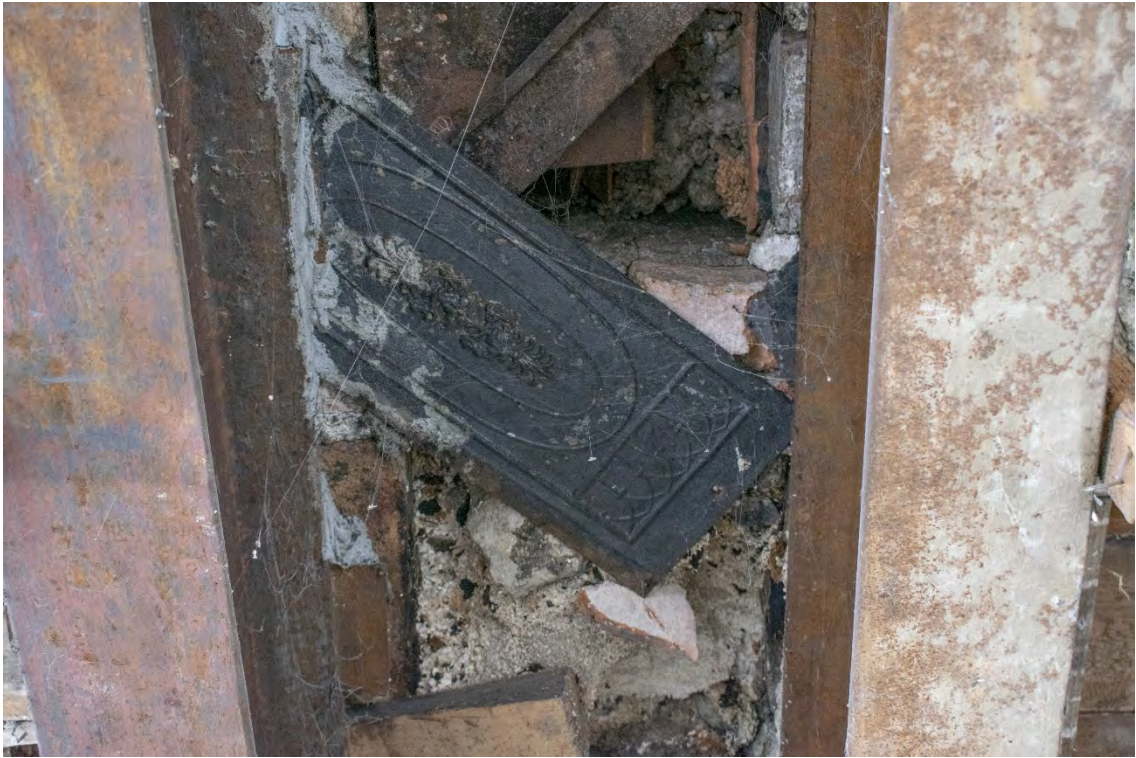
Plate 24 Metal fireback plate within rubble between steel beams.

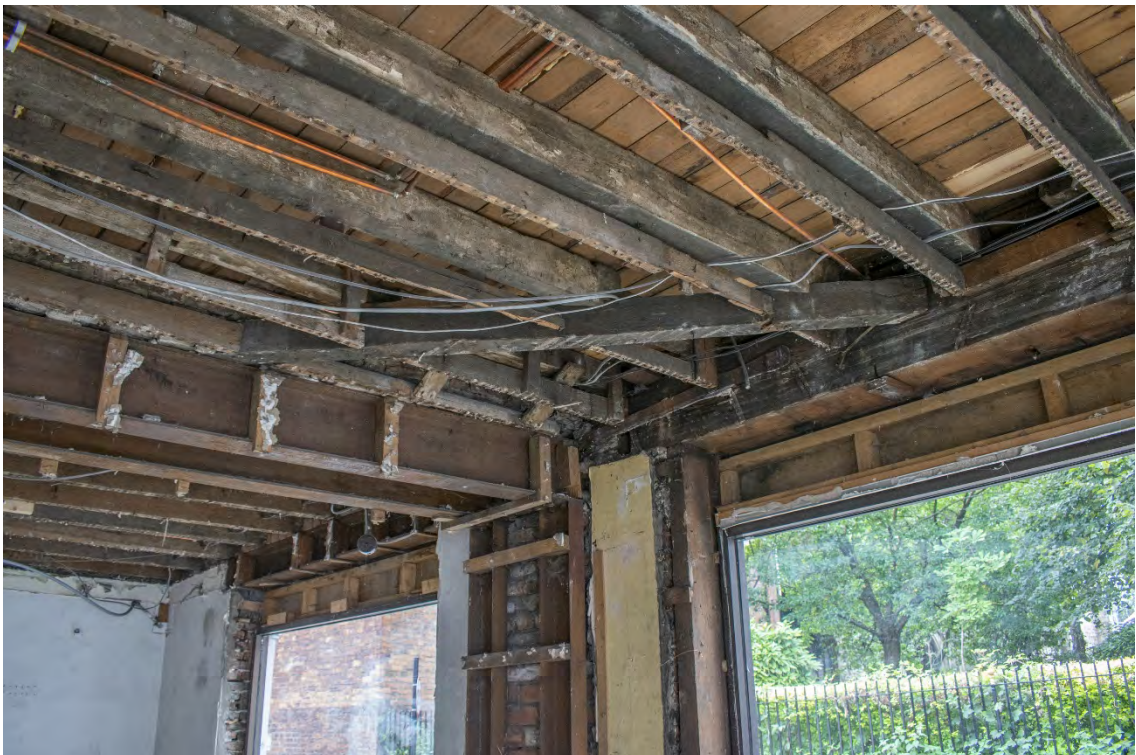
Plate 25 Diagonal support beam for chimney flue.

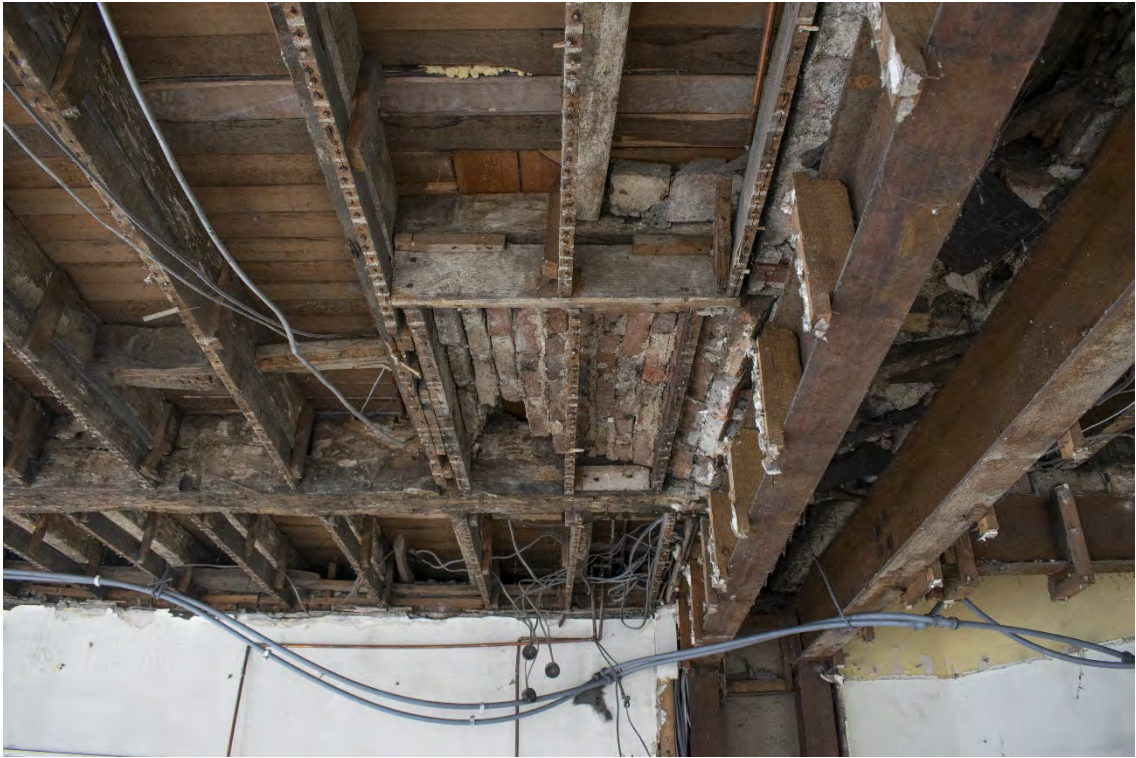
of timber offcuts and braces similar to those for the lath-and-plaster ceiling; potentially the chimney breast had been repaired at a similar period to the installation of the ceiling (Plate 26).

Plate 26 Brick chimney hearth with timber supports.

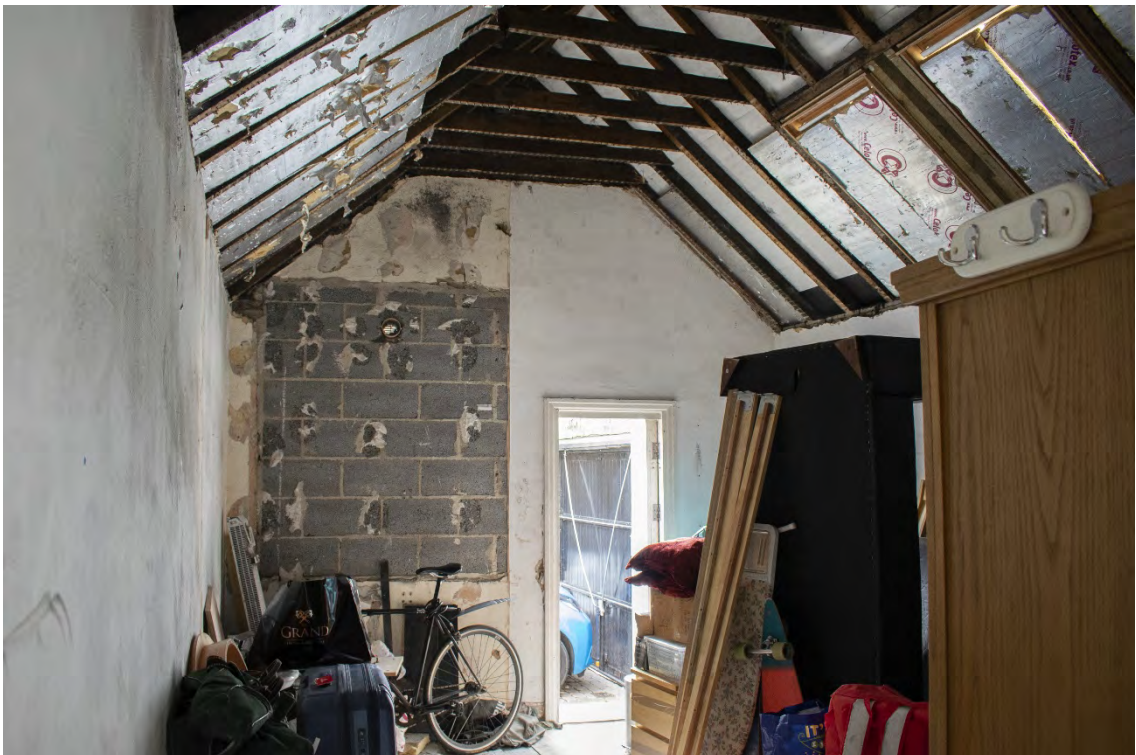
The rear room is a smaller rectangular shape with no features of note besides the infilled rear window in the south wall (Plate 27). The backdoor to the property is on the right of the south wall, next to the infilled window. The timber roof structure has been left exposed and two conservation skylights added.

Plate 27 Rear extension with infilled window and skylights.
