Archaeological Watching Brief at 10 Pavement/Lady Peckett's Yard, York

YAT Report 2019/90 October 2019

The work was undertaken for Northern Powergrid as an Operations Notice for works within the York Area of Archaeological Importance (AAI). The works involved the monitoring and recording of a trench for electric cabling.

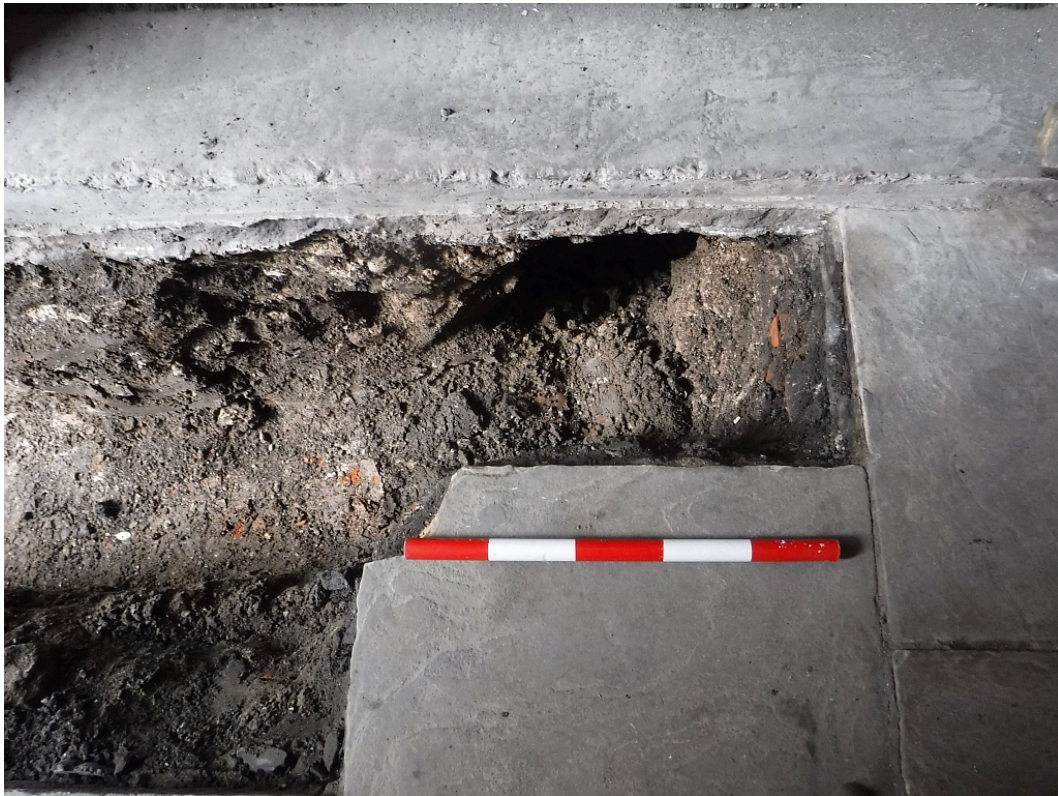
Plate 1 Deposits and opening under threshold, facing west-southwest, scale unit 100mm

In the northern extent of the works, under the covered passageway, the archaeological deposits appeared the best preserved across the site. The earliest deposit was a layer of broke medieval roof tiles (Context 1) at c.0.60m BGL (Figure 3, Plate 1). This deposit continued

beyond the limit of excavation, so the thickness of the deposit is unknown. The roof tiles were sealed by 0.10m of grey brown clayey silts (Context 2), which in turn were covered by 0.26m of loose brown sandy silt (Context 3) which contained numerous mortar fragments. Another layer of dumped medieval tile (Context 4), 0.04m thick, was followed by 0.12m of loose silty sand with brick and tile fragments (Context 5). The last 0.08m was the modern paving and bedding (Context 6).

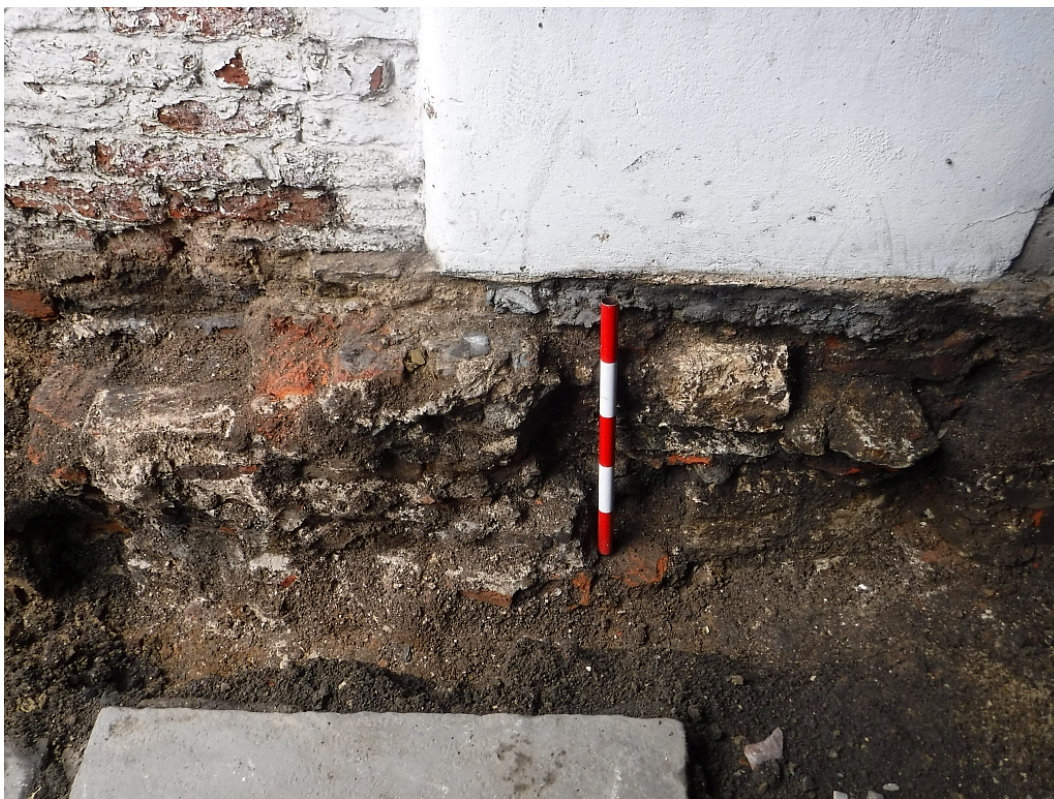
Plate 2 Foundations left and right of scale bar, facing west-south-west, scale unit 100mm

At the southern limit of the passageway foundation deposits were present (Figure 2, Plate 2). The foundations were 1.3m long, and consisted of two elements: northern and southern. The northern foundation was 0.60m long and was constructed from rough-hewn limestone blocks up to 0.45m across. Medieval tile was also present, and a single post-medieval brick was at the top. No mortar was visible. The southern foundation was 0.70m long and was constructed from medieval tiles, post-medieval brick and cobbles, bonded in rough layers with large volumes of lime mortar. Both foundations projected slightly into the route of the cable duct trench to the east, but did not cross the full width of the passageway. Beneath both of the foundations was 0.04m of an orange/brown sandy silt which extended beneath the limit of excavation.

The northernmost foundation seen in the southern part of the passageway may relate to medieval structures that pre-dated the present buildings, with the single post-medieval brick a later intrusion. The southernmost foundation could be part of the c.1700 rebuilding phase of 11 Lady Peckett's Yard, as the foundations may have had to be substantially reinforced during these works.

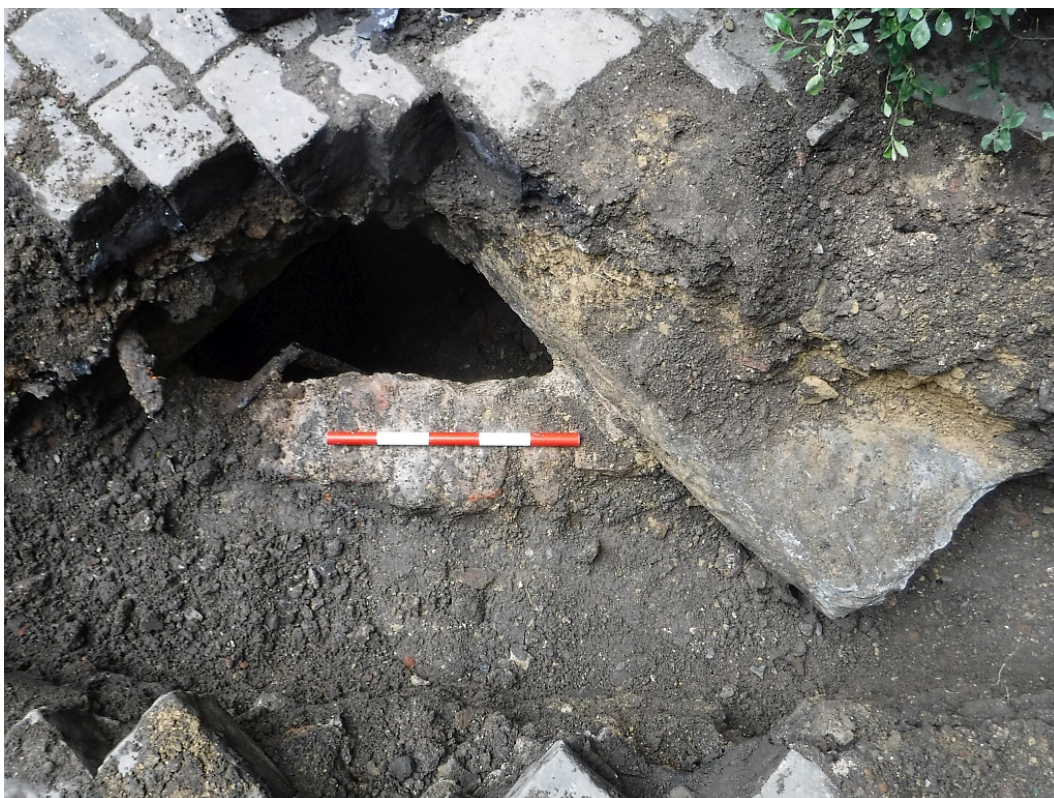
Plate 3 Wall for cellar and capping, facing south-south-west, scale unit 100mm

The deposits seen in the open yard were noticeably different to those under the covered passageway. Loose backfill was present around a structure for a cellar or possible stairwell (Figure 2, Plate 3). The brickwork for the structure was two courses wide, with bricks bonded with lime mortar. The capping stone for the structure had previously been cut into, and on removal it was possible to see within the cavity. Looking south-west towards the building now known as The Old Mill, a formal opening could be seen, indicating that there had previously been access into the structure (Plate 4). The large stone slabs capping the structure appear to have been built into the wall of The Old Mill. Looking towards the south, it appeared that the front wall of The Old Mill turned into the yard at an angle of 90°.

The 1852 Map of York and subsequent Ordnance Survey maps do not indicate any openings or stairs into the yard. The standing Old Mill building, to which the cellar would belong, has bricks which are 0.07-0.08m thick, indicating an 18th century or later date. These bricks do not match the bricks in the cellar structure, however, there were some courses of thinner, 0.06m thick bricks at the base of the Old Mill Building, which would match the bricks in the cellar structure. It may be possible that the current structure is a rebuild of an earlier building which was sat in the same position, and utilised the pre-existing foundations and cellar.

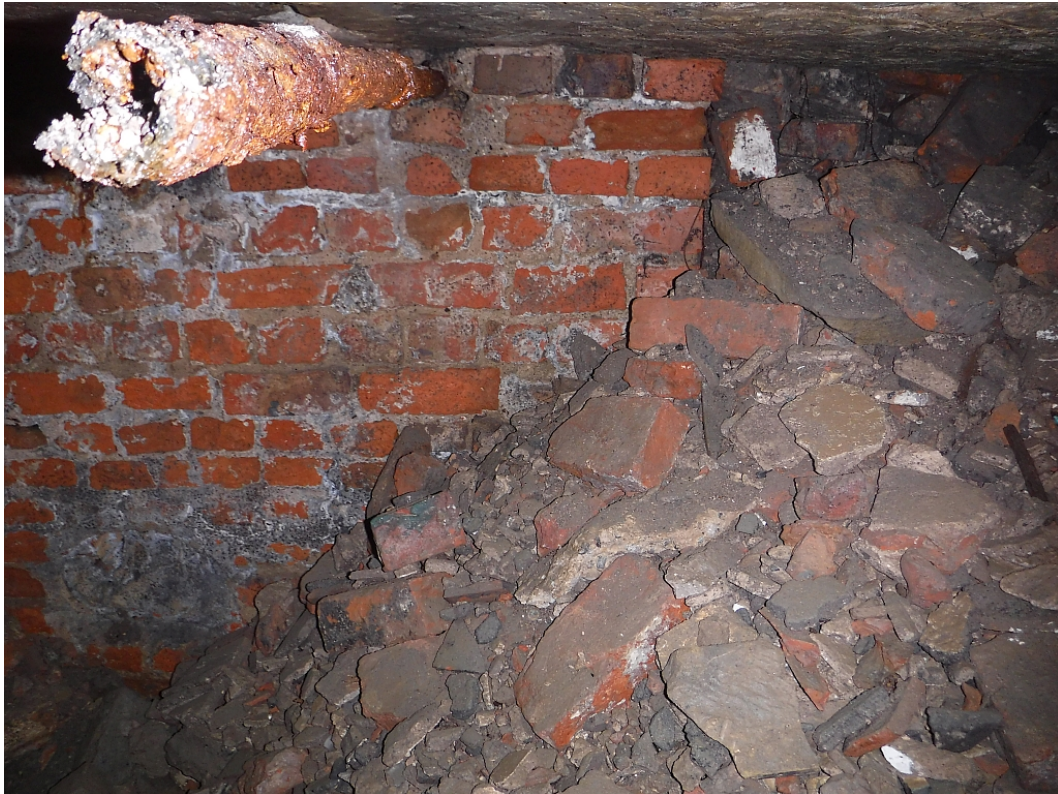
Plate 4 Looking into cellar opening, facing west, scale unit 100mm

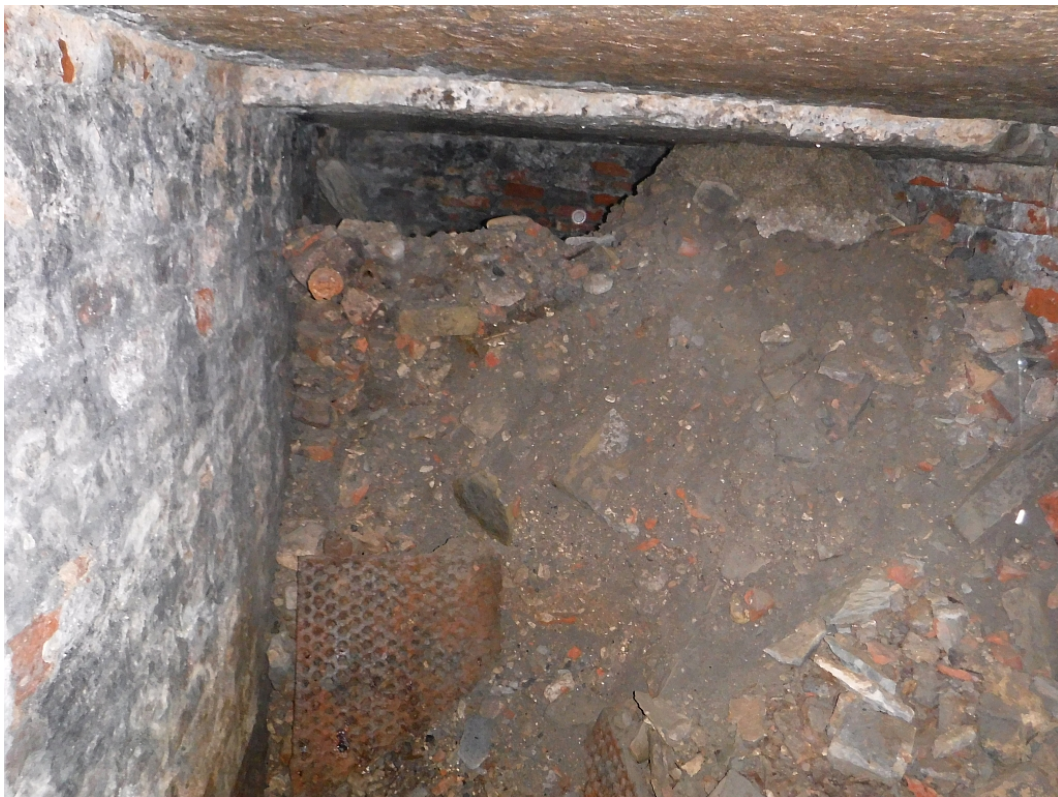
Plate 5 Looking into cellar with unusual wall return at right, facing east-south-east, scale unit 100mm

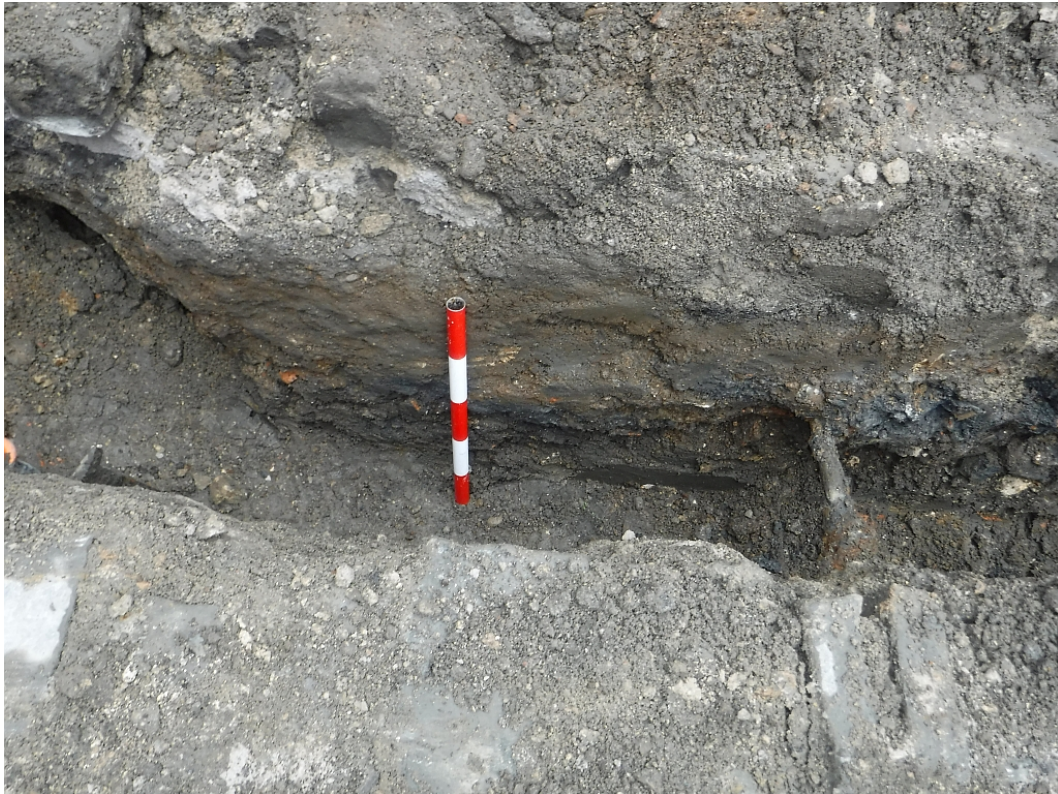
Plate 6 Typical yard section, facing north-west, scale unit 100mm

Away from The Old Mill and cellar, the deposits (Context 7) were still substantially disturbed by drains and other services (Figure 3, Plate 6). Small patches of clinker were seen, which may suggest the survival of earlier clinker yard surfaces (Context 8).

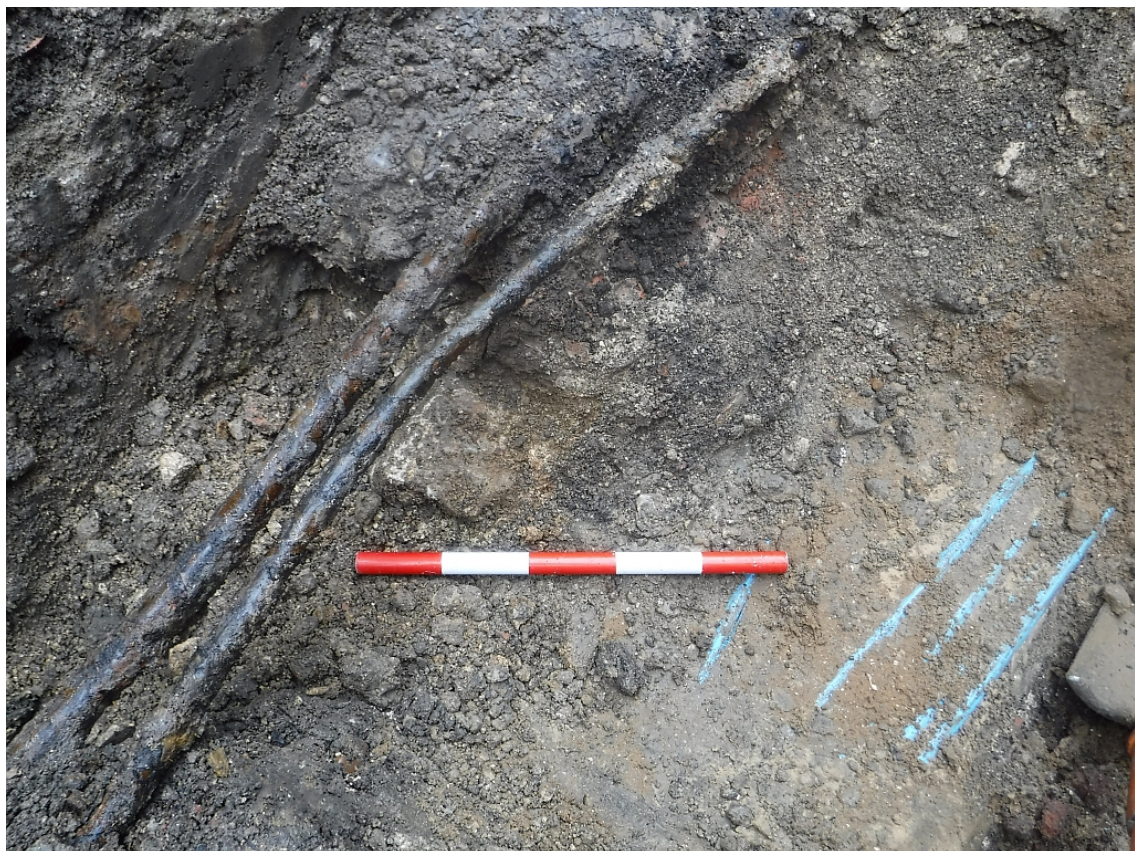
Plate 1 Footing and surrounding disturbance, facing north-north-east, scale unit 100mm

As the cable trench approached the electrical substation to the north-east, it was widened to create access for joints to be made. In this section a substantial stone and medieval tile footing was present (Figure 2, Plate 7). The footing was heavily truncated by services, but in some places it survived up to 0.40m BGL. It was constructed from a combination of irregular limestone fragments (up to 0.4m across) and occasional medieval tiles which had been mortared together with a soft, pale yellow lime mortar.

The substantial stone and tile foundation in the eastern area of the yard may be the footings for buildings which oversailed and sat to the south of the lane from Fossgate to Lady Peckett's Yard. These can be seen on the 1852 Ordnance Survey map. Otherwise they may relate to an earlier sequence of buildings across the site, dating from the medieval period. Within the footing was a single sherd of 14th century pottery, which could be residual, but along with the lack of post-medieval brick within the footings could suggest an earlier structure.
