46–50 PICCADILLY, YORK

DESK-BASED ASSESSMENT REPORT

Report Number 2016/85 November 2016

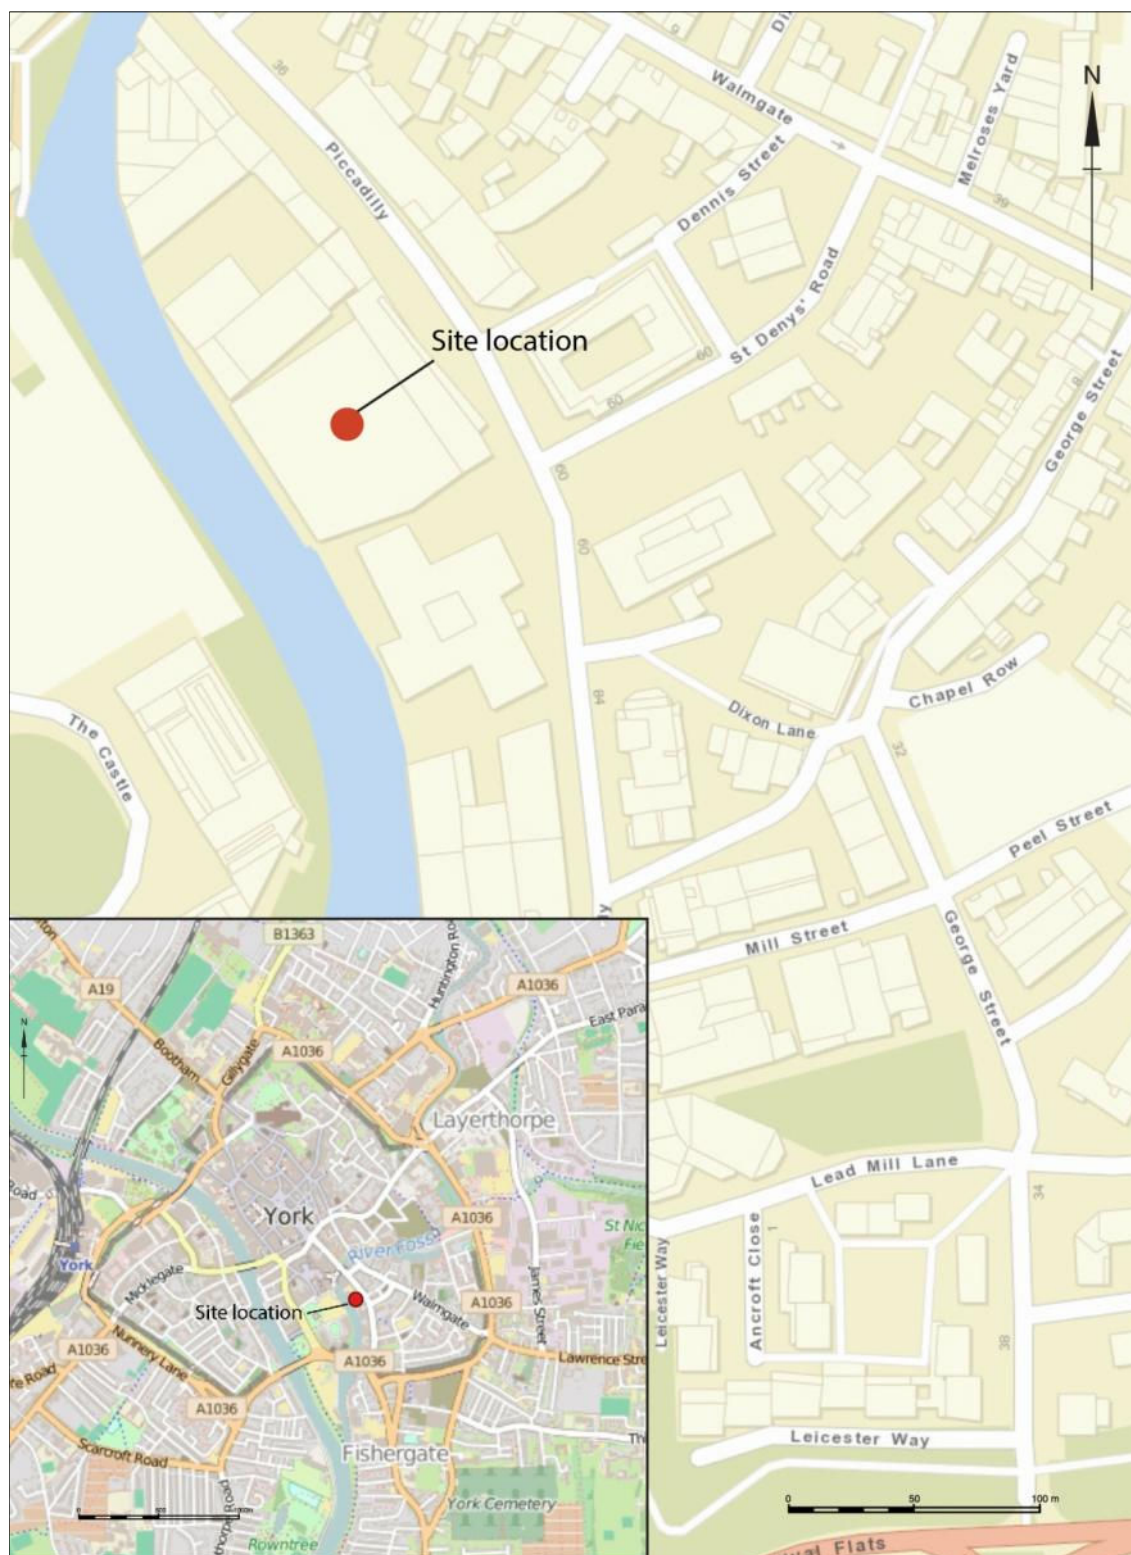
Figure 1 Site location

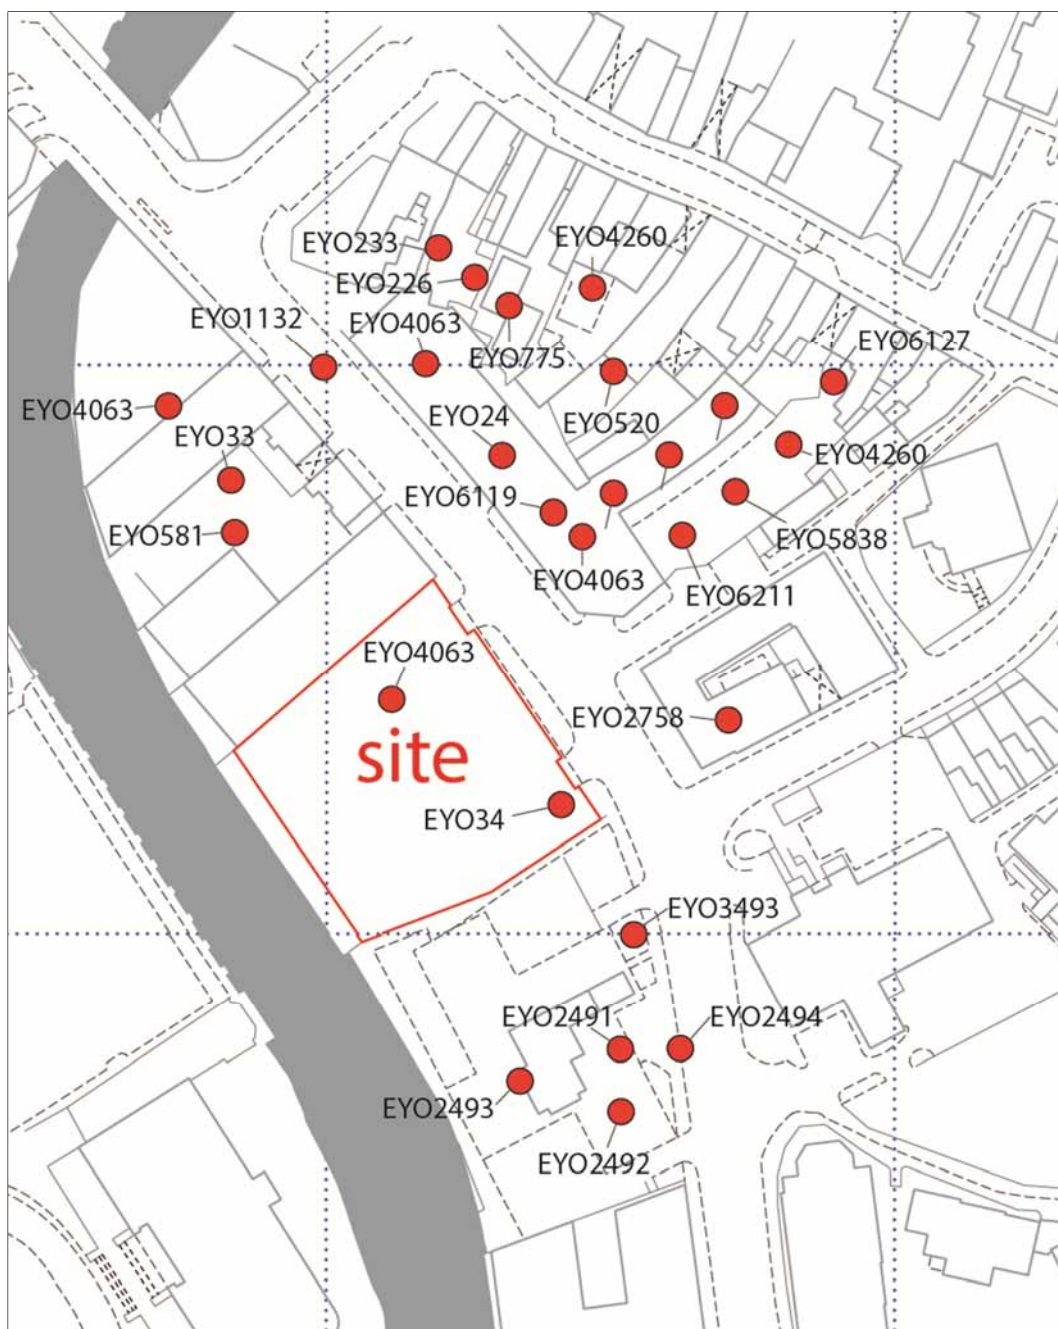
Figure 2 HER data plan

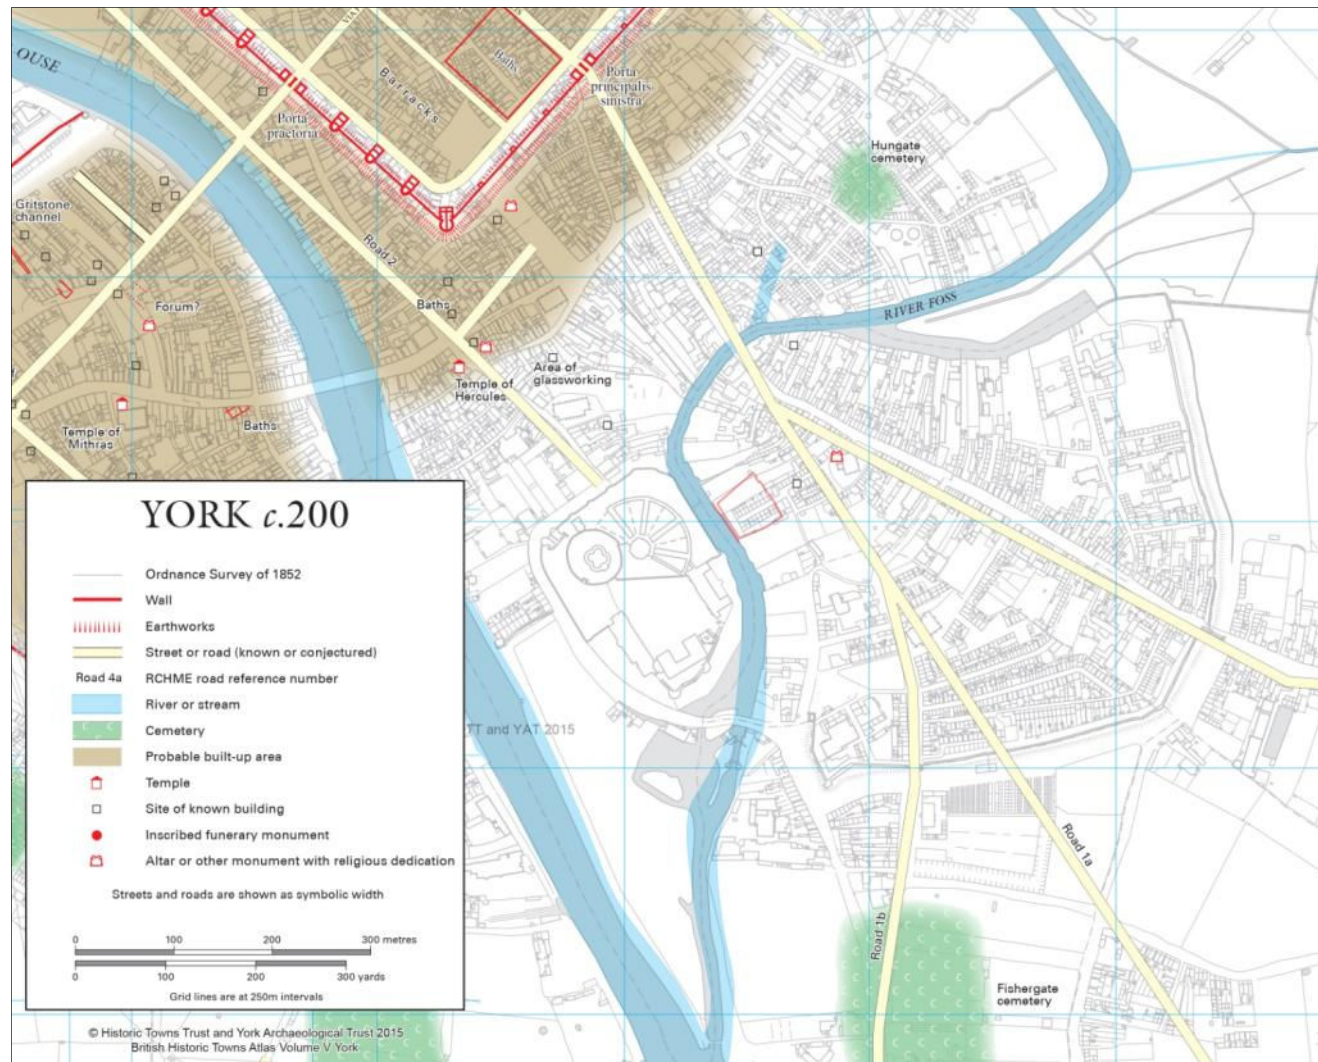
Figure 3 Roman York c.200 AD with site outline

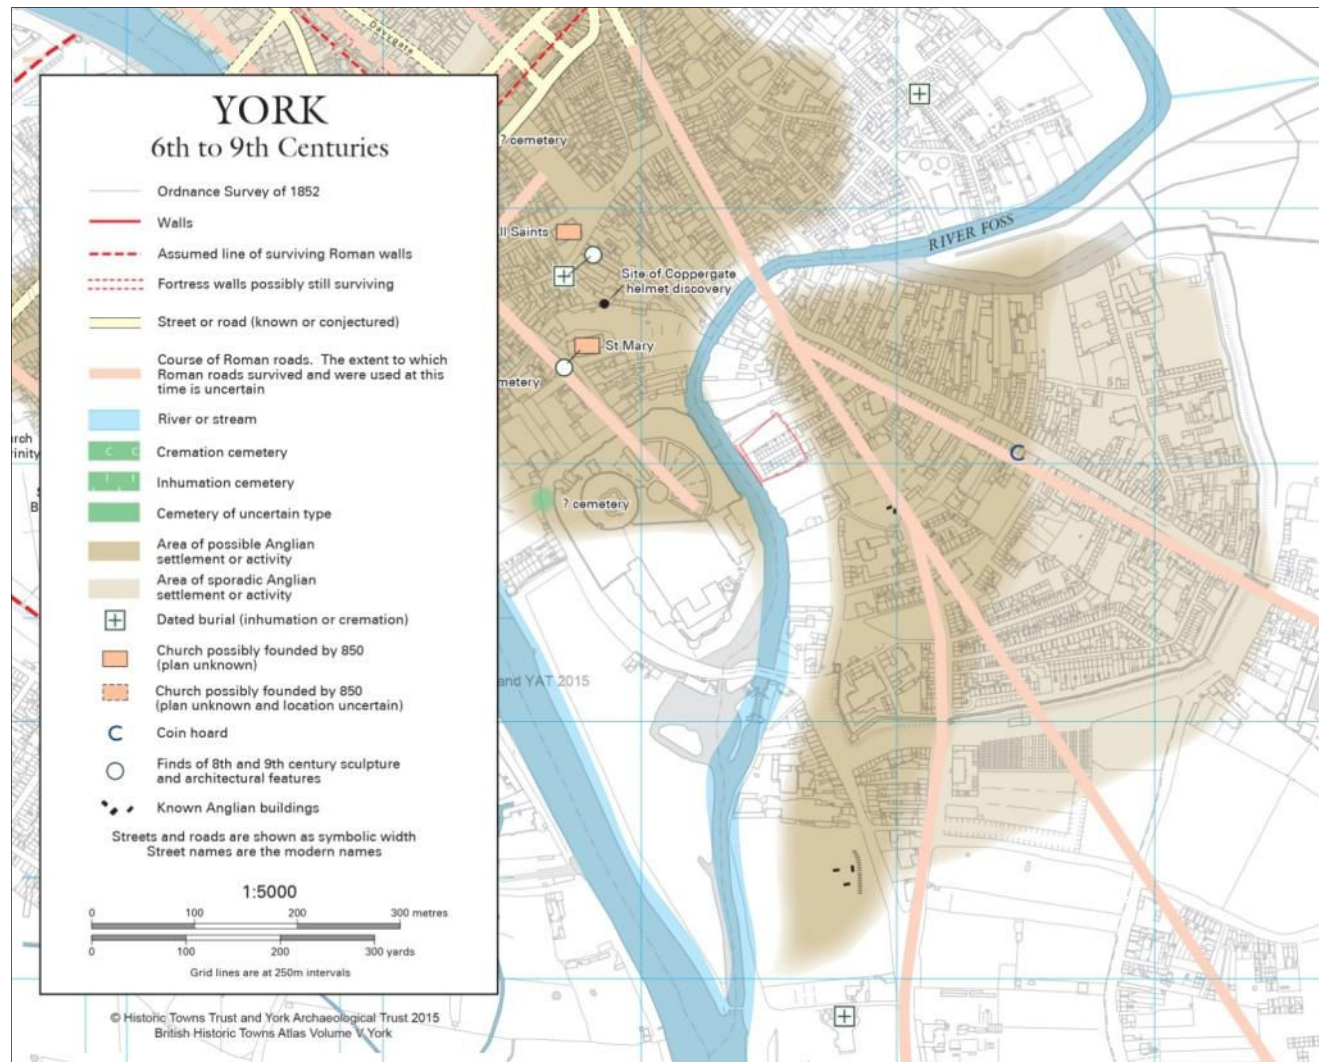
Figure 4 Anglian York, 6th–9th centuries, with site outline

on current archaeological evidence the 46–50 Piccadilly site lies just to the north-west of the possible Anglian settlement (Figure 4; Palliser 2014, 24).

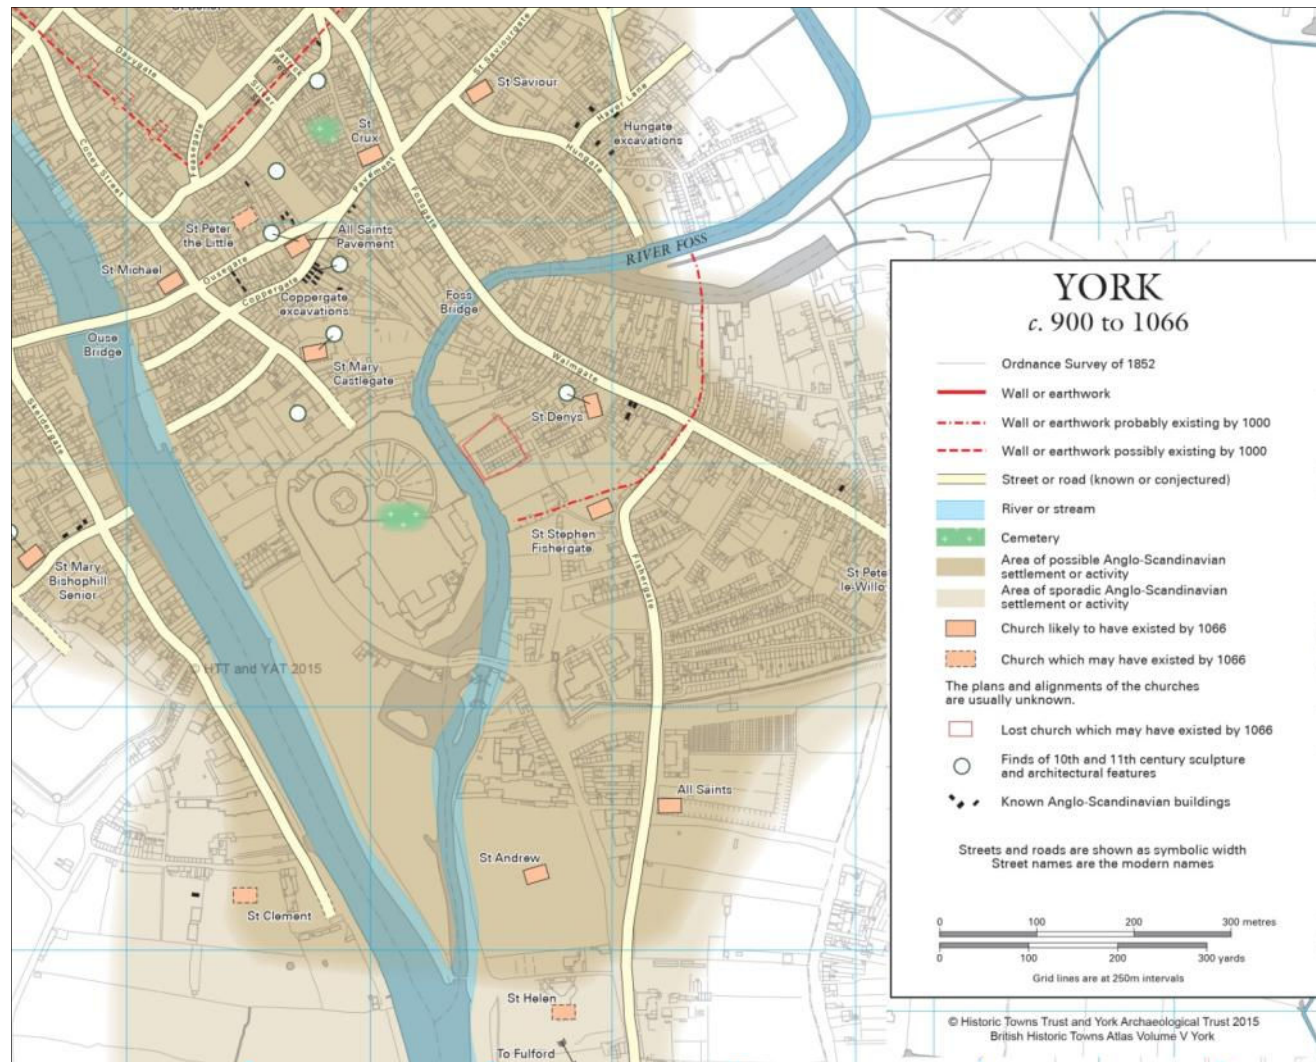
Figure 5 Anglo-Scandinavian York 900–1066 with site location

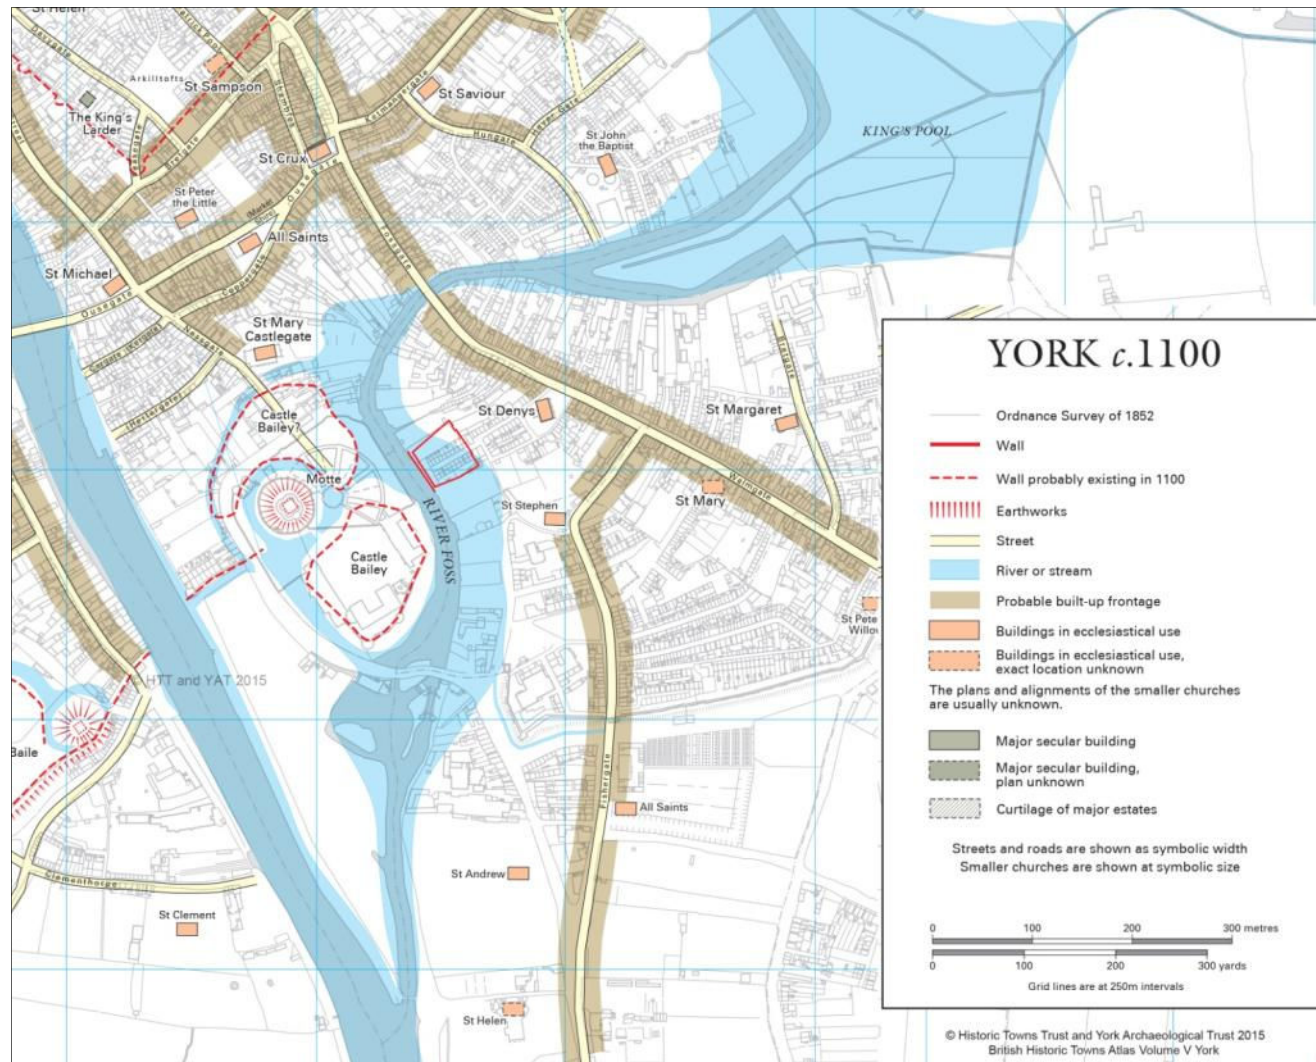
Figure 6 Norman York c. 1100

The Walmgate sector of the city was enclosed with defences in the late 12th century (Figure 6; RCHMY 2, 11; HTAY 2015, 31). Fishergate Postern, 0.2km to the south was built sometime in the 14th century (Raine 1955, 20).

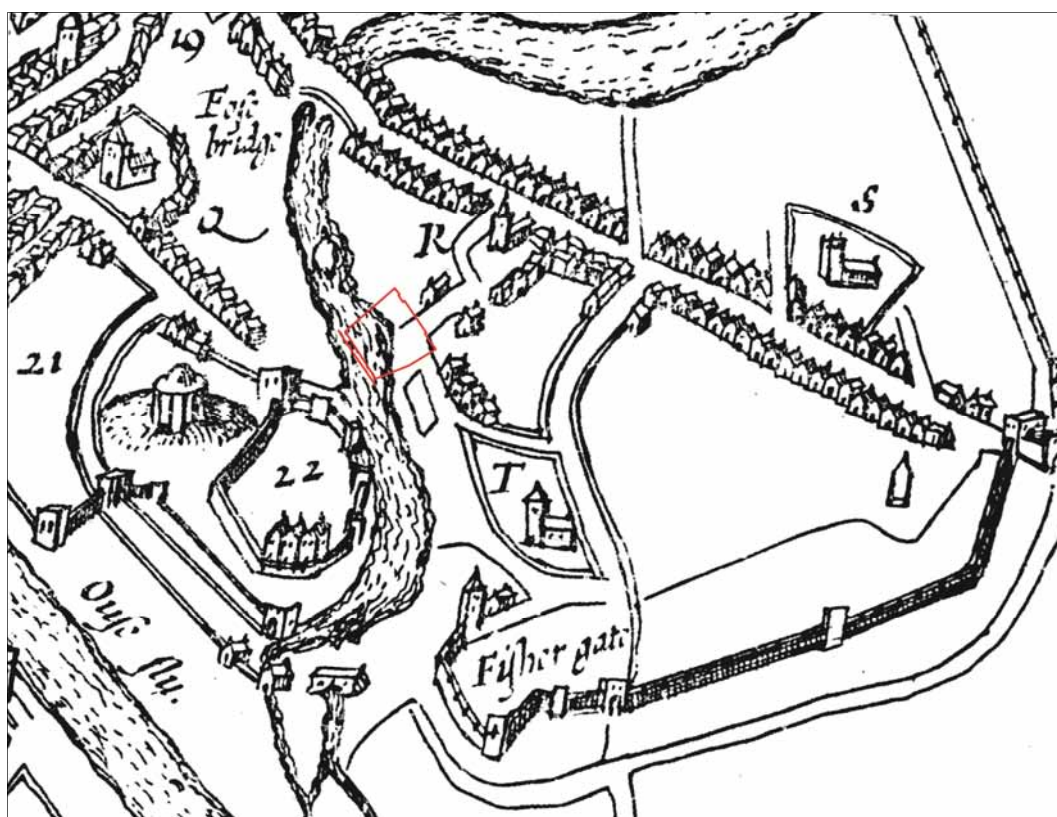
Figure 7 Speed 1610 with approximate site location

Much of the street is built over land that was formerly covered by the Kings Pool of the River Foss. The gradual development of the post-medieval landscape can be traced through the historic maps of which there is a sequence available dating from the 17th century (Figures 7–11). On Speed's map of 1610 the site is depicted as open ground

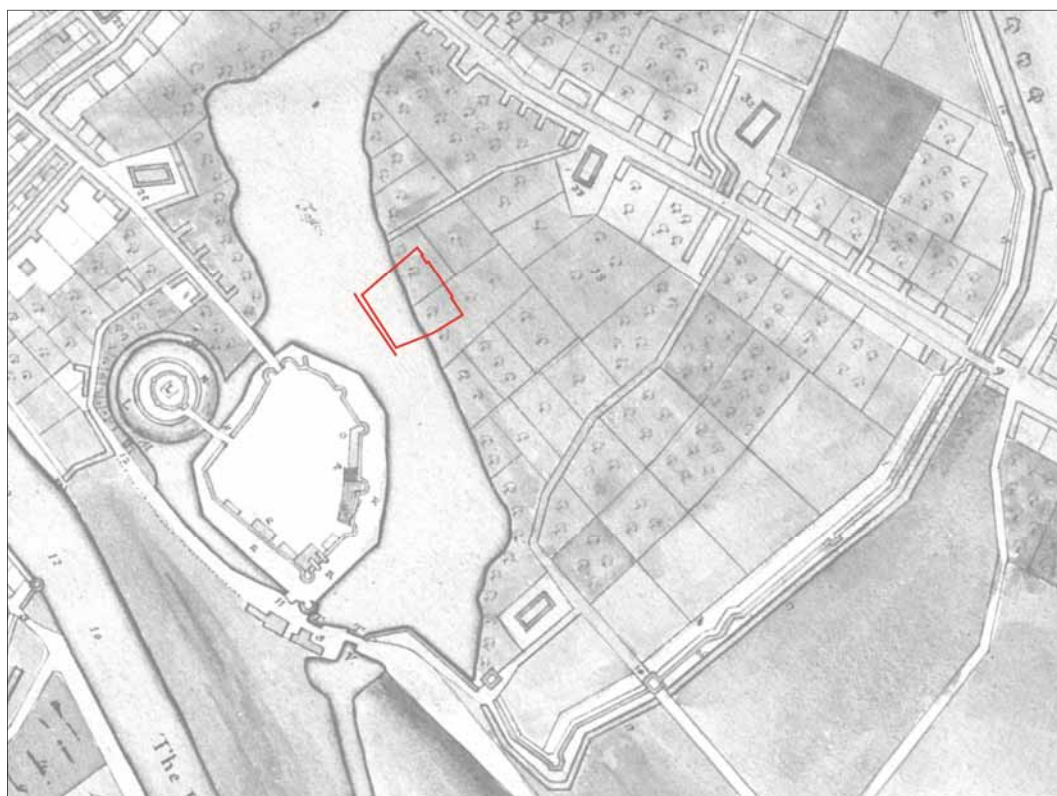
Figure 8 Richards 1685 with approximate site location

Richards' map of 1685 (Figure 8) which is largely a copy of an earlier map by Captain James Archer (surveyed 1673 and published 1682; not reproduced), shows open ground, presumably used for commercial horticulture with property boundaries and a path or street leading from Walmgate to the east bank of the River Foss. The distinction between streets built-up with houses, and lesser pathways without on these early maps is unclear. Their exact location and orientation in relation to the modern landscape is also difficult to determine with complete accuracy but it seems there has, for a considerable time, been some form of access to the east bank of the Foss from Walmgate and the north side of St Denys' church yard.

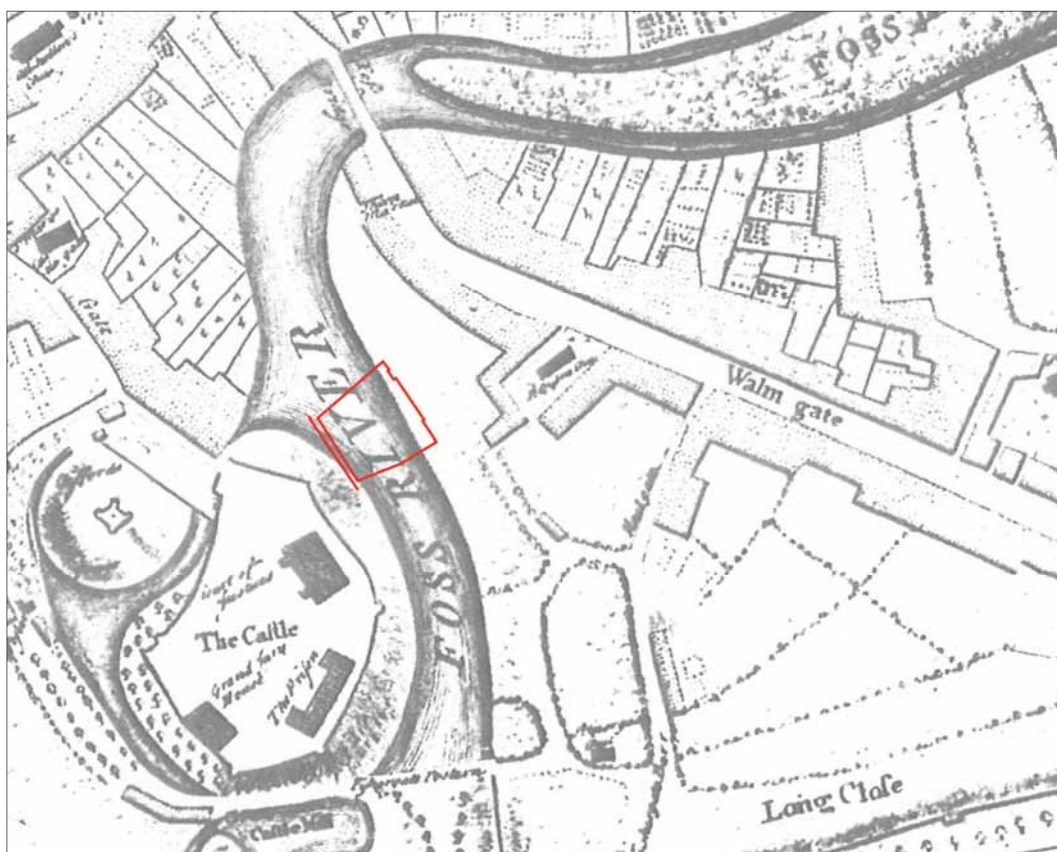
Figure 9 Chassereau 1750 with approximate site location

By 1750, the publication date of Chassereau's map, the area around St Denys' church is largely built-up, the path leading to the east bank of the Foss is no longer shown and a new path or street leading south towards the Castle Mills Bridge area is indicated, forming the predecessor to the modern southern end of Piccadilly.

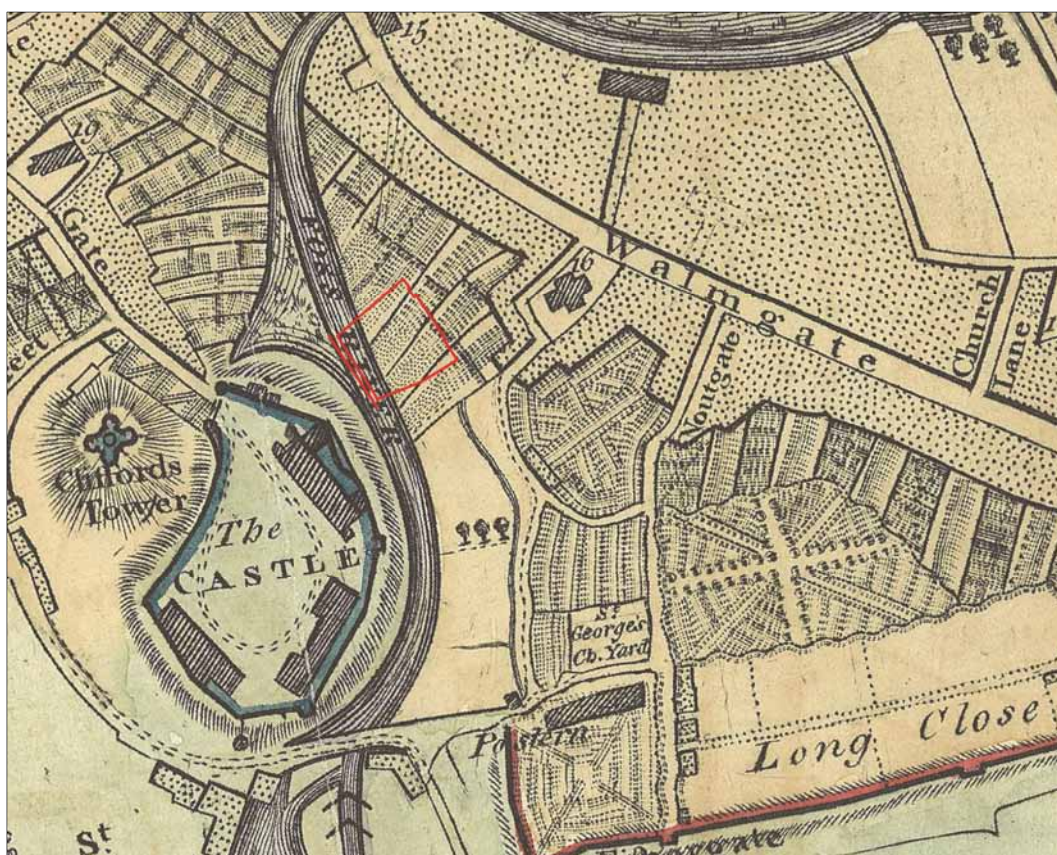
Figure 10 Hargrove 1818 with approximate site location

Hargrove's map of 1818 appears to differentiate between probable horticultural land to the north-west and west of St Denys' church and what appears to be open ground to the south-west (Figure 10). The line of the path running south towards Fishergate Postern from the west end of the churchyard is in Hargrove's map delineated with a dashed line, possibly indicating it was of lesser status than other lanes shown further to the east. The 1852 Ordnance Survey map shows the path widened and formalised after the creation of Piccadilly (Figure 11).

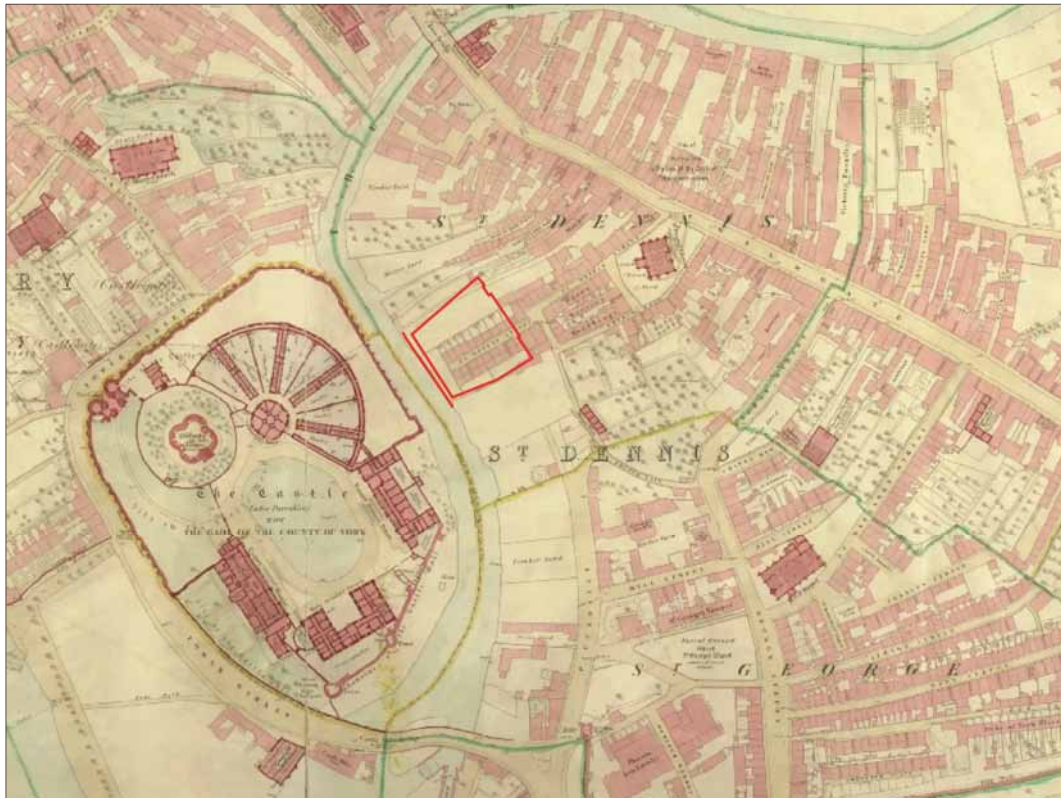
Figure 11 Ordnance Survey 1852 with site outline

By 1852 St Denys' Street had been extended along a line to the south-west with a slight dog-leg and is shown as a built-up street of terraced houses. The properties on the north side of the street appear to be small houses with yards and those on the south appear to be back-to-back houses. Walmgate was a notorious area in the 19th century associated with poverty, crime and prostitution. A block of terraced dwellings, immediately south-west of St Denys' Church, were known as Plow's Rectory Buildings. Finnegan describes these as an unwholesome terrace amongst which there were a small number of 'houses of ill fame' such

In the 19th-century the terraced houses of St Denys’ Street ran from Walmgate to the south-west across the 46–50 Piccadilly site almost towards the bank of the River Foss (Figure 11). A search of City of York Council ‘Imagine York’ images archive returned only 1, relatively uninformative, photograph of the east corner of St Denys Street at its junction with Walmgate taken in c. 1933. The eastern end of the street appears to follow a property boundary or thoroughfare running south-west from Walmgate along the north side of St Denys’ church, a route that can be traced in the historic maps as far back as Speed’s map of 1610 (Figures 7–11).

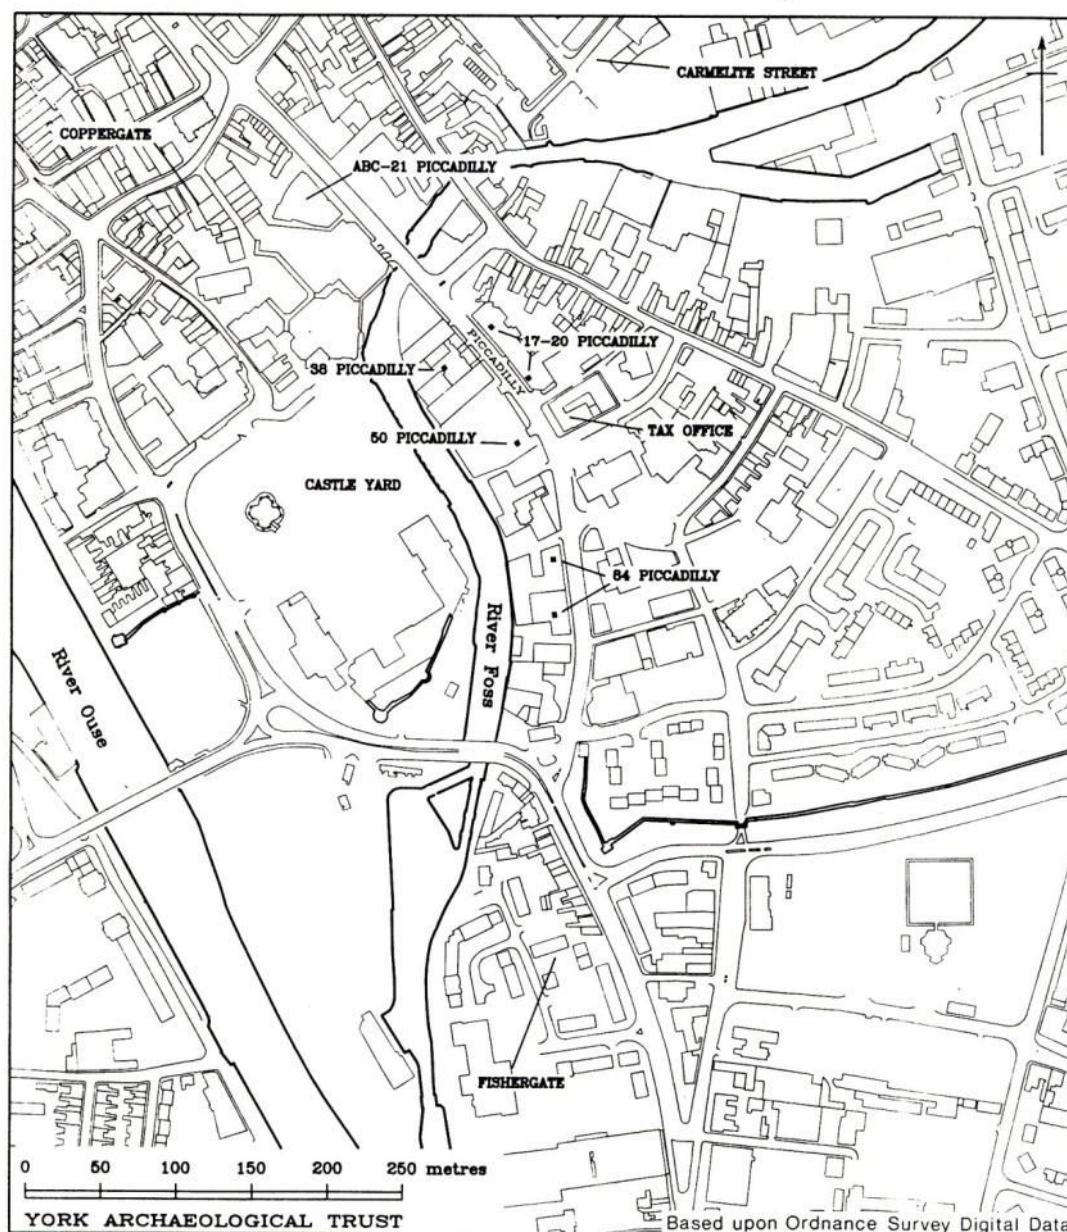
Figure 12 Sites in the vicinity of 50 Piccadilly up to 1992 (reproduced from YORYM: 1992.10; YAT Report 1992/14)

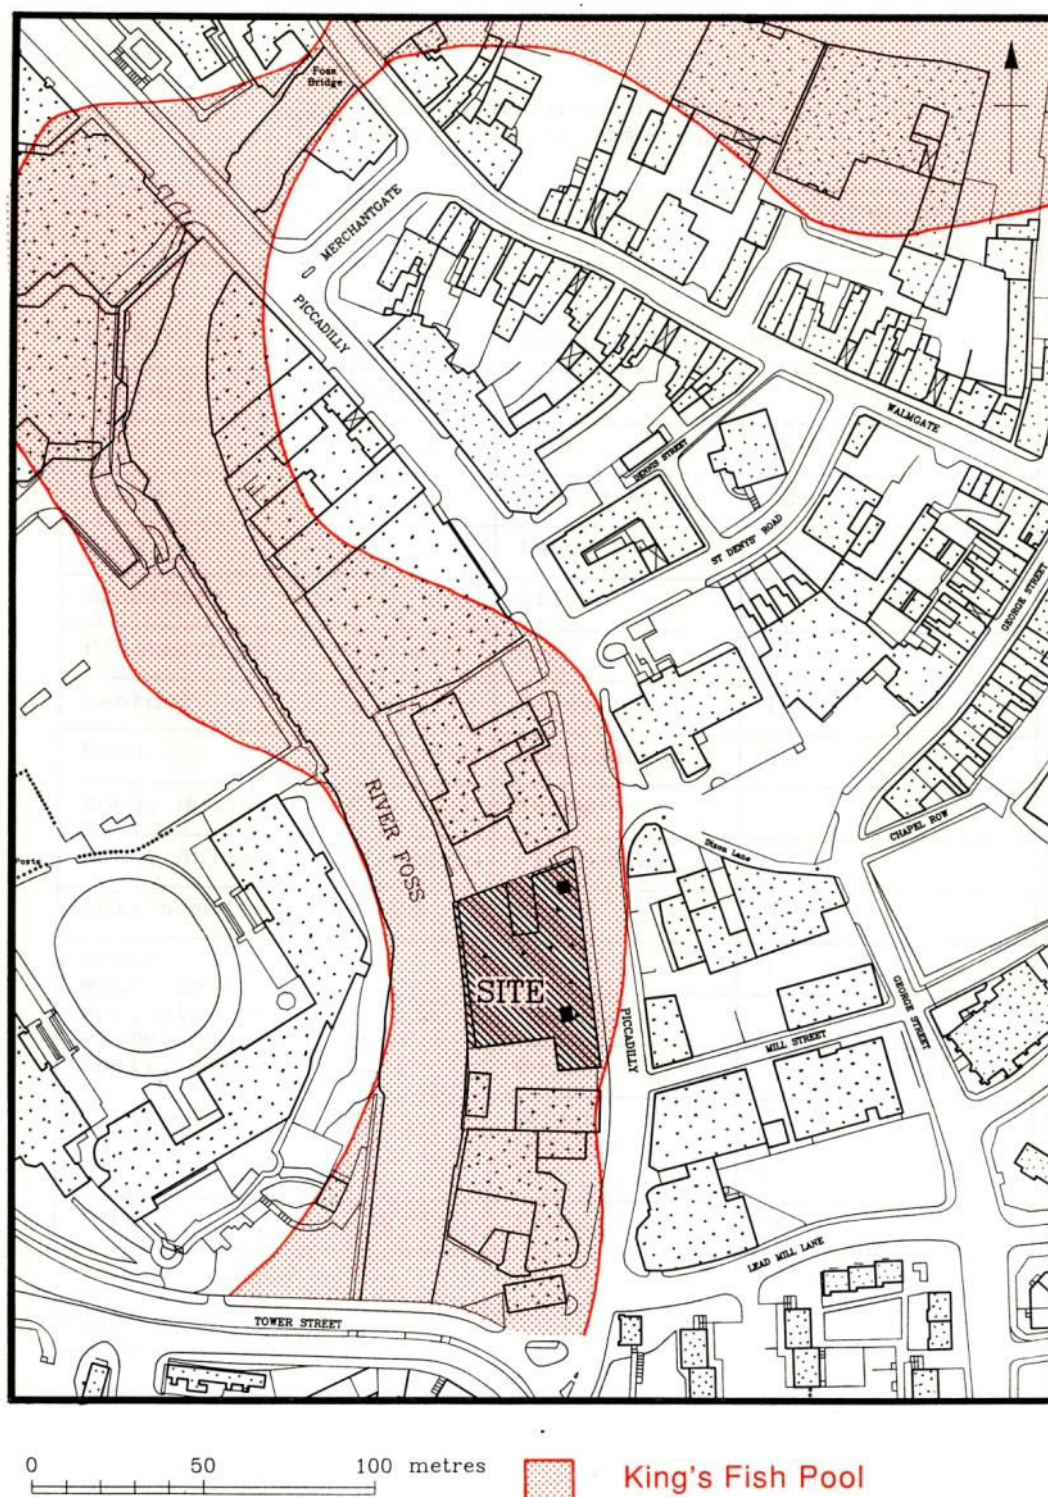
Figure 13 postulated extent of King's Fishpool based on excavated evidence (reproduced from YAT Evaluation report for YORYM:1991.16). Note: area labelled 'site' is that of 86 Piccadilly

The landscape of the River Foss was drastically altered by the damming of the southern end of the river at Castle Mills by William the Conqueror to exploit its waters to feed the moat of the Norman castle at York (VCHY 1961, 509–510; Figure 6). The resulting body of water was called the *Stagnum Regis*, the King's pool. The dam of the Fishpool of the Foss probably provided a causeway across the Foss at the site of the modern Castle Mills Bridge. The first documentary evidence for a bridge at Castle Mills is not until 1585 and the structure was destroyed during the Siege of 1644 (VCHY 1966, 519–520; Raine 1955, 196). Cartographic evidence, as well as evidence from the excavations at 38 and 84 Piccadilly show that the area which now forms the west side of Piccadilly was largely flooded by the creation of the Fishpool and remained so for much of the late medieval period, during which time the King's Fishpool gradually silted up and some of the land formerly flooded reclaimed. The series of maps reproduced in Figures 6 and 13 and historic maps Figures 7–9 show the areas flooded based on archaeological and cartographic sources and the gradual change in area taken up by the King's Pool during the early modern period.

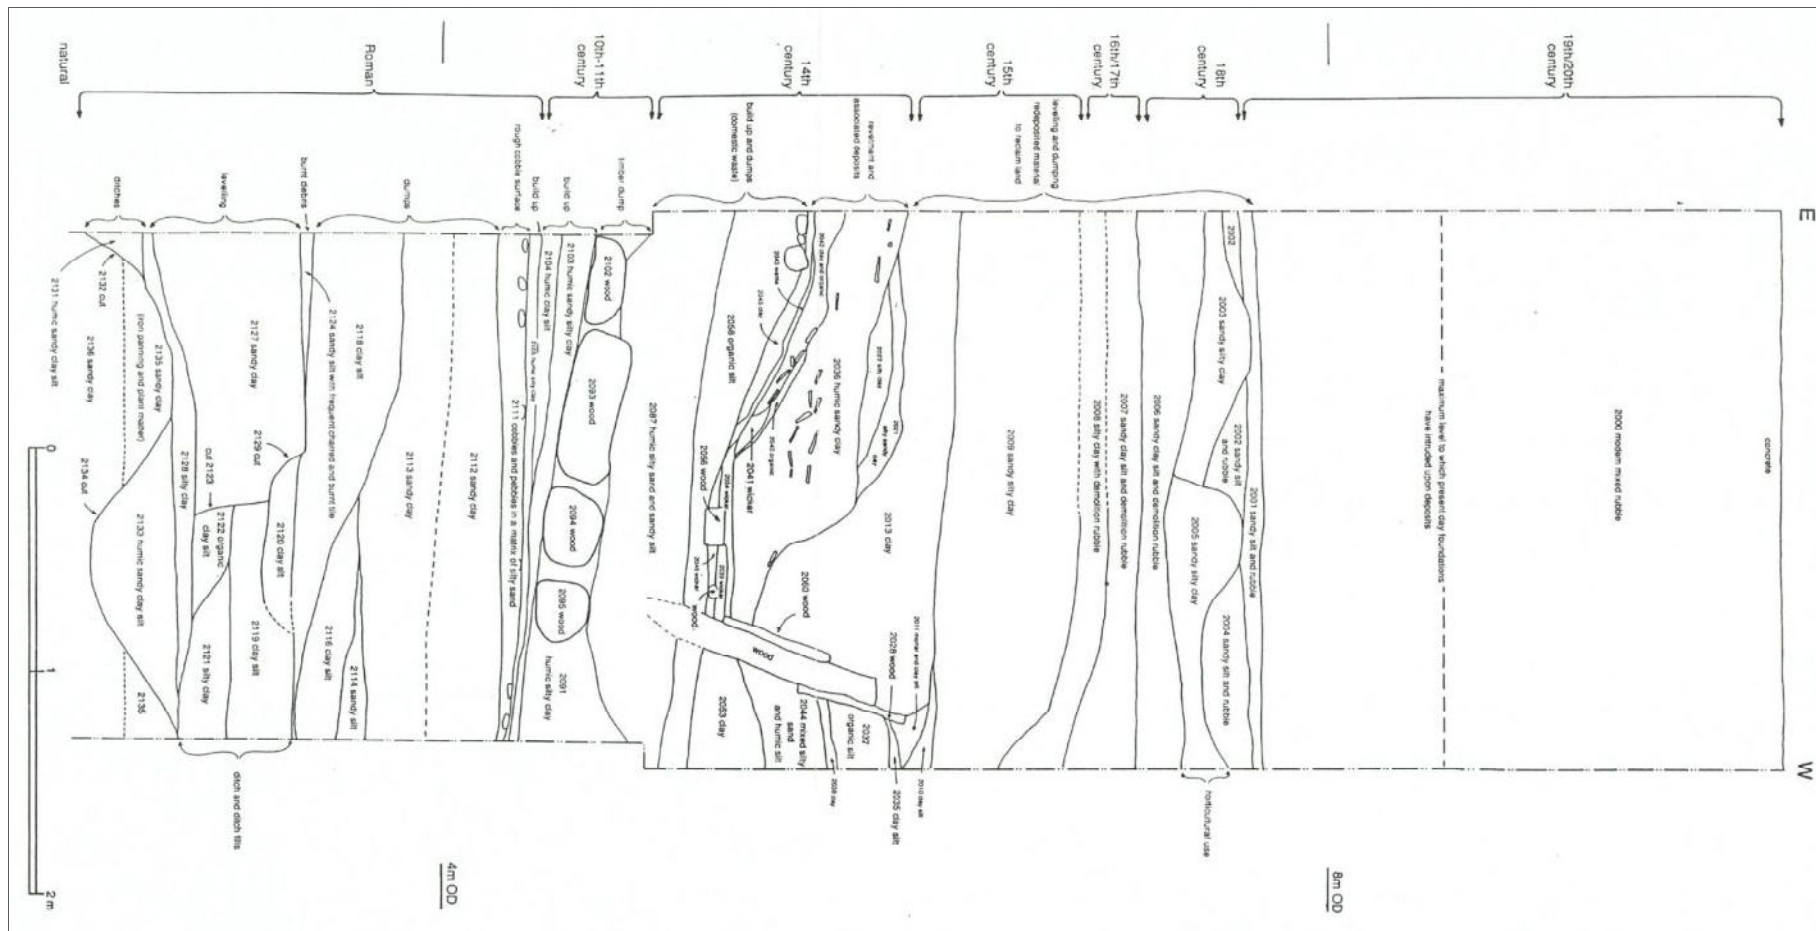
Figure 14 North-facing section through 1992 trench (reproduced from YORYM: 1992.10; YAT Report 1992/14)

The maximum impact of 1950s foundations according to the excavator of the 1992 investigation is approximately 8.5m OD or 1.5m below present ground level (Finlayson 1992, Figure 2). No further information could be found regarding the nature and depth of the 1955 building foundations. It is assumed therefore that the building foundation was not piled and that intrusions into the deposits below are presently minimal.

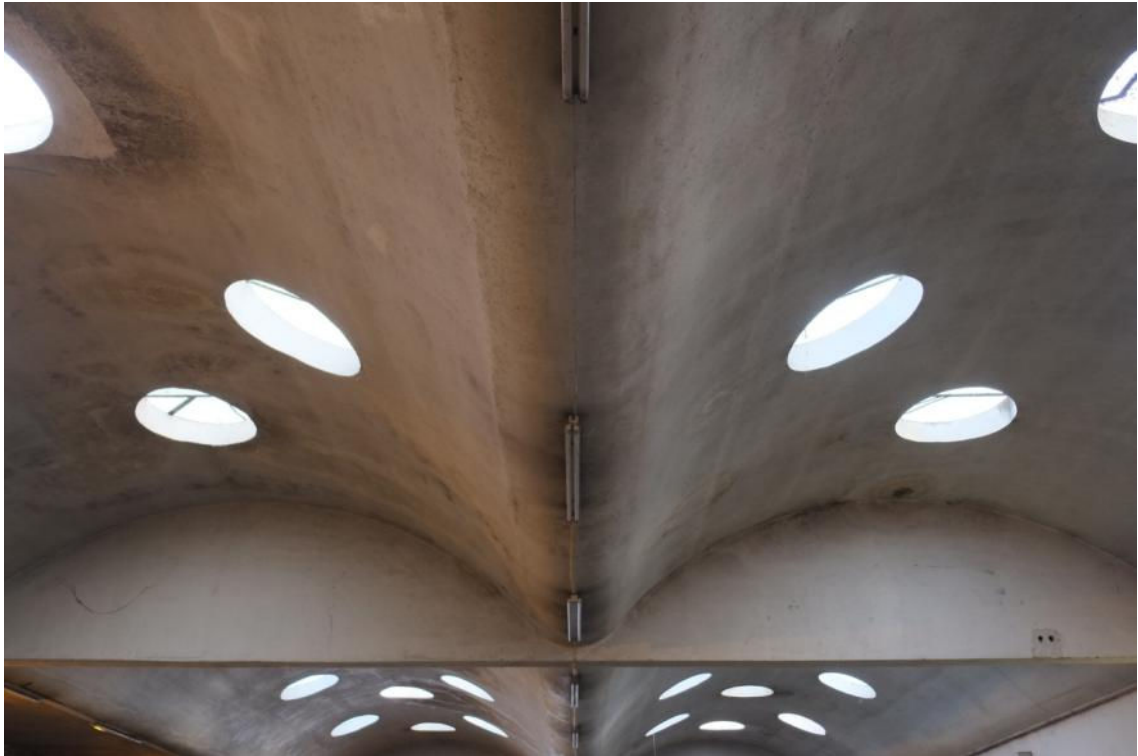
Plate 3 Roof structure with circular portal sky-lights

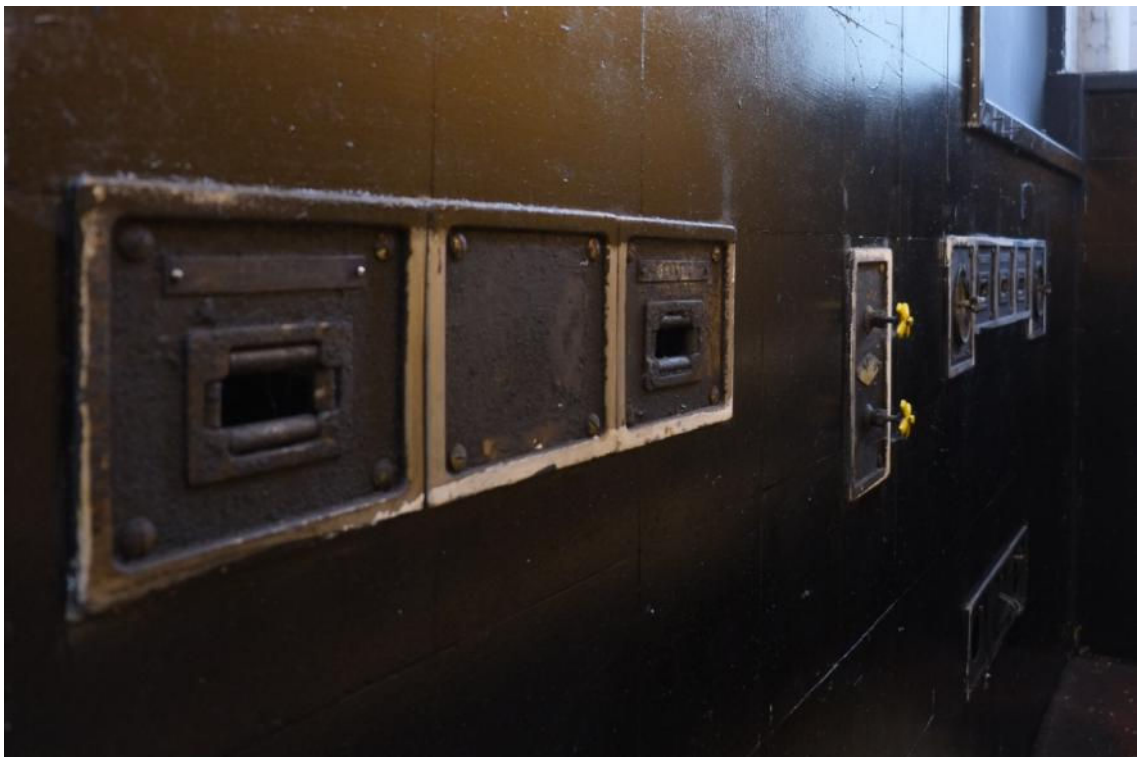
Plate 4 Fixtures relating to former garage

Number 46–50 Piccadilly was built as a motor garage in 1955 (Appendix 3) and evidence of this former use is present in both the internal layout of the building and surviving fixtures and fittings (Plates 1–5). An assessment of the architectural merit of these buildings and their historic landscape setting is beyond the remit of this report, however, the building is unusual and as there are few examples of such buildings remaining in York, many others having been destroyed without record investigation and recording of the buildings may be informative.

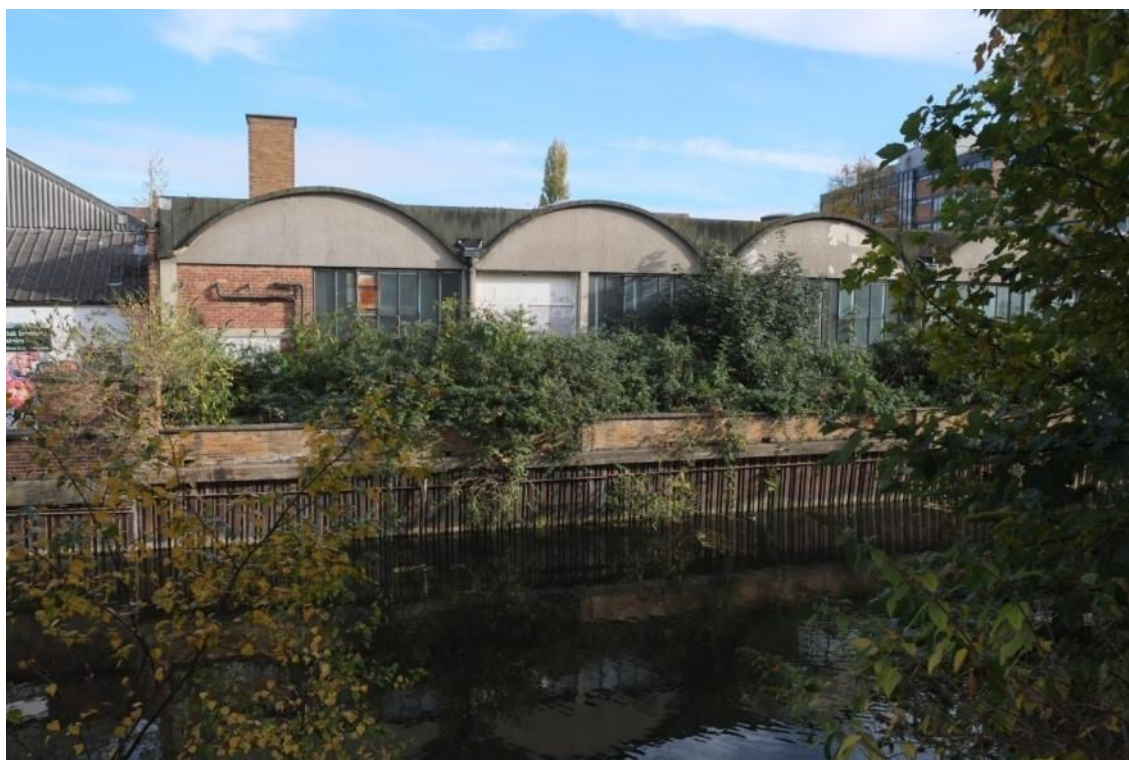
Plate 5 River Foss frontage showing river wall
