Archaeological Investigations at York Station Frontage - Toft's Tower (Tower 13)

YAT Assessment Report 2019/52 April 2019

Between the 8th and the 10th April 2019 York Archaeological Trust conducted a test pit evaluation at York Station Frontage - Toft's Tower (Tower 13) (SE 59647 51549).

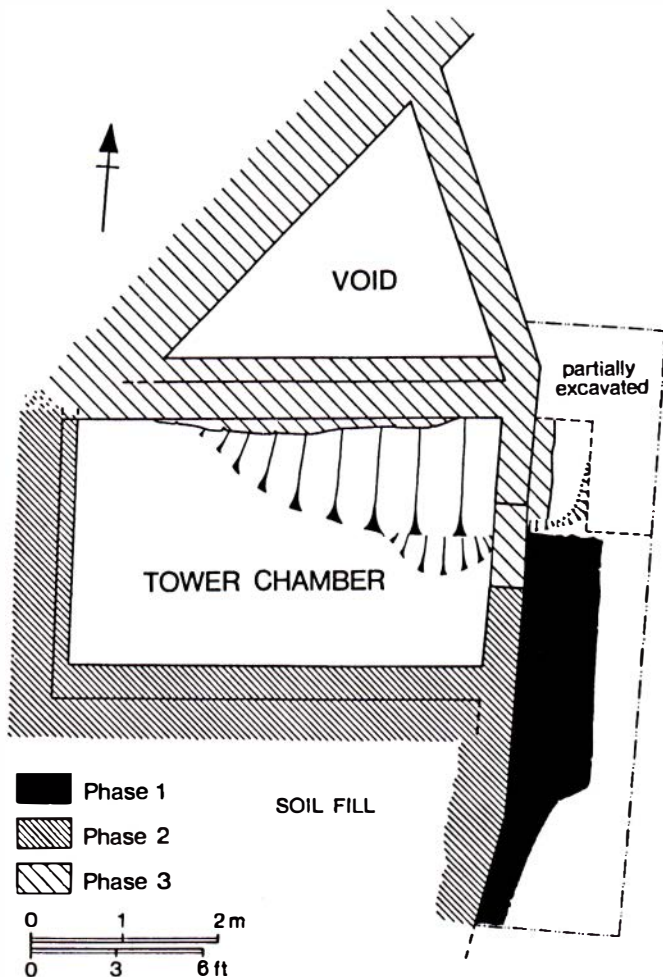
Plan of Tower 13 and the adjacent brick-vaulted void (see p.21)

The earliest structure recovered (Phase 1) survived as a 3.4m length of wall with a rubble and mortar core, faced with Magnesian Limestone. Its position shows that the present rear wall of Tower 13 does not follow the original line, but too little survived to give a clear indication of the plan of the structure it belonged to. No associated dating evidence was found, and it may belong anywhere from the 13th century to perhaps the 17th century.

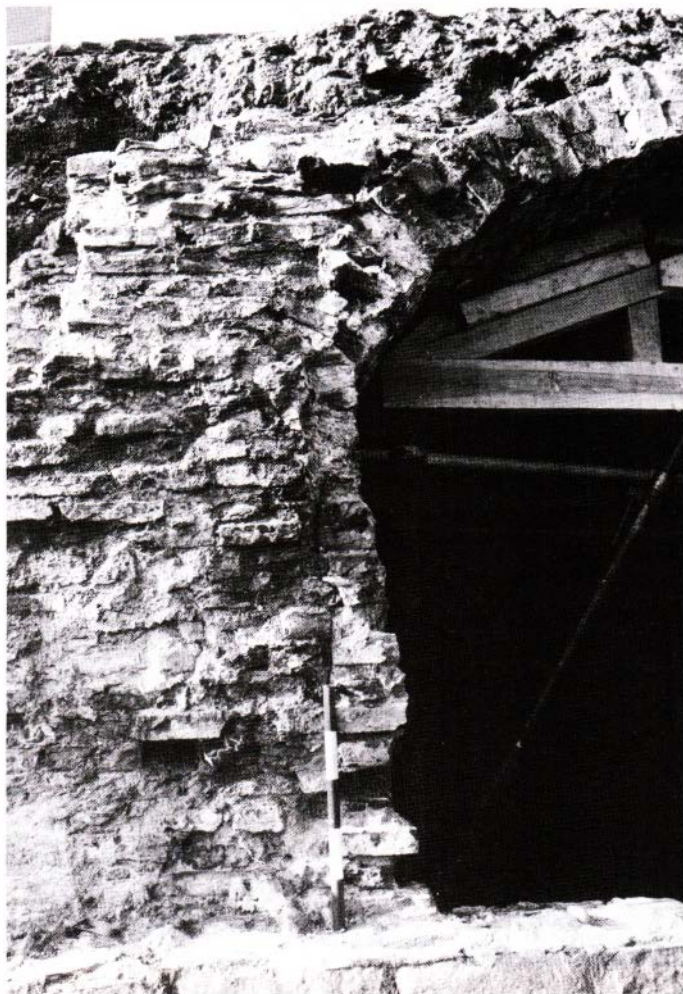
Tower 13 is irregular in plan, containing a rectangular chamber walled and vaulted in post-medieval brick. The fill between the chamber walls and the outer walls' limestone skin varies between earth and rubble. Although not the most inspiring site(!) - a tower in this position is believed to have been demolished after taking a direct hit during the Civil War siege of York - it was hoped that the plan and floor levels of the present, post-medieval tower's medieval predecessor(s) might be recovered.

Tower 13: tower structure - limestone facing, brick vault, earth fill.

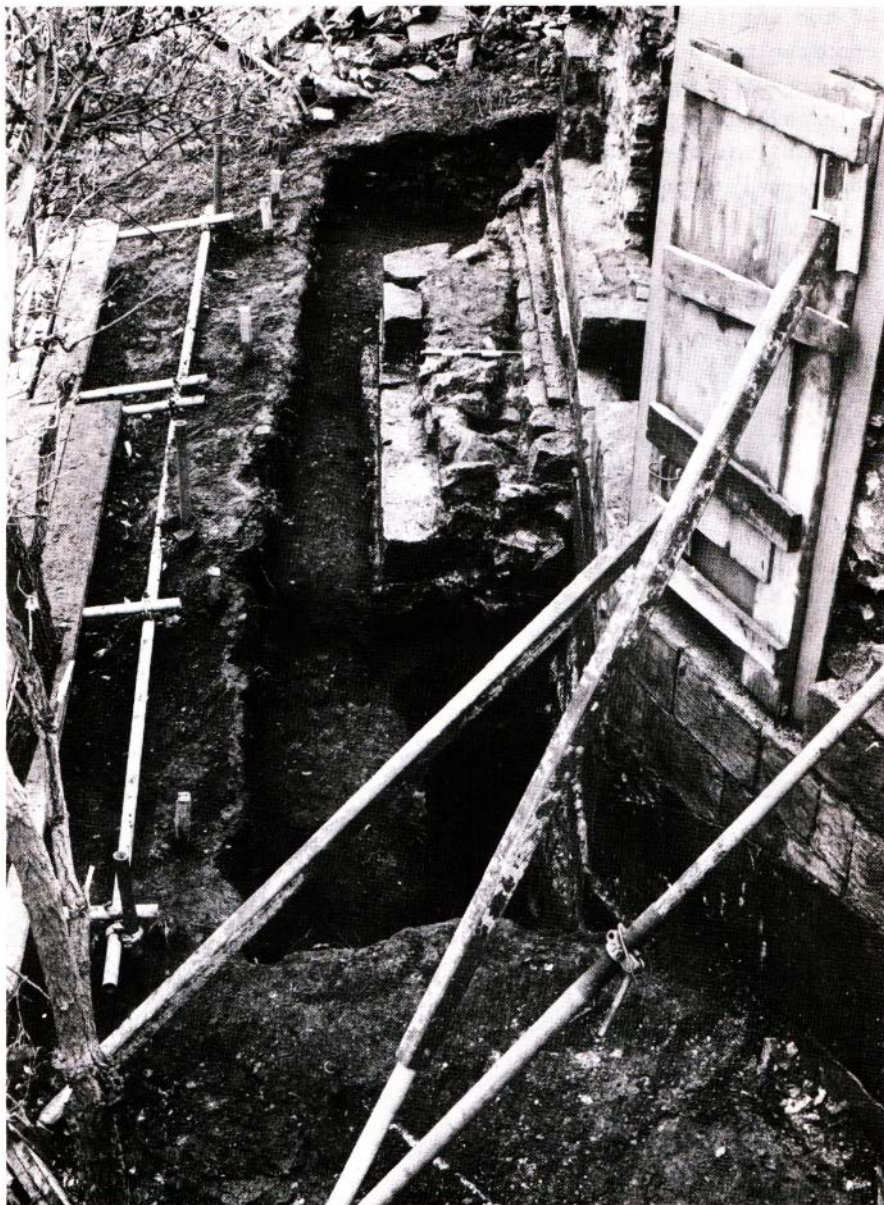
Tower 13: site fully excavated from the north - phase 1 wall, phase 3 cut.

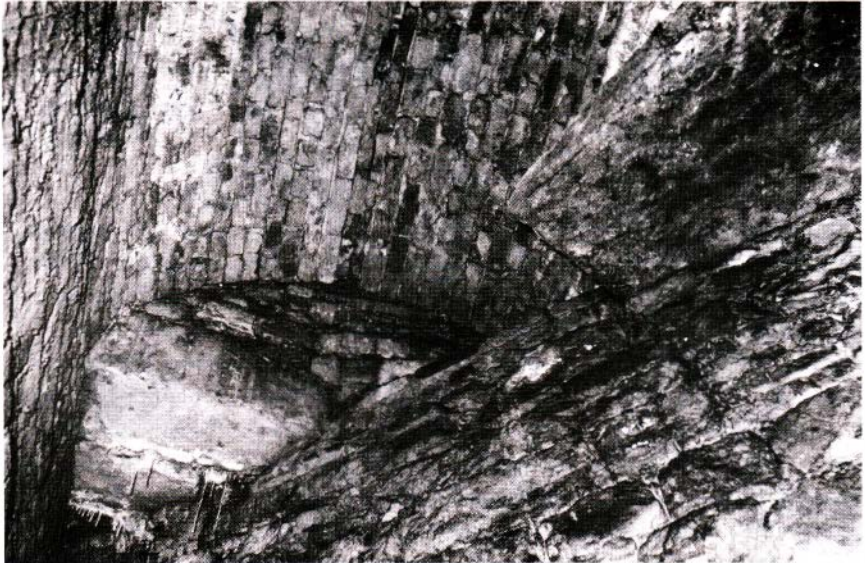
Tower 13: inside view of Victorian reconstruction of the angle in the defences immediately adjacent to Tofts Tower:- the brick vault and it's supports.

In the course of the consolidation work, a feature was revealed which gives an interesting insight into 'corner cutting' by Victorian engineers. North of the tower, a short length of Phase 3 wall runs into and is bonded with the main curtain wall. A poorly-built relieving arch resting on a rotten wooden tie beam carries the wall over the fill of the foundation cut, which has settled, producing a c30cm gap between the base of the wall and the fill. Even more disconcerting is that the space between facing stones and the main curtain is not infilled with rubble or earth so that it is possible to crawl into the hollow in the wall.

This space was never meant to be seen. Access would have been impossible and the stonework inside is unfinished. Is this a case of Victorian 'jerry building' or can INTERIM readers think of a sound engineering reason behind the feature?

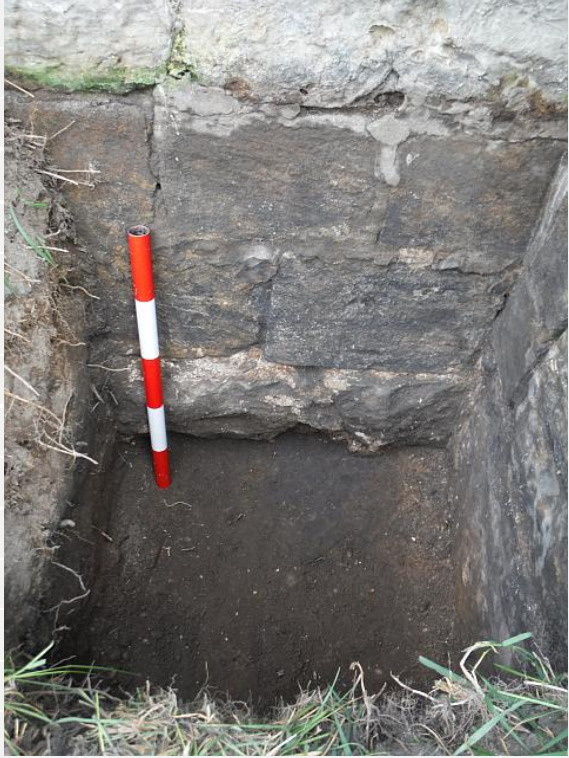
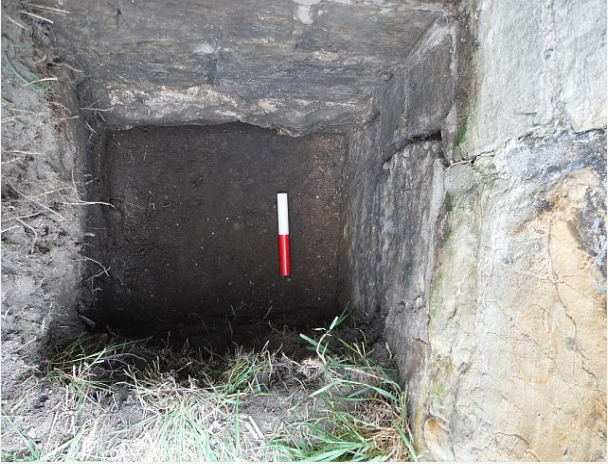
Sketch Section / Photo

Intervention No. TP5	
Time/Date am 08/04/19	
Contexts / Numbers Assigned	
5000	Topsoil - Turf and topsoil, friable/loose, brownish dark grey, sandy silt with modern debris.
5001	Disturbance/Rebuilt rampart - Loose, light brown, sand and mortar with limestone fragments up to 200mm.
5002	Buried surface/Rampart - Soft, dark to light grey silt and ash.
5003	Construction Spread - Firm, light brownish yellow, mortar.
5004	Rampart - Soft, orangey brown, silt sand with medieval tile
5005	Wall footing - Rough-hewn limestone blocks with light brownish yellow mortar.
5006	Wall - Smooth-faced rectangular limestone blocks with various mortars.
5007	Wall projection cut - Possible construction cut for wall projection. Not excavated.
5008	Wall projection foundation 5006
5009	Wall projection - see 5006
Notes	
580mm x 550mm x 600mm deep. Grid ref. 459652.7 451540.0	
<p>The projection where the wall becomes wider was assumed to be later. This conclusion was made because the foundations are deeper and thus 'reinforce' the wall. This addition has been keyed into the main wall from the base.</p> <p>A construction spread sealed the projection construction so it may be a single continuous build.</p>

Facing northeast

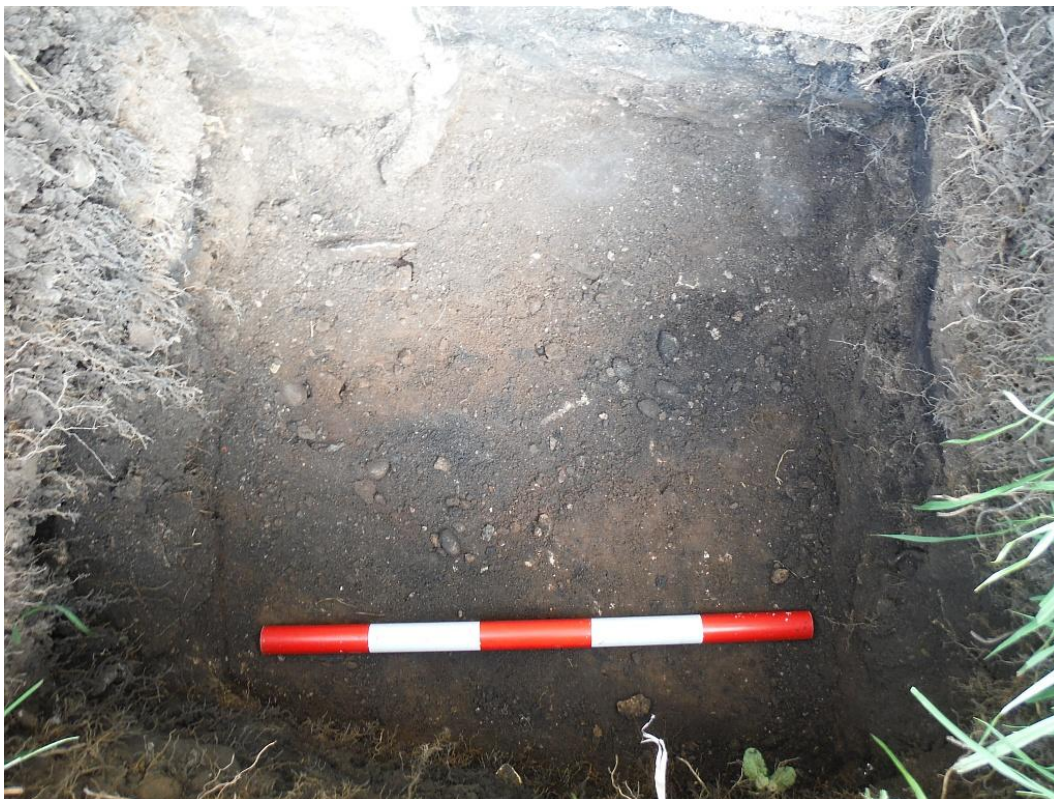
Plate 1 Disturbance from animal burrows in Test Pit 5, facing northeast, scale unit 100mm

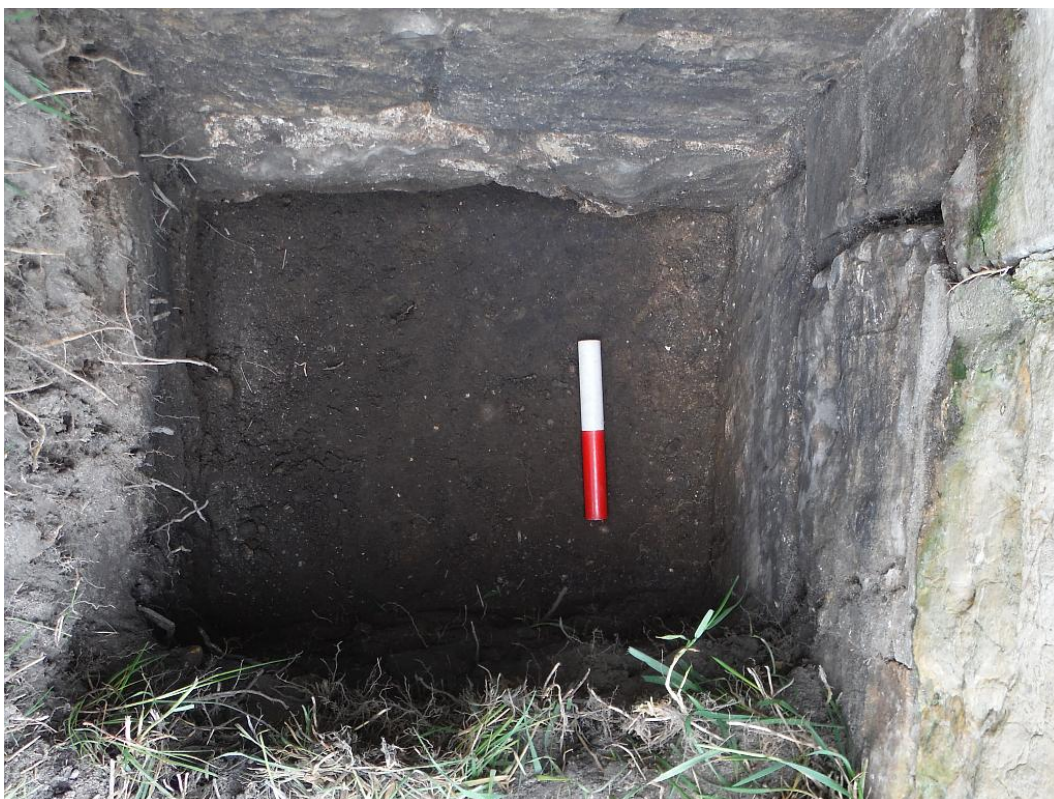
Plate 2 Test Pit 5 projection construction cut, facing northeast, scale unit 100mm

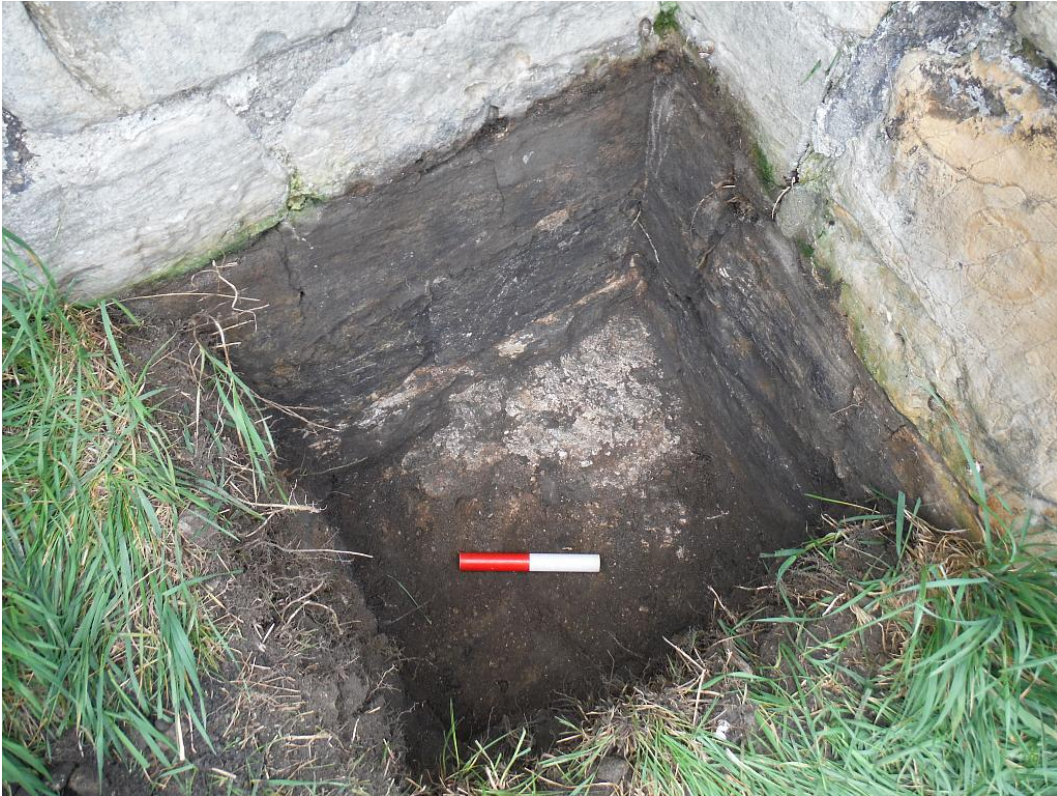
Within the angle of the two walls, at 500mm BGL was a firm mortar construction spread (5003) up to 100mm deep (Plate 3). This was sealed by 200mm of light grey ashy silt buried surface/rampart material (5002). The grey colour may have come from degraded buried organic material. It was interpreted that these were linked with the construction of the later projection and replacement/rebuilding of the rampart up against it.

Plate 3 Test Pit 5 construction spread, facing east, scale unit 100mm

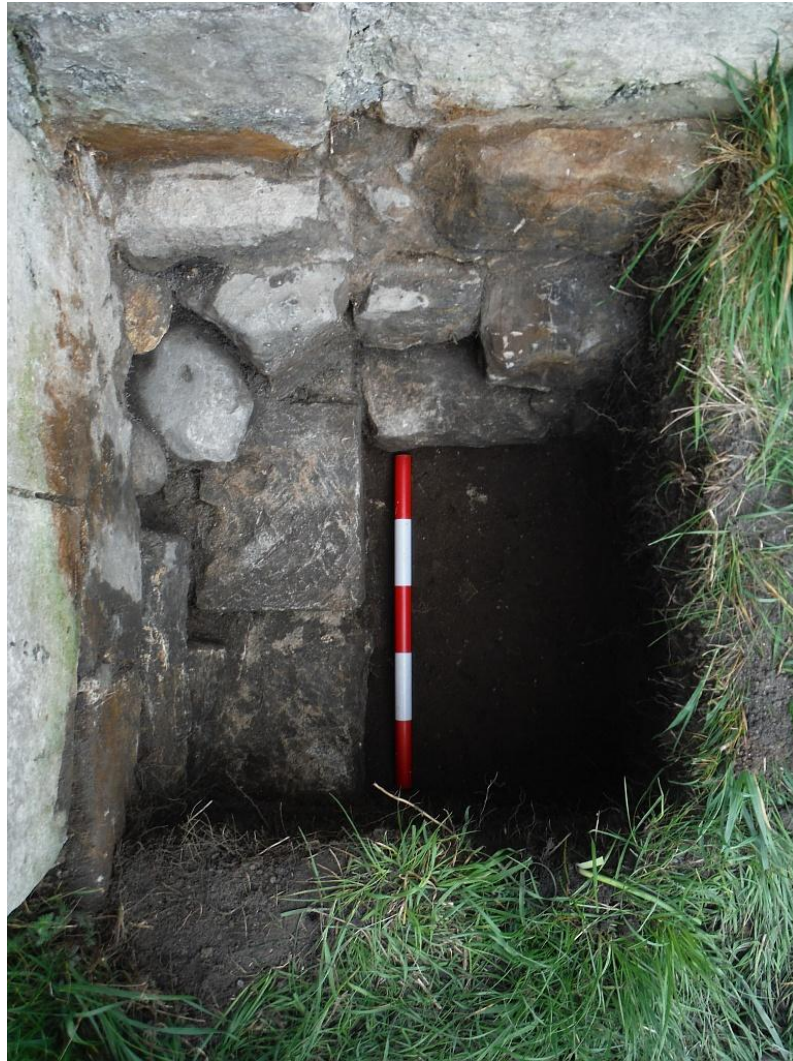
Plate 4 Test Pit 6 Buttress left of the scale, facing northeast, scale unit 100mm

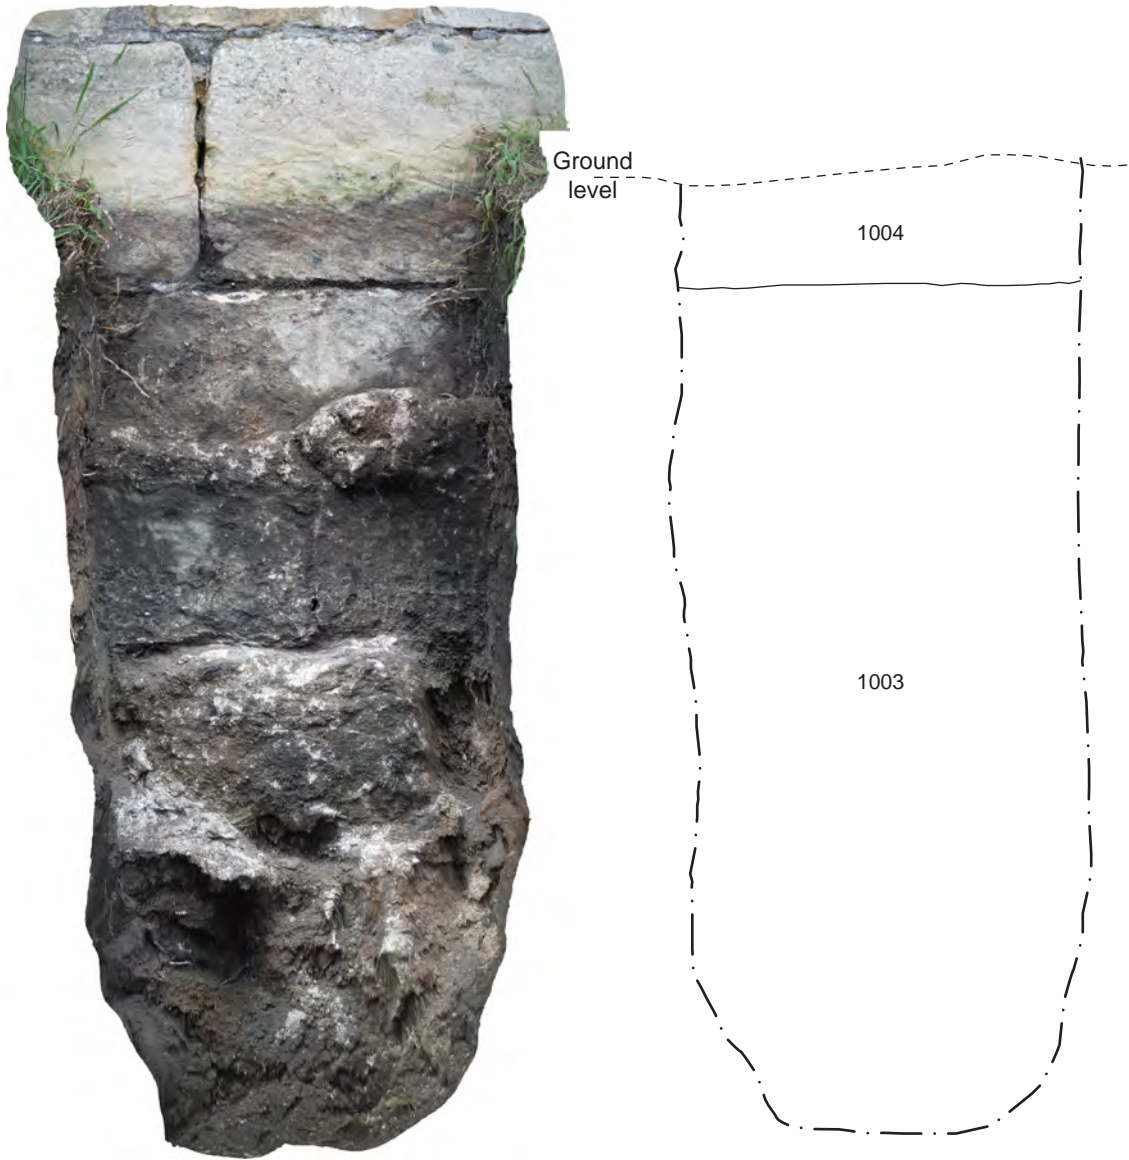
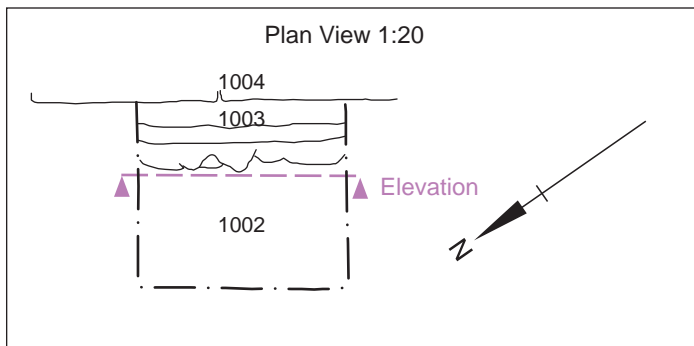
Figure 3 Test Pit 1 @A4

5.1.1 *Test Pit 1 550mm x 500mm, 1300mm deep. Investigating external foundations of City Wall northeast of Toft's Tower (Figure 3)*

The earliest deposit encountered was the 19th century wall foundation (1003) which extended beyond the limit of excavation. The lowest section was made up of rounded limestone blocks bonded with light grey mortar. Higher up the blocks were more regular and 'faced'. On top of this was the wall itself (1004) with smooth-faced limestone blocks that had been formally 'pointed up' as they were to be above ground and visible.

Up against the lower part of the foundation, up to 600mm BGL, there was a deposit interpreted as rebuilt rampart (1002). This was orangey brown clay/silt sand with mortar and clay lumps. This appeared to be disturbed when compared with the medieval rampart elements observed in other test pits and was assumed to have been disturbed during the 19th century wall rebuild. This was sealed by 500mm of soft, dark grey silt sand which contained several fragments of post-medieval brick (1001). Again this deposit was linked with the 19th century wall alterations.

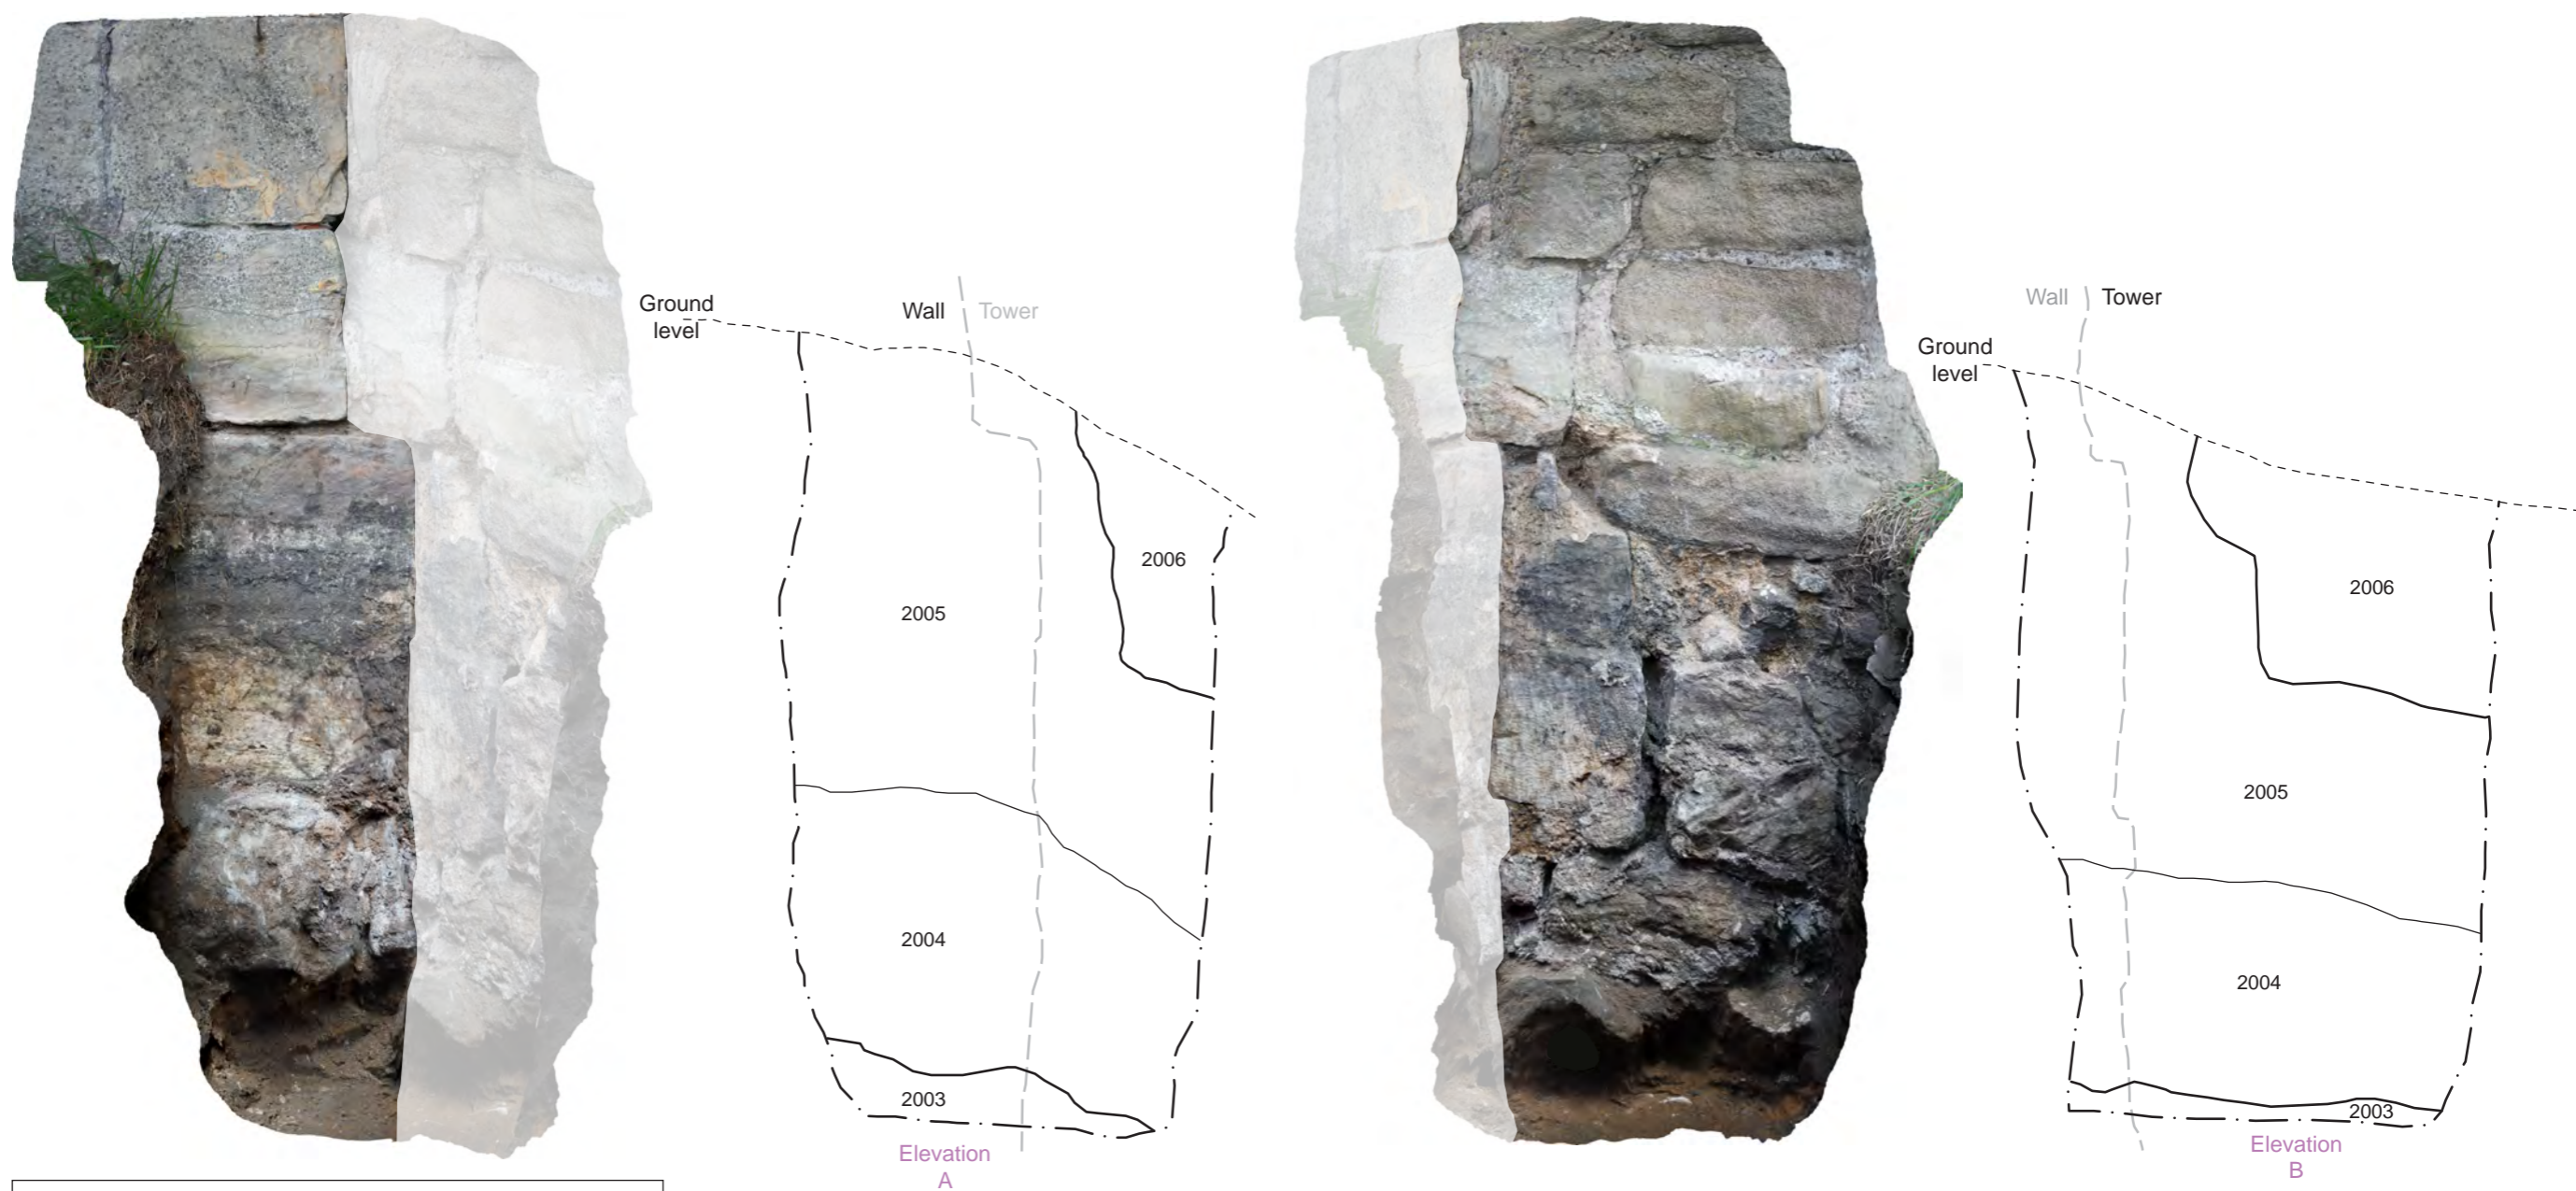
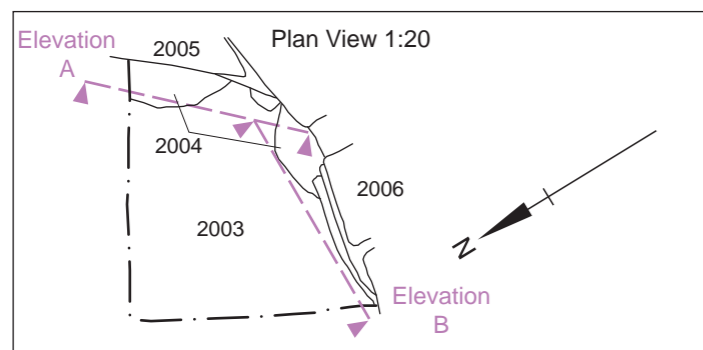
Figure 4 Test Pit 2 @A3

5.1.2 *Test Pit 2 c.650mm x c.650mm, 1100mm deep. Investigating external foundations of City Wall junction with northwest face of Toft's Tower (Figure 4).*

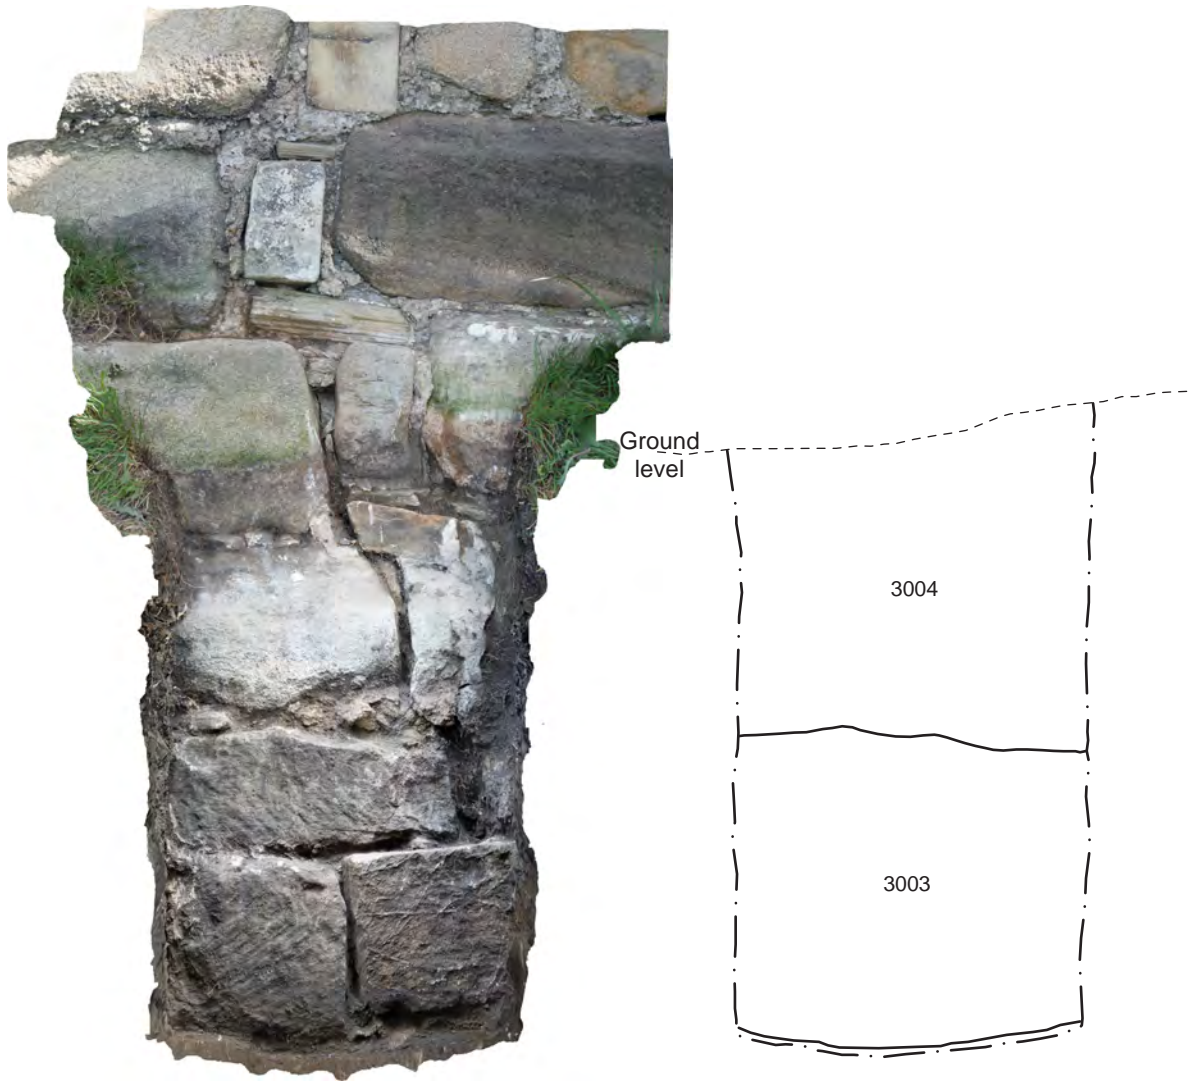
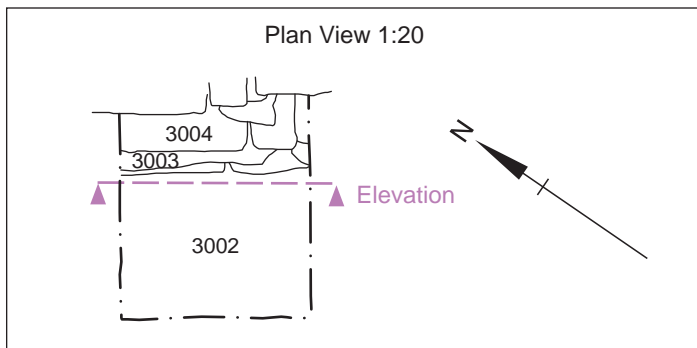
Figure 5 Test Pit 3 @A4

5.1.3 Test Pit 3 550mm x 500mm, 700mm deep. Investigating external foundations of southwest face of Toft's Tower (Figure 5).

On top of the foundation was the 17th century tower rebuild (3004). It was constructed in the same manner as seen in Test Pit 2, with gritstone, limestone and oolitic limestone. Later repairs were clearly visible in the structure. Against the tower rebuild and probably earlier footings was 500mm of disturbance and rampart rebuilding deposits (3001). This was again similar to the post medieval disturbance in Test Pit 2: loose, orange brown, gritty sand with large limestone and oolitic limestone fragments.

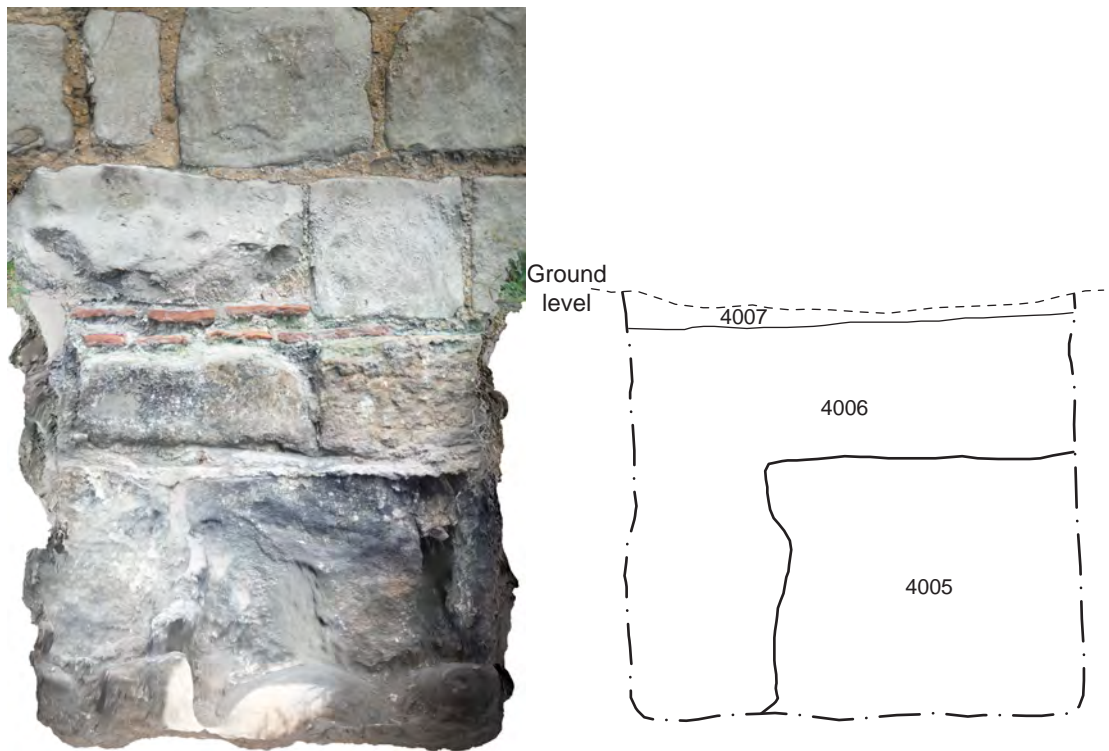
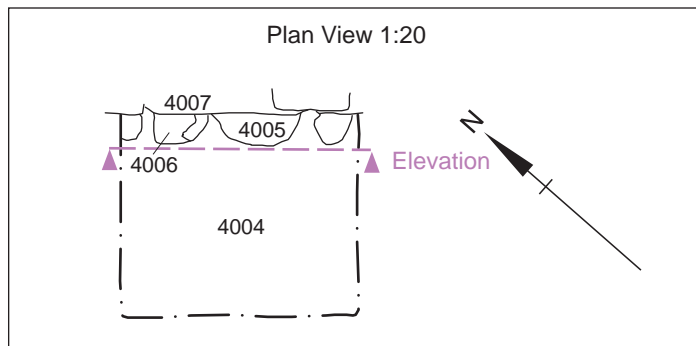
Figure 6 Test Pit 4 @A4

5.1.4 Test Pit 4 620mm x 540mm, 630mm deep. Investigating possible change in external foundations of City Wall southeast of Toft's Tower (Figure 6).

Cutting into the earlier foundations and deposits was the post medieval rebuild of the wall. The footing (4006) was smaller cobbles and a rectangular limestone block bonded with a hard mortar. The wall on top (4007) was rectangular limestone blocks, some rougher than others, as well as occasional re-used medieval tile and post-medieval brick. Against the rebuild was a 100mm thick layer of sand and mortar with limestone fragments (4001). This was interpreted as disturbance and/or rebuilding of the rampart linked with the building works.

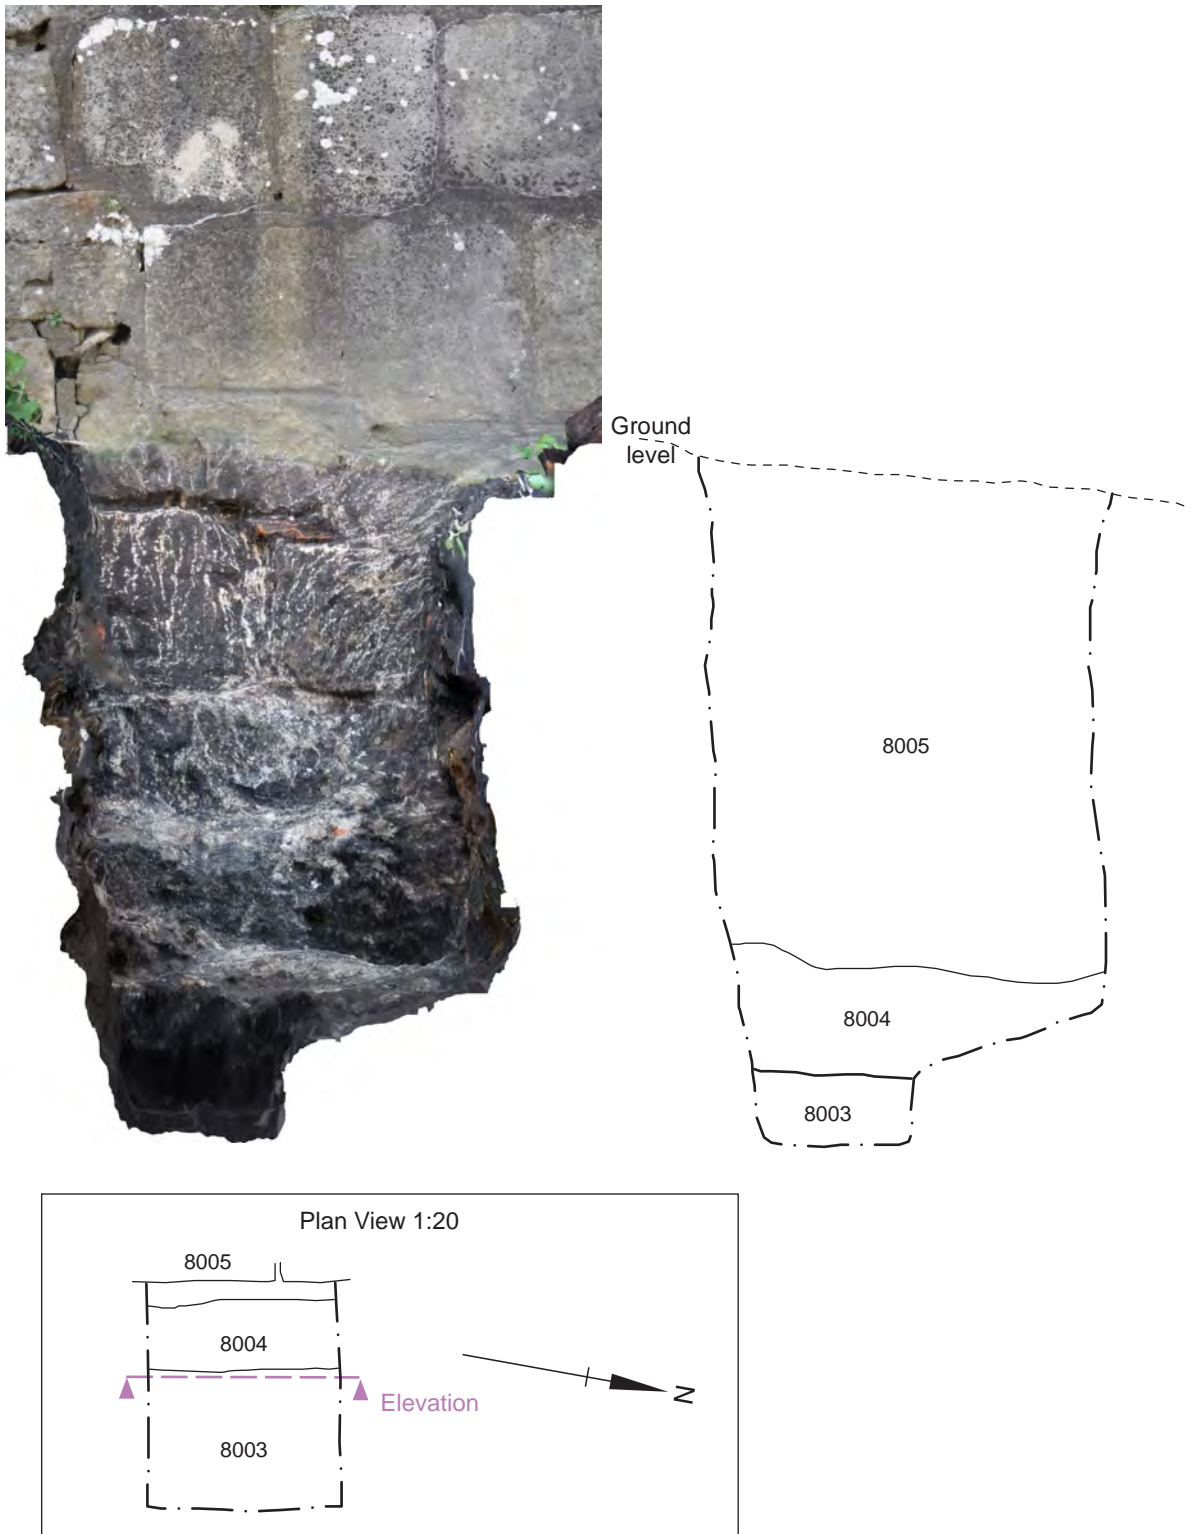
Figure 10 Test Pit 8 @A4

5.1.8 Test Pit 8 600mm x 500mm, 900mm deep. Investigating foundations on internal side of Toft's Tower (Figure 10)

On top of the rampart was the footing for the rebuild of the tower. This was rough-hewn limestone blocks with a light grey mortar (8004). The wall of the tower (8005) was rectangular limestone blocks. Up against the wall and foundation was a construction spread/rebuild of the rampart (8002). This material was a mixture of mortar spreads and orangey brown silt between 500mm and 820mm BGL. It contained several post-medieval brick fragments, 52mm-56mm thick, which would correlate with the 17th century rebuilding of the tower.

From 100mm to 400mm BGL was loose, brownish dark grey, sandy silt with limestone and mortar fragments (8001). This may have been further disturbance from the 17th century, disturbance during the 1830's repair and renovation works, or even disturbance from the 1985 excavations during reinforcement of the tower.
