Archaeological Investigations at St Mary's Church, Ecclesfield

By C. Jackson-Slater

YAT Assessment Report 2020/135 November 2020

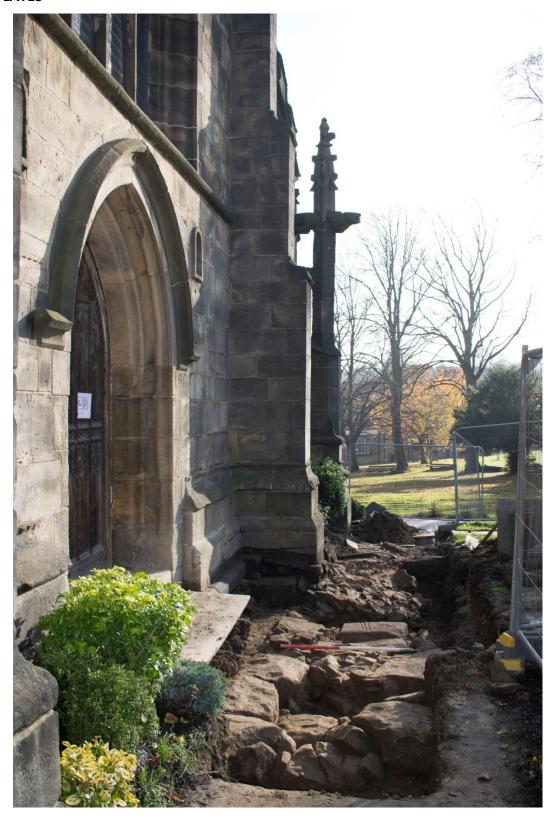
Plate 1 View of site, south facing

The earliest feature recorded was a stone foundation (C1028; Figure 6; Plates 1-2), extending almost the full length of the excavation area and measuring 6.26 x 1.6m, at depths of 88.39m to 88.20m AOD. The foundation was formed from sandstone, predominantly unworked apart from around six large stones with roughly hewn straight edging along one side, which formed the east and west edges of the structure at the northern end. In addition, three carved stone fragments also formed part of the foundation. The construction at the northern end was formed from large stones, laid flat, measuring a maximum of 1 x 0.68+ x 0.24m. These large stones were then packed around with smaller rocks, measuring around 0.10 x 0.11 x 0.10m. At the southern end the construction changed; the foundation in this part was formed from numerous small to medium sandstone fragments, randomly arranged, and extending under the foundations of the church. The foundation was loosely mortared together with a lightyellow brown slightly silty sand with chalky limestone inclusions A large gap in the stones at the northern end, measuring 0.75m diameter could be the cut for a large posthole; however, it could also be a space for a large foundation stone, now removed.

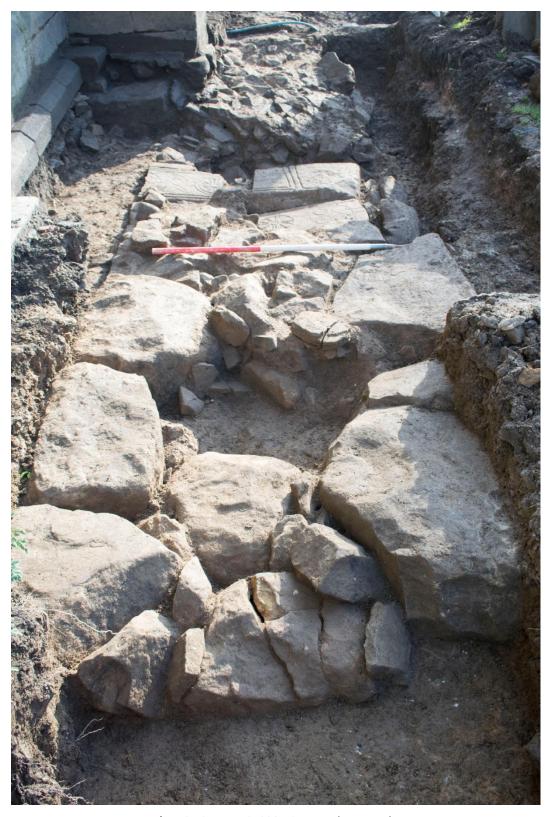
Plate 2 Context C1028, view south, 1m scale

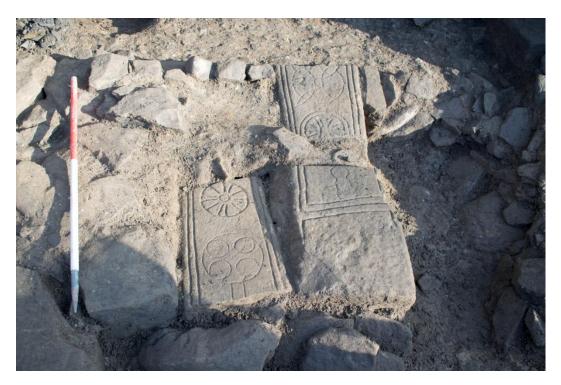
Plate 3 Fragments of decorated cross shaft, view east, 1m scale

The three carved stones found within the structure are of interest (Plates 3-11). They look to be three fragments of the same cross shaft (Plate 10), with one of the fragments clearly the base (Plates 5-7). The stones measured between 0.62 x 0.40 x 0.33m and 0.44 x 0.40 x 0.33m and were carved on all four sides, with a similar incised edging pattern as the cross shaft found in 1893. One of the patterns on the cross was of interlacing circles, typically 12<sup>th</sup> century in date (Plate 9), though there are possible indications that this is a later addition to an earlier Anglo-Saxon cross (Hugh Willmott, pers comm.).

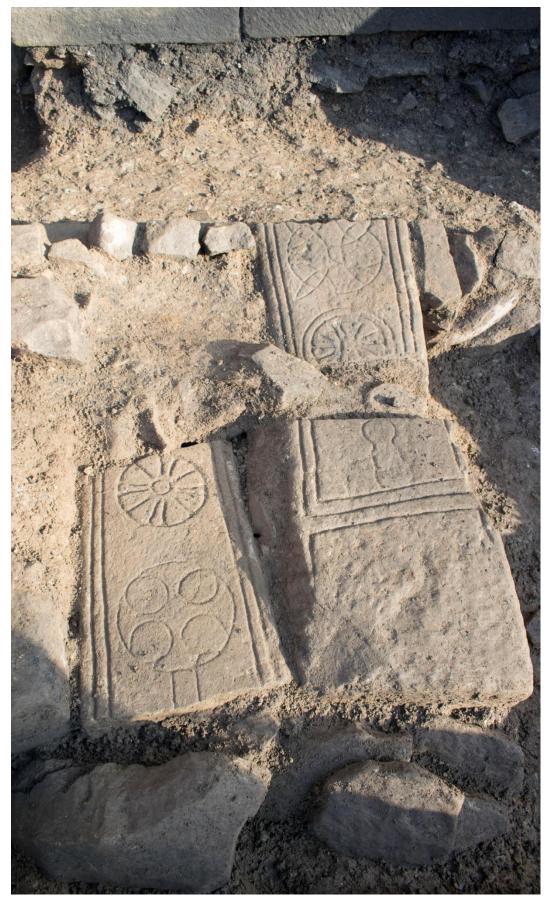
Plate 4 Decorated cross shaft in situ

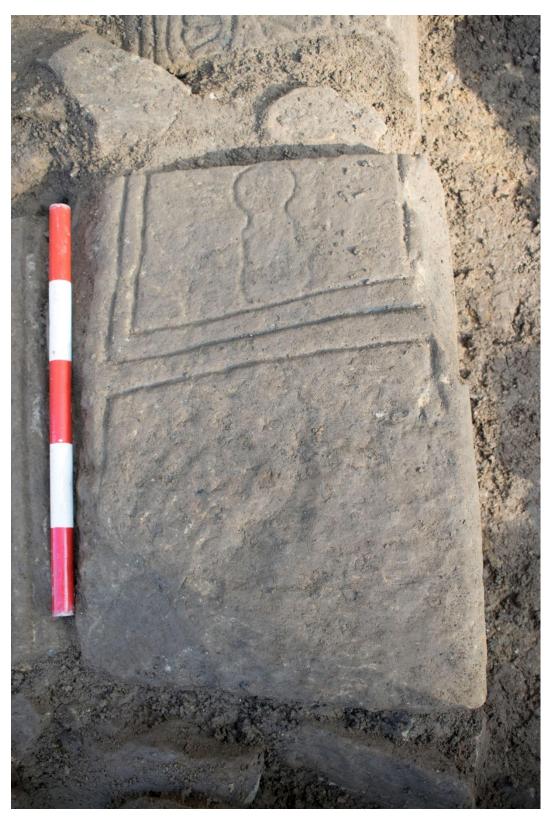
Plate 5 Base of cross shaft, 0.5m scale

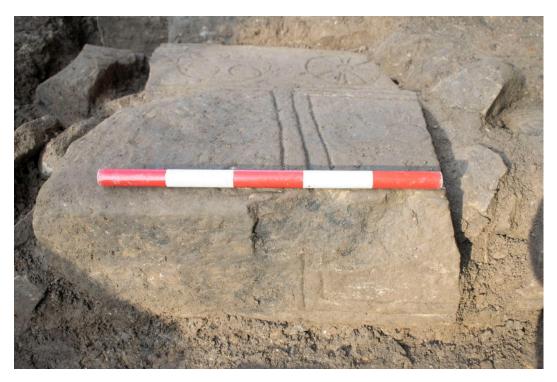
Plate 6 Side of base stone, 0.5m scale

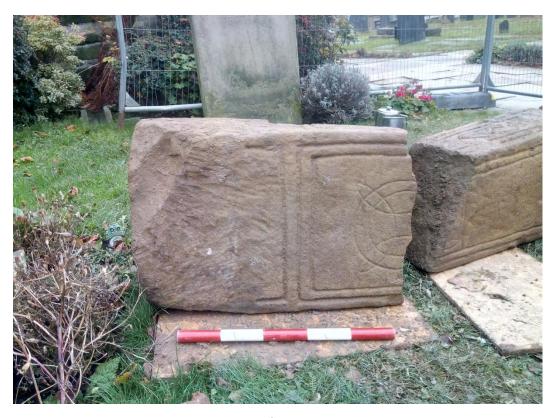
Plate 7 Underside of base stone, 0.5m scale

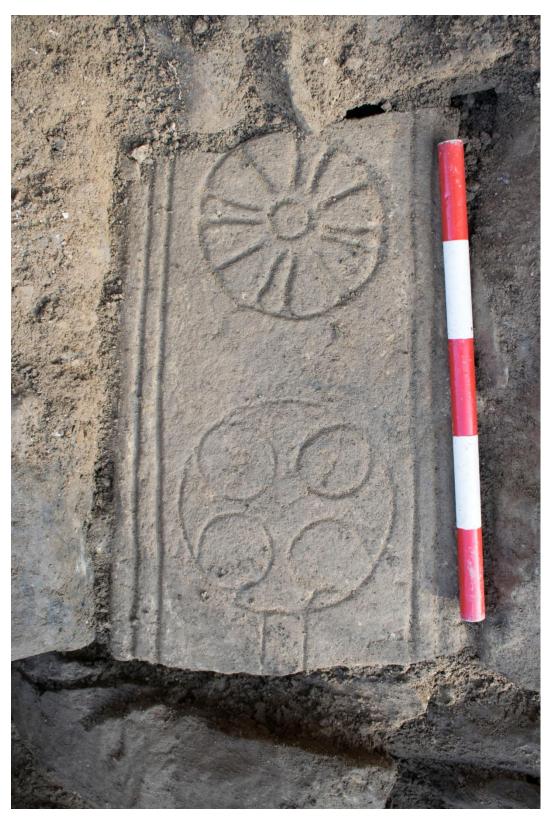
Plate 8 Second fragment of decorated cross shaft, 0.5m scale

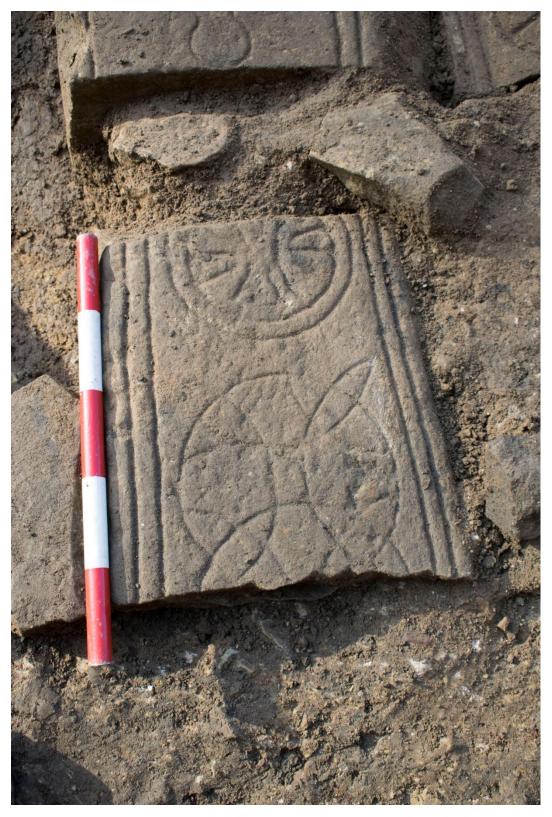
Plate 9 Third fragment of decorated cross shaft

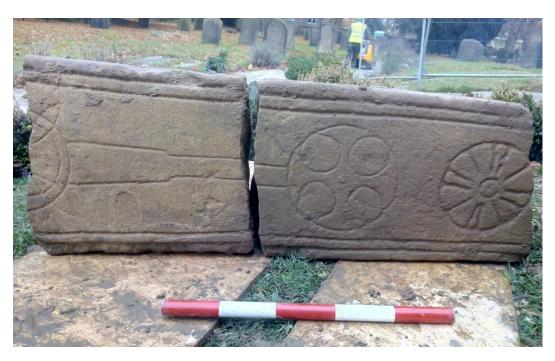
Plate 10 Fragments 2 and 3 joined, 0.5m scale

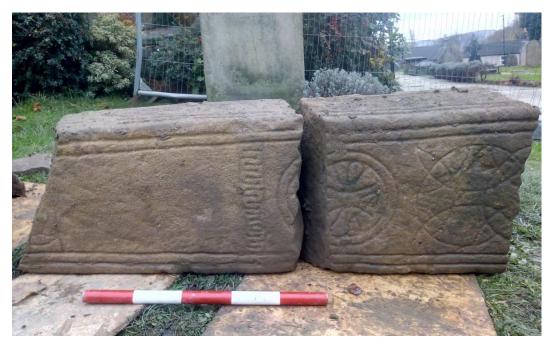
Plate 11 Underside of fragments 2 and 3 of cross shaft, 0.5m scale

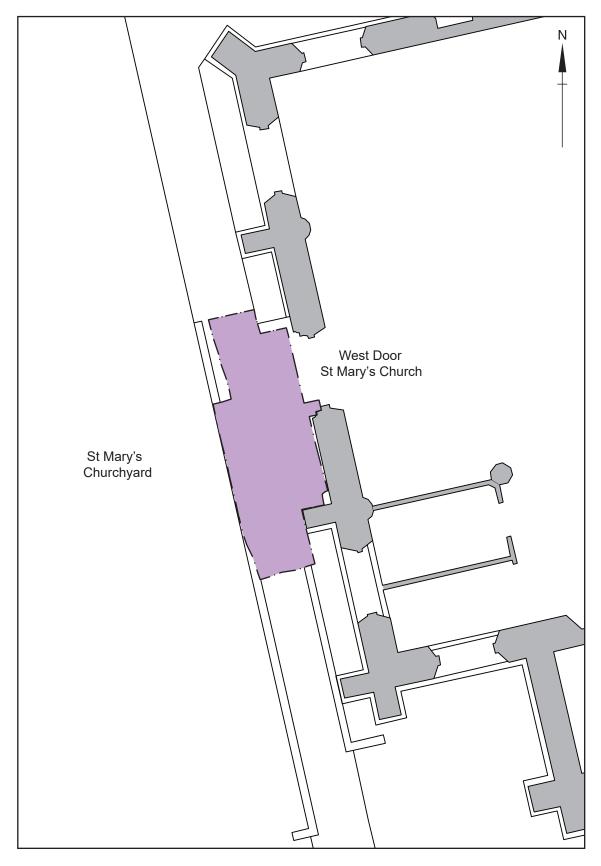
scale 1:1000 Figure 2 Works Location (using plan provided by client, Drawing no. (A) Plan of west end-ECC:03/310 Revision B)

The excavation covered a total area of 17.5m<sup>2</sup> (Figure 2), and was focussed on the area where burials and stone foundations had been uncovered during an earlier watching brief. In response to this Hugh Willmott, the DAC Archaeological Advisor, provided advice on how the excavation was to proceed;

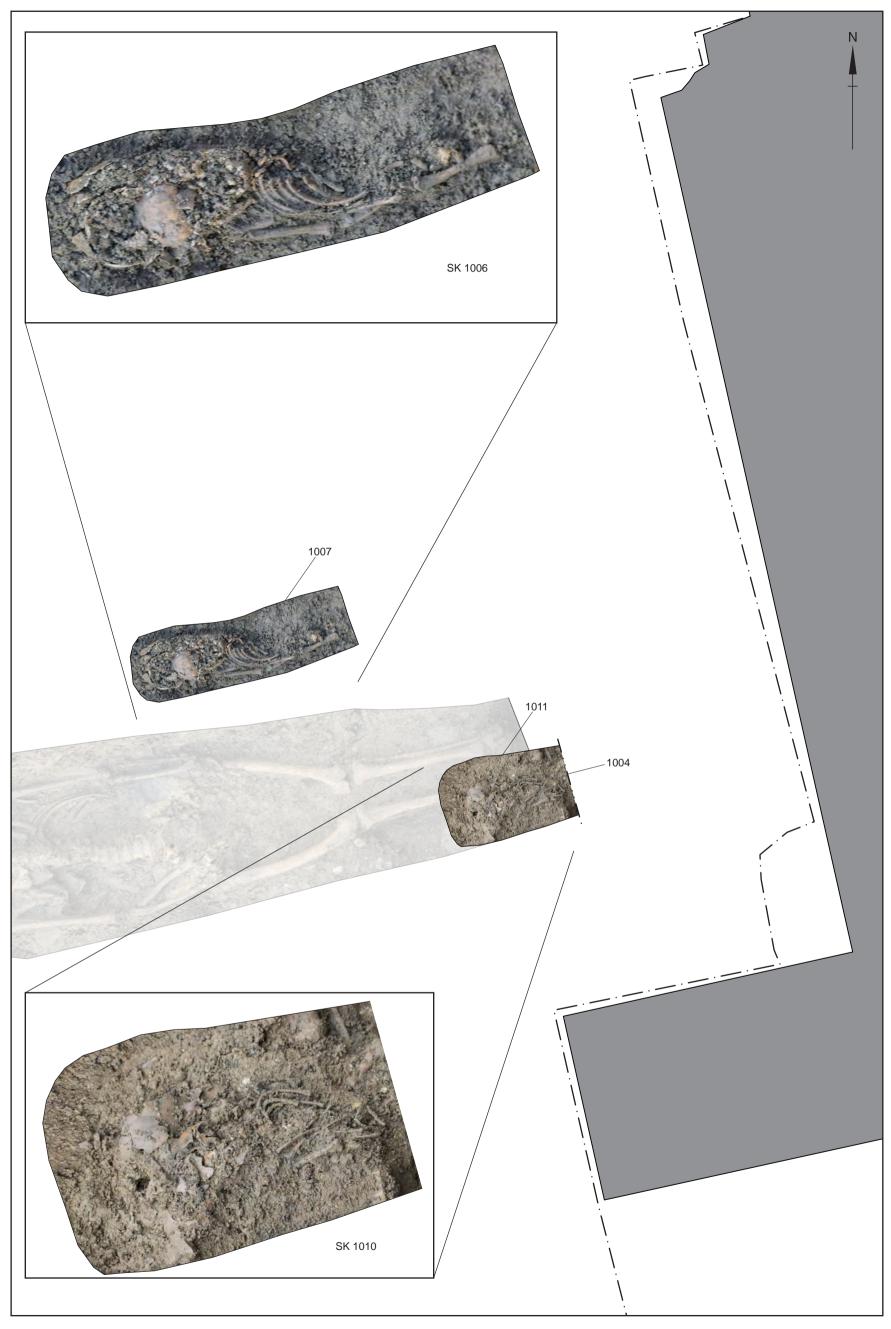
scale 1:100 Figure 3 Burials C1007 and C1011

Cut into layer C1028 were seven graves, (cuts 1002, 1007, 1010, 1014, 1017, 1020 and 1024; Figures 3-5), containing adult to potentially neonate remains. The graves were on a roughly east/west alignment, in line with the church, with the heads facing west. Shroud pins were found on the majority of the burials, as well as coffin nails in the surrounding grave fill.

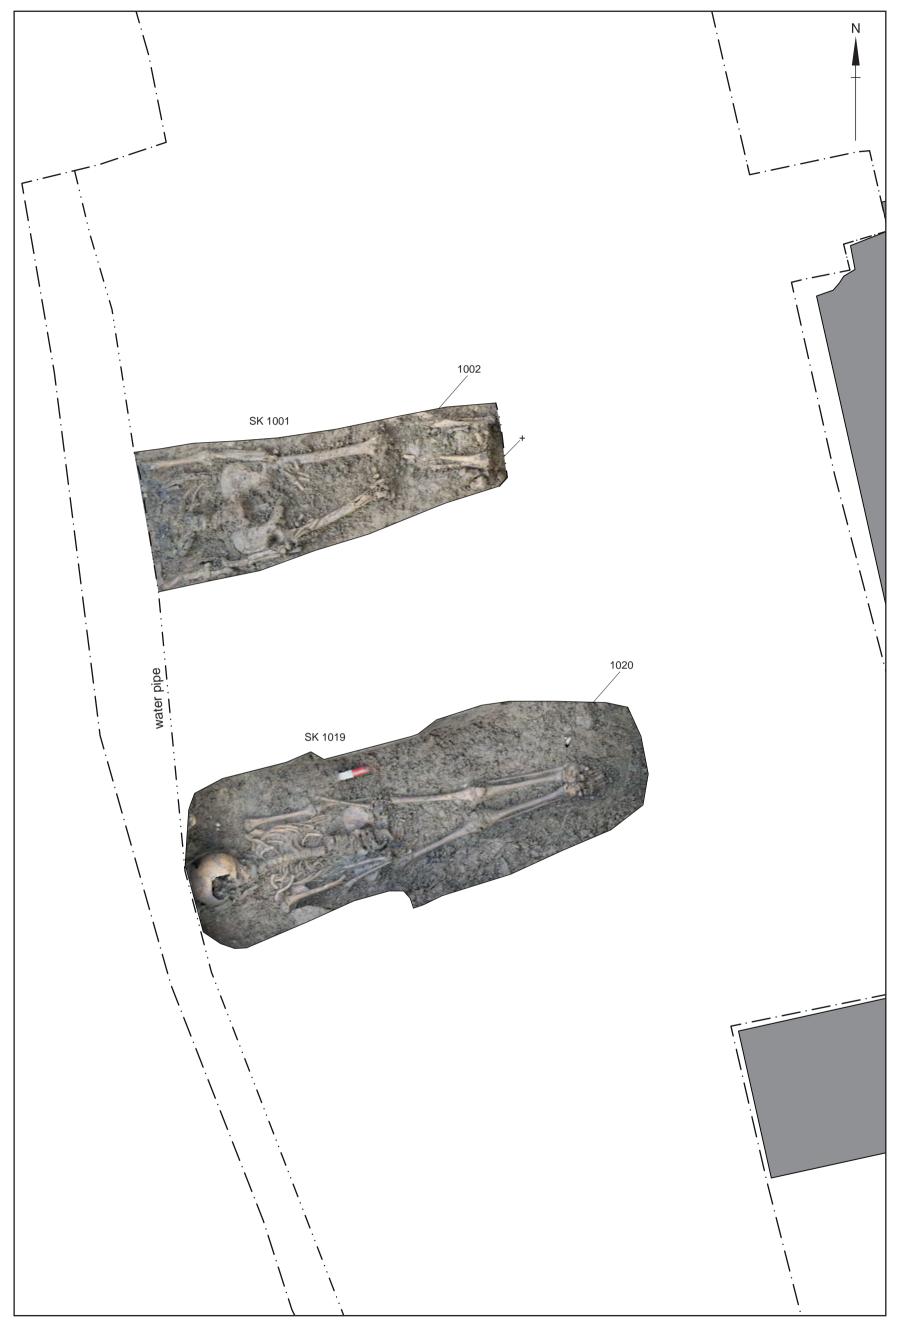
scale 1:125 Figure 5 Burials 1002 and 1020
