Archaeological Investigations at Bayle View, Burlington Centre, Long Lane, Bridlington

YAT Assessment Report 2020/142 December 2020

Project Name	Bayle View, Burlington Centre, Long Lane, Bridlington
YAT Project No.	6228
Document Number	2020/142
Type of Project	Watching Brief
Client	East Riding of Yorkshire Council
Planning Application No.	Pre-app ref HER/DE/CONS/26729
NGR	TA 17455 68174
OASIS Identifier	Yorkarch1-409926

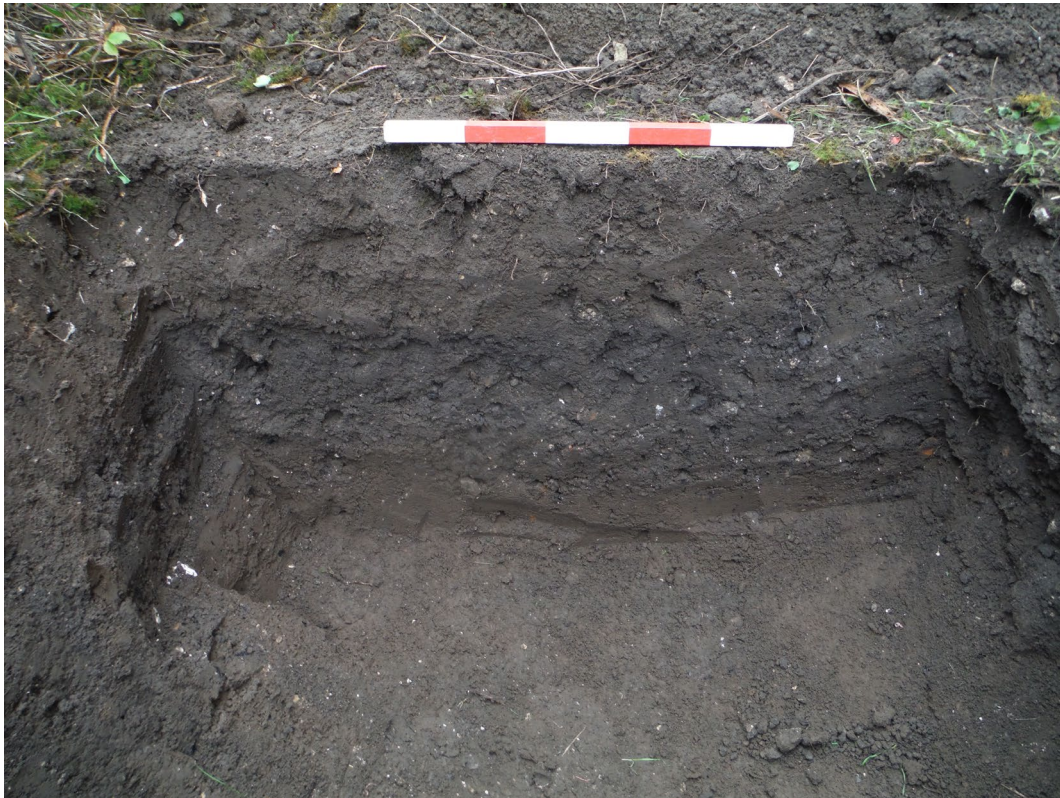
Plate 1 Test pit 1, looking west. Scale 0.5m

Test pit 1 measured 1.2 x 1 x 0.72m and was located in a grassy area south of Building A, adjacent to Long Lane. The earliest deposit recorded was seen at 0.5m below ground level (BGL) and comprised a firm, mid- brown silty clay (C1000) containing moderate chalk and charcoal flecks. Sealing this was a layer of friable to firm dark greyish brown clayey silt (C1001) containing frequent chalk and moderate charcoal flecks, along with a single sherd of 19th century white ware. The layer was recorded at 0.28m BGL and measured 0.22m thick. The topsoil layer sealed C1001 and comprised a firm mid- brown sandy silt (C1002).

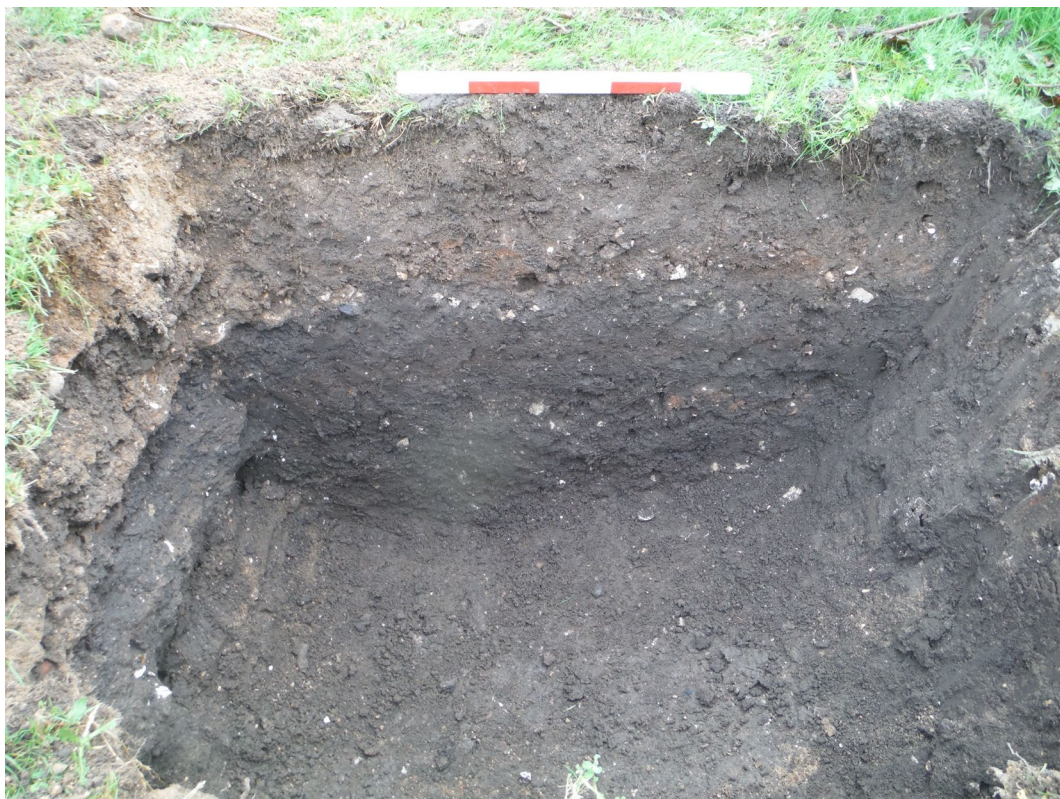
Plate 2 Test pit 2, looking east. Scale 0.5m

Test pit 2 measured 1.3 x 0.9 x 0.87m and was located in a grassy area south of Building A, east of TP1. The earliest deposit was recorded at 0.3m BGL and comprised friable, dark brown sandy silt (C2000) with frequent chalk flecks and moderate charcoal and mortar flecks with patches of light brown clay. Sealing this layer was a levelling layer of loose, light brown sand with frequent gravel (C2001), recorded at 0.24m BGL and measuring 0.06m thick. This in turn was sealed by the topsoil of loose, light brown slightly silty sand (2002).

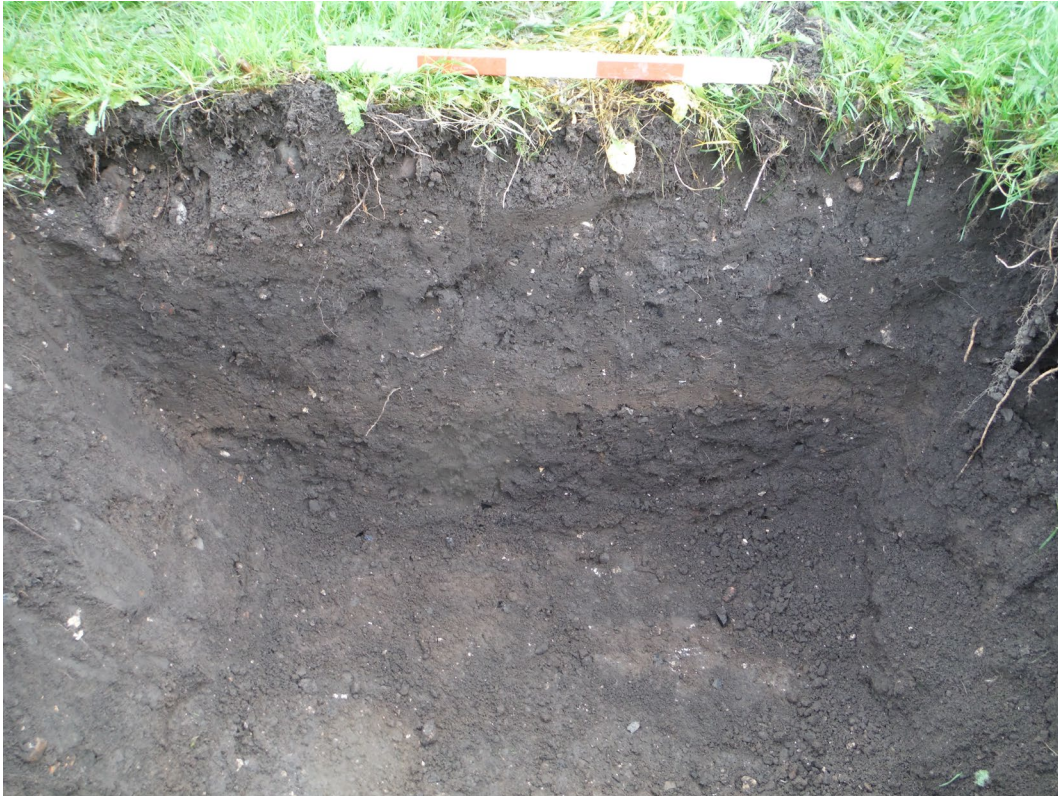
Plate 3 Test pit 3, looking south. Scale 0.5m

Test pit 3 measured 1.2 x 0.9 x 0.64m and was located in a grassy area south-east of Building A. The earliest deposit recorded was at 0.44m BGL and comprised friable, mid- to dark brown silty sand (C3000) with moderate chalk flecks and occasional charcoal inclusions. Sealing this was a homogenous made ground layer of friable to loose light brown slightly silty sand (C3001) containing occasional charcoal flecks.

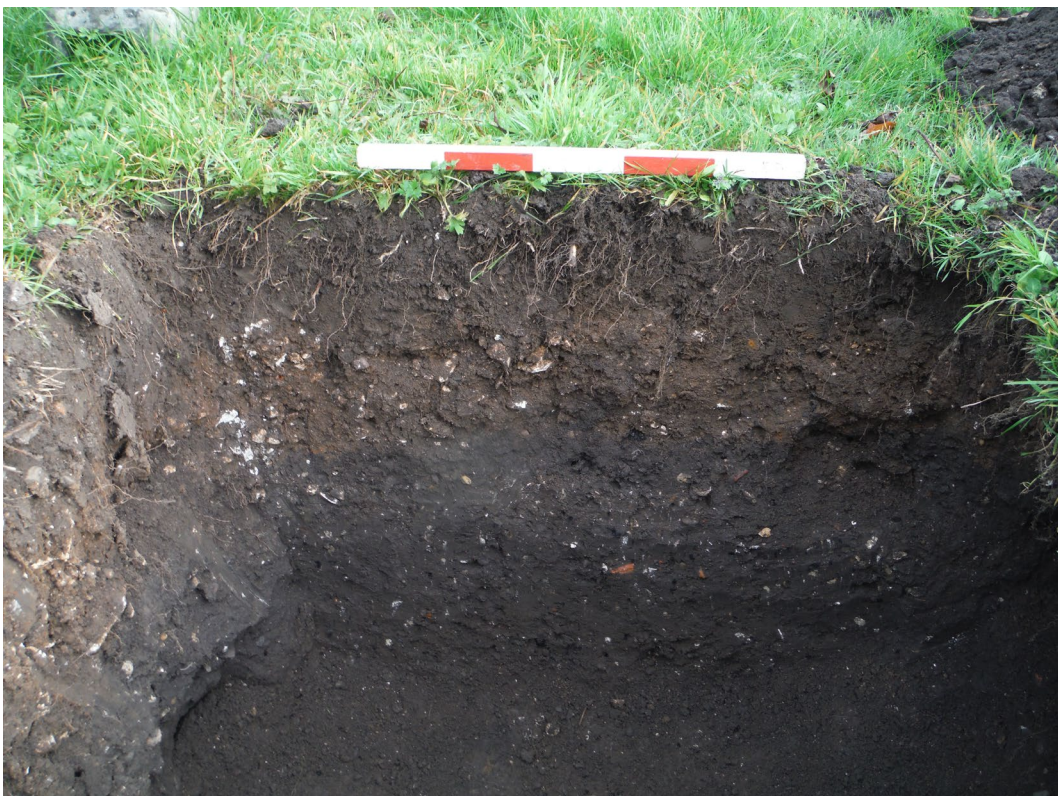
Plate 4 Test pit 4, looking east. Scale 0.5m

Test pit 4 measured 1 x 0.95 x 0.8m and was located in a grassy area east of Building A. The earliest deposit was recorded at 0.38m BGL and comprised firm, mid- brown silty sand (C4000) with frequent chalk and charcoal flecks, moderate small pebbles, and occasional small to medium sized CBM fragments. Sealing this layer was a made ground layer comprising soft, mid- brown silty sand (C4001) with moderate chalk and small pebbles and occasional CBM fragments. The layer was recorded at 0.29m BGL and measured 0.09m thick. Above C4001 was a further made ground layer of friable light brown clayey sand with frequent small to medium sized chalk fragments (C4002). The layer was recorded at 0.2m BGL and was a maximum of 0.19m thick. The topsoil lay above C4002 and comprised a soft light brown silty sand (C4003).

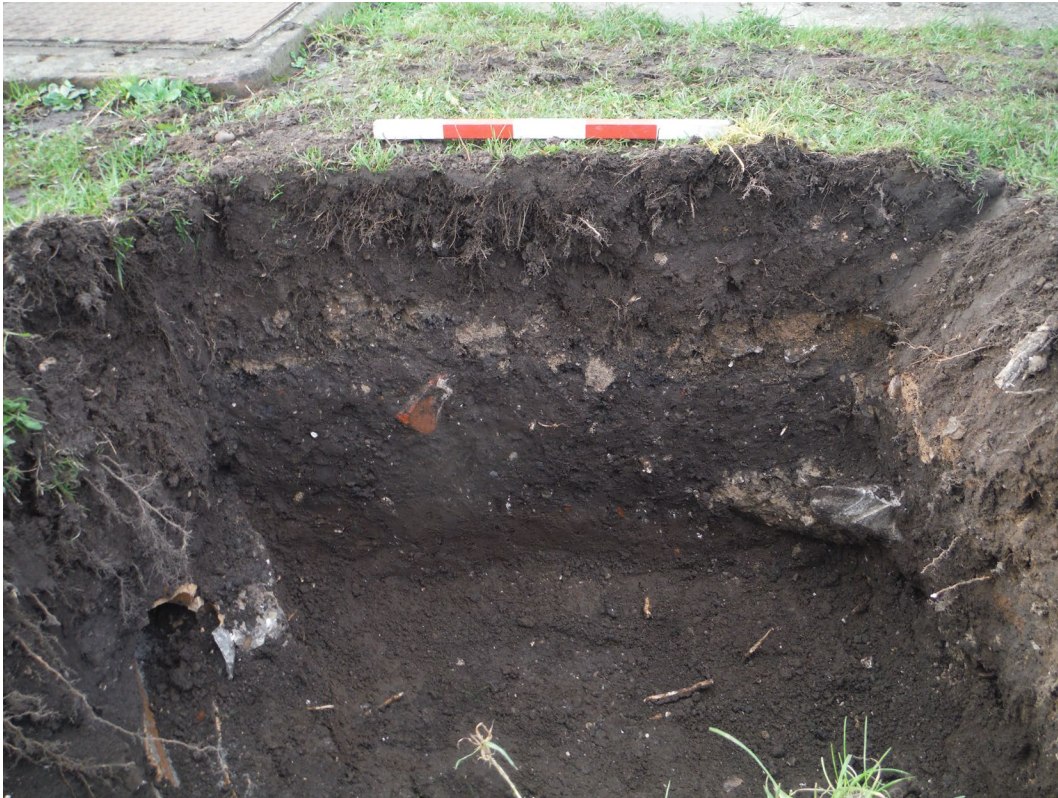
Plate 5 Test pit 5, looking west. Scale 0.5m

Test pit 5 measured 1.2 x 0.95 x 0.76m and was located in a grassy area east of Building A. The earliest deposit was recorded at 0.56m BGL and comprised a firm, mid- brown clayey sand (C5000) containing moderate chalk, charcoal and CBM flecks. In the northern corner of the test pit, above deposit C5000, a lump of concrete (C5001) was recorded at 0.48m BGL. Above the concrete was a 0.26m thick layer of firm mid- brown slightly silty sand (C5002) containing frequent chalk, sand and charcoal flecks, and occasional small to large CBM and mortar fragments. Sealing this layer was a made ground layer of friable, mid- yellow sand with moderate charcoal fleck inclusions (C5003), recorded at 0.2m BGL. A topsoil deposit comprising soft, mid- brown slightly silty sand (C5004) sealed all deposits.

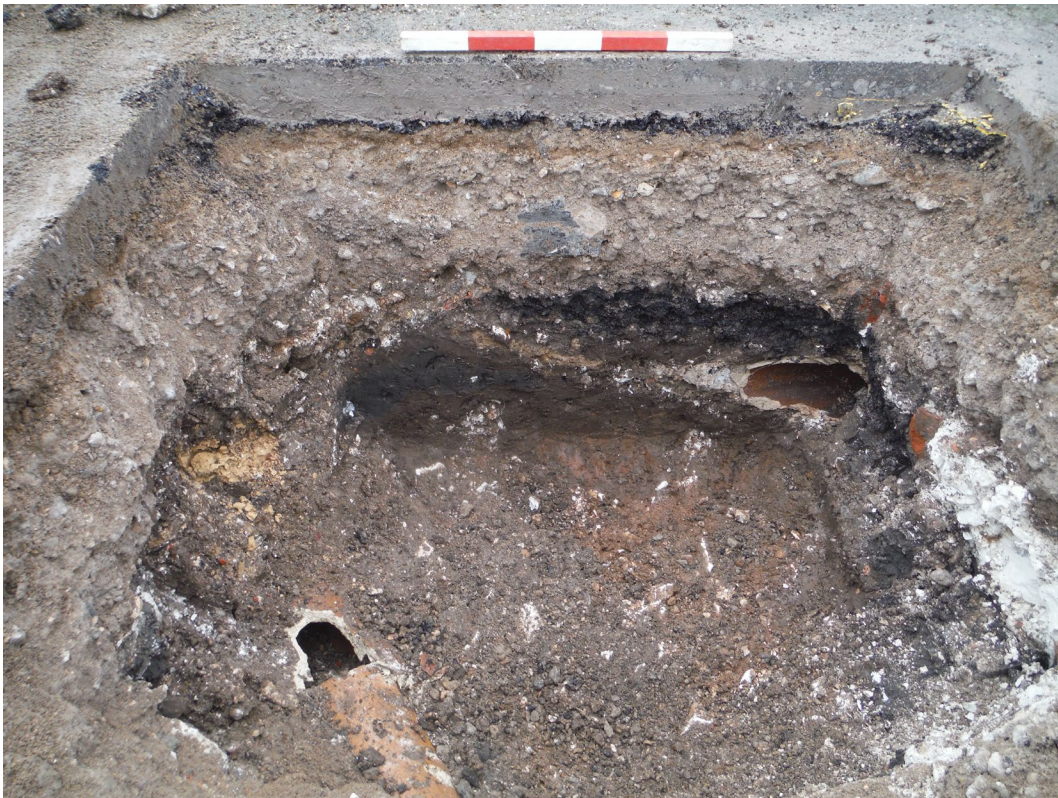
Plate 6 Test pit 6, looking south. Scale 0.5m

Test pit 6 measured 1.2 x 1.1 x 0.74m and was located on a tarmac footpath north-east of Building A. The earliest deposit seen was recorded at 0.46m BGL and comprised a firm, mid-brown sandy clay (C6000) containing occasional chalk fragments and charcoal fleck inclusions. A lens of grey silty clay was also present in the deposit. A cut (C6001) for a ceramic drain truncated the top of layer C6000, and was backfilled with a yellow sand (C6002) and mid-brown sandy clay (C6003). The top of the cut was recorded at 0.46m BGL. Above the drain was a layer of compact black cinder (C6004), measuring 0.14m thick and recorded at a depth of 0.35m BGL. In the eastern corner of the test pit a deposit of firm light brown clay and chalk (C6005) overlaid the cinder deposit. A 0.24m thick layer of compact light grey-brown sand, gravel and concrete (C6006) sealed both contexts C6004 and C6005. A thin layer of bitumen (C6007) overlaid the made ground layer C6006 and in turn was overlaid by a 0.1m thick layer of tarmac (C6008).

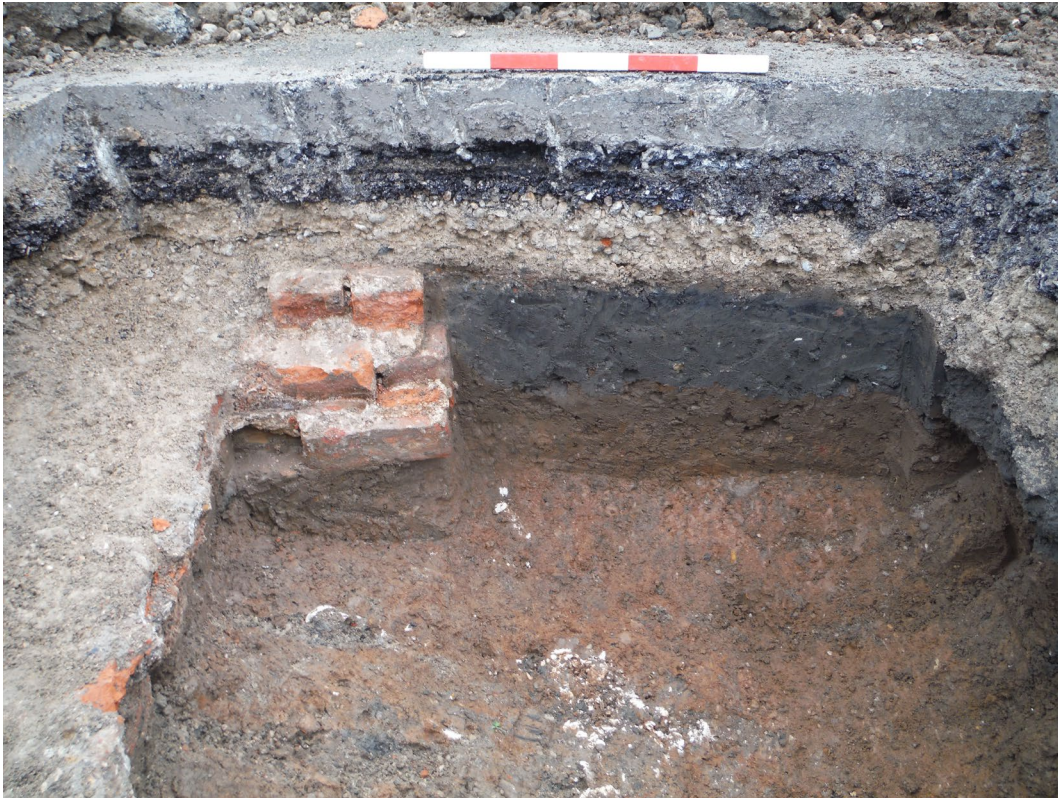
Plate 7 Test pit 7, looking south. Scale 0.5m

Test pit 7 measured 1.45 x 1.3 x 0.75m and was located on a tarmac footpath north of Building A. The earliest deposit seen was recorded at 0.5m BGL and comprised a firm mid-brown sandy clay (C7000) with moderate chalk inclusions. Above this layer was a deposit of firm, dark grey silty clay with frequent charcoal flecks and occasional small pebble inclusions (C7001). A construction cut (C7002) for a brick wall (C7003) cut into the top of layer C7001. The wall was aligned north/south, formed from red bricks measuring 230 x 110 x 65mm and mortared together with a light brown lime mortar. The construction cut was backfilled with a light brown sandy clay (C7004) and measured 0.25m deep. The wall and deposit 7001 were sealed by a made ground deposit of compact light brown sand and gravel (C7005) with in turn was overlaid by ground surfaces of tarmac (C7006) and concrete (C7007).

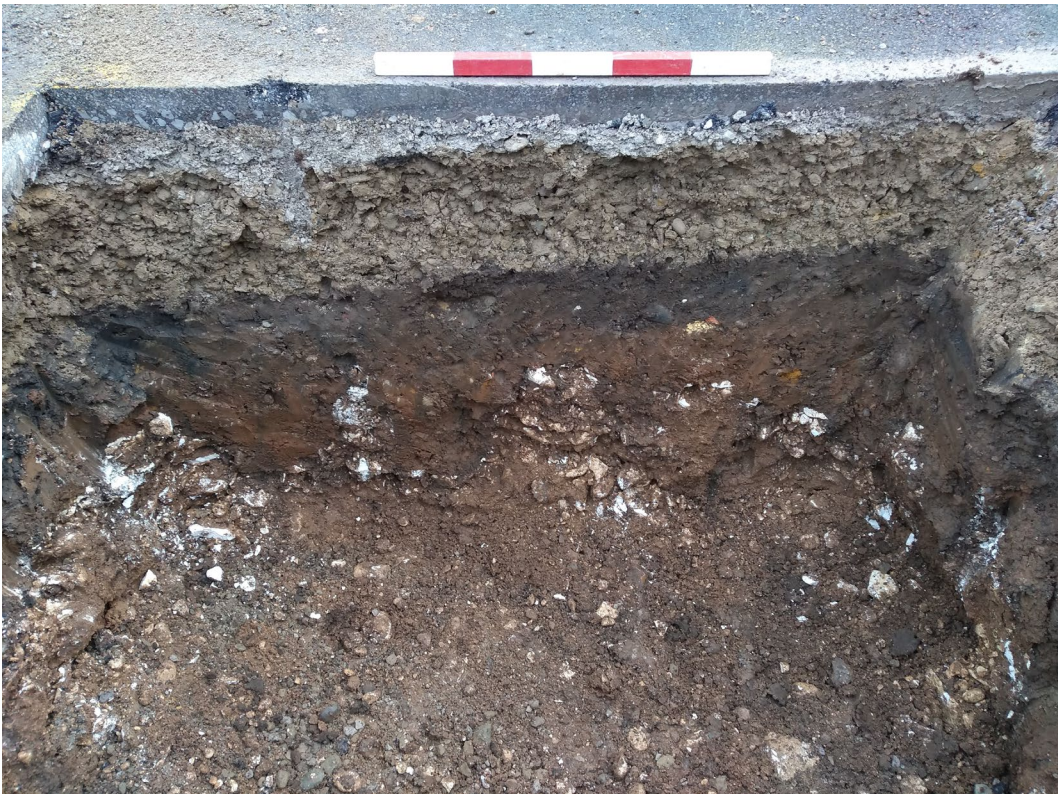
Plate 8 Test pit 8, looking south. Scale 0.5m

Test pit 8 measured 1.3 x 1.1 x 0.8m and was located on a tarmac footpath north of Building A. The earliest deposit seen was recorded at 0.55m BGL and comprised compact small to large chalk fragments with sand (C8000). Above this was a deposit of firm, light orangey brown clay (C8001), recorded at a depth of 0.45m BGL. Sealing deposit C8001 was a made ground layer of firm, mid-brown sandy clay with occasional chalk and charcoal inclusions (C8002). This layer was in turn overlaid by a 0.17m thick bedding layer of compacted sand and gravel (C8003) for the ground surface of concrete and tarmac (C8004).

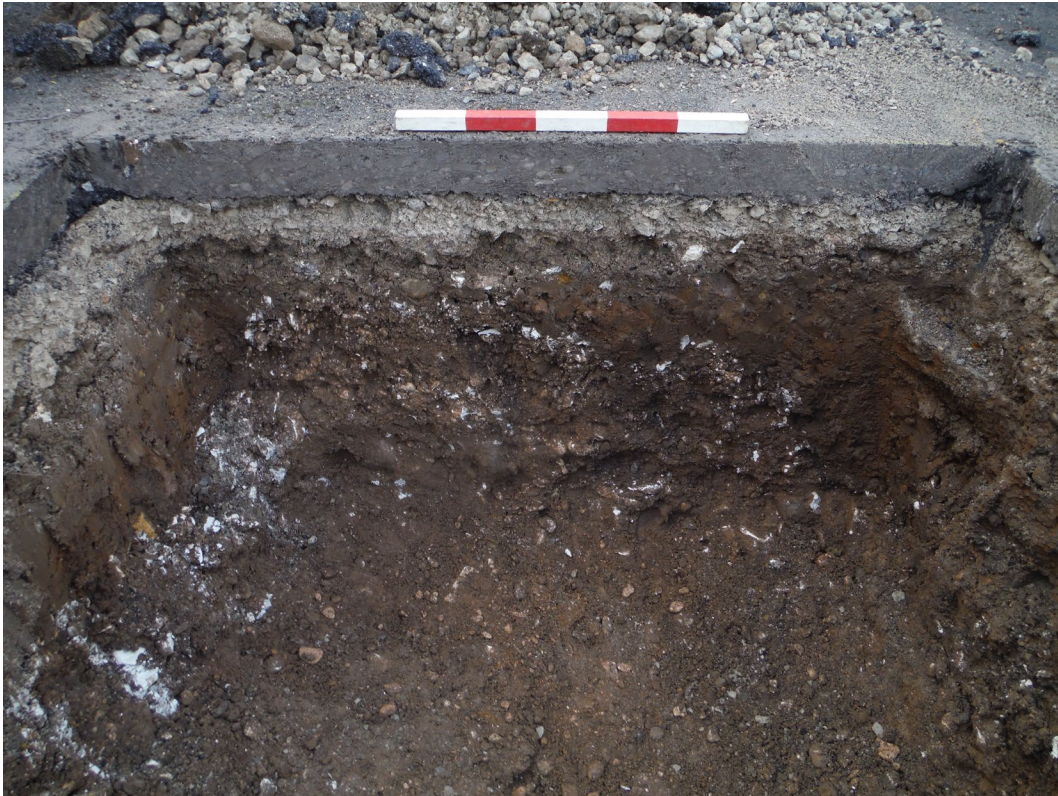
Plate 9 Test pit 9, looking west. Scale 0.5m

Test pit 9 measured 1.35 x 1.35 x 0.76m and was located on a footpath north-west of Building A. The earliest deposit seen was recorded at 0.24m BGL and comprised compacted chalk fragments with gravel and mid-orange brown sand (C9000). In the north and south corners of the test pit was also a made ground deposit of firm, mid-orangey brown clay (C9001), found at a similar depth as C9000. Sealing both deposits were two bedding layers of compact light grey coarse sand and gravel (C9002) and compacted grey sand (C9003). The bedding layers measured 0.06m and 0.1m thick respectively and were overlain by the ground surface of light grey concrete (C9004).

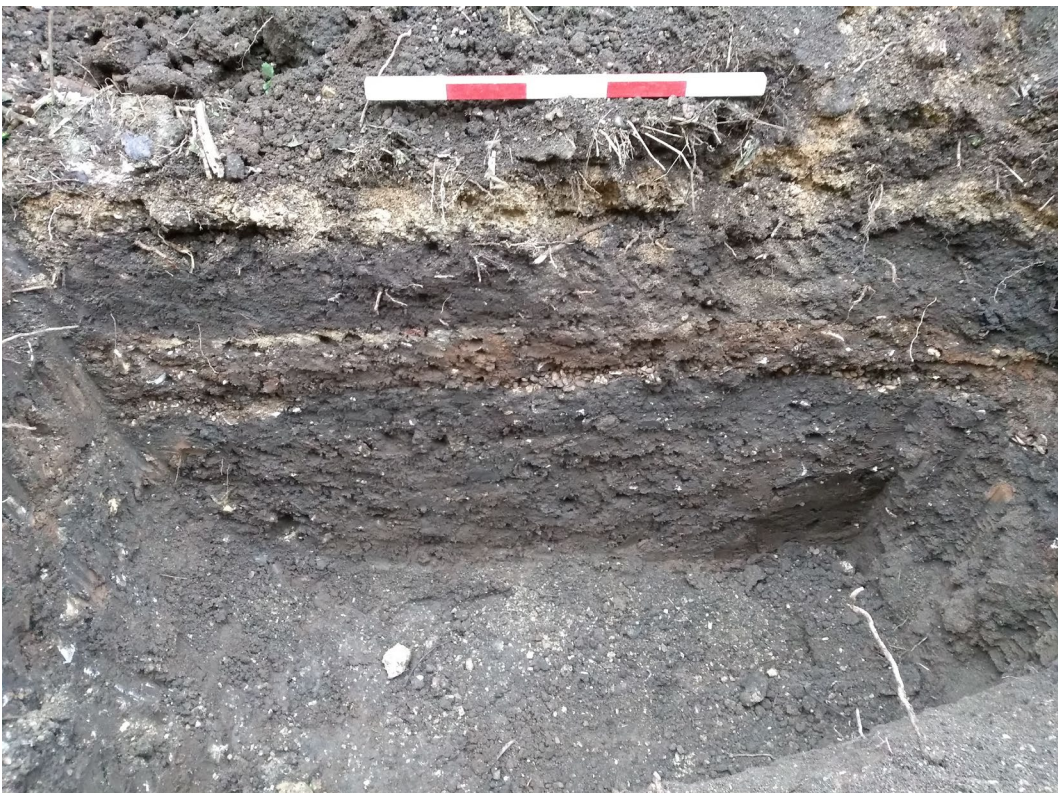
Plate 10 Test pit 10, looking south. Scale 0.5m

Test pit 10 measured 1.3 x 0.8 x 0.7m and was located in a courtyard area in the centre of Building A. The earliest deposit seen was recorded at 0.48m BGL and comprised firm, mid-

brown sandy clay with frequent small and medium sized chalk fragments (C10000). Overlying this deposit was a made ground layer of firm mid- brown clayey silt with moderate chalk and charcoal inclusions (C10001). The layer was recorded at a depth 0.36m BGL and had lenses of gravel along the upper horizon. Another layer of made ground overlaid the layer C10001, measuring 0.12m thick and comprising firm light brown silty clay and clay with frequent small chalk fragment inclusions (C10002). A thin layer of compact light brown sand (C10003) overlaid deposit C10002. A buried soil horizon comprising dark grey to brown sandy silt (C10004) sealed the thin sand deposit at 0.1m BGL. The ground surface for the test pit comprised compact light brown sand and gravel (C10005).

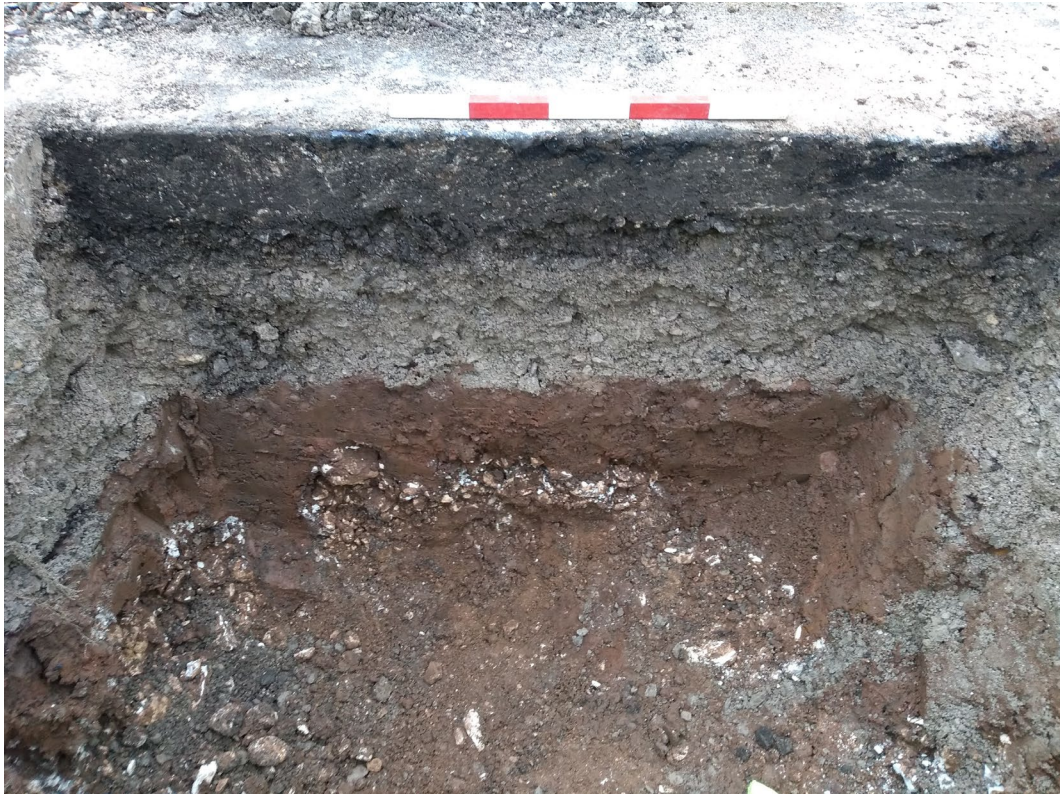
Plate 11 Test pit 11, looking west. Scale 0.5m

Test pit 11 measured 1.3 x 1.1 x 0.8m and was located to the east of Building C. The earliest deposit seen was present between 0.52-0.8m BGL and was comprised of chalk fragments (C11000). Overlying this was a firm, light to mid brown sandy clay (C11001), recorded at 0.4-0.8m BGL. Above this was a 0.29m thick deposit of compact light grey sand which contained angular stone fragments (C11002). This was overlain by the ground surface of light grey concrete (C11003).

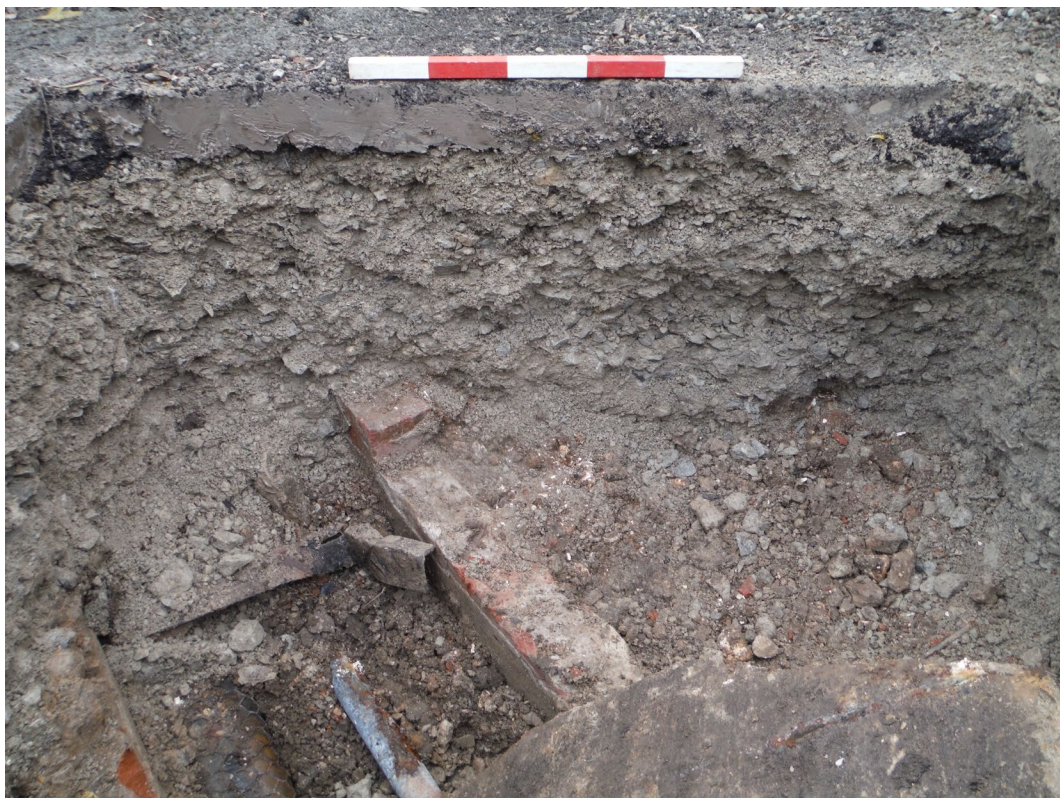
Plate 12 Test pit 12, looking south. Scale 0.5m

Test pit 12 measured 1.25 x 1 x 0.62m and was located to the south-east of Building C. The earliest deposit seen was a brick culvert at 0.62m BGL (C12000) which contained a cast iron pipe. The internal surface of the culvert was rendered with a light grey cement. Overlying this was a 0.52m thick compacted light grey sand deposit with frequent angular stones (C12001). The present tarmac surface was 0.1m thick (C12002).

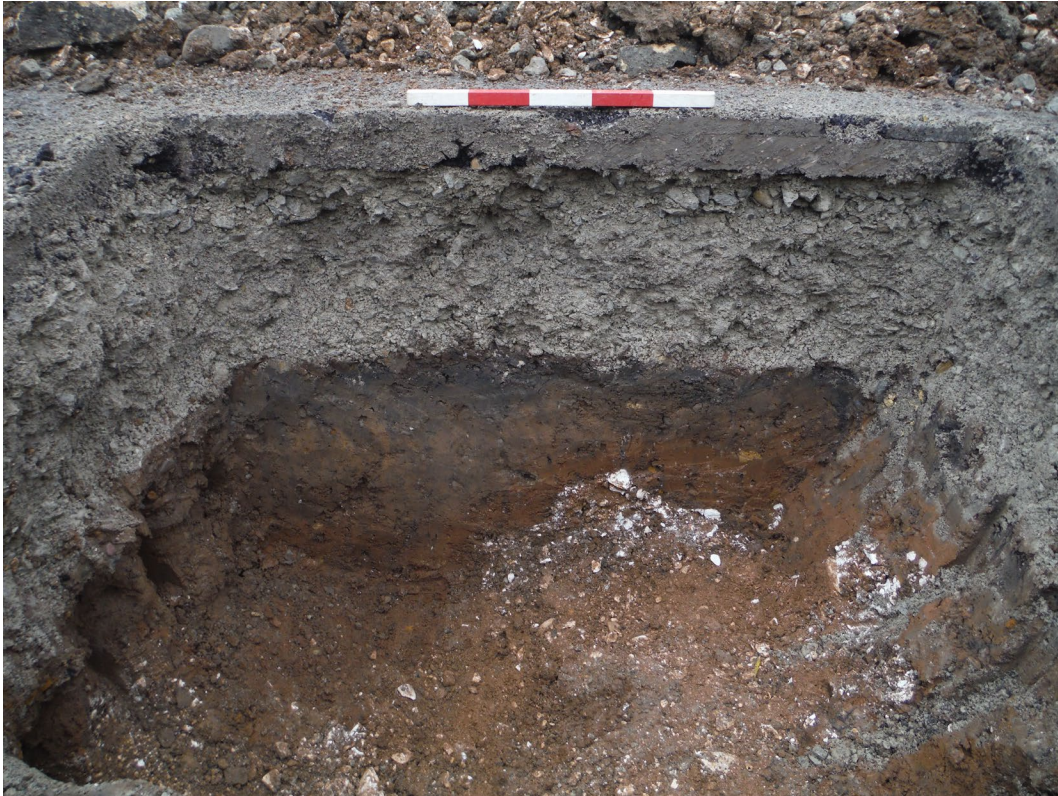
Plate 13 Test pit 13, looking south. Scale 0.5m

Test pit 11 measured 1.6 x 1.4 x 0.95m and was located in the car park to the south-west of Building C. The earliest deposit seen was comprised of compact chalk fragments and light brown sand present between 0.7-0.85m BGL (C13000). Overlying this was a firm mid-orange brown sandy clay with occasional chalk fragments, the highest point of which was at 0.66m BGL (C13001). Sealing this deposit was a firm light brown sandy clay with moderate charcoal flecks and occasional small stones (C13002), recorded at 0.55m BGL. Overlying this was a 0.13m thick deposit of firm, mid-brownish grey clay with occasional pebbles and charcoal flecks (C13003). Above this was a 0.36m thick compacted light grey sand deposit with angular stones (C13004). The present tarmac surface was 0.1m thick (C13005).

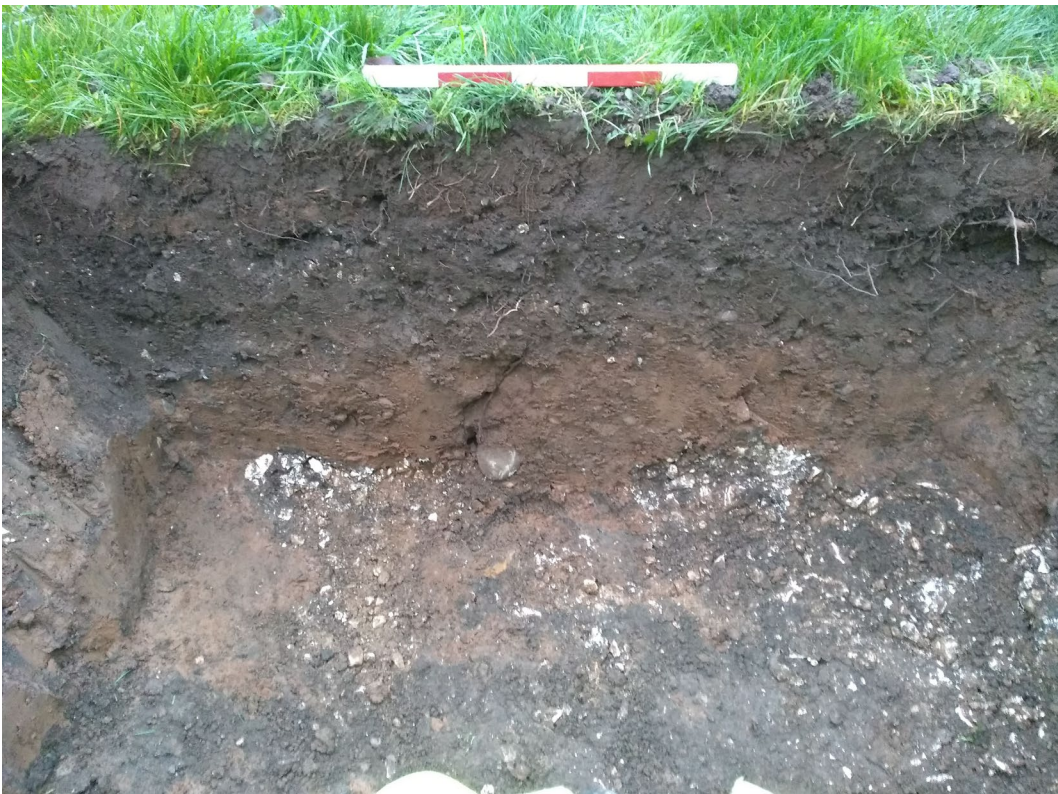
Plate 14 Test pit 14, looking east. Scale 0.5m

Test pit 14 measured 1.7 x 1 x 0.75m and was located in the grassy area to the south of Building D. The earliest deposit seen was a firm mid-orangish brown sandy clay with occasional pebbles and chalk fragments (C14000), present between 0.4-0.75m BGL. Sealing this deposit was a 0.23m thick firm mid-greyish brown sandy silt which contained frequent small chalk fragments and occasional charcoal flecks (C14001). Above this deposit was a friable mid-brown sandy silt with occasional small pebbles (C14002), recorded between 0-0.2m BGL.

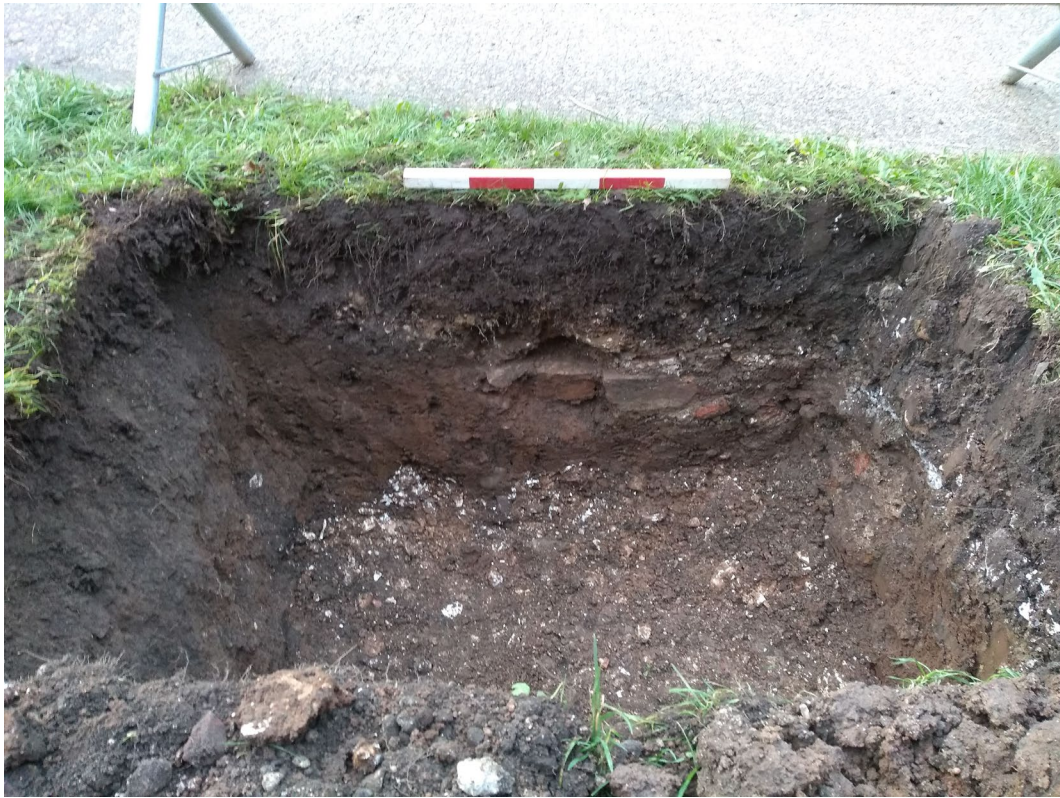
Plate 15 Test pit 15, looking west. Scale 0.5m

Test pit 15 measured 1.2 x 0.8 x 0.67m and was located in an area of concrete between Buildings C and D. The earliest deposit seen was a patch of chalk fragments at the base of the test pit (C15000). Sealing this was a firm light brown sandy clay layer (C15001), present between 0.4 – 0.67m BGL. Above this was a deposit of firm mid-brown sandy clay (C15002) between 0.2 – 0.4m BGL. Buff bricks were seen in the section at 0.45m BGL (C15003), overlain by a loose friable light brown sand and gravel with occasional CBM fragments (C15004). C15004 was present between 0.3-0.0.56m BGL. The final deposit present was a friable mid-brown sandy silt topsoil with occasional small pebbles (C15005).
