SITE	English Martyrs Church, Dalton Terrace, York					
CLIENT NAME	Diocese of Middlesborough					
YAT PROJECT #	5962	YAT REPORT #	2017/71			
MUSEUM ACCESSION #	tbc	GRID REFERENCE	SE 59300 51140			
PLANNING REFERENCE #	13/03595/FUL	AAI OPS NOTICE #	N/A

This report is an amalgamation of the original interim report on the two trial trenches and the findings of the service trench monitoring. This final report includes a figure showing the exact locations of the trenches.

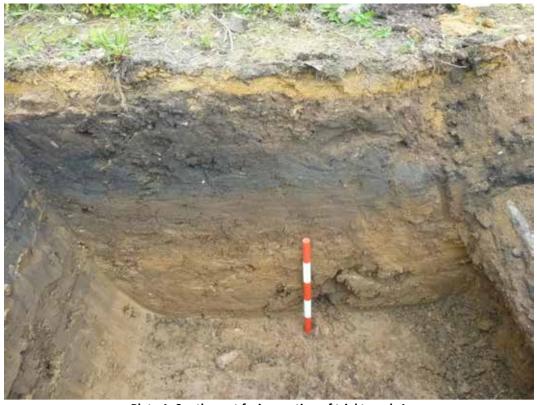
Plate 1: South-west facing section of trial trench 1

Trench 1 measured 1.9m in length, 1.2m in width and 1.1m in depth (Figure 2). Modern deposits including the current ground surface (C100), a makeup deposit (C101), a gas service trench (C107 and C108) and a succession of levelling deposits (C102 and C103) formed the upper 0.45m-0.55m of the trench section. These contexts overlay a 0.2m thick deposit of horticultural soil (C104) which appeared to be very similar in character to the horticultural deposit seen during the 2014 evaluation (Context 1003).

This horticultural soil overlay a heavily disturbed (possibly by root action) orangish brown clay (C105) which itself overlay an undisturbed firm orangish brown clay (C106). Both of these deposits are thought to be naturally occurring. The disturbed natural was encountered at a depth of 0.65m to 0.75m BGL (c.whilst the undisturbed natural deposits were encountered at a depth of 0.85m to 0.9m BGL.

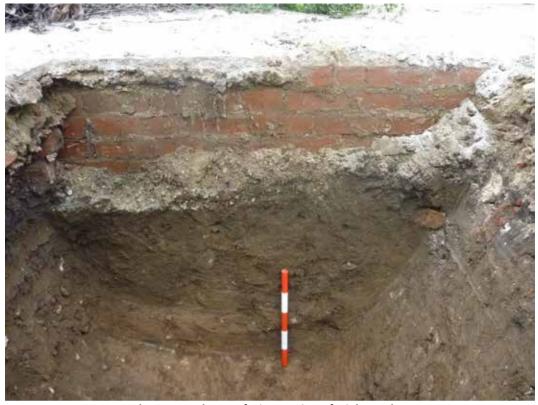
Plate 2: North-west facing section of trial trench 2

The concrete pad (C200) that formed part of the demolished church hall was 100mm thick. It overlay demolition rubble within most of the trench but the north eastern side was formed of a brick wall foundation (C201 and C200). The 20th century demolition deposits extended to a depth of 0.57m BGL. They overlay a 0.43m to 0.6m thick deposit of horticultural soil (C203) which appeared to be very similar in character to the horticultural deposit seen during the 2014 evaluation (Context 1003). A small quantity of animal bone, ceramic building material (including a piece of Roman Imbrex) and 12th century medieval gritty pottery was recovered from Context 203. This material was assessed to be of low research value and discarded.

This horticultural soil overlay a heavily disturbed (possibly by root action) orangish brown clay (C204) which itself overlay an undisturbed firm orangish brown clay (C205). Both of these deposits are thought to be naturally occurring. The disturbed natural was encountered at a depth of 1.00m to 1.05m BGL whilst the undisturbed natural deposits were encountered at a depth of 1.12m to 1.22m BGL.

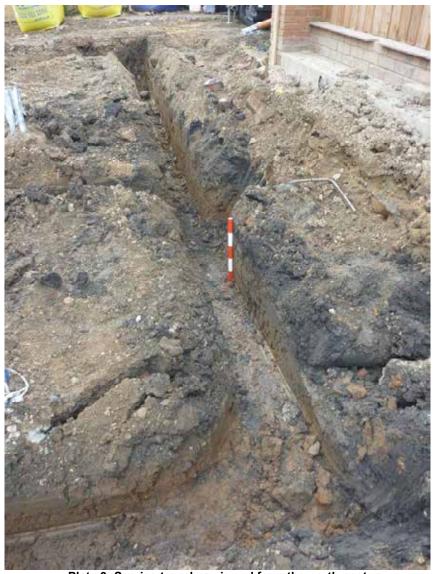
The service trenches were comprised of a main drainage channel running on a north-west to south-east alignment with four separate channels running off of it towards the south east or east (Figure 1, Plate 3).

Plate 3: Service trenches viewed from the north-east

The trenches were excavated to a depth of between 600mm and 800mm below ground level. The archaeological deposit sequence visible in their sections was identical to those identified in the trial trenches (a 20th century demolition material which overlay a horticultural soil which overlay the natural orangish brown clay). No context numbers were assigned to these deposits and no finds were recovered.

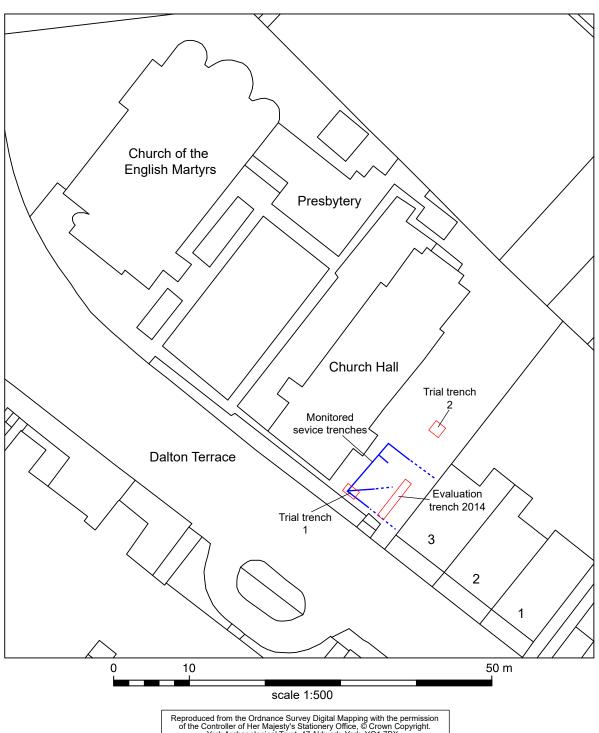
Fig. 1 Site and trench locations

Trial trench 1 was located at the south west end of the access ramp which itself was adjacent to the south east side of the English Martyrs Church Hall (Figure 1).

Trial trench 2 was located on one of the proposed pile locations that will form the foundation for the north eastern wall of the proposed building (Figure 1).

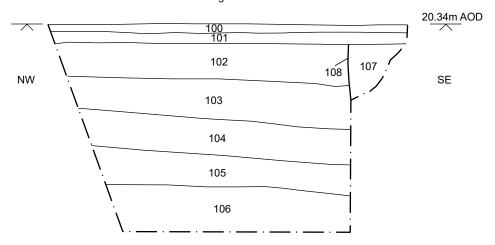
South-west facing section of trial trench 1

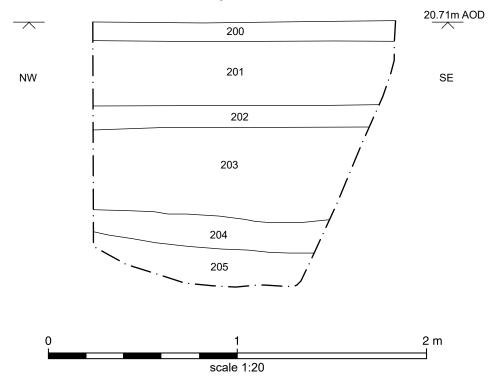
Fig. 2 Trench sections

Trench 2 measured 1.6m in length, 1.5m in width and 1.4m in depth (Figure 2).

North-west facing section of trial trench 2
