YORK ARCHAEOLOGICAL TRUST REPORT

SITE ADDRESS	The Dutch House, 4 Ogleforth, York		
CLIENT NAME	Rogers Homes (Ogleforth) Ltd.		
YAT PROJECT #	5206	YAT REPORT #	2009/23
MUSEUM ACCESSION #	n/a	GRID REFERENCE	SE 6050 5222
PLANNING REFERENCE #	06/0019/LBC	AAI OPS NOTICE #	n/a

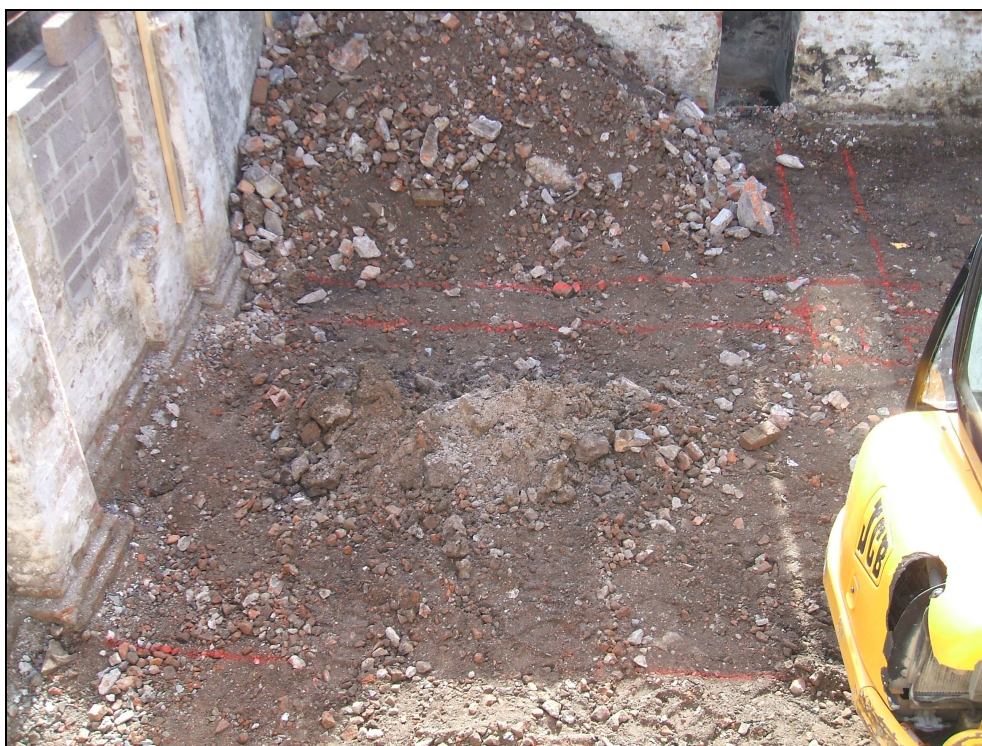
Plate 1 North-east corner of cellar at start of work, looking south-east

The earliest deposit noted in the cellar was a firm, light brown-yellow clay (1000) which became very sandy in some areas and towards the eastern corner of the cellar turned into almost pure sand. Sealing the clay was a dark brown slightly clayey silt (1001) which was at least 0.05m thick but appeared to have been truncated during the insertion of the cellar.

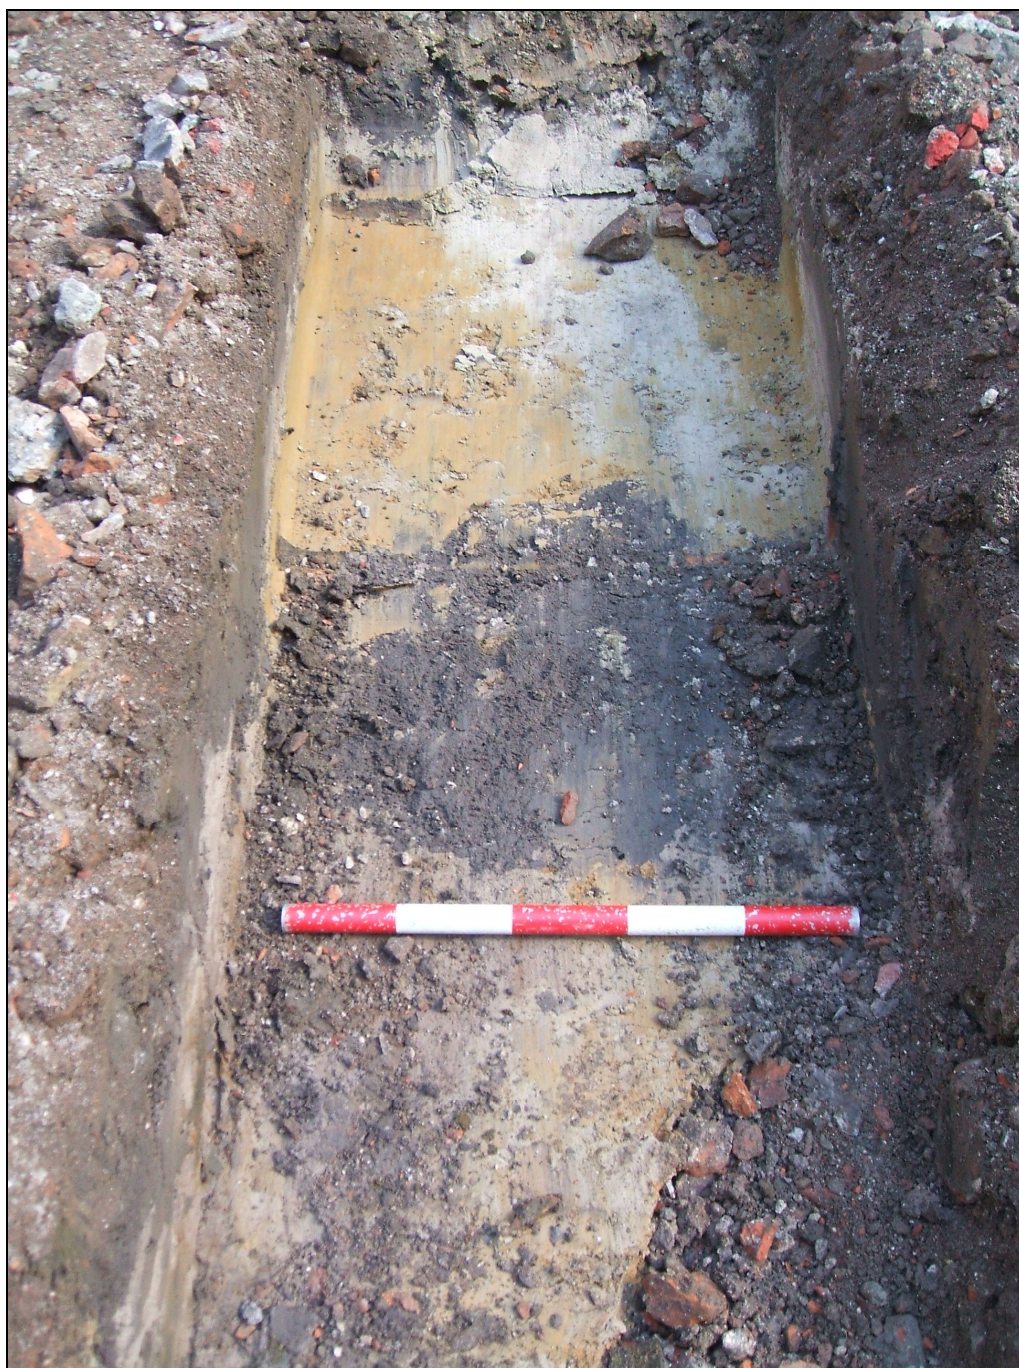
Plate 2 Linear backfill 1002, looking north-east

Probably cutting 1001 were a number of definite or probable features as represented by their backfills. Towards the northern angle of the cellar was a linear stain of dark greyish-brown slightly clayey silt (1002) aligned approximately north-west / south-east (Plate 2), and was 0.3m wide. Around 1.5m south-west of 1002 was a similar stain running almost parallel. It was 0.2m wide and was composed of a mid greenish-grey slightly clayey silt (1003). East of this was an area of dark reddish-orange burnt sand (1004) was noted which was roughly oval, c.0.8 x 0.5m. South-west of this was another possible linear feature, aligned roughly north-west / south-east, and with a fill of dark greyish-green slightly clayey silt (1005). It was at least 0.2m wide and did not appear to line up with either 1002 or 1003. To the south of 1005, seen only in section, was an area of hard, burnt dark reddish-brown clay (1006) which was at least 0.6m across (Plate 3). South-west of this, in the base of another foundation trench, another fairly definite linear feature, aligned north-east / south-west, was seen and recorded. This had a backfill of mid brown very slightly sandy clay (1007) and was 0.3m wide (Plate 4).

Although none of these features within the cellar were excavated and no finds were recovered during any of the works, some speculation and interpretation of the features can be attempted. All lay over 3m below the modern ground and although they could have been cut from higher their narrowness makes this very unlikely. The linear features are all roughly on the line expected of structures within the legionary fortress and this, coupled with their width may indicate that they are backfilled beam slots belonging to timber buildings of the early Roman period, probably late 1st to early 2nd century A.D. The fact that 1005 did not line up with 1002 and 1003 need not be a problem since it is known from elsewhere within the fortress that there was more than one phase of timber buildings which can move slightly from phase to phase. Burnt sand 1004 and burnt clay 1006 are most likely the remains of hearths within one or more timber buildings which in this area of the fortress, a good distance from the central Headquarters' building, are likely to be barrack blocks. Unfortunately too small an area was exposed to be certain of this interpretation but it seems likely that this watching brief afforded a tantalising, but brief, glimpse of a tiny portion of this part of the fortress which has seen no modern archaeological investigations.

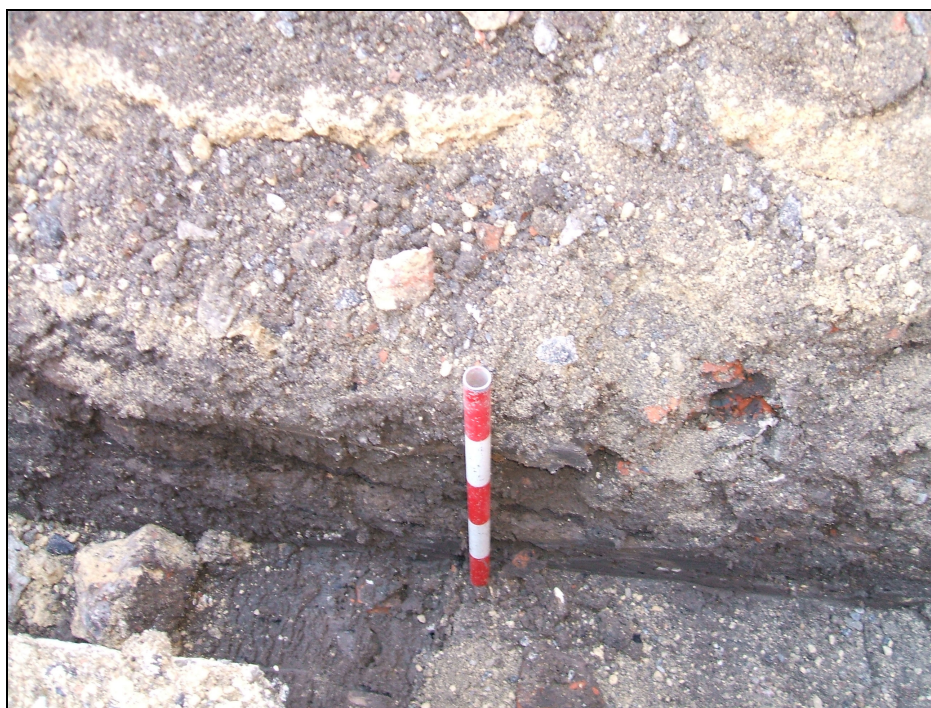
Plate 5 Typical section along south-east

The first section along the new south-east service trench was located approximately 1m north-east of the old warehouse. In this section the earliest deposit, noted between 0.5m and at least the base of the trench at 0.7m BGL, was a very dark brownish-grey slightly clayey silt with moderate flecks of white mortar and occasional brick / tile (1010). Overlying this was a 0.25m deep layer of dark brown very slightly clayey silt with moderate brick / tile and flecks of white mortar (1011). It was sealed by a 0.15m deep layer of pale grey concrete (1012) above which was the modern ground surface of black tarmac (1013).

Approximately 4m north-east of the first section a second short, c.1m, stretch of the drain run was recorded. Here, the lowest deposit, recorded between 0.7m and the base of the trench at 1m BGL, was a dark brown clayey silt with occasional large charcoal flecks (1014). Above it, lying between c.0.25m and 0.7m BGL was the apparent remains of a limestone wall (1015) possibly aligned south-east / north-west. It was at least 0.7m wide and was built of limestone blocks, and some brick / tile, bonded with a soft pale brown mortar. No details of any foundations were noted but it is possible that what was seen may have been foundations. It had been sealed by a 0.15m deep layer of concrete (1016) and above this was the existing ground surface of black tarmac (1017).
